Physical System Dynamics and White Phosphorus Fate and Transport, 1994, Eagle River Flats, Fort Richardson, Alaska

Daniel E. Lawson, Lewis E. Hunter, Susan R. Bigl,
Beth M. Nadeau, Patricia B. Weyrick and John H. Bodette

August 1996

CRREL Report 96-9

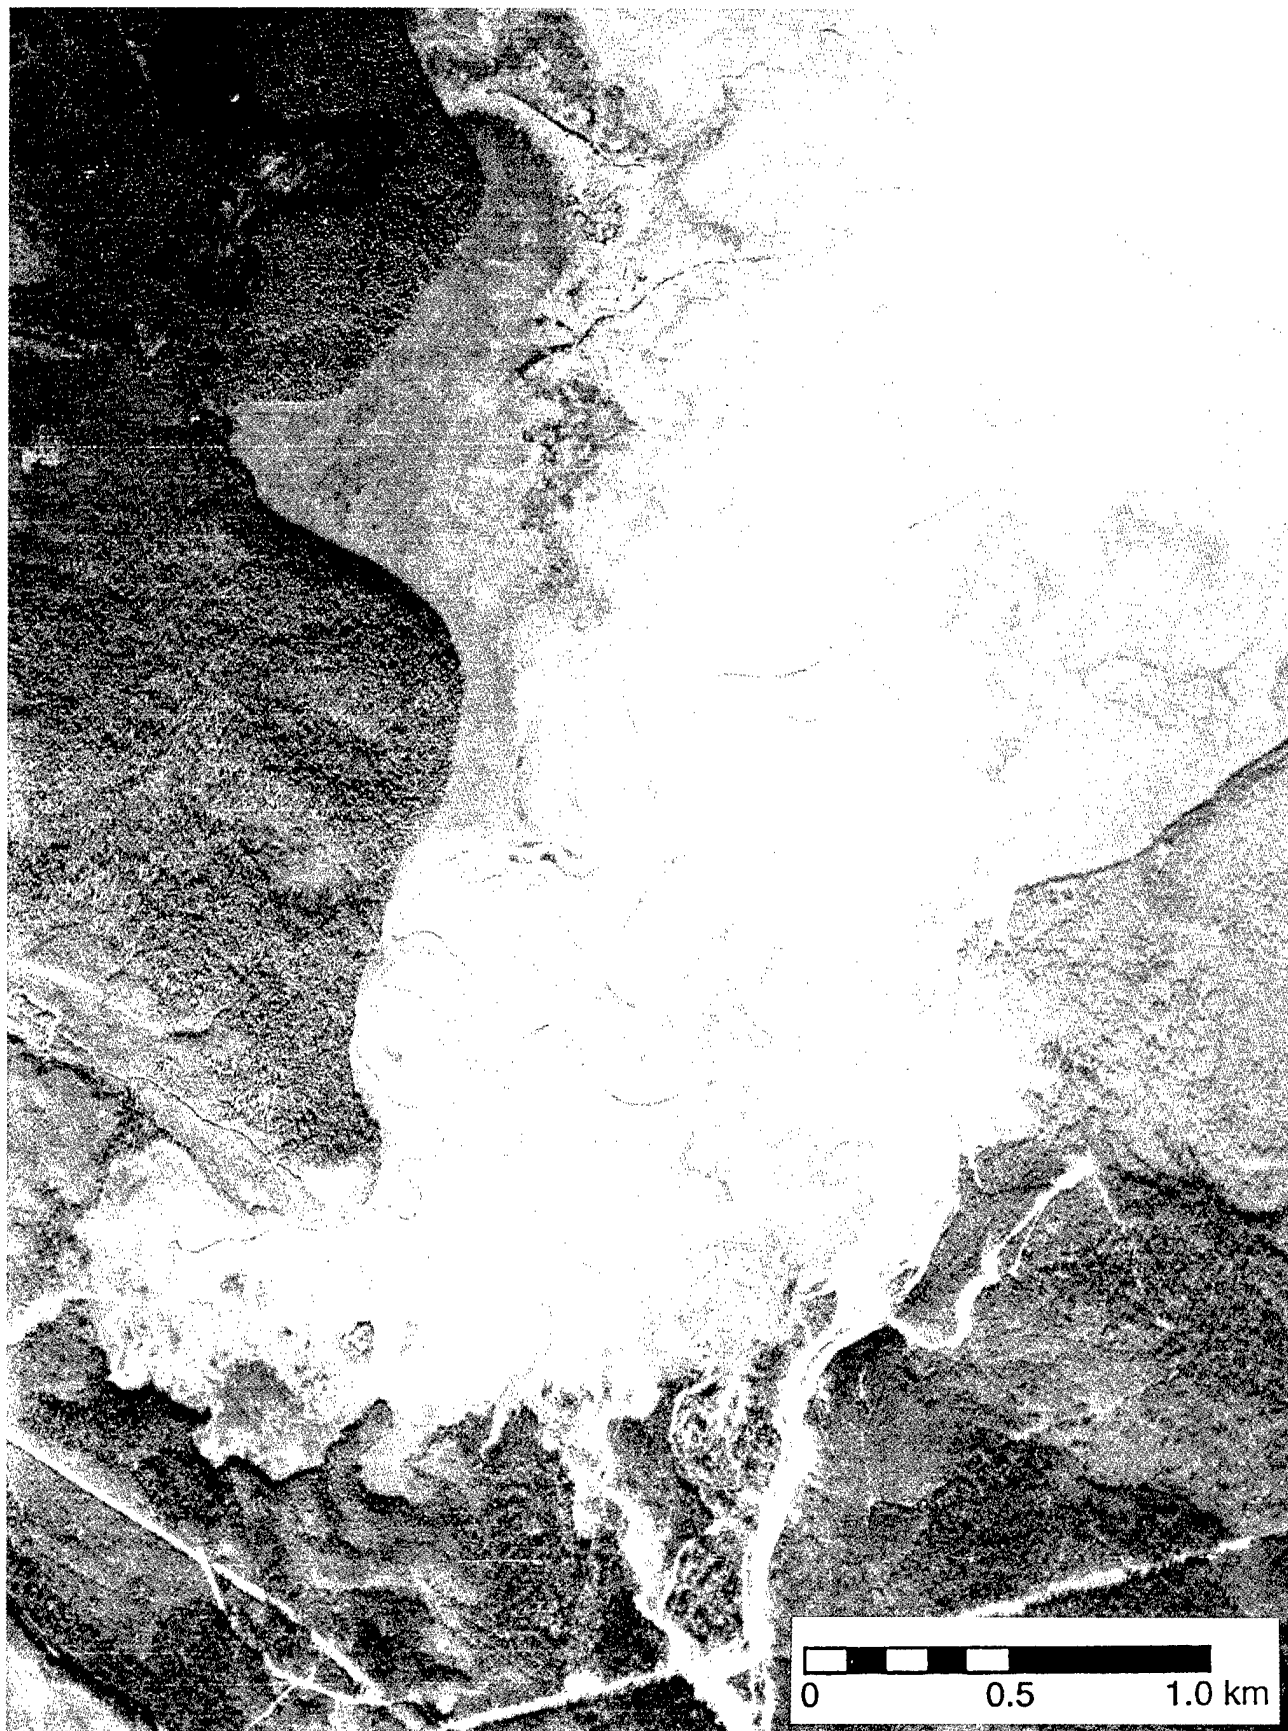
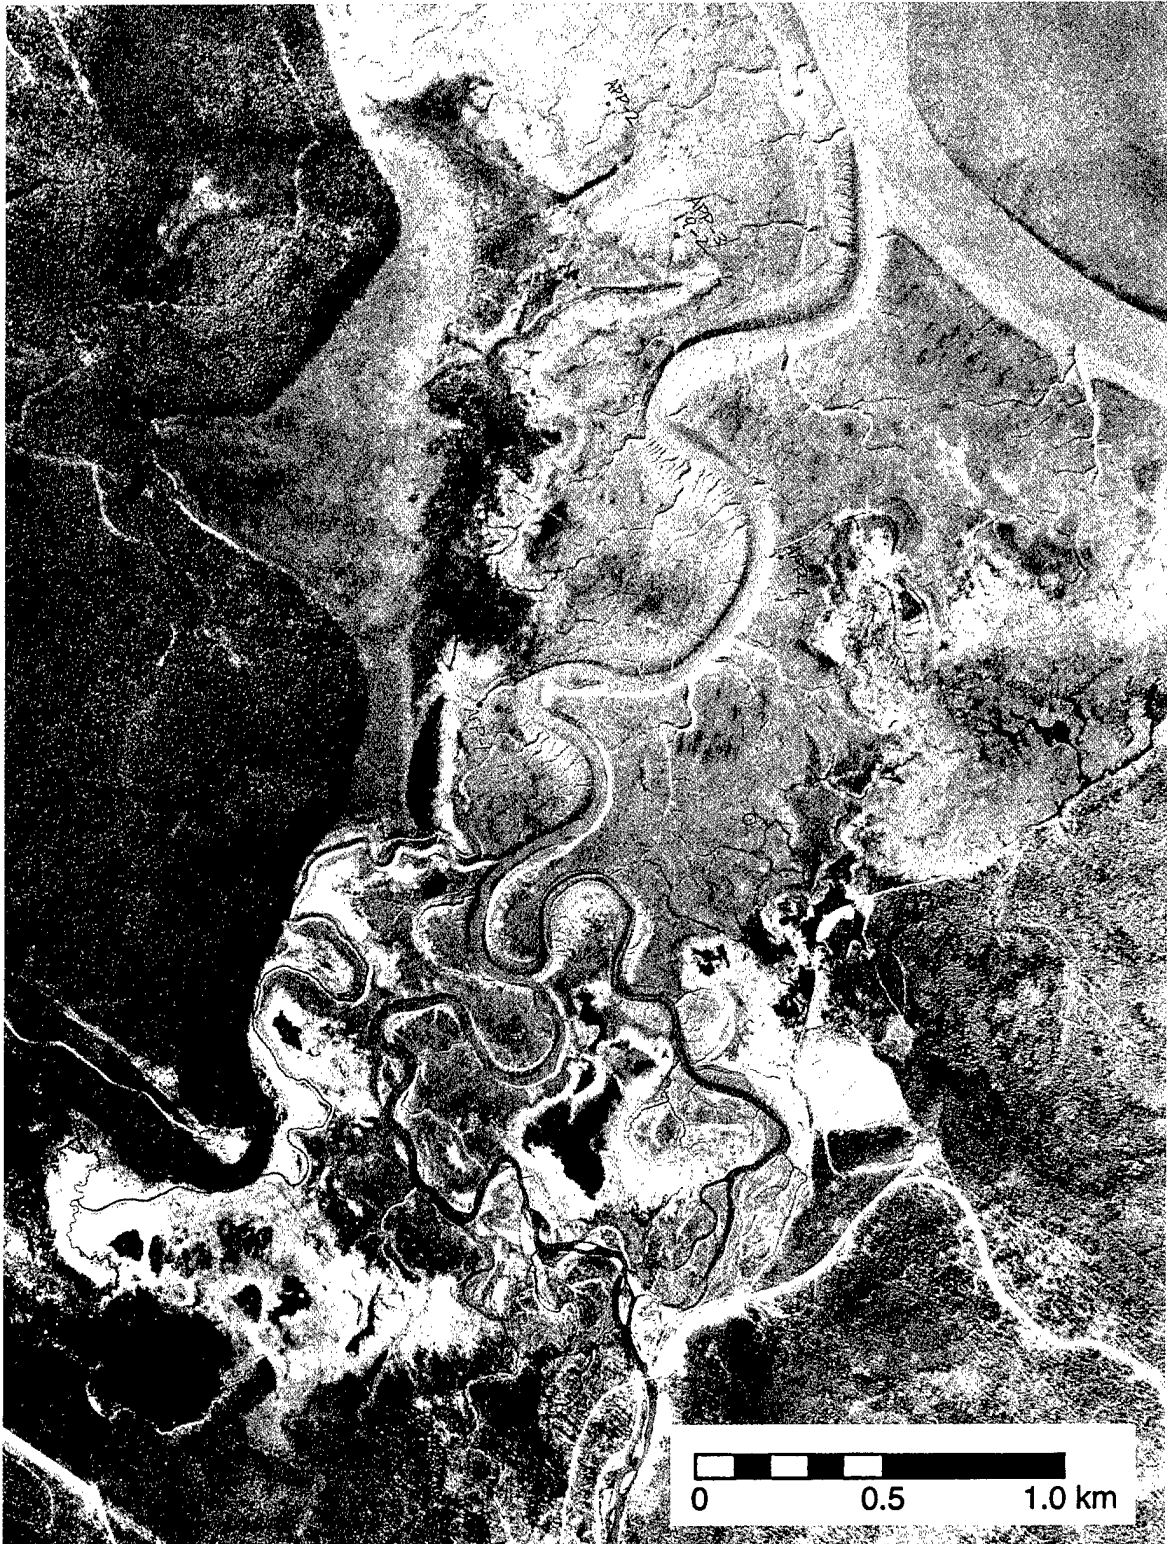
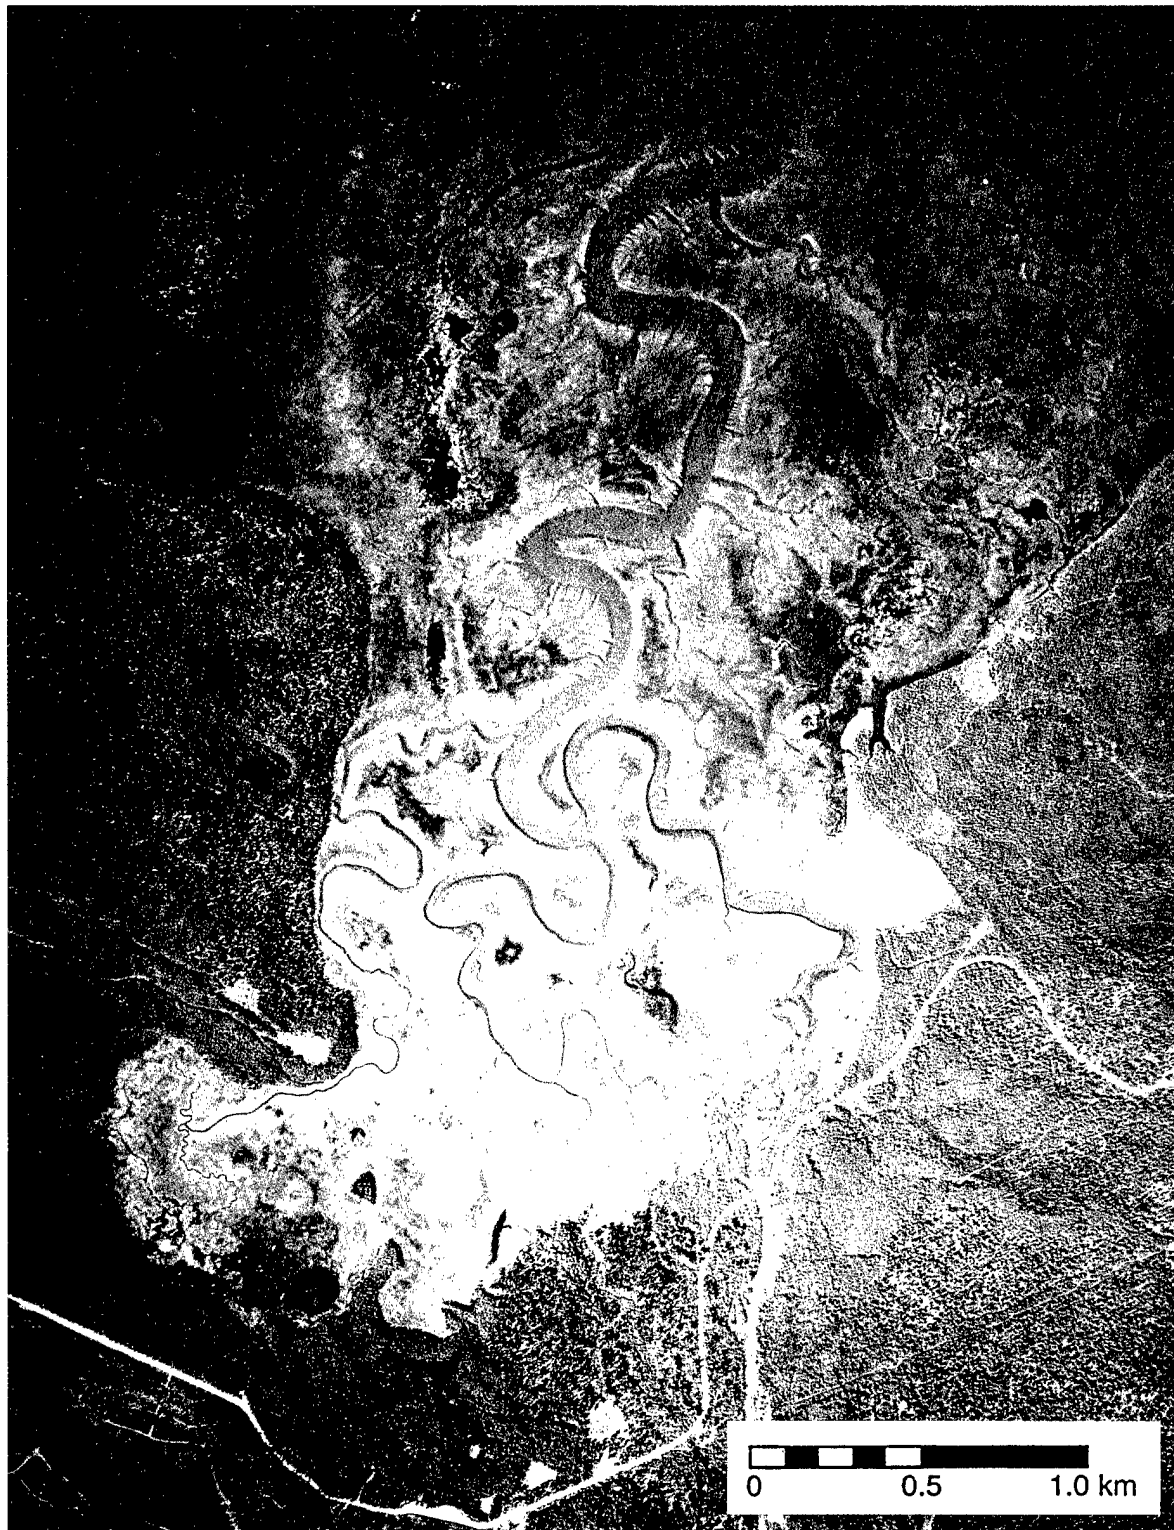
a. 1950.

Figure 5. Aerial photographs of ERF.

b. 1967.

c. 1993.
Figure 5 (cont'd).

doned point bars are common along the length of the active channel and are especially evident in photographs of the southern reaches of the Flats (Fig. 5c). Channel changes are a natural progression resulting from the erosion and recession of the outer banks of meander bends, deposition of sediments as point bars in the inner parts of each bend, and a general downstream migration of the channel (e.g., Allen 1982). At some locations, a breaching of tight meander loops causes their abandonment.

Gullies in the mudflats have also lengthened and deepened during the last 40 years, in some cases extending over 200 to 300 m. A significant extension of gullies toward the ponds and marshes is particularly evident in Figures 5b (1967) and 5c (1993). Headwalls recede during flood or ebb flow, as water is funneled into and out of the ponds and mudflats through the drainage system. The cause of gully expansion is not proven. But the tectonic activity during and following the 1964 Alaskan earthquake or large-scale river channel changes caused by flooding can cause the gully expansion. We must further quantitatively analyze historical aerial photographs and deposits in the alluvial landforms to find its cause.

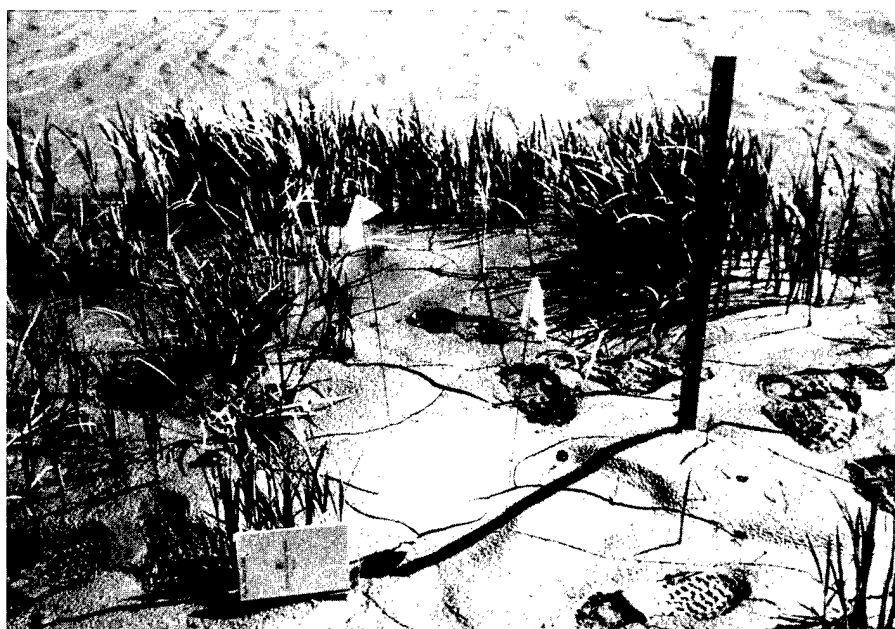
a. Sedimentation stake with plate that slides freely on the rod.

Figure 8. Sedimentation measurement techniques.

b. Wire flags mark an area of painted ground.

We used "sedimentation stakes" to measure erosion and deposition at transect points where the surface was wet or standing water was present (Fig. 8). These stakes consist of a rod and a square, rigid plate (about 7 cm²) that slides freely on the rod as used by Ovenshine et al. (1976a,b) in Turnagain Arm, Alaska. Erosion depth is defined by the increase in distance between the top of the rod and the top of the plate, as measured periodi-

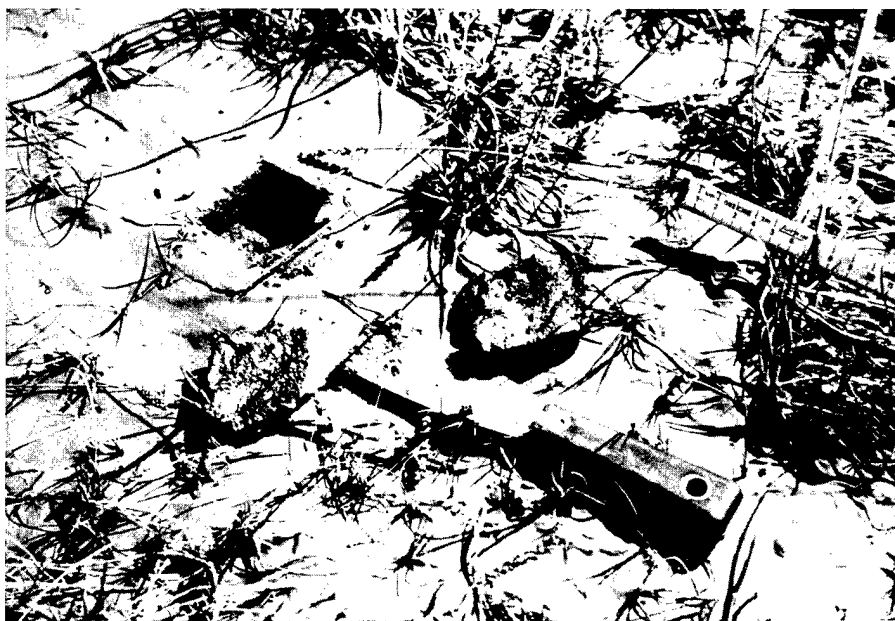
Figure 9. Paint layer depth within block of sediment is measured to define sedimentation rates.

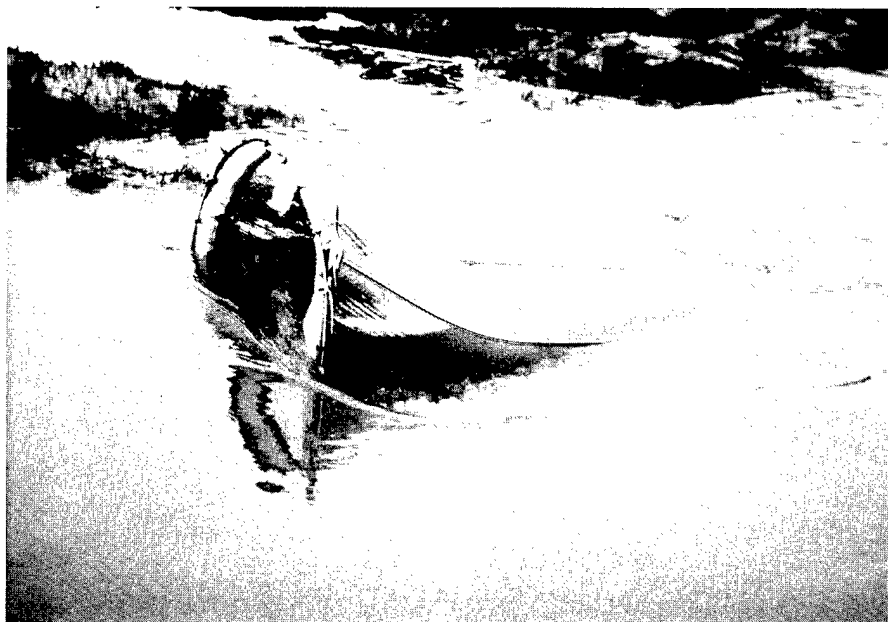
Figure 20. Plankton net used for collection of WP in transport through gullies.

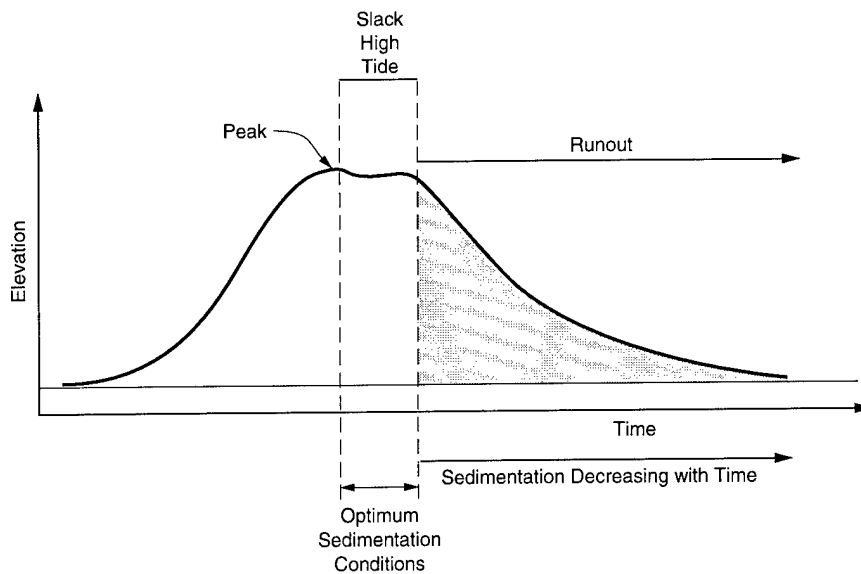
Figure 22. Typical high-tide curve showing period of sedimentation.

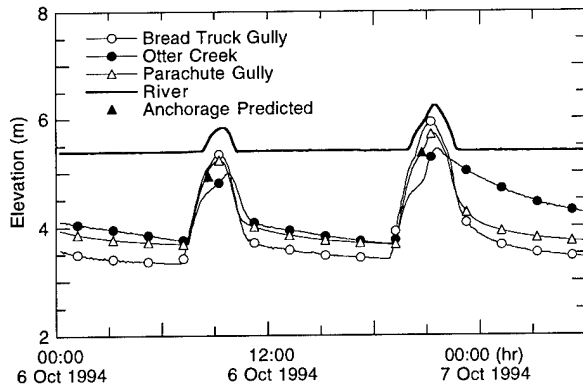
Figure 23. Water elevations as measured by pressure transducer for two flooding tide events.

tually reverse its flow direction in the upper Flats. This damming effect causes the water of the river to rise higher than the elevation of water in the gullies and reverses flow in the drainage system. We saw this happen in September and October 1994 during flooding events with a predicted high tide of at least 4.0 m. The damming effect may be accentuated during spring snowmelt or mid- to late-summer runoff peaks caused by a large volume of glacial melt in the Eagle River. Water depths measured at the hydro-stations and the tidal gauge in Knik Arm show that during the September and October flood tides, the peak water elevation on the Flats exceeded the predicted

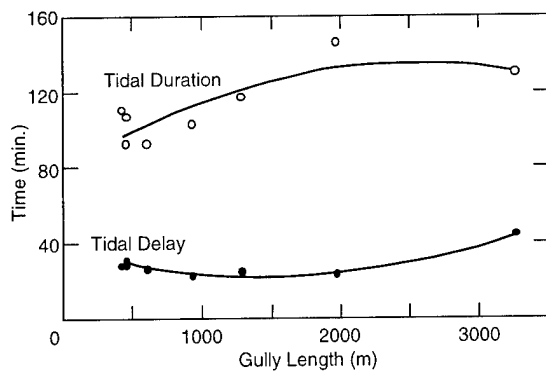
a. Gully length vs. tidal duration and delay. Regression line for tidal duration is expressed by $y = -8E-06x^2 + 0.0437x + 79.818$ ($R^2 = 0.6964$); and for tidal delay, $y = 7E-06x^2 - 0.0187x + 35.887$ ($R^2 = 0.9655$).

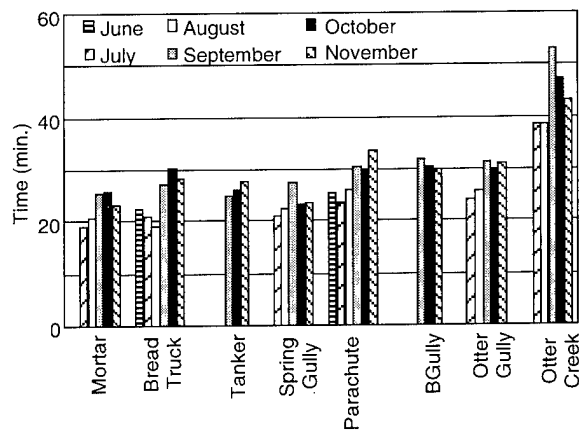
Figure 30. Delay in peak high tide from Anchorage to ERF sites, June through November.

Water level measurements at the river and gully sites (Fig. 16) verified our observations that the flood cycle normally starts with a progressive rise in the river channel and adjacent gullies before the mudflats gradually flooded. Flooding begins first in the coastal mudflats on Knik Arm while water is moving progressively inland up the Eagle River channel. The delay in flooding at the hydrostation sites from that predicted for Anchorage is illustrated by data from June through November (Fig. 30).

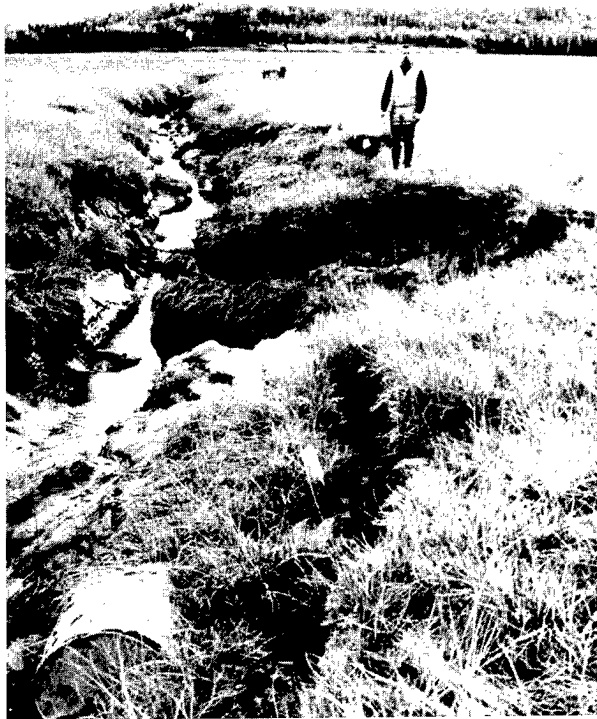
Figure 52. Eastward view of eroded cusped embayment at monitored section of B-Gully where white phosphorus was recorded in transport.

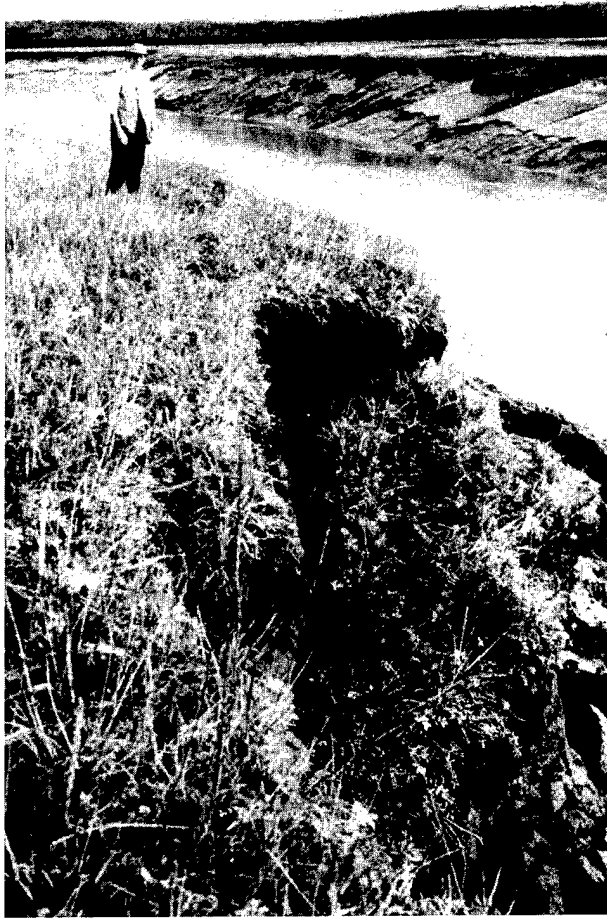
Figure 54. Rotational slump block failure at River Section-North.

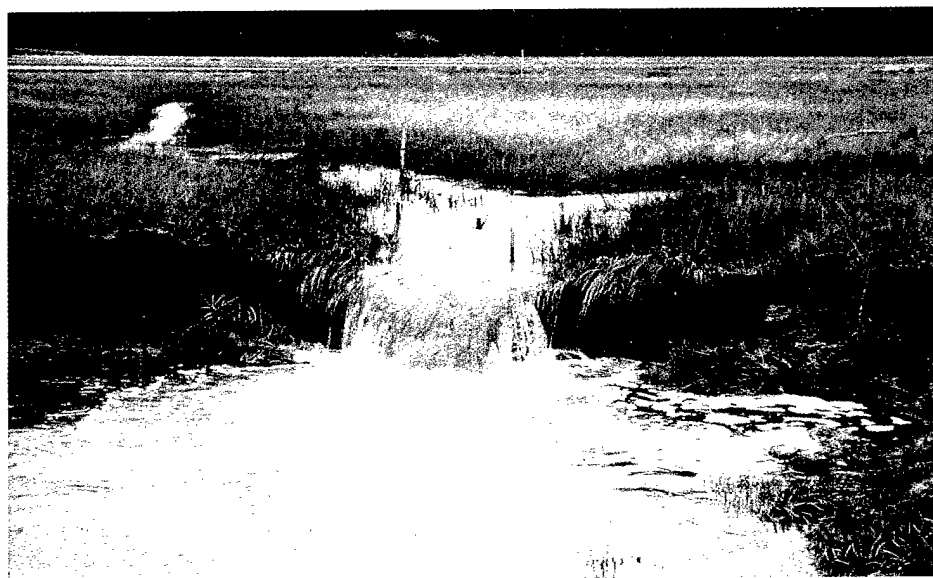
Figure 57. Water flowing over gully headwall at Parachute Gully plunge pool.

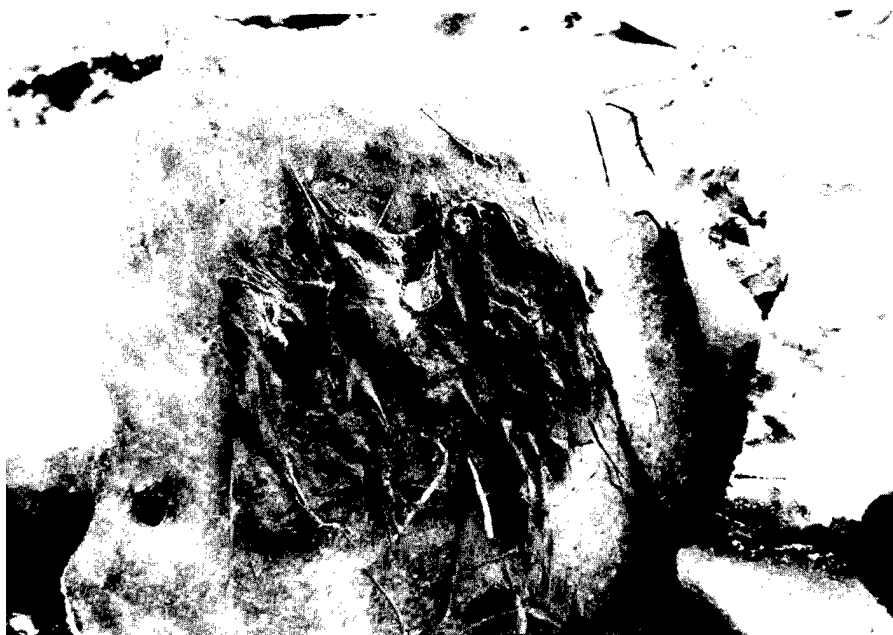
a. Vegetated pond bottom sediments frozen onto ice near the In-between Gully.

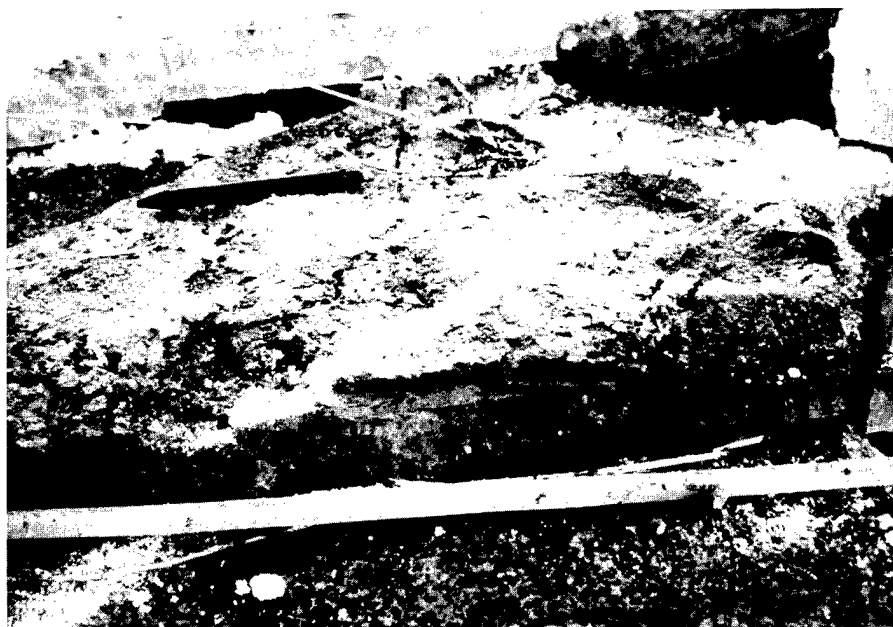
b. Sediment layer frozen onto an ice block at Otter Gully.
