Mechanical Behavior
and Fracture Characteristics
of Off-Axis Fiber Composites
I - Experimental Investigation

John H. Sinclair and Christos C. Chamis

DECEMBER 1977

NASA Technical Paper 1081

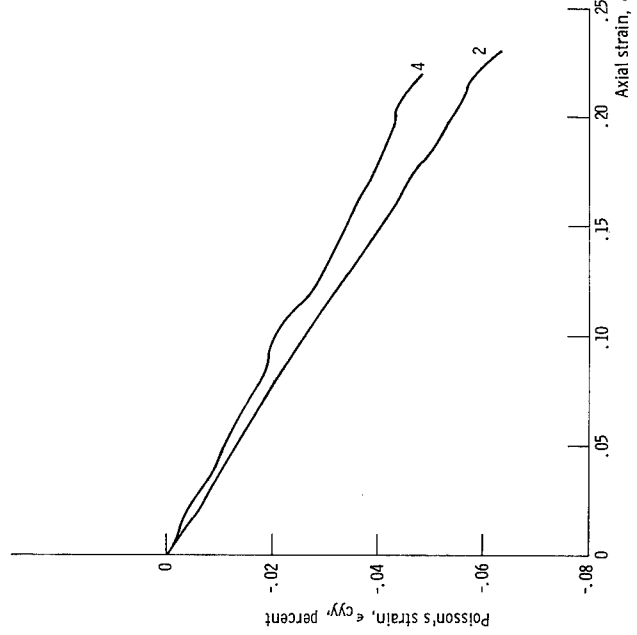
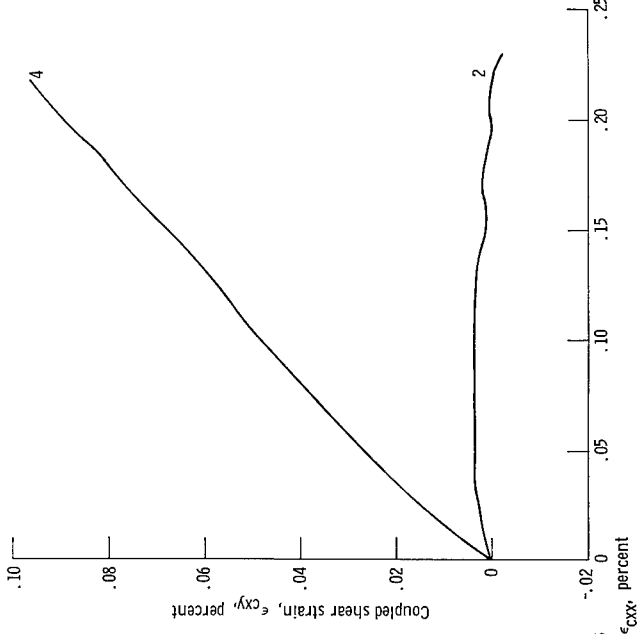
(a) Stress-strain curves.

(b) Transverse (Poisson) strain curves.

(c) Shear strain curves.

Figure 4. - Computer plotted curves through experimental data for longitudinal (θ^0), Mod I/E fiber-composite, tensile specimen.

The fracture stress ($S_{\ell_{11T}}$) of the longitudinal tensile specimen (0° off-axis) was 56.3 newtons per square centimeter (81.7 ksi), and the gage near the tensile grip recorded a strain of 0.22 percent or 96 percent of the midlength gage, which gave a strain measurement of 0.23 percent.

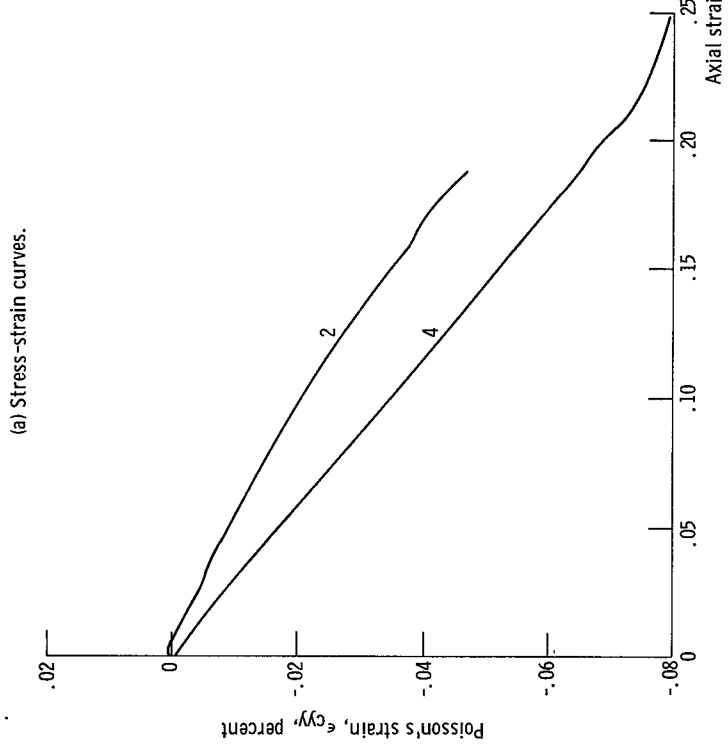
Figure 5. - Computer plotted curves through experimental data for 5° off-axis, Mod I/E fiber-composite, tensile specimen.

Axial strains at fracture measured at the tab end and at the midlength of the 5° off-axis specimen (fig. 5(a)) did not agree as closely as they had in the 0° case. The specimen fractured at a stress of 38.1×10^3 newtons per square centimeter (55.2 ksi). The gage near the specimen grip indicated a strain of 0.250 percent, which is 1.35 times the 0.185 percent strain shown by the midlength gage. It was observed that the specimen thickness beneath the gage near the tab end was 0.138 centimeter (0.0542 in.), the thinnest area measured on the specimen, whereas that beneath the midlength gage was 0.141 centimeter (0.0556 in.).

The coupled shear strains for this group of specimens lie between 0.08 percent and 0.74 percent. Again, the larger values for a given specimen are found sometimes at the tab end and sometimes at the midlength (parts (c) of figs. 5, 7, 9, and 11).

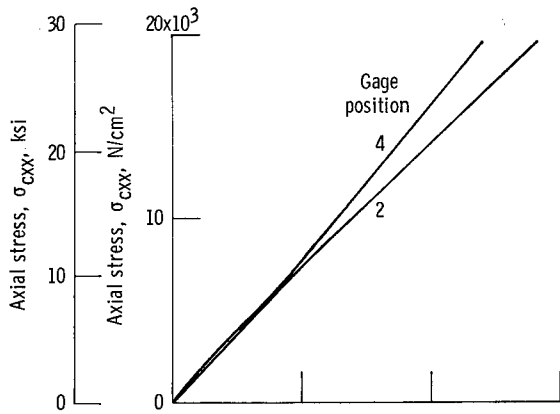
(a) Stress-strain curves.

(b) Transverse (Poisson) strain curves.

(c) Shear strain curves.

Figure 7. - Computer plotted curves through experimental data for 15° off-axis, Mod I/E fiber-composite, tensile specimen.

Tab-end strains for the specimens tested at 15° , 45° , and 75° off-axis had magnitudes between 0.24 and 0.45 percent and did not vary from midlength strains by more than 18 percent (figs. 7(a), 9(a), and 11(a), but the transverse specimen (90° off-axis) had a tab end strain of 0.50 percent, which is 139 percent of the midlength strain of 0.36 percent (see fig. 12(a)). The cause for this difference is probably nonuniformities in the laminate due to out-of-plane eccentricities.

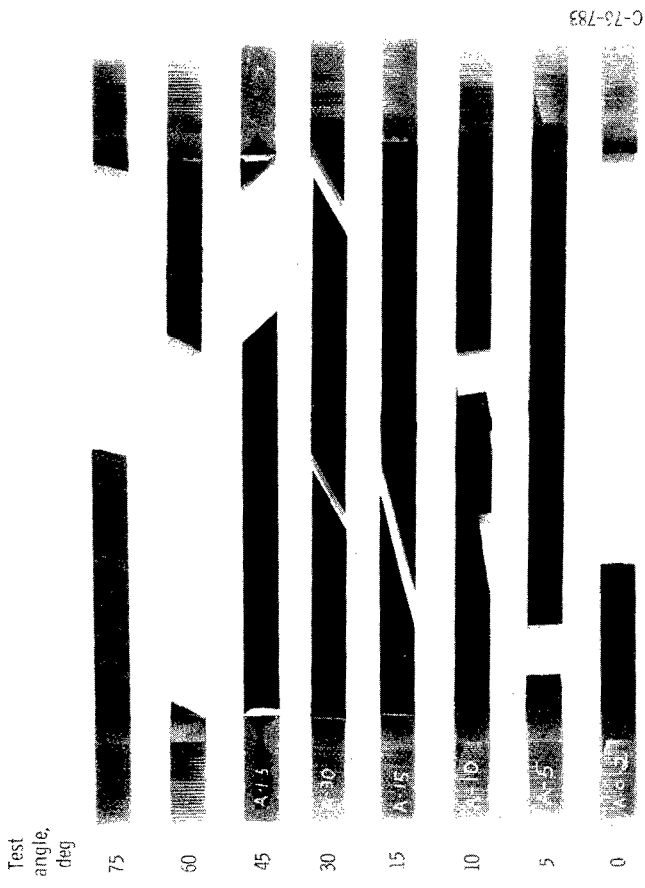
Figure 14. - Fractured test specimens (Mod I/E).

The fractured specimens are shown in figure 14. The fracture of a five-gage instrumented specimen is shown in figure 15. Note in figure 14 that the specimens tested at 0° , 5° , 10° , 15° , and 30° off-axis fractured away from the end tabs and those tested at 45° , 60° , 75° and 90° fractured near the end tab. Fractures occurring at or near end tabs are to be expected. Finite-element analyses results to be discussed in Part II show that the stresses at the edge near the end tab are higher than at the center in certain orientations. Consequently, these stresses can initiate fractures near the end-tab region. This leads to the interpretations that the fracture stresses of specimens that fractured near the end tabs are on the conservative side. Therefore, the axial stress

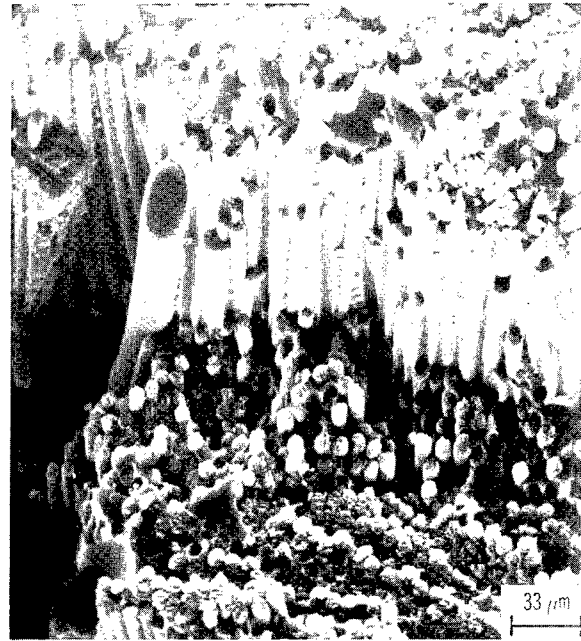
Figure 17. - Scanning electron photomicrographs of fractured surface of Mod I/E composite tested at 5° to fiber direction.

The fracture surface of the 5° off-axis tensile specimen (fig. 17) reveals the following features:

- (1) Surface tiering (fig. 17(b)) and matrix cleavage (fig. 17(c)) both of which are indicative of tensile fracture
- (2) Extensive matrix surface lacerations, indicating substantial fracture by intralaminar shear
- (3) Fiber pull-out and fiber surfaces free of matrix residue, indicating weak interfacial bonding.

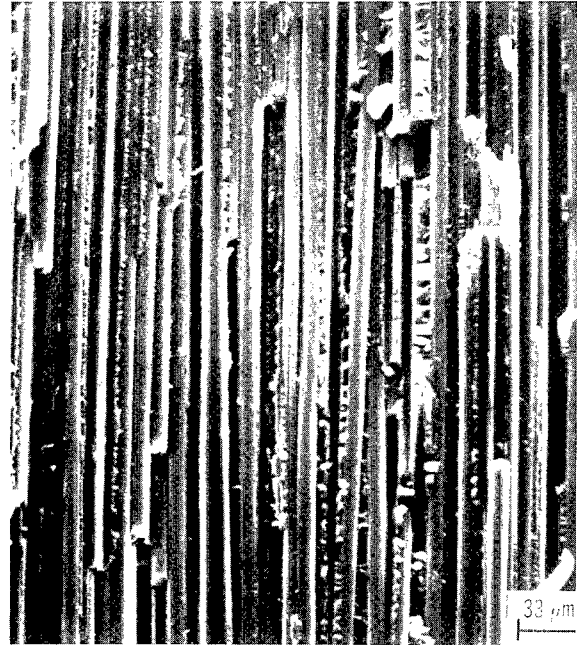
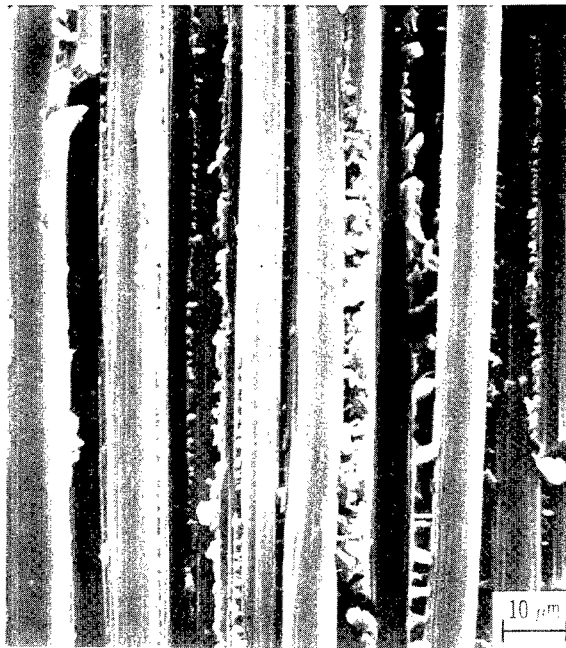
Figure 18. - Scanning electron photomicrographs of fractured surface of Mod I/E composite tested at 10° to fiber direction.

The fracture of the 10° off-axis tensile specimen (fig. 18) reveals (1) matrix surface lacerations and (2) fiber surfaces free of matrix residue. Both of these features indicate that a different fracture mode became active. We will consider this mode to be induced by intralaminar shear stress. It is this observation and the theoretical considerations to be described in Part II that led to the recommendation that the 10° off-axis tensile specimen is suitable for intralaminar shear characterization of unidirectional fiber composites.

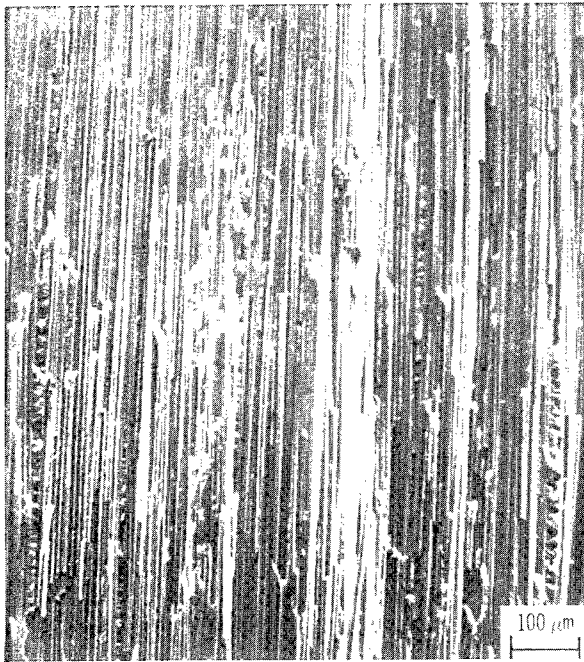
Figure 19. - Scanning electron photomicrographs of fractured surface of Mod I/E composite tested at 15° to fiber direction.

The fracture surfaces of the 15° and 30° off-axis tensile specimens (figs. 19 and 20) reveal similar features to those of the 10° off-axis tensile specimen. These surfaces, too, indicate that fracture was induced mainly by intralaminar shear stress.

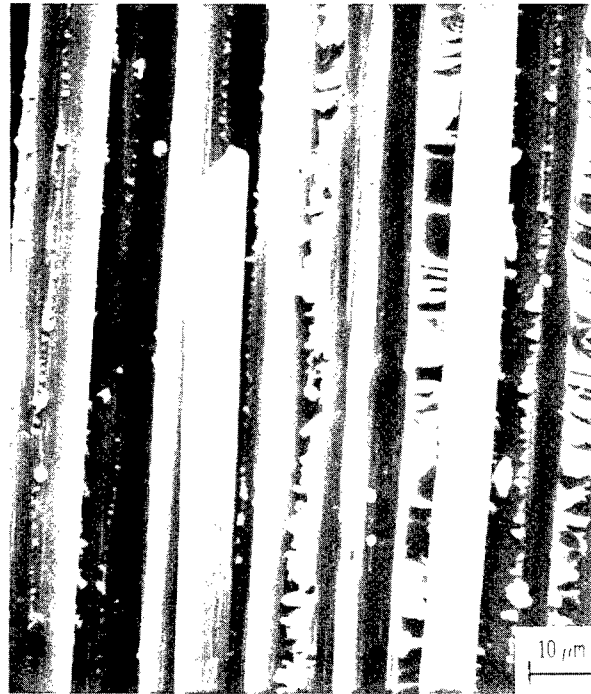
Figure 20. - Scanning electron photomicrographs of fractured surface of Mod I/E composite tested at 30° to fiber direction.

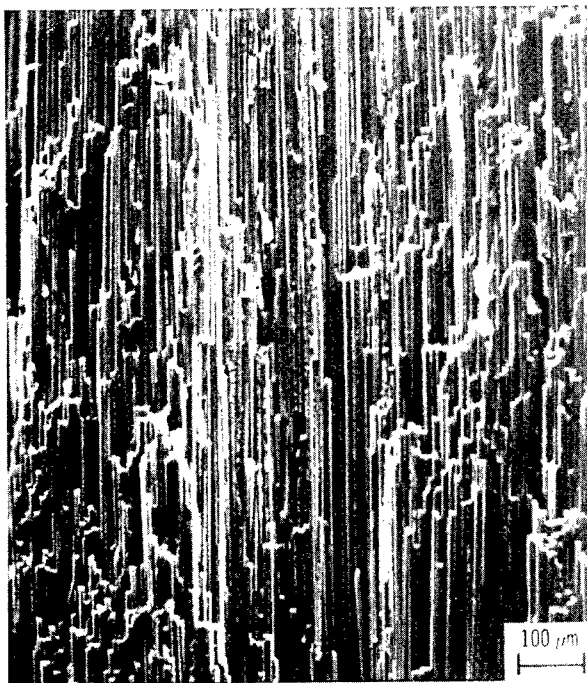
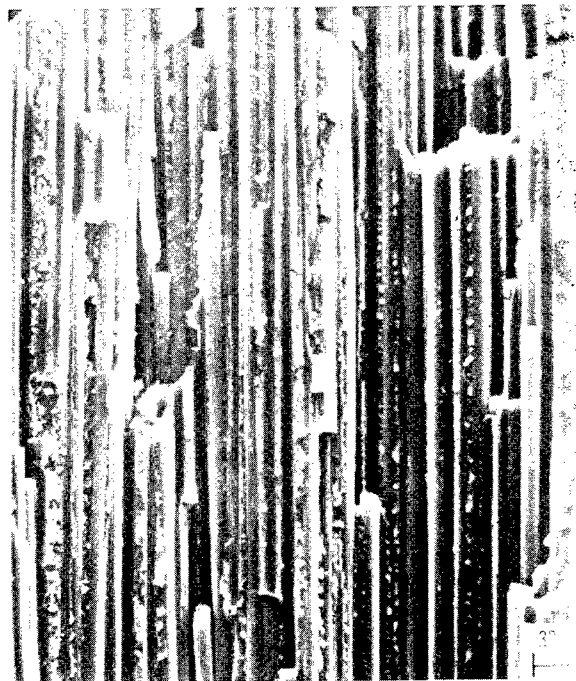
Figure 21. - Scanning electron photomicrographs of fractured surface of Mod I/E composite tested at 45° to fiber direction.

The fracture surface of the 45° off-axis specimen (fig. 21) reveals the following features:

- (1) Matrix cleavage with irregular boundary, indicating some transverse tensile fracture
- (2) Matrix debris resulting probably from tensile matrix fracture
- (3) Some matrix lacerations, indicating some intralaminar shear stress fracture.

These surface fracture features show that another fracture mode becomes active somewhere between a load angle of 30° and 45° . This mode is construed to have been induced by the transverse tensile stress.

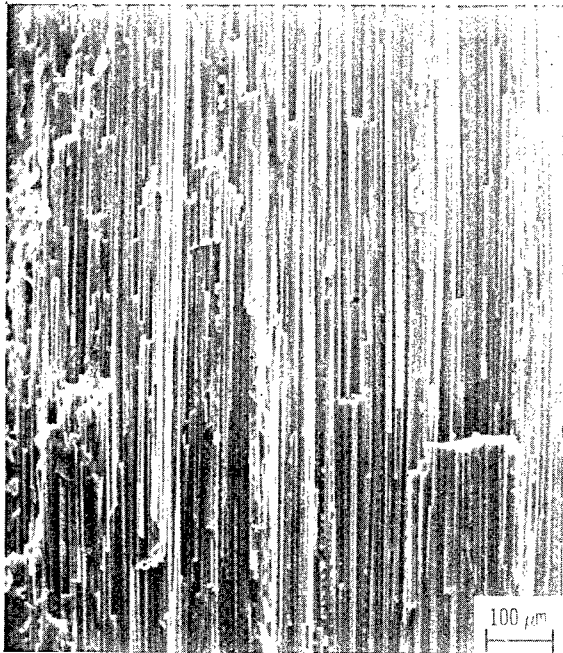
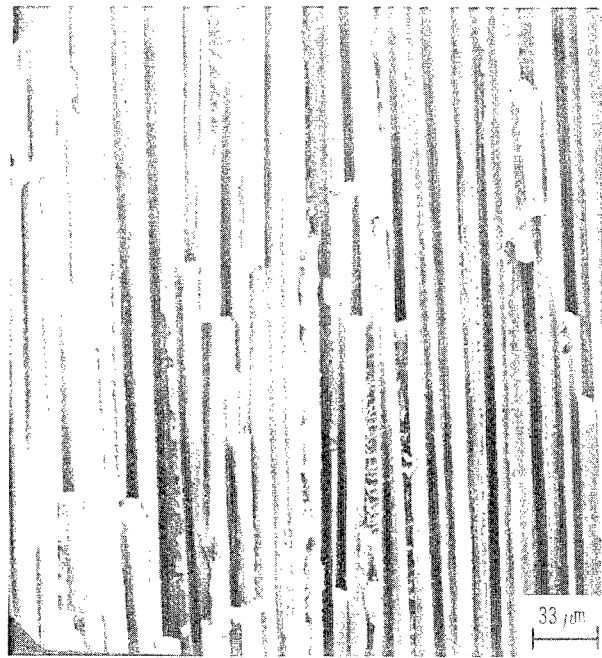
Figure 22. - Scanning electron photomicrographs of fractured surface of Mod I/E composite tested at 60° to fiber direction.

The fracture surfaces of the 60° off-axis tensile specimen (fig. 22) and the 75° specimen (fig. 23) reveal mainly matrix cleavage and some fiber surface free of matrix residue; both of these features indicate that fracture was induced by transverse tensile stress.

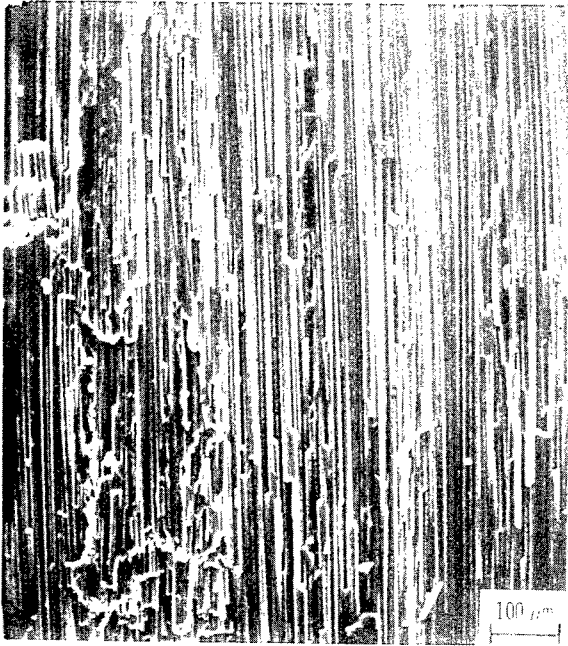
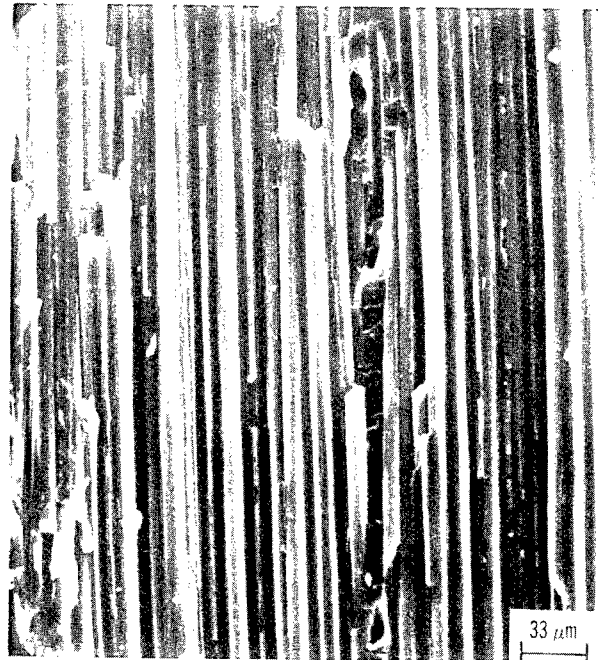
Figure 24. - Scanning electron photomicrographs of fractured surface of Mod I/E composite tested transverse to fiber direction.

The fracture surface of the 90° tensile specimen (fig. 24) reveals the following features:

- (1) Matrix cleavage, indicative of tensile fracture of brittle materials
- (2) Fiber surfaces free of matrix residue, indicative of weak interfacial bond, as was already mentioned
- (3) Some matrix lacerations, indicating shear fracture at surfaces connecting two different levels.

These features indicate that transverse tensile stress produces fracture surfaces characterized by (1) matrix cleavage and (2) fiber surfaces clear of matrix residue.
