**Wear of Single-Crystal Silicon
Carbide in Contact With
Various Metals in Vacuum**

Kazuhisa Miyoshi and Donald H. Buckley

NASA Technical Paper 1198

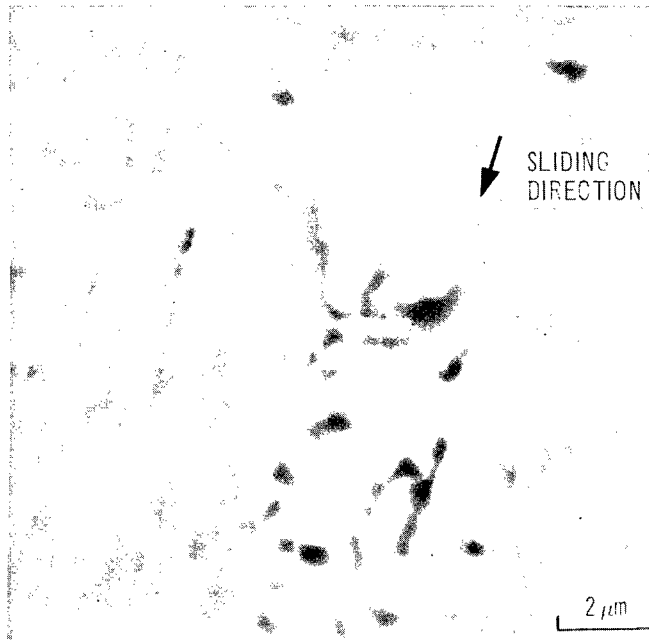
(a) Scanning electron micrograph.

(b) Silicon K_{α} X-ray map of cobalt rider; 1.0×10^4 counts.

Figure 7. - Indentations on cobalt rider produced by rolling of silicon carbide wear debris during sliding contact. Ten passes on SiC (0001) surface; sliding direction, $\langle 10\bar{1}0 \rangle$; sliding velocity, 3 mm/min; load, 30 g (0.29 N); temperature, 25° C; vacuum pressure, 10^{-8} Pa.

The wear scars on metals after sliding on silicon carbide surfaces may contain the silicon carbide wear debris. Figures 5 to 7 indicate that the wear debris of silicon carbide, produced in sliding on rhodium, copper, and cobalt, transferred to or was embedded in the metal riders. The wear debris generally slides or rolls on the metal surfaces and produces the indentations and deep grooves shown in figures 5 to 7. Figure 6 shows straight grooves, along the sliding direction on the metal, formed by the sliding of silicon carbide wear debris. Figure 7 also shows straight rows of indentations, along the sliding direction, formed by the rolling of silicon carbide wear debris.

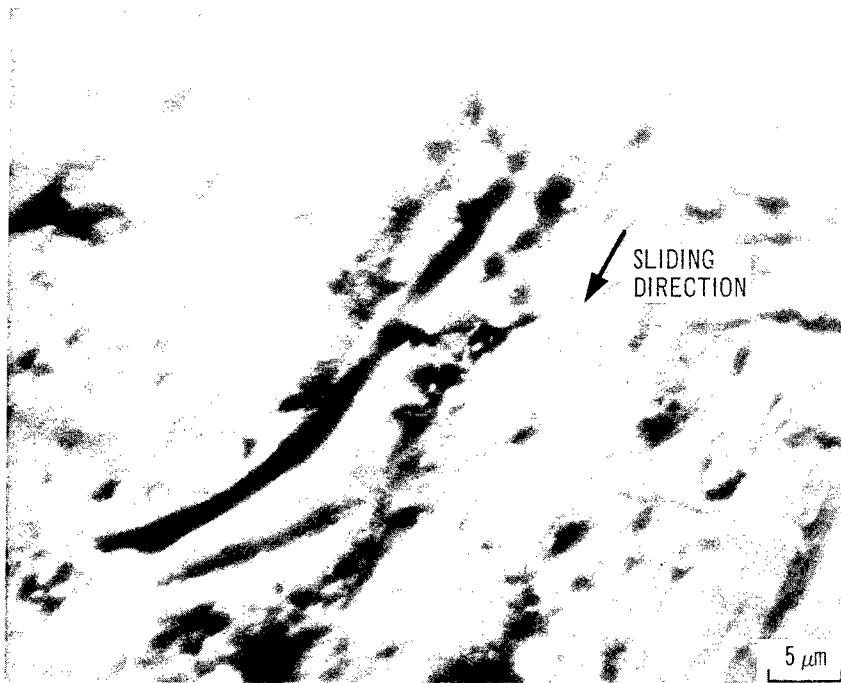
(a) Aluminum.

(b) Titanium.

Figure 9. - Wear scars on metal riders produced during sliding contact with silicon carbide. Ten passes on SiC (0001) surface; sliding direction, $\langle 10\bar{1}0 \rangle$; sliding velocity, 3 mm/min; load, 30 g (0.29 N); temperature, 25°C; vacuum pressure, 10^{-8} Pa. (Scanning electron micrographs.)

(c) Copper.

(d) Nickel.

(e) Cobalt.

(f) Iron.

The wear scars on the metal riders after sliding against silicon carbide revealed a large number of plastically deformed grooves and indentations (which seem to depend on the nature of transfer of silicon carbide and the metal) formed primarily by the sliding and rolling of silicon carbide wear debris. (See fig. 9.) The less the chemical activity and the greater the resistance to shear of the metal, with the exception of rhodium and tungsten, the less the transfer to silicon carbide (ref. 1). (See tables I and II.) The wear scars are generally rougher with aluminum and titanium, which have much stronger chemical affinity and less resistance to shear than copper, nickel, cobalt, or iron. The wear scar of iron is much smoother, with fewer deep grooves and indentations (fig. 9(f)). The titanium wear scar has the roughest surface (fig. 10). This reflects the large amount of silicon carbide transfer to titanium. Figure 10 reveals that most of the large contact indentations contain silicon carbide wear debris.
