| 4. TITLE AND SUBTITLE The Use of Electrochemistry and Ellipsometry for Identifying and Evaluating Corrosion on Aircraft. | 5. FUNDING NUMBERS Program Solicitation 94-1 Control # 94-NC-133 Contract # F49620-95-C-0040 3005/SS 65502F |

FINAL TECHNICAL REPORT

**THE USE OF ELECTROCHEMISTRY
AND ELLIPSOMETRY FOR IDENTIFYING AND EVALUATING
CORROSION ON AIRCRAFT**

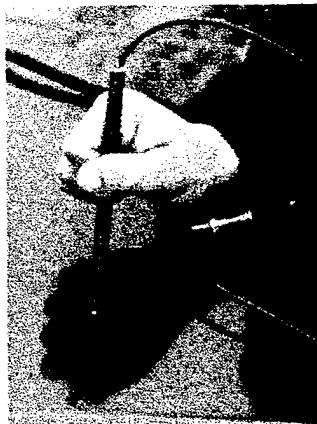
Figure 3. *Hand held in-situ corrosion sensor.*

Two versions of the *in-situ* sensor have been developed: a permanently attached sensor and a portable hand-held sensor. The former is suitable for corrosion inspection in inaccessible areas or for automatic or semi-automatic inspection of a particular area. A laboratory test specimen with an attached sensor is shown in Figure 2. The hand-held sensor is suitable for spot inspection where a permanent sensor is not desired or had not been previously placed. Figure 3 shows a prototype in use.

The final prototype sensor (Figure 3) was designed to provide easier use than the upscale sensor. It had a much smaller diameter and was several inches longer. A long shielded lead wire was permanently attached. This allowed the connection to the Gamry to be made at a distance from the sensor, thus eliminating the wire congestion around the sensor. The connection to the Gamry was made with a BNC connector. The sensor was intended to be used like a pen-type probe. The final sensor was much easier to use and provided results similar to both the first prototype sensor and the upscale sensor (Figure 27).

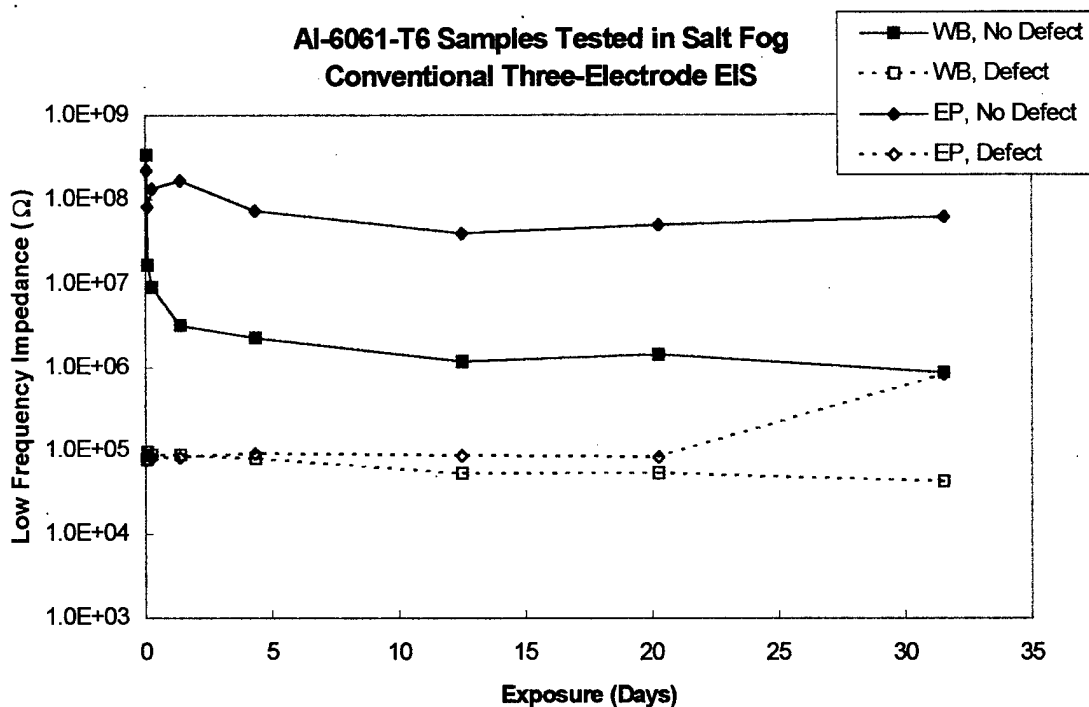
Figure 8. Corrosion Behavior of Coated Al 6061-T6 Tested in Salt Fog.

Based on these plots, a single low frequency impedance measurement can be made on a coating to characterize the stage and severity of corrosion that the coating is experiencing. Once the low-frequency impedance reading has been measured, the corresponding impedance can be found on the corrosion behavior curve for the appropriate metal/coating system.

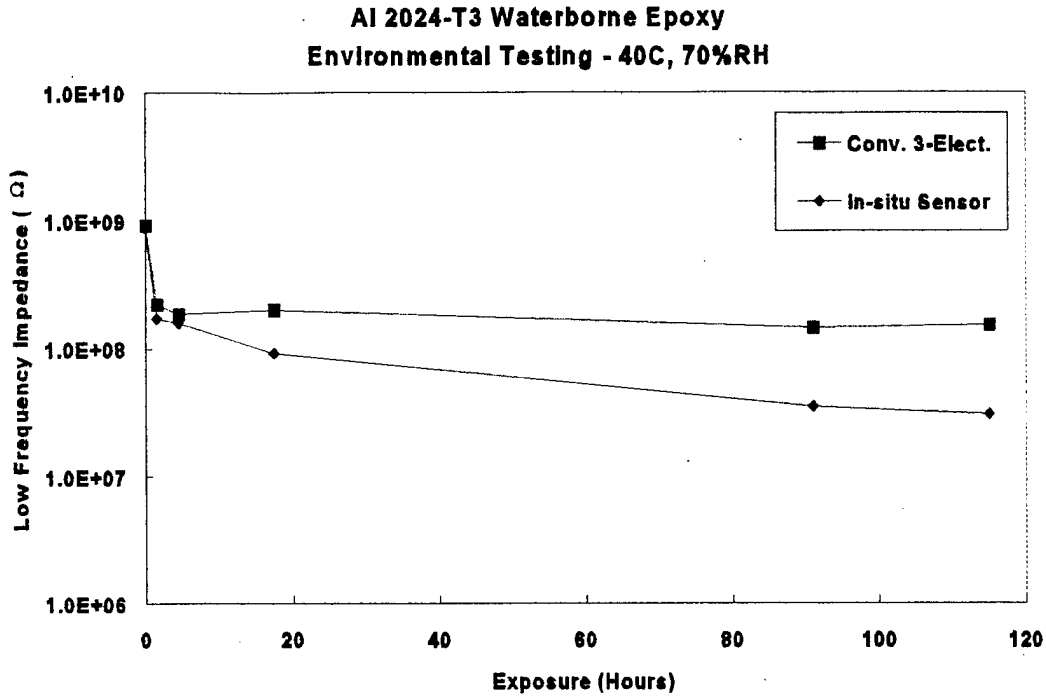
Figure 12. Corrosion Behavior of Al 2024-T3 with Waterborne Epoxy at 40°C, 70% RH.

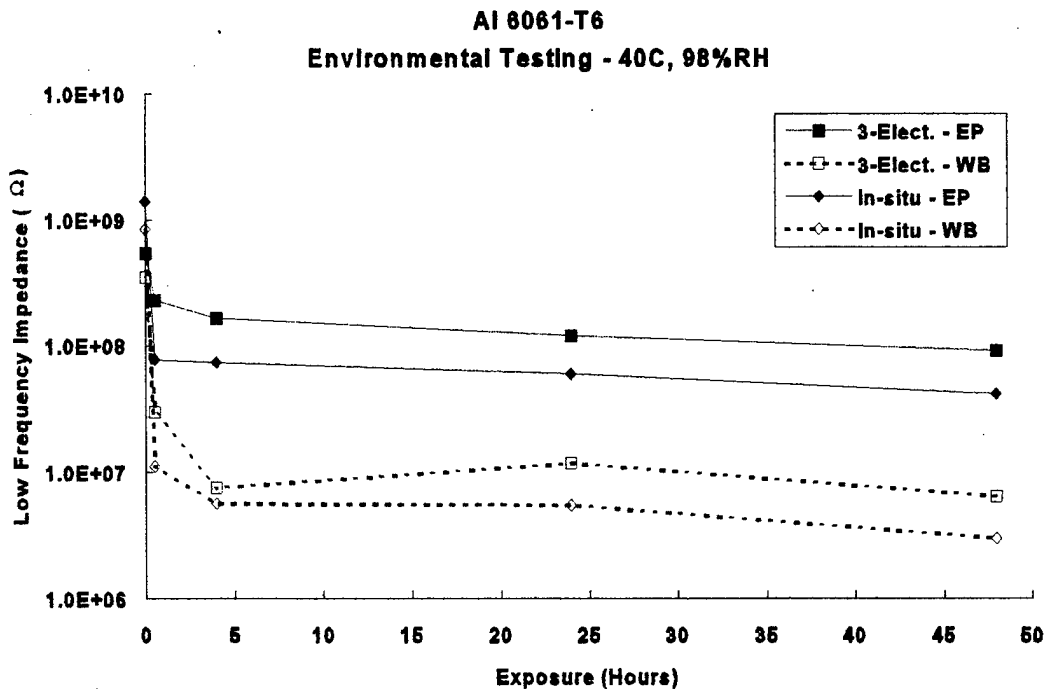
Figure 13. Corrosion Behavior of Al 6061-T6 Samples at 40°C, 98% RH.

Testing was then conducted at 40°C and 98% RH on Al 6061-T6 samples coated with epoxy polyamide and waterborne epoxy primer (Figure 13). The elevated humidity increased the rate of initial water absorption as seen by the sharp drop in low-frequency impedance within the first thirty minutes of exposure in the environmental chamber. Samples with the waterborne epoxy primer exhibited a sharper drop in impedance during the environmental testing than the samples with the epoxy polyamide. This behavior was also witnessed in Task 1 testing.

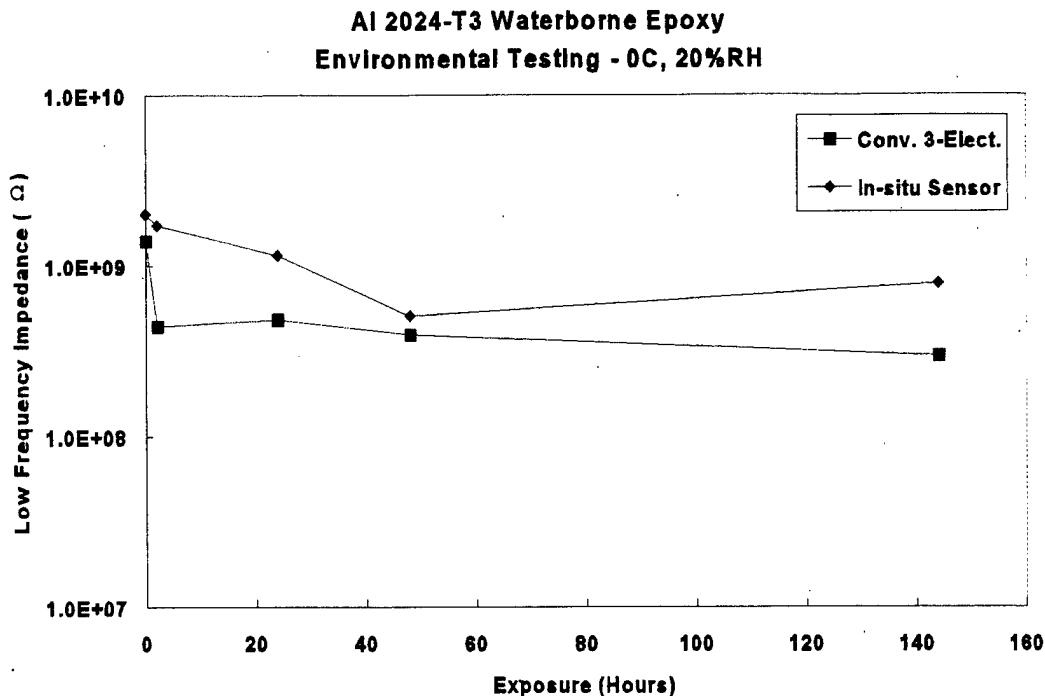
Figure 14. Corrosion Behavior of Al 2024-T3 with Waterborne Epoxy at 0°C, 20% RH.

Testing was then conducted at 0°C and 20% RH on Al 2024-T3 samples coated with waterborne epoxy primer (Figure 14). There was no difficulty in acquiring the data, however, the low-frequency impedance data did not yield as smooth a plateau. Some deviation was seen in the impedance values of the low-frequency regime, but an evaluation of the coating could still be easily made based on the data.

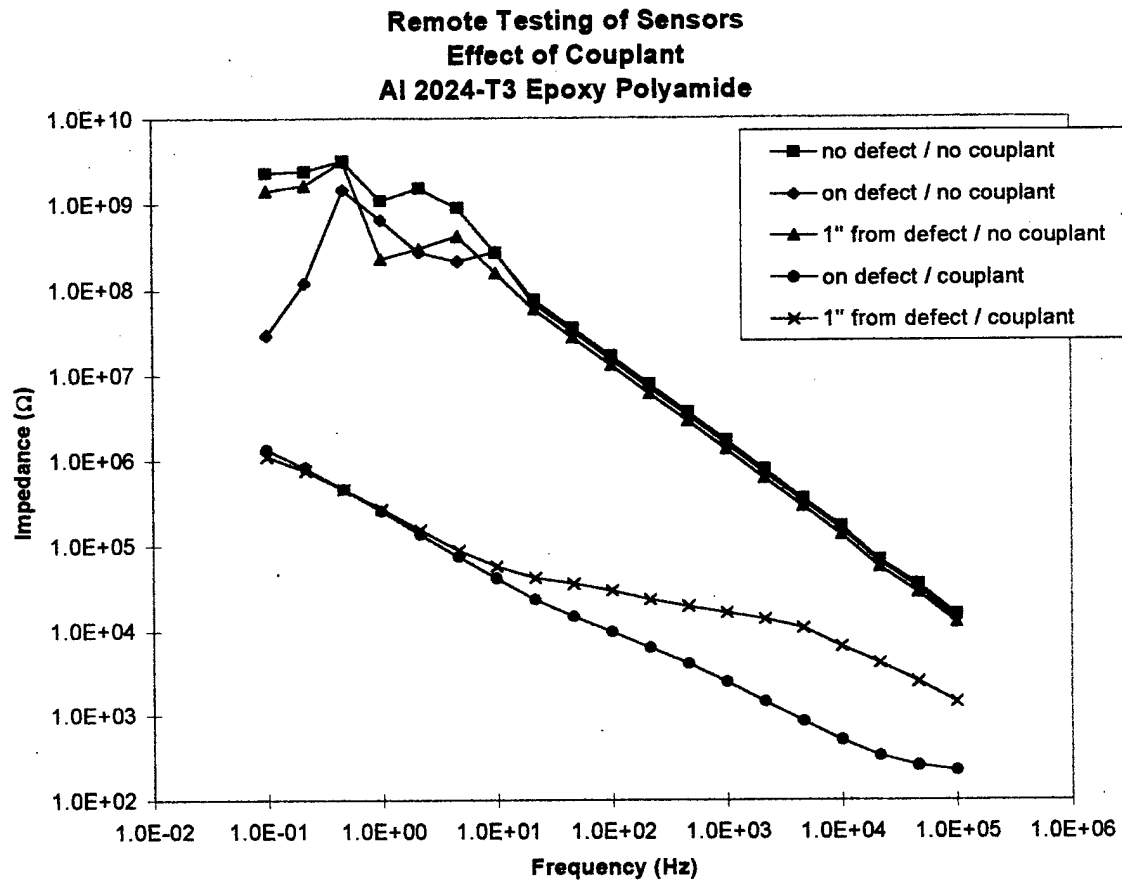
Figure 15. *Effect of Couplant on Impedance Spectra of Defective Coating.*

Task 3 was conducted using the first set of prototype electrodes (See Task 5 and 6 results). Testing was performed in order to determine the effective range that the sensors could detect coating degradation. Initial testing indicated that the sensors could only detect coating degradation underneath the sensor itself on a dry surface. On a wetted surface, though, the effective range of the sensor is appreciably increased. In the laboratory, a conductive path was created artificially through the application of a couplant. In the field, the paint surfaces could be wetted to provide surface conductivity. Figure 15 shows the effect of the presence of a couplant on the impedance spectra of Al 2024-T3 coated with epoxy polyamide primer before and after an intentional defect.

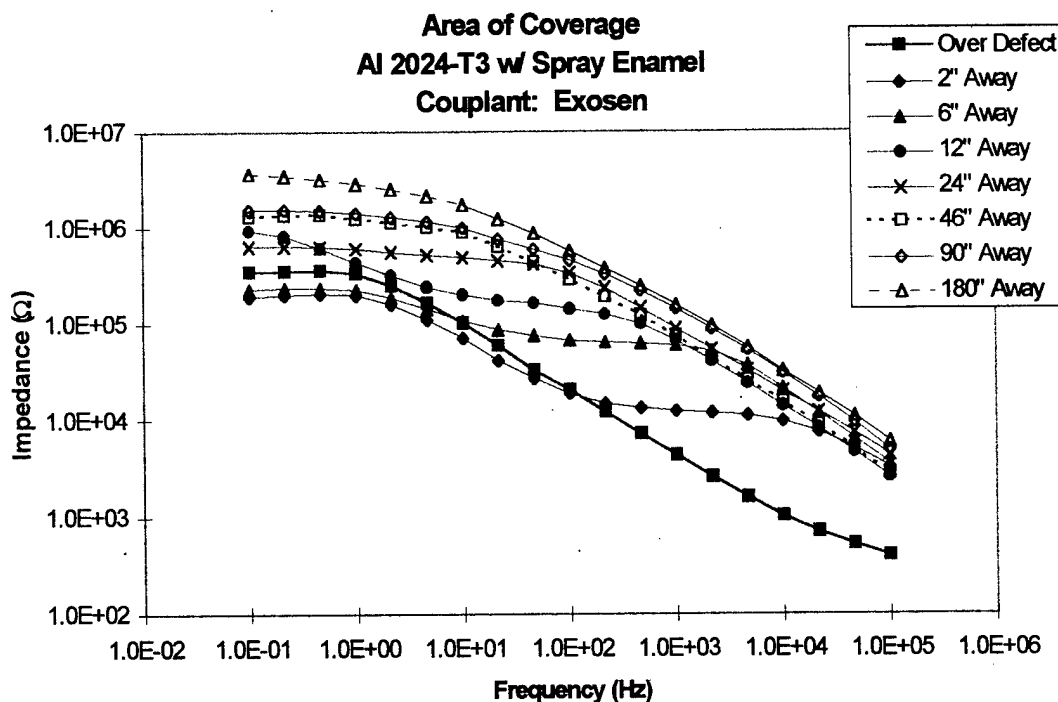
Figure 16. Area of Coverage Testing with Beaded Couplant.

The next set of tests were conducted to determine the effective range of the sensor using exosen as a couplant. For this testing a 48" x 6" x 1/32" Al 2024-T3 panel coated with a spray enamel was used. Before the defect was introduced, a series of baseline tests were conducted to measure the impedance of the proposed defect location from distances up to 46". After the defect was created, the results show that it could be identified to 46" away. However, the difference in impedance between the defective and non-defective coatings became increasingly small due to the resistance of the couplant. Under carefully controlled laboratory conditions, a defect was identified at distances up to 180" from the defect site (Figure 16). Figure 17 shows a plot of the plateau frequency (i.e., where the slope of the impedance spectra is zero) impedance versus distance from the defect. A nearly linear relationship exists between the plateau frequency and the distance from the defect.

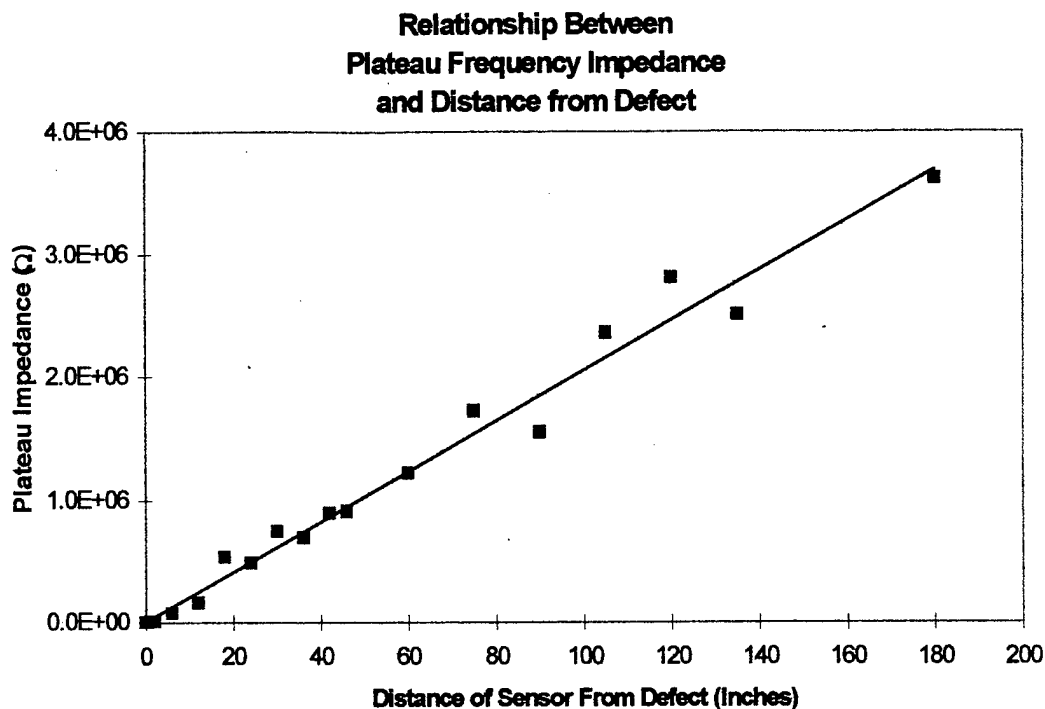
Figure 17. *Relationship Between Plateau Frequency Impedance and Distance from Defect.*

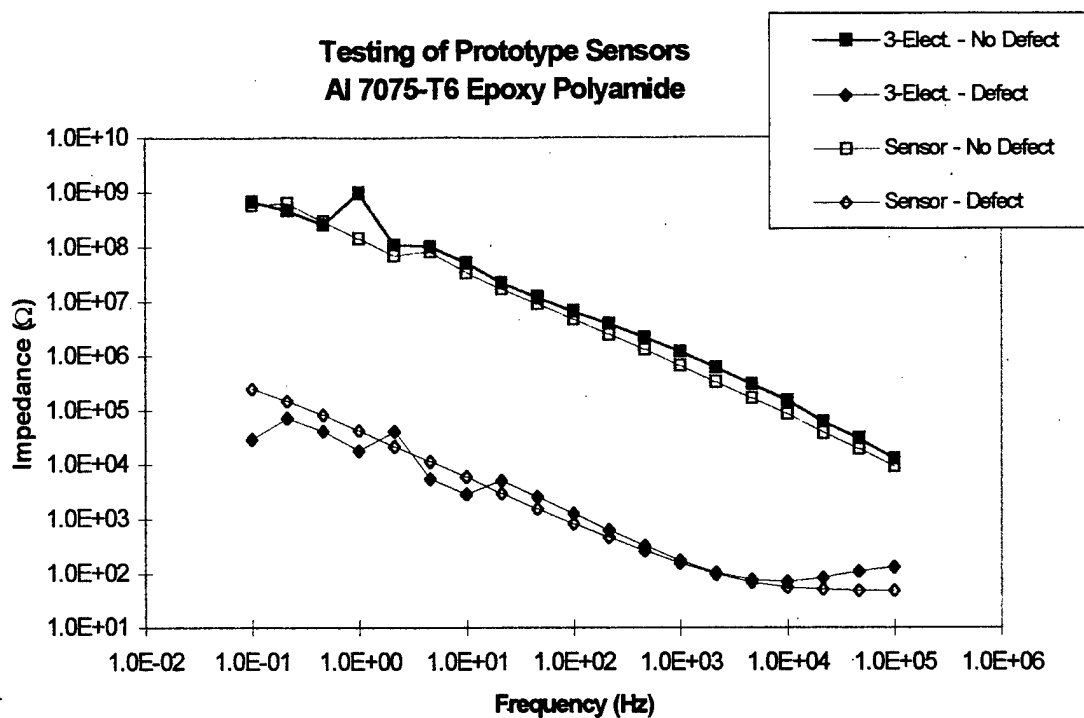
Figure 20. Impedance Spectra of Al 7075-T6 with Epoxy Polyamide.

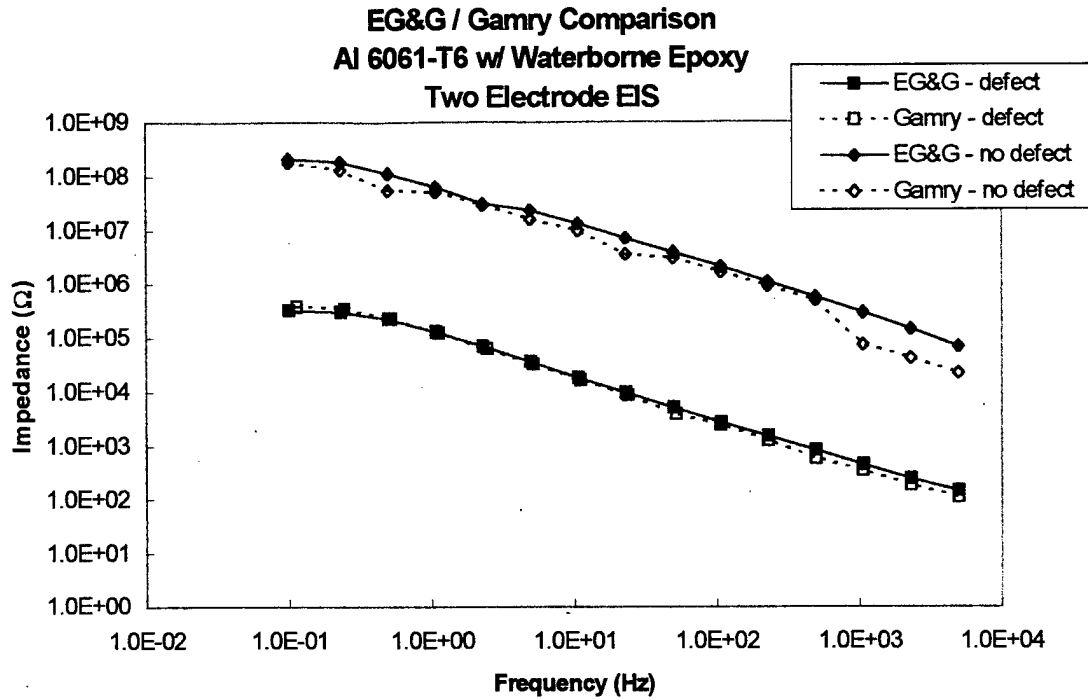
Figure 22. Comparison of EIS Data Acquired by EG&G and Gamry Units.

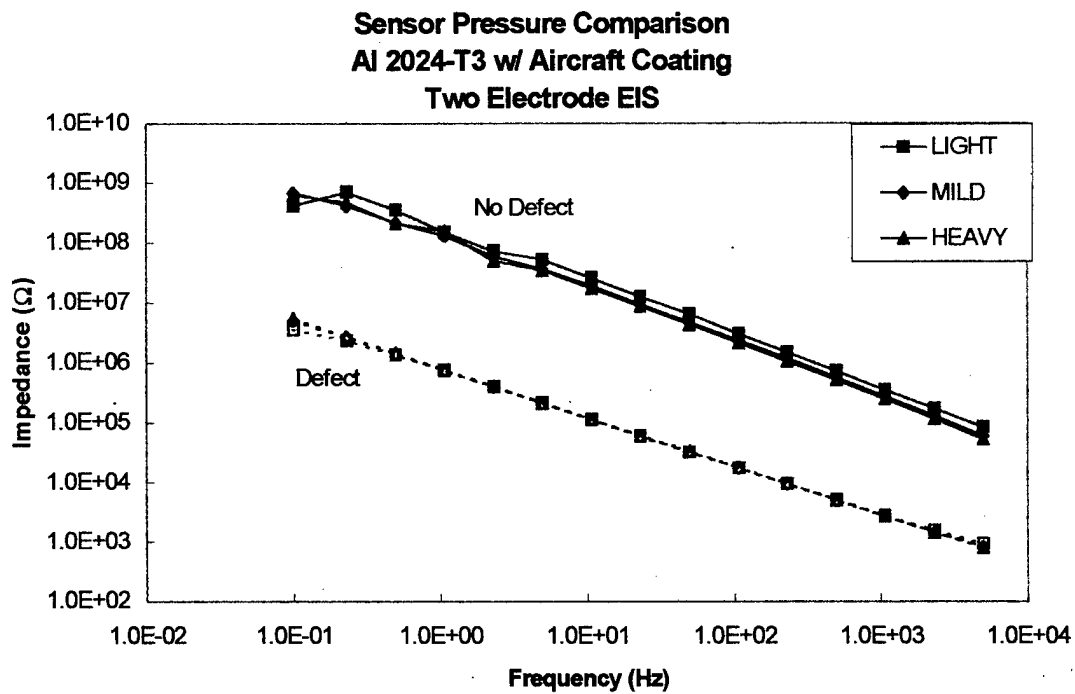
Figure 23. Effect of Pressure Applied to Sensor on Impedance Spectra.

The results in Figure 23 show that consistent results were obtained on both systems with all of the test pressures. This is an important finding because field testing with the upscale sensor requires hands-on use. It is believed that the force required to keep the sensor on the testing surface will be adequate to yield consistent results.

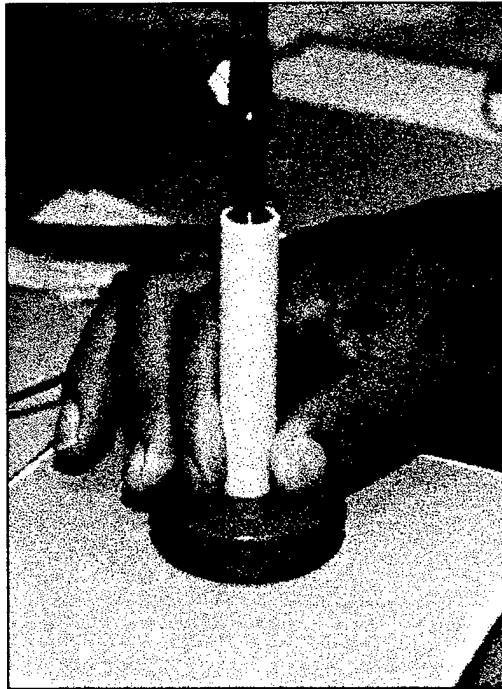
Figure 25. *Upscale Prototype Sensor.*

The upscale prototype hand-held sensor was fabricated with the sensing component encased in a PVC shell (Figure 25). The circular base of the sensor was also constructed of PVC and was sized to allow the sensor to be held by the fingertips or in a manner similar to a joystick.

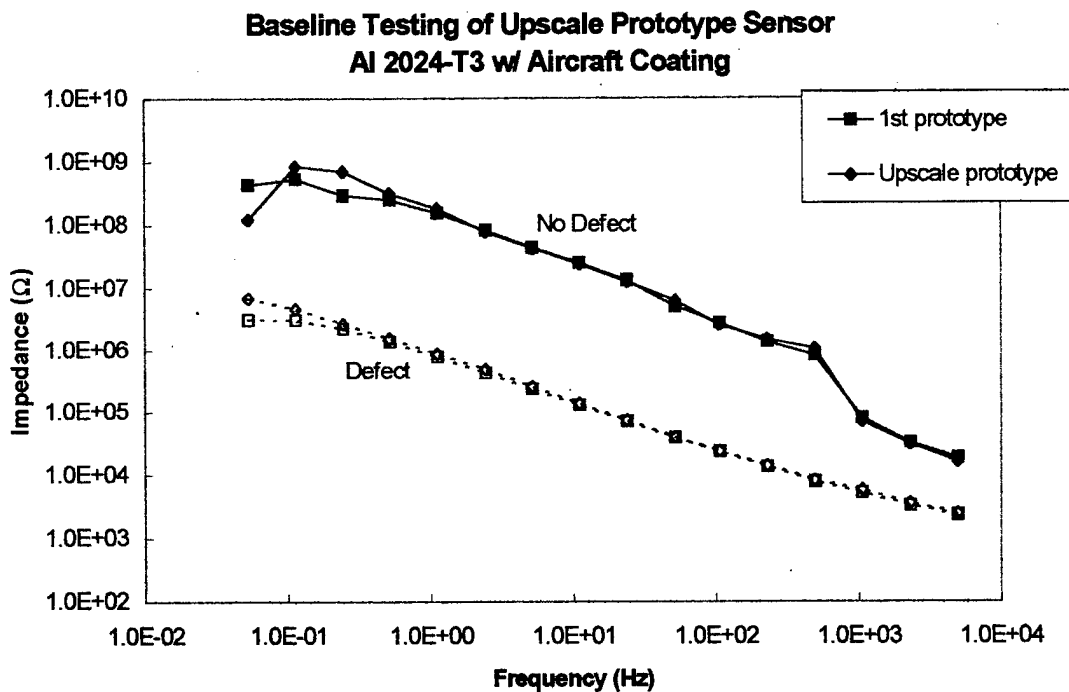
Figure 26. Baseline Upscale Prototype Sensor Testing.

Measurements taken with the upscale sensor were comparable to the first prototype sensor (Figure 26). No problems existed when measuring low impedances at all frequencies (i.e., samples with defects), but higher impedances (at low frequencies) showed some fluctuation. The major problems with the upscale sensor involved operation. It was awkward and tiring to hold for an extended period of time. The ratio of the areas of the fingertip base to the sensing component was too large, which made it tend to rock when holding. The handle was too short, which made it very difficult to hold like a joystick and presented some minor congestion between the user's hand and the wire connections. Vertical and over-head surfaces were virtually impossible to test due to hand fatigue.

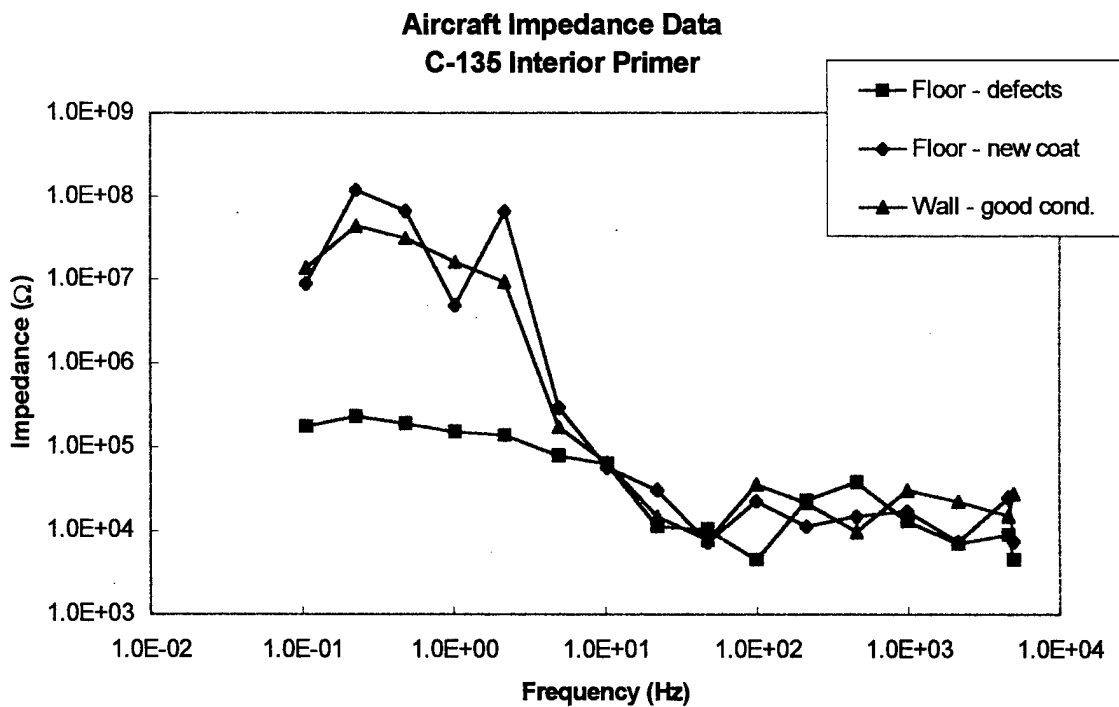
Figure 30. Impedance Spectra of C-135 Aircraft Parts.

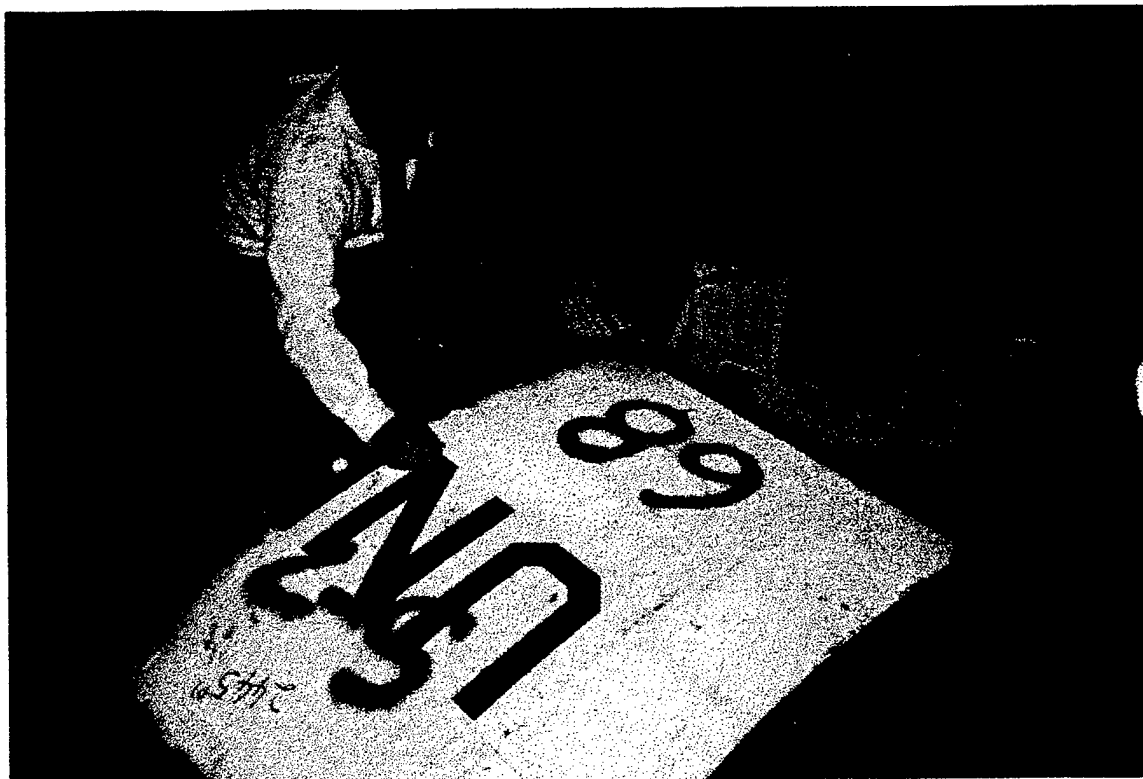
Figure 31. *Photograph of Testing on C130 Fuselage.*

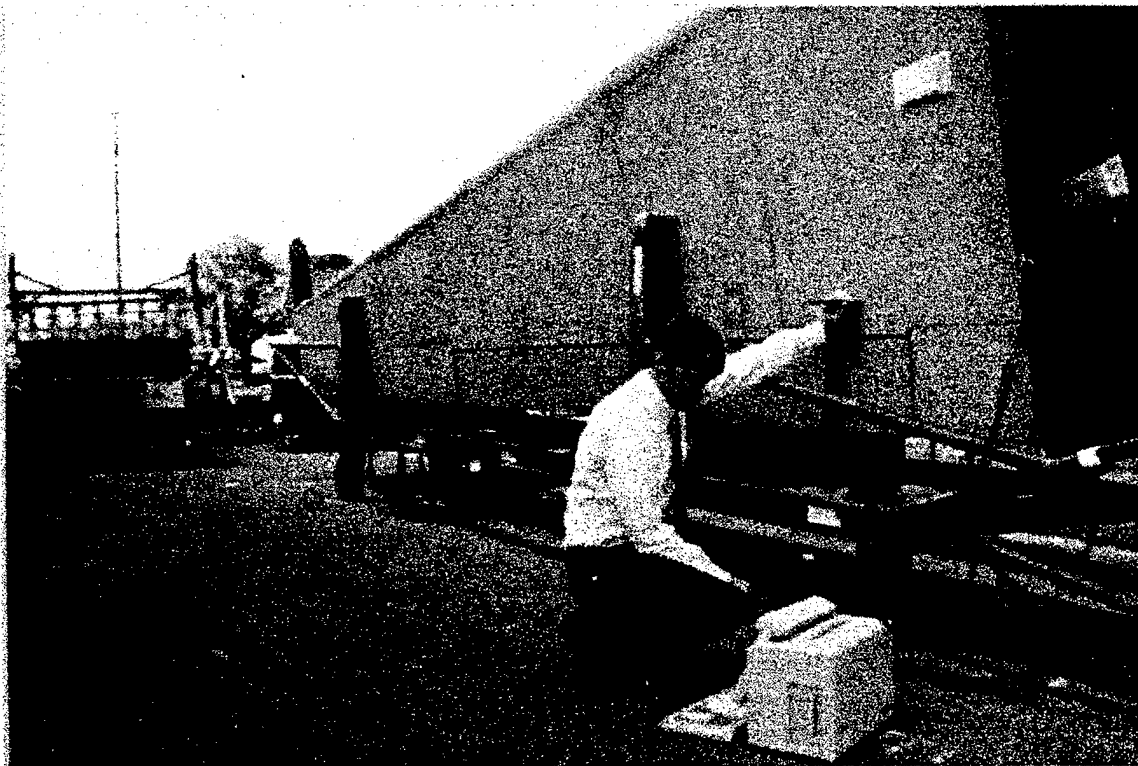
Figure 34. *Photograph of Testing on C130 Elevator Rudder.*
