**NONDESTRUCTIVE METHODS FOR EVALUATING DAMAGE EVOLUTION
AND MATERIAL BEHAVIOR IN METAL MATRIX COMPOSITES**

Final Technical Report

Grant No. F49620-93-1-0461

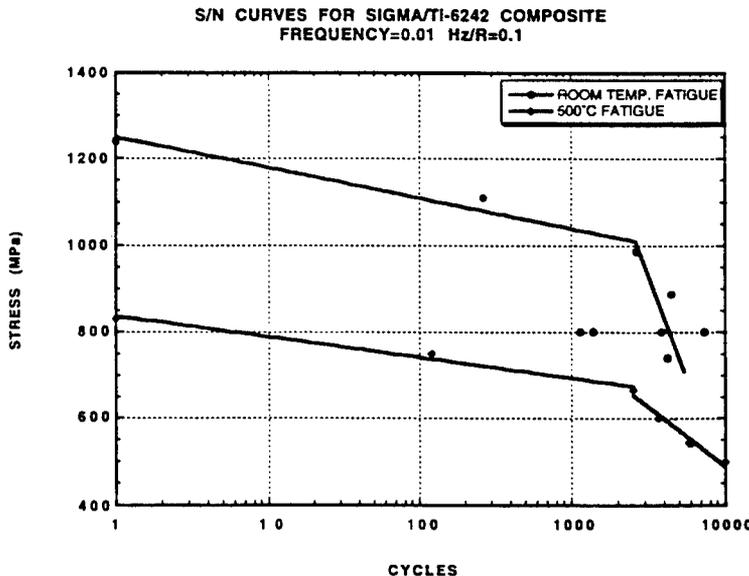
Figure. 1--Baseline isothermal fatigue curves for Sigma/Ti-6242 composite at room temperature and 500°C. Solid lines are drawn to show the change of trend in the data only (not a curve fit).

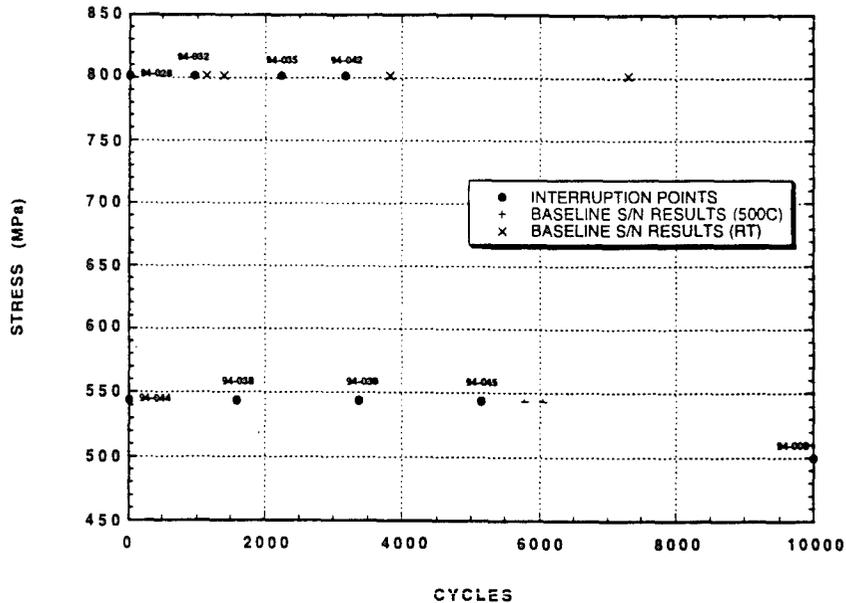
Figure 2 Cycles accumulated prior to interruption or failure for fatigue specimens used in this study.

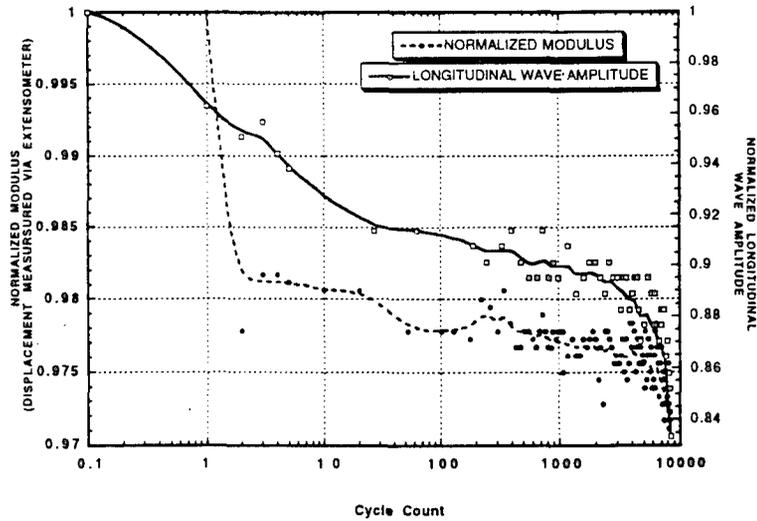
SPECIMEN 94-046: 65% UTS/ROOM TEMP/1 Hz

Figure 5 *in situ* longitudinal wave amplitude versus mechanically measured modulus of specimen 94-046.

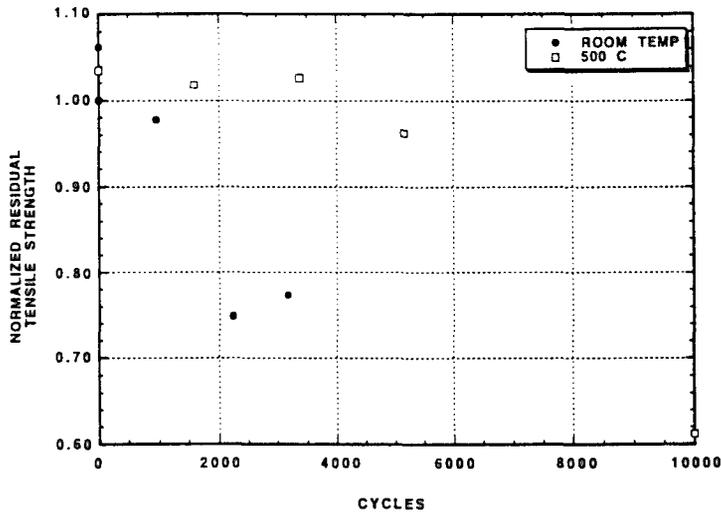
Figure 6 Residual tensile strengths of the interrupted fatigue specimens.

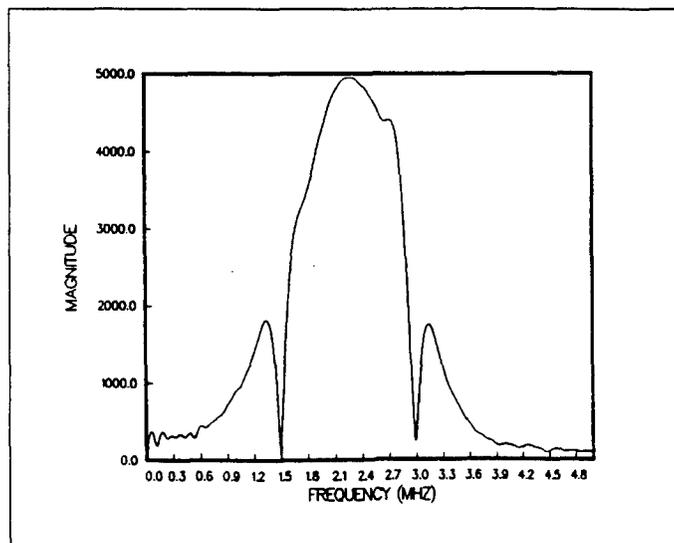
The null zone position changes in presence of an internal defect. Hence, when a defect is encountered, the receiver voltage amplitude is altered and the image of the defect is generated. The major problem with this arrangement is that the null zone position is very sensitive to the plate thickness. Therefore, a few percent change in the plate thickness alters the receiver voltage amplitude significantly. To avoid this problem one needs to filter the L -scan generated

Figure 1 — Spectral nulls produced in the swept frequency "null zone monitoring" method.

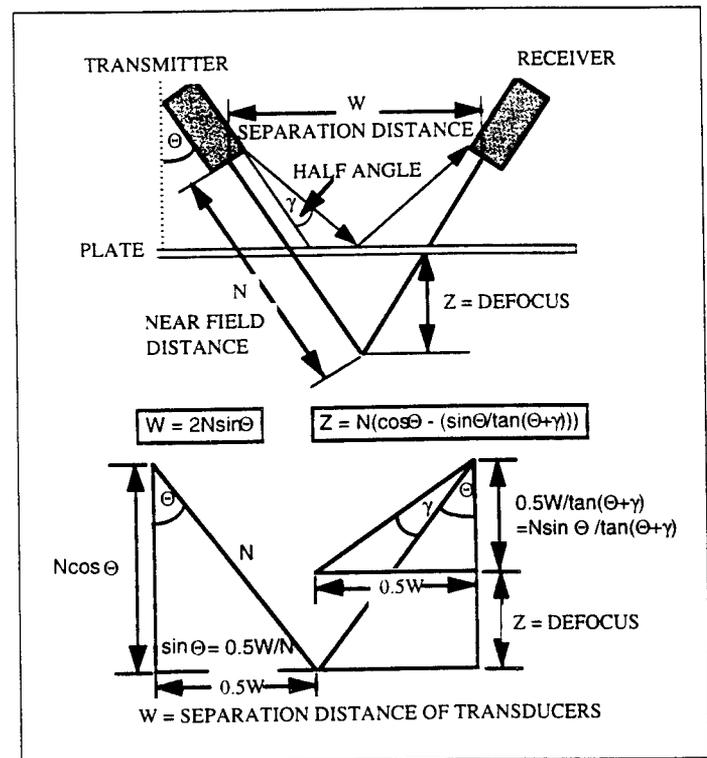
Figure 3 — Geometric considerations based on beam diffraction and nearfield calculations.

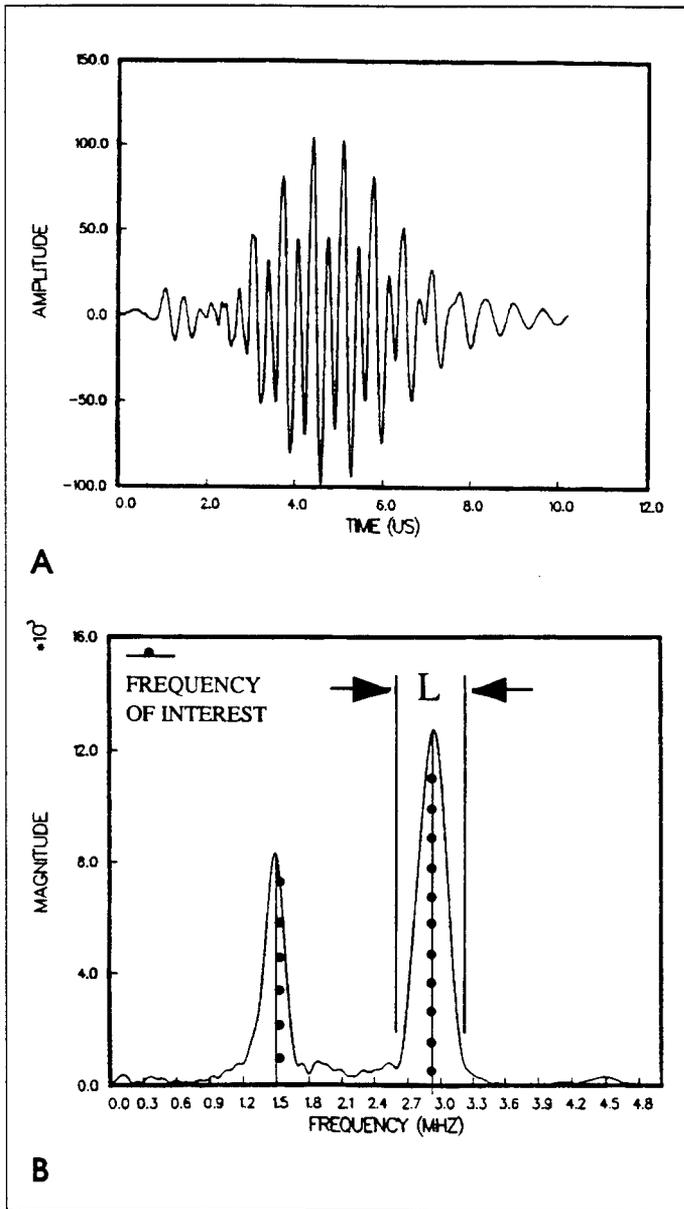
Figure 4 — (a) Received signal when the transducers are properly positioned as per the calculations shown in Figure 3. (b) Fourier analysis of the reflected (leaky) signal in the optimum position.

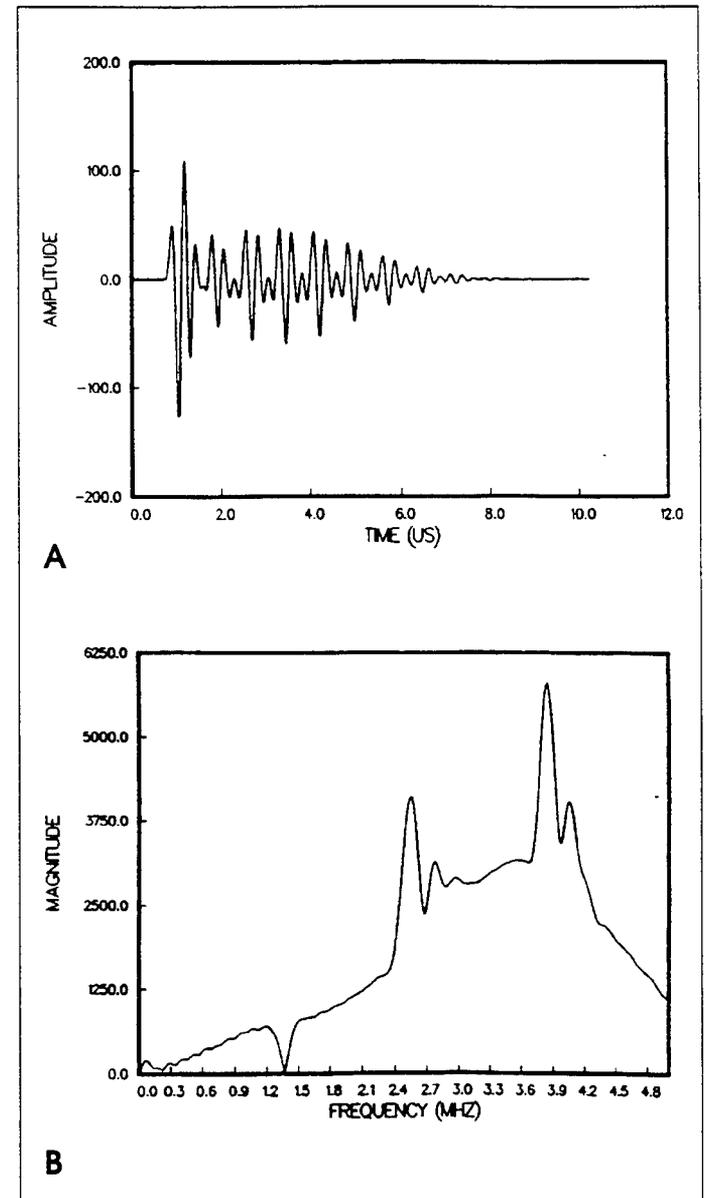
Figure 6 — (a) Received signals when the transducers are in an undesirable location bounded by both the geometric and non-geometric reflection zones. (b) Fourier analysis of the reflected (combination of specular and leaky) signal shown in (a).

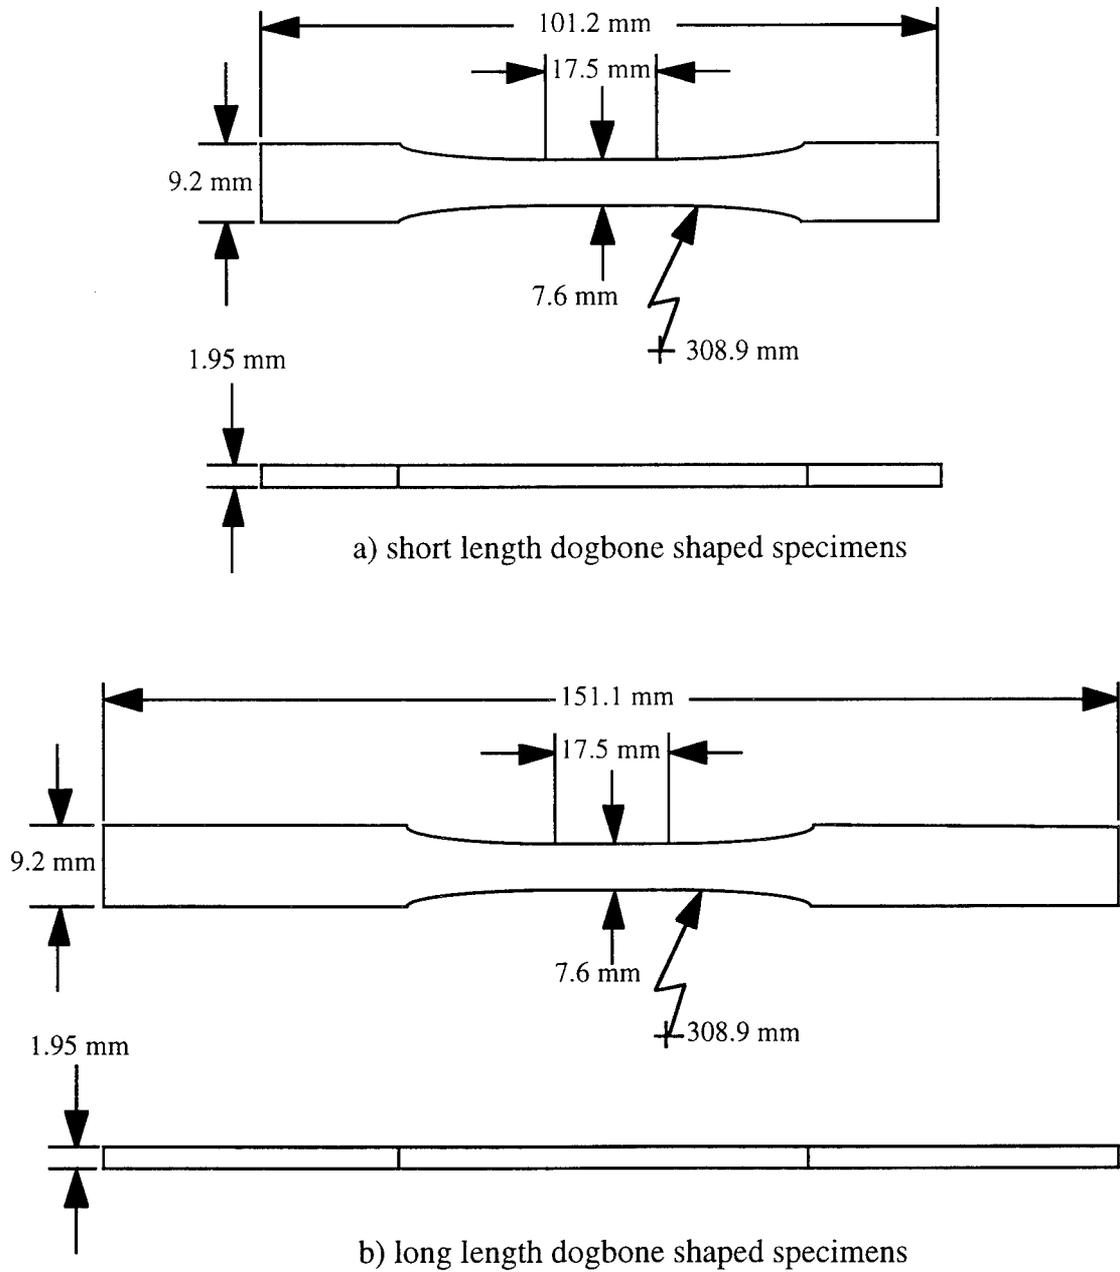
Figure 3. Specimen geometry a) short length and b) long length dogboned shaped specimens. The longer specimens allowed for NDE equipment to be placed on the specimen during testing.

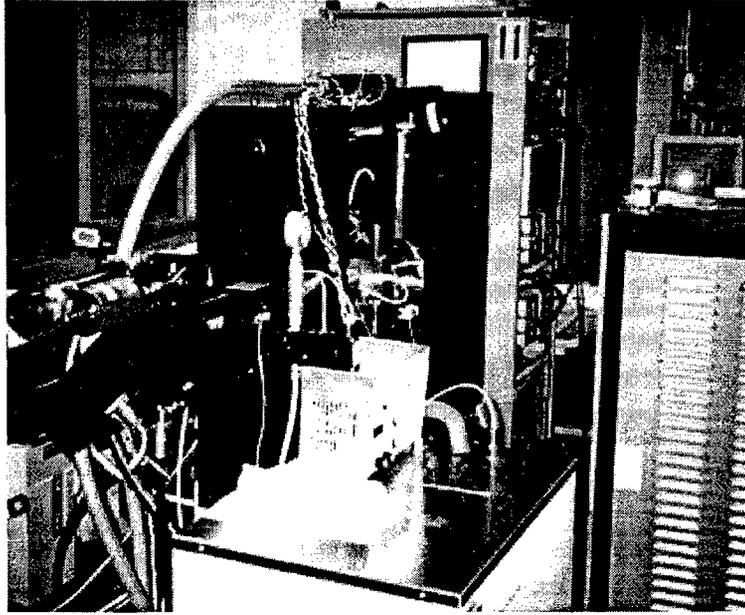
Figure 4. Test control equipment. Clockwise from bottom center: chiller, test frame, MTS controller, MATE system, nitrogen dewars, AE system (monitor on right edge), and UT system (backside shown in right bottom corner of photo).

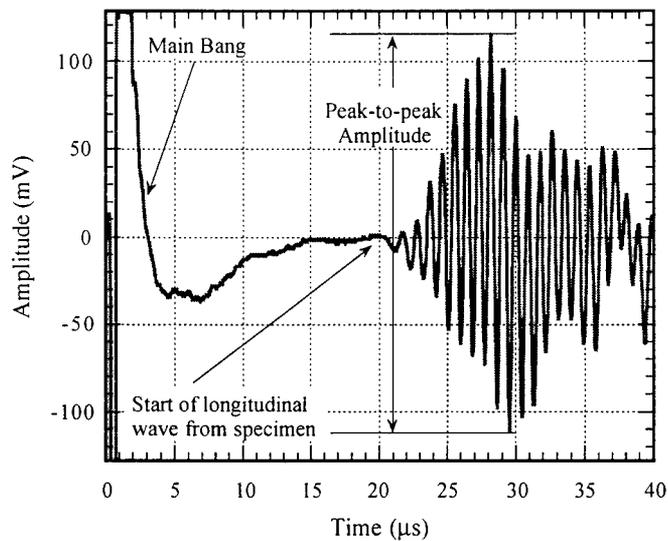
Figure 5. Sample longitudinal bulk wave signal from an SCS-6/Ti-6Al-4V composite before mechanical testing.

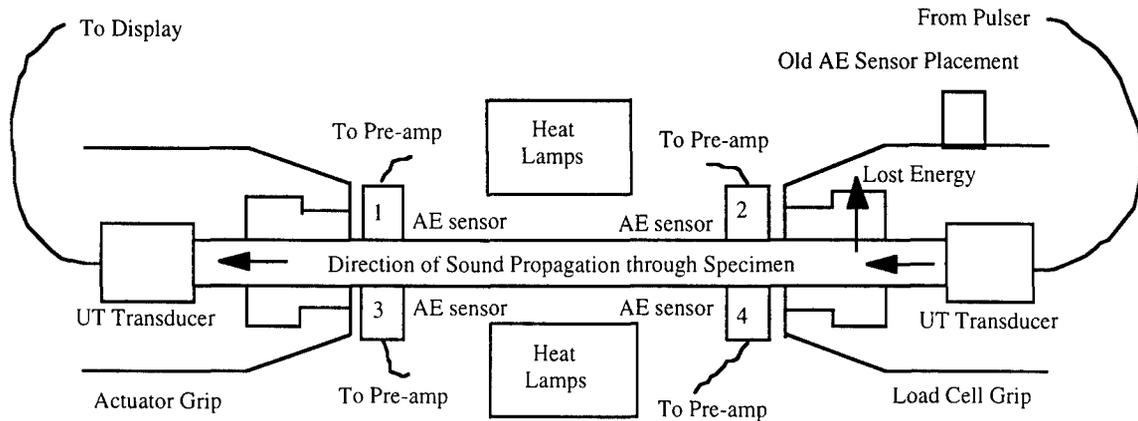
Figure 6. Schematic test set-up showing *in situ* NDE sensor placements in test frame. All sensors are held in place with spring force.

Ultrasonic signal amplitude has been demonstrated as sensitive to material changes during the progression of damage [12, 13]. As damage progresses in the material, the amplitude of the ultrasonic signal decreases. The decrease in ultrasonic amplitude is due to microcracks that reflect and scatter the ultrasound, allowing less signal energy to reach the receiving transducer. The *in situ* setup is demonstrated in Figure 6.

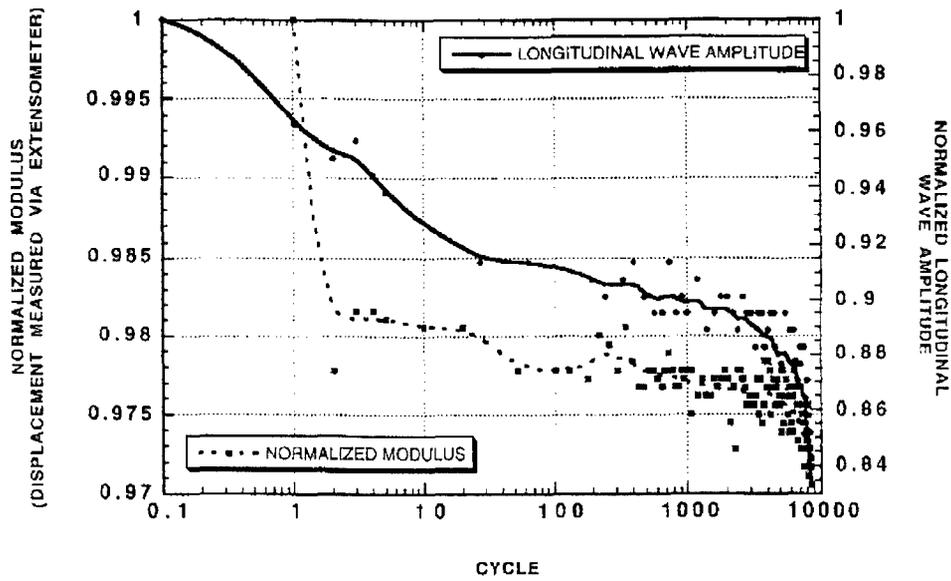
Figure 8. Comparison of normalized modulus degradation to bulk wave signal amplitude degradation vs. fatigue cycles demonstrated by Benson [13].

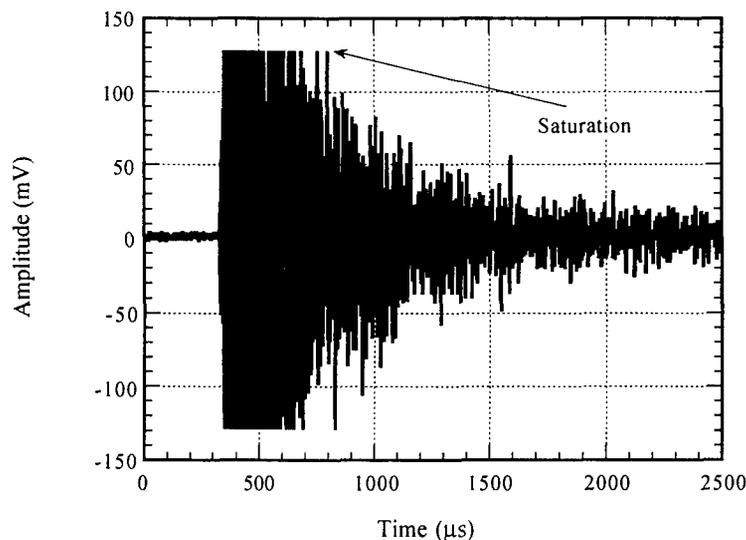
Figure 9. Acoustic Emission signal acquired on the Digital Wave Fracture Wave Detector (FWD) system with the AE sensors located on the test grips.

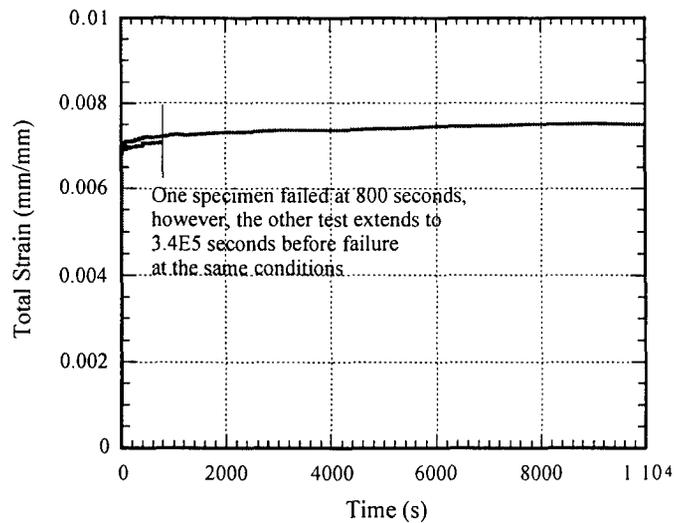
Figure 10. Strain vs. time plot for 96-A49 (short life) and 96-A13 (long life) at the same test conditions.

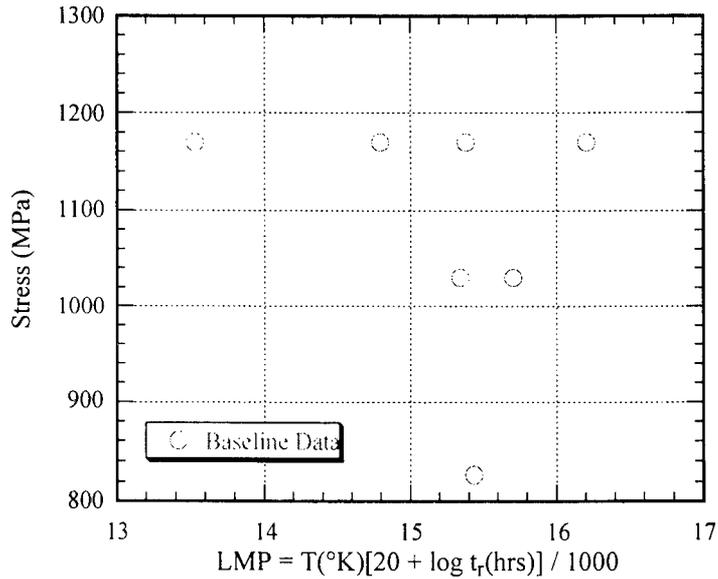
Figure 11. Baseline sustained load test results based on the Larson-Miller Parameter.

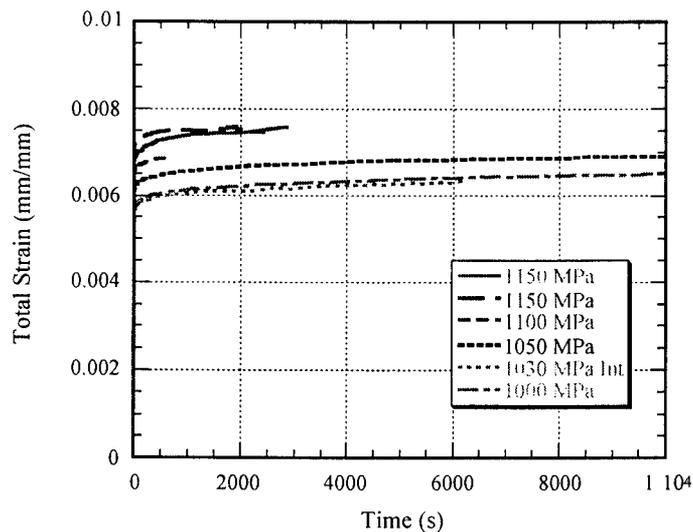
Figure 12. Strain vs. time plot for all NDE samples. The 1030 MPa stress test was interrupted for fiber fracture analysis.

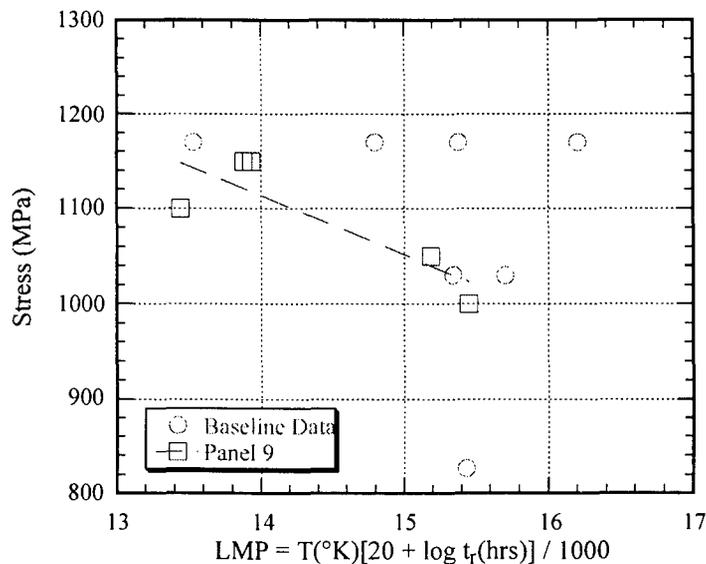
Figure 13. Comparison of baseline data to NDE specimen data using the Larson-Miller Parameter.

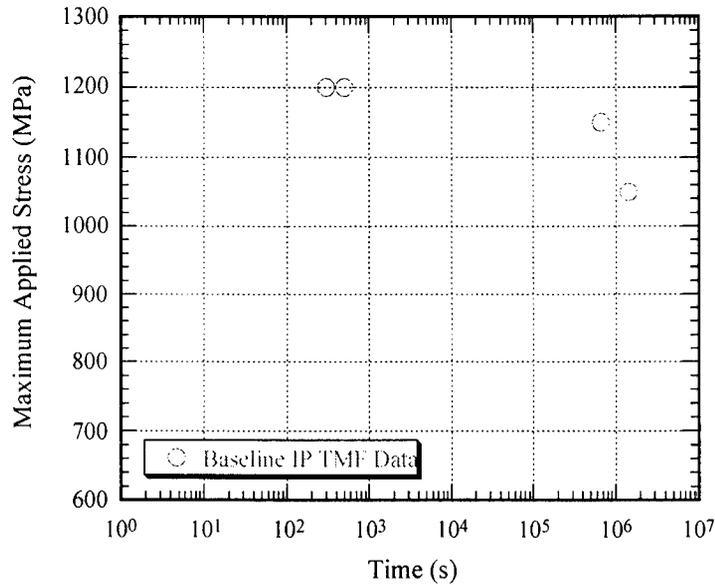
Figure 15. Baseline IP TMF time-to-failure data for the maximum applied stress.

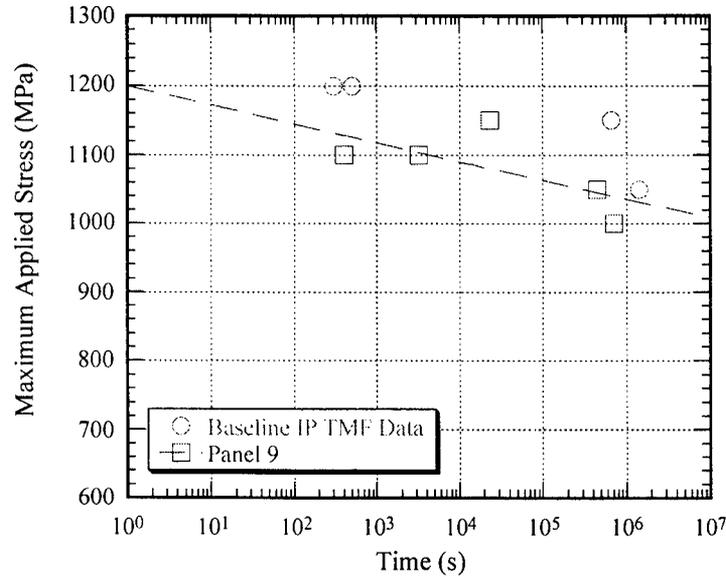
Figure 16. Semi-log plot of IP TMF results for baseline data and NDE study.

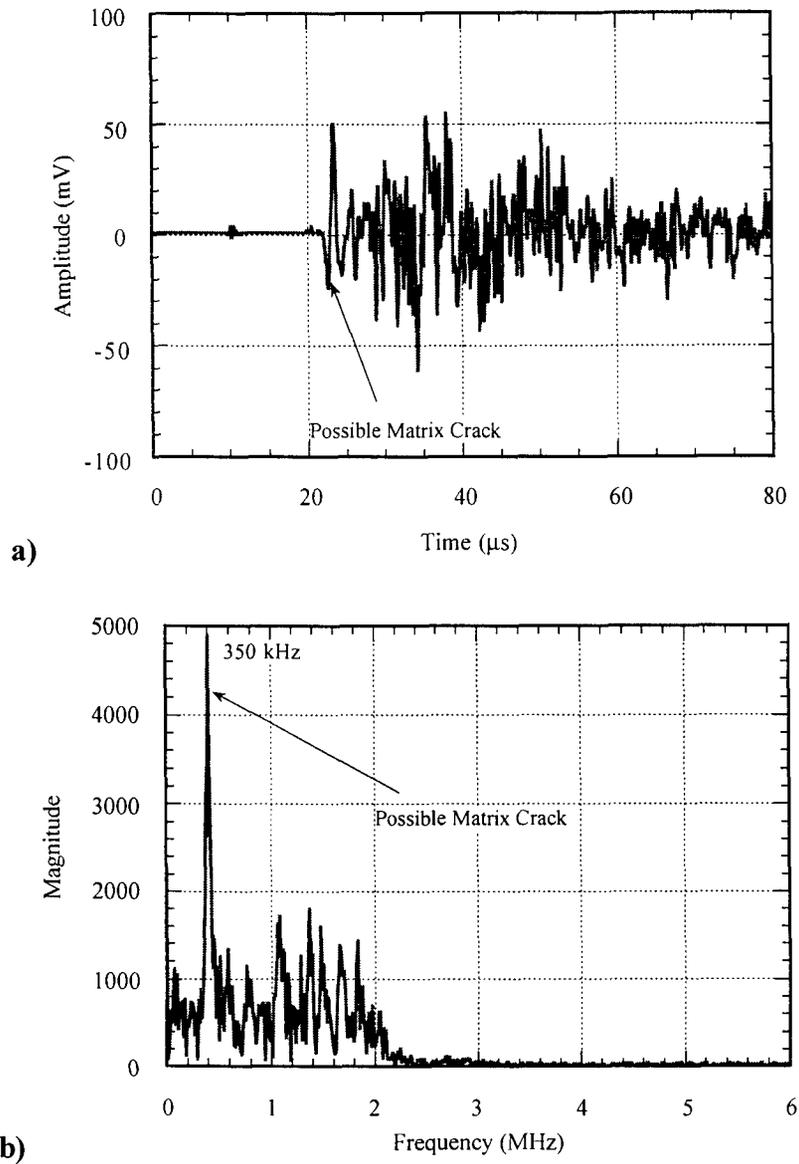
Figure 19. Possible matrix crack waveform from specimen 96-778. a) time domain and b) frequency domain.

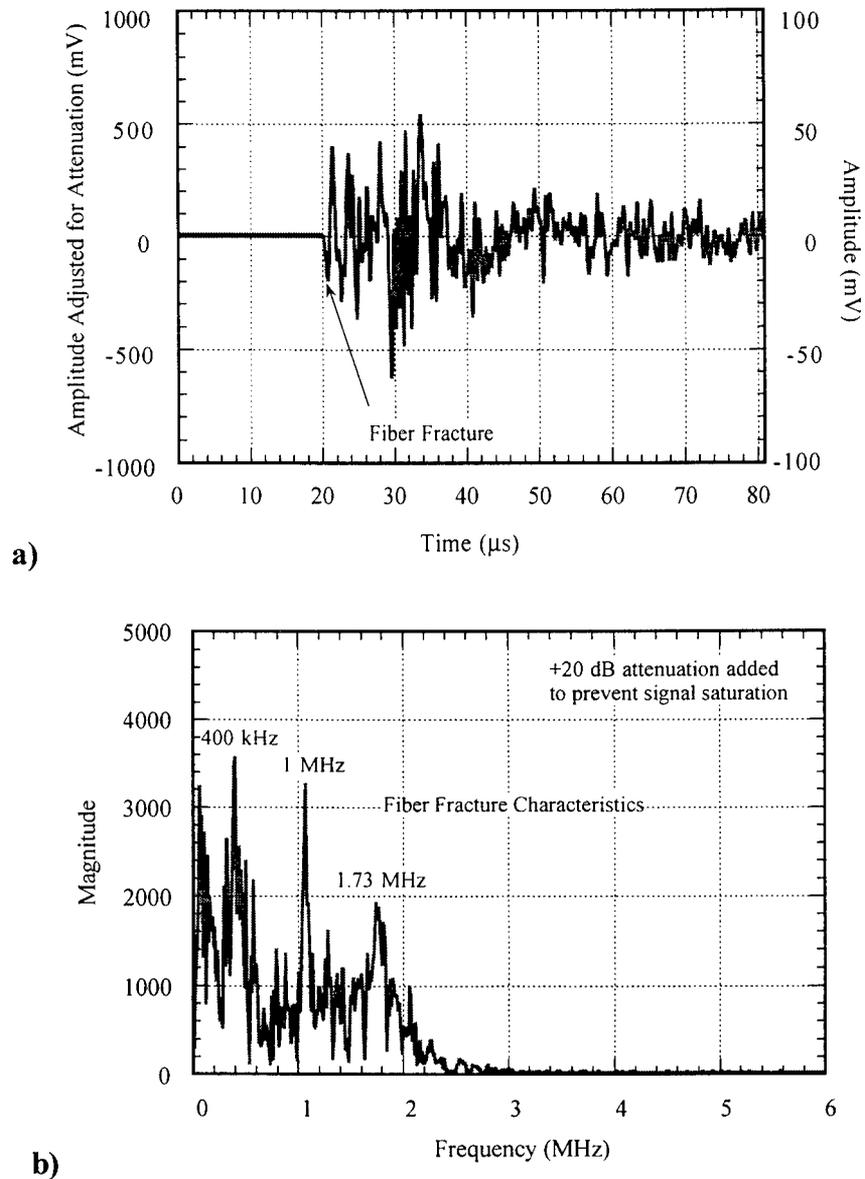
Figure 20. Fiber fracture waveform from specimen 96-778. a) time domain and b) frequency domain.

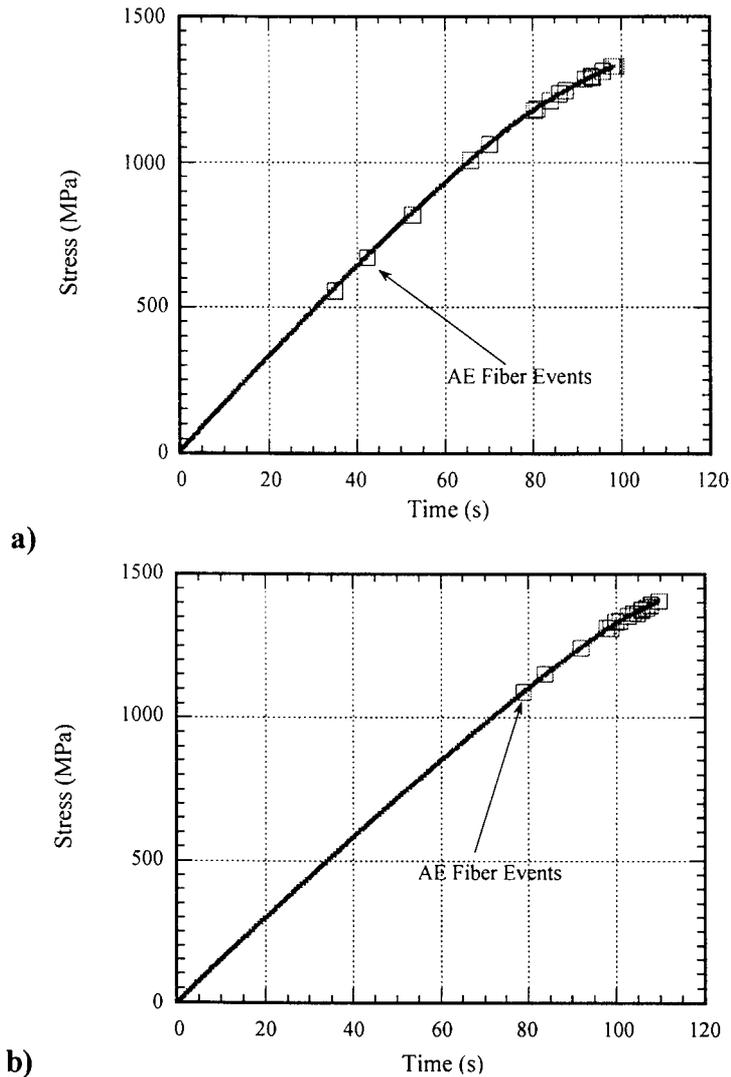
Figure 21. Acoustic emission fiber fracture events recorded during RT tension tests.
 a) UTS = 1329 MPa b) UTS = 1409 MPa.

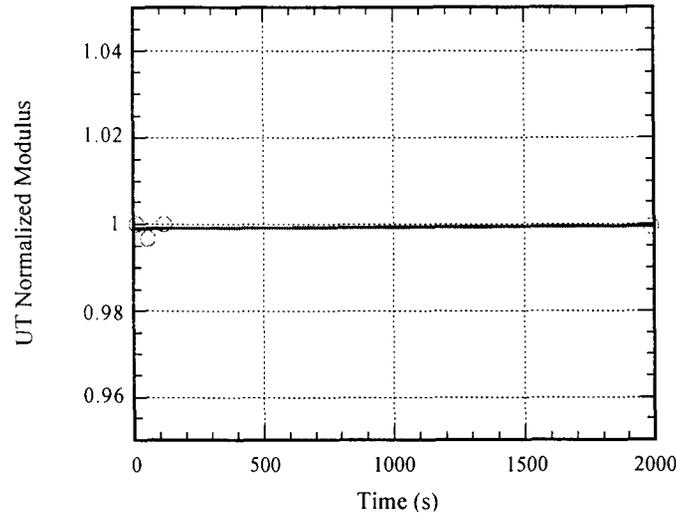
Figure 23. Ultrasonic modulus values during sustained load test at 1150 MPa.

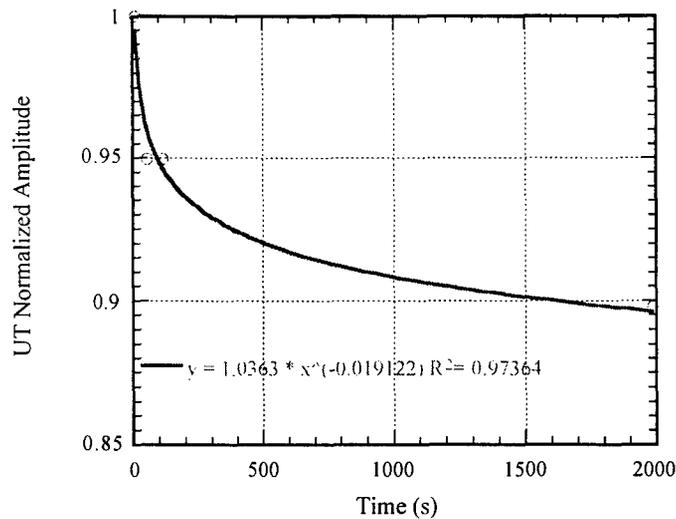
Figure 24. Ultrasonic amplitude response under sustained load conditions for 1150 MPa. Data were fit to power equation displayed in the figure.

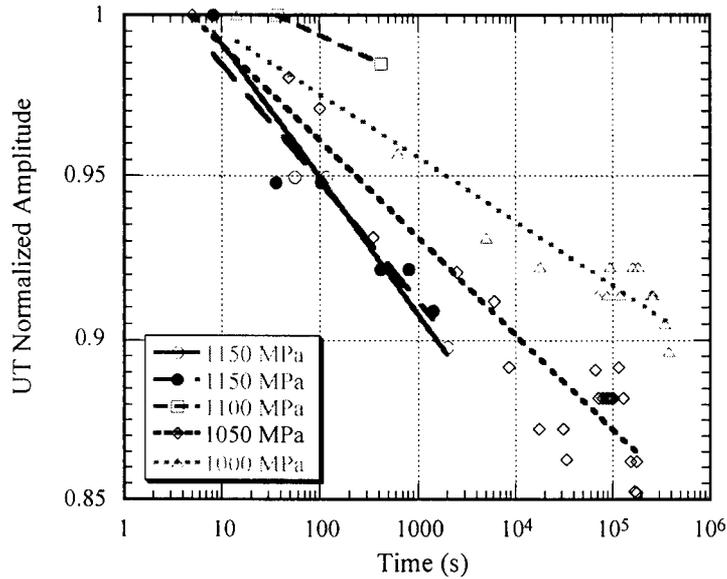
Figure 25. All ultrasonic amplitude data for sustained load tests.

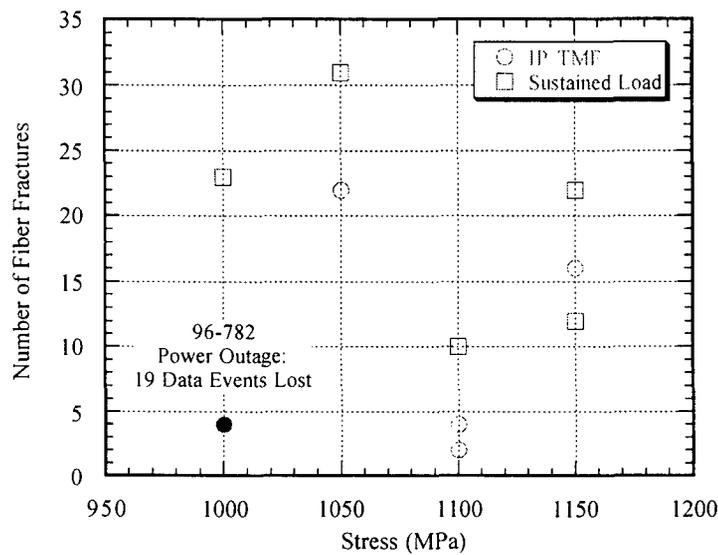
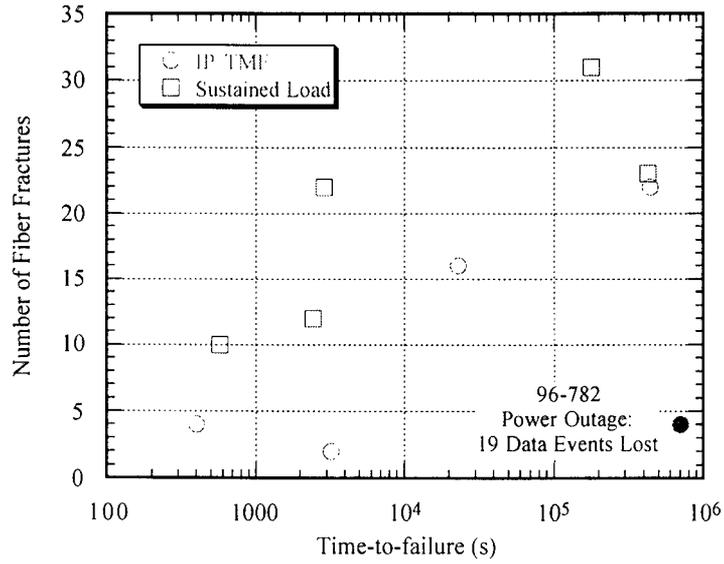
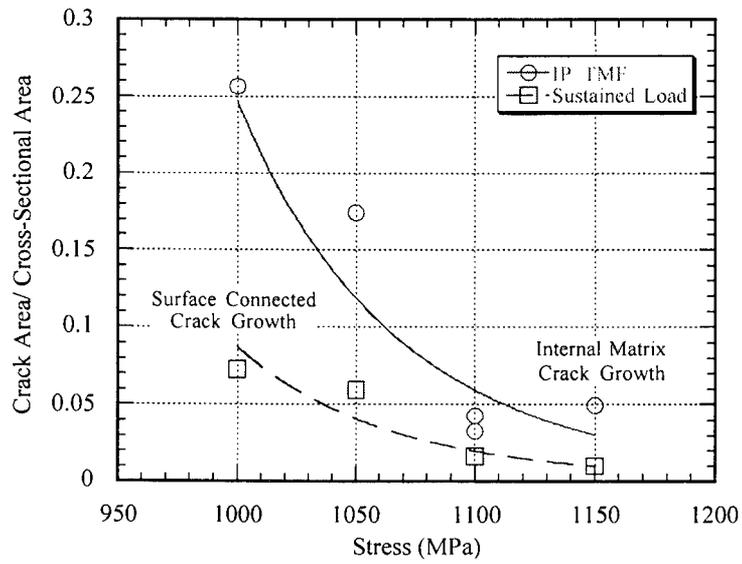
a) **Figure 26.** Fiber fractures determined by AE analysis as a function of a) stress level and b) time-to-failure in comparison to c) matrix crack growth size on the fracture surfaces.

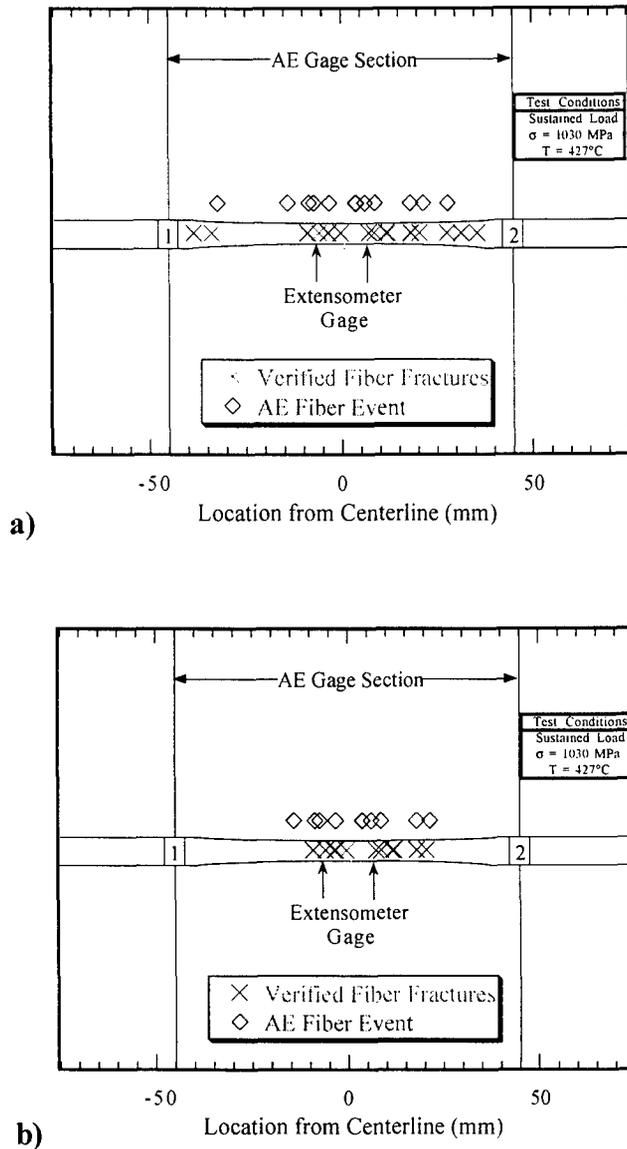
Figure 30. Comparison of location of AE fiber fracture events based on amplitude to verified optical measurements a) in total AE gage section, and b) in heated test section.

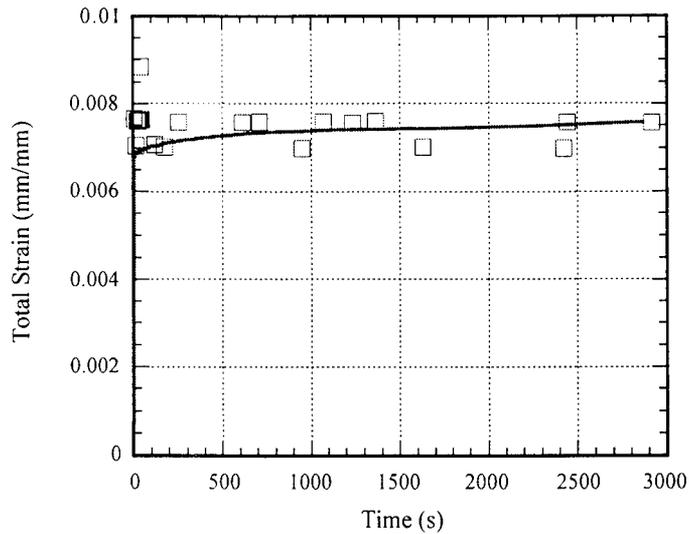
Figure 31. AE fiber fractures compared to mechanical sustained load data for 1150 MPa.

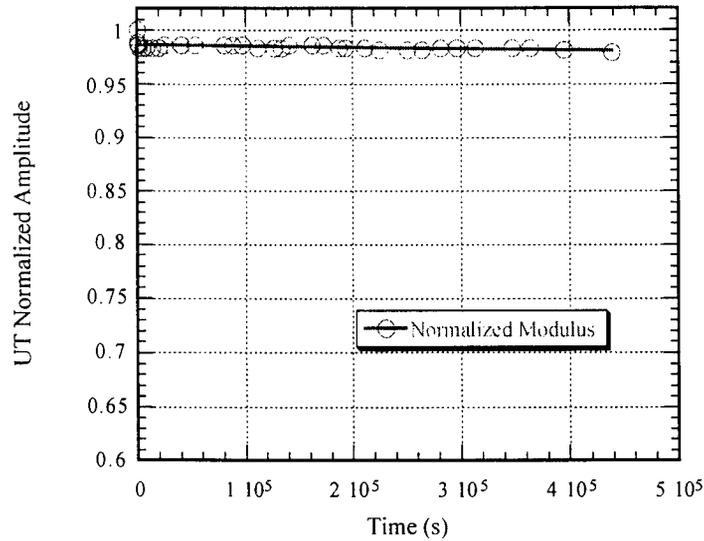
Figure 32. Ultrasonic modulus values acquired during IP TMF test for 1050 MPa.

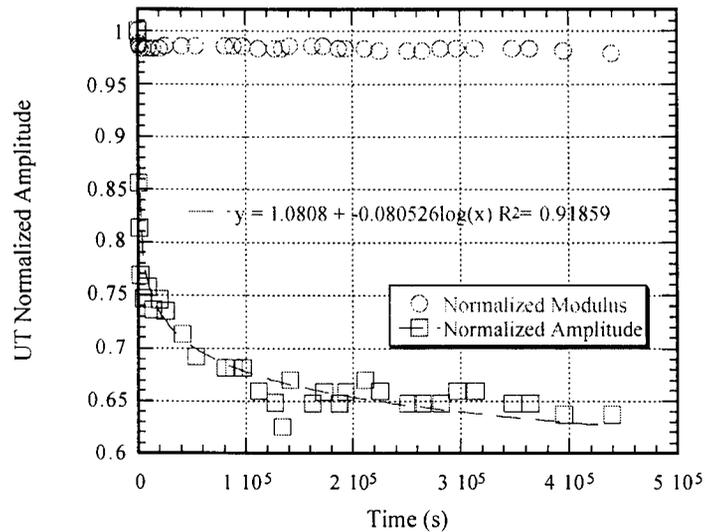
Figure 33. Ultrasonic amplitude response under IP TMF conditions for 1050 MPa test compared to ultrasonic modulus.

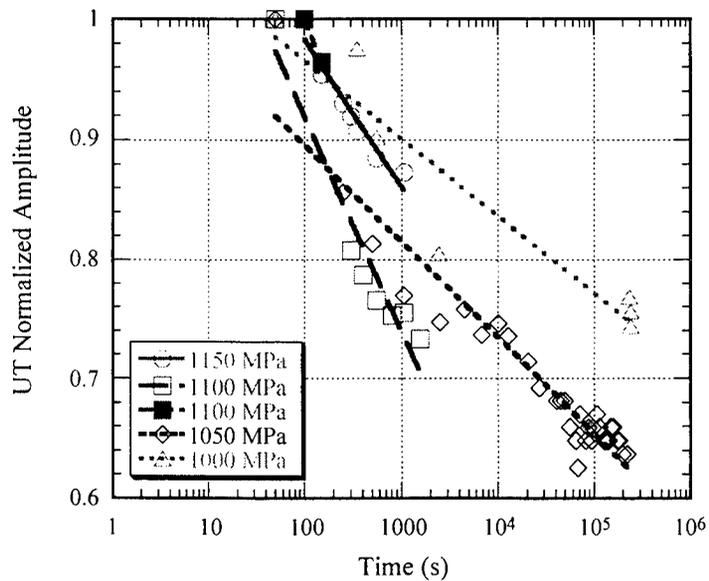
Figure 34. All IP TMF ultrasonic amplitude data. Slopes generally decreased with decreasing stress except for irregularities at 1100 MPa.

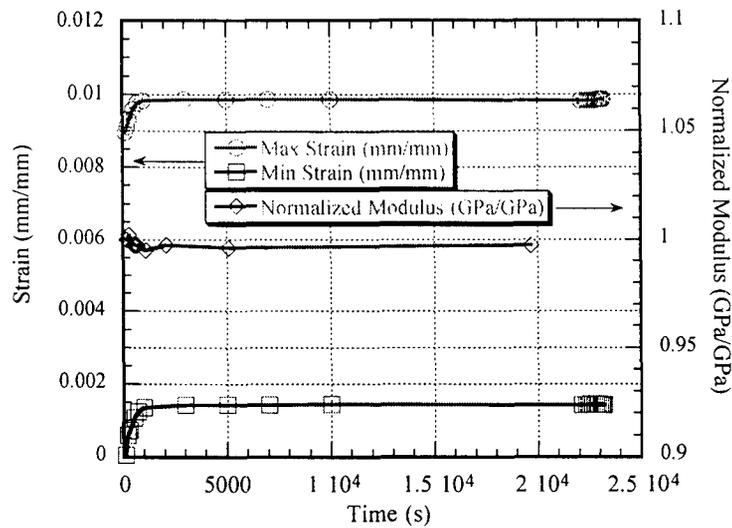
Figure 35. Comparison of mechanical strain sensitivity to UT modulus sensitivity for 1150 MPa IP TMF test.

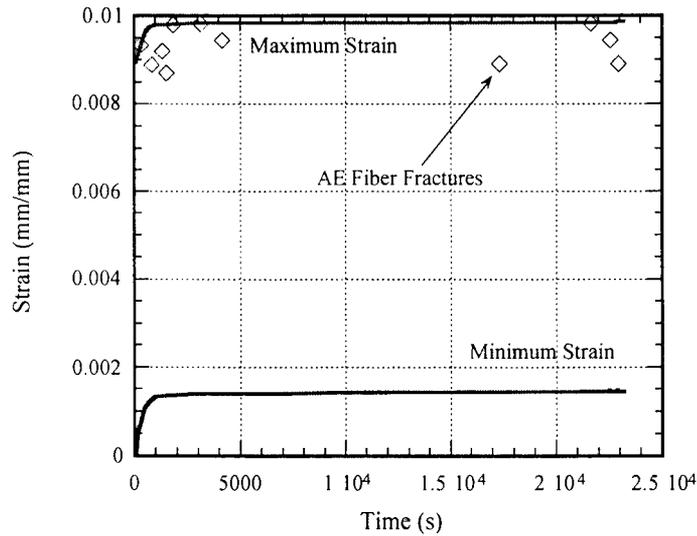
Figure 36. AE fiber fractures compared to mechanical data for 1150 MPa IP TMF test.

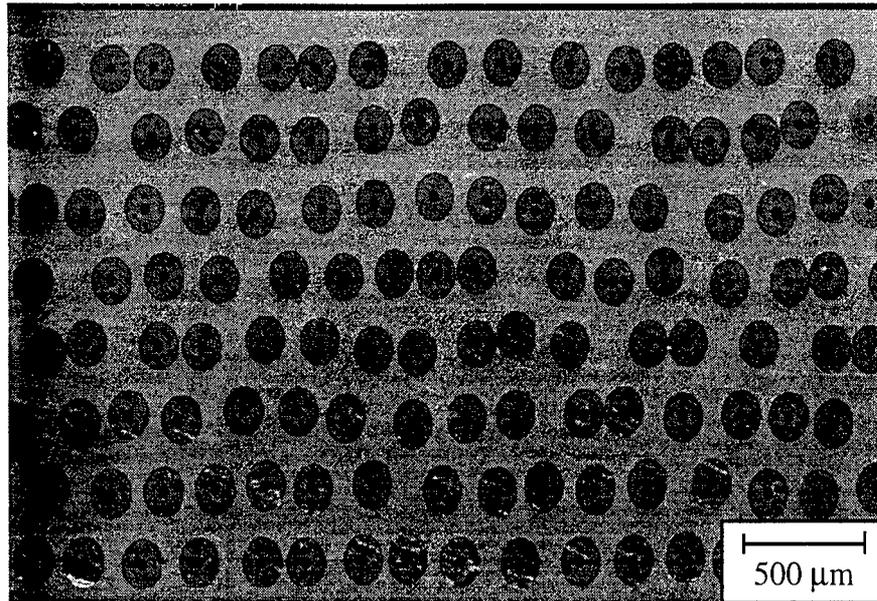
Figure 41. Typical cross section of SCS-6/Ti-6Al-4V composite specimen.

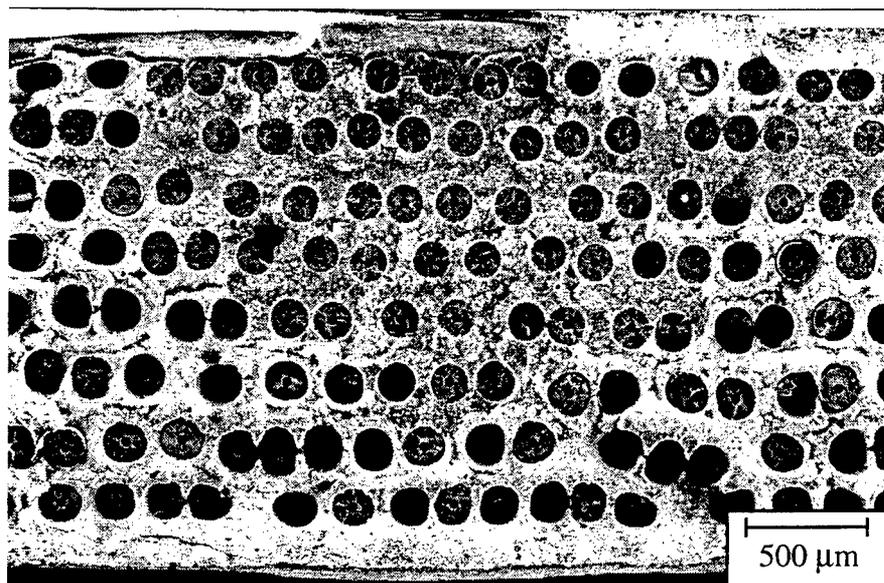
Figure 42. Typical fracture surface of SCS-6/Ti-6Al-4V composite specimen.

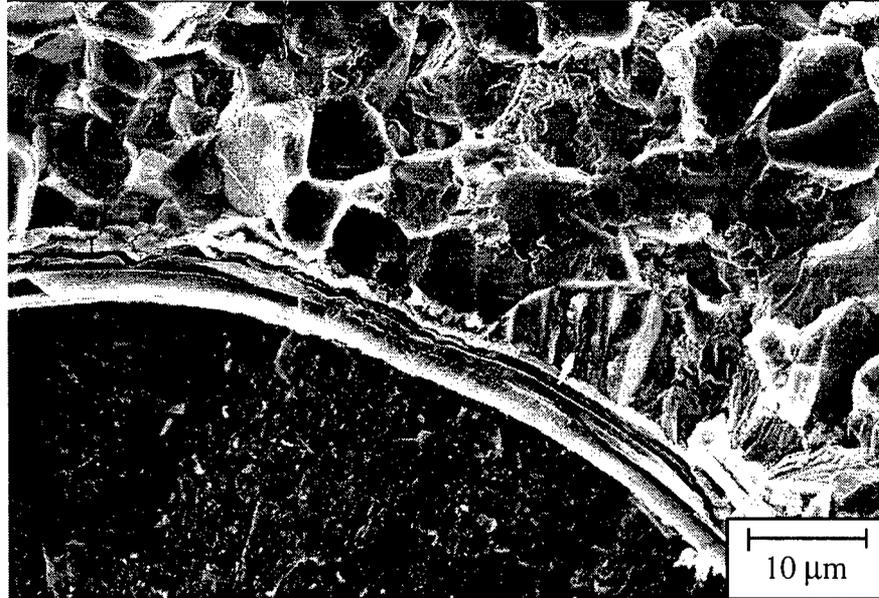
Figure 43. Close examination of fiber failure. Fiber appears to lack coating layer, causing intergranular matrix crack growth to begin at the fiber/matrix interface.

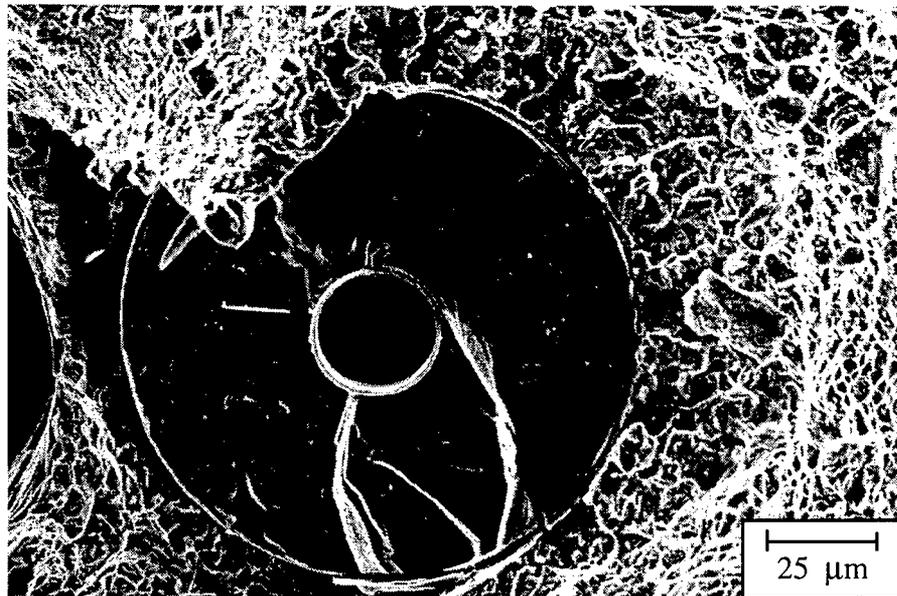
Figure 44. Intergranular crack propagation in the matrix.

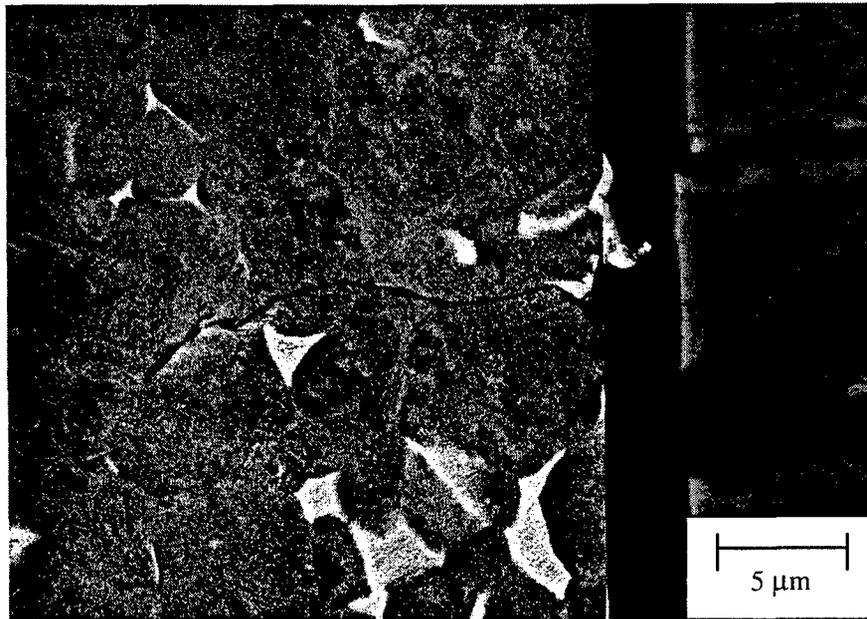
Figure 45. Matrix crack emanating from a fiber fracture in specimen 96-782 away from the fracture surface. There is no debond between the fiber and matrix.

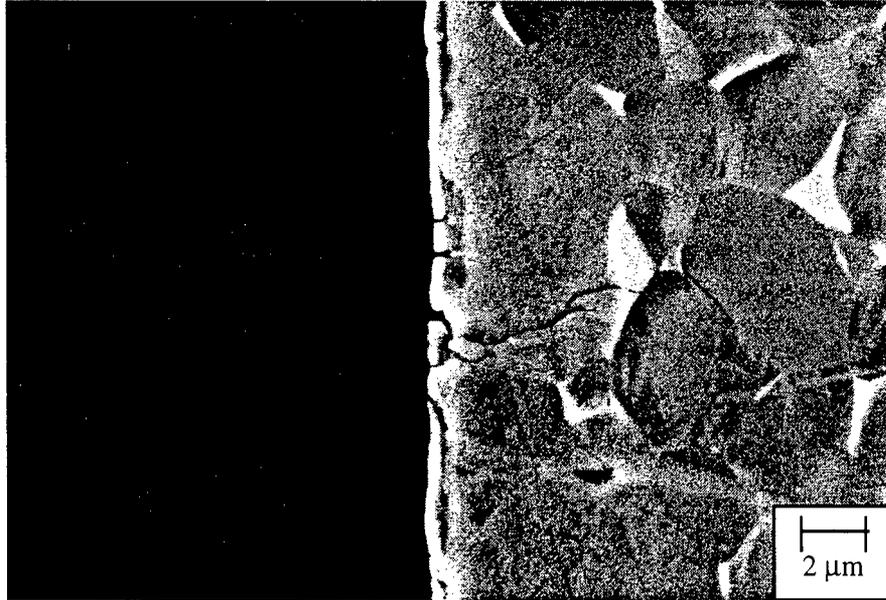
Figure 46. Matrix crack growth along grain boundaries in specimen 96-782. Matrix crack is approximately 11 μm in length.
