**NONDESTRUCTIVE METHODS FOR EVALUATING DAMAGE EVOLUTION
AND MATERIAL BEHAVIOR IN METAL MATRIX COMPOSITES**

Final Technical Report

Grant No. F49620-93-1-0461

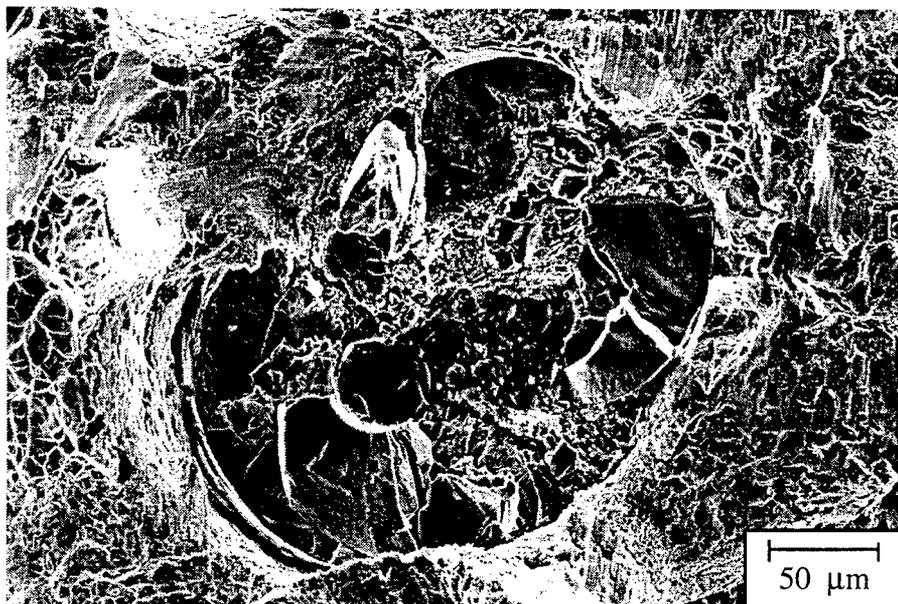
Figure 48. Crushed fiber with matrix consolidated around the pieces. It was concluded that the fibers were broken prior to matrix consolidation in processing.

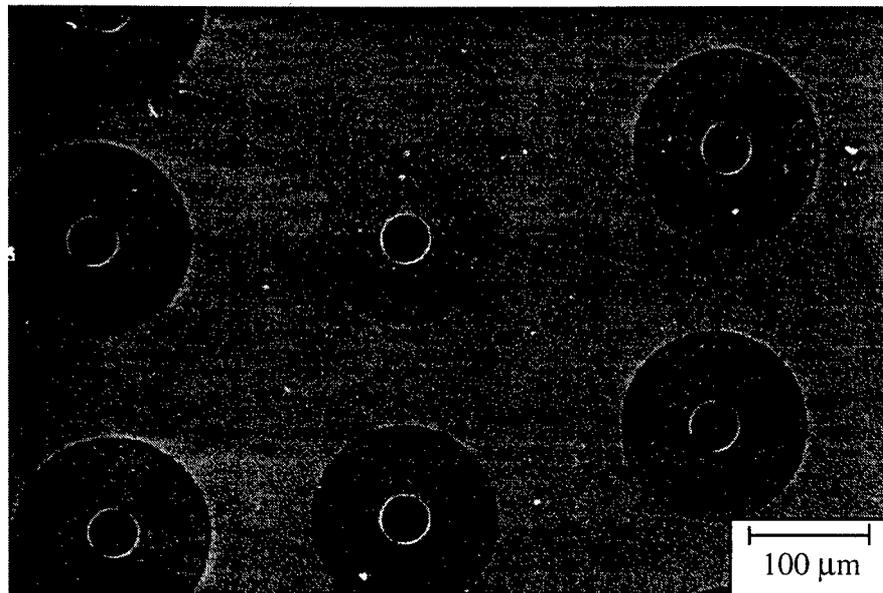
Figure 49. Magnification of 96-775 cross section. Central fiber has no outer carbon coating layer.

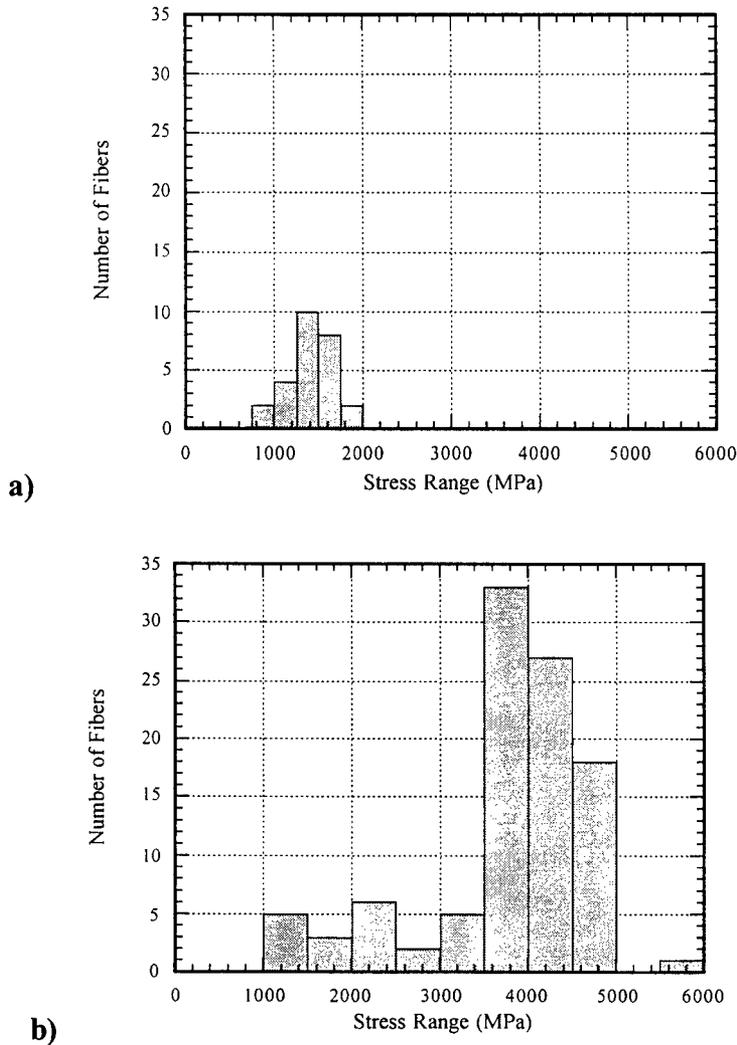
Figure 50. Fiber strengths based on coating determined by Gambone [54]. a) uncoated fibers b) coated fibers.

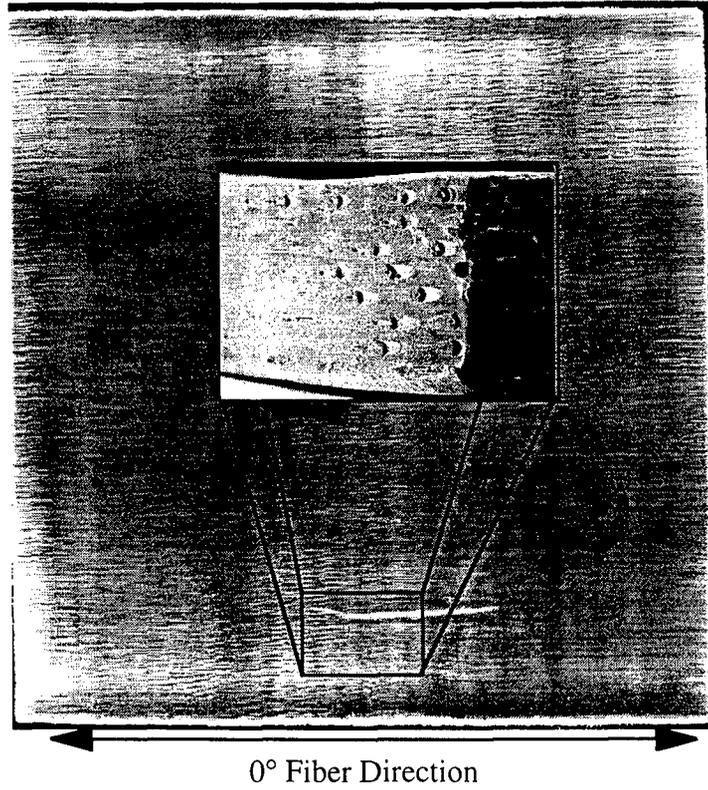
Figure 51. X-ray radiograph of composite panel used in study. Marked region indicates fiber swimming. SEM image from region shows fibers swimming out of loading axis.

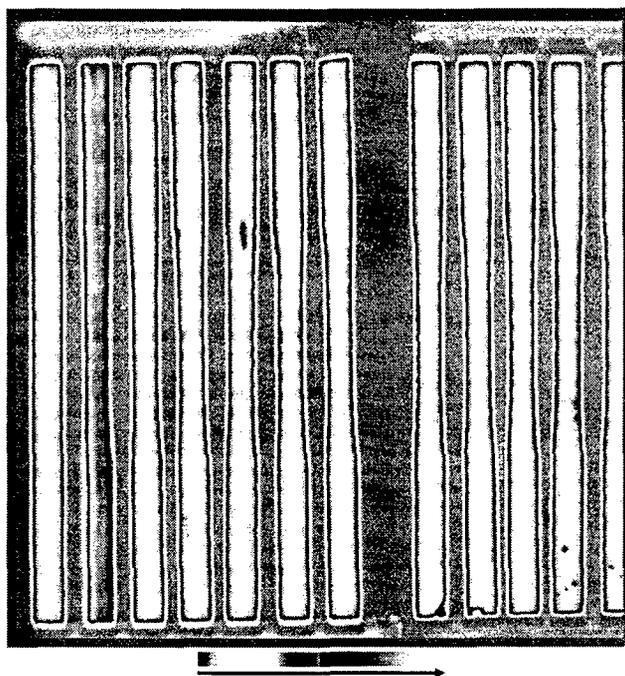
Figure 56. Reflector plate C-scan of specimens. Specimens are in sequential order from left to right. Straight-sided specimen placed at left end.

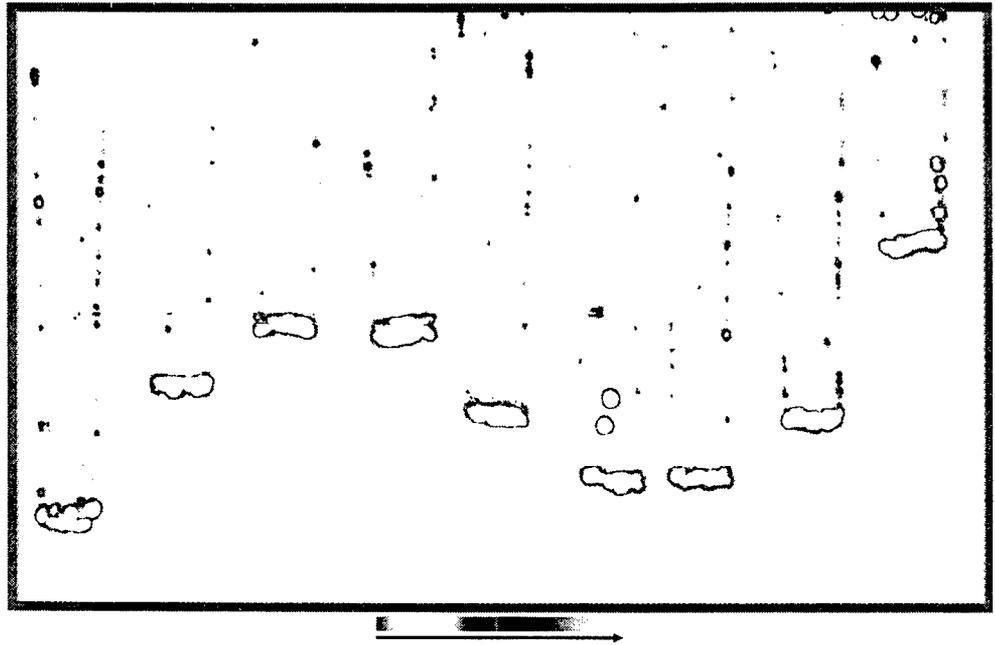
Figure 63. Backside of failed sustained load and IP TMF specimens scanned using backscatter shear wave technique. Specimens in sequential order from left to right (96-772 and 96-775 not shown here). White regions indicate fracture surfaces, specimen edges and thermocouple welds (96-779).

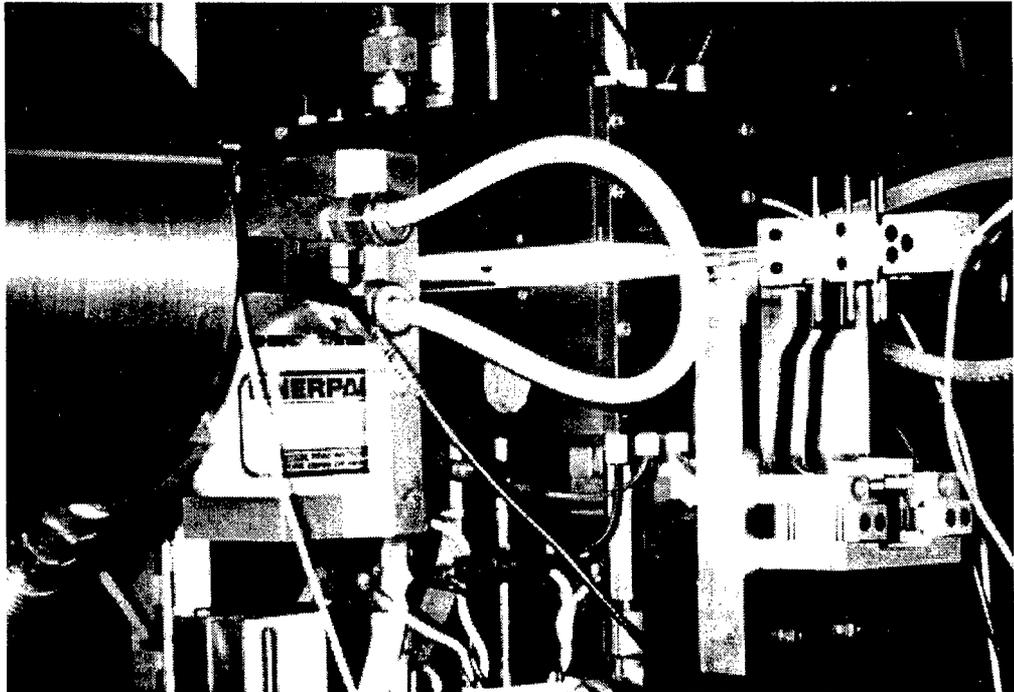
Figure 64. Specimen in test frame. Quartz heat lamps and grips shield the specimen from view.

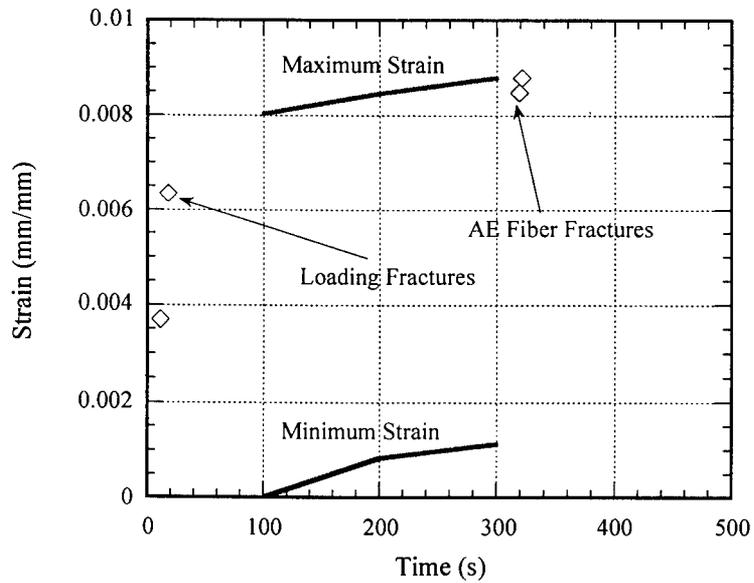
Figure 85. AE data overlaying mechanical strain data. Fiber fractures occurred on loading and at composite fracture.

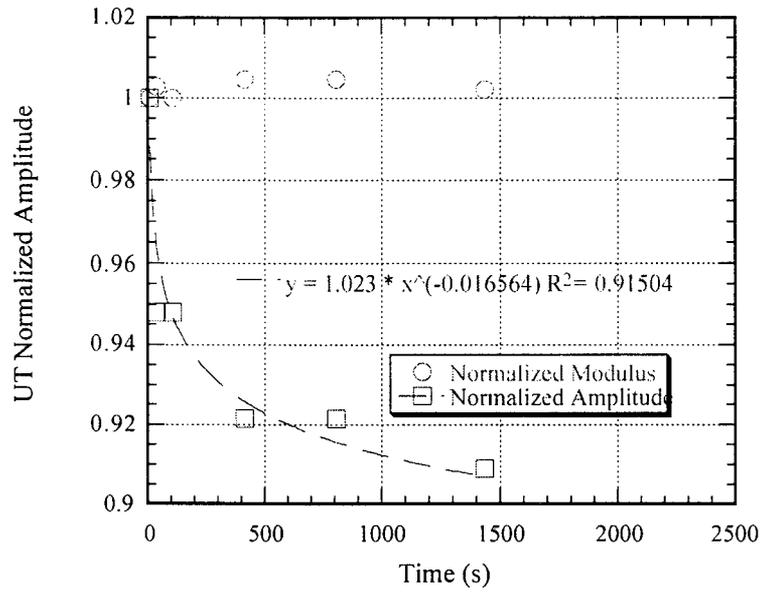
96-776: Sustained Load at 1150 MPa

Figure 86. Modulus and amplitude data.

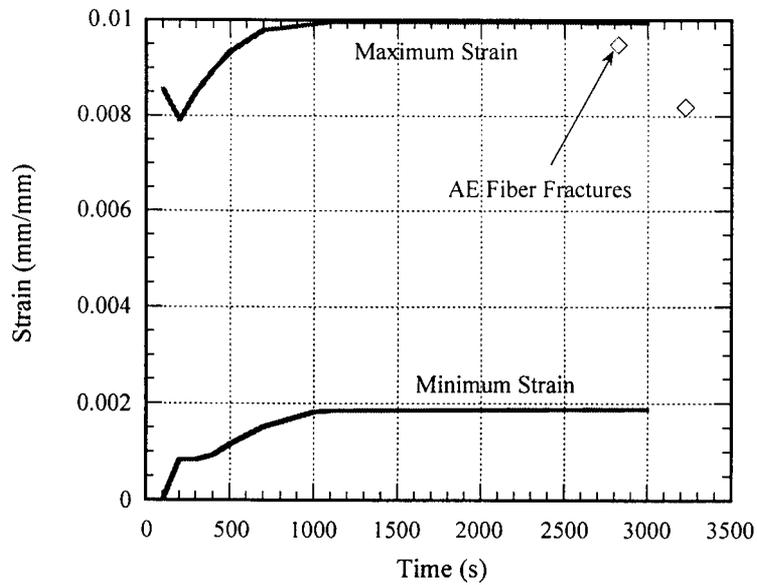
Figure 89. AE data overlaying mechanical strain data. Decrease in strain levels on AE events is due to inaccurate measurements and total specimen fracture.

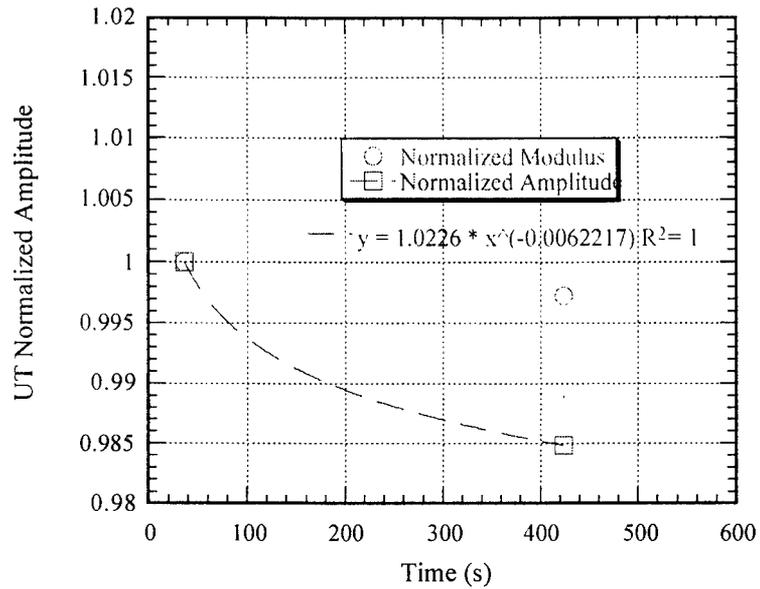
Figure 90. Modulus and amplitude data.

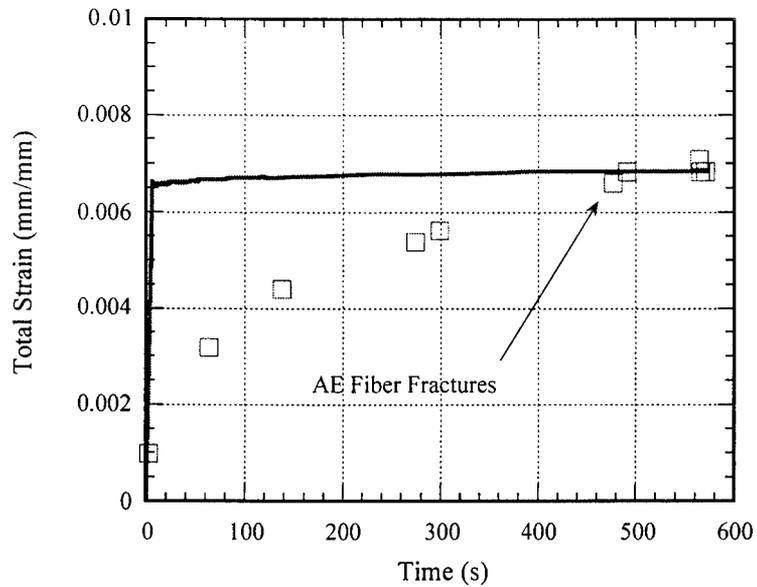
Figure 91. AE data overlaying mechanical strain data. Data confirms fracture approximately 0.25 mm from centerline. Deviation of AE strain values from mechanical data is due to inaccurate recording of strain level values by the AE system.

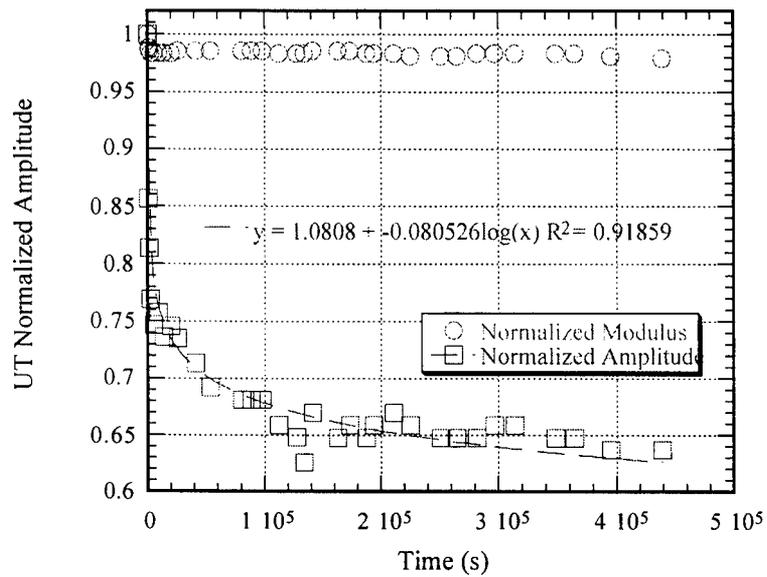
Figure 92. Modulus and amplitude data.

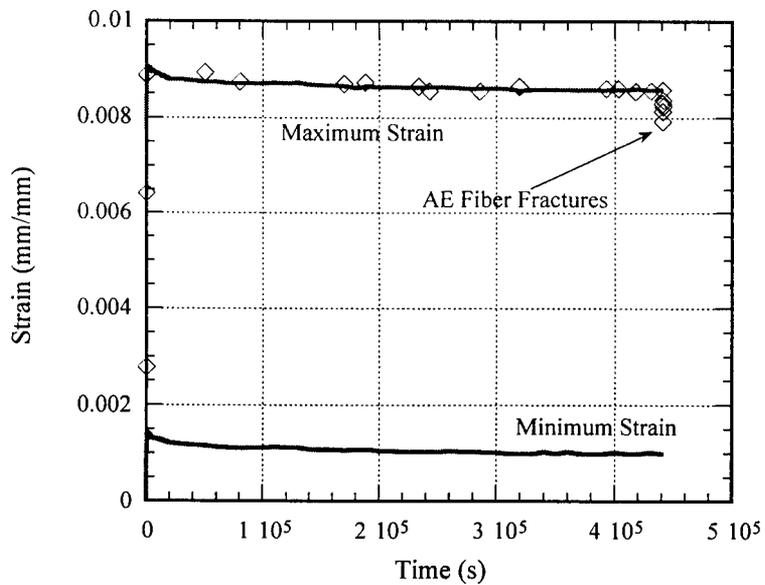
Figure 93. AE data overlaying mechanical strain data. Decrease in strain at end of test is due to displacement in final fracture.

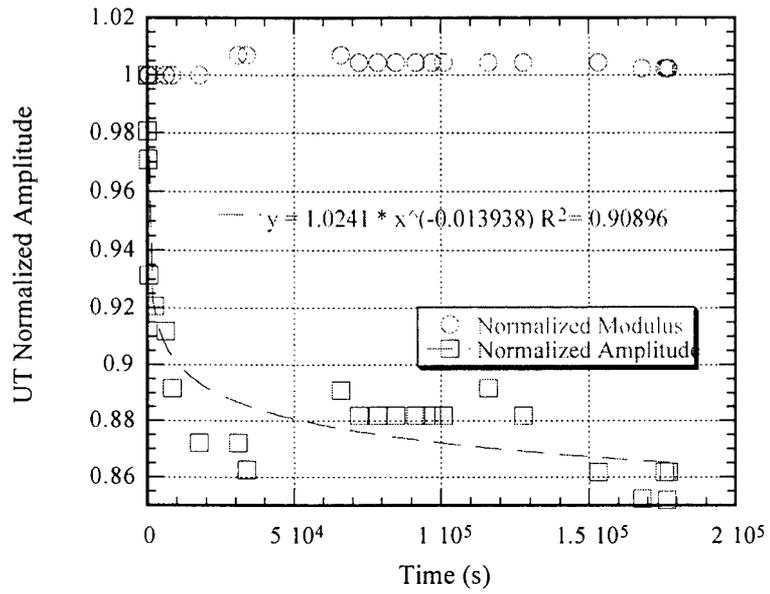
Figure 94. Modulus and amplitude data.

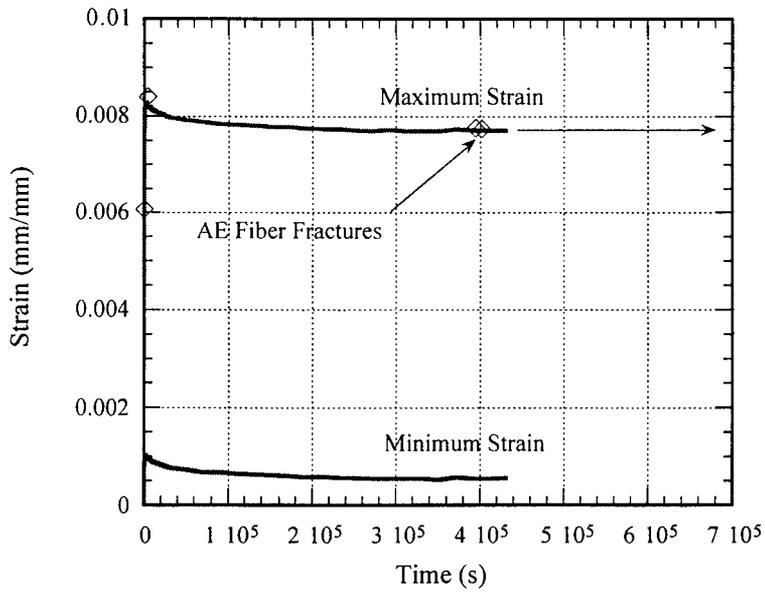
Figure 99. AE data overlaying mechanical strain data. Electrical outage caused loss of data at end of test indicated by arrow.

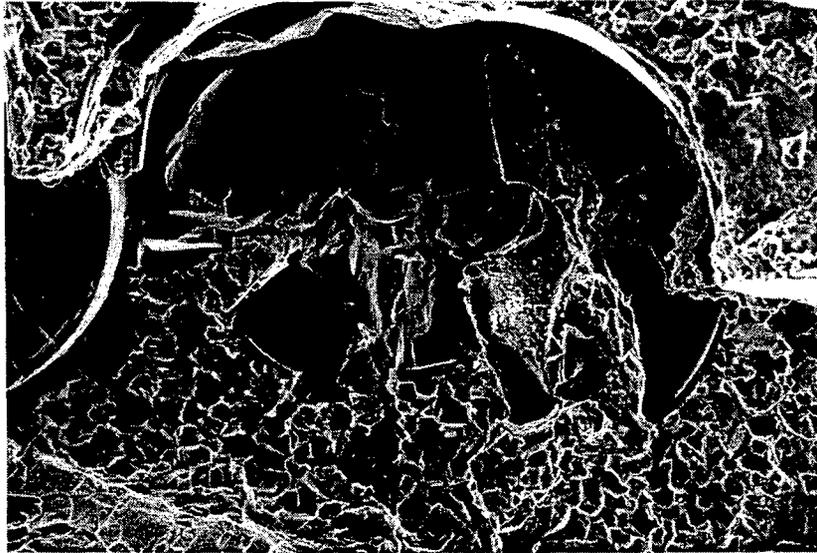
Figure 100. Smashed fiber on fracture surface. Matrix is consolidated around shards indicating fiber failure during consolidation of composite, prior to mechanical testing.

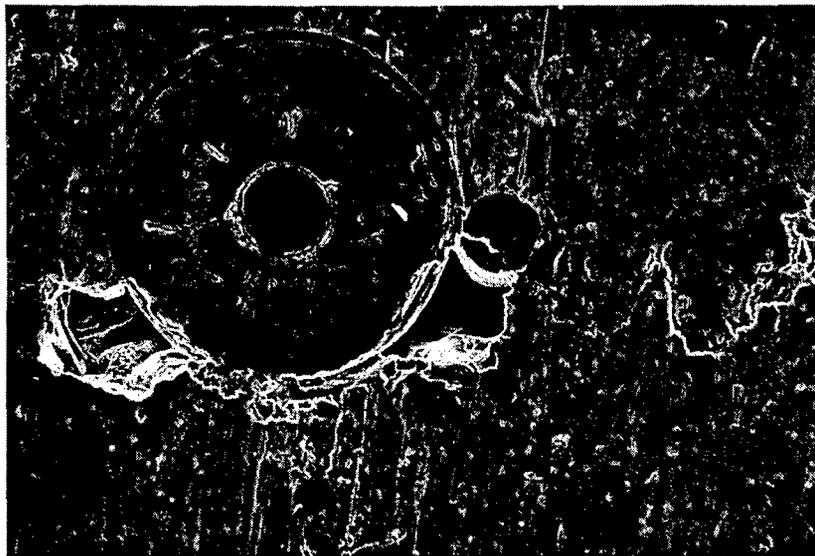
Figure 101. Cross section of 96-775. Fiber core and shards are surrounding another fiber. The matrix was unable to consolidate completely around the fiber, creating voids. This area was detected using ultrasonic immersion C-scan techniques.
