NASA  
Technical Memorandum 107457

# Stressed Oxidation of C/SiC Composites

Prepared for the  
21st Annual Conference on Composites, Advanced Ceramics,  
Materials and Structures  
sponsored by the American Ceramic Society  
Cocoa Beach, Florida, January 12-16, 1997

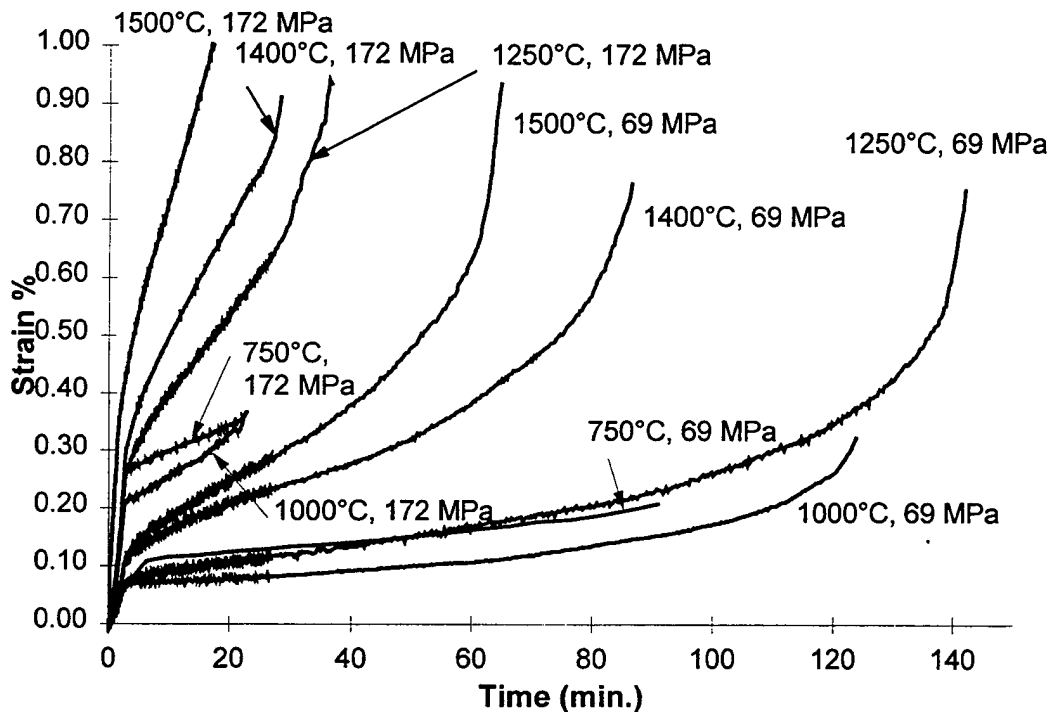
Figure 2. Strain versus time curves for all coupons tested at temperatures of 750°C and above. All specimens failed within 2 1/2 hours and showed the three regions of inelastic strain.

Strain versus time curves for the two stresses are shown in Fig. 2 for the samples tested at 750°C and above. In these plots, three regions were observed that are similar to the trends observed in a typical creep test. After the elastic strain due to loading, the first trend is observed as an inelastic region of decreasing strain rate. The second trend is a steady-state region where the increase in non-elastic strain is very gradual. Although, creep of carbon fibers has been observed (4,5), it is believed that in this region most of the strain is due to an inelastic strain other than creep (this statement will be further supported in the discussion of testing in an inert environment). As the interphase and fibers begin to oxidize, the fibers and matrix debond which accounts for the gradual increase in strain. Also, the woven fiber bundles begin to shift along adjacent void space and straighten along the loading axis. In the third region, there is a sharp increase in strain. In this region, the fibers located in areas of high oxygen concentration, i.e., near the composite edge or along matrix microcracks, have begun to oxidize through their cross-sectional areas. Reduced cross-sectional area fibers begin to fail and no longer bridge cracks. Loads are redistributed and fibers fail progressively until the coupon ultimately fails. The coupons that failed during stressed oxidation showed all three regions while those that survived 25 hr. showed only the first two. Note that on the plot, it is difficult to see all three trends on the short-lived tests due the scaling on the time axis.
