NASA Contractor Report 189628

**ANALYSIS OF SYSTEMS HARDWARE FLOWN ON LDEF -
RESULTS OF THE SYSTEMS SPECIAL INVESTIGATION
GROUP**

**BOEING DEFENSE & SPACE GROUP
Seattle, Washington**

**Contract NAS1-19247
April 1992**

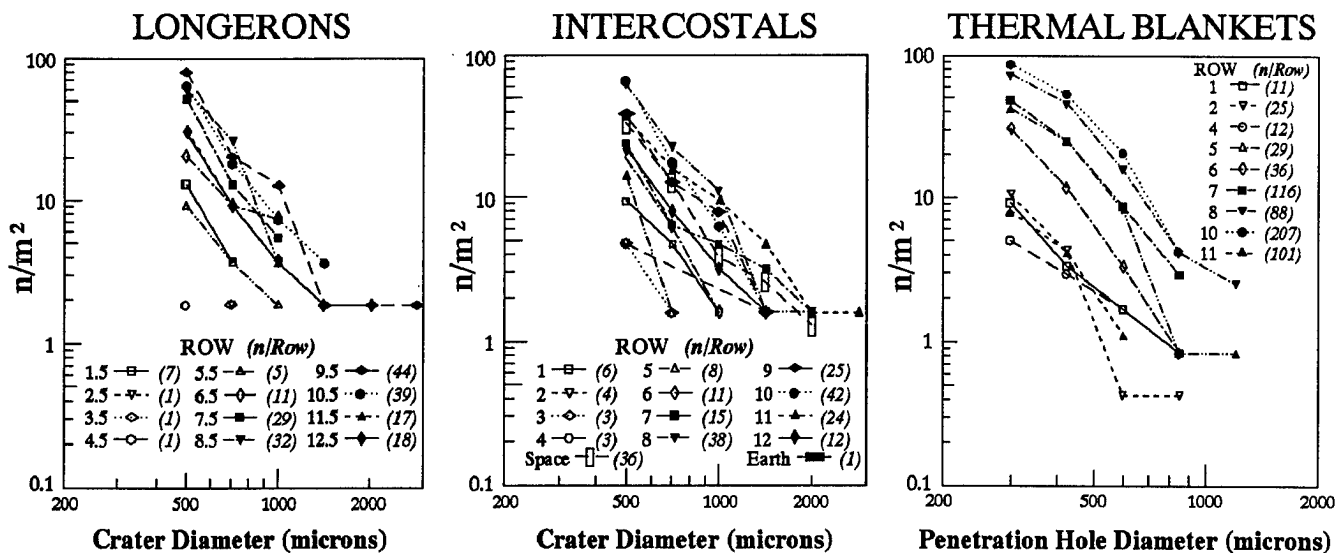
Figure 3.1-3. Absolute spatial density (plotted in polar coordinates on logarithmic scales) of impact features (N/m^2) observed on frame components and thermal blankets.
