# Laboratory Investigation of Selected Sensors for Use With Passive Roof Leak Detection Systems

by  
David M. Bailey, Allen Prell, and Christopher Coad

REFERENCE: USACERL Technical Report 98/09, *Laboratory Investigations of Selected Sensors for Use With Passive Roof Leak Detection Systems*

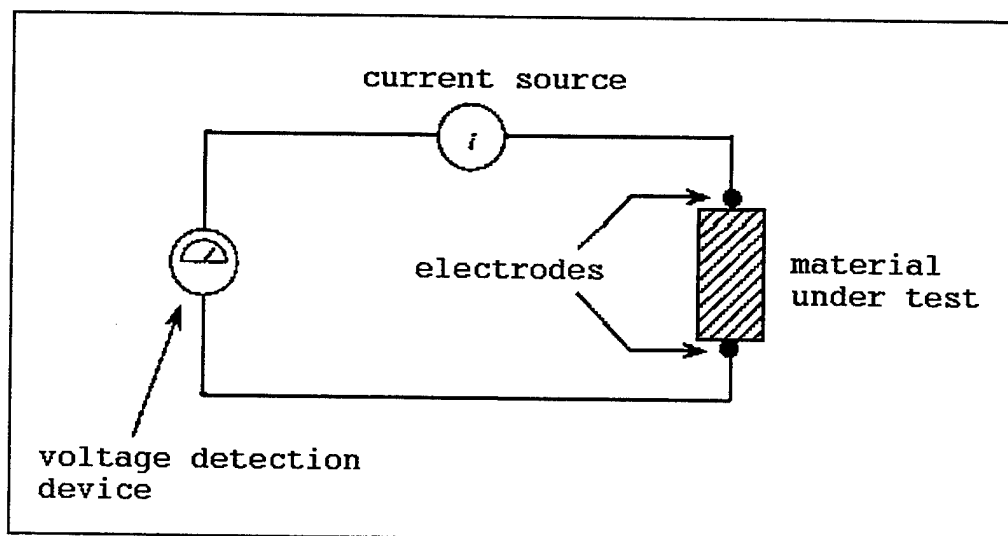
Figure 1. Basic circuit diagram for a resistance sensor.

A basic circuit diagram for a resistance sensor is shown in Figure 1. A constant current is introduced into the circuit and passes through the material under test.

The voltage across the electrodes is monitored and related to the electrical resistance of the material through Ohm's Law,  $R=V/I$ , where  $I$  is the current flowing in the circuit and  $V$  is the voltage across the electrodes. A pair of conductive wires serves as the transmission medium for this type of sensor.

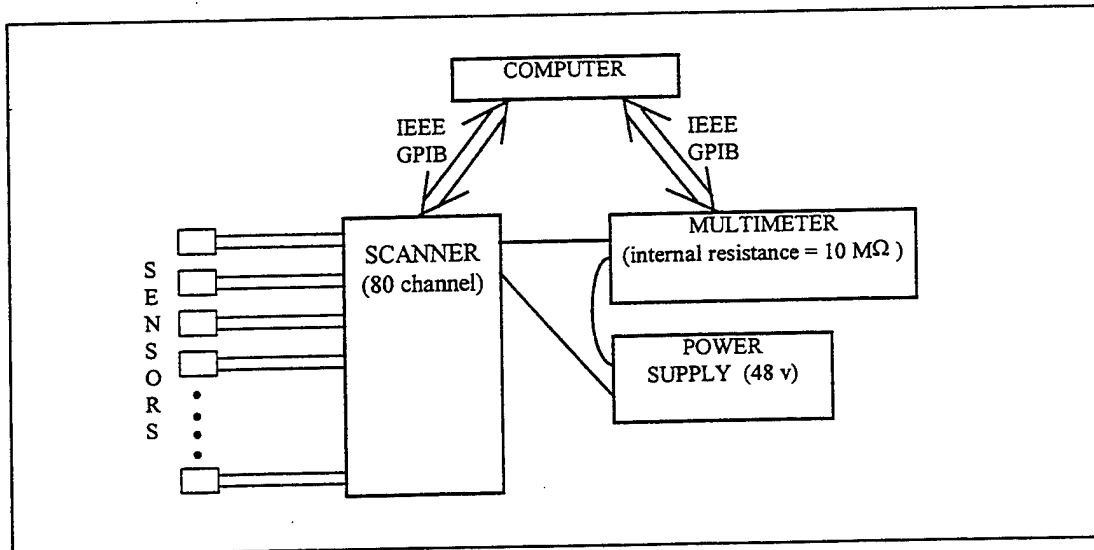
Figure 16. Hardware schematic of data acquisition system.

Figure 16 shows the hardware schematic of the data acquisition system used to process and record the data. Two such setups were necessary because the scanner was limited to 80 data channels. Each sensor was connected to the scanner, which was connected to a power supply and multimeter. The scanner and multimeter were controlled by a personal computer through a standard IEEE-GPIB data acquisition card.

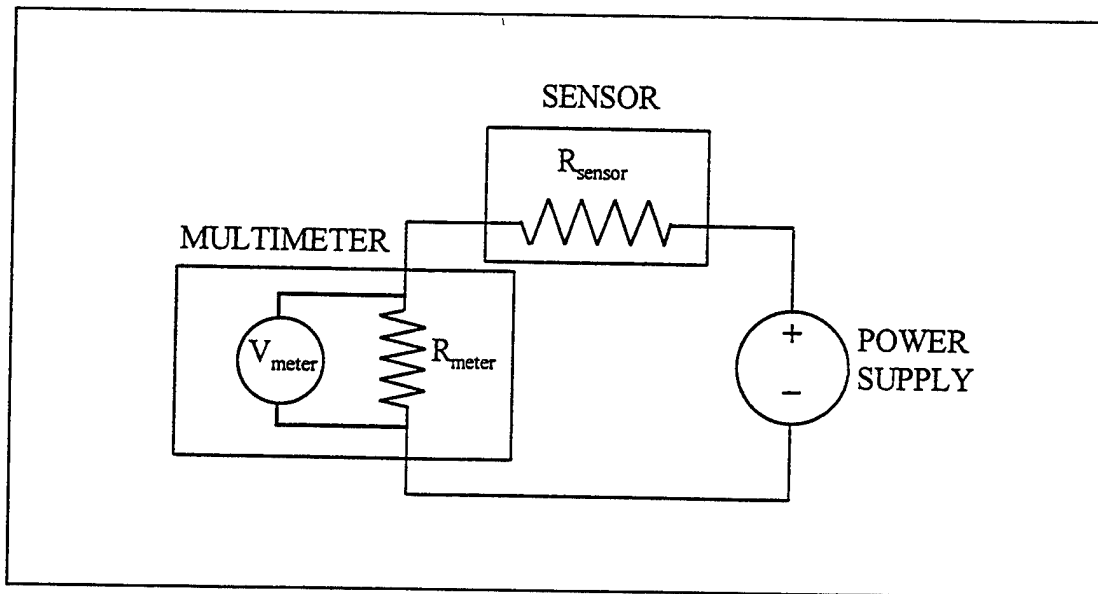
Figure 17. Schematic of resistance measurement circuit.

Because the resistances of most of the sensors were very high ( $10^9$  to  $10^{12}$  ohms in the dry state), the multimeter could not be used in the standard resistance measurement configuration. Instead, the set-up shown in Figure 17 was used. It was necessary to place the multimeter in series with the sensor and power supply and measure the voltage across the internal resistor within the multimeter. The computer converted the voltage reading to a resistance value for the sensor through the use of Equation 2.

$$R_{\text{sensor}} = \frac{V_{\text{PS}} - V_{\text{meter}}}{V_{\text{meter}} / R_{\text{meter}}} \quad [\text{Eq 2}]$$

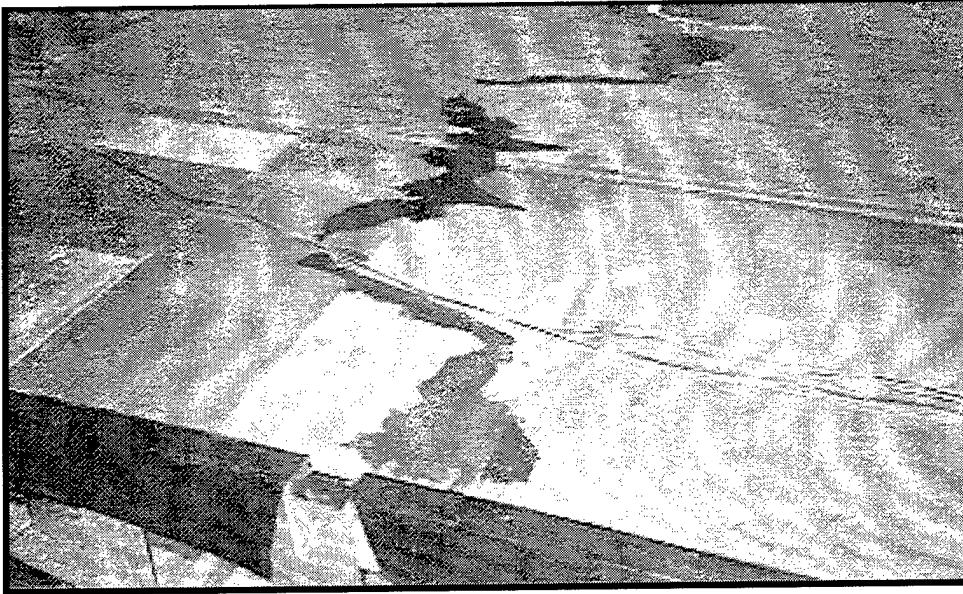
Figure 28. Evidence of water accumulation between membrane and perlite board observed during disassembly of test setup.

After completion of each test, the researchers carefully removed the membrane and insulation layers to investigate and record the areas of water accumulation between component layers (Figure 28).
