**The Role of Protective Visors
in Injury Prevention During
U.S. Army Rotary-Wing
Aviation Accidents**

**U.S. Army Aeromedical Research Laboratory
Fort Rucker, Alabama 36362-0577**

| REPORT DOCUMENTATION PAGE | | | | Form Approved OMB No. 0704-0188 | |
|--|--|---|--|---|---|
| 4. PERFORMING ORGANIZATION REPORT NUMBER(S) USAARL Report No. 98-18 | | 5. MONITORING ORGANIZATION REPORT NUMBER(S) | | | |

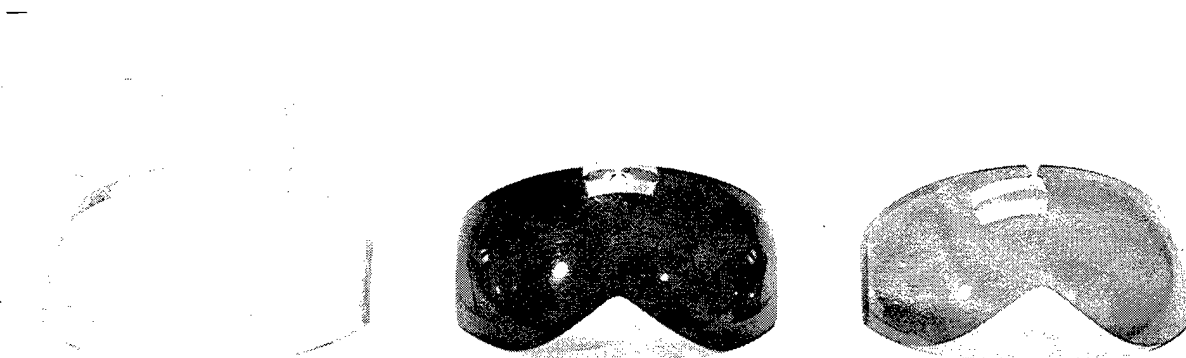
Figure 1. Examples of Class I (clear), Class II (tinted), and laser protective visors.

In Army aviation, visors are classified as Class I or II (Figure 1). These classes are defined in military specification MIL-V-43511C, "Visors, flyer's helmet, polycarbonate." Class I visors are clear, having a photopic (daytime) luminous transmittance of 85 percent or greater. Class II visors are tinted, having a photopic luminous transmittance between 12 and 18 percent. An exception to the Class II luminous transmittance requirement is granted to the tinted visor used in the Integrated Helmet Unit (IHU) of the Integrated Helmet and Display Sighting System (IHADSS) in the AH-64 Apache. The IHADSS Class II visor has a photopic luminous transmittance between 8 to 12 percent. This lower transmittance range is needed to improve visibility of real-time imagery provided by the IHADSS helmet-mounted display. Regardless, all visors generally are held to the optical specifications for refractive power, prismatic deviation, distortion, haze, impact resistance, etc., cited in MIL-V-43511C. The test for compliance of impact resistance uses a caliber .22 T37 fragment simulating projectile at an impact velocity between 550 and 560 feet per second. The test is conducted in accordance with MIL-STD-662.

Another deviation from the visor classes above is special purpose visors which are designed to provide protection from lasers (Figure 1). The luminous transmittance of laser visors can vary greatly depending on the wavelengths or combination of wavelengths for which the protection is being provided. Over the years, a number of types of laser visors have been evaluated for use (Rash and Martin, 1990; Bohling and Rash, 1991; Rash, Bohling, and Martin, 1991). However, except for a brief fielding period during the Desert Shield/Desert Storm war, the authors are not aware of any official designation of laser visors. However, a number of various types of laser visors are in use among many Army aviation units.

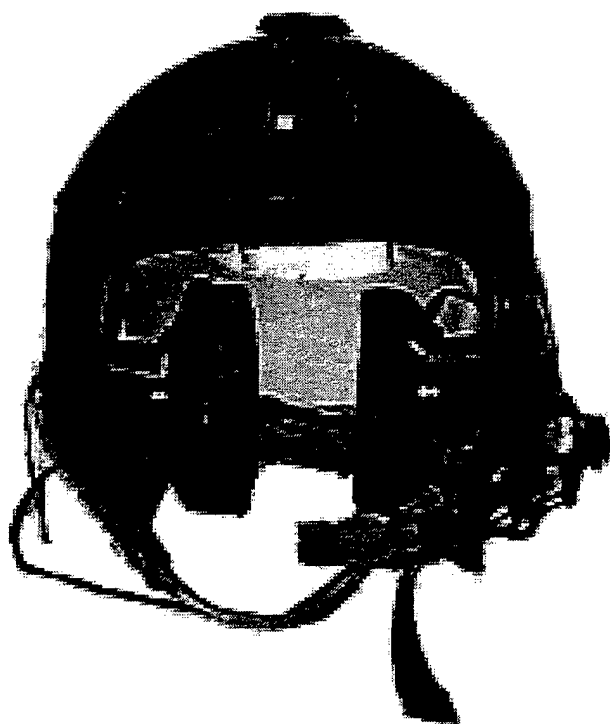
Figure 2. Aviator's Protective Helmet No. 5 (APH-5).

The APH-5 was based on a previous U.S. Navy design. It was molded from glass fabric and polyester resin, providing force distribution and penetration resistance. Helmet fit was achieved by means of pads used to contour the helmet to the head. While maintaining previously

available impact protection, the APH-5 provided minimal hearing protection from aircraft noise (McEntire, 1997). The APH-5 incorporated a single visor.

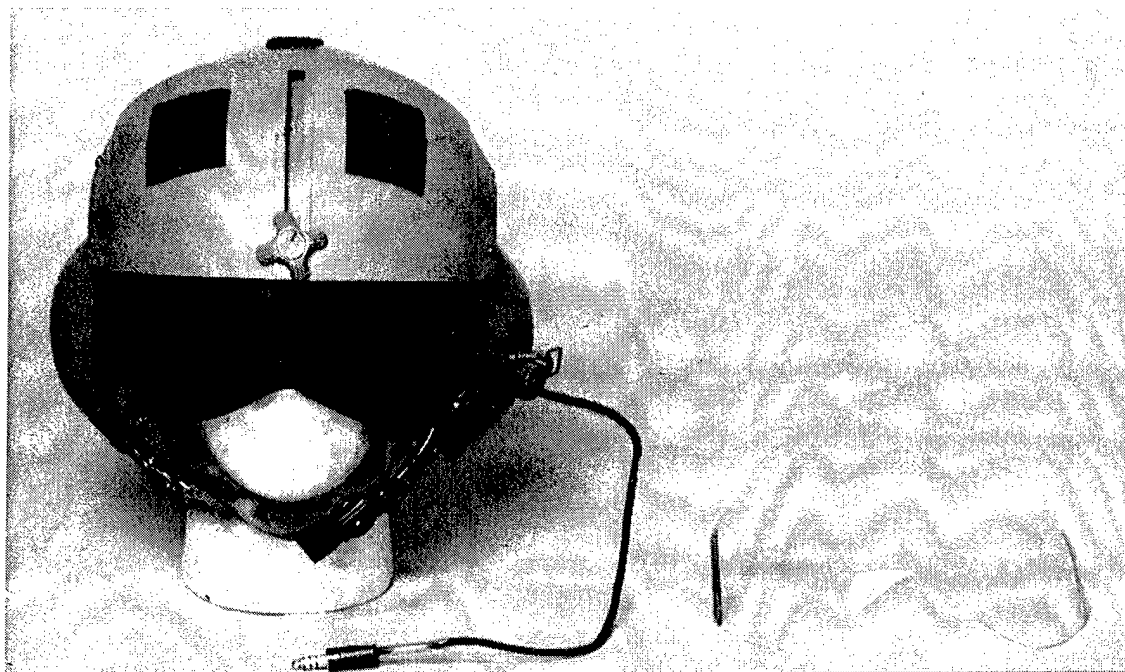
Figure 3. Special Protective Helmet No. 4 (SPH-4).

The SPH-4 was introduced in 1969. At that time, it provided state-of-the-art acoustic and crash protection to aircrew members. The single visor configuration was a tradeoff between weight, impact protection, electronics, etc. A maximum weight, a critical factor in fatigue and crash dynamics, was set at 3.5 pounds. The standard SPH-4 underwent two minor changes: in 1974, a thicker foam liner was used and, in 1982, a thinner shell was adopted. Post-fielding dual-visor adaptor kits were evaluated but rejected due to undue neck muscle fatigue which would be incurred. The recommended visor use at that time was to wear standard issue sunglasses under the clear visor (USAAAVS, 1975).

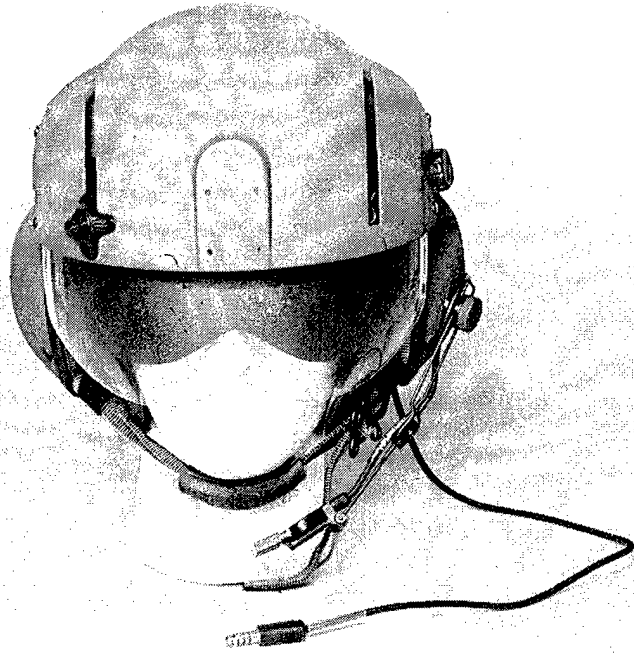
Figure 4. Special Protective Helmet No. 4B (SPH-4B).

The SPH-4B, a vastly improved version of the SPH-4, was fielded initially in July 1991. Its outward appearance is similar to that of the SPH-4. However, its performance is quite different. It has an improved Styrofoam™ liner, new energy absorbing earcups, an improved retention system, a lighter shell of Kevlar™, an Aviator's Night Vision Imaging System (ANVIS) mount, a Thermoplastic Liner™ (TPL)™, and a dual visor assembly (Carter, 1992). The dual visor design allows the use of either or both visors. The SPH-4B is issued with a Class I (clear) and Class II (tinted) polycarbonate visor. The clear visor is mounted on the outside track, with the tinted visor being closer to the face.

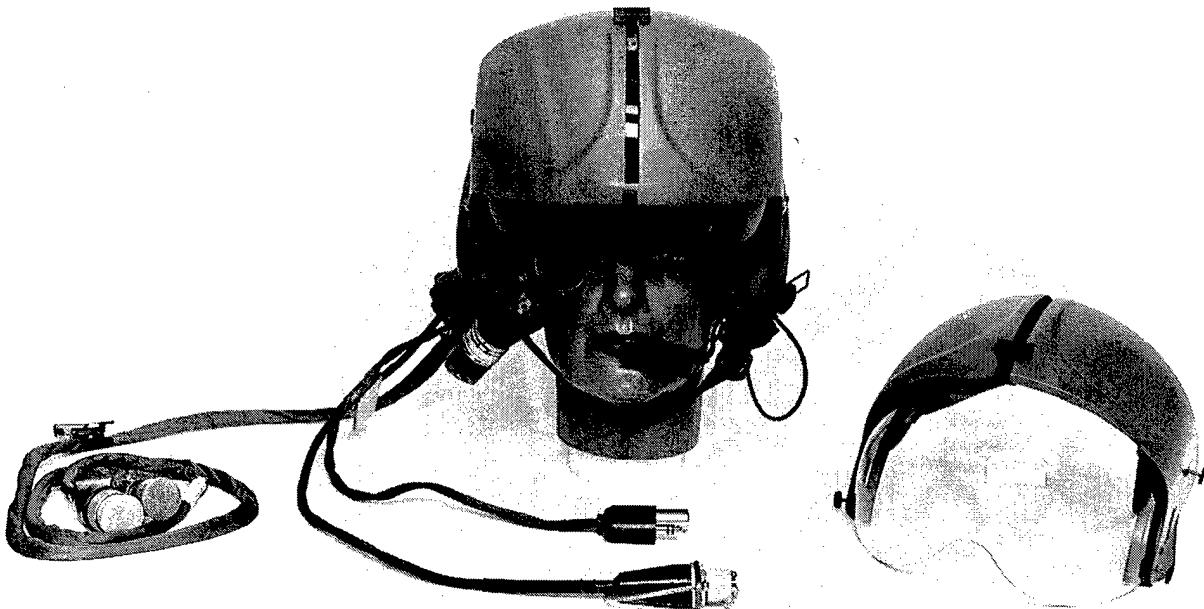
Figure 5. Integrated Helmet and Display Sighting System (IHADSS) Integrated Helmet Unit (IHU).

The IHADSS helmet was developed specifically and exclusively for use in the AH-64 Apache attack helicopter. First fielded in the early 1980's, the IHADSS helmet incorporates a helmet mounted display and head motion sensing capability. The IHADSS helmet provides impact and acoustical protection at least equivalent to that of the SPH-4 (which was, at the time of the IHADSS fielding, the current aviator helmet). Two visors (Classes I and II) are provided in separate visor housings. While only allowing use of a single polycarbonate visor at a time, the two visor housings can be rapidly changed out using simple thumbscrews. [Note: Due to the uniqueness of the IHADSS, the visors must be custom trimmed to enable them to be lowered over the helmet mounted display optics.] The IHADSS helmet was a crashworthiness challenge because now the helmet was being used as a platform for an HMD but still had to provide the visual, acoustical, and impact protection expected from a standard helmet.

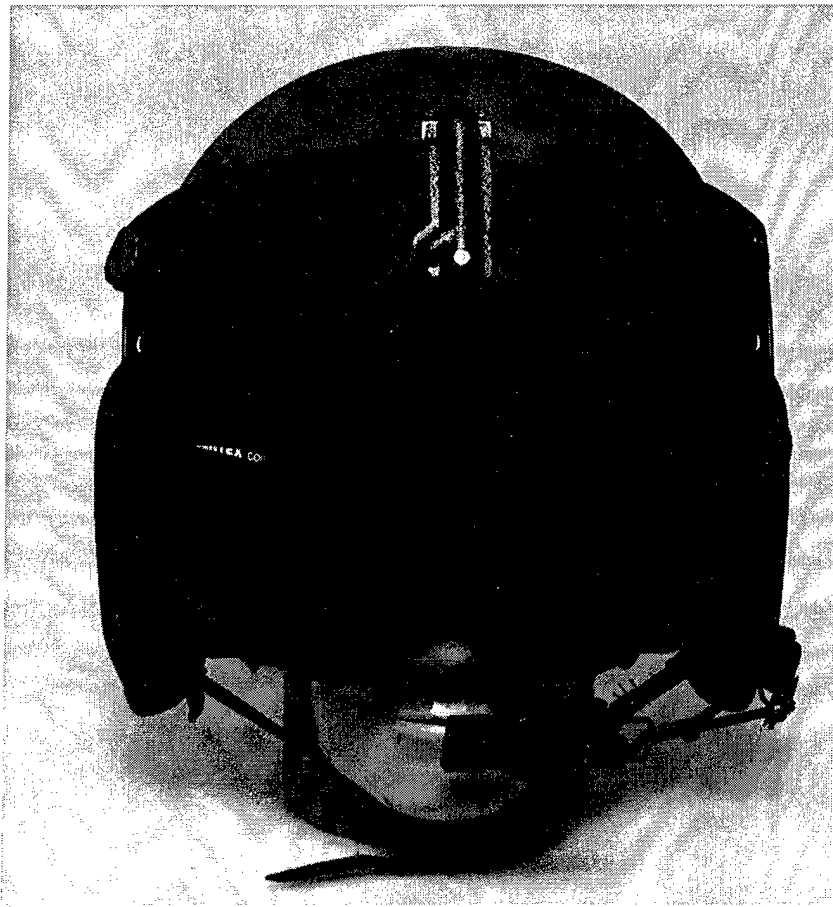
Figure 6. Helmet Gear Unit No. 56/P (HGU-56/P).

The most recently fielded aviator helmet is the HGU-56/P. Besides providing improved impact protection over the SPH-4B, the HGU-56/P moves toward an Army goal of having one common aviation helmet. The final version was fielded in 1995. The HGU-56/P (2.6 pounds) has a reduced weight over the SPH-4B (2.8 pounds). It retained the TPL™ liner and crushable earcups, but the Kevlar™ cloth shell used in the SPH-4B was replaced with a nylon and graphite cloth shell. The HGU-56/P uses polycarbonate visors, clear and tinted, mounted in a dual visor assembly. The clear visor is mounted closest to the face, reversed from the mounting in the SPH-4B. This change was initiated in hopes that future ANVIS designs would allow visor usage without degrading user performance.

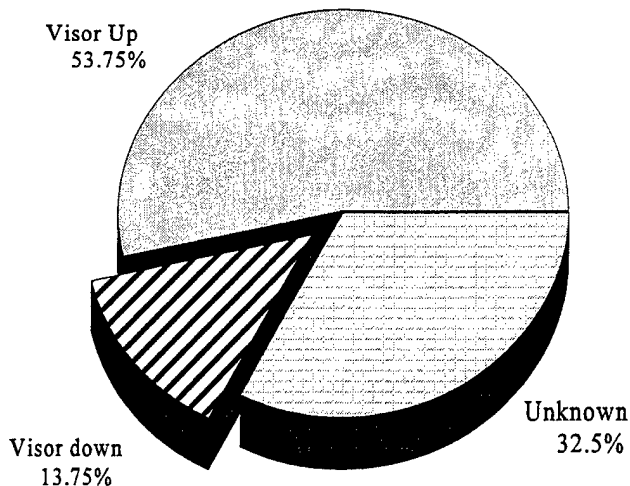
Figure 8. Visor Position for ALSERP
1990-1996 data.

For all retrieved helmets, visor damage was analyzed to determine the visor position at the time of impact. Of the helmets recovered, a majority of individuals (53.75 percent) were found to have been wearing their visor in the "up" position. [These figures include individuals who were flying with ANVIS. Because the visor cannot be deployed while using ANVIS, the visor is assumed to be in the "up" position.] Only 13.7 percent of the individuals were found to have been wearing their visors down at the time of the mishap (Figure 8). Helmets and visors too badly damaged to ascertain this information were classified as "visor position unknown." For the accidents where visor position was known, it is of interest to note that the frequency of

head/neck and facial injuries experienced by both groups, visor up and down, was identical (70 percent) but varied drastically in severity. Those who wore their visors down frequently were reported to have minor injuries caused by the visor (often due to the visor edge impacting the cheek), but experienced fewer fatalities (18.2 percent for visor down versus 53.5 percent for visor up). This trend is consistent with results reported by Vyrnwy-Jones, Lanoue and Pritts (1988). Their study reported fatality rates of 26 percent among aviators wearing their visor down versus 34 percent for visor up.
