**FINAL TECHNICAL REPORT**

**FRETTING CORROSION IN AIRFRAME RIVETED  
AND PINNED CONNECTIONS**

**George T. Hahn and Carol A. Rubin**Department of Mechanical Engineering  
Vanderbilt University  
Nashville, Tennessee 37235

March 20, 1998

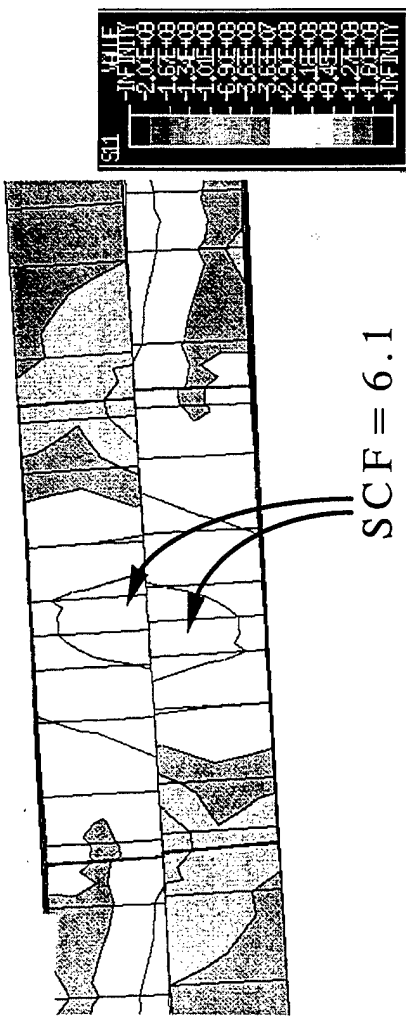
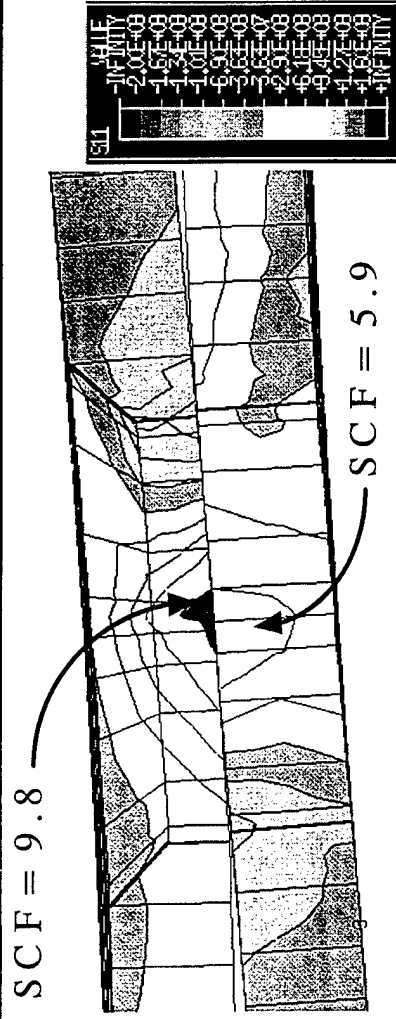
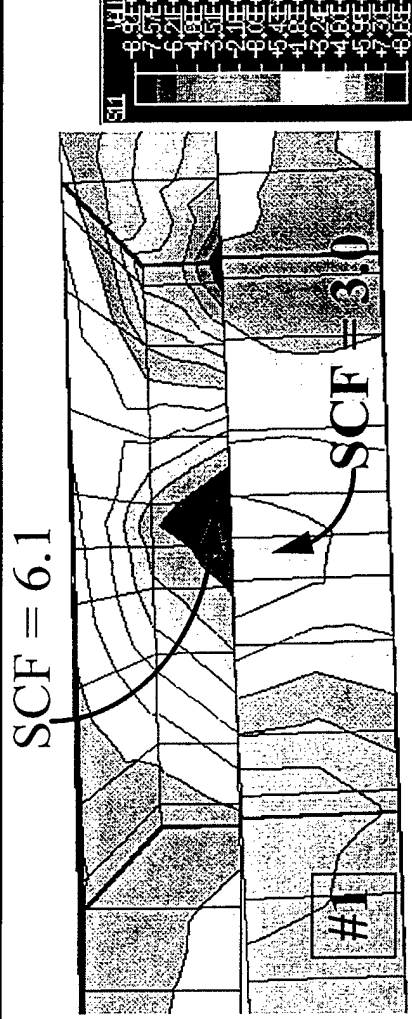
Figure 1. Results of finite element calculations of the distortion and local panel stresses of riveted lap joints: (a) single rivet-row with conventional rivets, (b) single rivet-row with countersunk rivets and (c) double rivet-row with countersunk rivets. Displacements are magnified 3x. The contour plots on the right describe the  $\sigma_{11}$  - stress field and identify the (peak) stress concentration factor (SCF) and its physical location.

Unlike the failures illustrated in Figure 3 where the failure originated at the hole edge of the upper, countersunk panel (refer to Figure 1) of a joint fastened with aluminum rivets, this failure originated remote from the hole in the lower, noncountersunk panel. The failure is believed to be related to the high stresses at the interior surface of the lower panel (see location B in Figure 2), and the effects of the lateral clamping produced by the stiffer, steel fasteners. Fretting wear damage produced by the fracture edge is visible at (d).

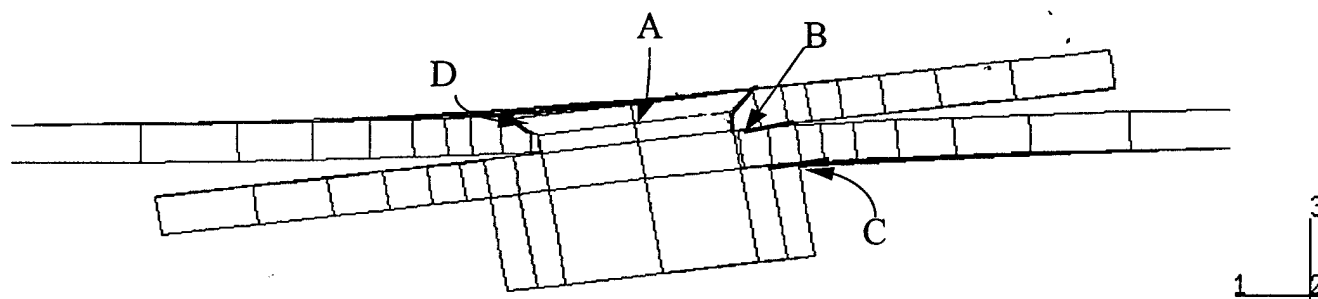
Figure 2. Regions of the joint interfaces where contact pressure and slip are combined with cyclic tension favorable for fretting fatigue: (A) rivet shank-panel interface (near the  $\theta = 0^\circ$  and  $\theta = 180^\circ$  angular locations) and (B) panel-panel interface where the edge of the lower panel hole rubs against the upper panel. Contact in regions (C) and (D) is attended by low values of cyclic tension and produce only fretting wear.

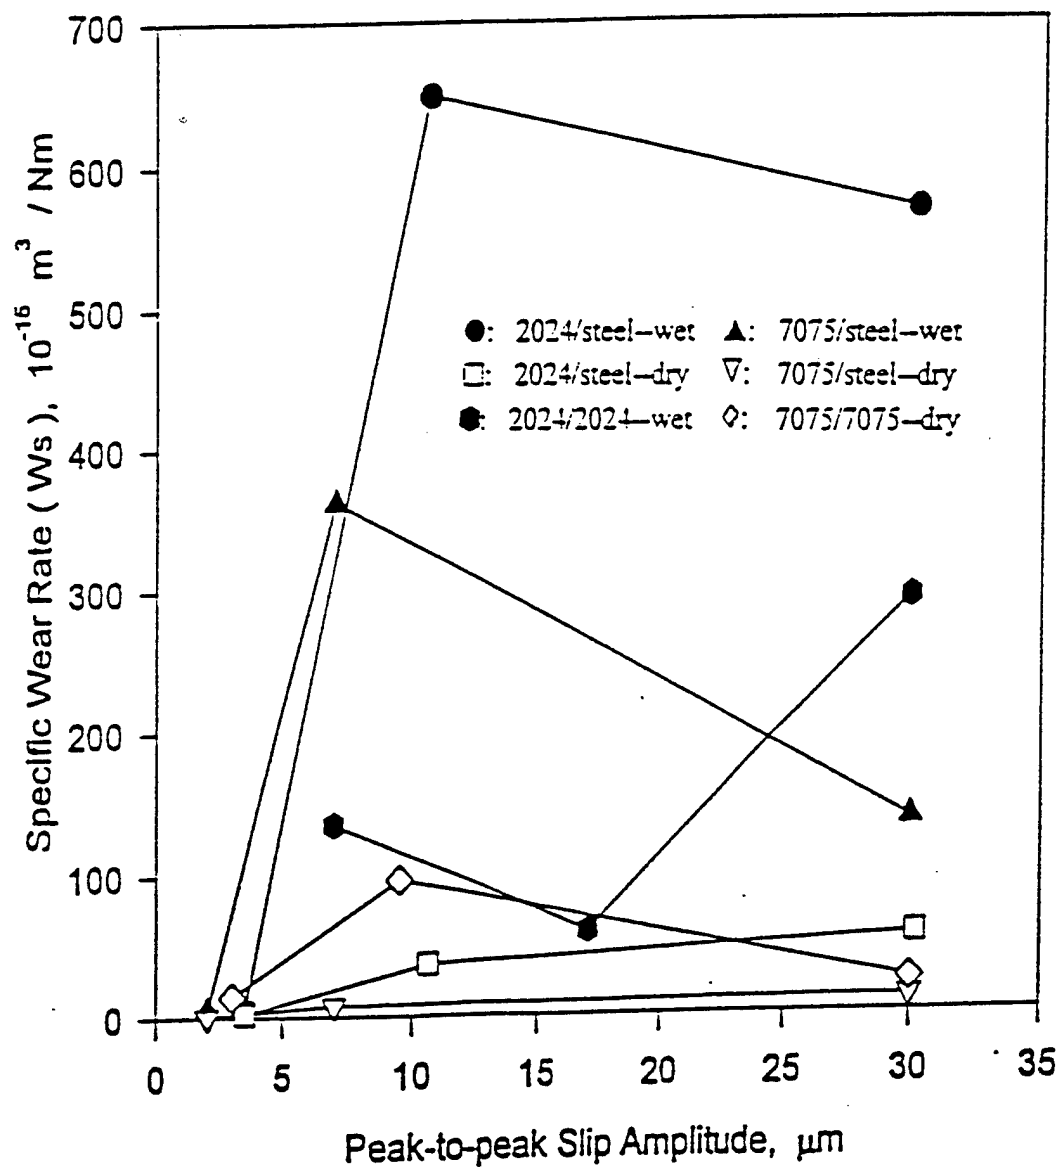
Figure 6 Variation of the specific fretting wear rate with slip amplitude for aluminum sheet alloys in contact with either aluminum or hardened steel and subjected to a nominal contact pressure of 408 GPa in laboratory air and 3.5% NaCl solution.

Values of the friction coefficient and specific fretting wear rates for contact between the following couples: 2024-T3 / 2024-T3, 7075-T6 / 7075-T6, 2024-T3 / hardened steel, and 7075-T6 / hardened steel under dry and corrosive conditions have been obtained. Examples of the results can be found in Figure 6 and in Appendices D and E. Corrosive conditions elevate the specific wear rate by 20-fold.

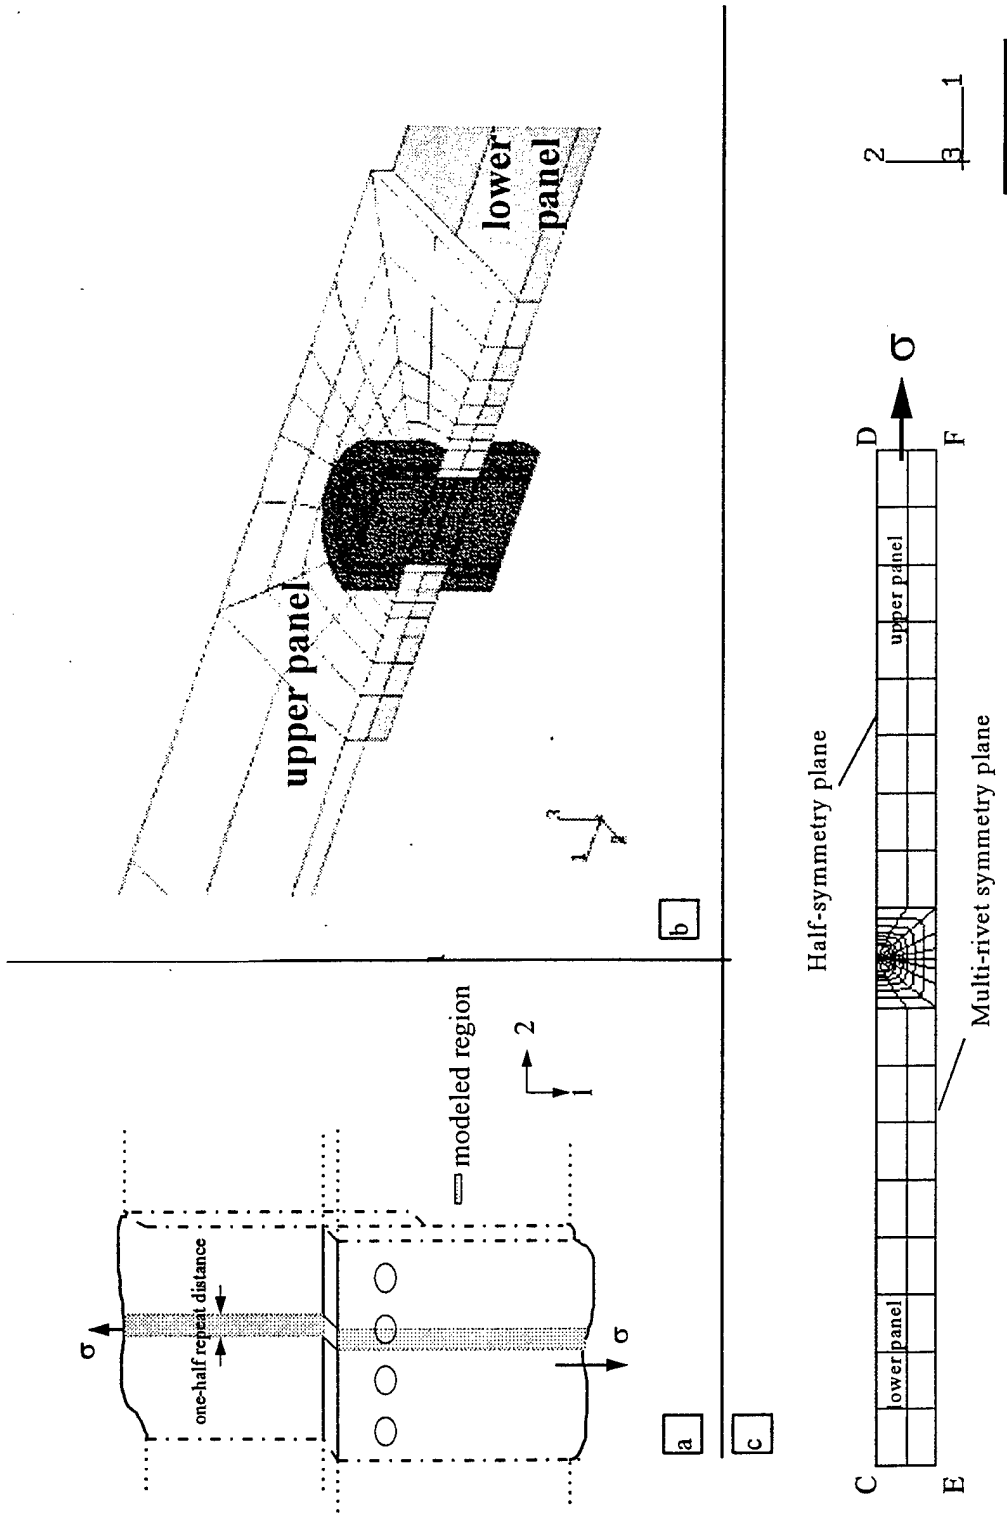
Figure 1. (a) Multi-riveted, single rivet-row lap joint, of which one half-unit is considered for the 3D half-symmetry finite element model, (b) the thickness of each panel is  $t=1.53$  mm. The rivet is non-countersunk with a shank diameter of 6.12 mm; the rivet head diameter and height are 9.792 mm and 3.83 mm respectively, (c) plan view of the mesh. The overall length of the model is 306 mm, the length of the overlap region is 30.6 mm and the width of the model (half the repeat distance) is 15.3 mm.

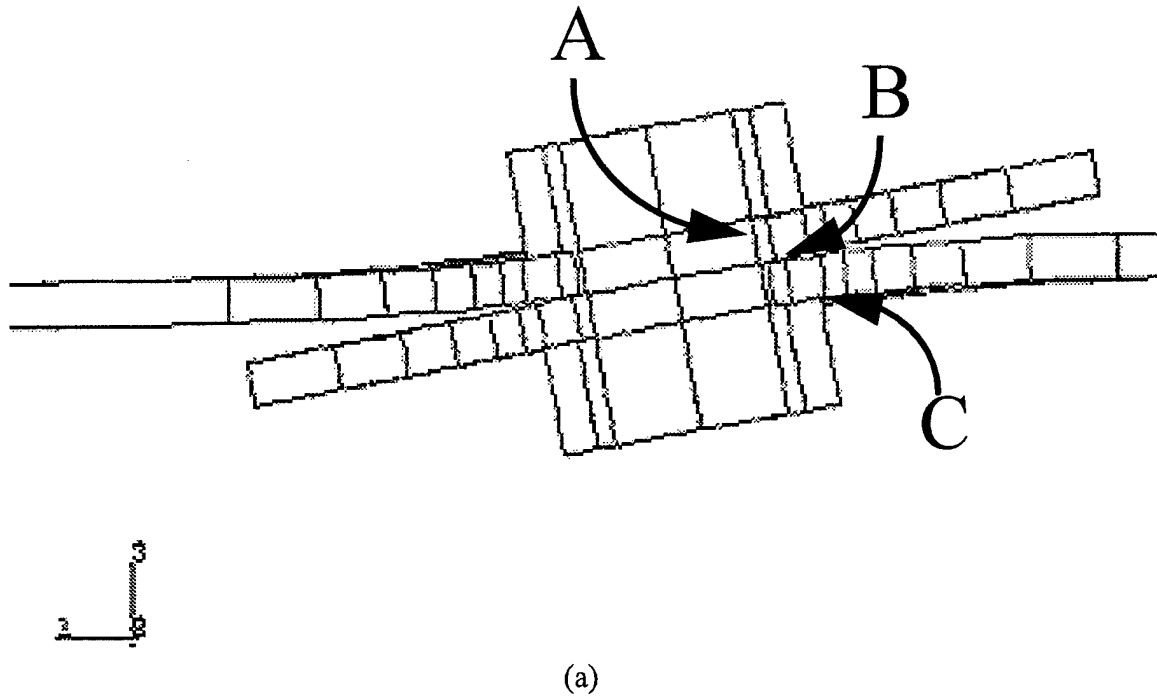
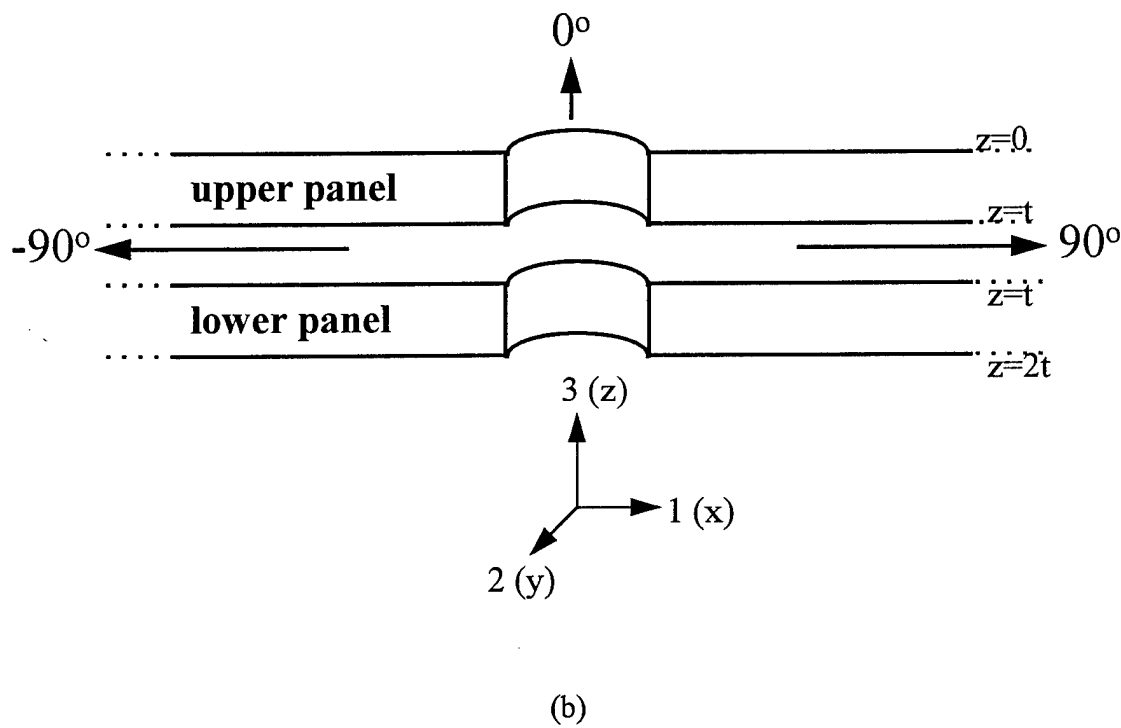
Figure 2. (a) Profile of a deformed mesh showing the three main rivet-panel and panel-panel fretting fatigue contact locations, (b) Schematic showing the definition of the angular locations and depth in the models.

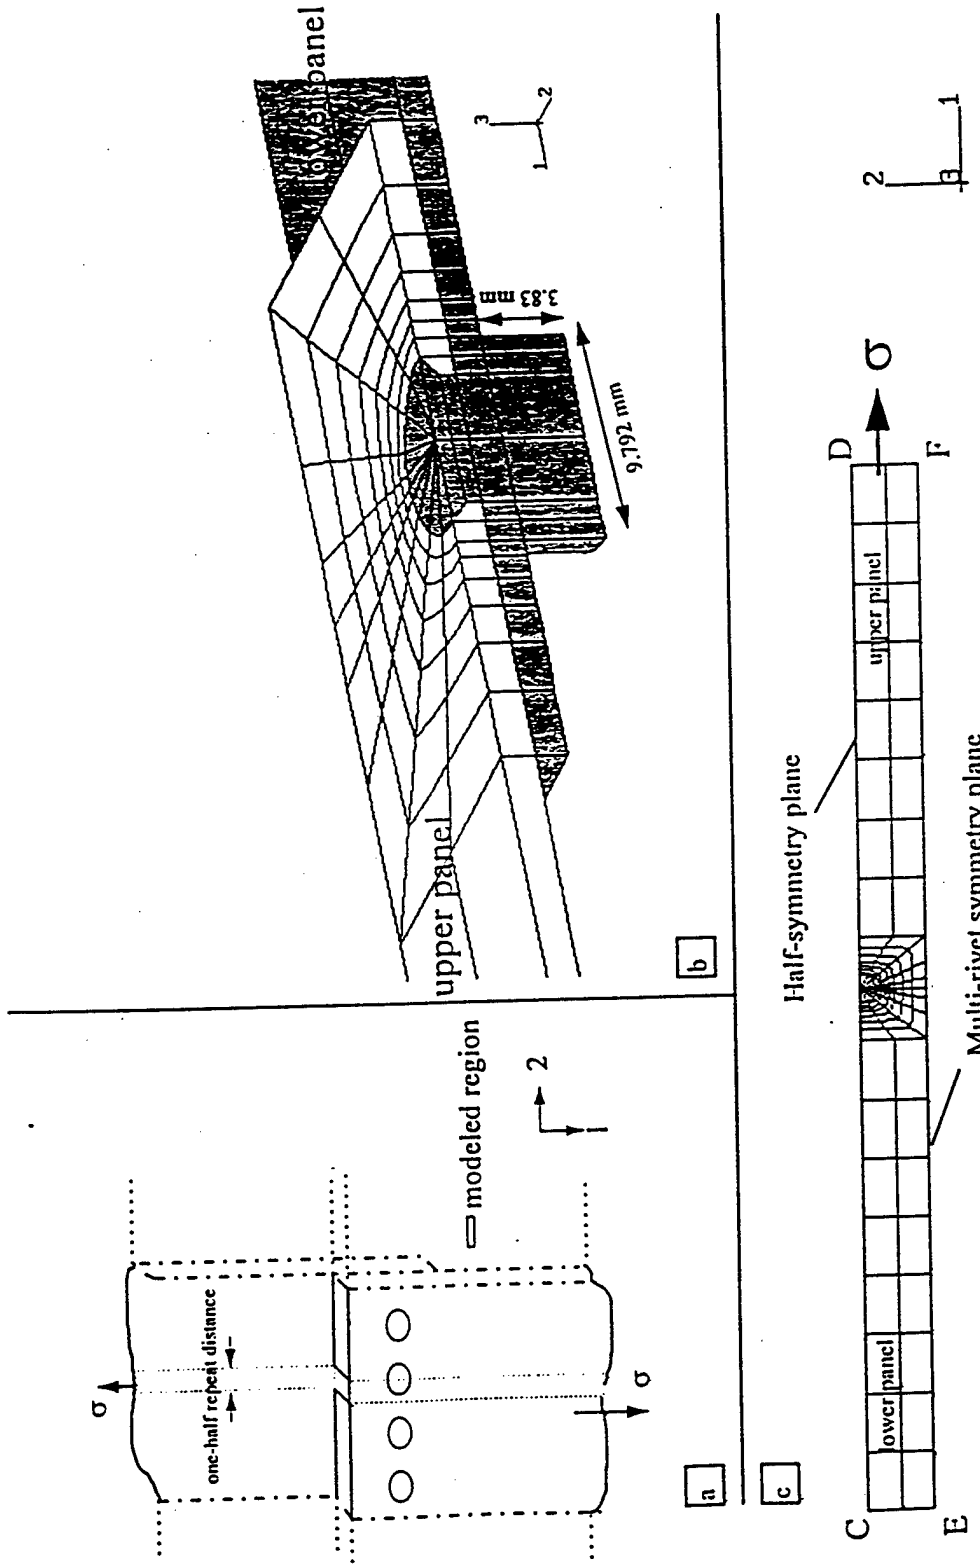
Figure 1. (a) Multi-riveted, single rivet-row lap joint, of which one half-unit is considered for the 3D half-symmetry finite element model, (b) the thickness of each panel is  $t=1.53$  mm. The rivet is countersunk with an included angle of  $100^\circ$  and a shank diameter of 6.12 mm; the rivet head diameter and height are 9.792 mm and 3.83 mm respectively, (c) plan view of the mesh. The overall length of the model is 30.6 mm, the length of the overlap region is 30.6 mm and the width of the model (half the repeat distance) is 15.3 mm.

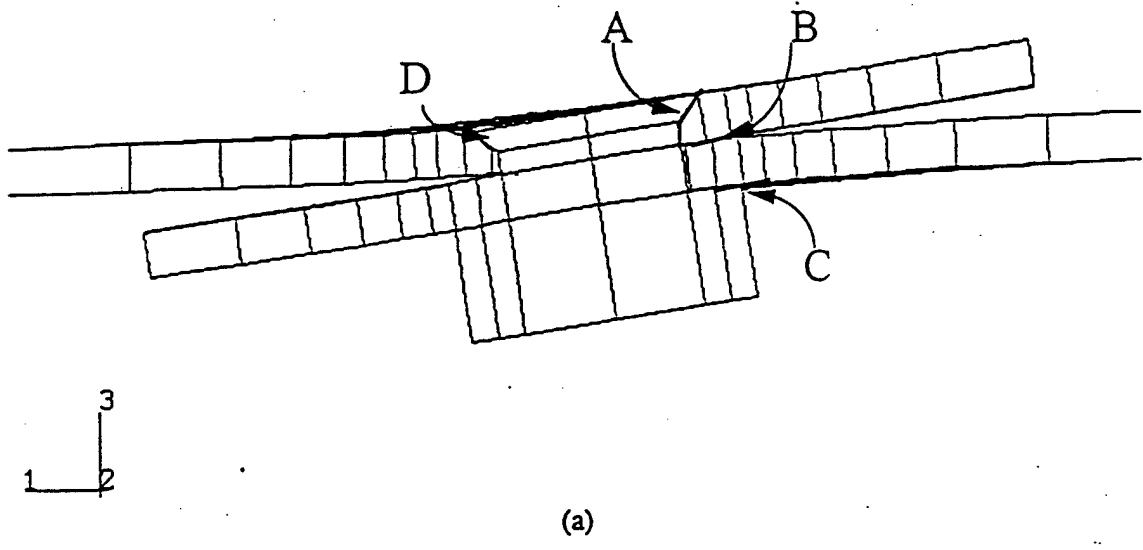
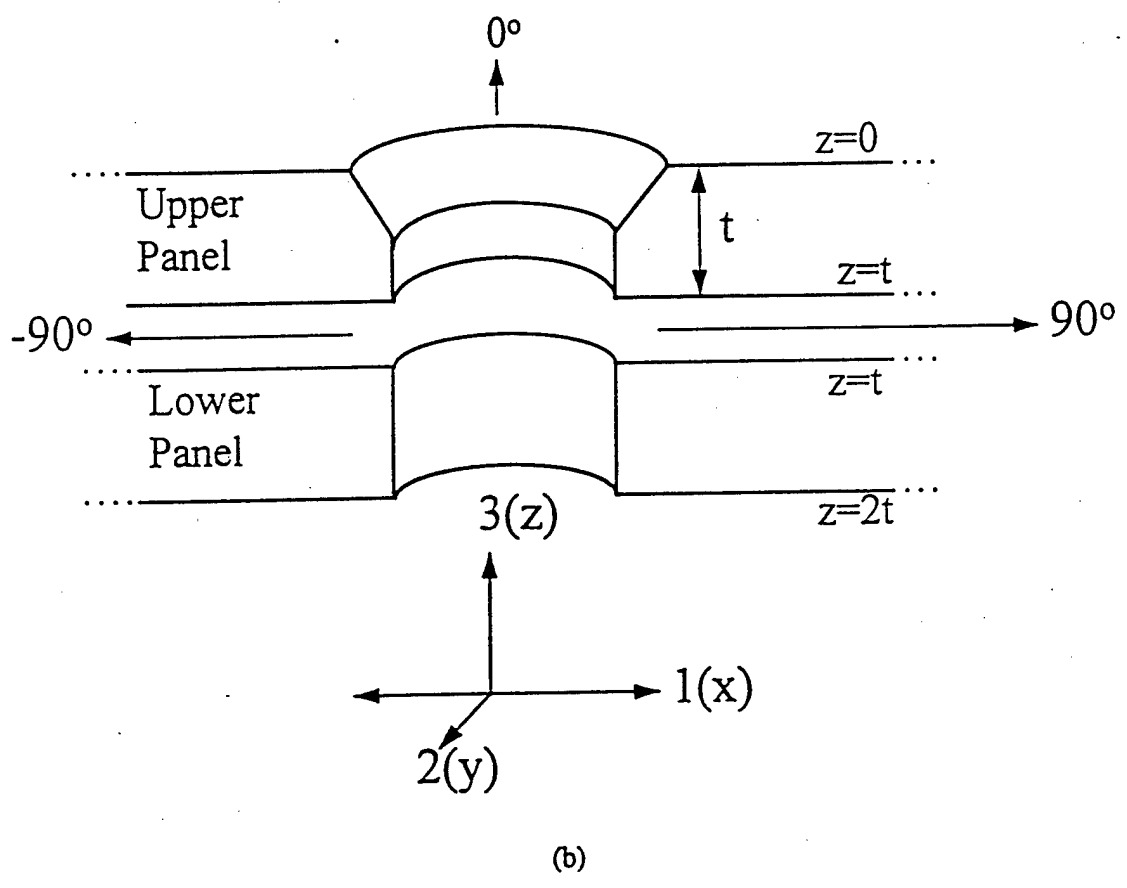
Figure 2. (a) Profile of a deformed mesh showing the four main rivet-panel and panel-panel fretting fatigue contact locations, (b) Schematic showing the definition of the angular locations and depth in the models.

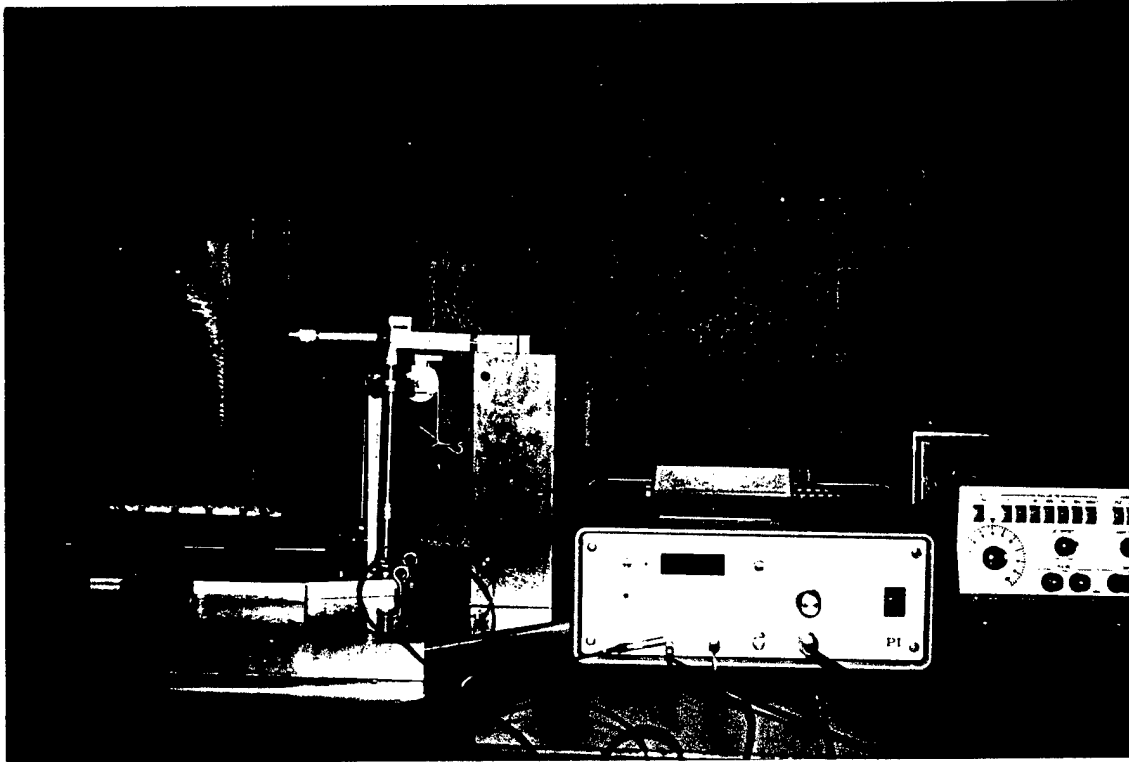
Figure 1 Overview of the fretting wear machine

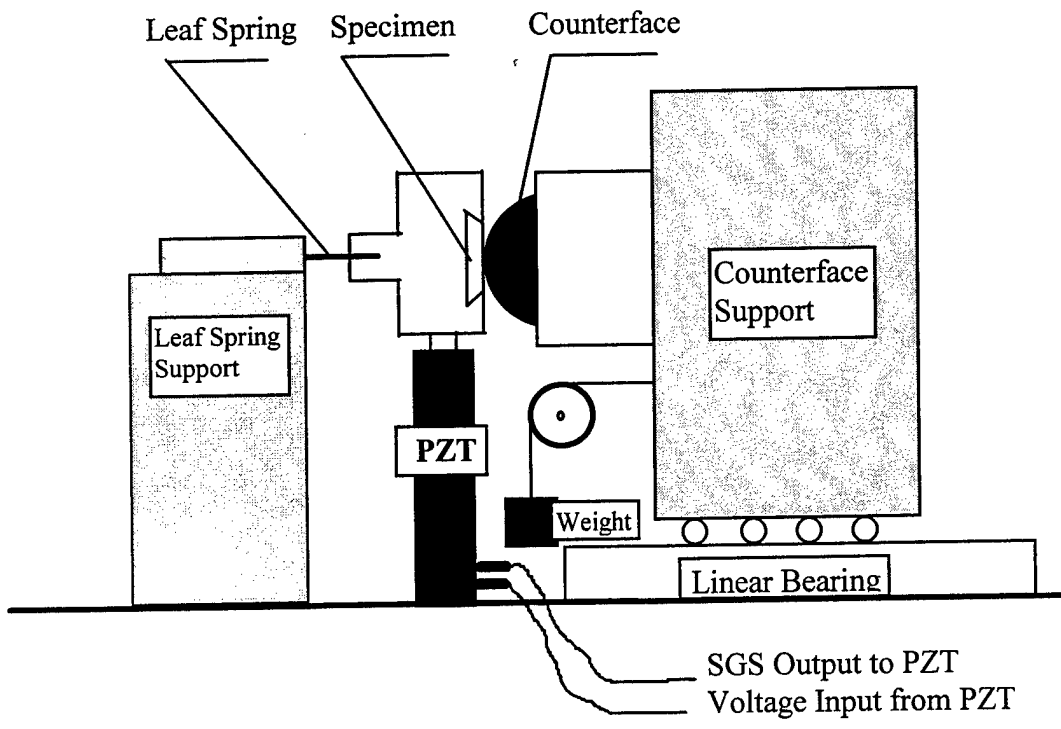
Figure 2 Schematic diagram of the fretting wear machine (mechanical part)

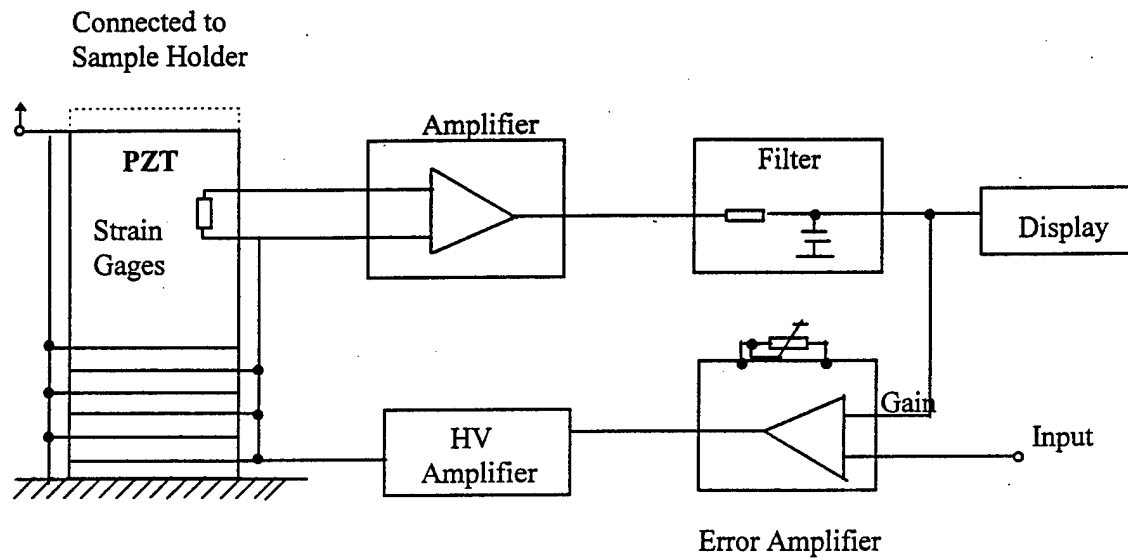
Figure 3 Closed-loop control (EC mode) of the piezoelectric transducer with strain gage sensors.

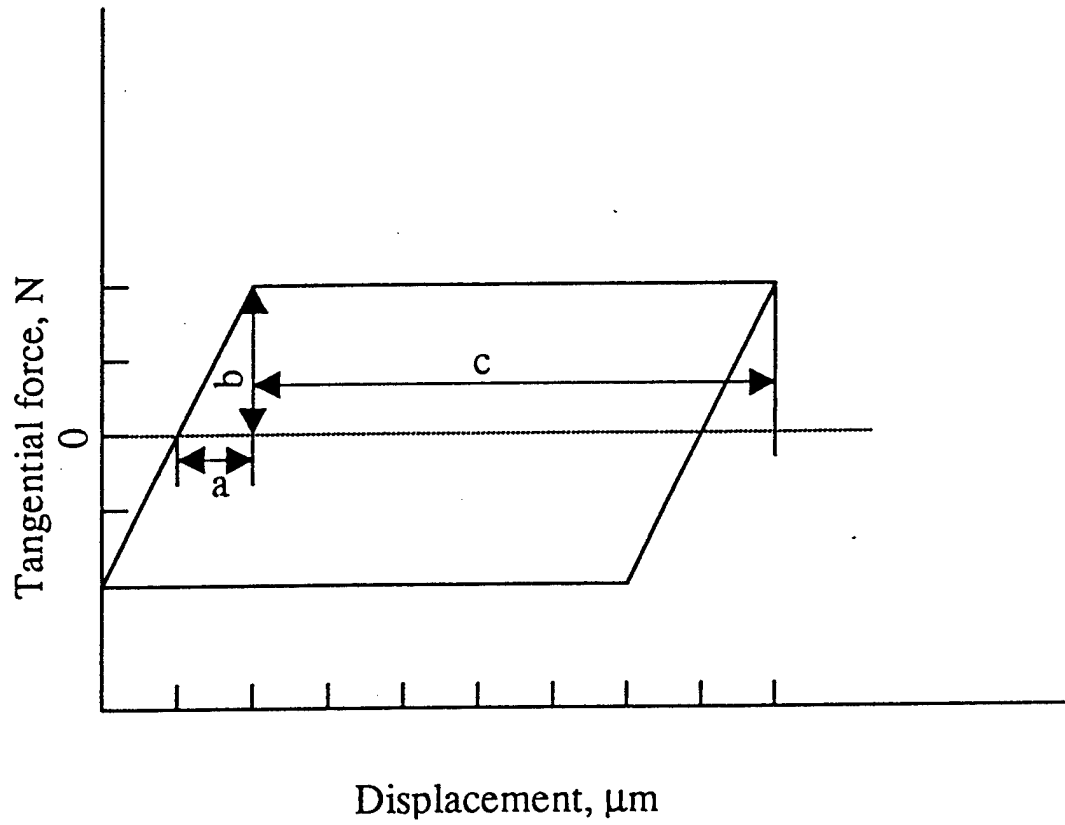
Figure 4 Schematic drawing of a typical tangential force-displacement (Ft-D) hysteresis loop.  $a/b$  defines the system compliance and  $c$  is the local slip amplitude.

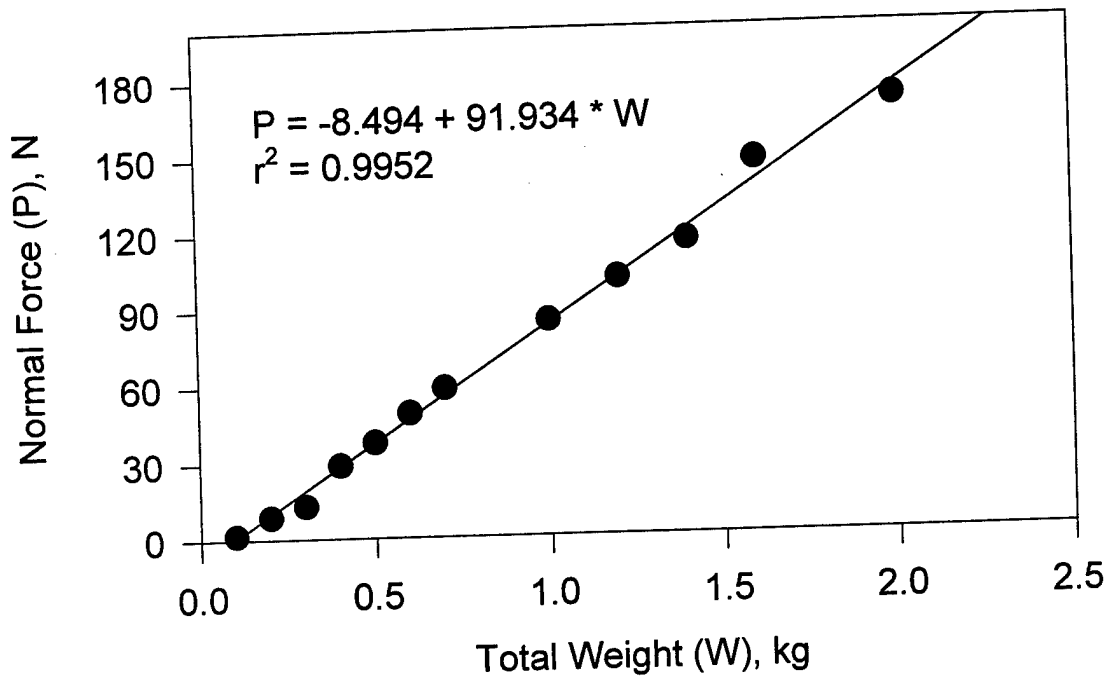
Figure 5 Calibration curve of the normal force.

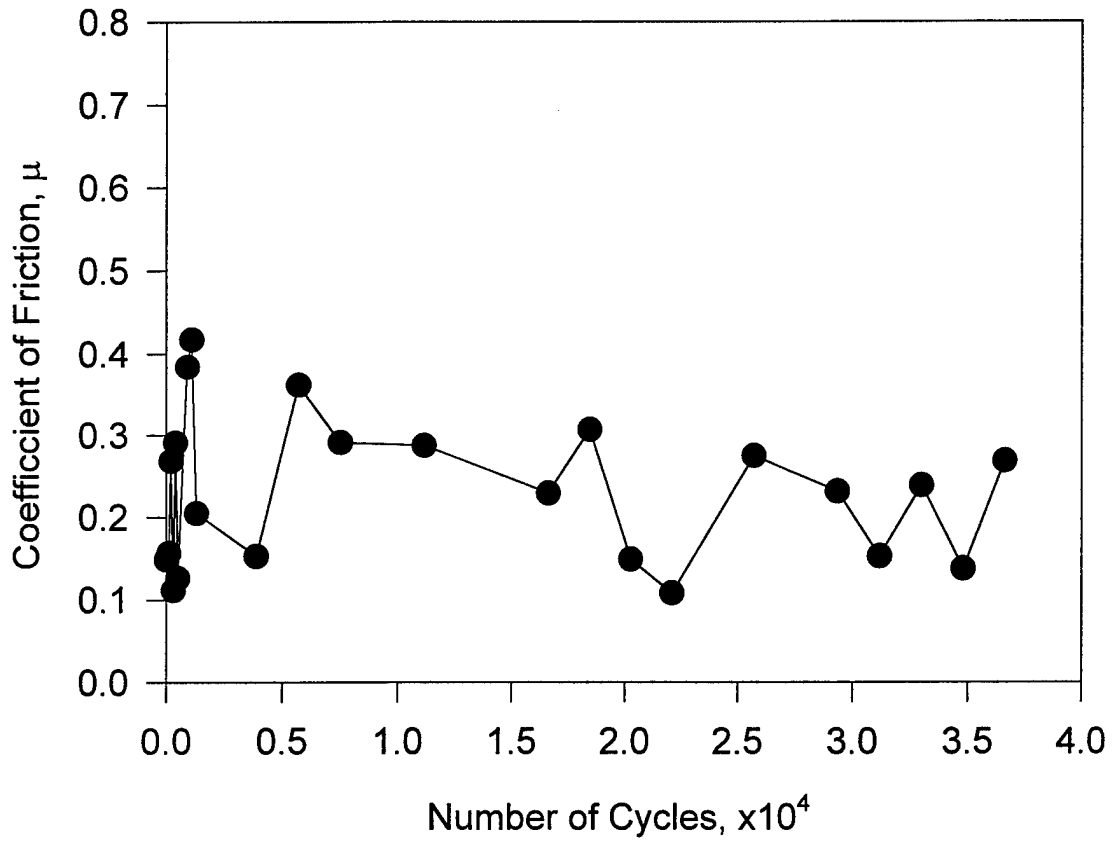
Figure 8 Plot of coefficient of friction against number of fretting cycles for 7075-T6 in 3.5% NaCl solution at 40 μm displacement, 37.3 N normal force and 1 Hz frequency.

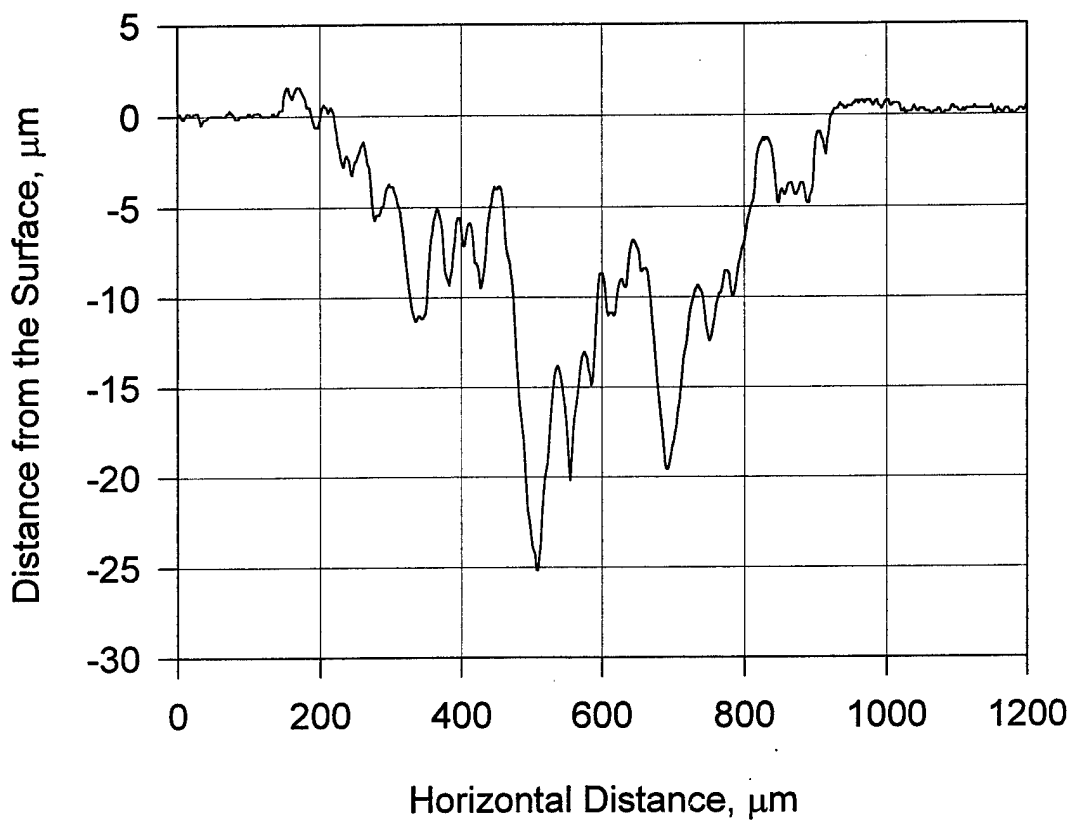
Figure 9 Profile of fretting wear scar of 7075-T6 specimen after  $N = 40,000$  cycles in 3.5% NaCl solution. Total displacement is 40  $\mu\text{m}$  and normal force is fixed at 37.3 N.

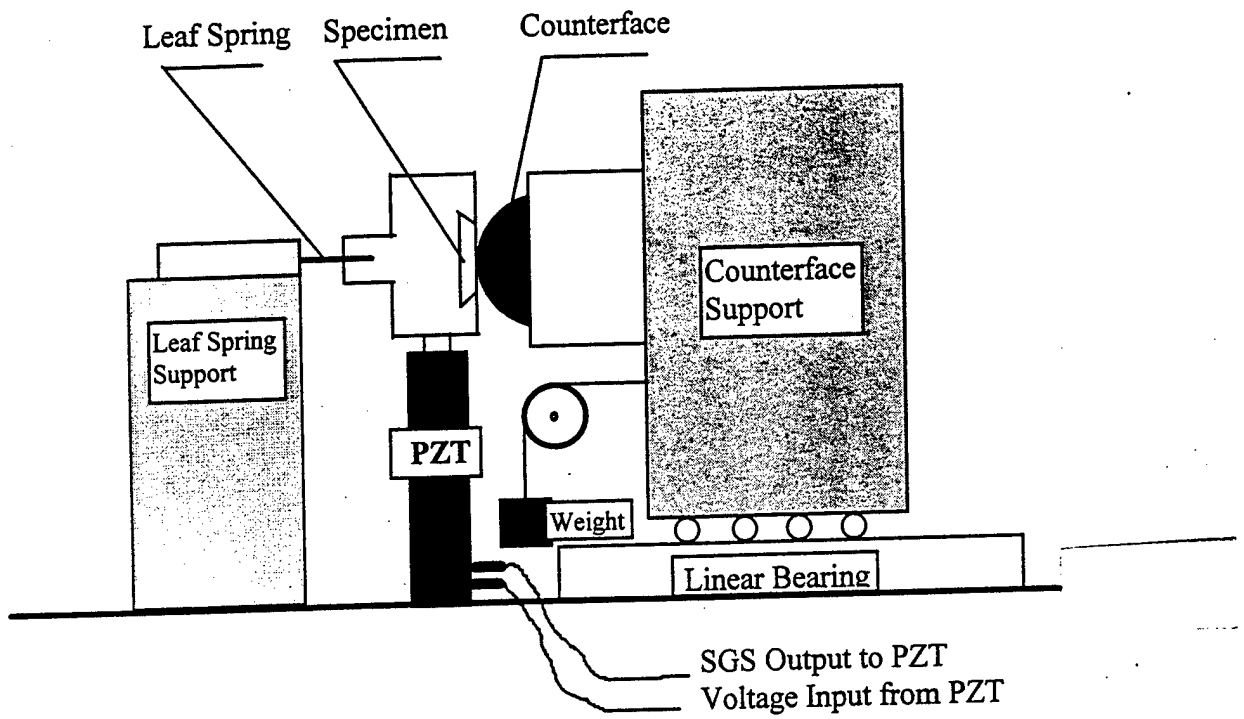
Figure 1 Schematic diagram of the fretting wear machine (mechanical part)

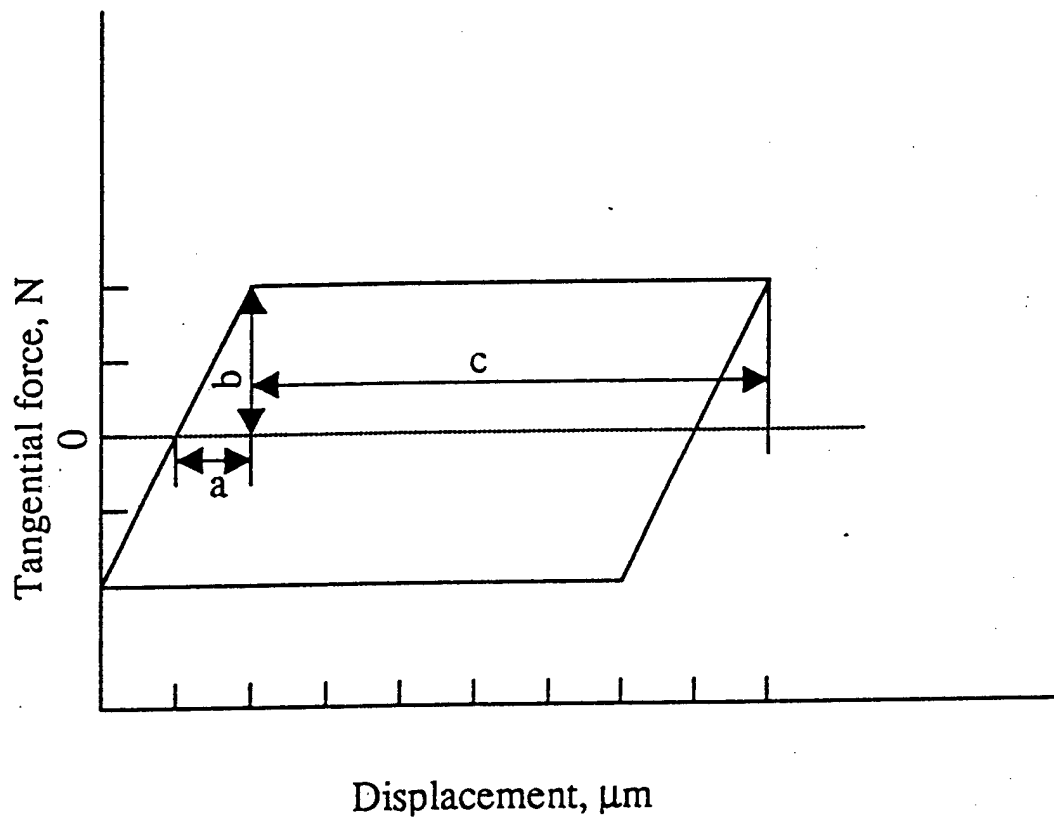
Figure 2 : Schematic drawing of a typical tangential force-displacement (Ft-D) hysteresis loop.  $a/b$  defines the system compliance and  $c$  is the local slip amplitude.

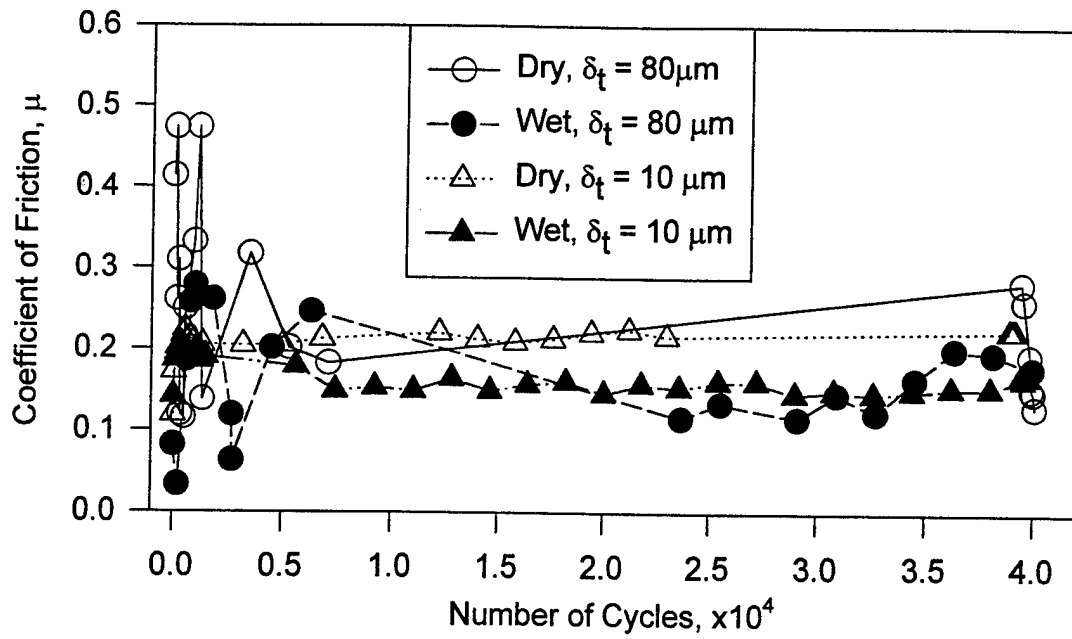
Figure 4 Typical friction coefficient curves as the function of number of fretting cycles for 2024-T3 fretting against a 52100 steel ball in both dry and wet conditions.

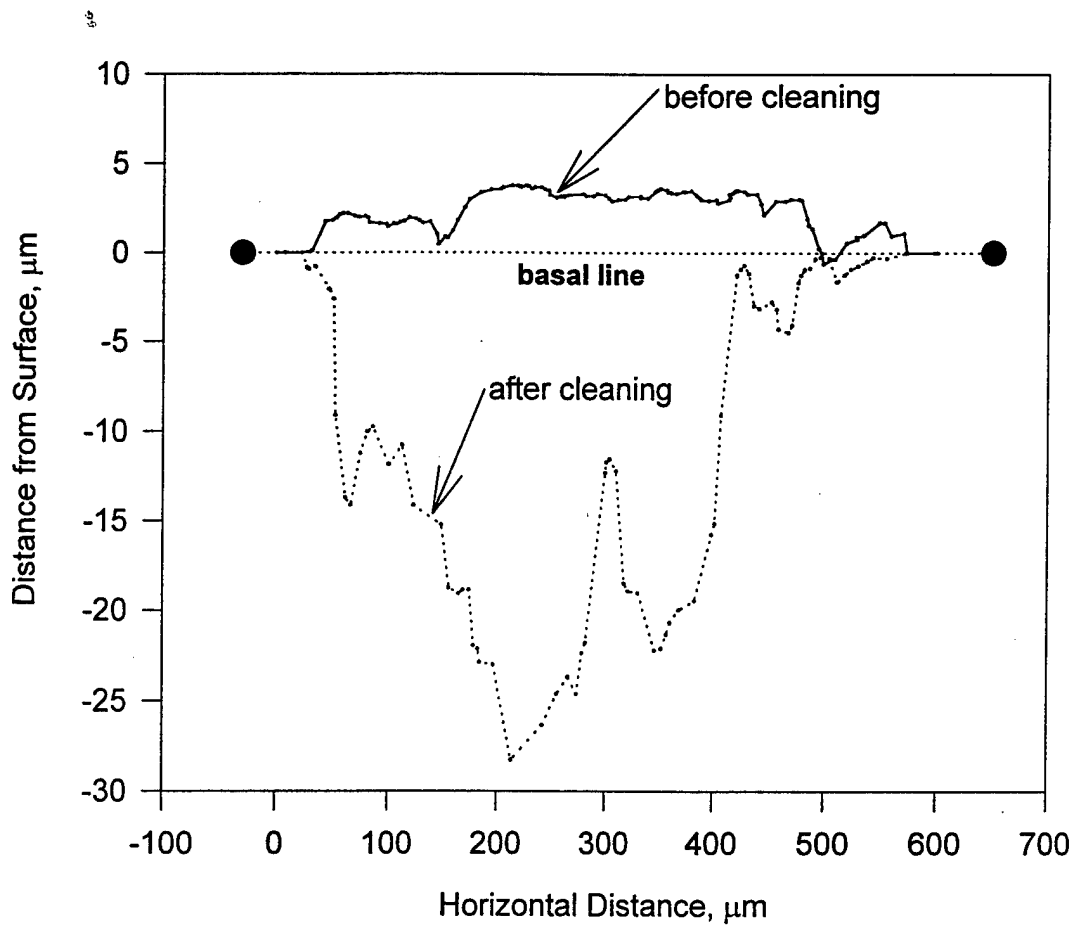
Figure 5 Profilometer measurements of the wear scars produced by  $N = 10^4$  fretting cycles for a 2024-T3 sample against a steel ball in ambient air for a contact pressure  $p_0 = 407$  MPa. Fretting produces a build-up of debris. Removal of the debris by washing reveals a  $25 \mu\text{m}$ -deep wear scar.

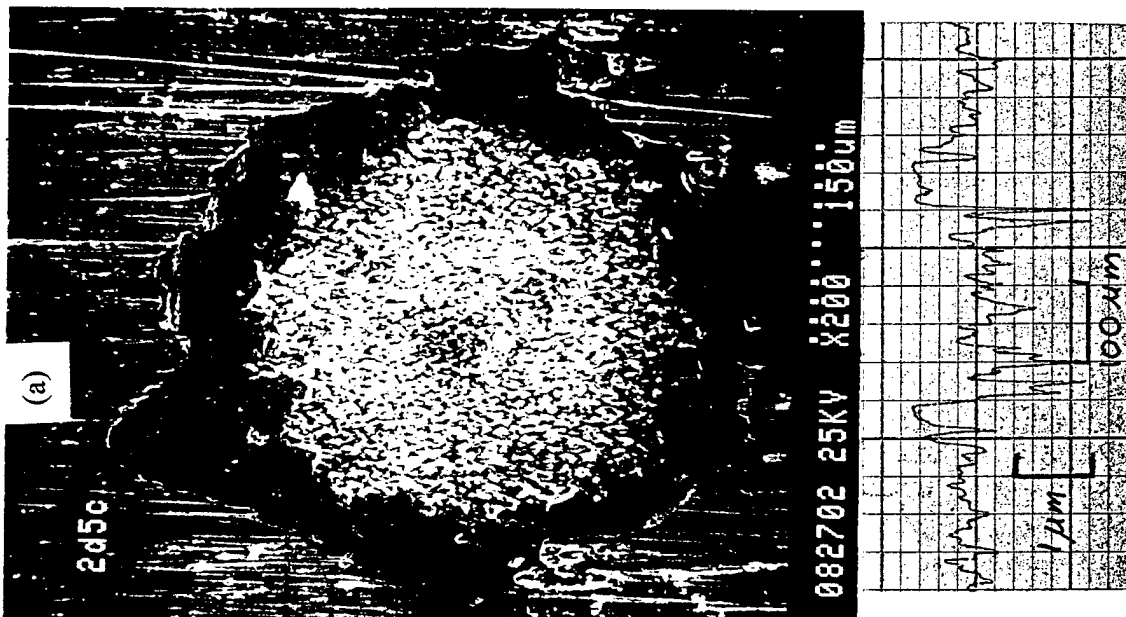
Figure 6 Examples of wear scars and profilometer traces obtained after  $N = 1 \times 10^4$  fretting cycles for  $p_0 = 407$  MPa,  $\delta_t = 25$   $\mu\text{m}$  and  $f = 1.0$  Hz for 2024-T3 against steel: (a) in air,  $W_s = 8.5 \times 10^{-15}$   $\text{m}^3/\text{Nm}$ , and (b) in saline solution,  $W_s = 90 \times 10^{-15}$   $\text{m}^3/\text{Nm}$ .

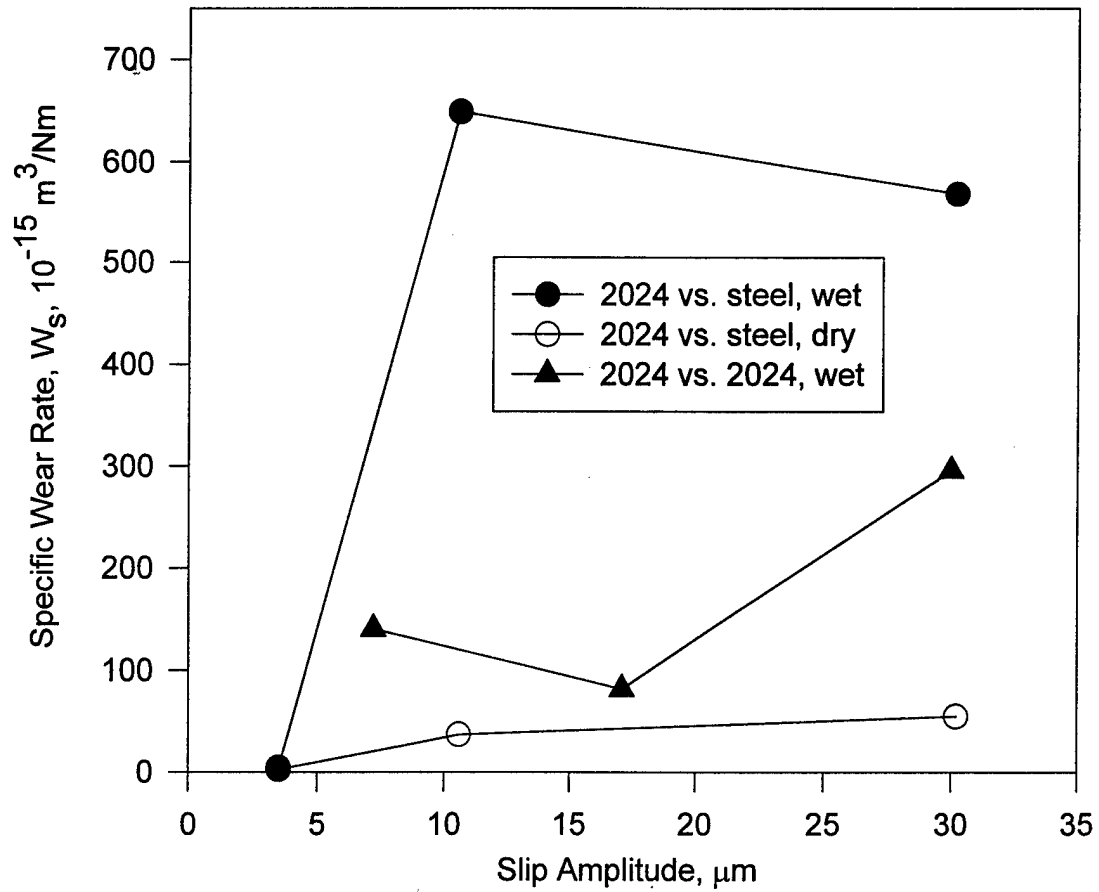
Figure 7 Variation of the specific wear rate,  $W_s$ , with slip amplitude for 2024-T3 against a 52100 sphere or 2024-T3 hemisphere in air and in a 3.5% NaCl solution after  $N = 1 \times 10^4$  fretting cycles for  $p_0 = 407 \text{ MPa}$  and  $f = 1.0 \text{ Hz}$ .

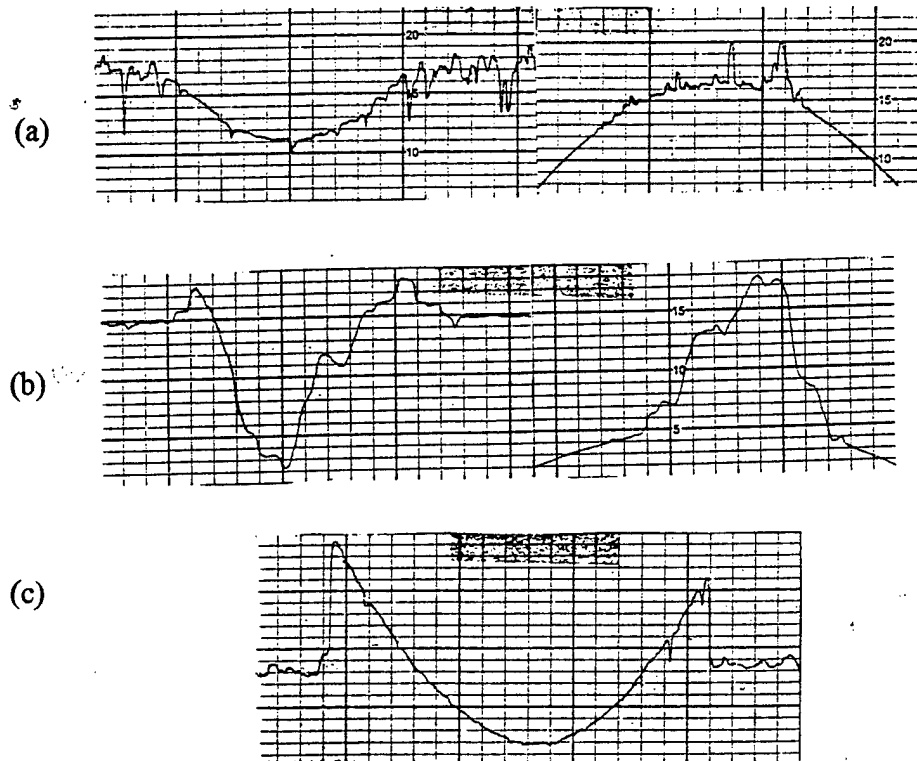
Figure 10 Profilometer traces of 2024-T3 sample and steel ball prior to cleaning, after (a) 500 fretting cycles, 10K $\times$ , (b) 50,000 cycles, 2K $\times$ , and (c) perpendicular to (b) for  $p_0 = 407$  MPa,  $\delta_t = 25$   $\mu$ m.

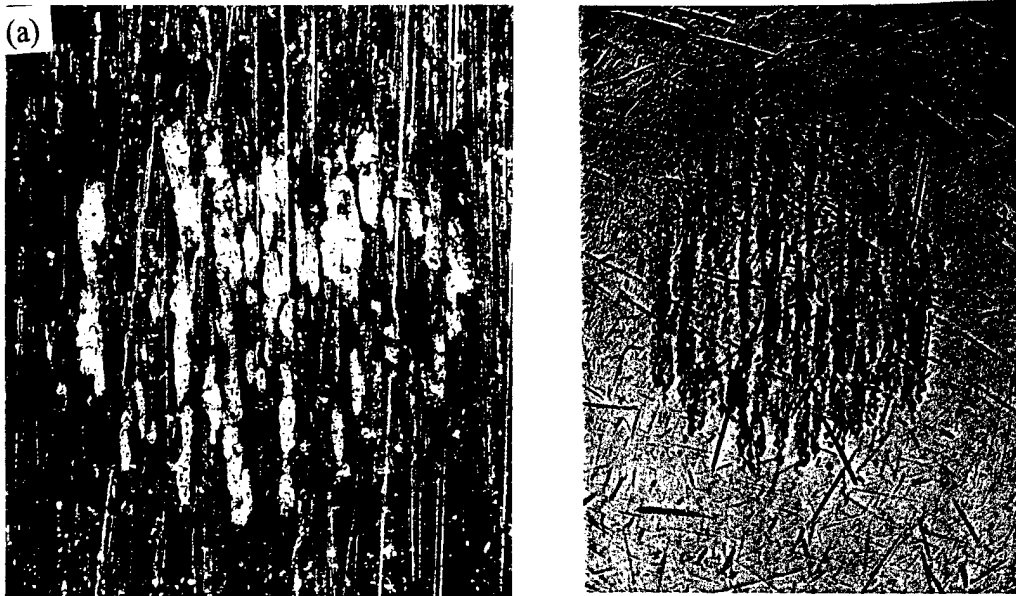
Figure 12 SEM and optical images of (a) 2024-T3, and (b) the counterface for 5,000 cycles with a frequency of 1 Hz under  $p_0 = 407$  MPa for  $\delta_t = 10$   $\mu\text{m}$ .
