**FINAL TECHNICAL REPORT**

**FRETTING CORROSION IN AIRFRAME RIVETED  
AND PINNED CONNECTIONS**

**George T. Hahn and Carol A. Rubin**Department of Mechanical Engineering  
Vanderbilt University  
Nashville, Tennessee 37235

March 20, 1998

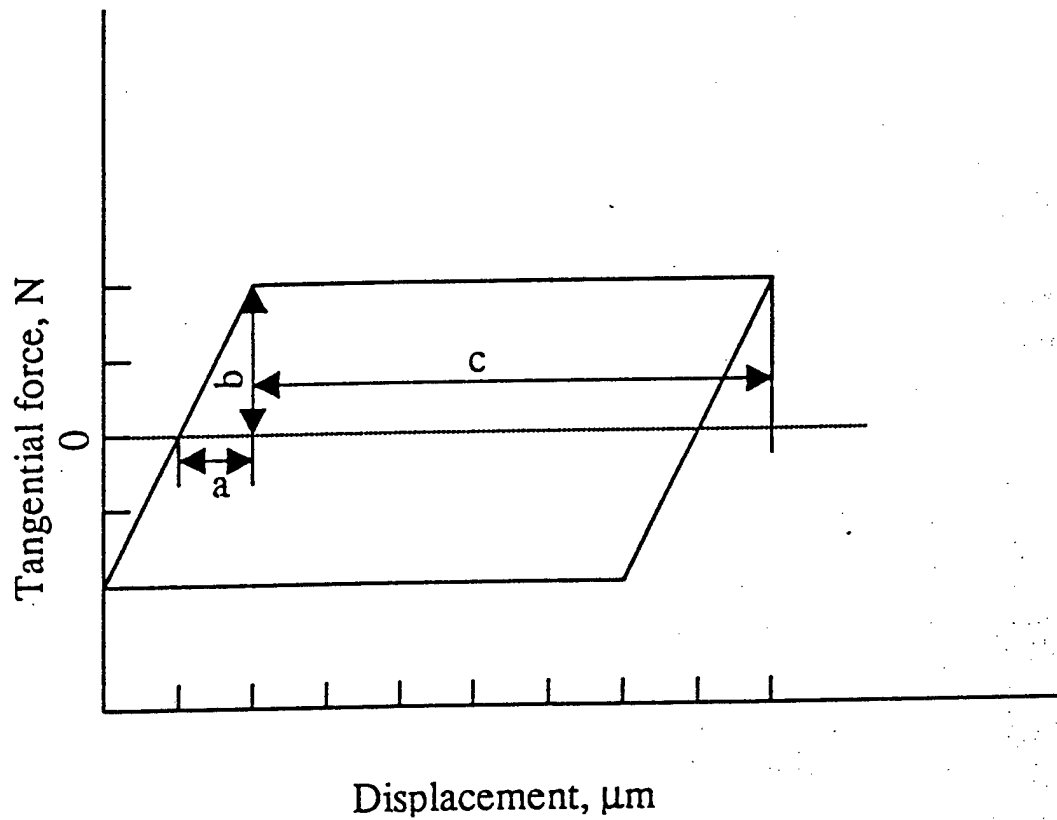
Figure 2 Schematic drawing of a typical tangential force-displacement (Ft-D) hysteresis loop.  $a/b$  defines the system compliance and  $c$  is the local slip amplitude.

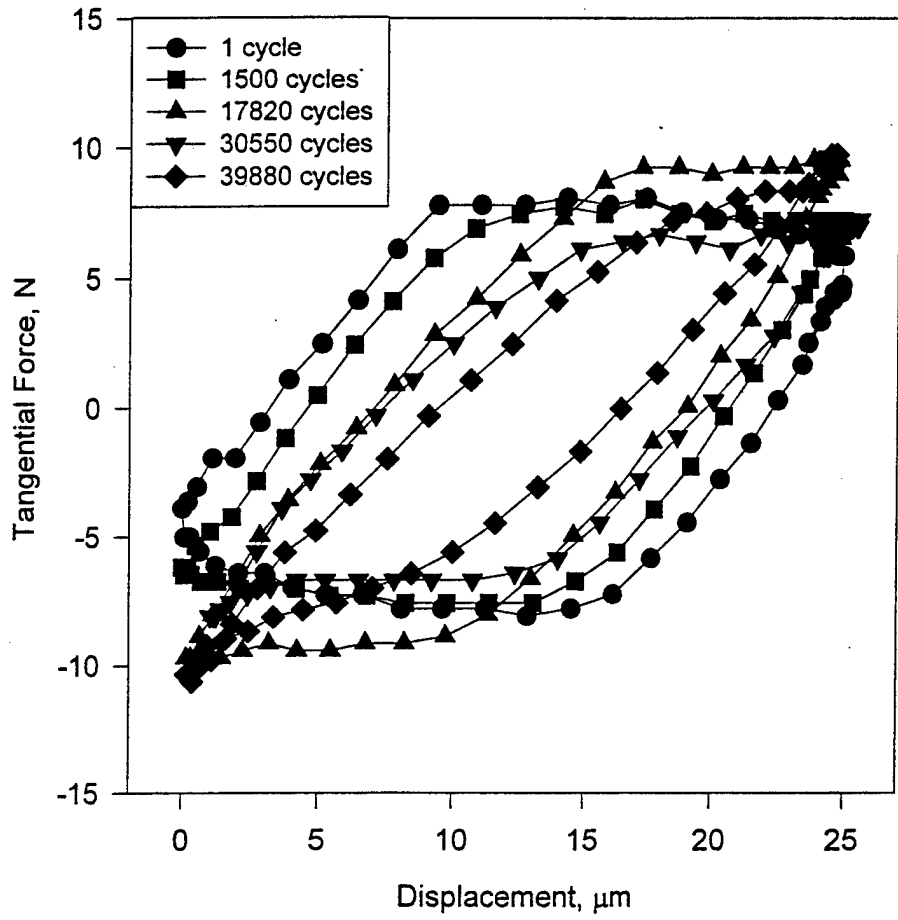
Figure 3(a) Evolution of friction logs with number of fretting cycles for 7075-T6 vs. 7075-T6 with  $f = 1.0$  Hz under  $p_0 = 1000$  MPa at a total displacement  $\delta_t = 25$   $\mu\text{m}$  in saline solution.

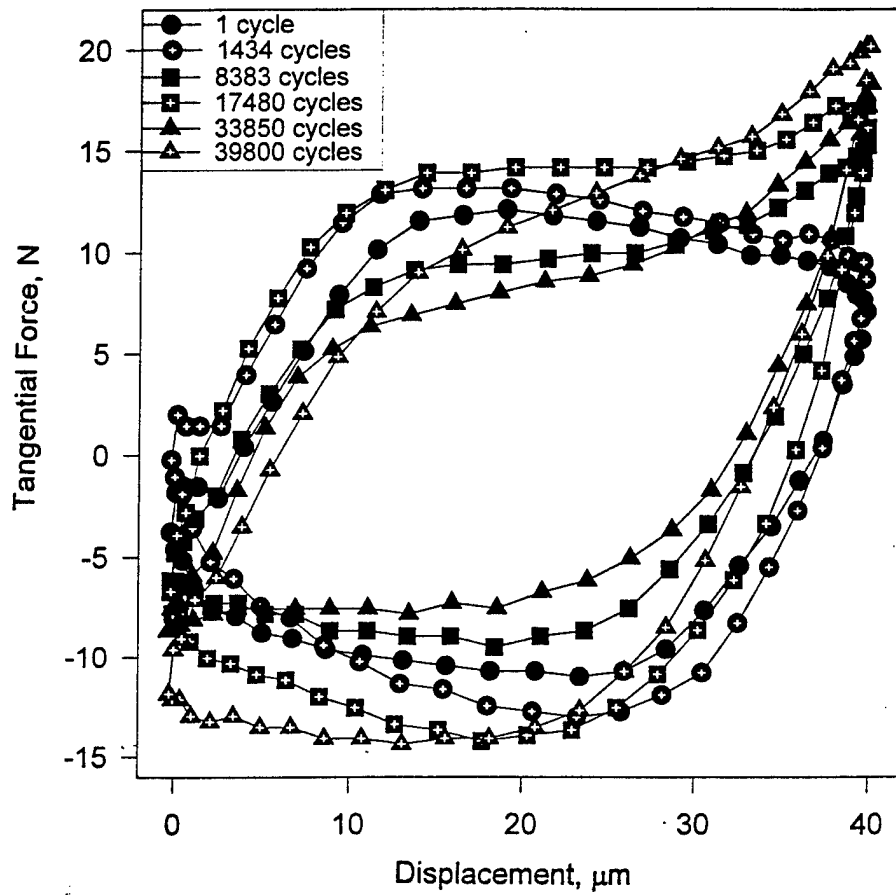
Figure 3(b) Evolution of friction logs with number of fretting cycles for 7075-T6 vs. 7075-T6 with  $f = 1.0$  Hz under  $p_0 = 1000$  MPa at a total displacement  $\delta_t = 40$   $\mu\text{m}$  in saline solution.

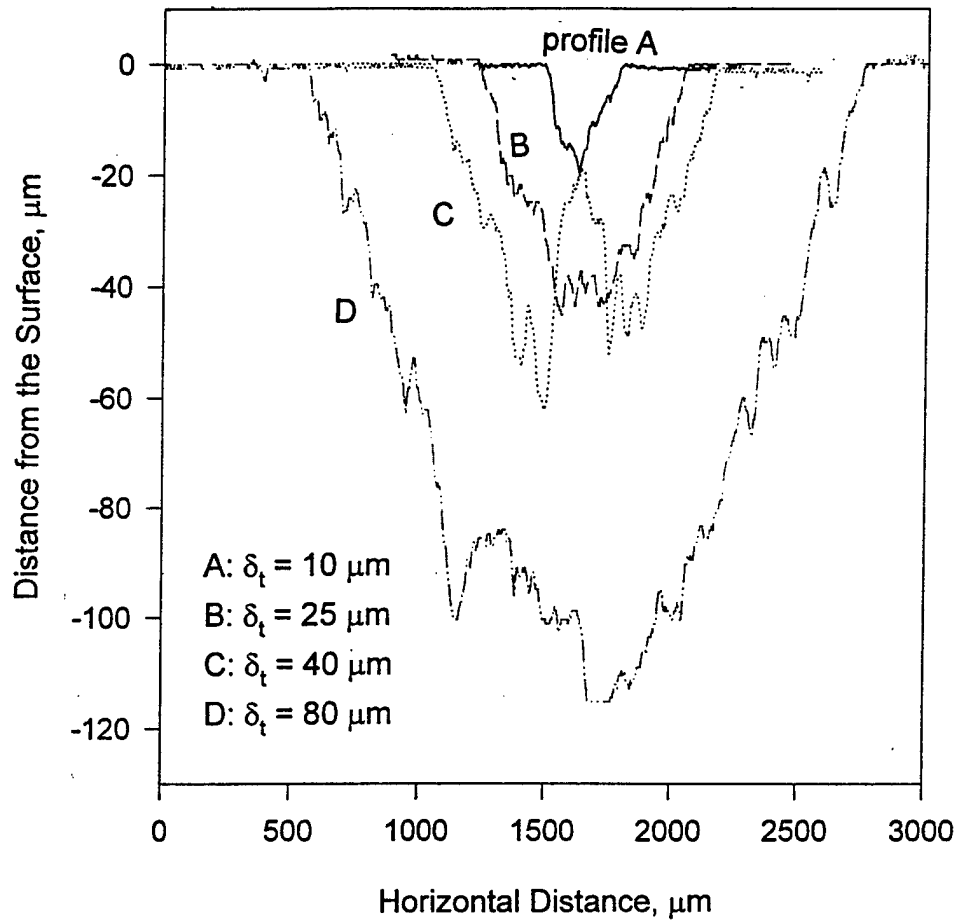
Figure 5(a) Profilometer measurements of the wear scars produced by  $N = 4 \times 10^4$  fretting cycles for 7075-T6 samples against 7075-T6 in saline solution with  $p_0 = 1000$  MPa, and total displacement  $\delta_t = 10 \mu\text{m}$ ,  $25 \mu\text{m}$ ,  $40 \mu\text{m}$  and  $80 \mu\text{m}$ , respectively.

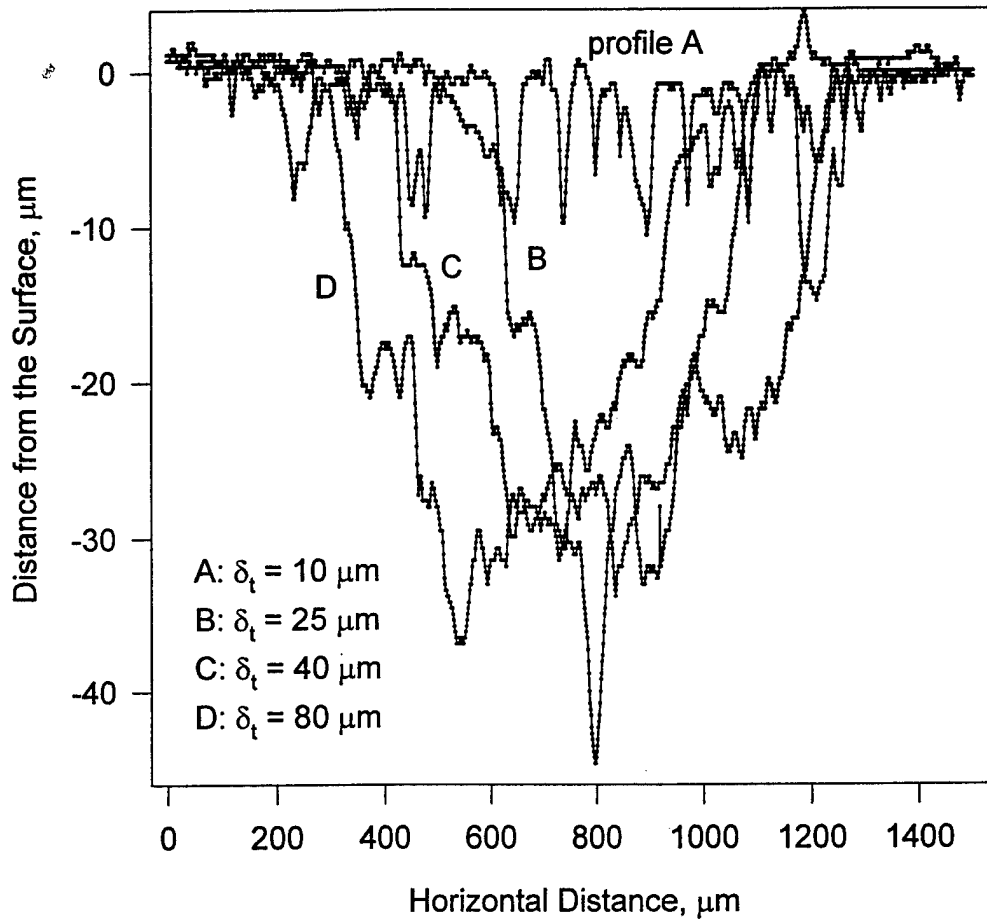
Figure 5(b) Profilometer measurements of the wear scars produced by  $N = 4 \times 10^4$  fretting cycles for 7075-T6 samples against steel in saline solution with  $p_0 = 1000 \text{ MPa}$ , and total displacement  $\delta_t = 10 \mu\text{m}$ ,  $25 \mu\text{m}$ ,  $40 \mu\text{m}$  and  $80 \mu\text{m}$ , respectively.

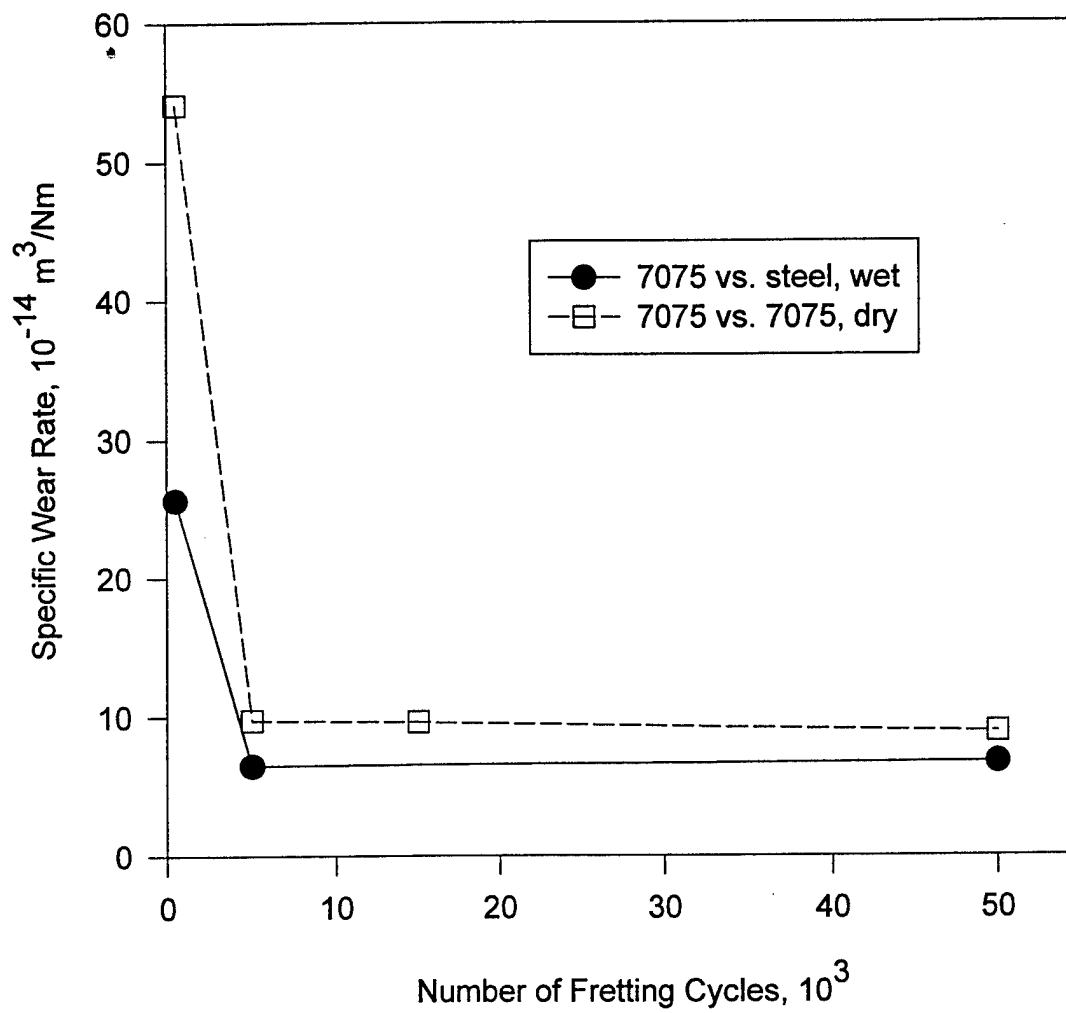
Figure 7 Variation of the specific wear rate,  $W_s$ , with the number of cycles for 7075-T6 against a 52100 sphere ( $\bullet$ ) in saline solution, and against 7075-T6 ( $\square$ ) in ambient air for  $p_0 = 1000 \text{ Mpa}$ ,  $\delta_t = 40 \text{ }\mu\text{m}$  and  $f = 1.0 \text{ Hz}$ .

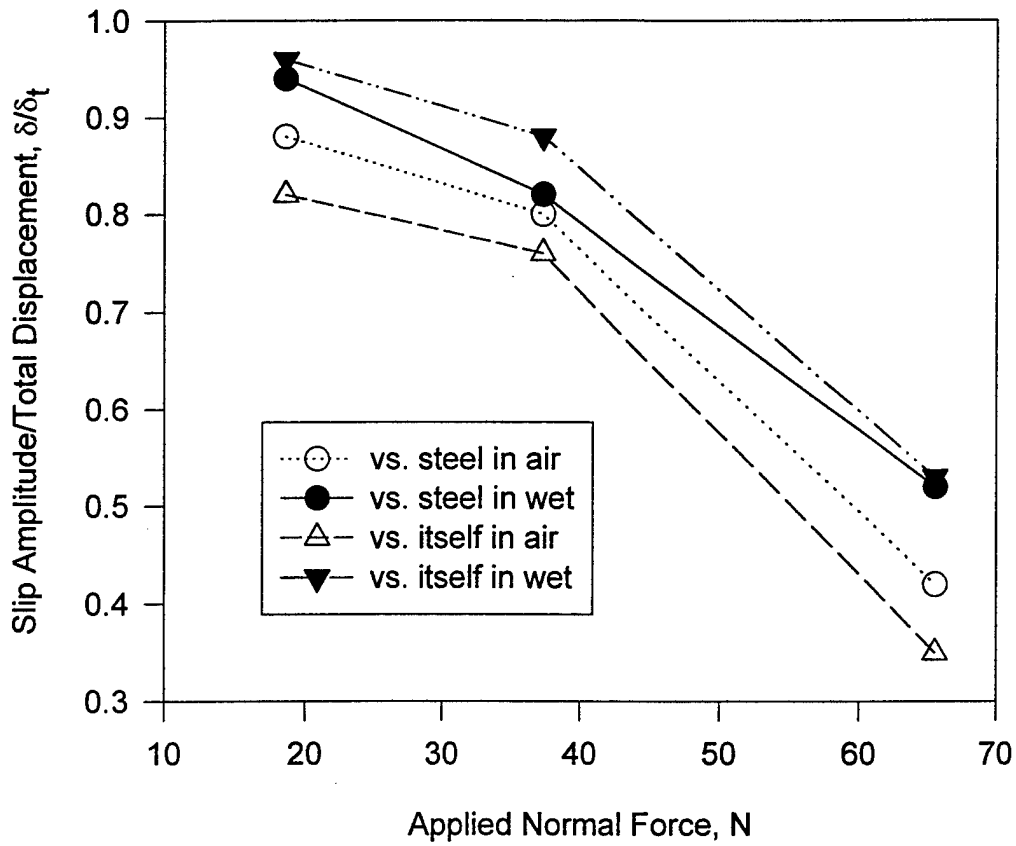
Figure 10 Plot of fretting ratio, slip amplitude/total displacement ( $\delta/\delta_t$ ), as a function of the normal force for 7075-T6 after  $N = 4 \times 10^4$  fretting cycles against 7075-T6 in ambient air ( $\blacktriangledown$ ) and saline solution ( $\Delta$ ), against steel in air ( $\circ$ ) and in saline solution ( $\bullet$ ). Higher normal force leads to smaller local slip amplitude.

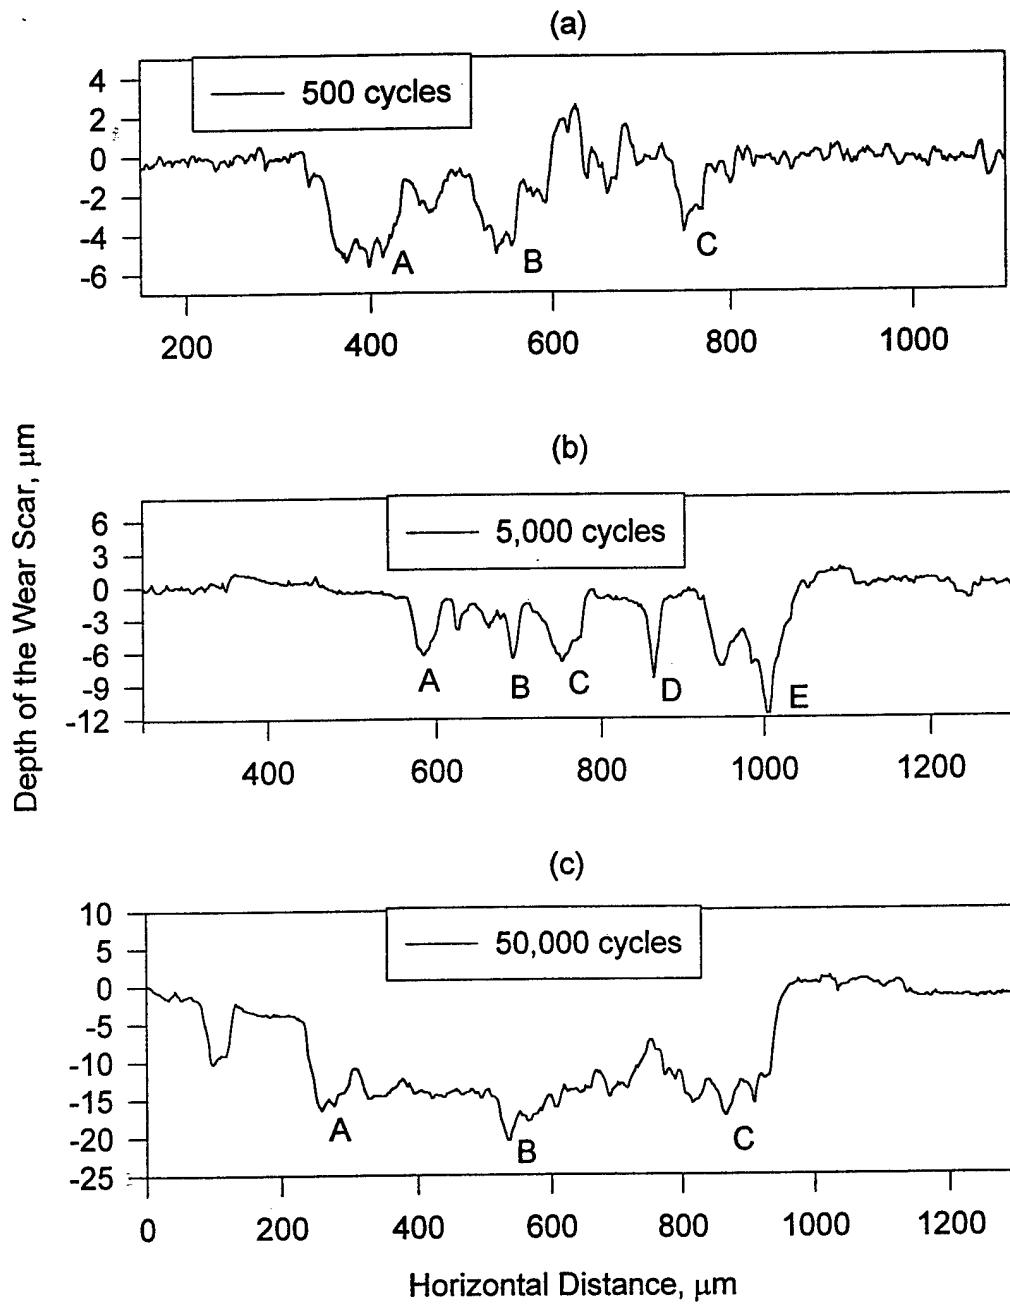
Figure 12 Profilometer traces of cleaned 7075-T6 sample against a steel ball in saline solution after: (a)  $N = 500$ , (b)  $N = 5,000$ , (c)  $N = 50,000$  fretting cycles, for  $p_0 = 407$  MPa and  $\delta_t = 40 \mu\text{m}$ .

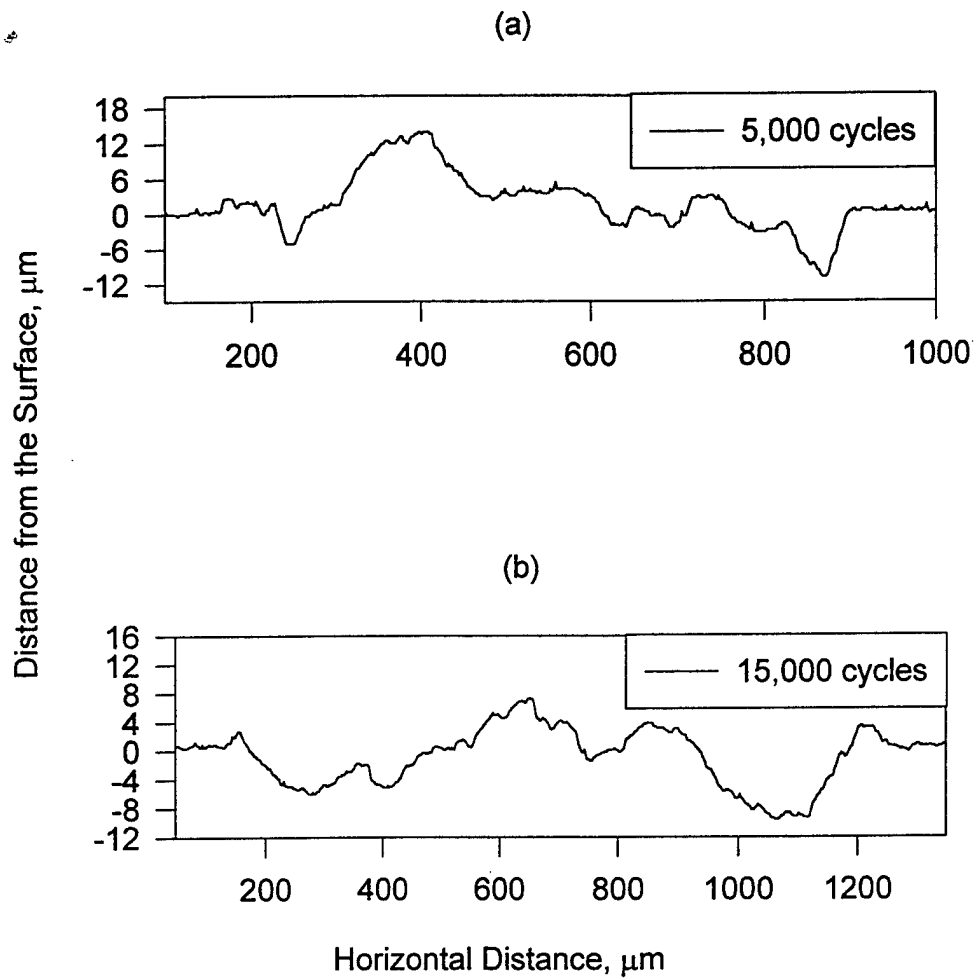
Figure 13 Profilometer traces of cleaned 7075-T6 sample against a steel ball in air after: (a)  $N = 5,000$ , (b)  $N = 15,000$  fretting cycles for  $p_0 = 407 \text{ MPa}$  and  $\delta_t = 80 \mu\text{m}$ .
