**US Army Corps  
of Engineers**

USACERL Special Report 99/01  
October 1998

# **Shear Strengthening of Reinforced Concrete Beams Using Fiber-Reinforced Polymer Wraps**

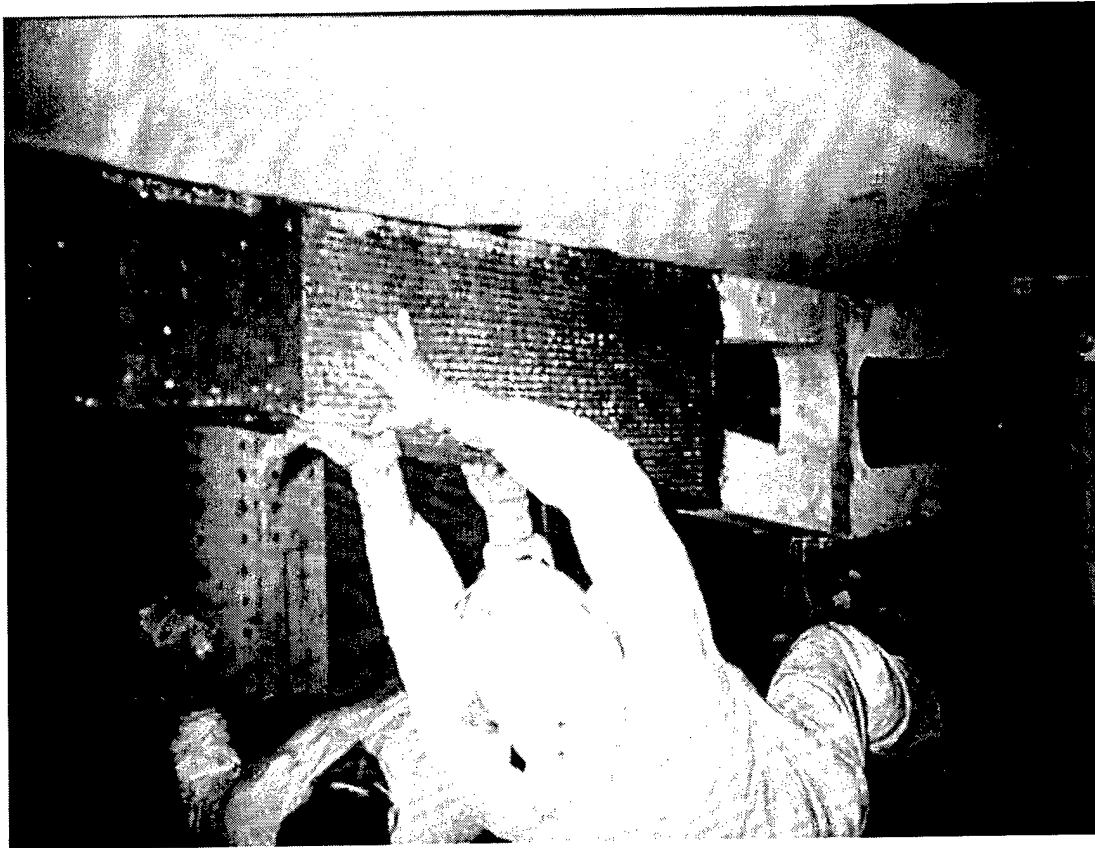
Figure 9. FRP application.

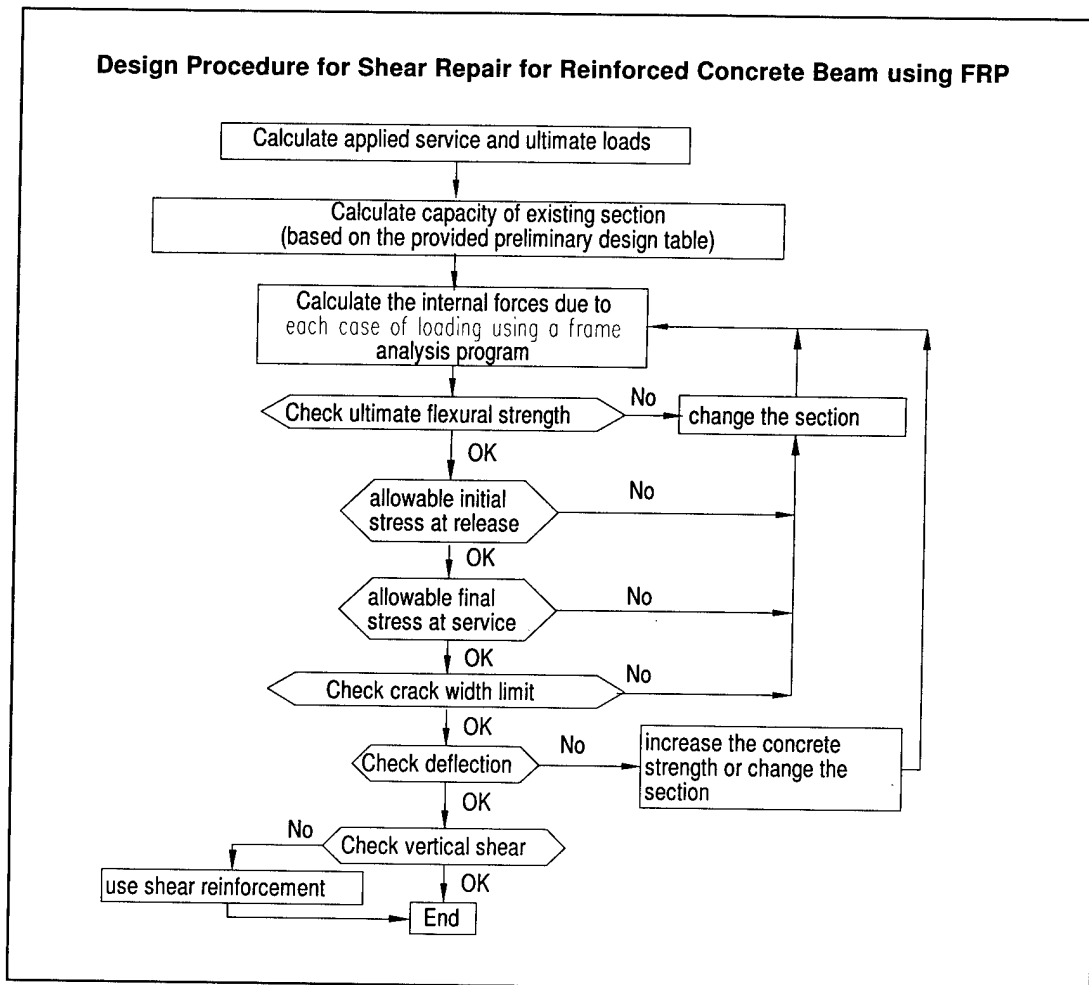
Figure 42. Shear repair design procedure.

Based on standard structural engineering design principals and the experimental test results, a simple procedure was developed to design FRP composite system repairs for reinforced concrete joists deficient in shear capacity. This design procedure is a step-by-step process wherein load demands are assessed for an existing member cross-section, a repair is designed based on specified engineering properties of the FRP composite system to achieve the required capacity, and stresses and deflections for the repaired joist are checked. Figure 31 shows the flowchart for the joist design procedure.
