**AFRL-ML-WP-TR-1998-4211**

**ENDURANCE PUMP TESTS WITH  
FRESH AND PURIFIED MIL-H-5606  
HYDRAULIC FLUID**

**FINAL REPORT FOR PERIOD APRIL 1, 1995 – JUNE 1 1998**

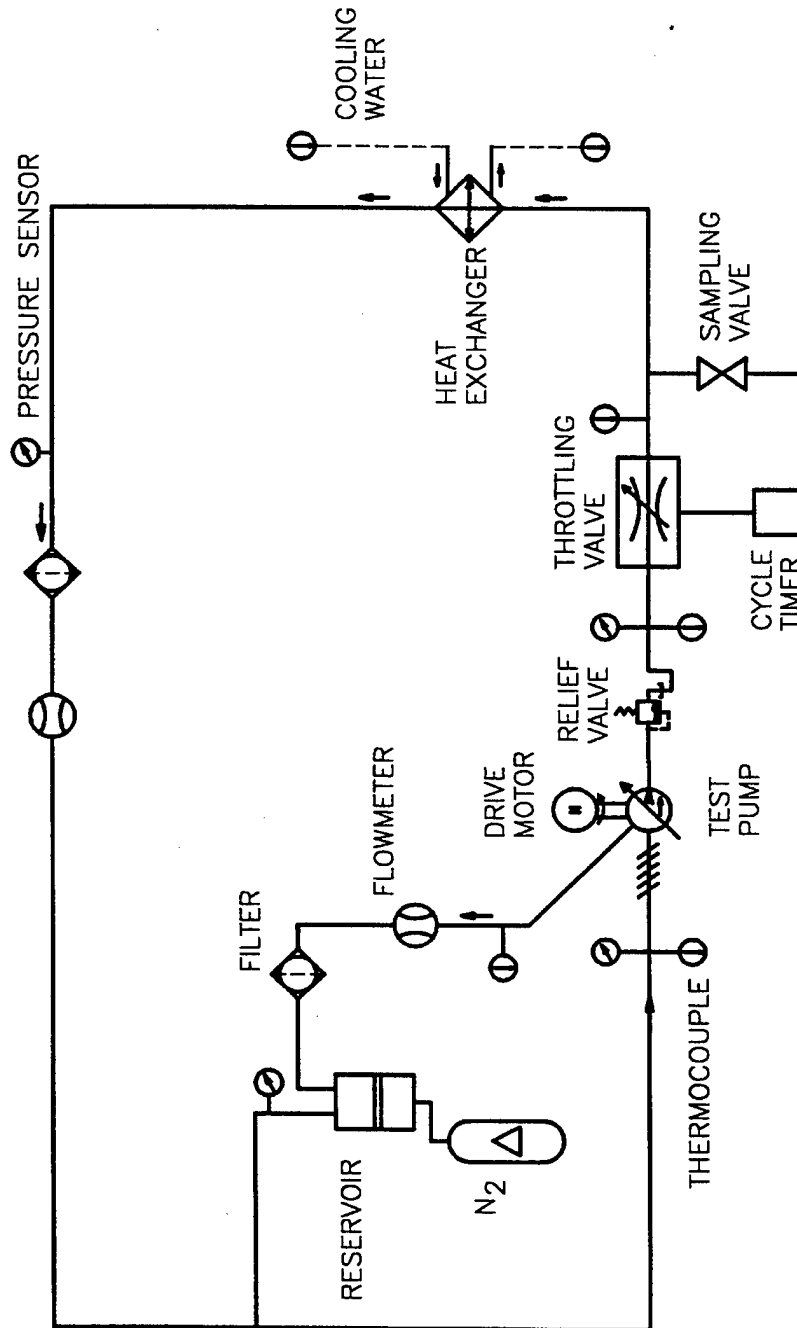
FIGURE 1: HYDRAULIC PUMP TEST CIRCUIT

The pump test stand at AFRL/MLBT was designed primarily for testing new and experimental hydraulic fluids using small to medium displacement aircraft hydraulic pumps. This test stand as shown in Figure 1 has been described in previous publications [3, 4].

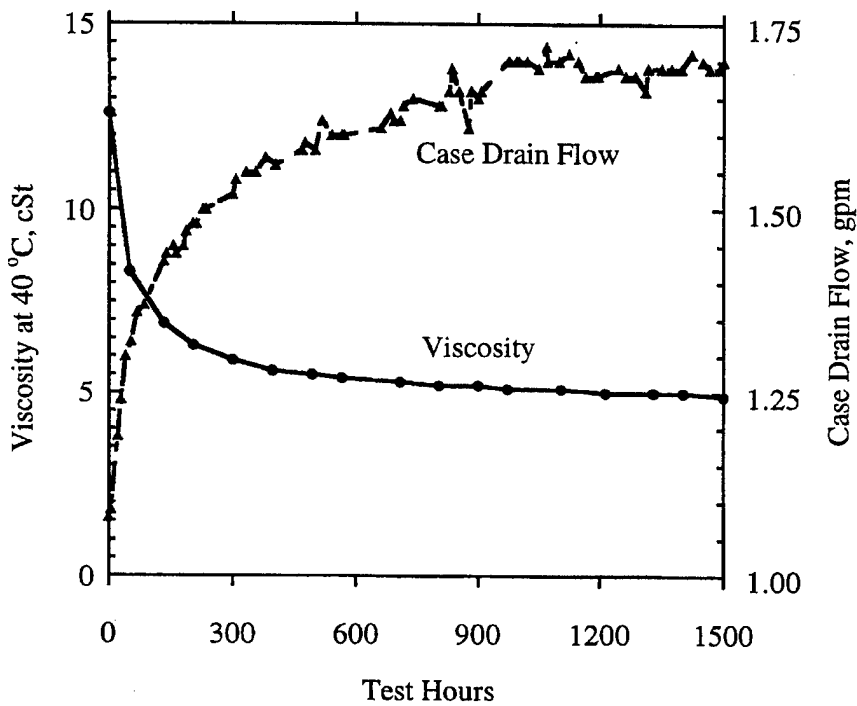
Figure 3. Case Drain Flow and Viscosity for Test 35 with Fresh Mil-H-5606

The case drain flow in both tests increased rapidly first, and then almost leveled off. An increase in the case drain flow is generally attributed to increased pump wear, but that is not true for these tests. A comparison of the case drain flow and the fluid viscosity showed an inverse relationship (see Figs 3 and 4). Due to shearing of the VI (viscosity index) improver in MIL-H-5606, the fluid viscosity dropped rapidly, thereby causing an increased case drain flow. Once the fluid viscosity leveled off, so did the case drain flow. The pumps performed well in both tests in spite of a big reduction in fluid viscosity.

In all cases, no performance difference was found in fluid samples from either test. The viscosity of the fluid samples taken was determined at 40 °C (see Figures 3 and 4). It is easily seen that MIL-H-5606 suffered significant viscosity losses during the first 30 hours of pump testing, but a similar amount in both tests. The viscosity index (VI) improvers used to boost the viscosity of MIL-H-5606 break up under the high shear environment inside the pump and the throttling valve, causing a permanent loss of the fluid viscosity. Under the high pressure and high shear rate environment, the VI improved fluids behave more like the base oil [4].

5.2 There was significant viscosity loss in both the fresh and the purified fluid tests. The reduction in viscosity with test time caused a corresponding increase in case drain flow. There was no significant change in the other fluid properties monitored.

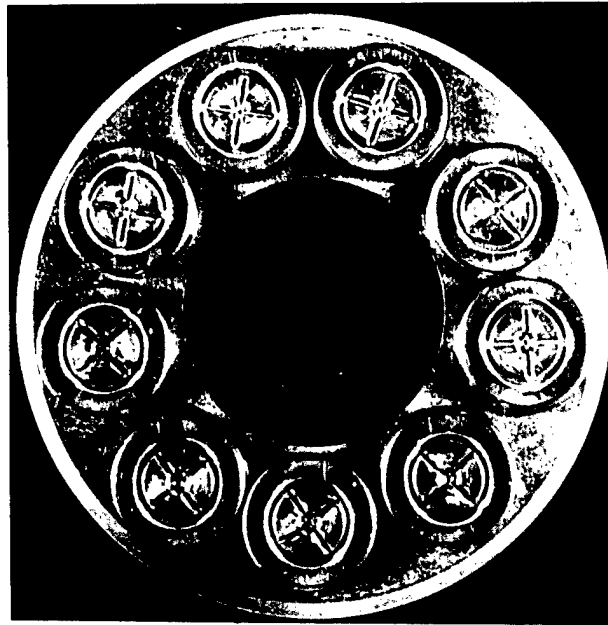
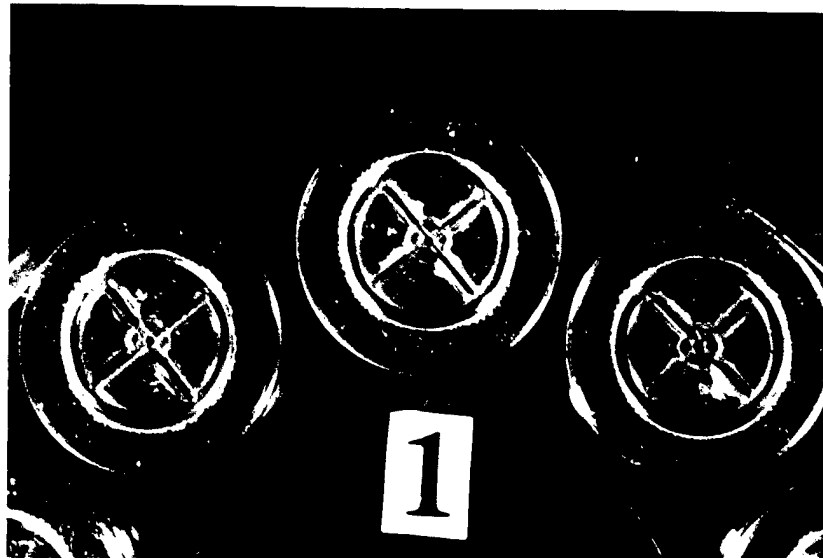
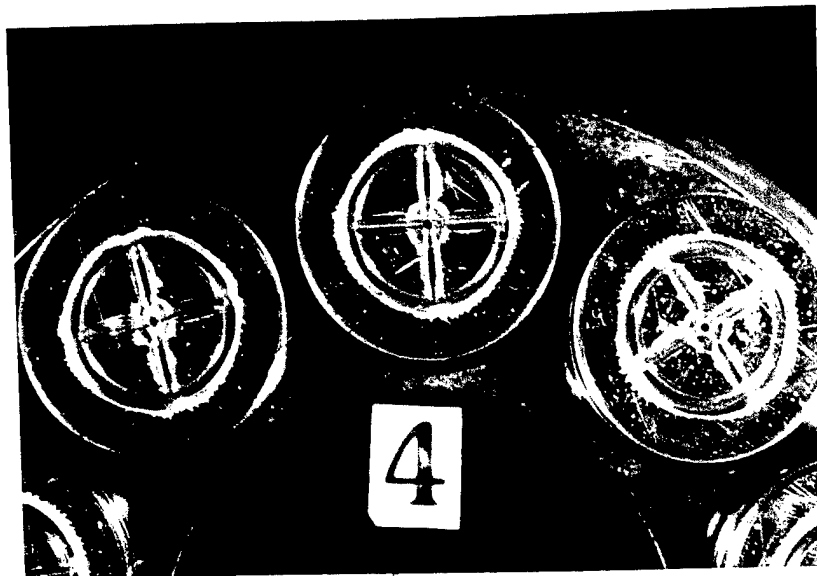
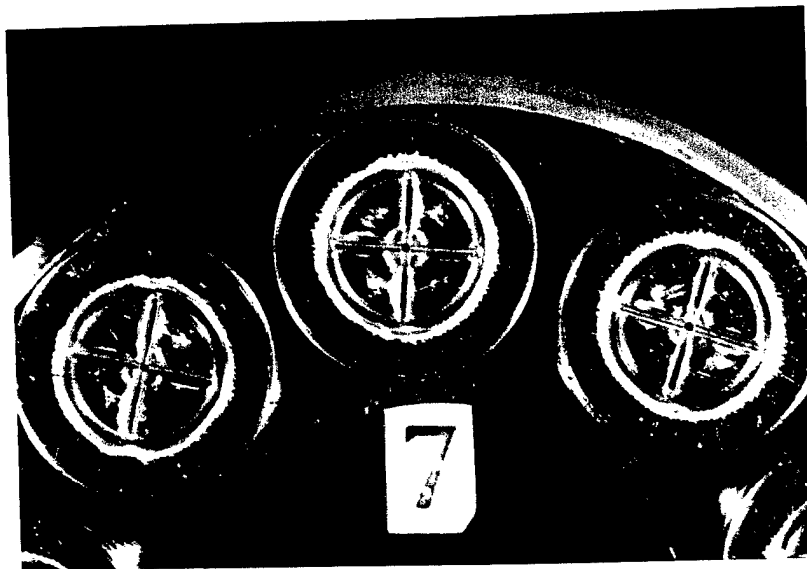
Piston Shoe Faces after 972 Hours  
Pump Test 35 with MIL-H-5606

The base line test was completed successfully. At 946 hours, the throttling valve stuck in the maximum flow cycle (12.5 gpm) and the test continued until 972 hours. The test was stopped to fix the problem, and to inspect the pump. The pictures taken before the test, after 972 hours and after the completion of the 1500 hours are shown in Appendix-A. Polishing wear was observed on most of the pump parts except on the cylinder block face, on the piston shoe faces and on the main shaft end that mates with the needle bearing. Some erosion was observed around the kidney ports, on the cylinder block face and on the piston shoe faces. The main shaft, that acts as the inner race for the needle bearing, showed considerable spalling possibly due to the cyclic forces at the roller bearing/shaft interface. It was decided to continue the test without replacing any parts. No degradation in the pump performance was

5.1 Pump tests with both fresh and purified MIL-H-5606 fluids were successfully completed, and there was no apparent difference in pump performance with either fluid. In test with fresh MIL-H-5606, the main shaft that acts as the inner race for the needle bearing, showed considerable spalling. Polishing wear was observed on most of the pump parts except that there was some erosion on the cylinder block face and on piston shoe faces. The erosion on the piston shoe faces was somewhat more with the purified fluid than observed in the test with fresh MIL-H-5606. No degradation in the pump performance was observed due to shaft spalling or the erosion on cylinder block and piston shoe faces.

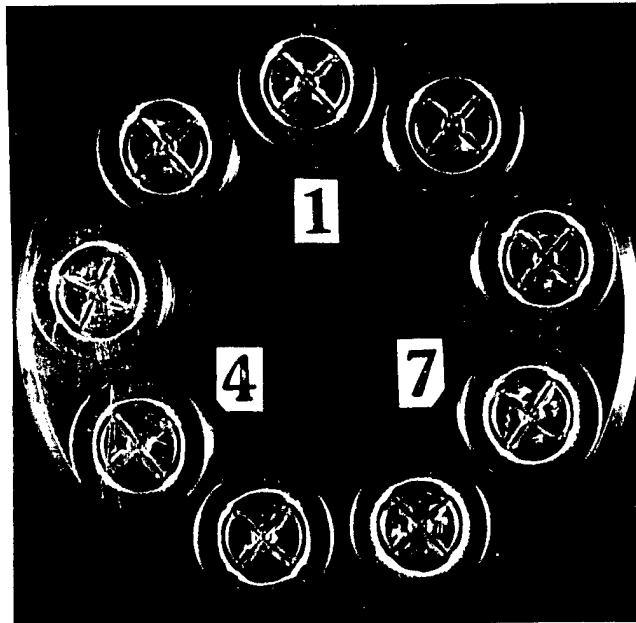
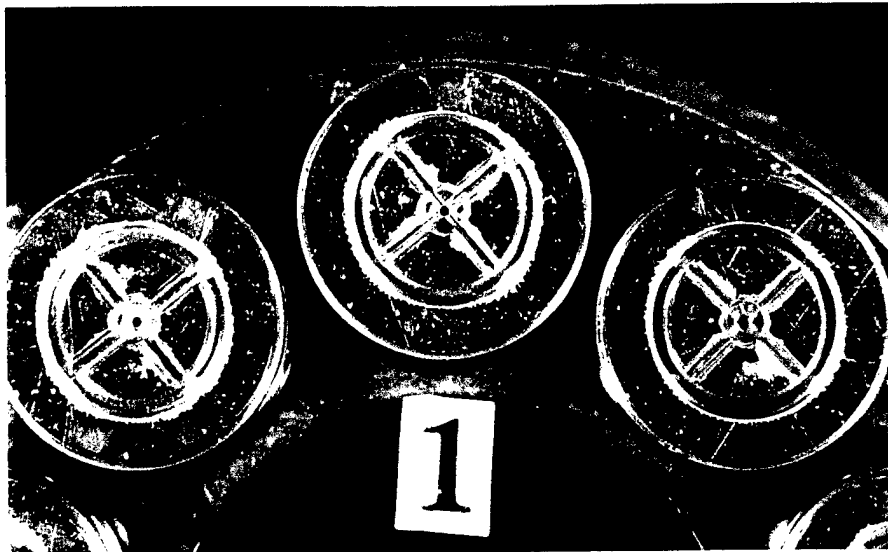
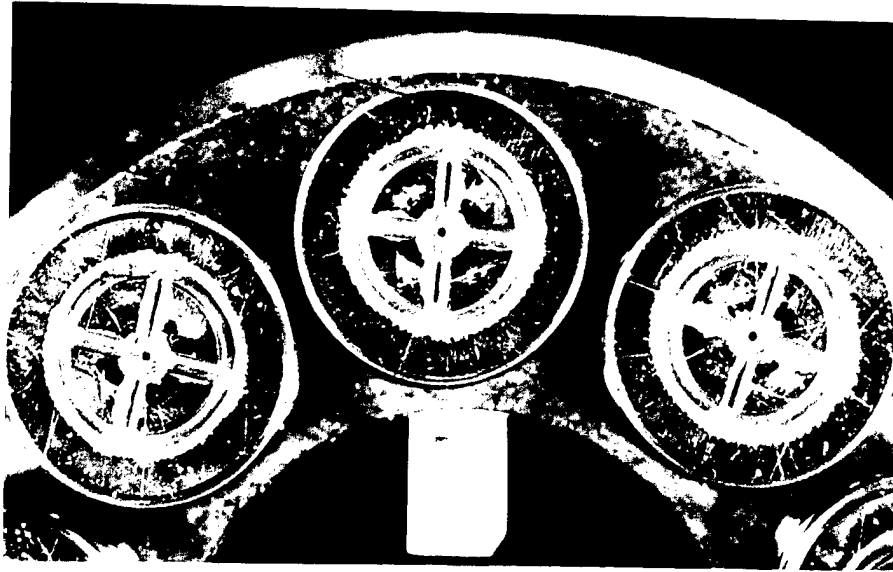
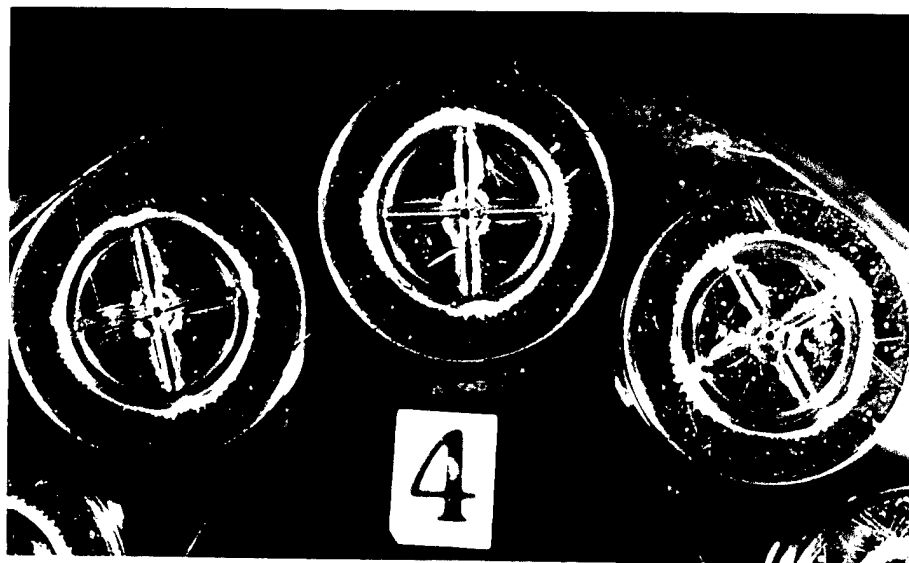
Piston Shoe Faces after 1500 Hours  
Pump Test 35 with MIL-H-5606

observed due to the spalled shaft or the erosion on cylinder block and piston shoe faces. The 1500 hour inspection showed an increase in the erosion around the kidney ports on the cylinder block face and on the piston shoe faces. The spalling on the shaft did not seem to increase.

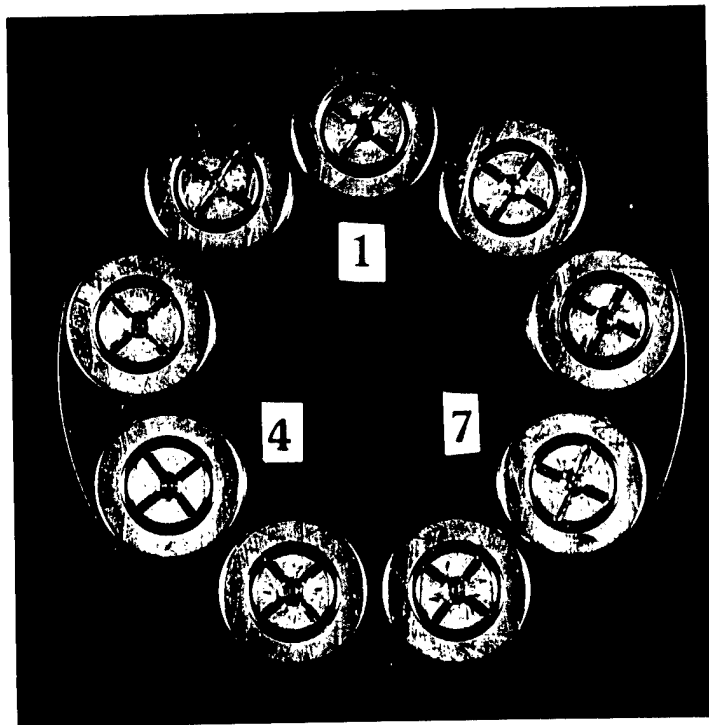
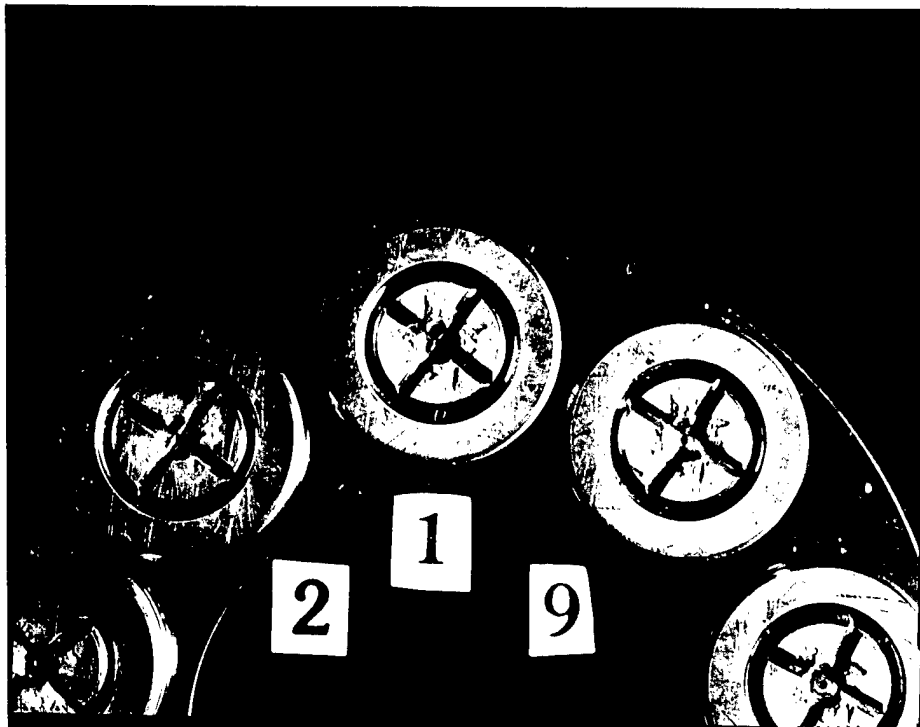
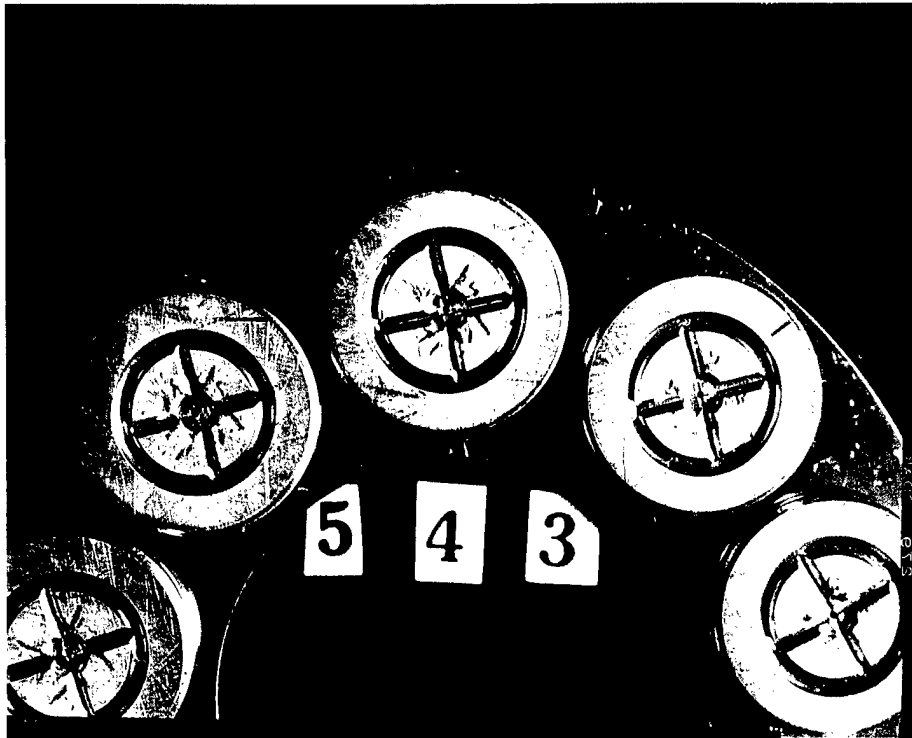
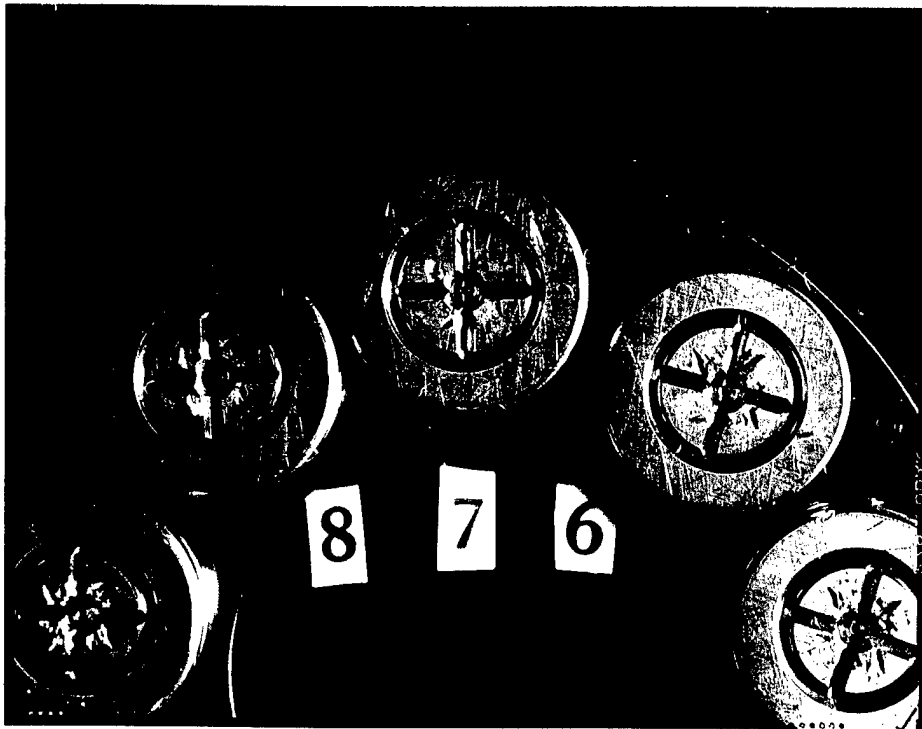
Piston Shoe Faces after 1500 hrs.  
Pump Test 36 with MIL-H-5606

The pump test with purified fluid was completed successfully as planned. In order to subject this test to the same kind of conditions as experienced in Test 35, the throttling valve was set in the full flow condition at 946 hours. From 946 hours to 972 hours, the test was continued at a pump outlet flow of 12.5 gpm. The test was stopped at 972 hours, to inspect the pump. The pictures taken before the test, after 972 hours and after the completion of the 1500 hours are shown in the Appendix-B. Polishing wear was observed on most of the pump parts except that there was some erosion on the cylinder block face and on piston shoe faces. No degradation in the pump performance was observed due to the erosion on the cylinder block and on the piston shoe faces. The 1500 hour inspection showed an increase in the erosion around the kidney ports on the cylinder block face and on the piston shoe faces. The erosion on the piston shoe faces was somewhat more in this test than observed in Test 35.

may extend the life of the hydraulic fluid (and reduce the waste stream of used fluid), this benefit must be weighed against possible lower hydraulic pump life due to increased cavitation erosion.
