CRREL REPORT

Investigation of the Roosevelt Road Transmitter Site, Fort Richardson, Alaska, Using Ground-Penetrating Radar

Lewis E. Hunter, Allan J. Delaney, and Daniel E. Lawson

March 1999

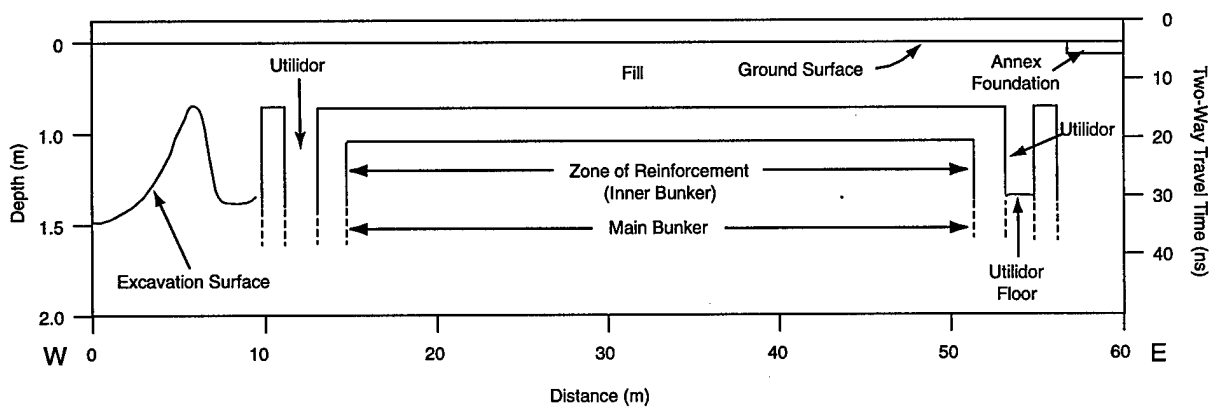
Figure 12. Interpretive depth sections for transect 2.

a. 100-MHz transducer.

b. 400-MHz transducer.

c. Annotated sketch of 400-MHz profile.

Transects 2, 3, and 5 delineate the bunker and the adjoining utilidors. Transect 2 extends 60 m from the overgrowth west of the bunker to the top of the concrete slab of the Transmitter Annex at the south end of the bunker (Fig. 5). The 100-MHz profile is distinguished by the limited penetration where the antennas were directly over the bunker, and by strong diffractions at its edges (Fig. 11a and 12a). There is a near-horizontal reflector at a depth of 5 m on both sides of the bunker (Fig. 11a). The depth of this reflector corresponds to the strong reflector in transect 1 (Fig. 9a and 10a), suggesting that it is probably the same excavation surface. The reflection bands at a depth of 50 to 70 cm above the bunker (Fig. 11b) appear to reflect its upper surface (Fig. 12b).

The 400-MHz profile shows distinct diffractions that originate from the utilidor structures on either side of the bunker (Fig. 12b). These diffractions appear as broad arches in the 100-MHz profile, where the wavelength is about 1.3 m long (Fig. 11a). Two distinct hyperbola sets can be distinguished in the 400-MHz data with the smaller (30-cm) wavelength (Fig. 11b). The higher resolution allows us to distinguish between the outer and inner walls of each utilidor. The top of the utilidor appears to be at about 1 m depth; a lower diffraction at 1.5 m depth and 54 m distance along the transect may locate the utilidor floor (Fig. 12b and 12c). Utilidors seen during the investigation were constructed of concrete walls, with railroad ties covered with soil for a ceiling and an earthen floor.
