**US Army Corps
of Engineers**
Waterways Experiment
Station

Coastal Inlets Research Program

Shinnecock Inlet, New York, Site Investigation

Report 1 Morphology and Historical Behavior

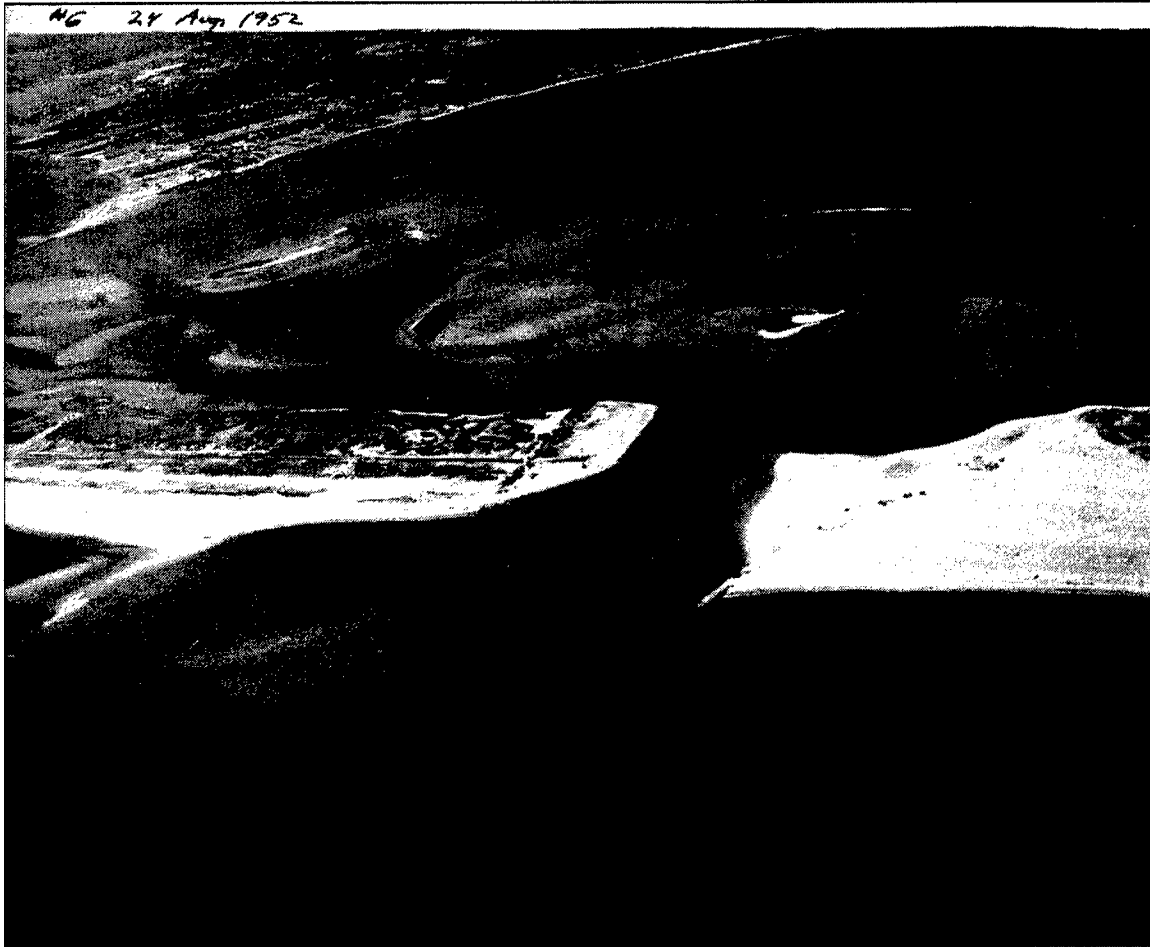
Figure 10. Photograph taken during construction of east jetty, 24 August 1952 (Channel runs northeast-southwest, closely following revetment on west shoreline and heads out to sea just east of a spit on Tiana Beach. Ebb shoal has an almost straight seaward margin. On flood shoal, three channels merge at bay end of inlet. Two of these channels, east and central, have shoaled) (Westhampton Photo Studio, from Suffolk County Department of Public Works)

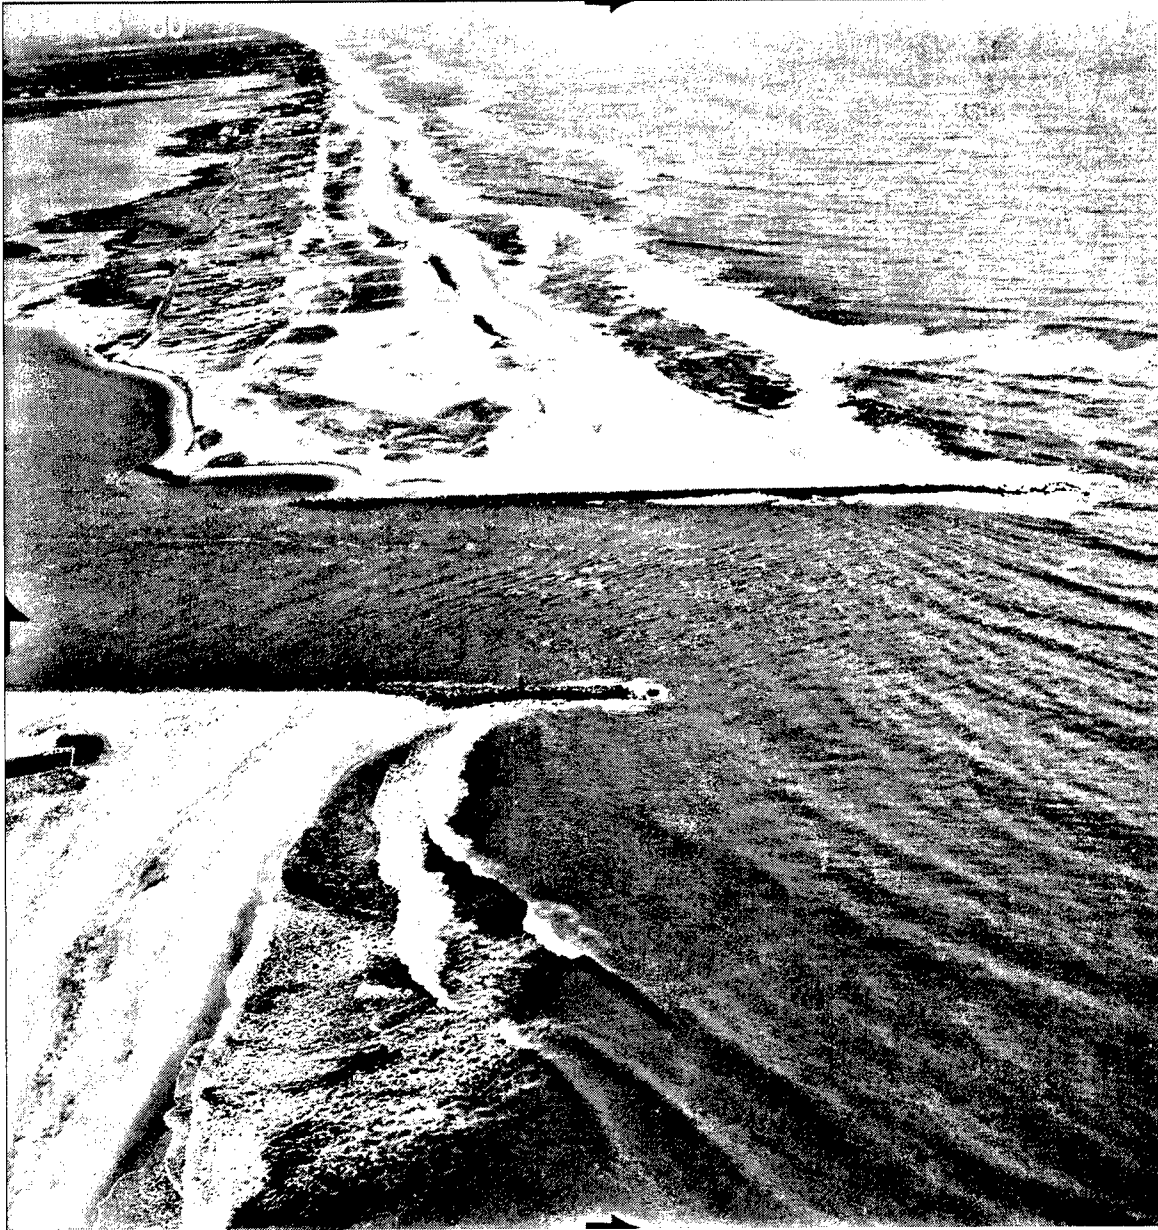
Figure 13. View east, with Atlantic Ocean to right, 18 January 1980 (Triangular-shaped updrift fillet is pronounced just beyond east jetty. Original, pre-inlet dune line approximately followed white line that marks dune crest in distance. Road paralleled dune crest and continued west before inlet was cut in 1938. Tip of west jetty has deteriorated. Remains of 1940 revetment are not visible in this image) (Topo-Metrics image 08013 0-16)

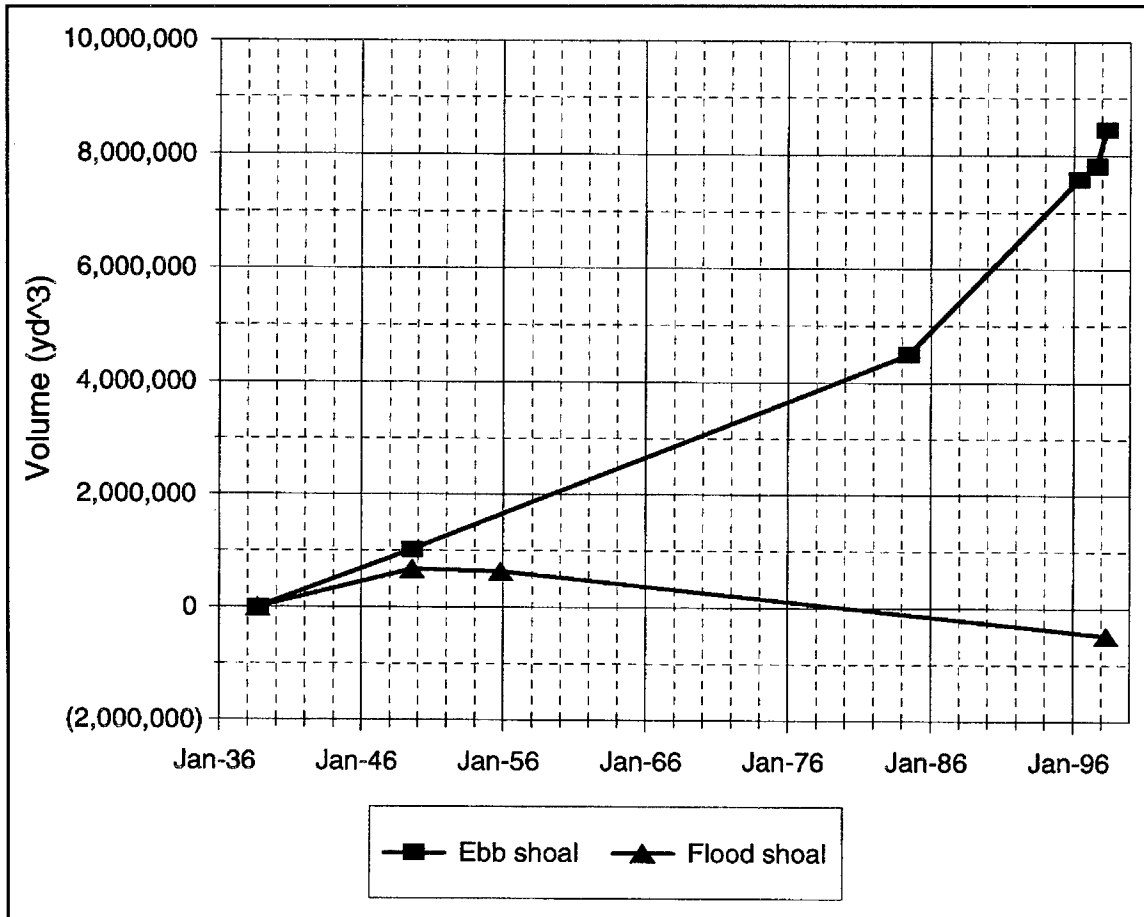
Figure 15. Volume changes, ebb and flood shoals (Although original survey data were collected in 1933, base condition (zero) is plotted at 21 September 1938, when inlet was cut by Great New England Hurricane)

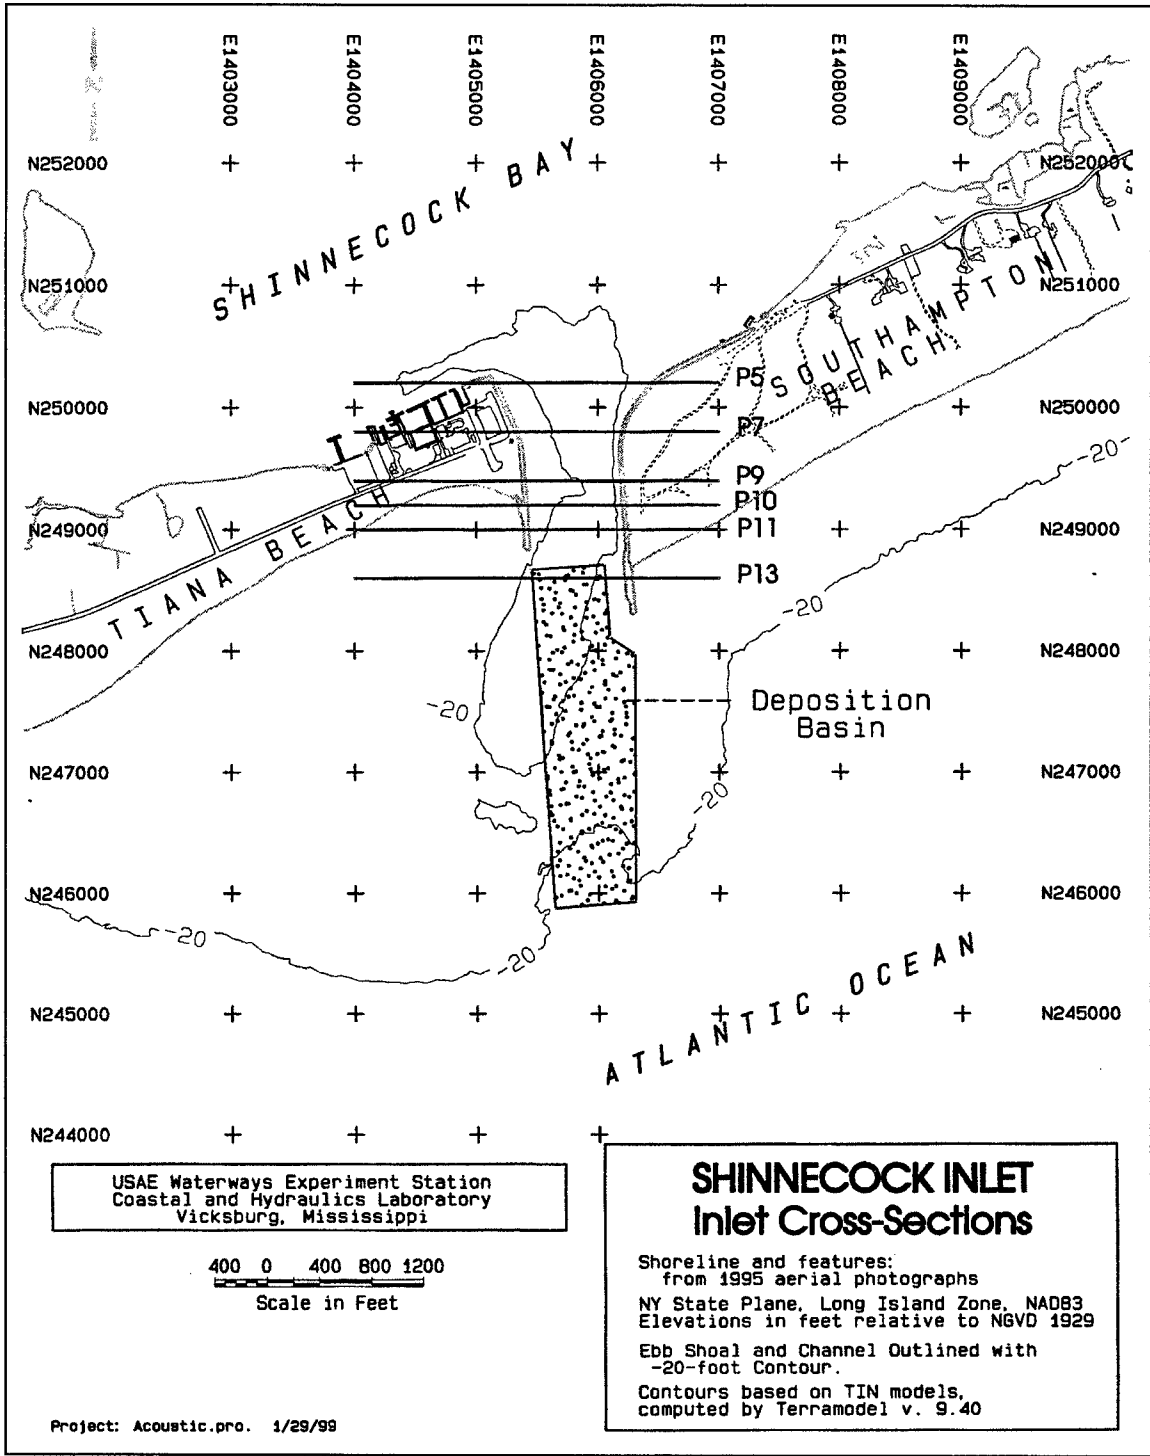
Figure 20. Profile lines across Shinnecock Inlet defining locations of cross-sectional area measurements

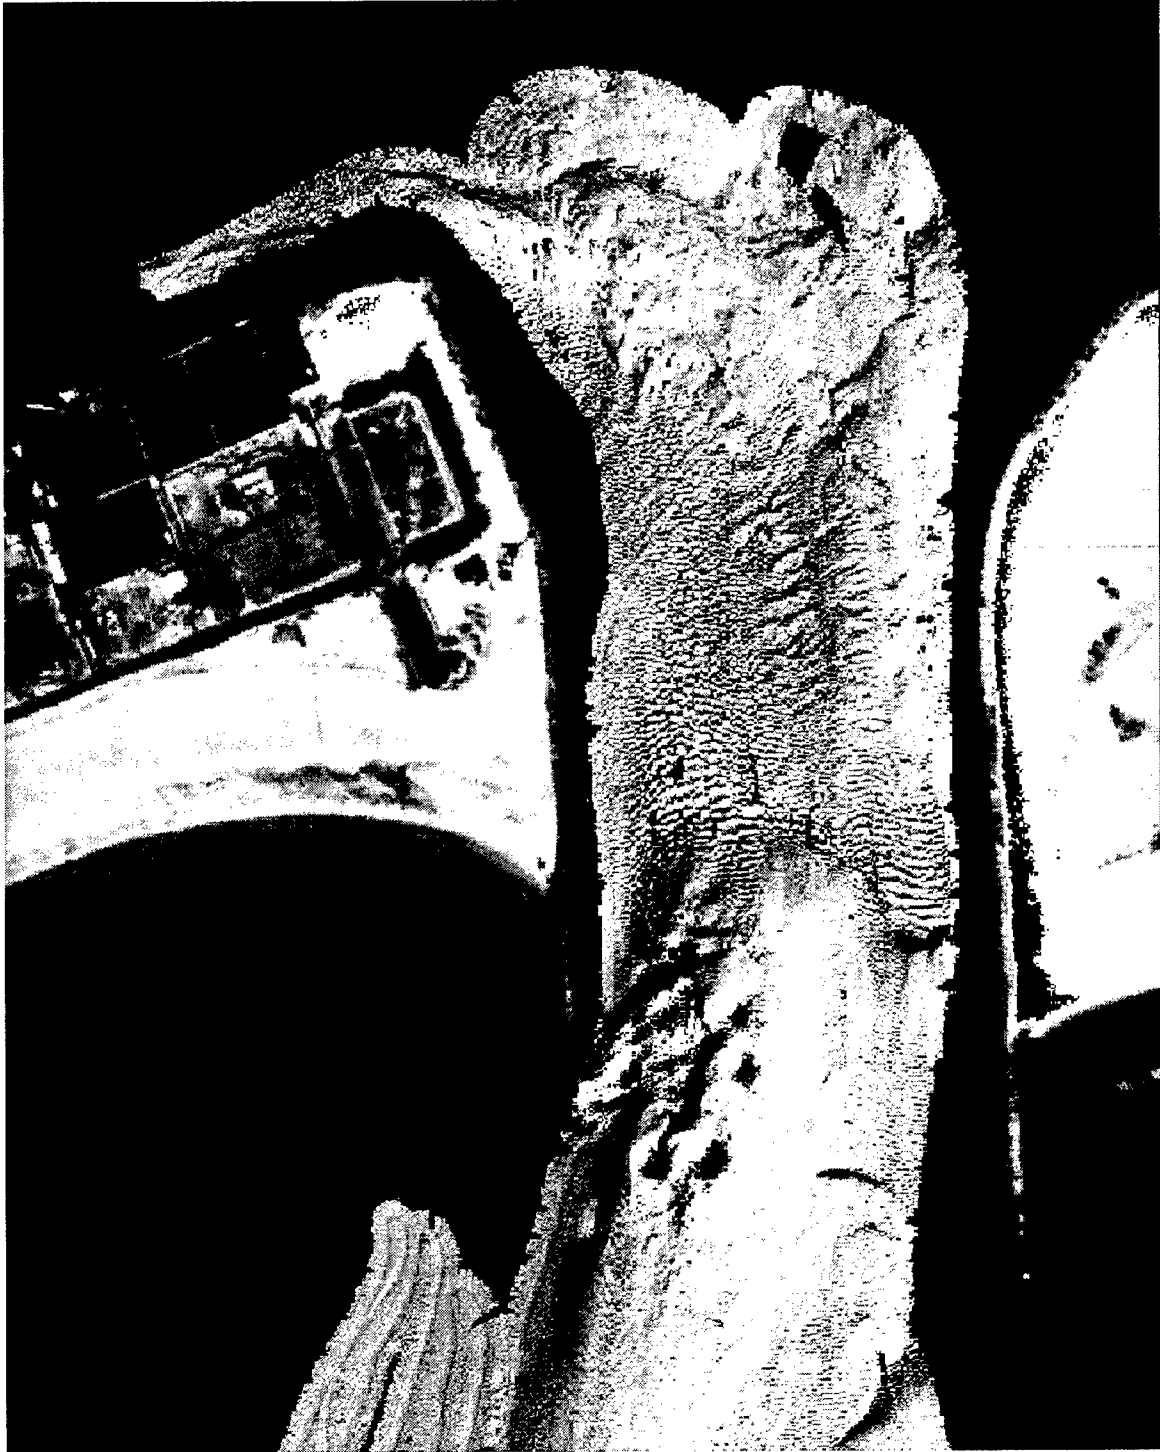
Figure 28. Multibeam acoustic data, 31 October 1998 (Sand waves are evident in inlet. Edge of sand ridge (discussed in text) is marked by line where the sand waves join featureless inlet floor. Highly irregular bottom near tip of west jetty indicates scour holes and remnants of scour blanket. Acoustic data processed at 1-m grid size, shaded with simulated sun position at 315° azimuth and elevation of 45°. Data collected and processed by Marine Sciences Research Center, State University of New York, Stony Brook, NY)

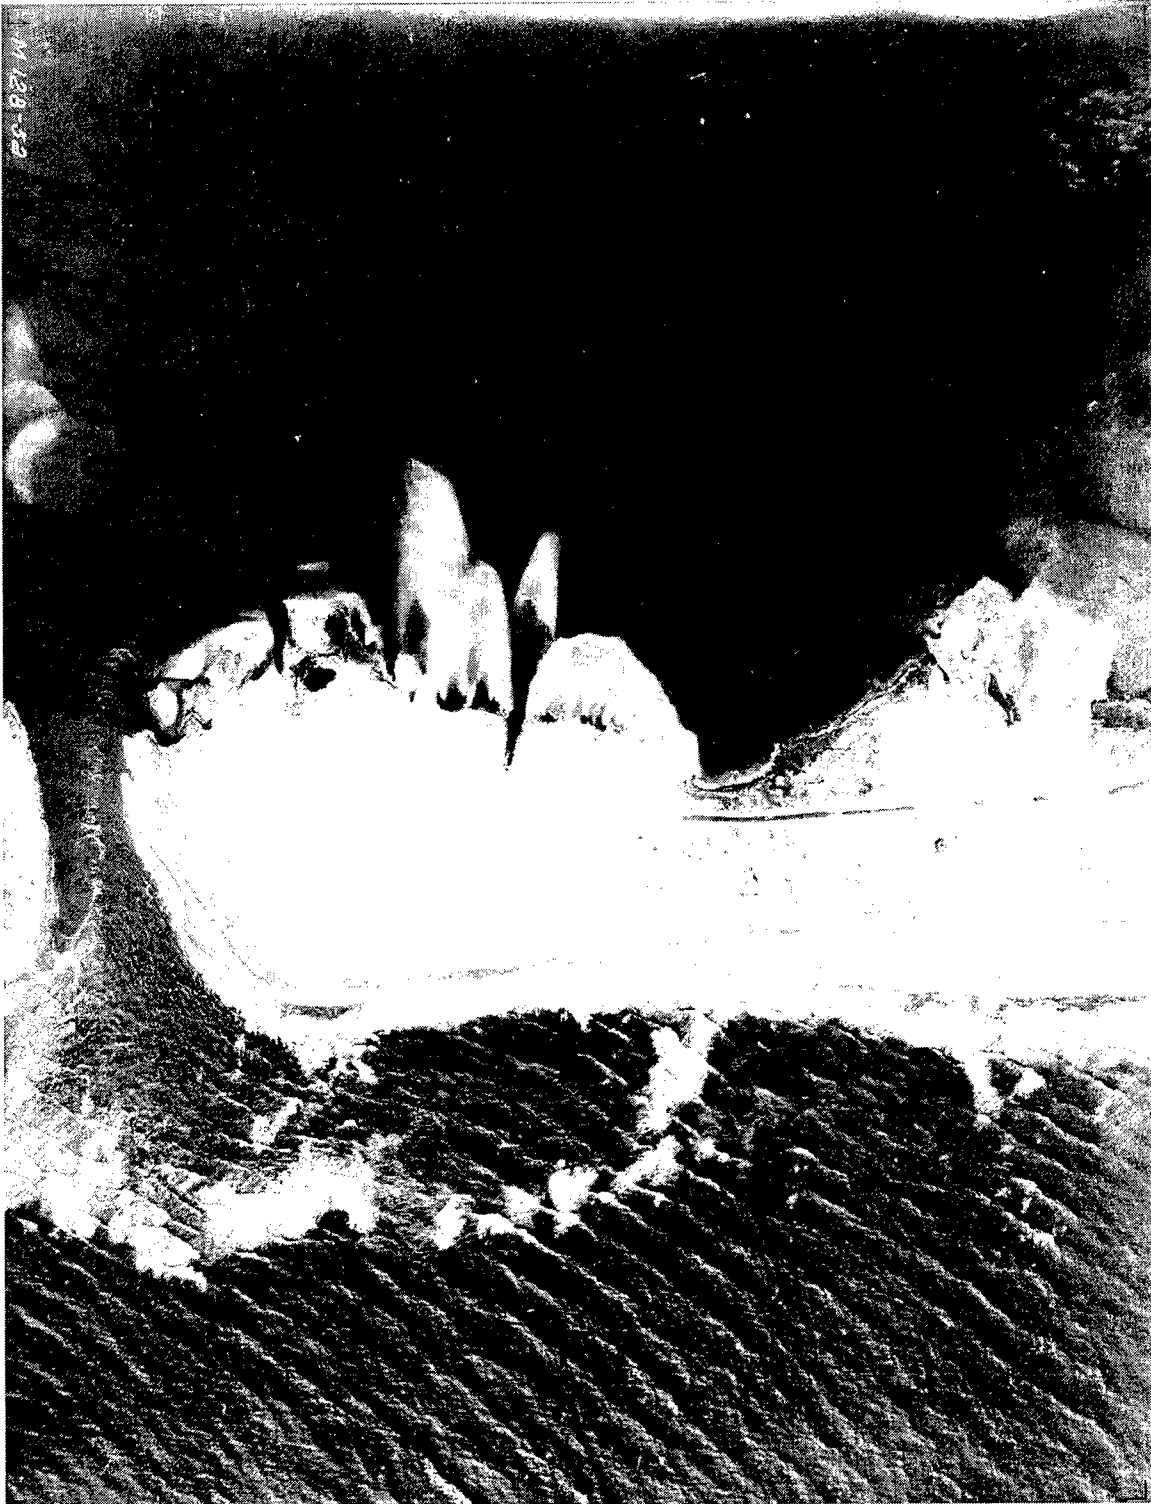
Figure A3. 29 November 1938 (Photograph one of three (east of inlet). Taken 1 month after the 21 September hurricane breached the barrier island. Washover deposits have covered most of the paved road. Breaking waves outline recently formed ebb shoal. Series of photographs taken by the Army Air Corps)

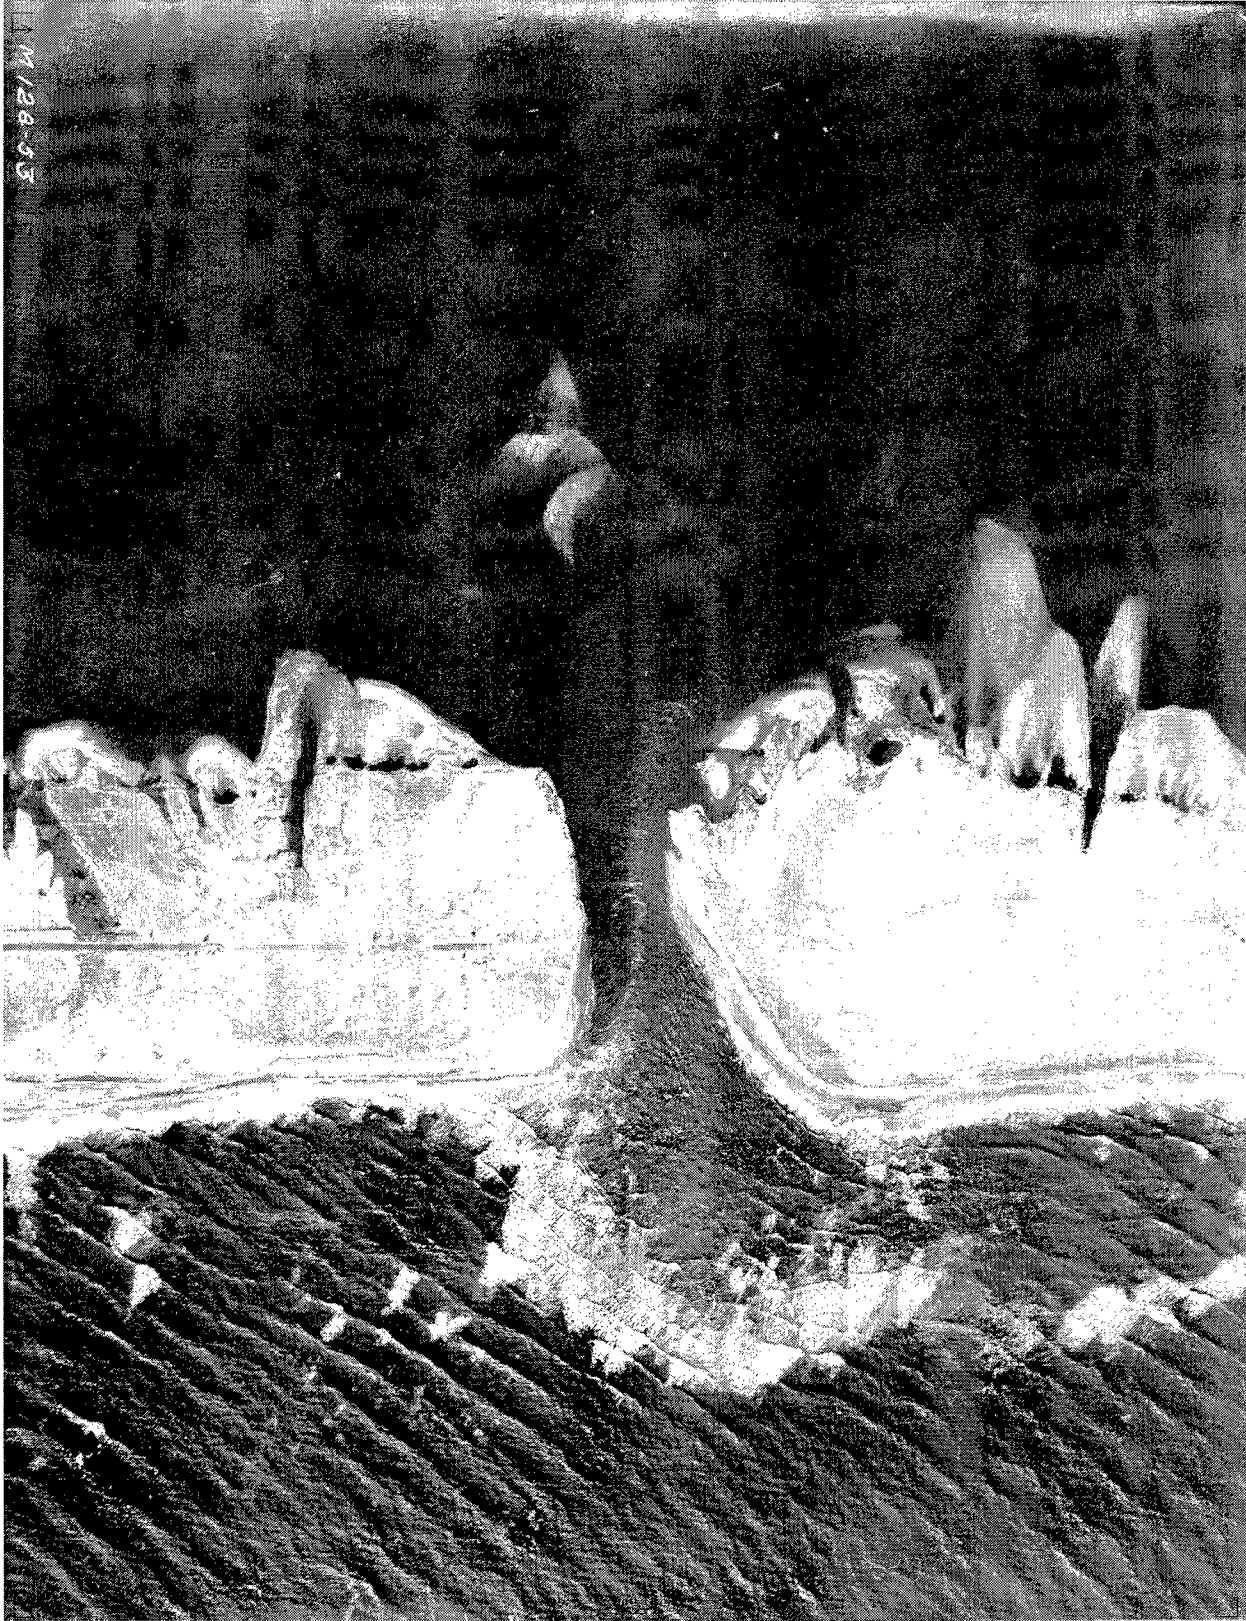
Figure A4. 29 November 1938 (Photograph two of three (centered on inlet). Ebb and flood shoals are already forming)

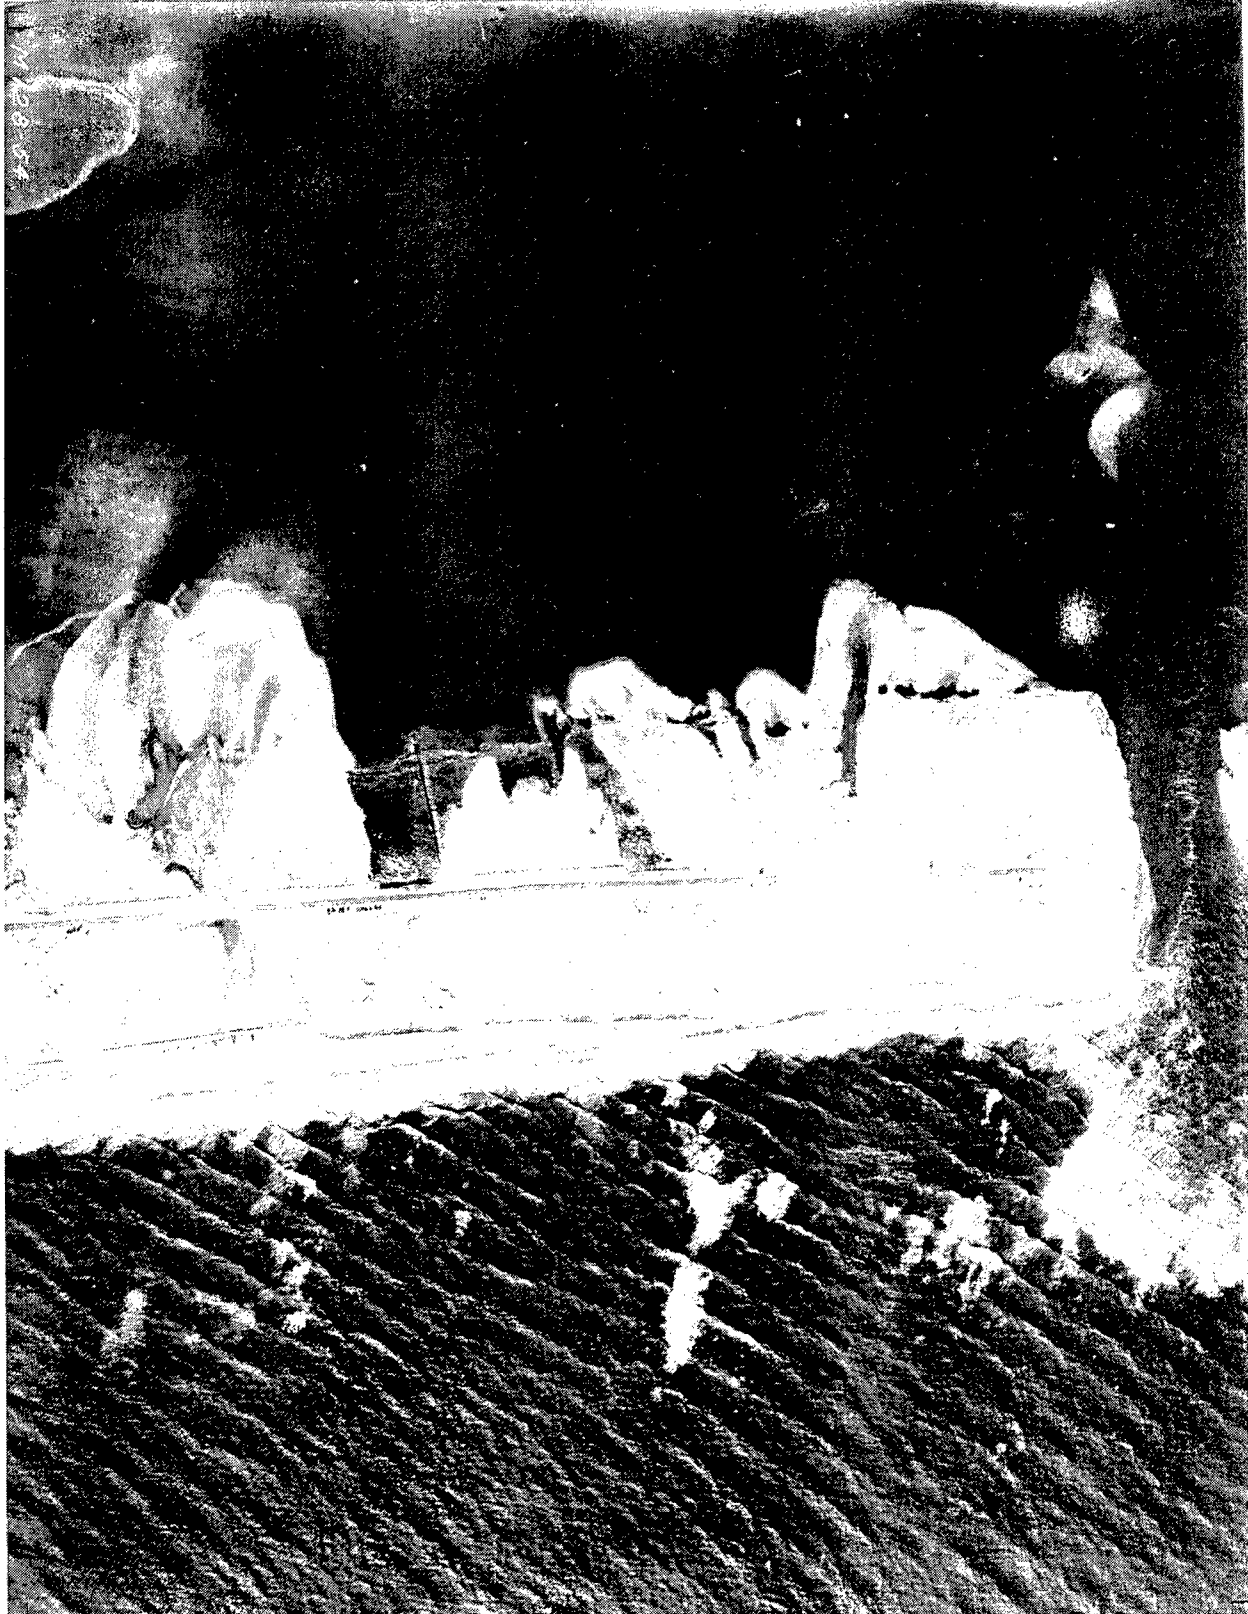
Figure A5. 29 November 1938 (Photograph three of three (west of inlet). Minor inlet, in the leftmost overwash fan, has closed (see Figure A2))

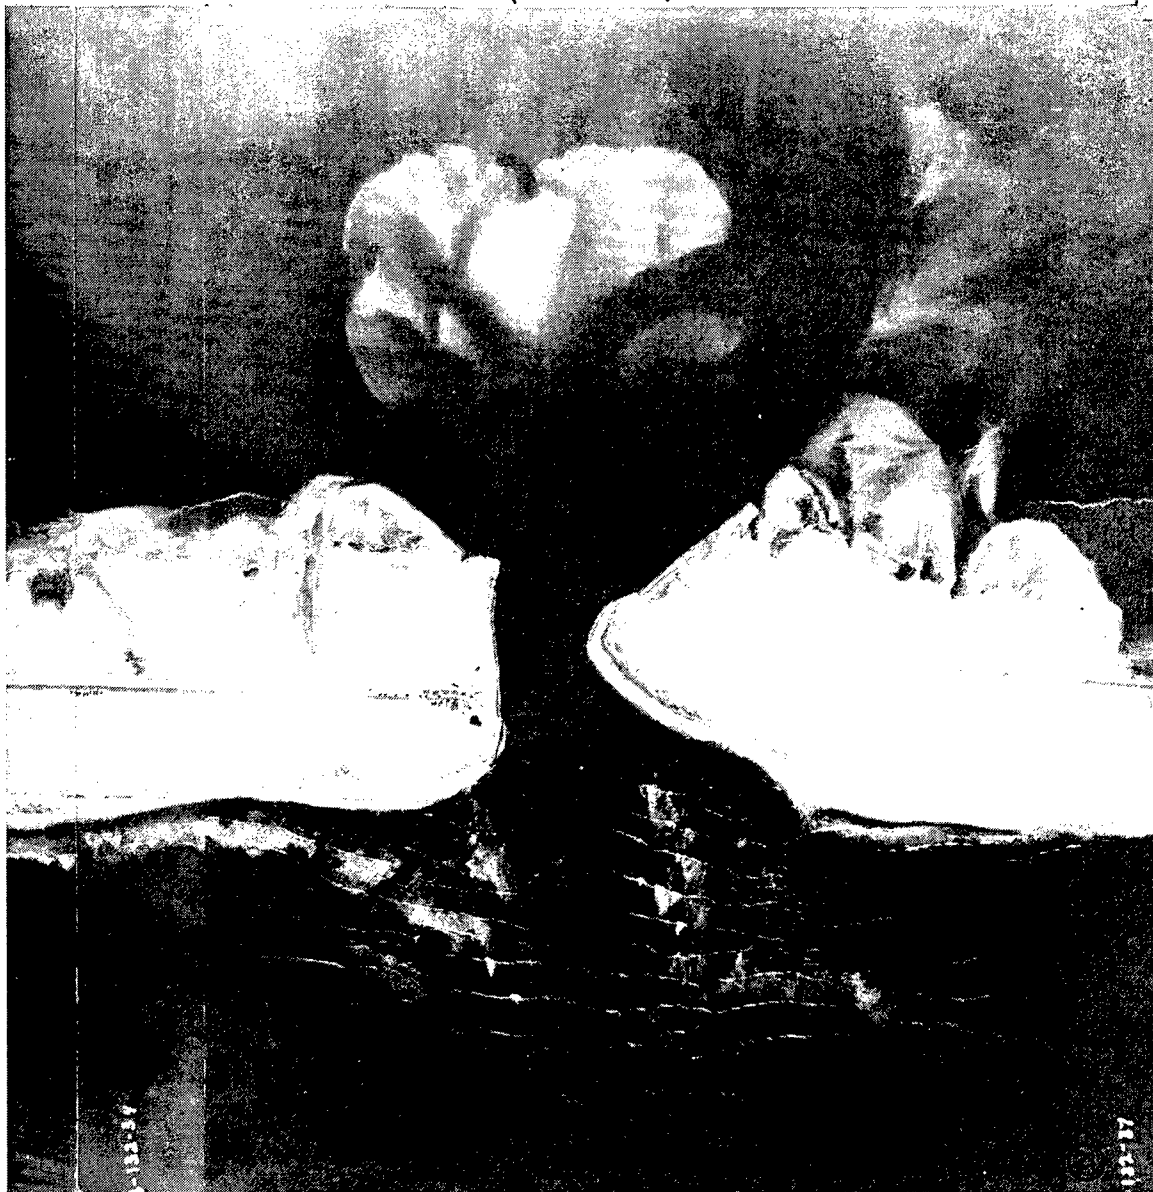
Figure A7. 24 February 1939 (Five months after the hurricane, a prominent flood shoal has formed in Shinnecock Bay, while ebb shoal appears to have diminished since December 1938. Construction equipment is stockpiled on road just west of inlet in preparation for construction of a bulkhead. Ocean shore east of inlet has eroded. Photographic mosaic prepared by BEB)

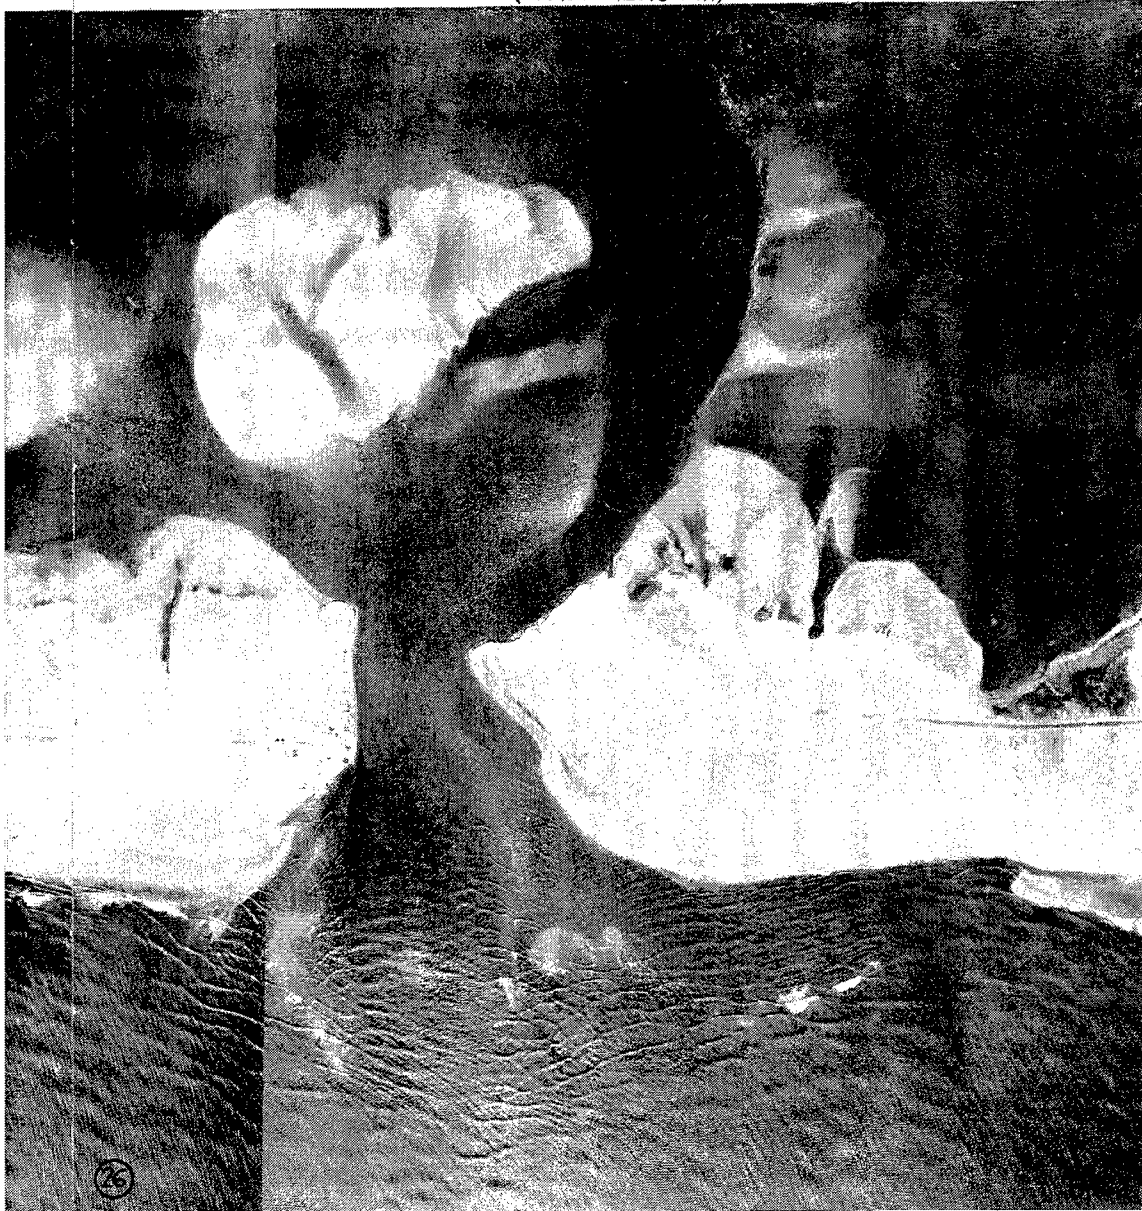
Figure A8. 21 March 1939 (Flood shoal continues to grow. An area of wave disturbance outlines ebb shoal. Main Shinnecock Bay channel runs east of the flood shoal. Construction of revetment on west side of inlet is underway. Mosaic prepared as part of a BEB study of shoreline erosion)

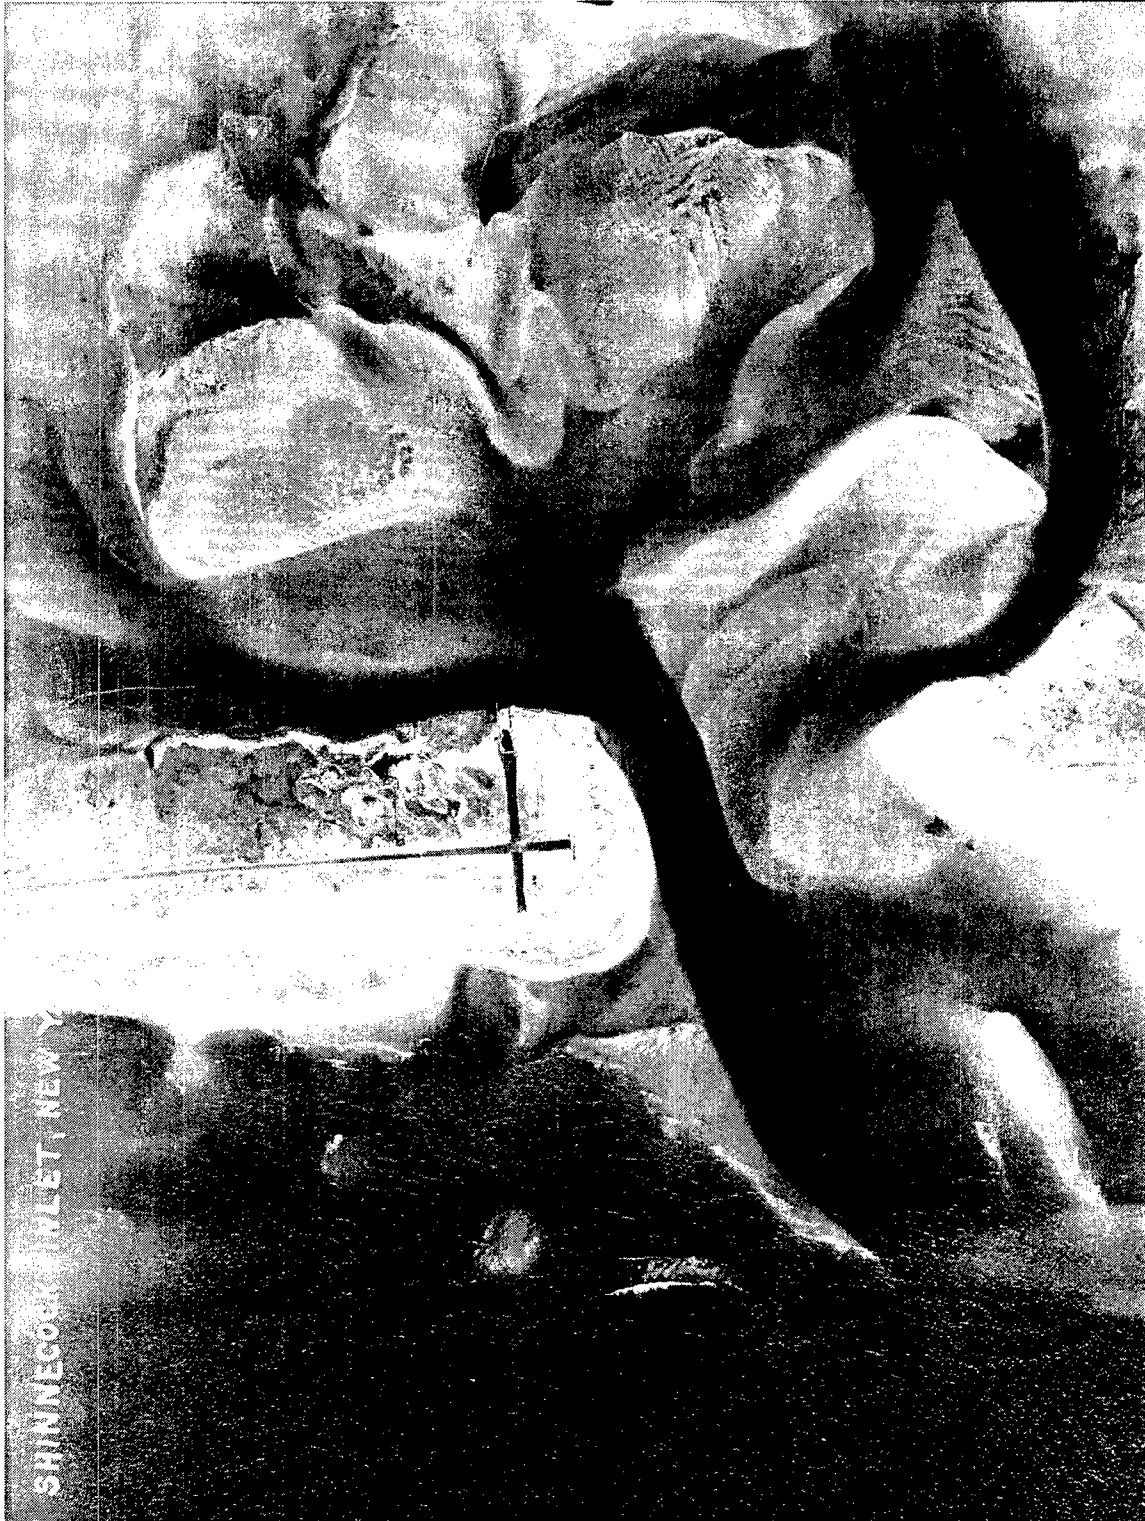
Figure A13. 1 April 1947 (Photograph one of two (inlet and west beach). Flood shoal has grown notably since 1941. Main channel through inlet has migrated away from west shore revetment and extends out to sea in a NW-SE direction. On flood shoal, east channel has shoaled next to east shoreline of inlet. Main channel now turns west and follows bay shoreline of west beach)

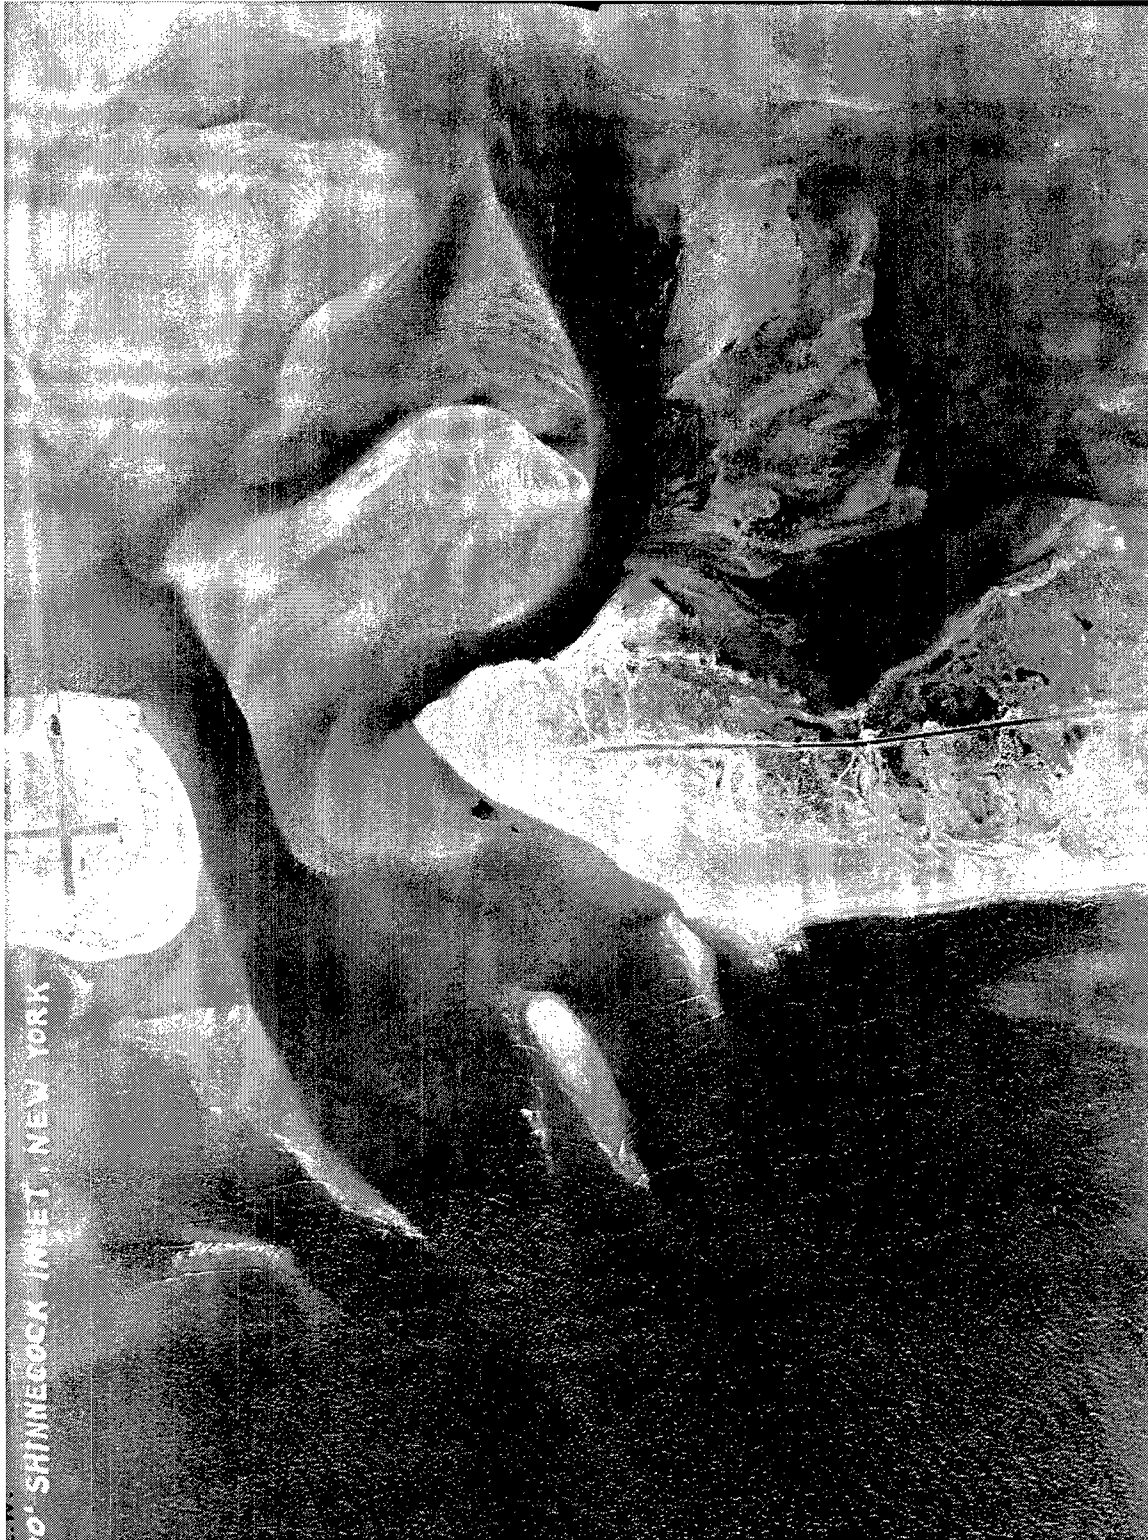
Figure A14. 1 April 1947 (Photograph two of two (inlet and east beach). Inlet's mouth contains two exposed sand shoals, and a spit has emerged from the west beach. Predominant longshore drift appears to have been west to east for a period before image was taken)

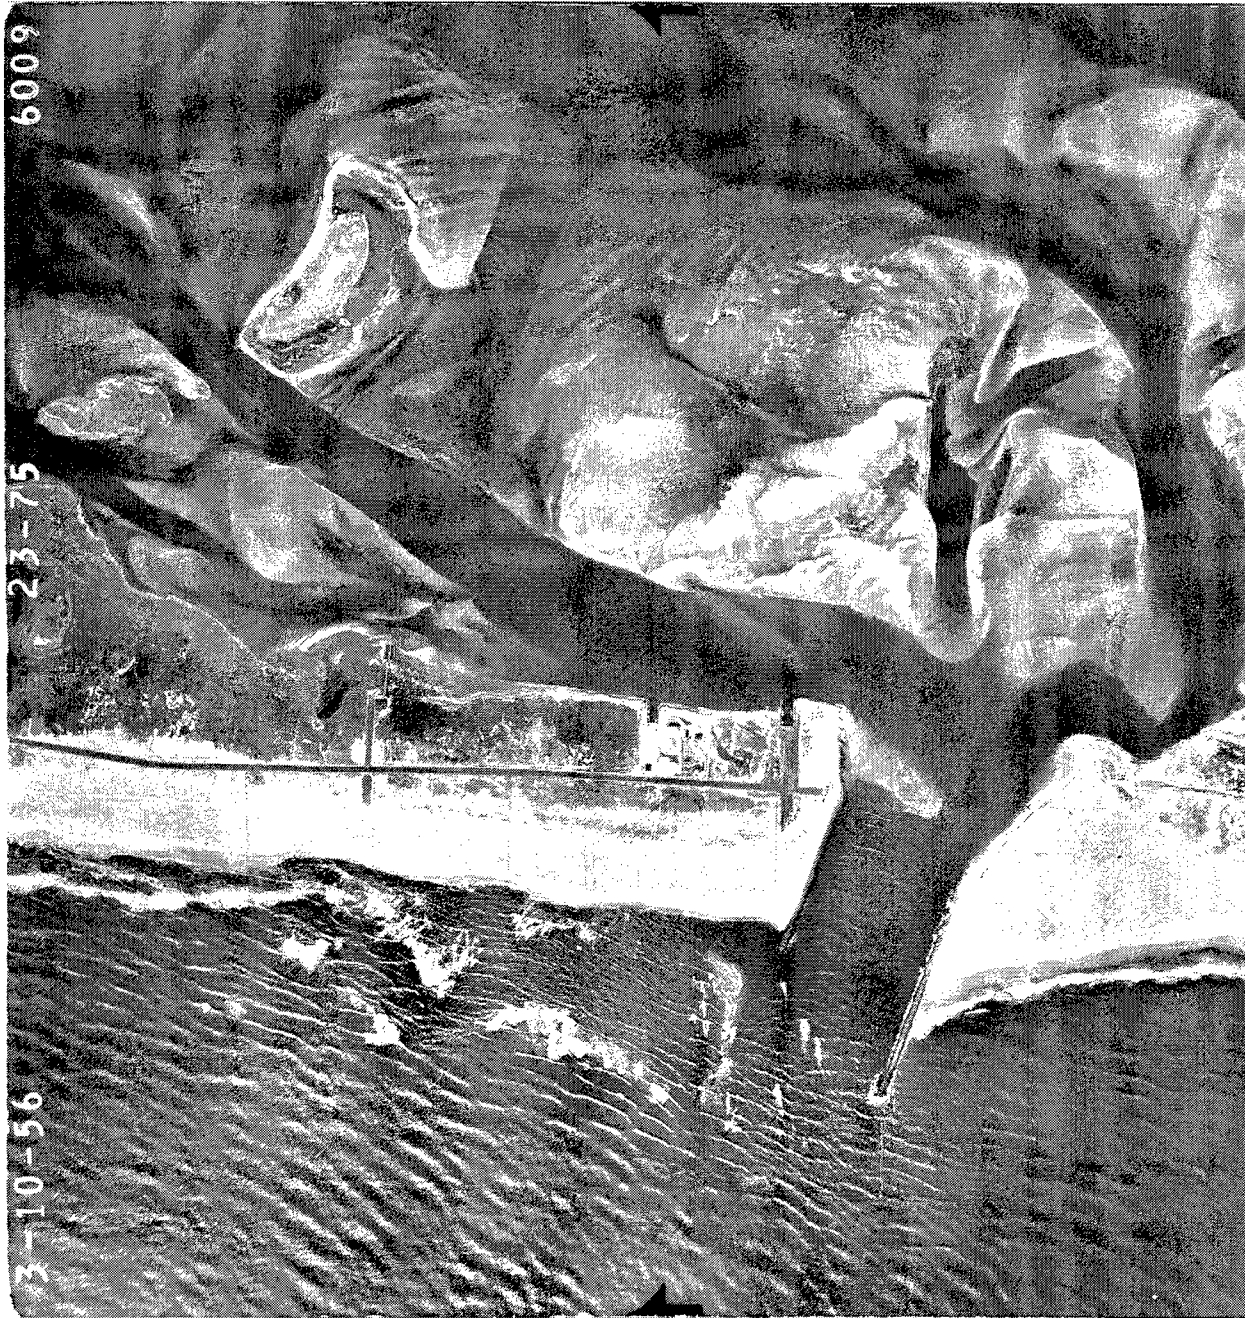
Figure A18. 10 March 1956 (West jetty has been completed, and the channel is restricted to a N-S direction. A spit still protrudes from west beach into inlet. Updrift fillet has grown seaward since previous photograph was taken (1953). Note that west beach is straight; area directly west of west jetty has not yet eroded)
