**US Army Corps
of Engineers**
Waterways Experiment
Station

Coastal Inlets Research Program

Shinnecock Inlet, New York, Site Investigation

Report 1 Morphology and Historical Behavior

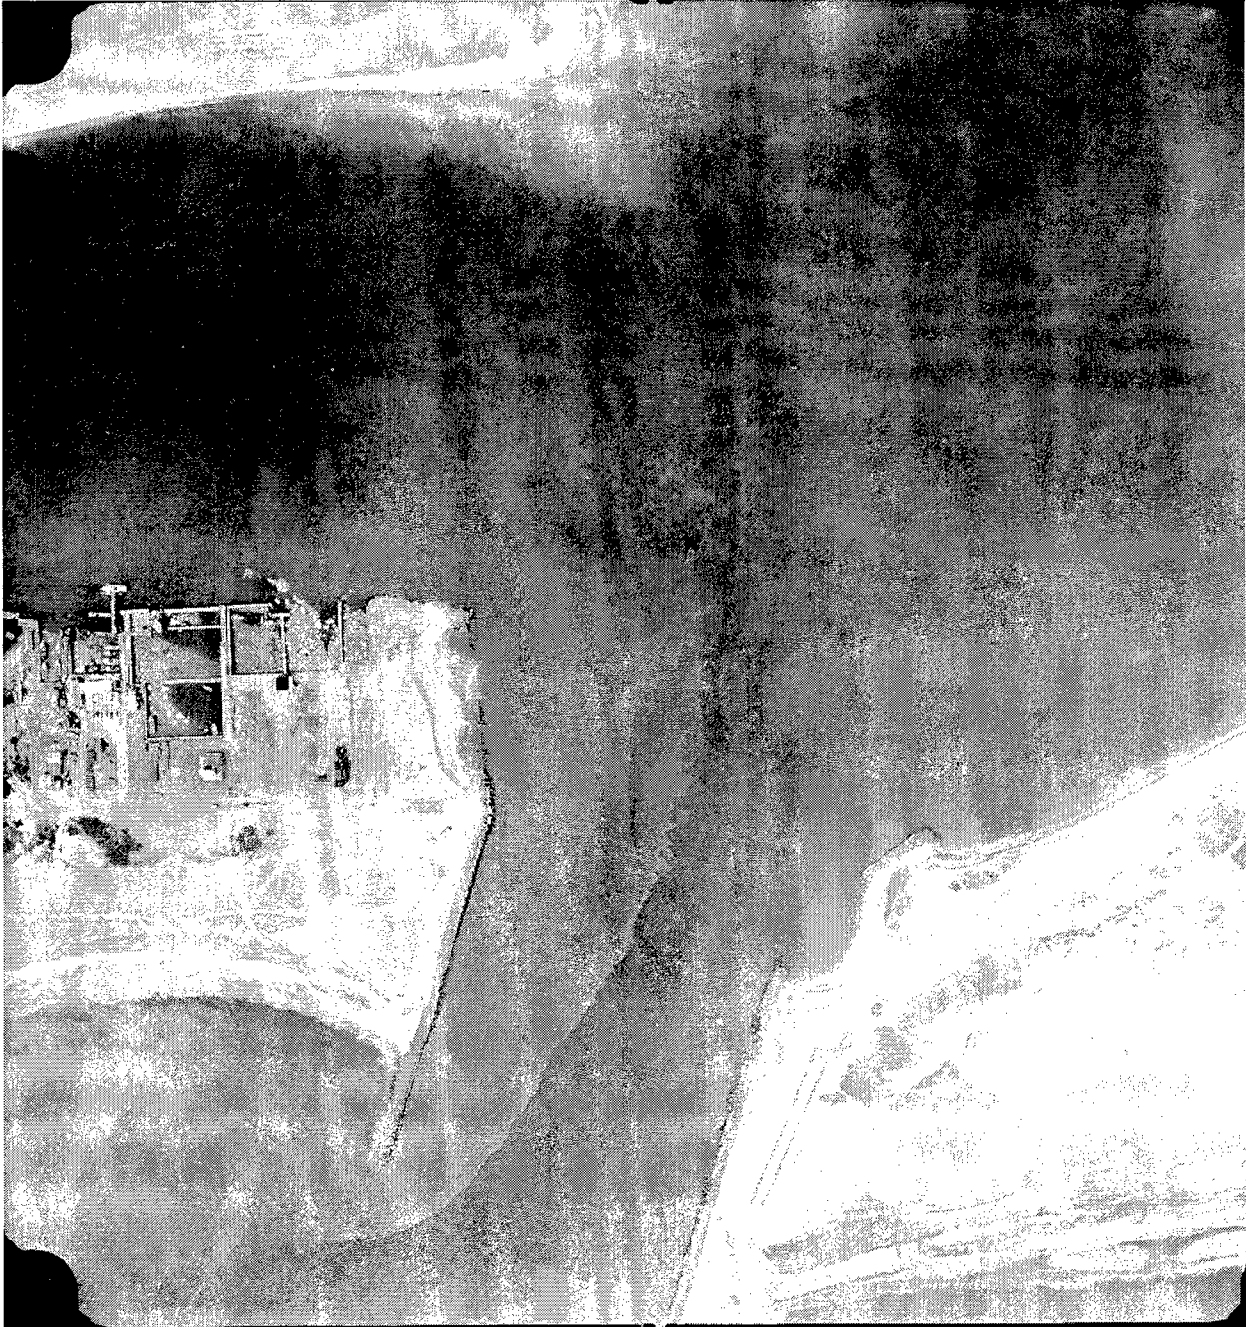
Figure A22. 23 February 1972 (Photograph, taken at lower altitude than previous images, shows damage to west and east jetties. Flood tide is entering inlet on east (right) side. A discontinuity marks where the flood tide entrains slack water. On west beach, dunes are vegetated as far east as cross road)

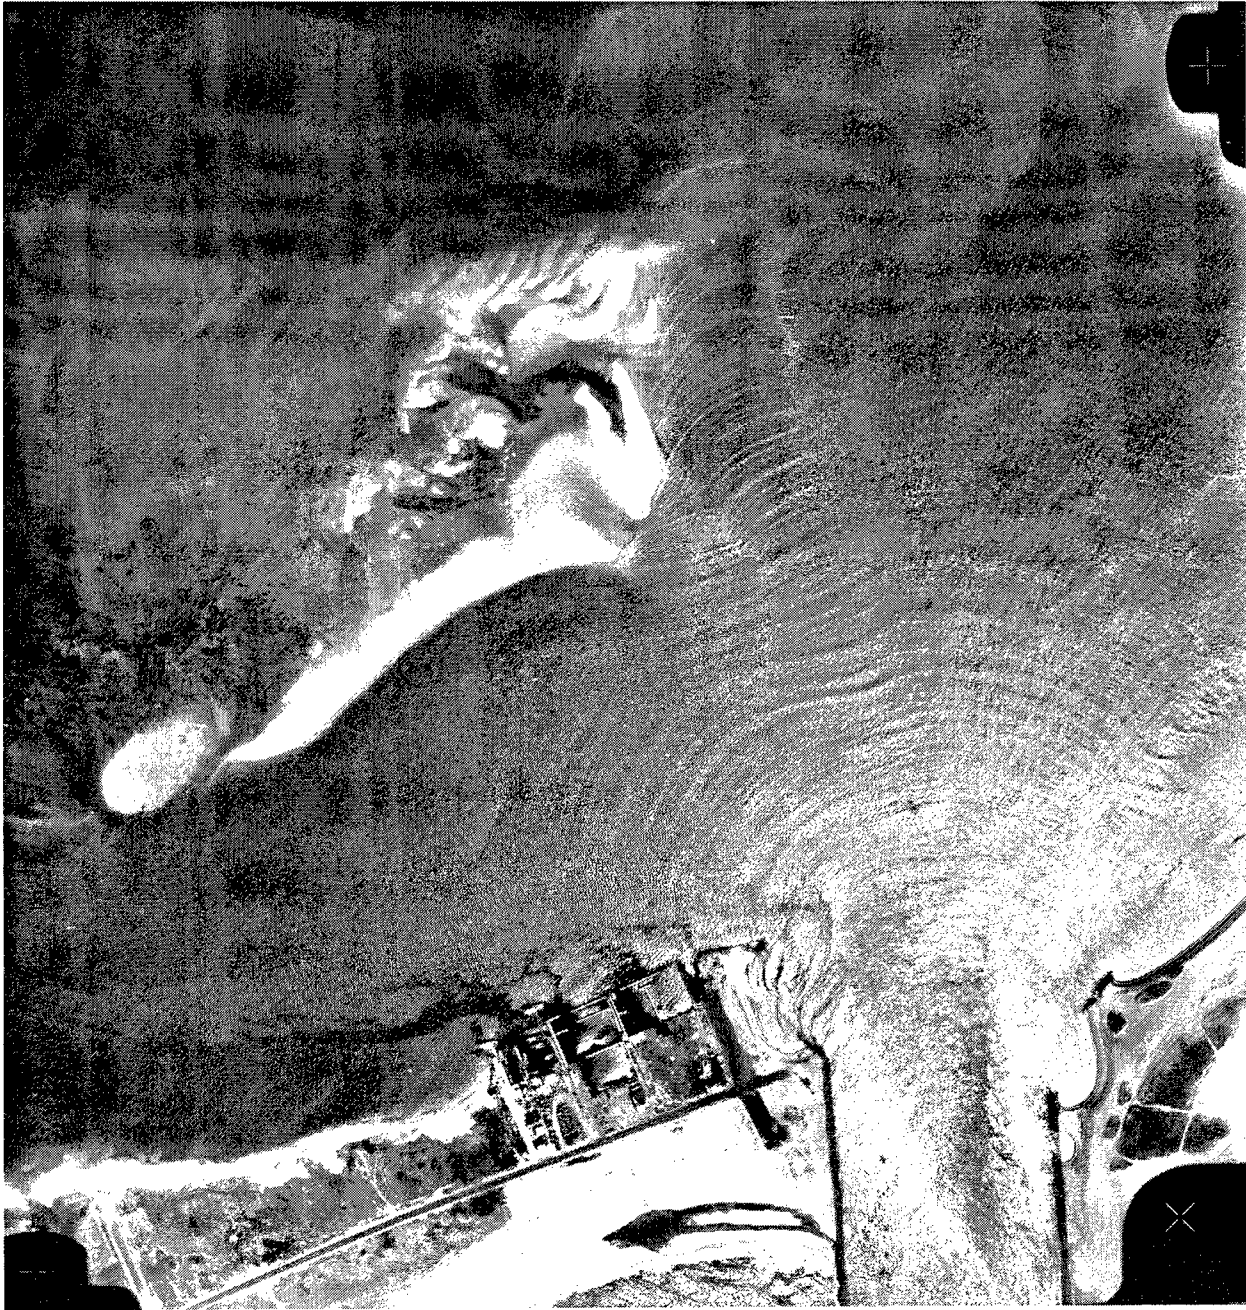
Figure A24. 6 April 1976 (Closeup view of north (bay) end of inlet. Sun glint reveals circular wave crests, a result of wave diffraction. Waves can be seen refracting into indentation in shore directly north of end of west jetty)

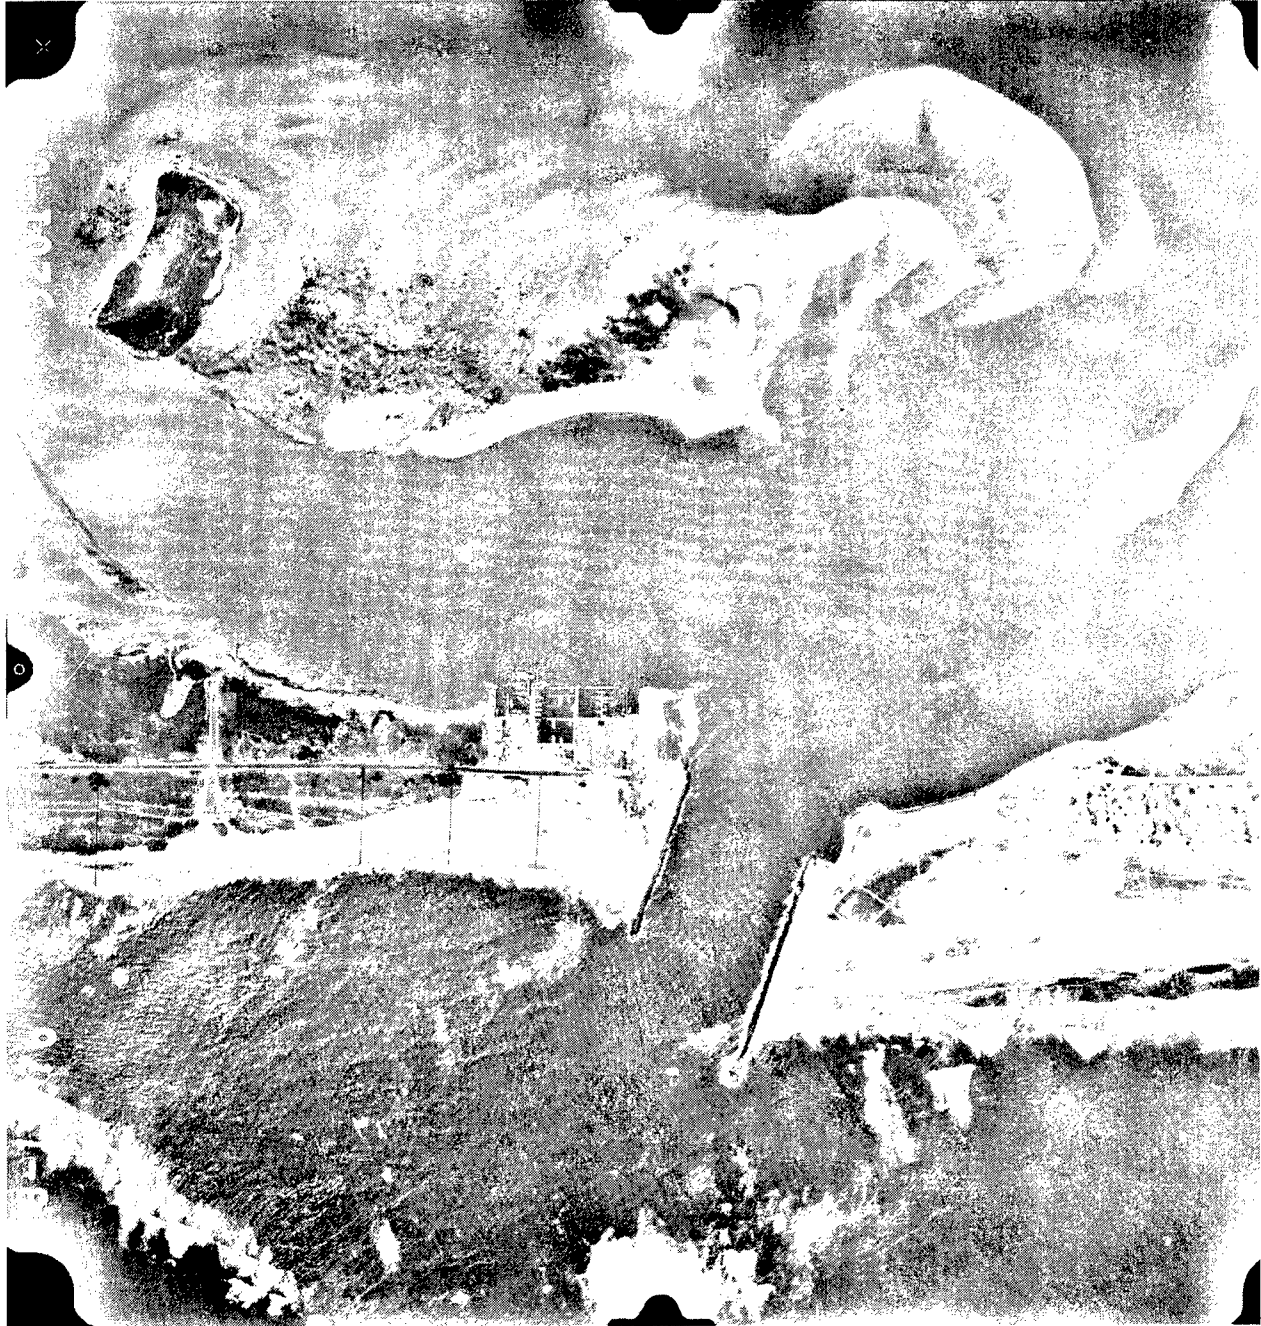
Figure A25. 10 August 1976 (Photograph was taken 1 day after Hurricane Belle crossed area. West beach is flush with end of west jetty. Only minor changes in flood shoal had occurred compared with April image. Compared with 1962, ebb shoal had grown and seaward edge moved further offshore. Four black lines crossing west beach appear to be drawn with a pen on photographic paper print)

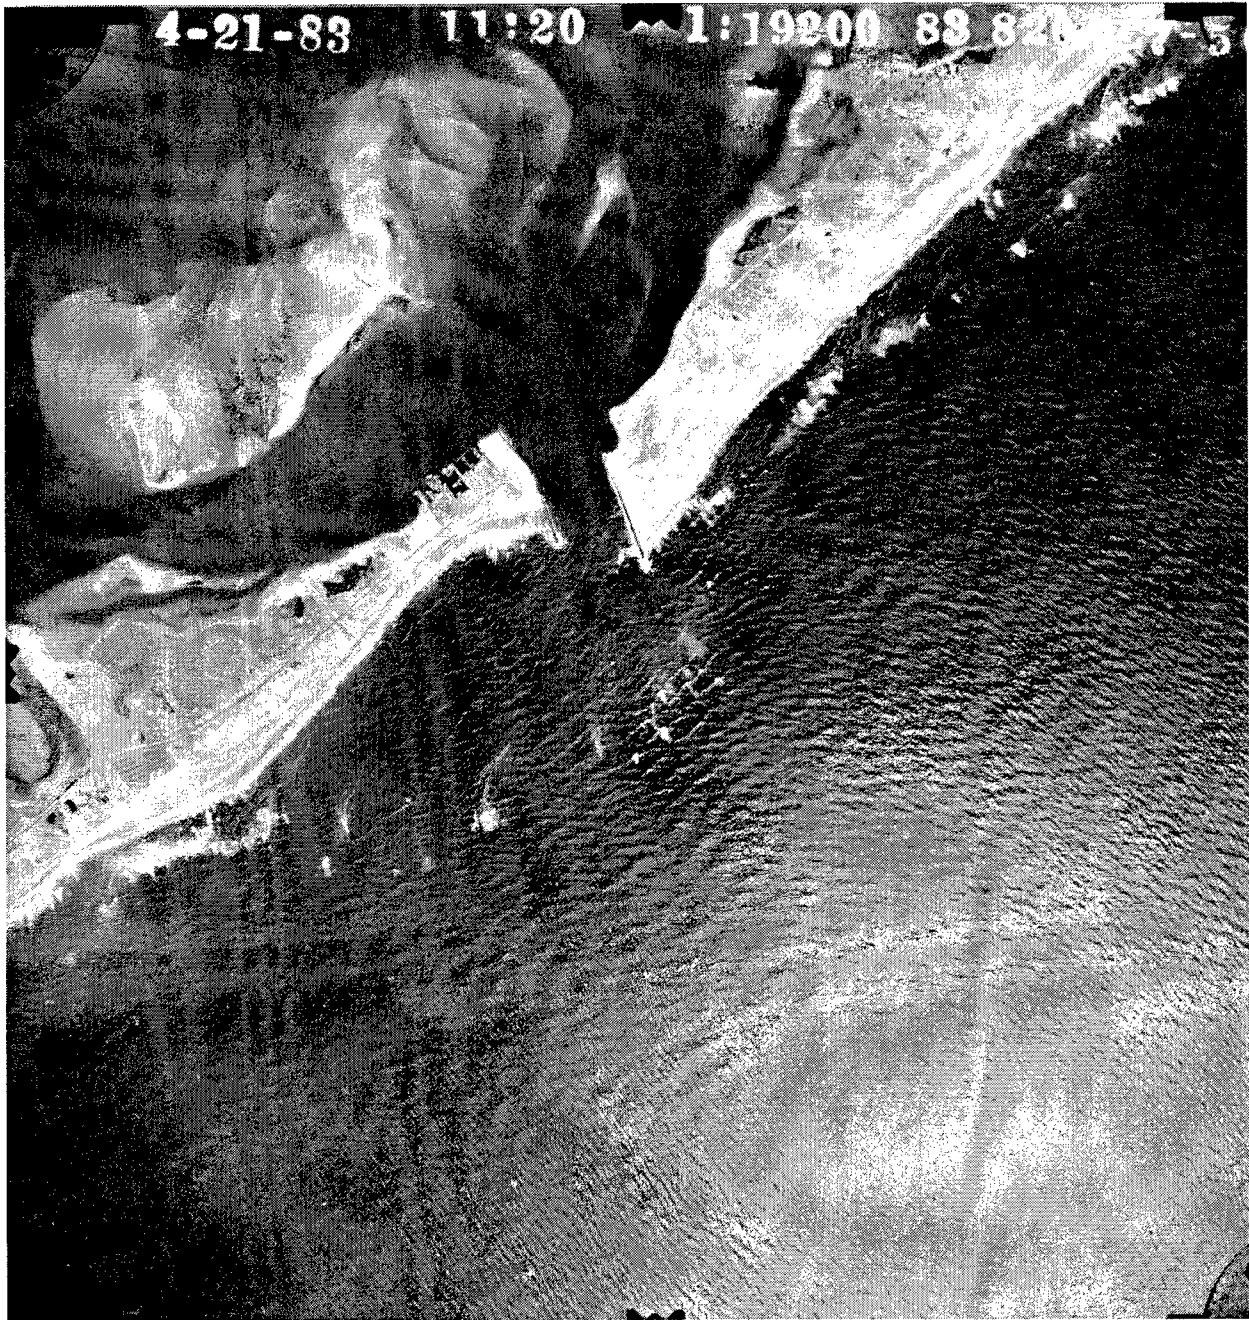
Figure A28. 21 April 1983 (Oval ebb shoal is outlined by breaking waves. The shoal attaches to downdrift (west) beach at the bulge in the shoreline. Bulge has moved about 500 m west compared with 1976)

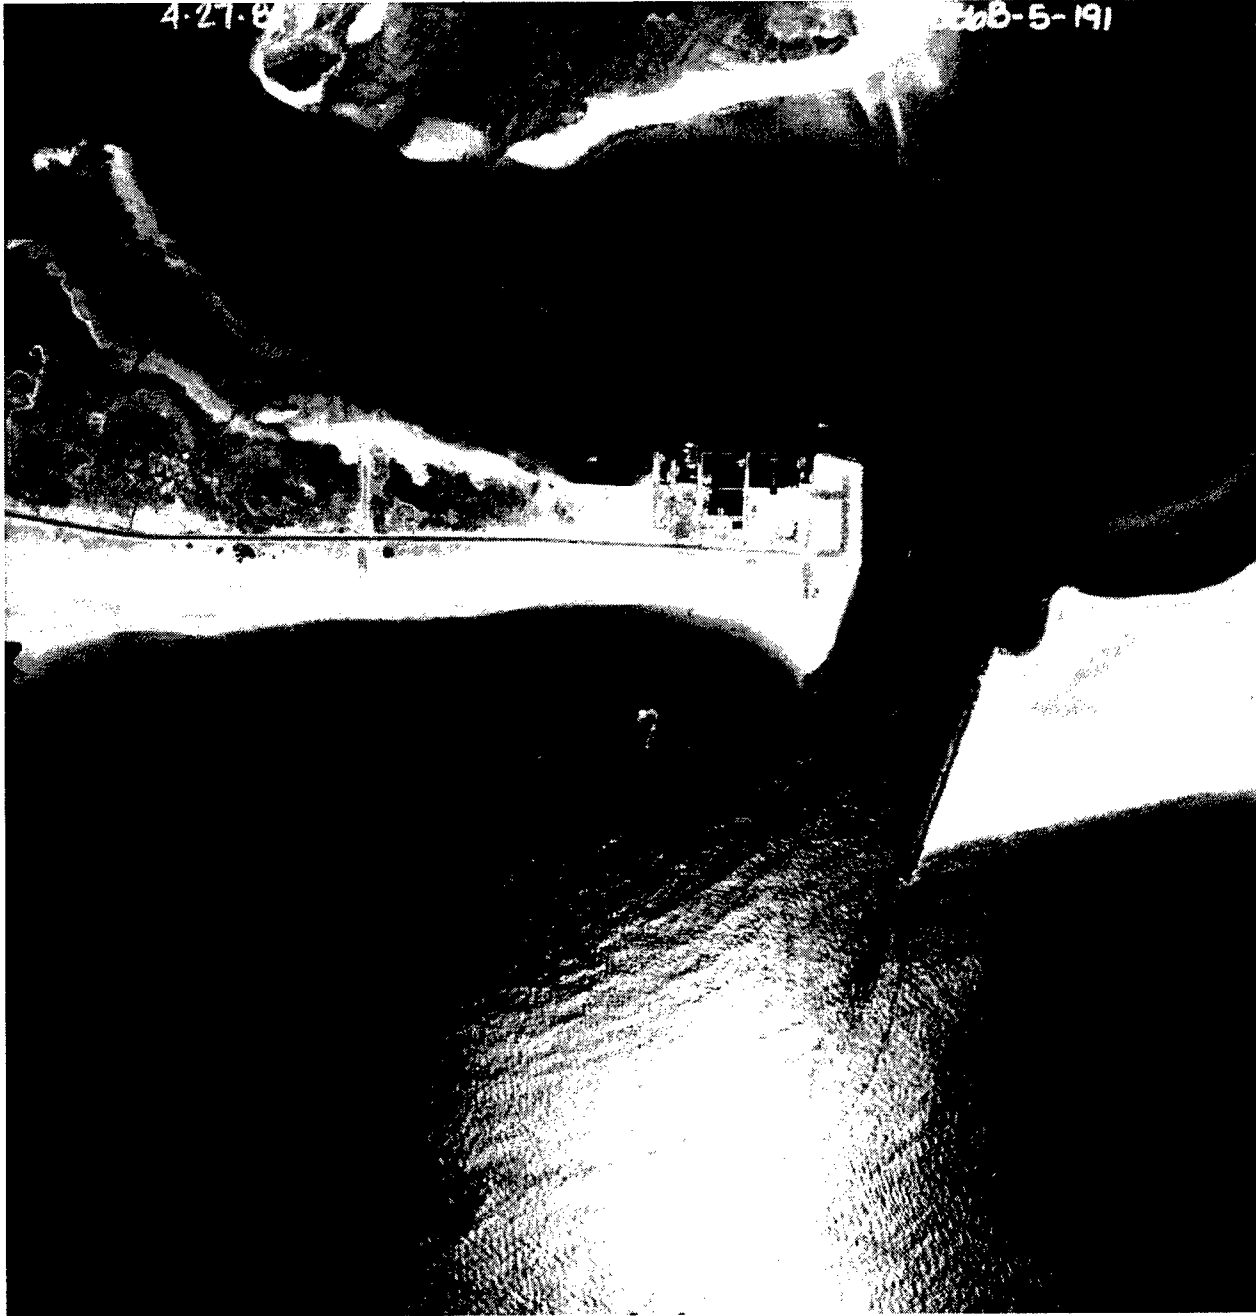
Figure A29. 27 April 1984 (Only minor shoreline changes have occurred since 1983. However, the dunes on the west beach have eroded further, and vegetation line now stops well west of the fishing docks) (Photograph courtesy of Moffatt & Nichol Engineers)

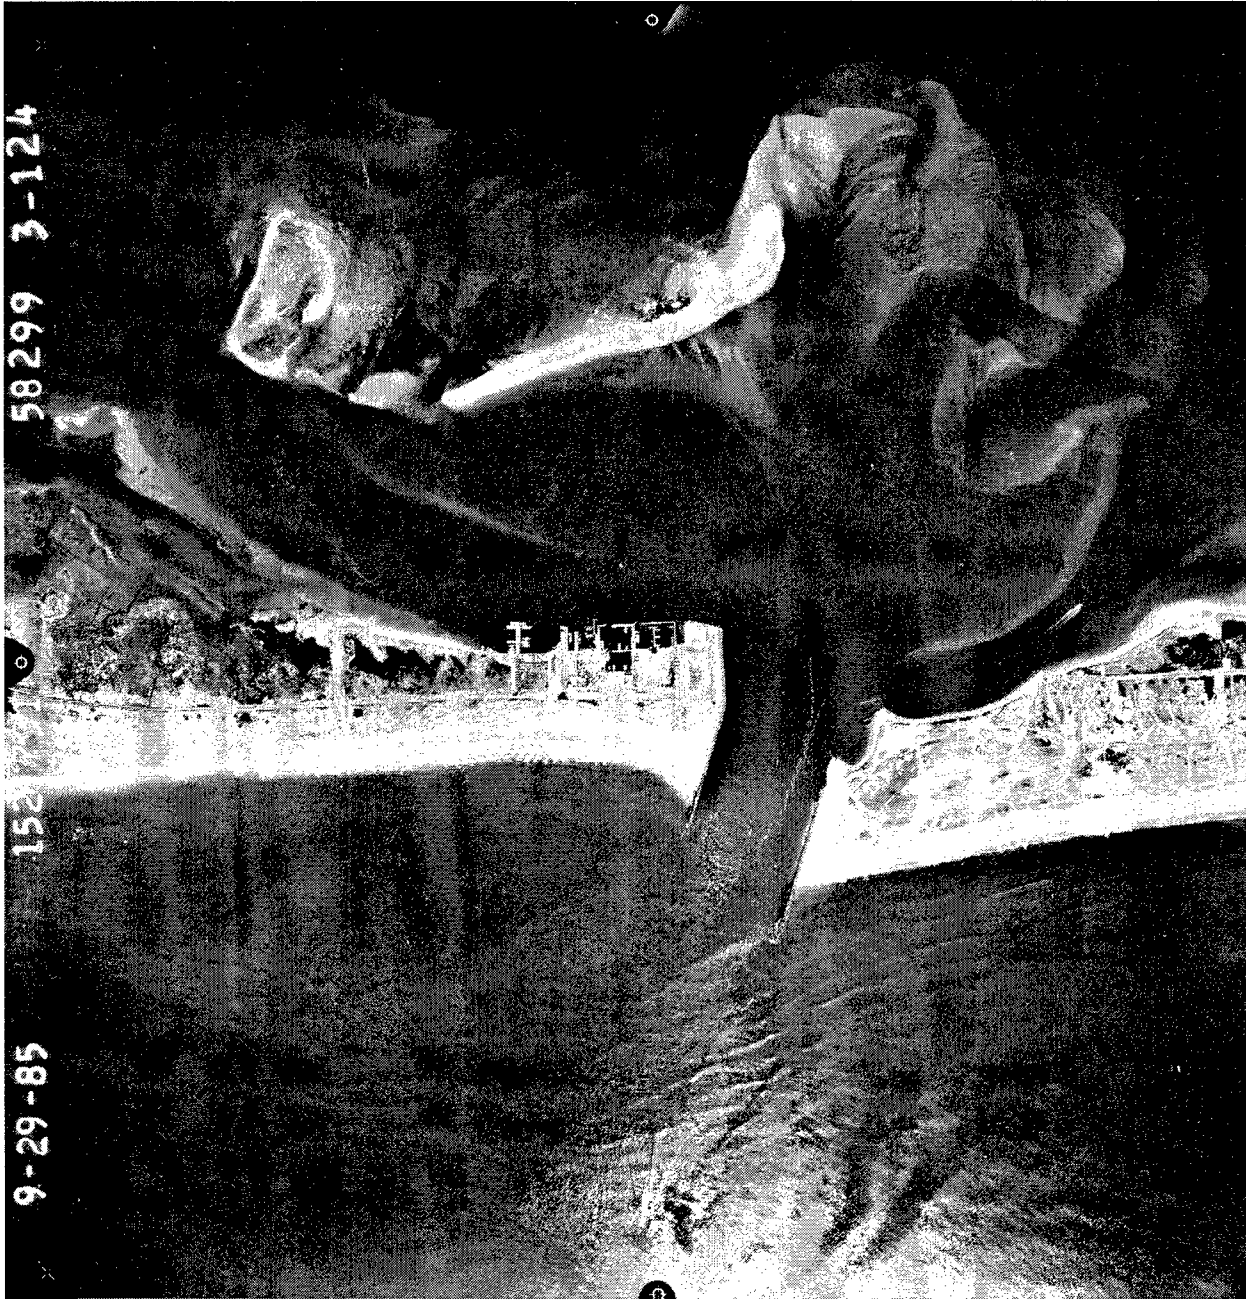
Figure A30. 29 September 1985 (West beach is wider than in 1984 because of placement of material dredged from inlet (see Table D1). East flood channel hugs north side of east beach)

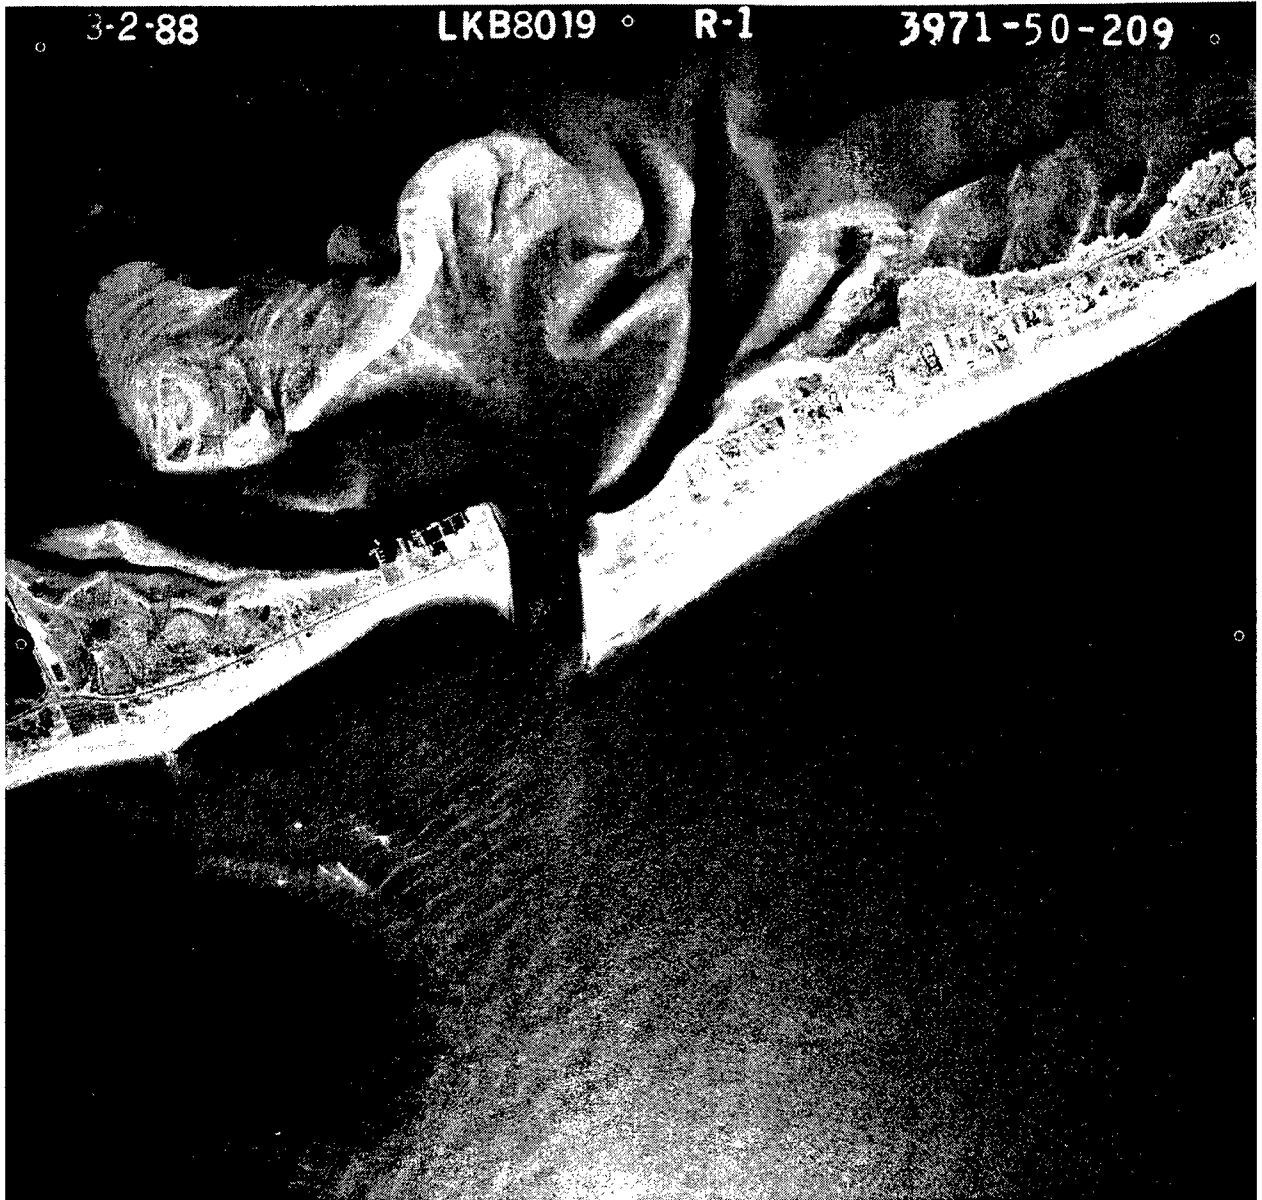
Figure A31. 2 March 1988 (West beach has eroded compared with 1985, but east beach has advanced to near tip of east jetty. East flood channel continues to push against the bay side of the east beach, but it is unclear if the shoreline has eroded since 1985)

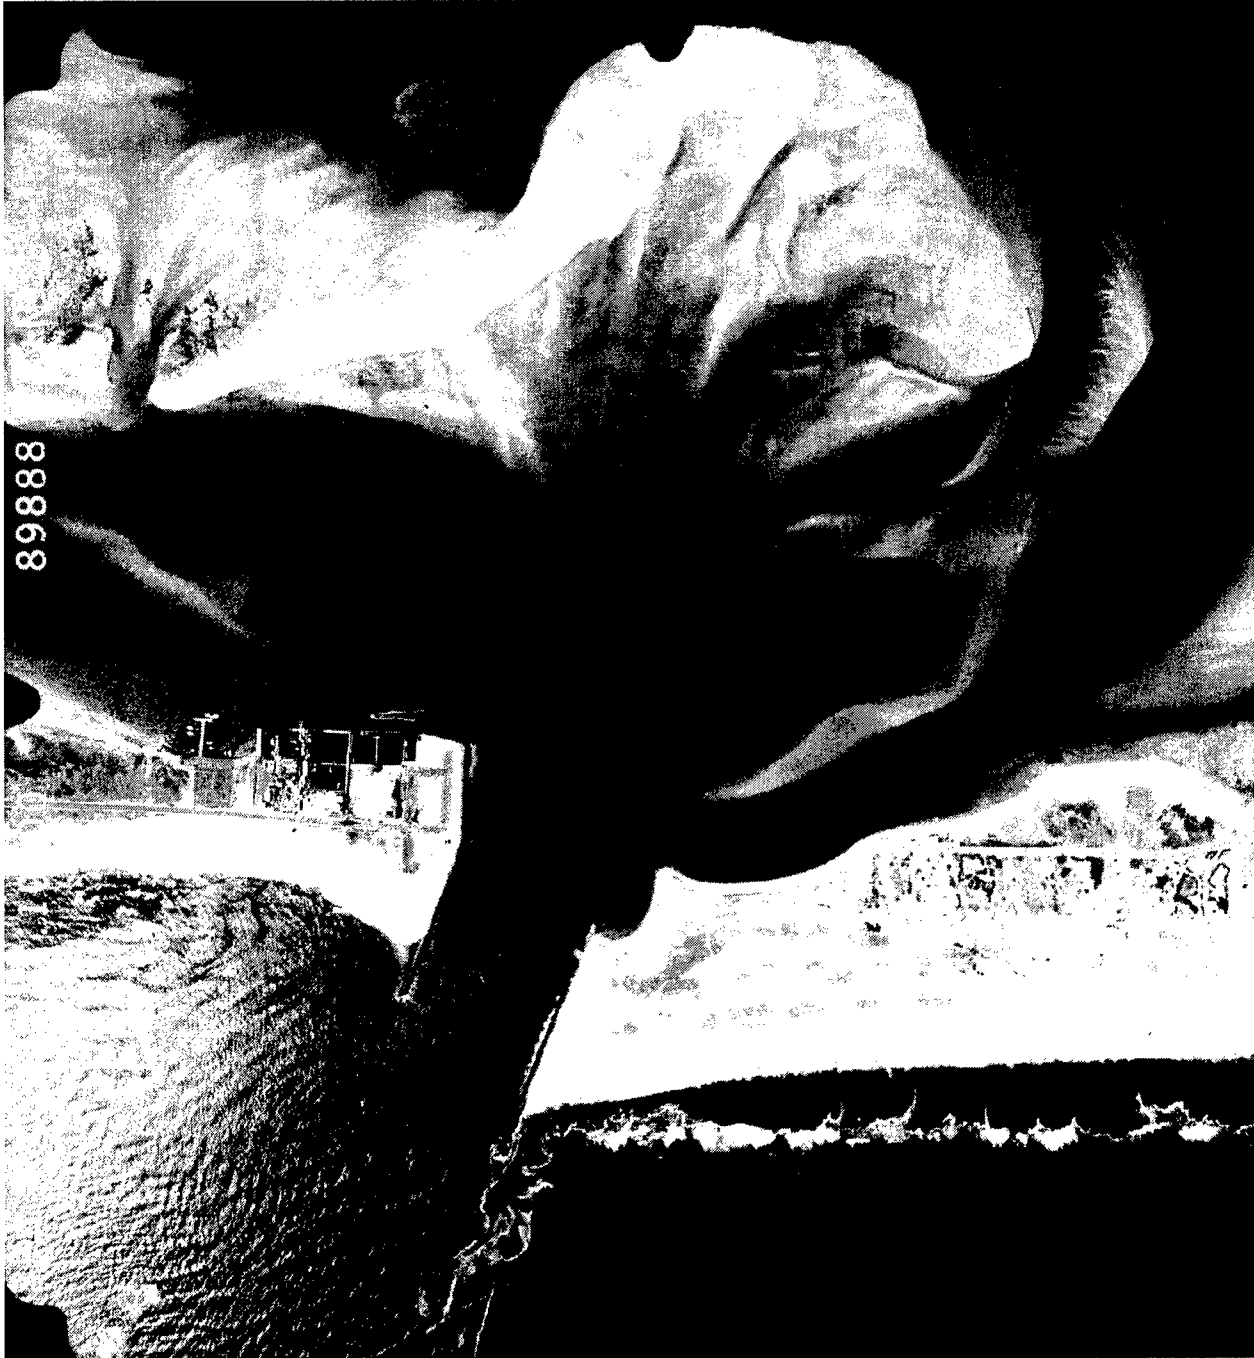
Figure A33. 22 March 1989 (East beach has retreated to landward end of jetty tip compared with 1988. Waves are breaking on a sandbar that parallels the east beach. Flood shoal has about same configuration as in 1988, although sandbars and shoals are more visible in this image)

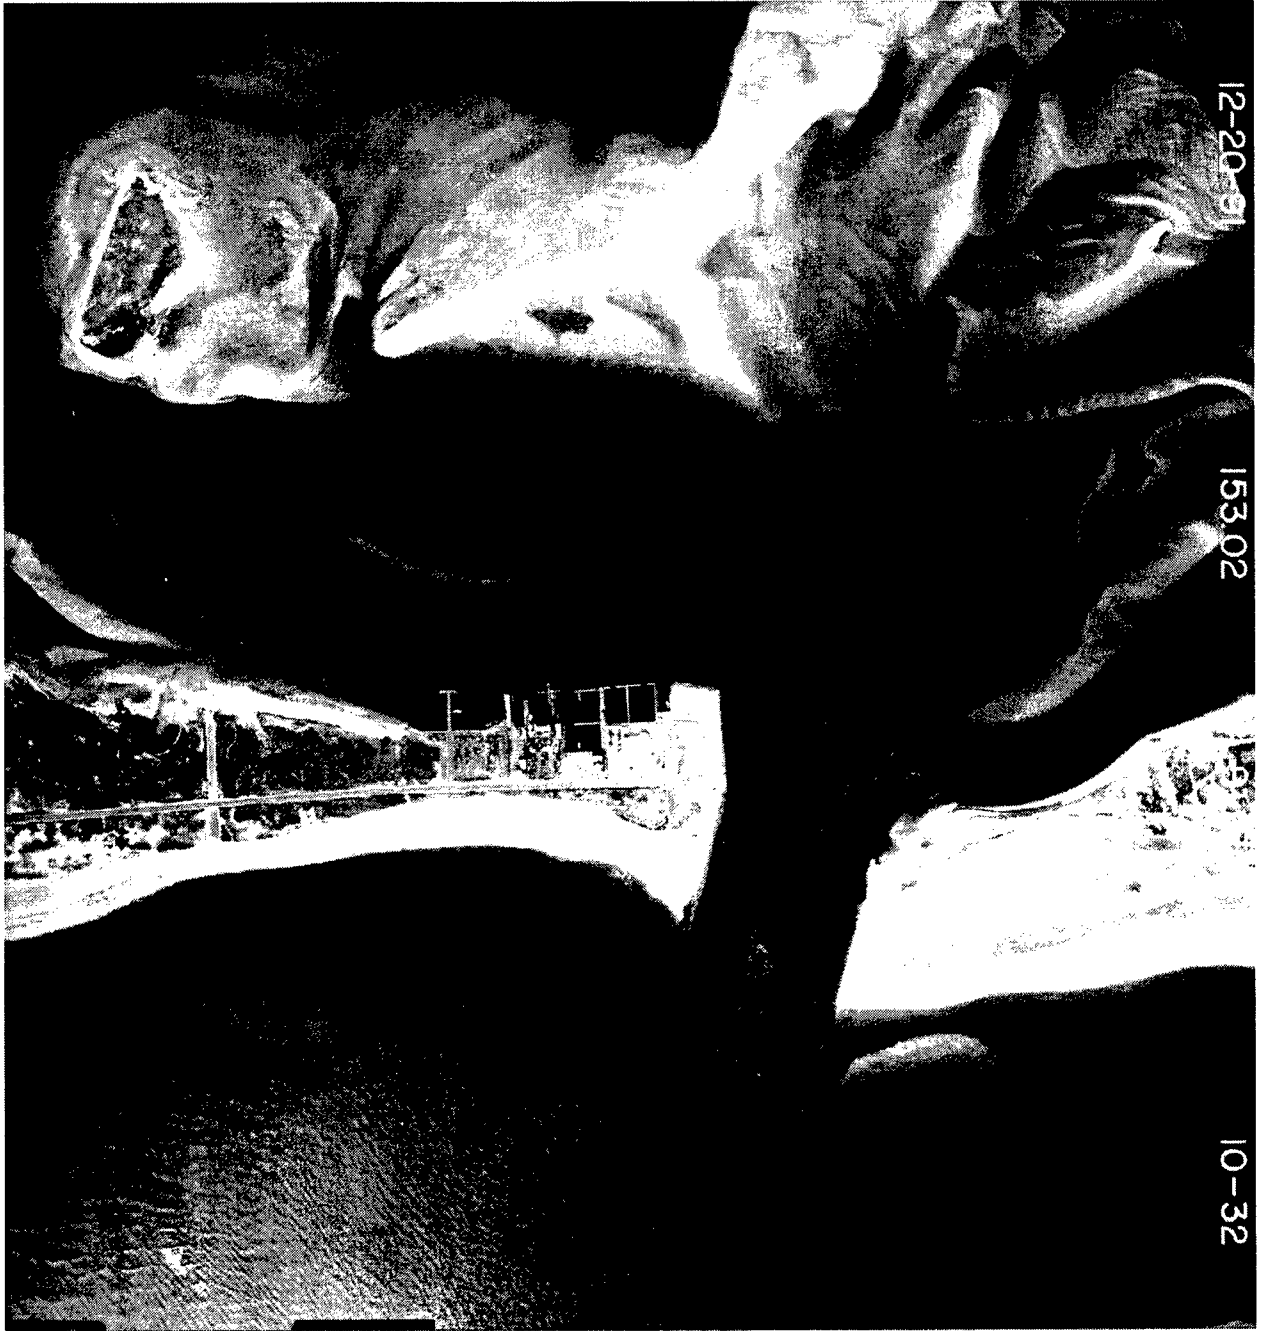
Figure A35. 20 December 1991 (Most features are unchanged from the previous figure, taken in September. Lack of change is surprising because the Halloween Northeaster of 30-31 October was reported to have caused erosion and damage along much of Long Island shore. Erosion pocket in east revetment has shoaled, and west beach has advanced about one-half of the distance to the jetty tip)

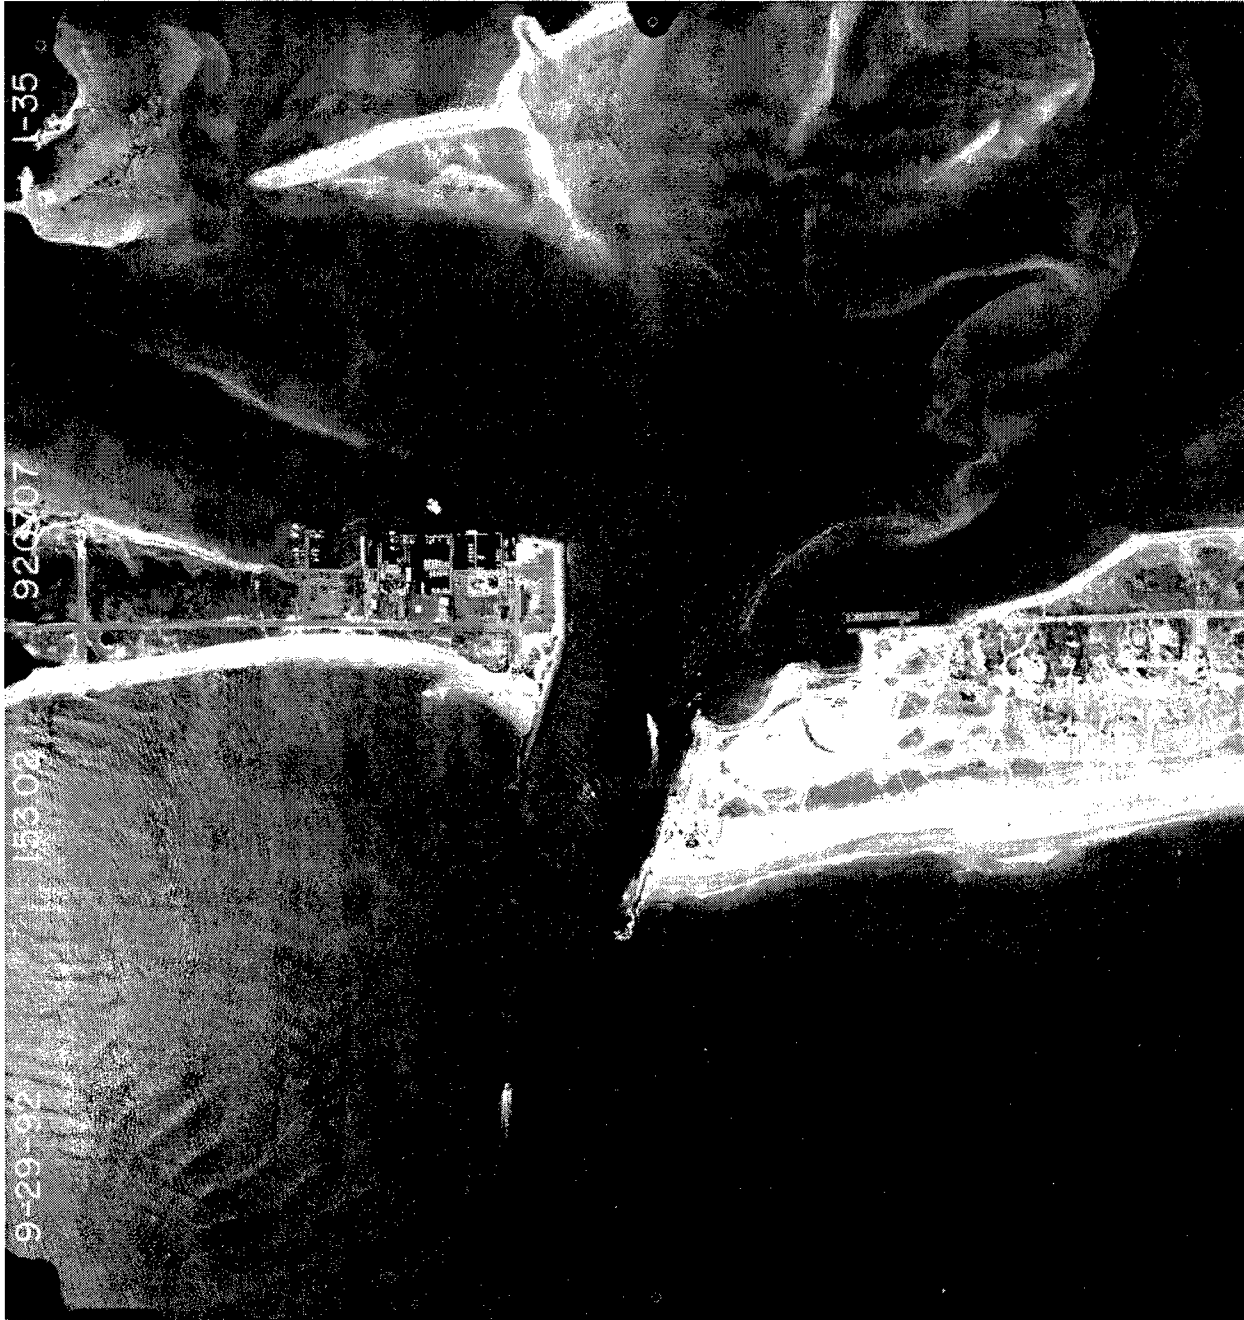
Figure A36. 29 September 1992 (East beach has advanced about 70 m compared with December 1991, and west beach has receded severely. More of the east revetment has deteriorated, accompanied with erosion of east shore. Jetty repair has begun, and a barge containing rock is moored in east channel in Shinnecock Bay. On the flood shoal, the right arm of the T-shaped sandbar has moved north)

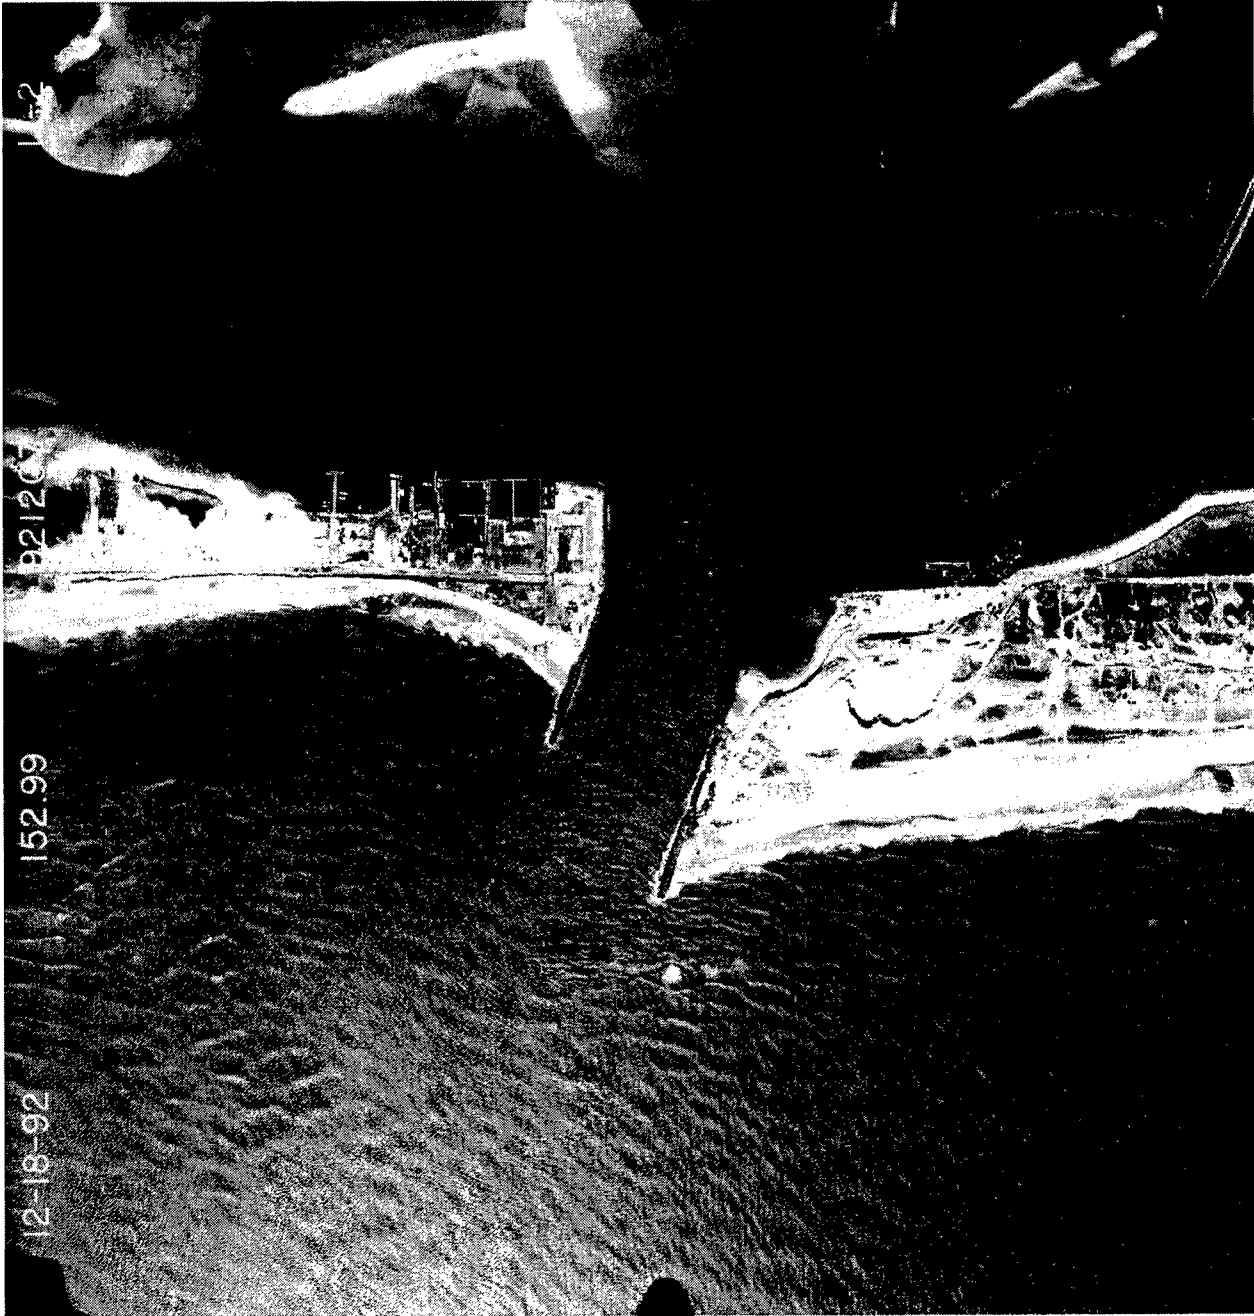
Figure A37. 18 December 1992 (One of three photographs for this date) (In 3 months, the east beach has advanced almost to the tip of the east jetty. West beach has continued to erode, and waves are breaking only a few meters from Dune Road. More work barges are in position near the east revetment)

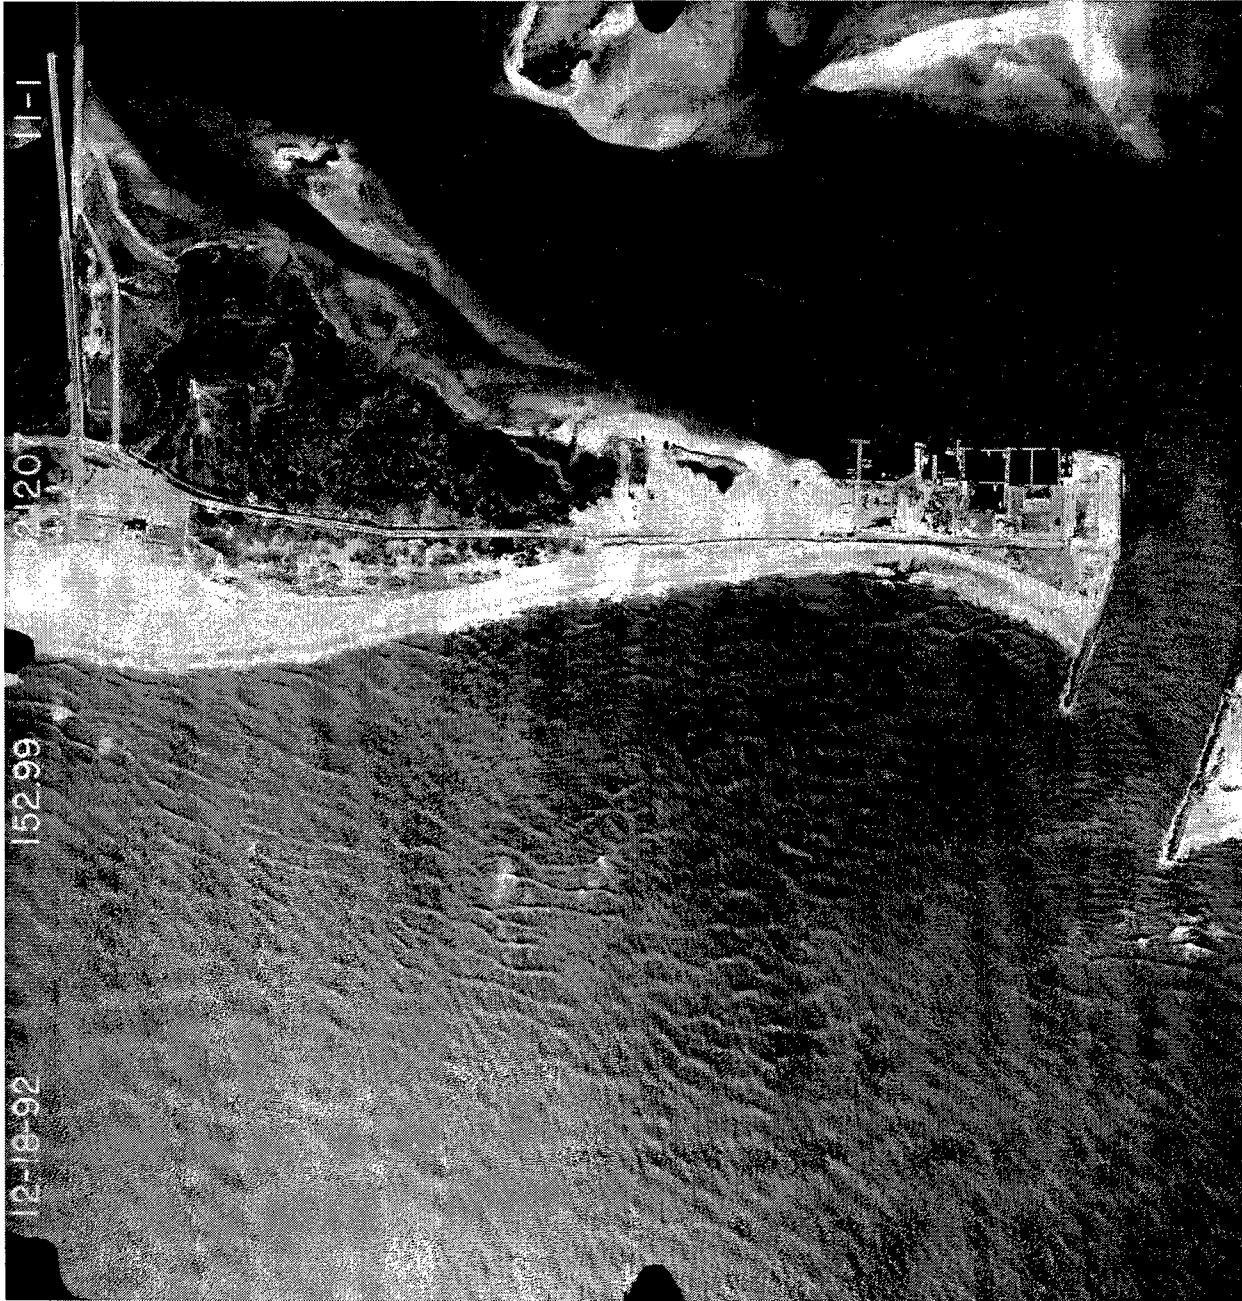
Figure A38. 18 Dec 1992 (No. 2 of three images this date) (This photograph shows how severely the west beach has eroded west of the west jetty. Shoreline bulge, where the ebb shoal joins the beach, is adjacent to the Ponquogue Bridge road intersection. This location is in contrast to 1983 and 1988, when the bulge was much smaller and located further east. Disturbed wave crests approximately outline ebb shoal. Note fresh washover fans just west of the docks. Barrier was overwashed during powerful northeaster of 11-14 December)

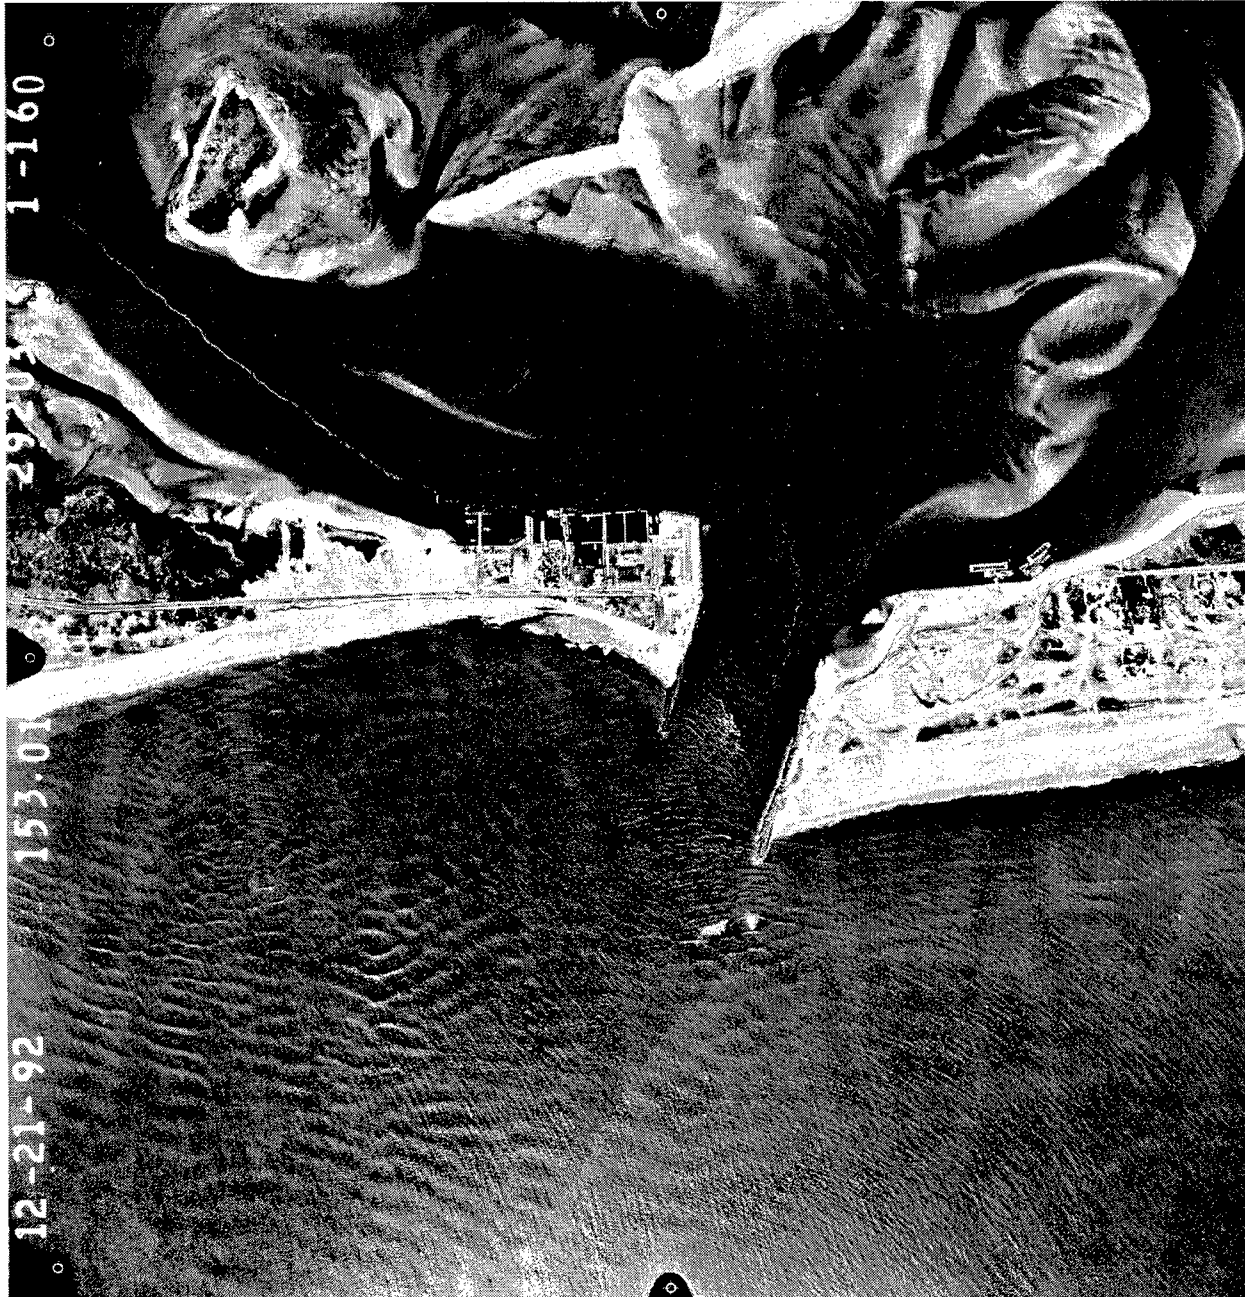
Figure A40. 21 December 1992 (Similar conditions as previous photographs taken 3 days earlier. Waves still appear to be concentrated along the east shore where part of the jetty has failed. T-shaped sandbar in flood shoal has been divided into two sections)
