**US Army Corps
of Engineers**
Waterways Experiment
Station

Coastal Inlets Research Program

Shinnecock Inlet, New York, Site Investigation

Report 1 Morphology and Historical Behavior

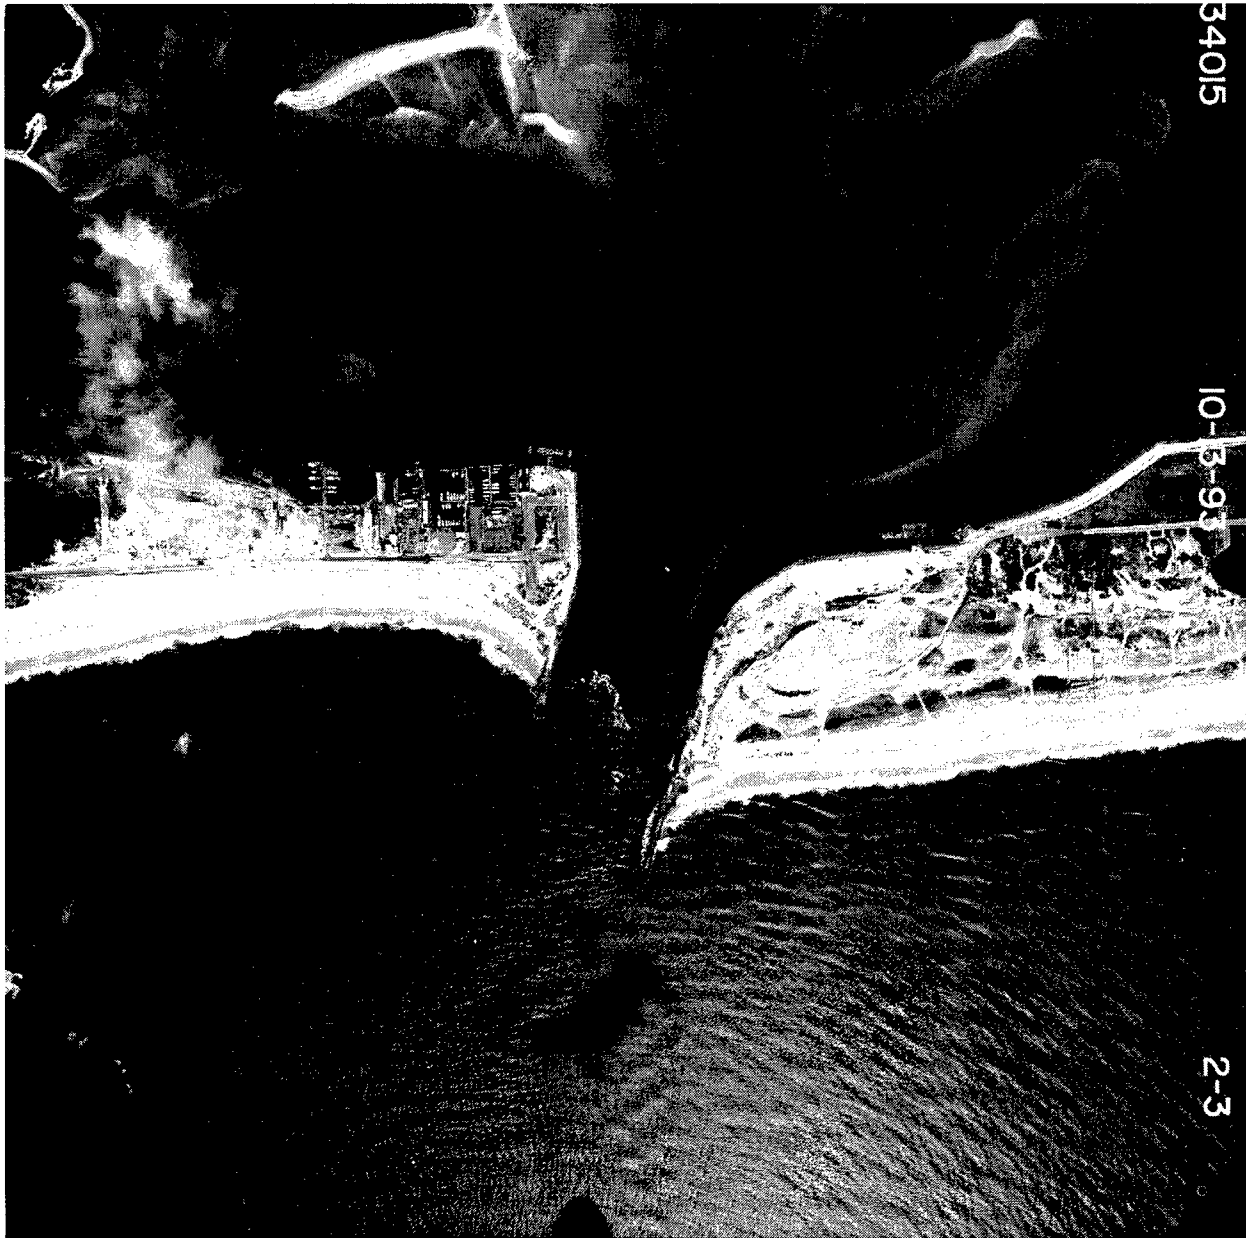
Figure A42. 13 October 1993 (Ocean shorelines have not changed since the previous photograph was taken in June. Repair of the east revetment is almost complete)

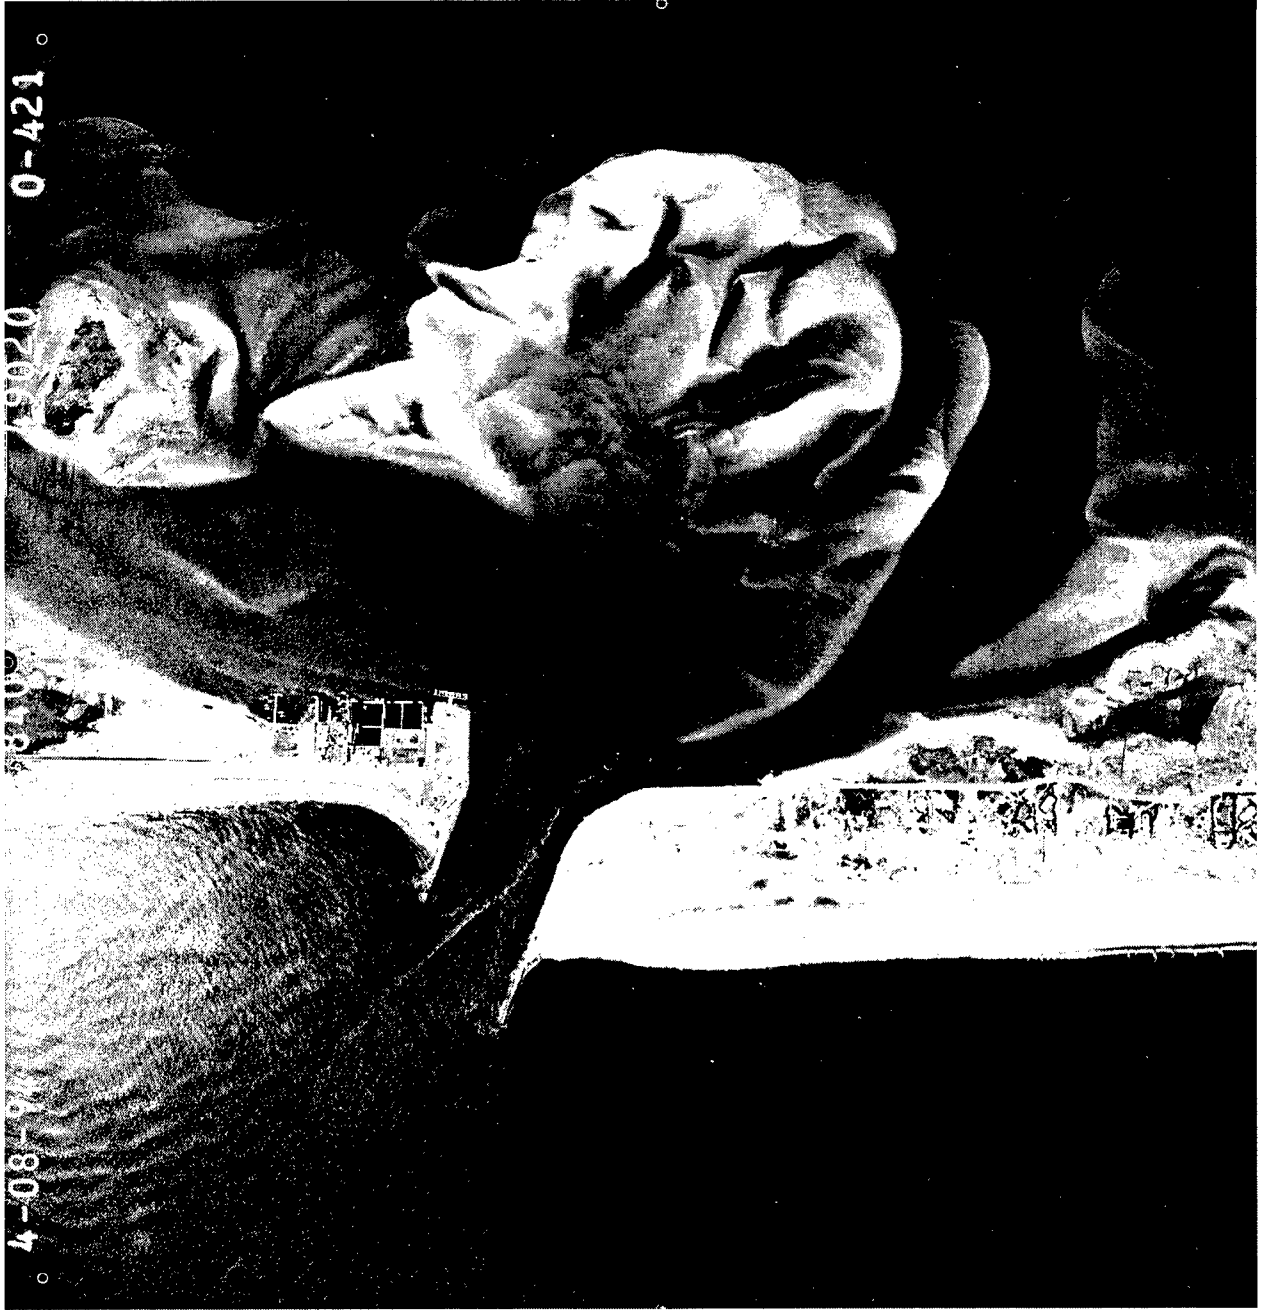
Figure A43. 8 April 1994 (West beach has eroded again, and east beach has also retreated. Repair of east jetty and revetment is complete. Repairs are underway on west jetty, and rock and materials are stockpiled in parking lot)

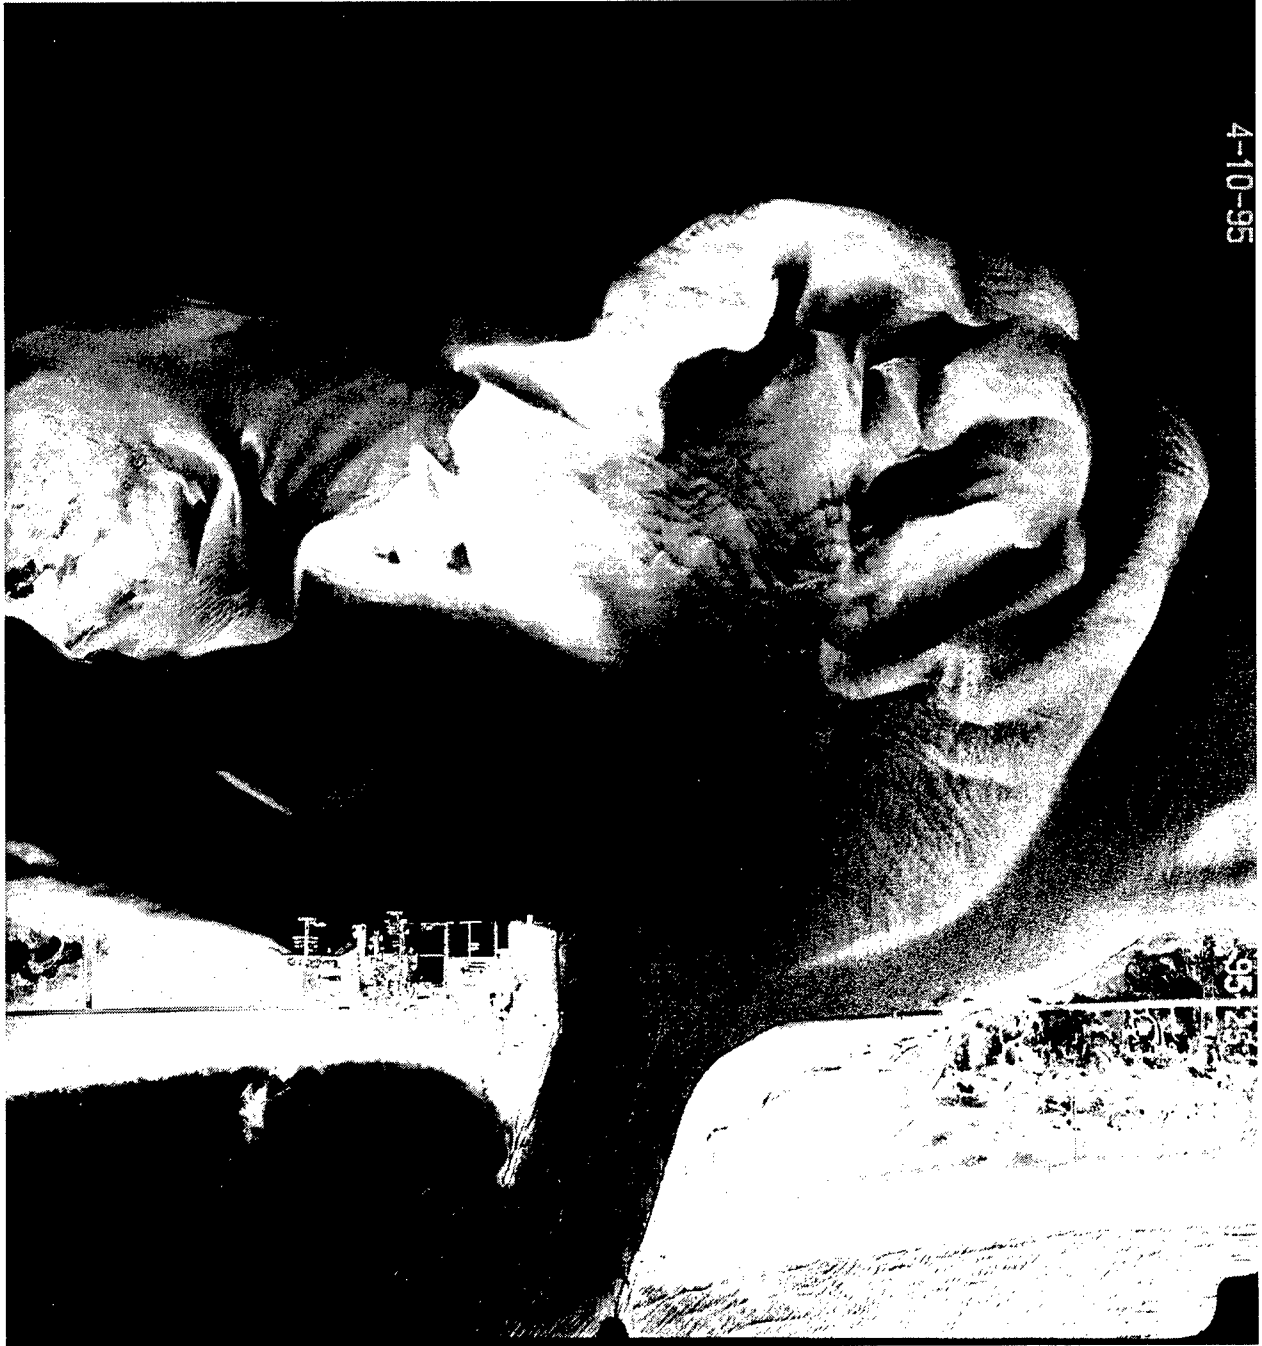
Figure A45. 10 April 1995 (East beach has advanced compared with September 1994, while west beach has eroded. A spit projects from the west beach, as shown by breaking waves)

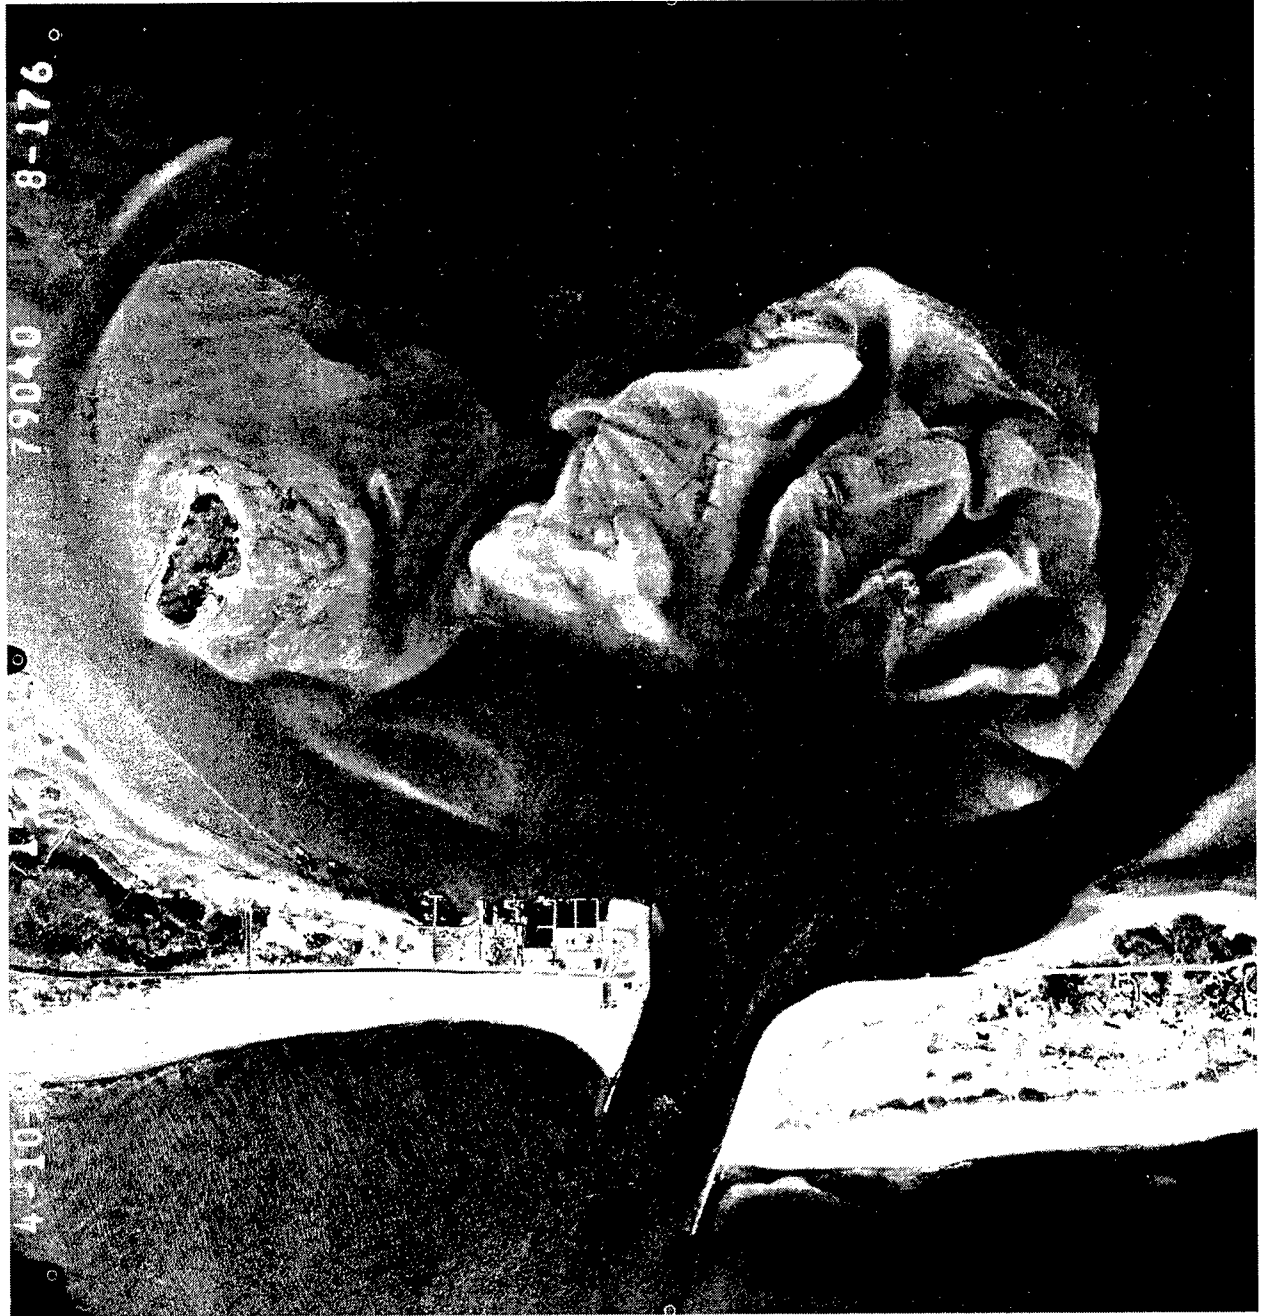
Figure A49. 10 April 1997 (East beach has receded about 100 m from tip of west jetty. West beach was repaired with sand dredged from channel in February and March (see Table D1). Active portion of flood shoal is now symmetrically positioned in line with axis of inlet. This is east of its 1970s position)

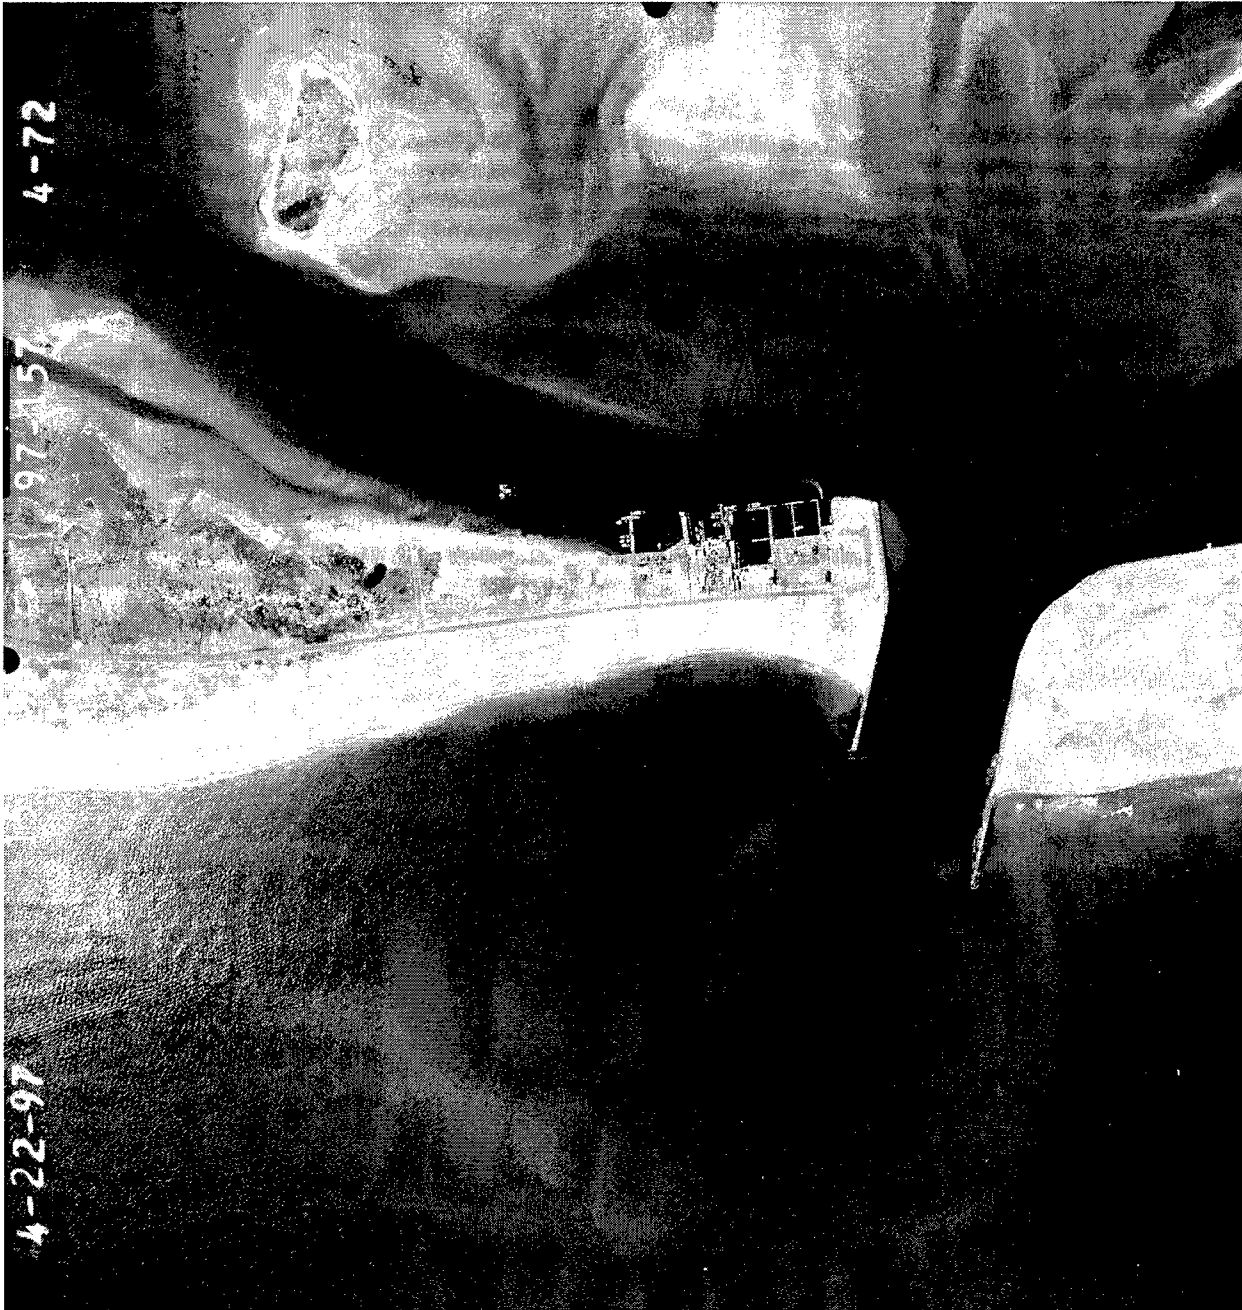
Figure A50. 22 April 1997 (Edge of ebb shoal is clearly visible in this image, taken on a day with almost no waves. Water depth at the bar is about 3 m (10 ft). Dark water off the mouth of the inlet is the dredged deposition basin. A ridge of sand that projects seaward from the west jetty and a deep hole to its west were measured by bathymetric surveys (see Appendix B))

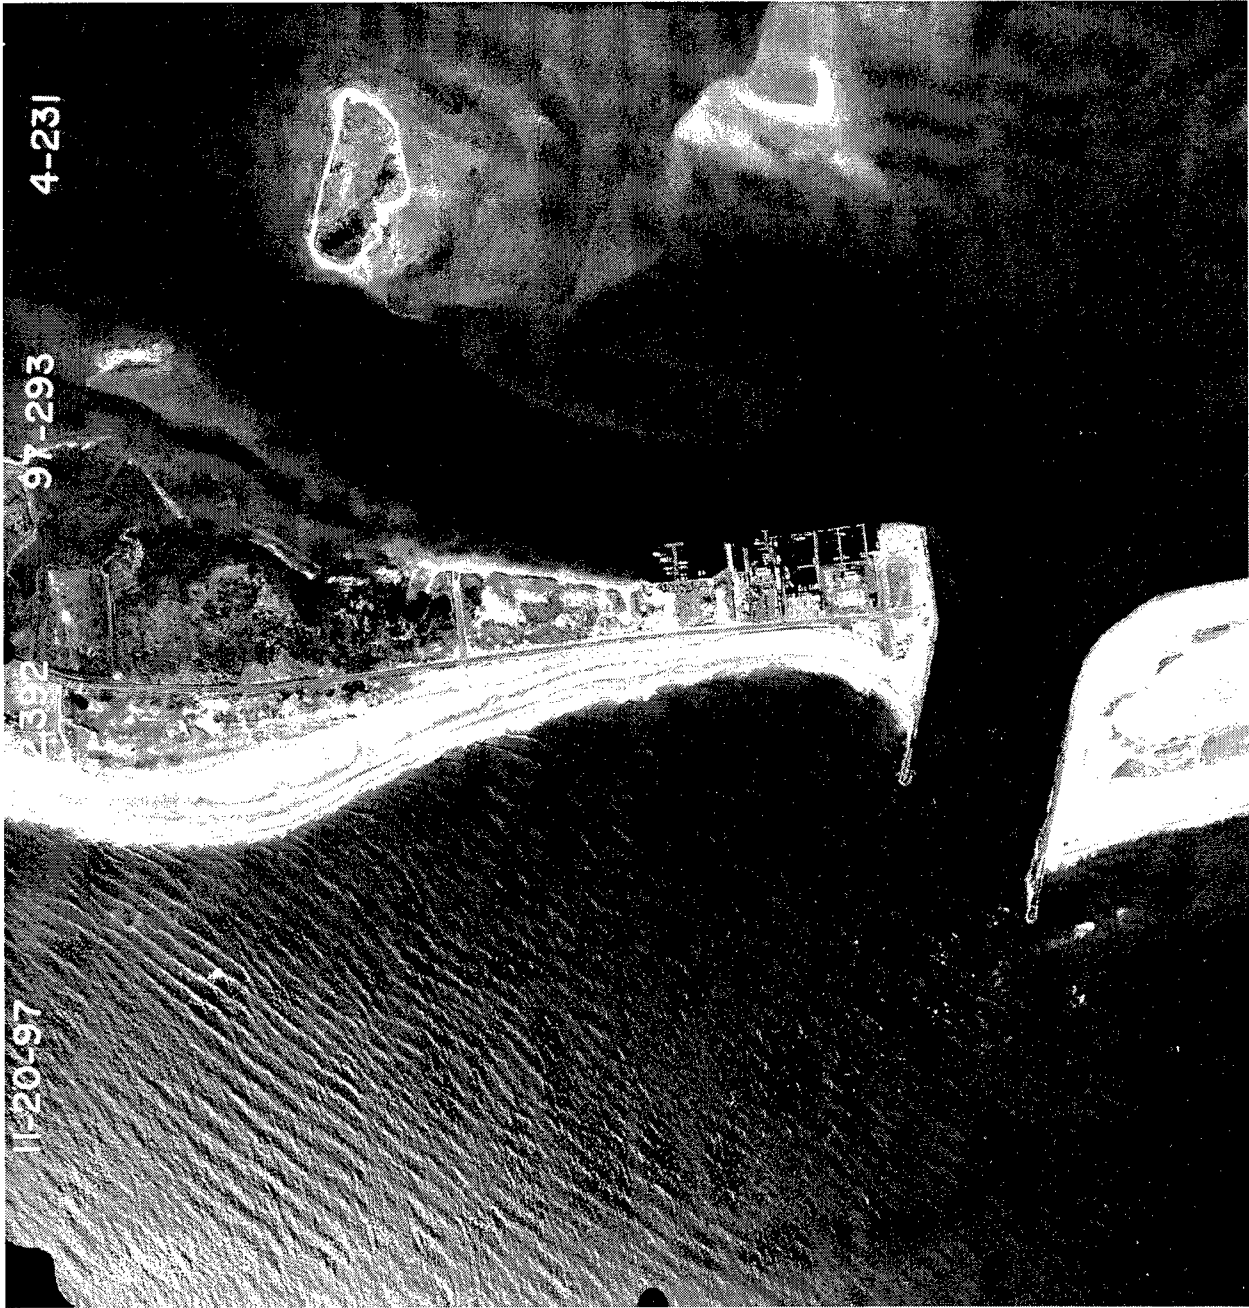
Figure A52. 20 November 1997 (In only a month, west beach had notably receded. Image shows how narrow the west beach is near fishing docks and, therefore, how vulnerable to breaching. The shoreline bulge where ebb shoal attaches to beach has continued to advance seaward. Because of clear water, sandbars off the east beach are visible)
