Navigation for the Derbyshire Phase2 Survey

May 1999

Technical Report

WHOI-99-11

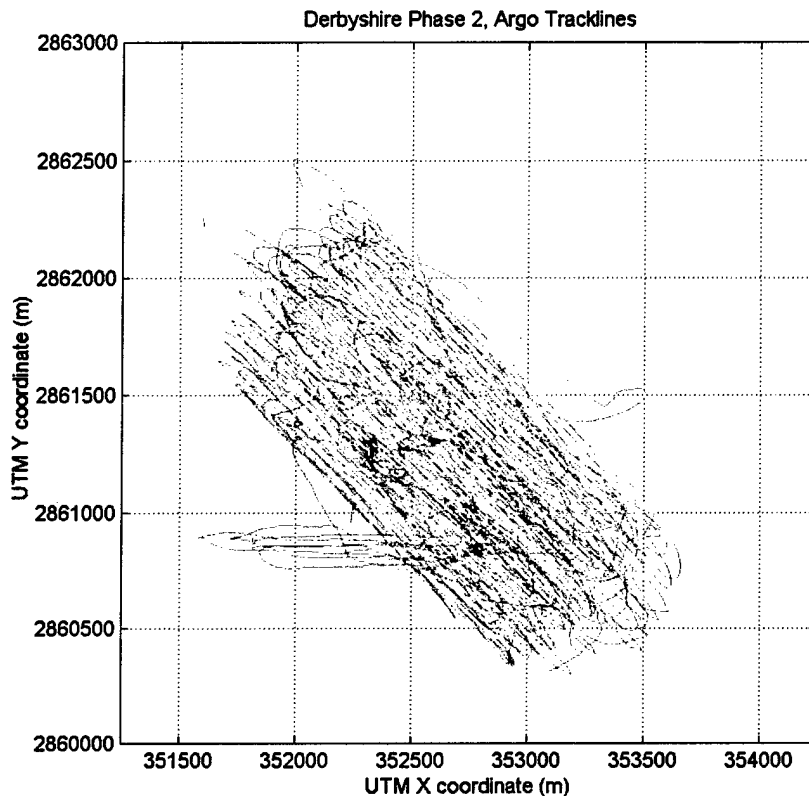
Figure 6: Complete set of Argo tracklines

Our goal was to obtain complete photographic coverage of the entire wreck site. As we control Argo primarily by maneuvering the vessel, this represented a challenge in over 4000 meters of water. In particular, the sluggish response of the vehicle to vessel movements makes the task difficult. Figure 6 shows the complete set of Argo tracklines.

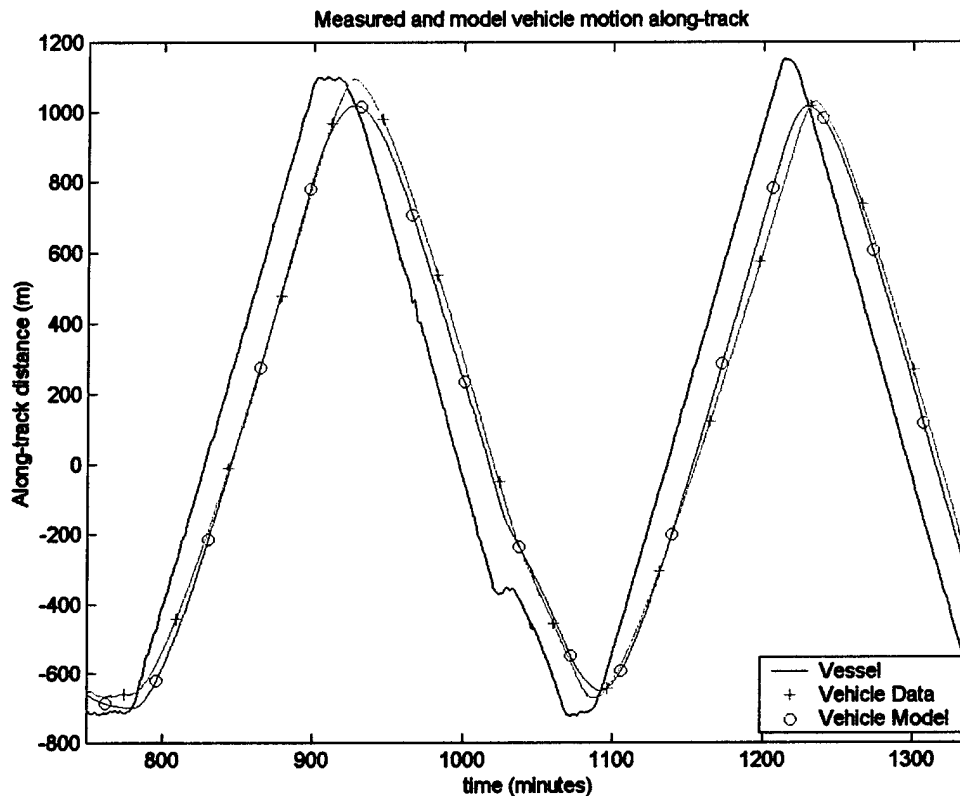
Figure 7 Modelled versus measured vehicle response along track. This plot shows distance traveled by the ship, vehicle, and a model. The model is a simple first-order system with a time constant of 18 minutes.

Figure 7 shows the dynamic response of the vehicle to vessel motion along with the response of a simple first-order model. Both vessel and vehicle movements have been transformed into a plane oriented along the nominal trackline direction. While the model is naïve in several ways (it ignores currents, depth changes, hydrodynamic nonlinearities, and out-of-plane motion), it clearly captures much of the relevant dynamics. It performs worst in turns, where the vessel motion is most extreme, velocity changes and out-of-plane motion are the large.

By fitting the model to the vehicle response, we can determine the time constant of the primary vehicle dynamic response to one-dimensional vessel motion. In the model shown in figure 7, the time constant was set to 18 minutes.

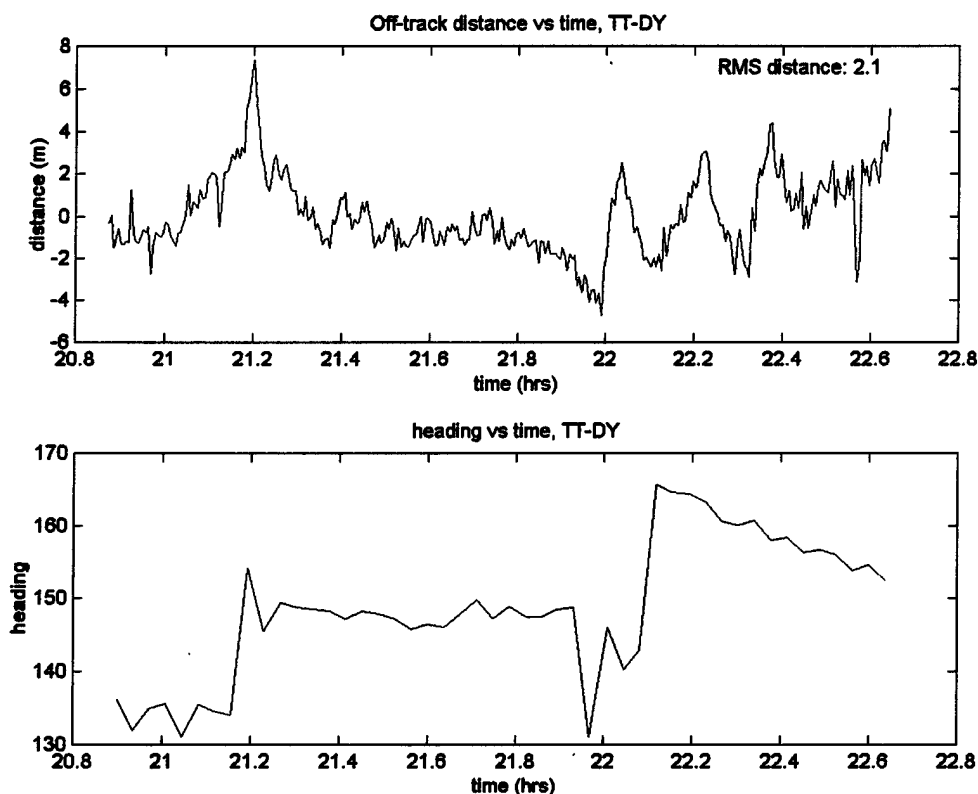
Figure 9. This plot shows trackline error and vehicle heading. As the track error grows just prior to 22 hours, a heading change is applied.

Figure 9 shows vehicle off-track error versus time along with the vehicle heading. The errors are quite low, $\text{rms} = 2.1$ meters. Just before 22 hours, the vehicle trackline error starts to grow, and a heading was commanded to change in order to counter the error. This heading change (probably along with side thrust),
