DOT/FAA/AR-99/6

Fiber-Reinforced Structures for Turbine Engine Rotor Fragment Containment

Final Report

6. Performing Organization Code	
7. Author(s) John Pepin		8. Performing Organization Report No.	
9. Performing Organization Name and Address Pepin Associates, Inc. North Main St. PO Box 397 Greenville, ME 04441		10. Work Unit No. (TRAIS)

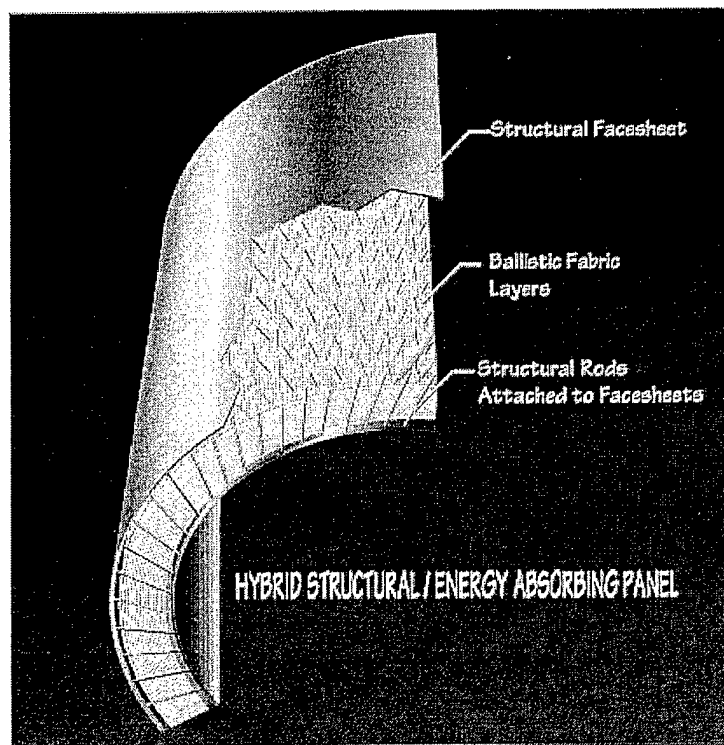
FIGURE 1. HYBRID STRUCTURAL/ENERGY-ABSORBING PANEL

This program was built upon previous work [1] to develop lightweight fiber-reinforced structures to contain turbine engine rotor failures. In this previous program a hybrid sandwich panel concept was shown to be effective as both a static structure member and as a containment barrier to protect critical aircraft systems from high-energy fragments. This concept is a sandwich panel whose core consists of dry, energy-absorbing fabric layers. This dry laminate is penetrated through its thickness by many closely spaced rigid rods which are attached to the panel's facesheets. These rods mechanically connect the facesheets as would a honeycomb core such that the panel can support shear, compressive, and tensile loads. Figure 1 shows a drawing of this panel.

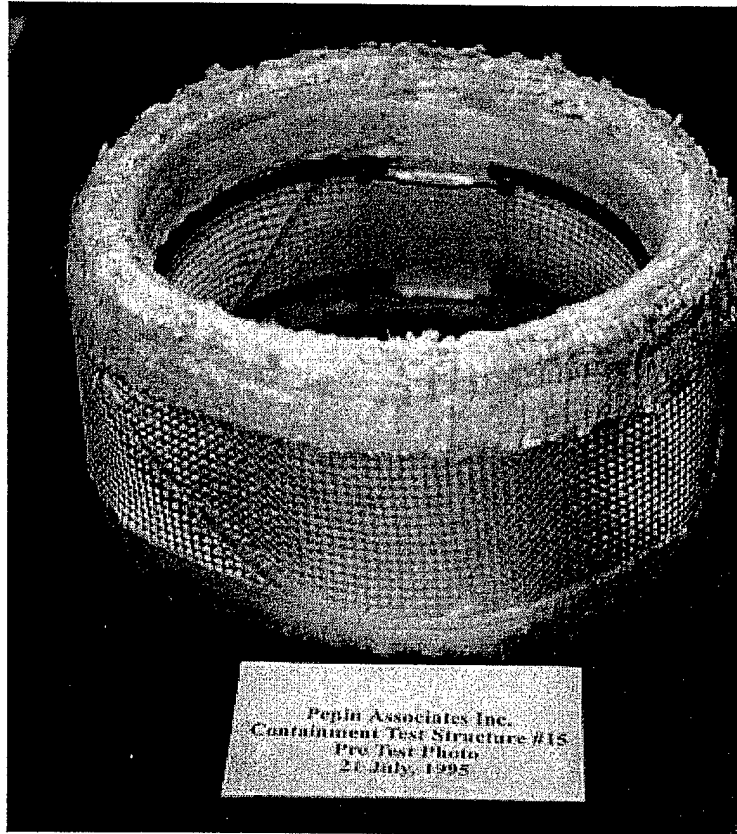
FIGURE 6. S GLASS RING WITH $\pm 45^\circ$ REINFORCEMENT

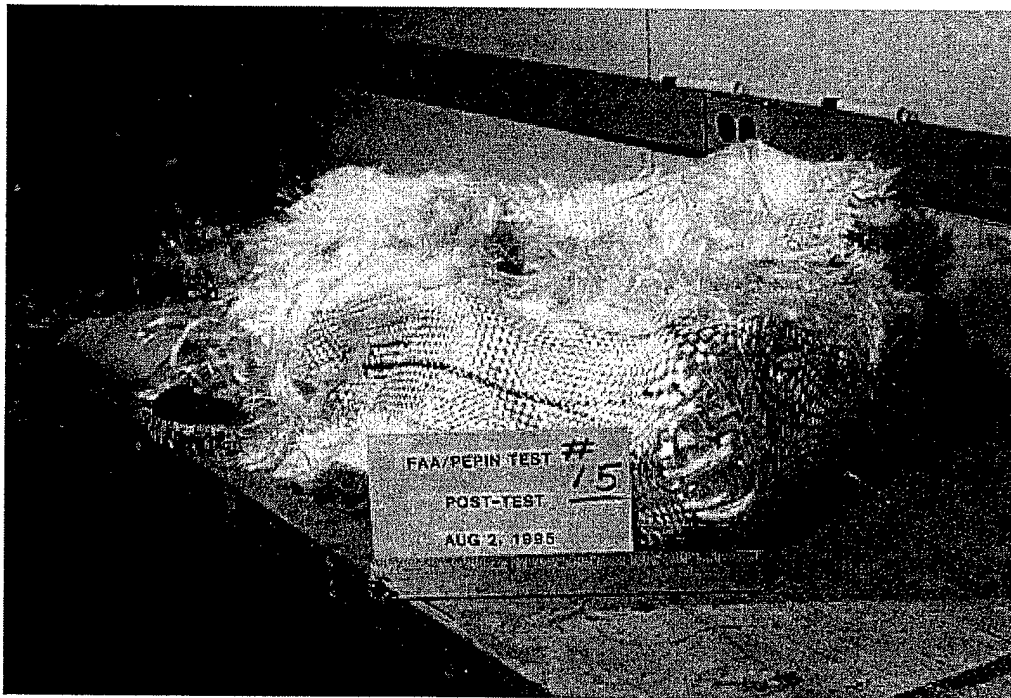
FIGURE 7. POSTTEST PHOTO OF S GLASS RING WITH $\pm 45^\circ$ REINFORCEMENT

The S Glass ring with $\pm 45^\circ$ reinforcement did not contain the rotor burst. One of the disk fragments penetrated the ring wall while the other two remained within the ring. Figure 7 is a posttest photo of this ring.

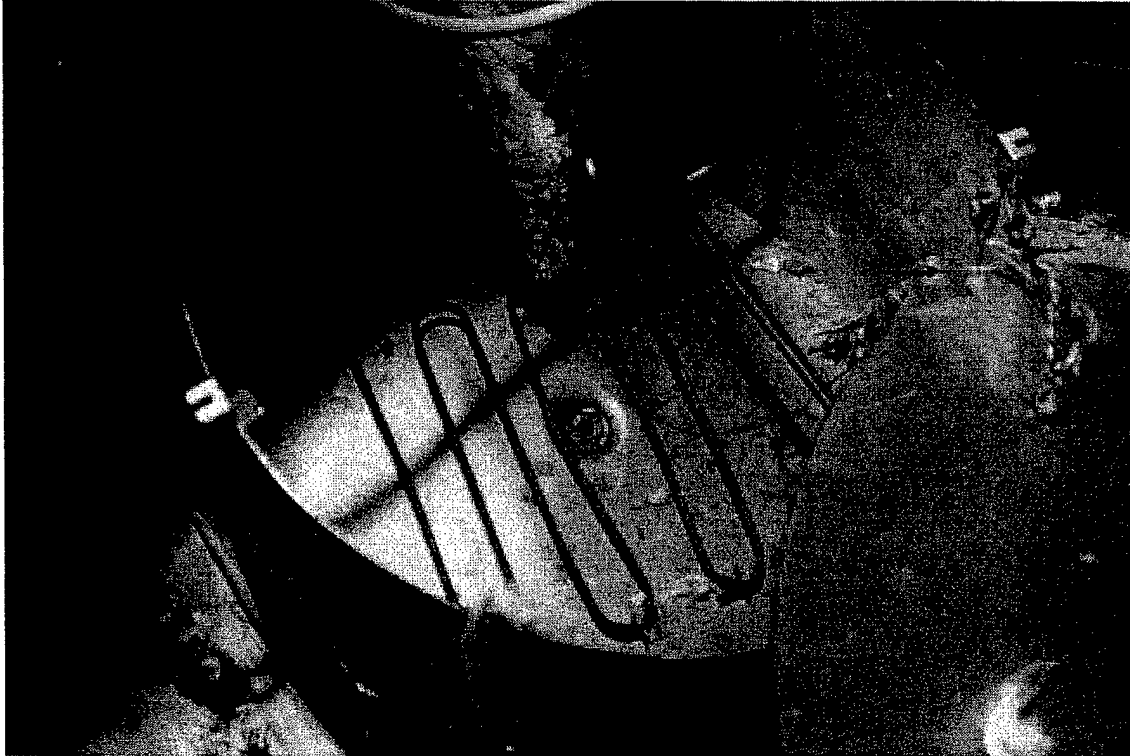
FIGURE 29. OVEN USED TO HEAT THE THERMAL TEST RINGS JUST BEFORE SPIN TESTING

the ring and acted as a witness shield. Two shallow dents were found in this sheet but no holes were found. Figure 27 shows the ring mounted to the spin chamber cover but the oven has not yet been placed over it. Figure 28 is a posttest photo and figure 29 shows the heating element inside the oven.

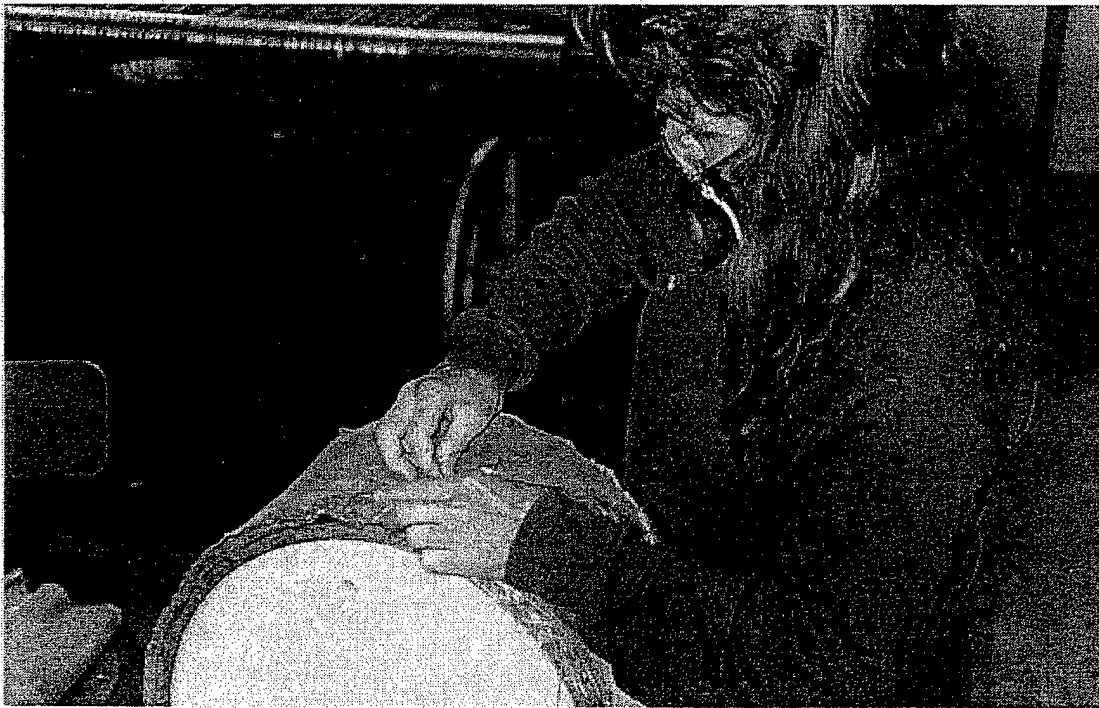
FIGURE 30. CUTTING THE PBO FABRIC AT A 45° ANGLE

FIGURE 31. CLOSE-UP OF MANUAL CUTTING OF PBO FABRIC

FIGURE 32. SEWING DRAW STRING STRIPS TO EDGE OF FABRIC

FIGURE 33. LAYUP OF PBO CONTAINMENT RING

The PBO fabric used for this test ring was a 16 x 16 plain weave with 3000 denier unsized but twisted yarns. Since the tows were available only in the unsized condition, they were twisted so they could be easily woven. Fabric weight was 0.439 kg/m². This ring had 43 plies with the same layup and architecture as the Kevlar thermal test ring previously described. As with the previous ring, no rods or facesheets were added. The mass of this ring was 5.73 kg and it had the following dimensions: ID 38.10 cm, OD 43.78 cm, and axial length 24.13 cm. Figures 30 through 33 show the cutting and sewing steps required to build the ring, and the finished ring is shown in figures 34 and 35.
