TECHNICAL REPORT ARCCB-TR-99019

**FATIGUE LIFE ASSESSMENT OF
155-MM M776 CANNON TUBES**

NOVEMBER 1999

| | <p>US ARMY ARMAMENT RESEARCH, DEVELOPMENT AND ENGINEERING CENTER CLOSE COMBAT ARMAMENTS CENTER BENÉT LABORATORIES WATERVLIET, N.Y. 12189-4050</p> | |

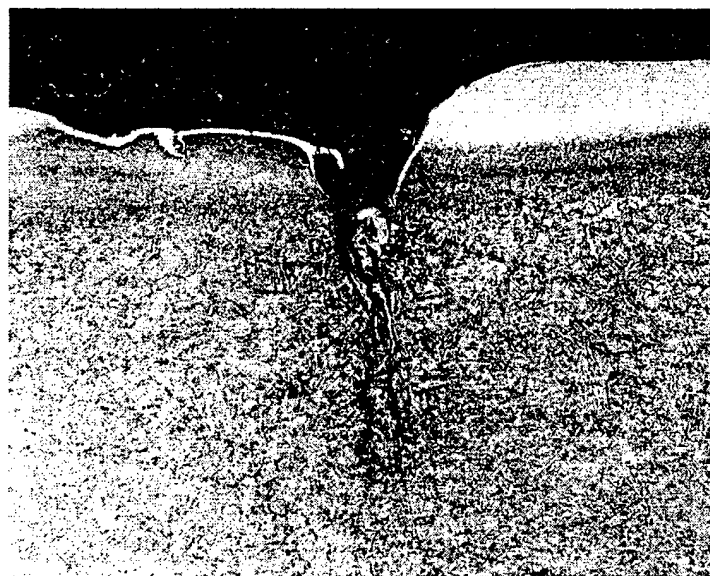
Figure 1 illustrates a macroscopic view of a typical bore surface after sufficient live fire rounds have been applied for the commencement of laboratory cycling. The heat-checking, or "dry lake bed" appearance, is apparent. Figure 2 is a transverse section of Figure 1 showing the uniform array of heat checks and the fatigue cracks that grow from heat checks. The heat checking in this photograph ranges from 0.010-inch to 0.020-inch. Figure 3 is a high magnification micrograph of Figure 2. Once again, a fatigue crack emanating from a heat-check location is apparent. Finally, Figure 4 shows how a heat-check crack has initiated a fatigue crack that has penetrated through the chromium plate and into the base metal causing chromium loss

and substrate melting. With acceptable bore damage developed during prelaboratory live firing, laboratory fatigue testing has proven to be equivalent to test firing in propagating this initial damage to failure.

Figure 4. Continued fatigue crack growth plus substrate melting and chromium loss.

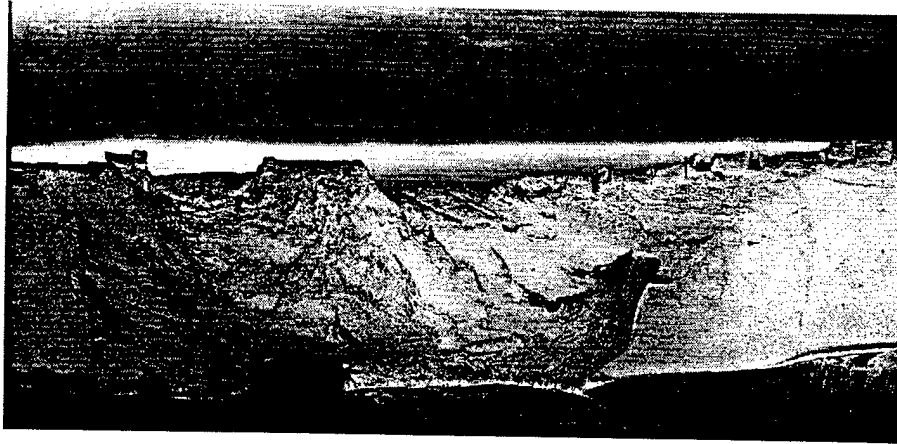
Figures 9 and 10 show failure locations of the two breech end test sections. Figures 11 and 12 show an enlarged view of the breech end test sections and the failure location. The fracture surface for each breech end test section is shown in Figures 13 and 14. Figures 15 and 16 illustrate the two keyway test sections with the failure location noted. Figures 17 and 18

Figure 14. XM776 S/N 003 breech end fracture surface.

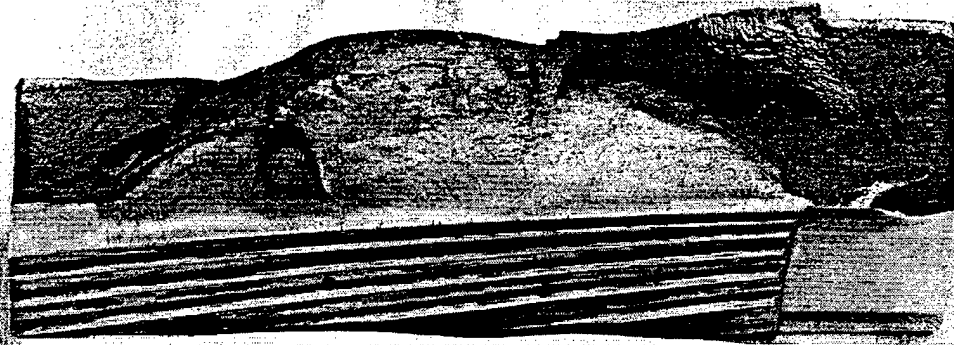
illustrate an enlarged view of the keyway test sections with the failure location noted. The fracture surface for each keyway test section is shown in Figures 19 and 20.

**155mm XM776 Lightweight
Tube #003
17,457 Lab Cycles**

Figure 20. XM776 S/N 003 keyway fracture surface.
