NRL/MR/6180--99-8423

Thermal Insult Produced by the Residual Liquid Fuel in a Missile Hit Scenario

December 23, 1999

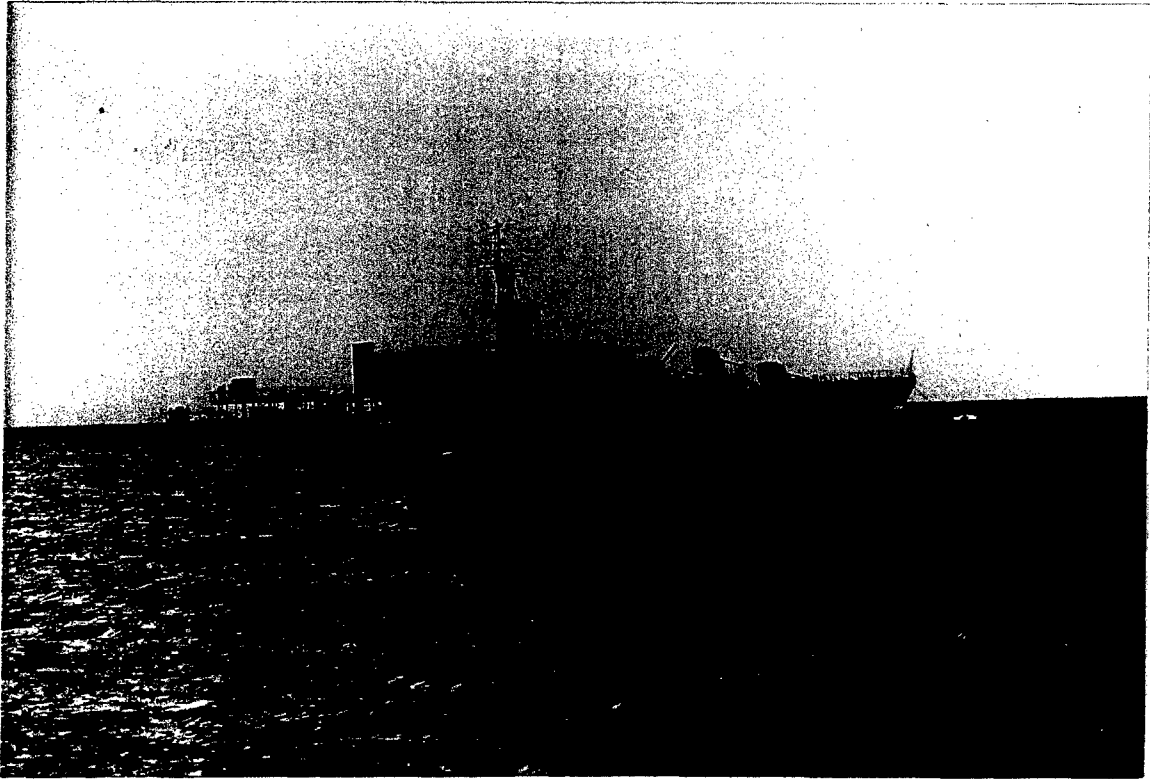
Fig. 1 - ex-Margottini

Two tests were conducted on board the decommissioned BERGAMINI Class frigate, the ex-MARGOTTINI (Fig. 1). The ship is approximately 95 m (311 ft) long, 11.3 m (37 ft) wide and displaces 1500 metric tons (1650 English tons). The test compartment was located on the Corridoio Deck between frames 36 and 48 as shown in Fig. 2. The size and shape of the compartment had to be modified due to damage sustained during a previous blast test. The final compartment dimensions are shown in Fig. 3.

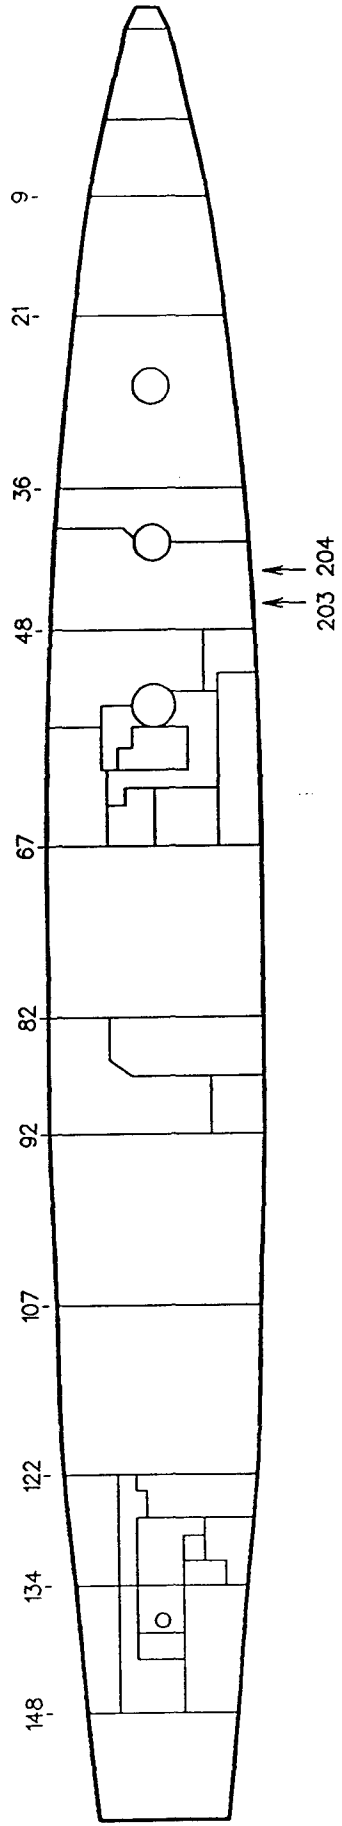
Fig. 2 - Test compartment location - Corridoio deck

The charges were mounted on platforms on the exterior of the starboard hull at locations shown in Figs. 2 and 3. The warheads were fired horizontally through the compartment at a height of approximately 1.3 m (50 in.) above the deck. A 5 cm (2 in.) thick steel plate was fastened to the port side of the ship to contain the blast. The warhead was initially aligned using a laser.

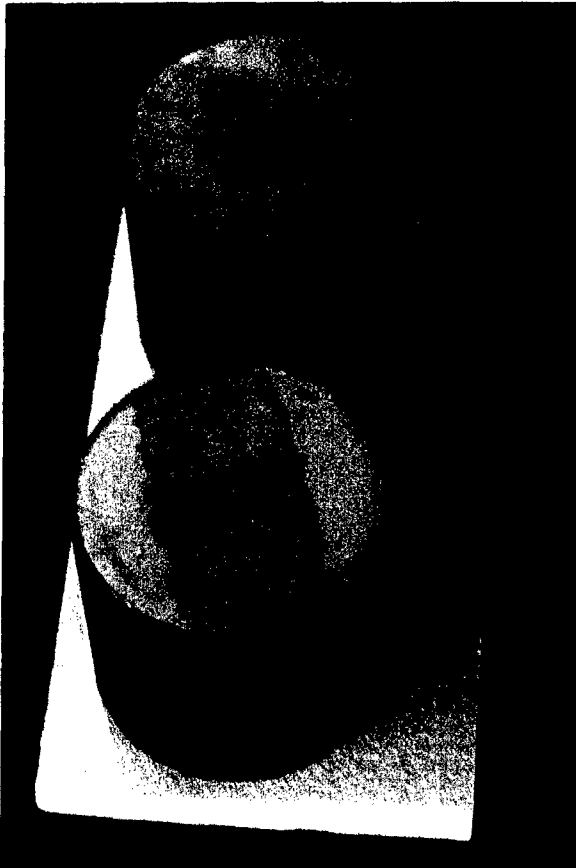
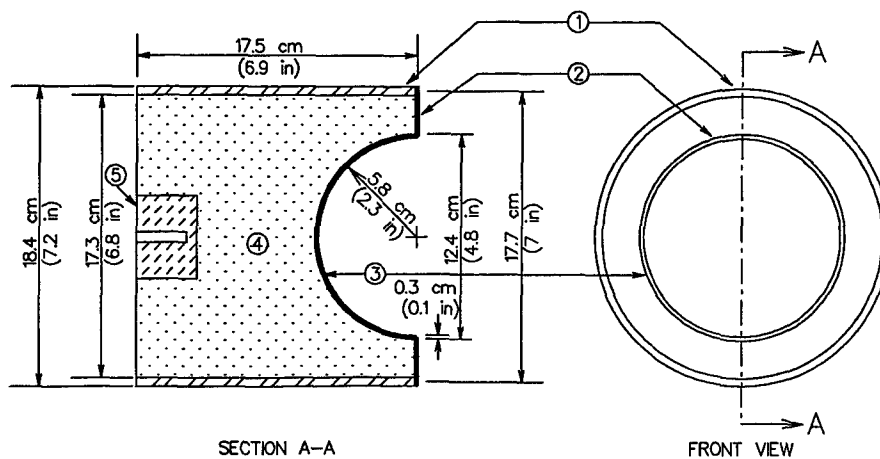
Fig. 4 - Shaped charge

The shaped charge consisted of a 6.3 kg (14.0 lb) of C-4 plastic explosive with a 100 g (0.2 lb) 50/50 Pentolite booster. The explosive was housed in a 18.4 cm (7.25 in.) diameter cylinder (OD) by 17.5 cm (6.9 in.) in length as shown in Fig. 4. The casing was 1.0 cm (0.4 in.) thick and was made of 1008 steel. The charge was activated using a J-2 or RP-80 detonator.

MATERIALS LIST		
PART	DESCRIPTION	MATERIAL
1	CASING	18.4 cm (7.2 in) OD x 17.1 cm (6.7 in) ID TUBING
2	DISC	16 ga. MLD STEEL
3	LINER	AISI 1008 STEEL
4	EXPLOSIVE FILL	14 lb HBX-1
5	BOOSTER	100 g 50/50 PENTOLITE

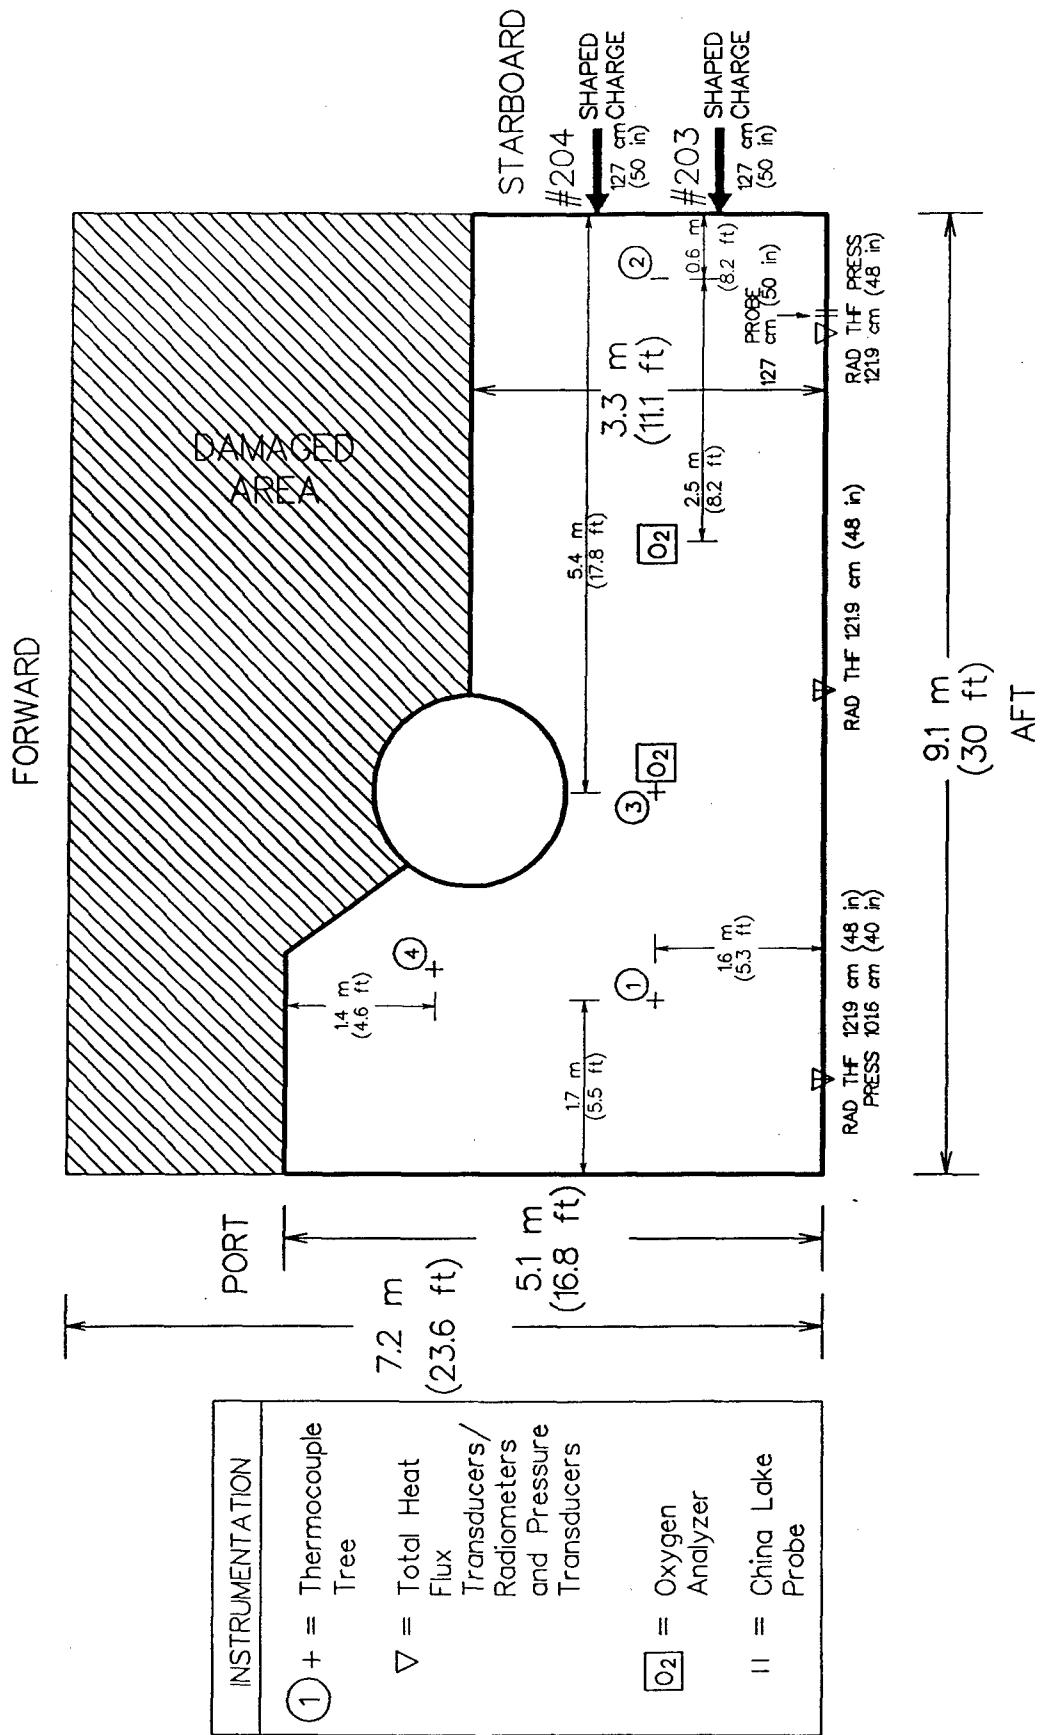
Fig. 6 - Instrumentation layout

heat flux, oxygen concentrations, and compartment blast pressures. The instrumentation scheme is shown in Fig.6. Due to safety requirements, the data acquisition systems were activated remotely from a control room located on the hanger deck well aft of the test compartment. A further description of the instrumentation is as follows.

Four Type "K" thermocouple trees (arrays) were placed in the test compartment. Three trees were positioned equidistant from port to starboard along the centerline of the compartment. The fourth tree was positioned in a void forward in the compartment. These trees consisted of three thermocouples, each spaced 0.6 m (2 ft) apart at heights of 0.6, 1.2, and 1.8 m (2, 4, and 6 ft) above the deck. The thermocouples were glass braided, 36 gauge wires having a response time/time constant of approximately 0.15 seconds.

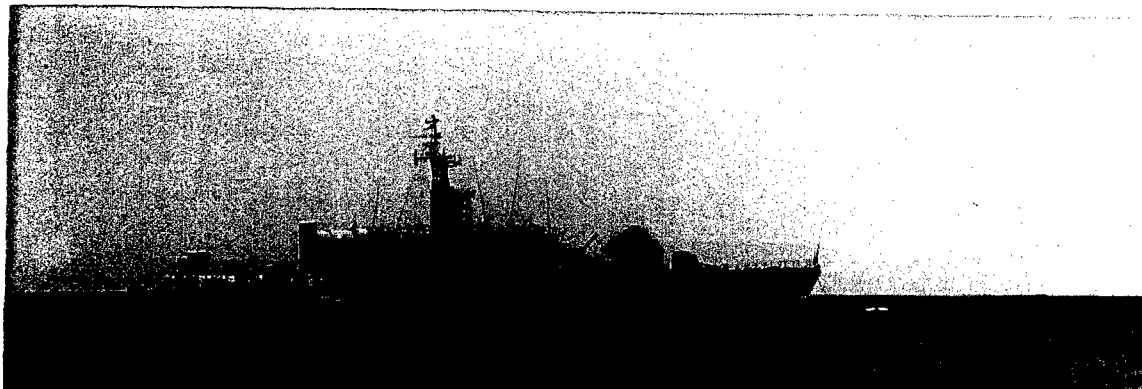
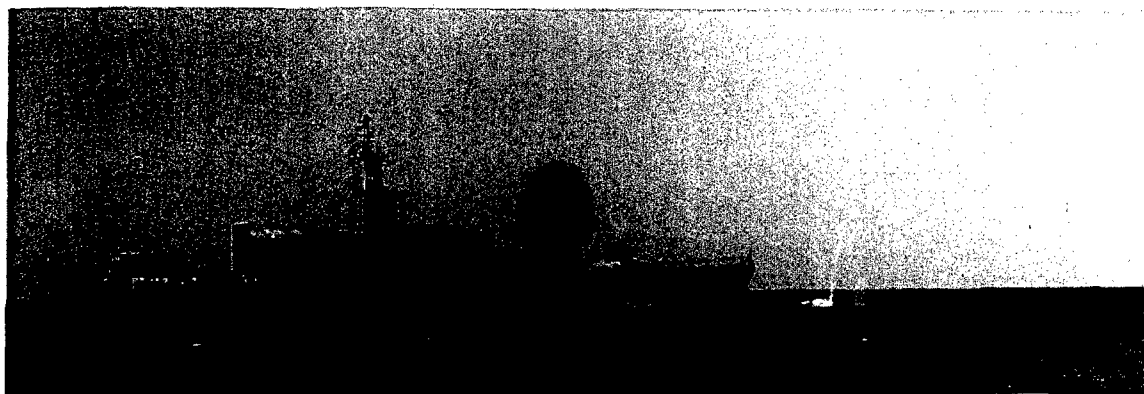
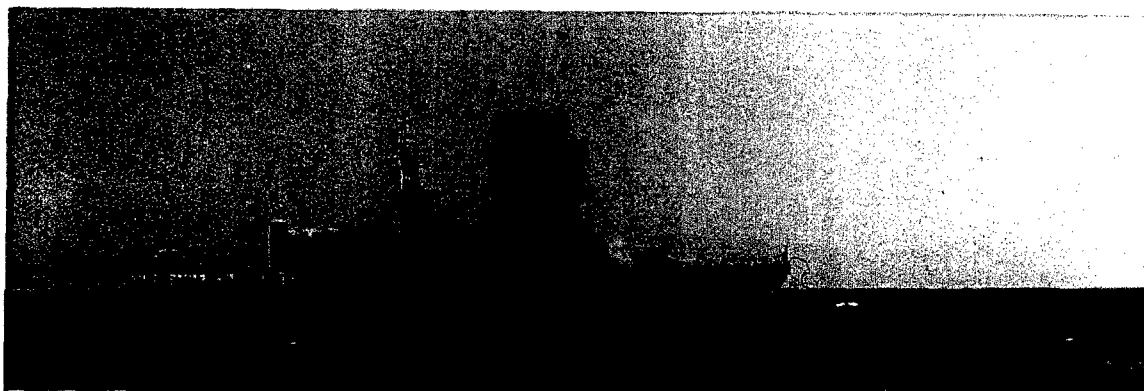
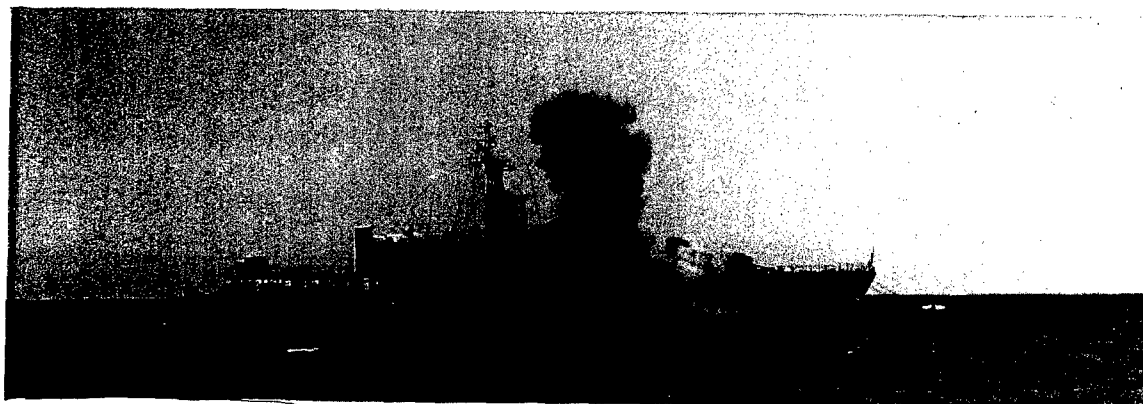
Fig. 7 - Martest 203 blast sequence

A series of photographs capturing the blast sequence for Test 1 is shown in Figure 7. The charge did not pass directly through the ship as anticipated. Instead the shaped charge entered the ship through the 1.25 cm (0.5 in.) thick hull on the starboard side and continued across the ship striking the aft bulkhead approximately three-quarters of the way across the compartment as shown in Fig. 8. The warhead cut an almost perfect circular opening through the starboard hull as shown in Fig. 9a. The blast fragment pattern was approximately 1.0 m (~ 3 ft) in diameter and consisted of holes and deep pits on the aft bulkhead as shown in Fig. 9b. Other than the area in the blast pattern and the hole through the hull, the compartment was relatively unaffected by the blast.

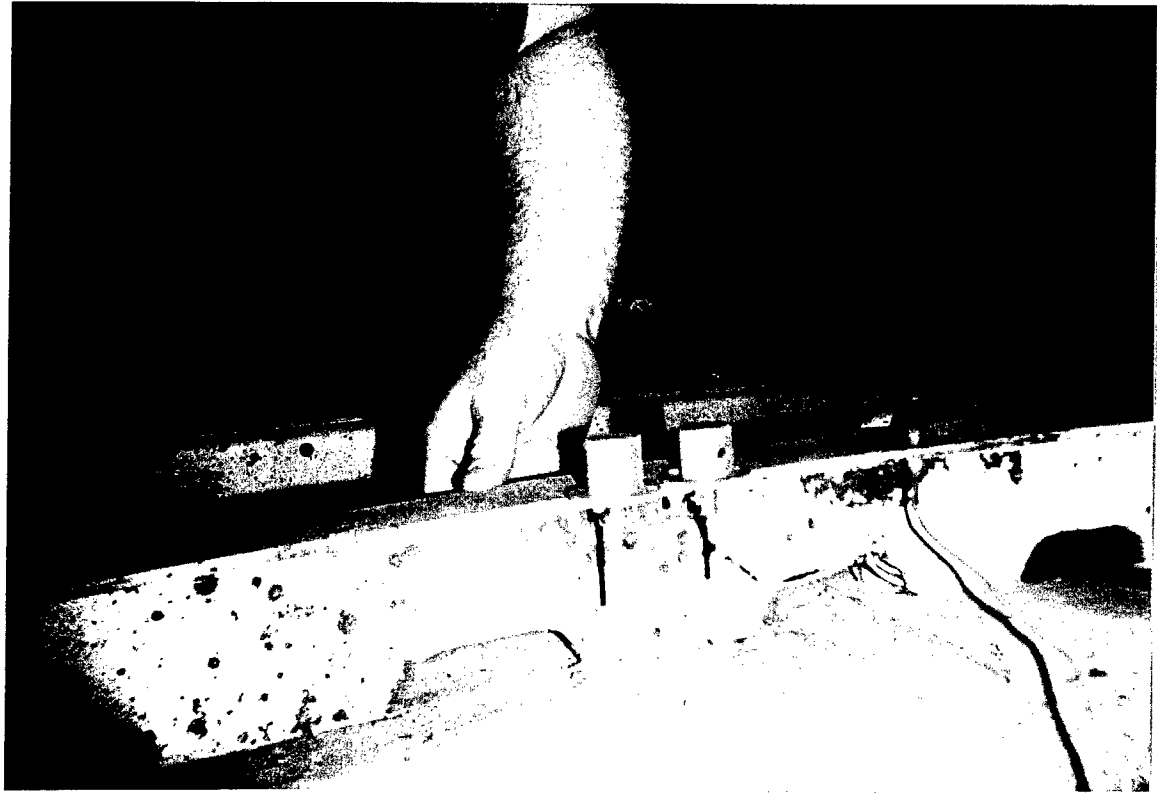
Fig. 9b - Martest 203 fragment illustrations

Although the ignition indicators did not ignite, another possible source of ignition could have been hot fragments resulting from the SCJ. If hot fragments had landed on a Class A material, this too could have caused ignition. However, in this case, the hot fragments did not land on the ignition indicators, but rather impacted the bulkhead on the port side of the compartment.

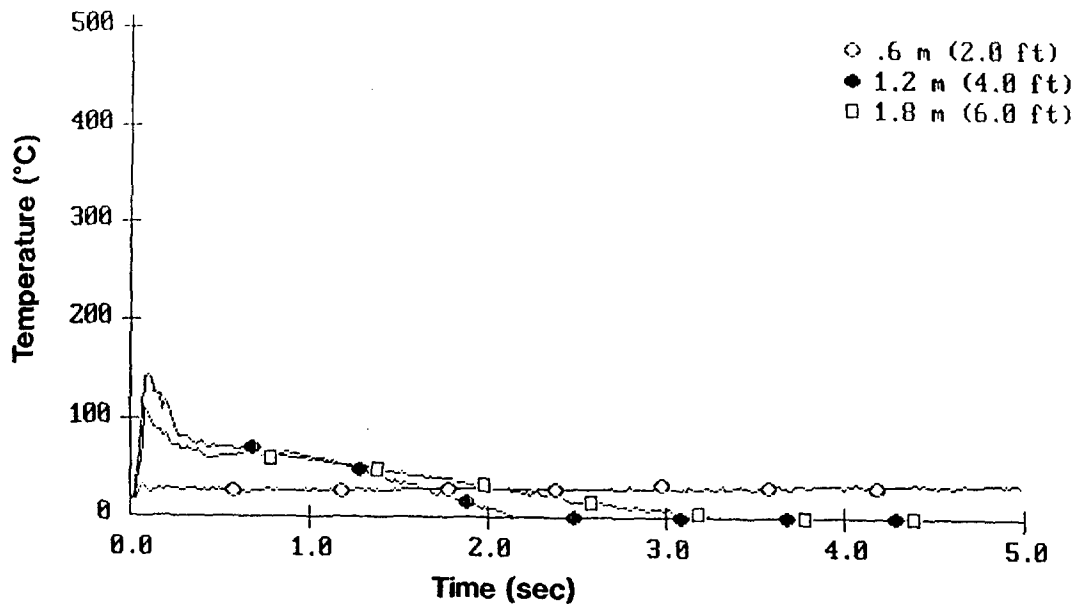
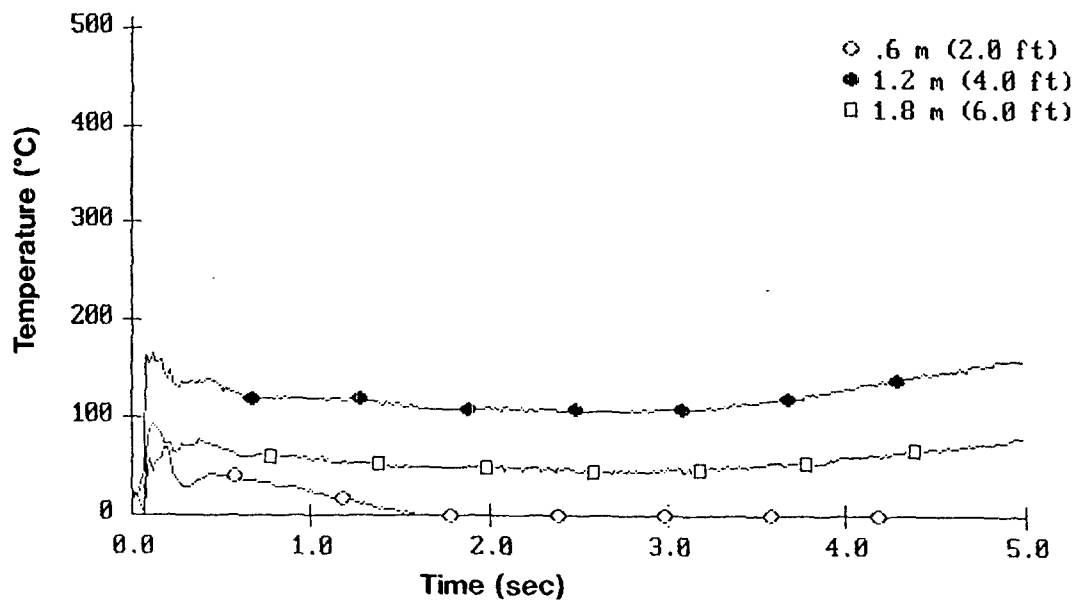
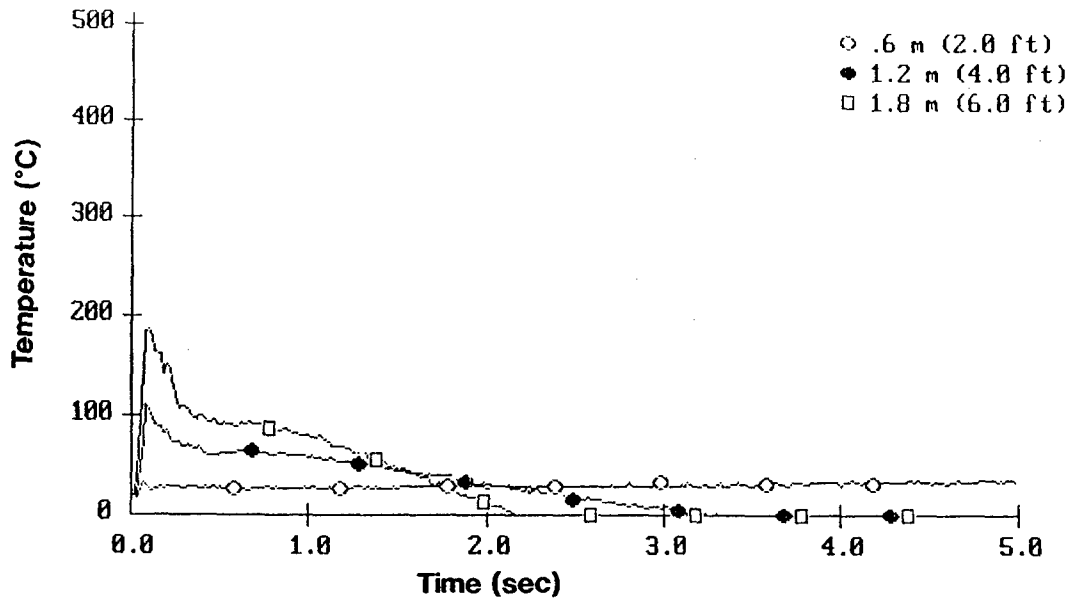
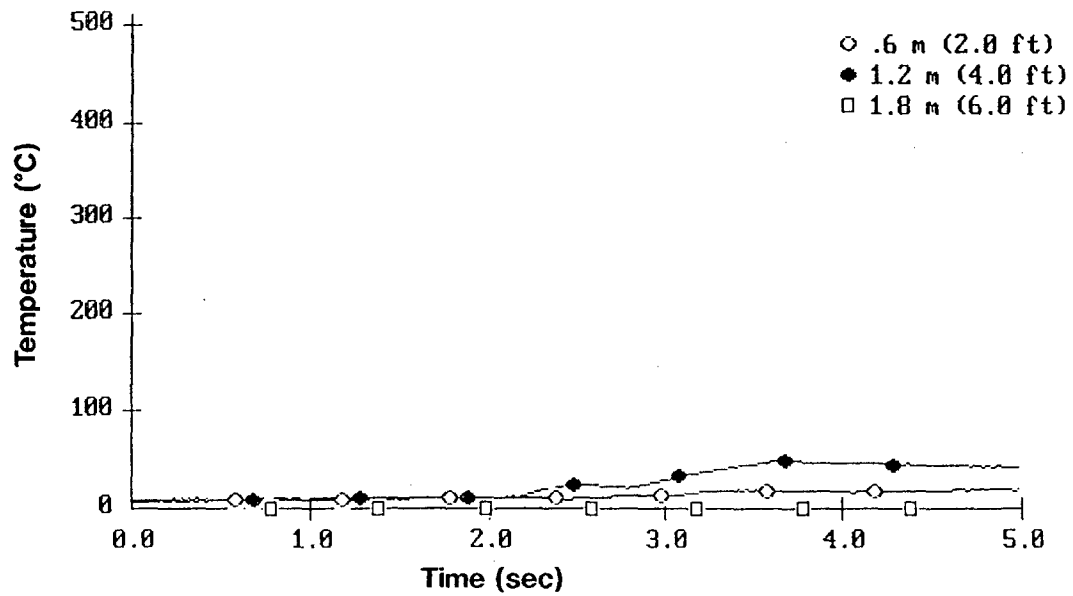
The thermal insult to the compartment resulting from the shaped charge jet was of low intensity and extremely short duration. The temperatures measured along the line of the shot (Figs. 10a - 10d) were found to increase rapidly, reaching a peak value of up to 190°C, depending on the height, and then rapidly decay, i.e., within two seconds the temperatures were back to baseline, i.e., 30°C. The center thermocouple tree (tree #3 - Figure 10b) was hit with blast fragments during this test resulting in a longer period of time for the thermocouples to return to ambient temperatures. The highest temperature recorded on each tree was measured at the approximate height of the shot (1.2 m (4 ft)). The overall thermal pulse was found to be higher on the port side of the ship than on the starboard side (where the jet originated). This may be attributed to two factors: (1) the convective heat transfer may have been greater on the port side due to the spreading of the blast pattern with increased distance from the charge; and (2) when the fragments (molten metal) struck the port bulkhead, small amounts of materials (paint, etc.) may have briefly ignited. On the other hand, the temperature rise in the area remote from the blast (Tree 4) was negligible.

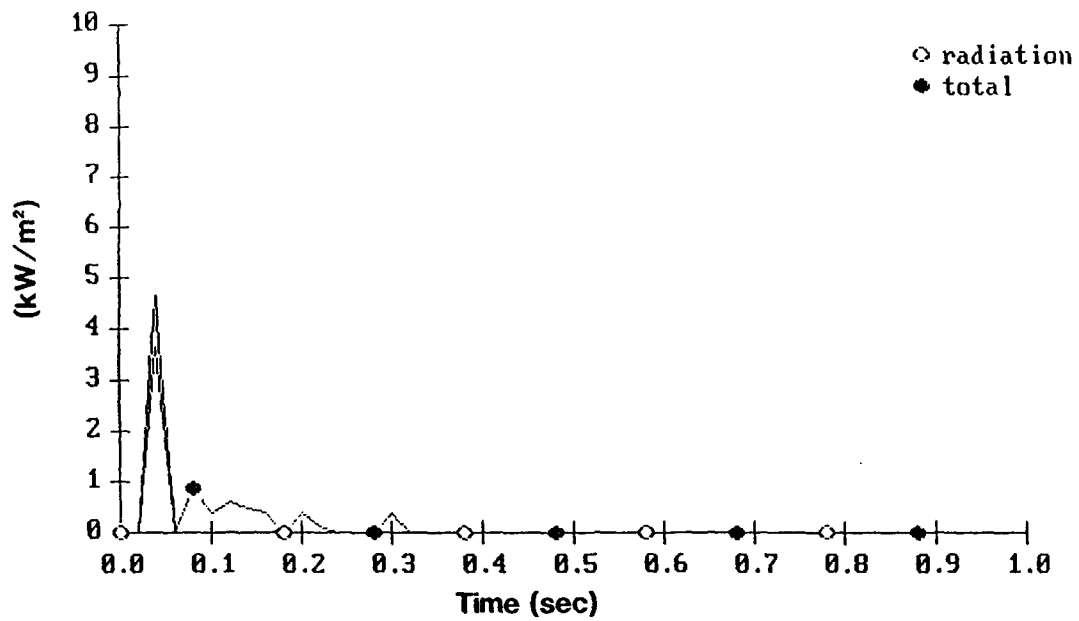
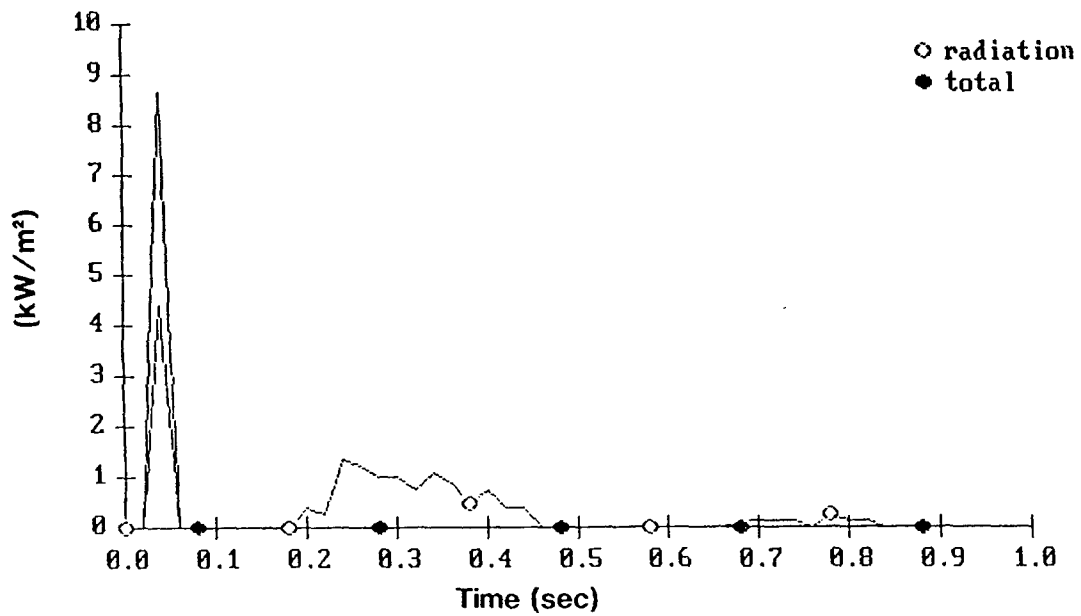
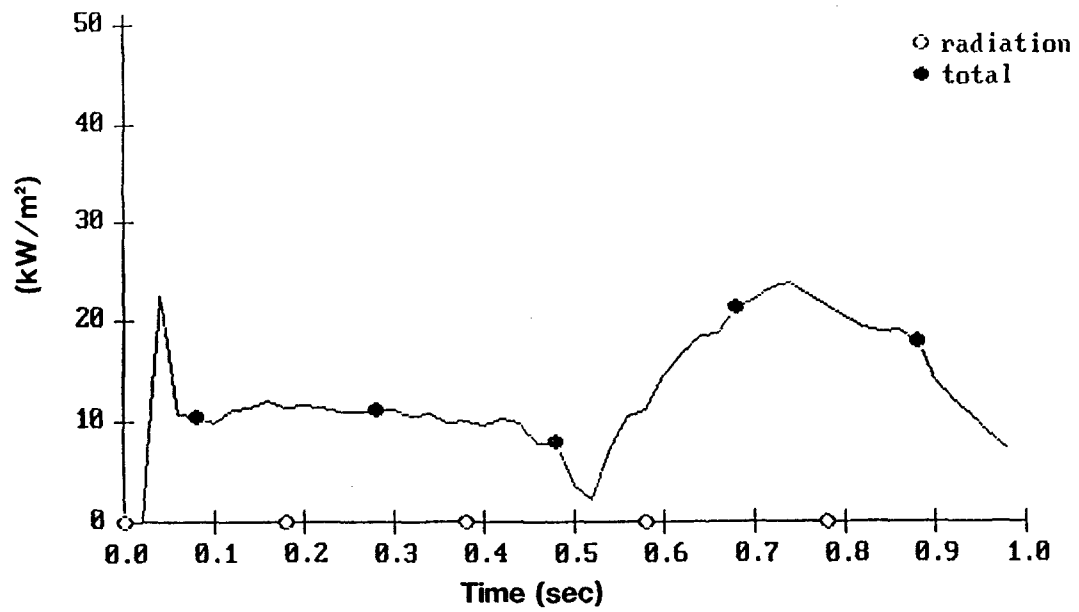
The radiant and total heat flux measurements also followed the same trend with the fluxes increasing with increased distance from the blast (Figs. 11a-c). The peak values were reached in less than 50 ms. In this case, this higher exposure on the port side may not only be attributable to the spreading of the pattern or localized ignition but may also be a function of the distance between the radiometers and the plasma jet. The jet struck the aft bulkhead near the port side of

the ship shortening the distance between the jet and the radiometers at this location. The maximum total heat flux was recorded as 22.5 kW/m² (2.0 Btu/ft² sec). The maximum radiant flux was measured as 4.5 kW/m² (0.4 Btu/ft² sec). For comparison, it was shown in separate test that a total exposure on the order of 150 kW/m² sec is required to ignite paper [7]. When considering the thermal/radiant exposure produced by the charge only lasts 0.1 seconds, a heat flux of 1500 kW/m² would be required to cause ignition, far in excess of the peak value of 22.5 kW/m² recorded in this run.

The radiant and total heat flux measurements were also dramatically higher for the second test (compare Figs. 11a-c and 19a-c). The maximum exposures were measured on the starboard side of the ship with both the radiation and total heat flux levels reaching values over 60 kW/m^2 (Fig. 19a). This increase was well over an order of magnitude greater than those measured during the first test. The exposures in the center of the compartment were also observed to increase a factor or two from the first test (averaged from 6.5 kW/m^2 to 12.5 kW/m^2) (see Fig. 19b). Although the heat fluxes recorded in Martest 204 were higher than in Martest 203 and of longer

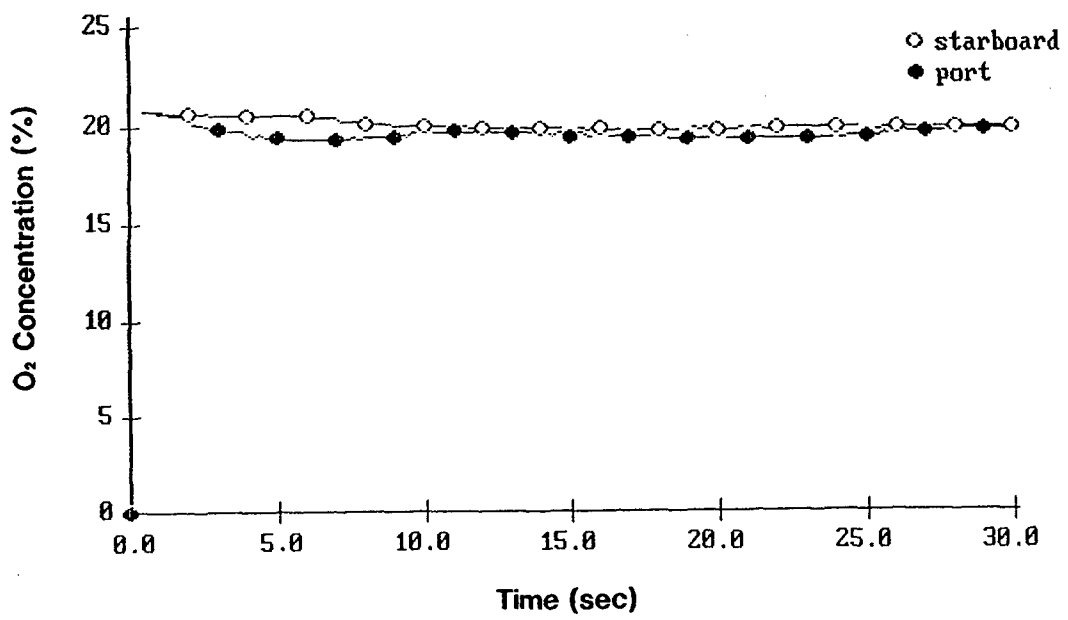
Fig. 12 - Fire compartment oxygen concentrations Test #1

The oxygen concentrations during this test (Fig. 12) remained fairly constant at about 20 percent although there was a slight momentary drop to 19 percent on the port side, suggesting some minor burning in this area. At any rate, the oxygen concentration in the compartment was high enough throughout the test to support combustion if any Class A material had been ignited.

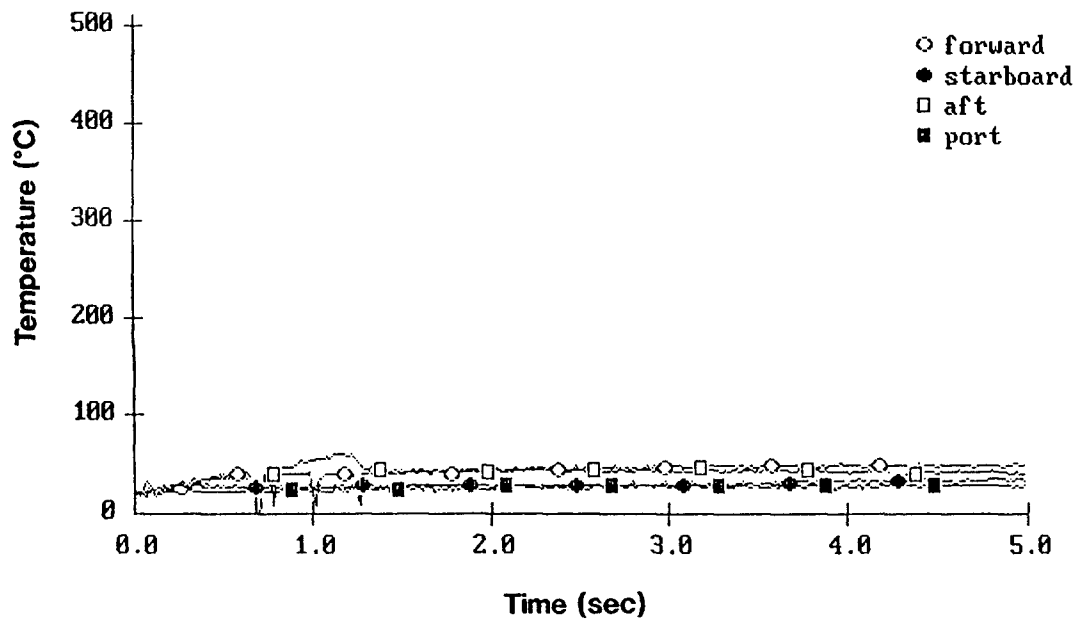
Fig. 13 - Ignition indicator temperatures (all) Test #1

The low intensity short duration thermal pulse had no effect on the four ignition indicators as shown in Fig. 13. The thermocouples positioned in/above the materials recorded temperature increases of less than 30°C. For comparison, the accepted spontaneous ignition surface temperature of Class A materials is 400-500°C [4], almost three times that recorded anywhere in the compartment.

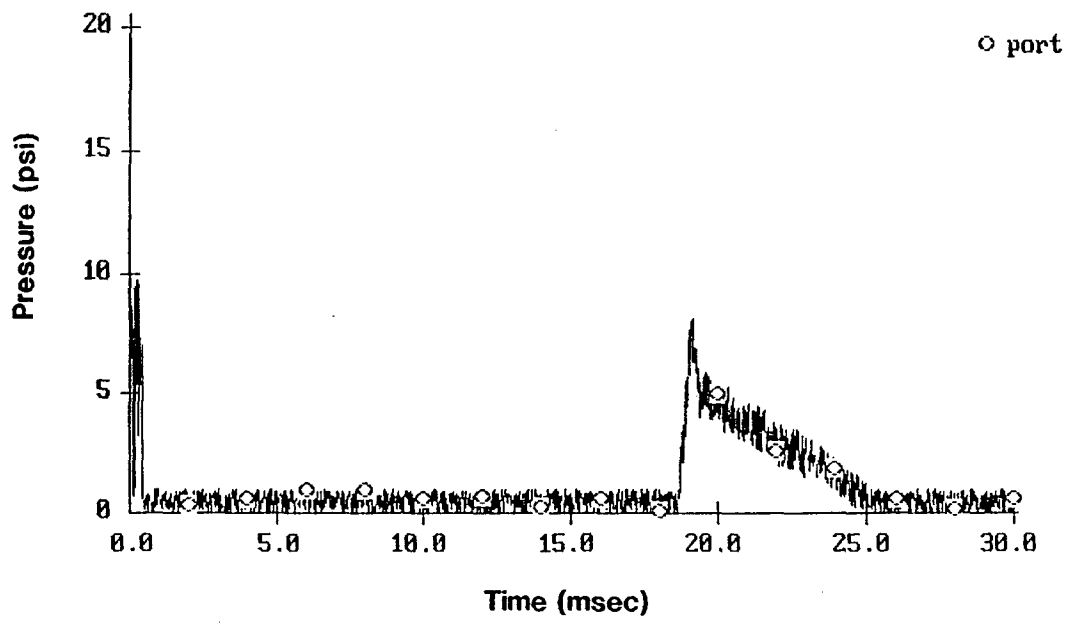
Fig. 14 - Fire compartment pressures in Martest 203

Although two pressure transducers were also installed for this test, the transducer on the starboard side of the ship was damaged by the blast, and hence, no readings were obtained at this point. However, the port pressure transducer worked properly and recorded a peak pressure of 51.7 kPa (7.5 psi) 19 ms after the blast (Fig. 14). The duration of the pressure wave was measured to be 5 milliseconds (ms). This relatively high pressure, but short duration pulse

inflicted no visible damage on the compartment. (The initial pressure spike at < 1.0 ms was attributed to the detonation of the warhead.)

The combustion of the liquid fuel had very little effect on the shape of the pressure curve. A comparison of the pressure readings for Martests 203 and 204 (Figs. 14 and 22) shows that the peak pressures were approximately the same in both tests (8 psi in Martest 203 and 7 psi in Martest 204), but the pressure was drawn out for an additional 5 ms in Martest 204. The shape of the pressure pulse indicates an initial spike in pressure due to the hull penetration and then a sustained pressure as the fuel/air cloud ignited. The only explanation for the similarity in magnitude between the two tests was the presence of the opening produced during the first test which may have served to vent a portion of the pressure pulse in the second test.

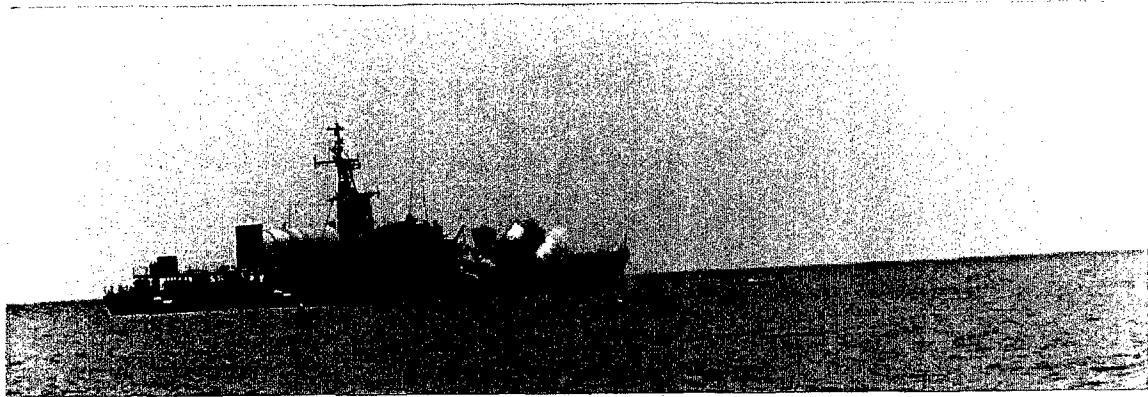
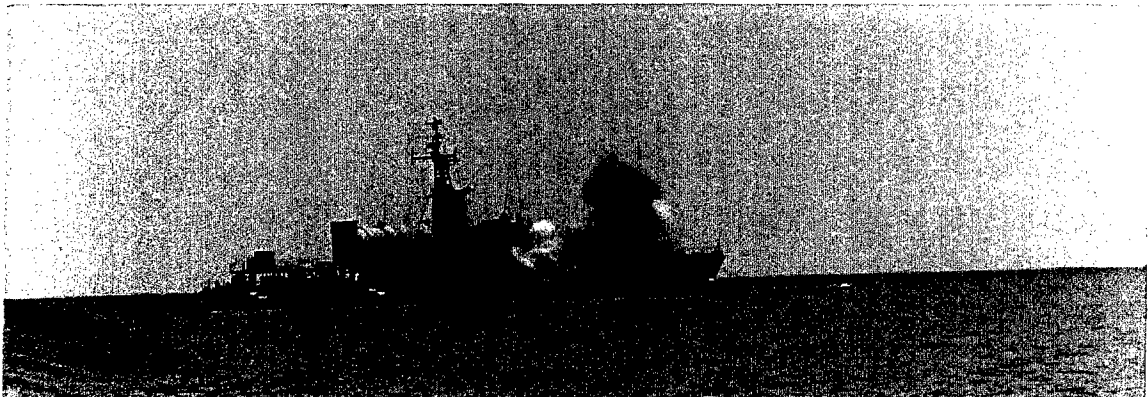
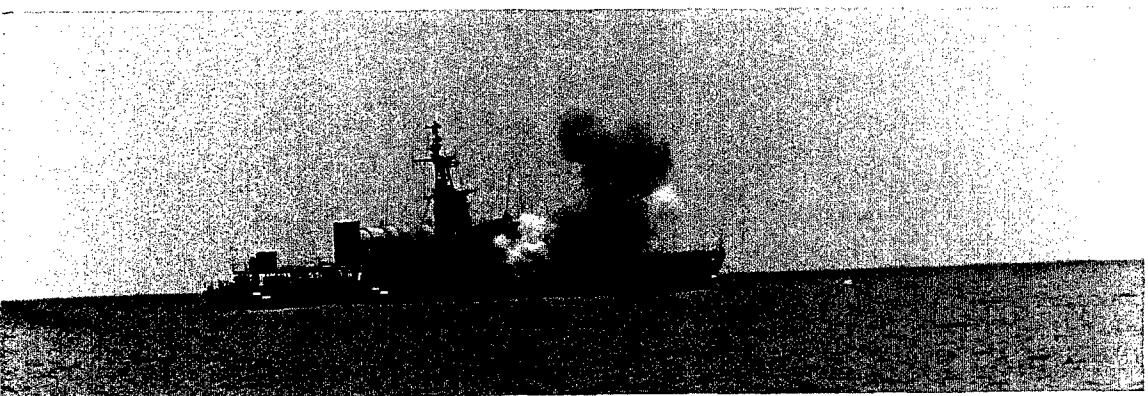
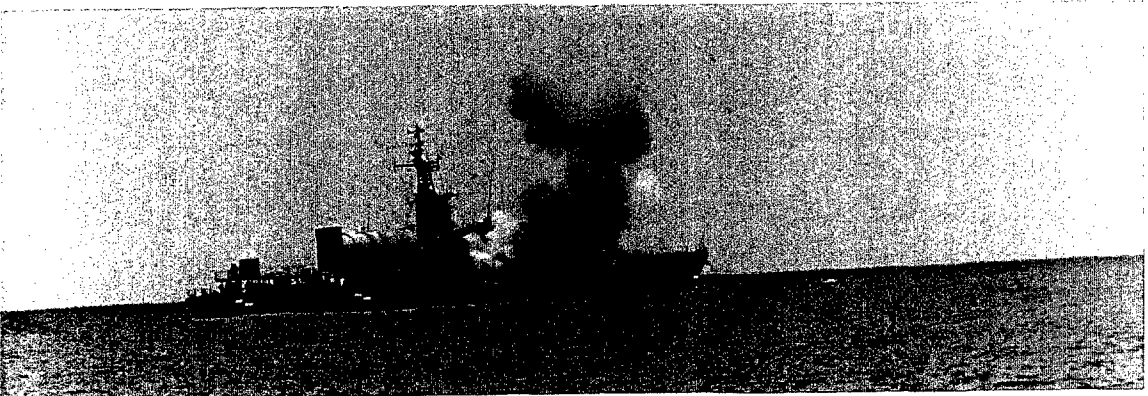
Fig. 15 - Martest 204 blast sequence

A series of photographs capturing the blast sequence in Martest 204 is shown in Fig. 15. The jet did not cut cleanly through the hull as in Martest 203, but rather left two semicircular openings which served to deflect the jet towards the overhead and towards the deck (Fig. 16a). The same types of openings (Figs. 17a and 17b) were observed in the China Lake tests [2], namely a clean hole when no fuel tank was used (Fig. 17a) and a partially cut hole when the fuel tank was placed in front of the SSCJ warhead. In Martest 204, it appeared that the majority of the diesel fuel carried by the blast was entrained through the upper opening, producing an inefficient fuel/air explosion at this location. This is evident by the residue/char pattern observed on the overhead at this location (Fig. 16a). A portion of the jet did, however, pass through the entire ship exiting the port bulkhead. The presence of the fuel tank significantly altered the conditions in the compartment.

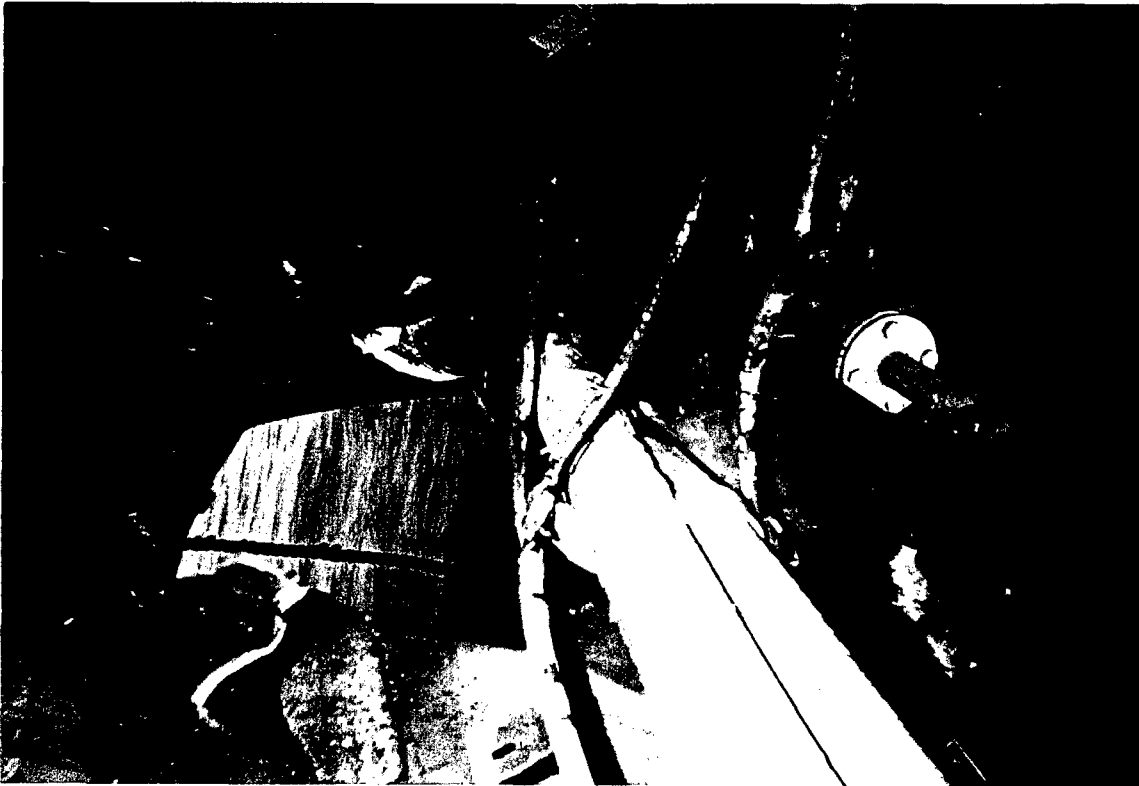
**Fig. 16a - Martest 204 blast and fragment illustrations
(cable that deflected the jet)**

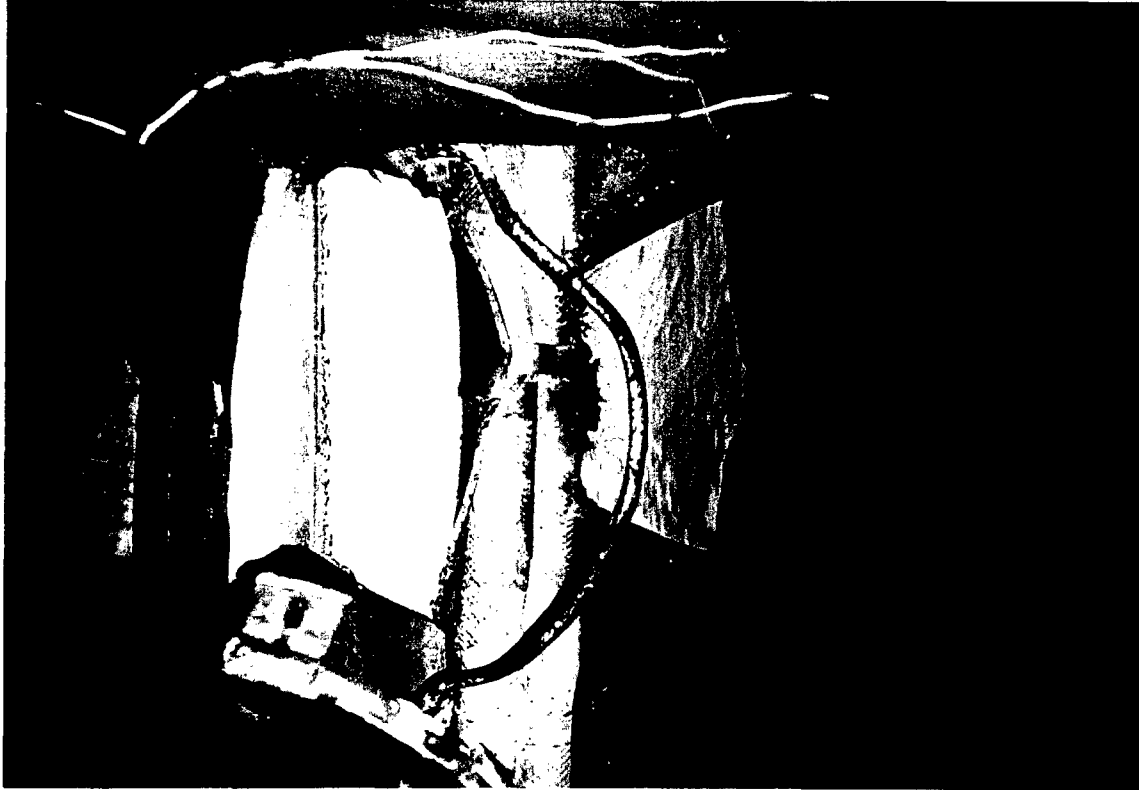
**Fig. 16b - Martest 204 blast and fragment illustrations
(char pattern on overhead)**

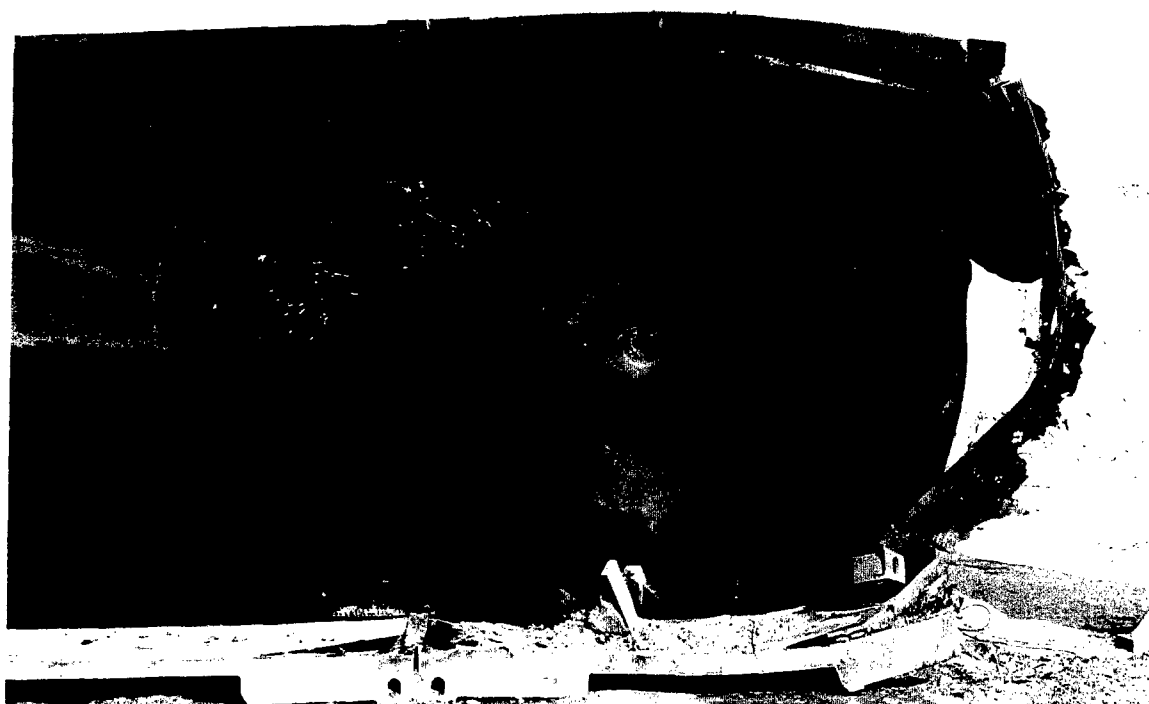
Fig. 17b - Partially cut hole obtained when fuel tank was placed in front of SCJ [2]
