NRL/MR/6180--99-8423

Thermal Insult Produced by the Residual Liquid Fuel in a Missile Hit Scenario

December 23, 1999

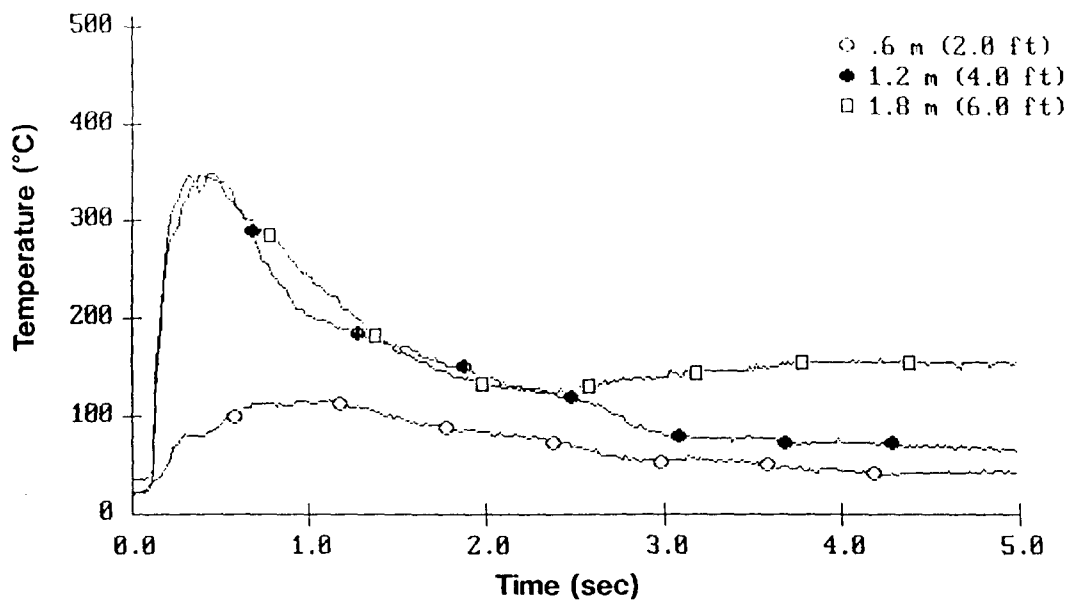
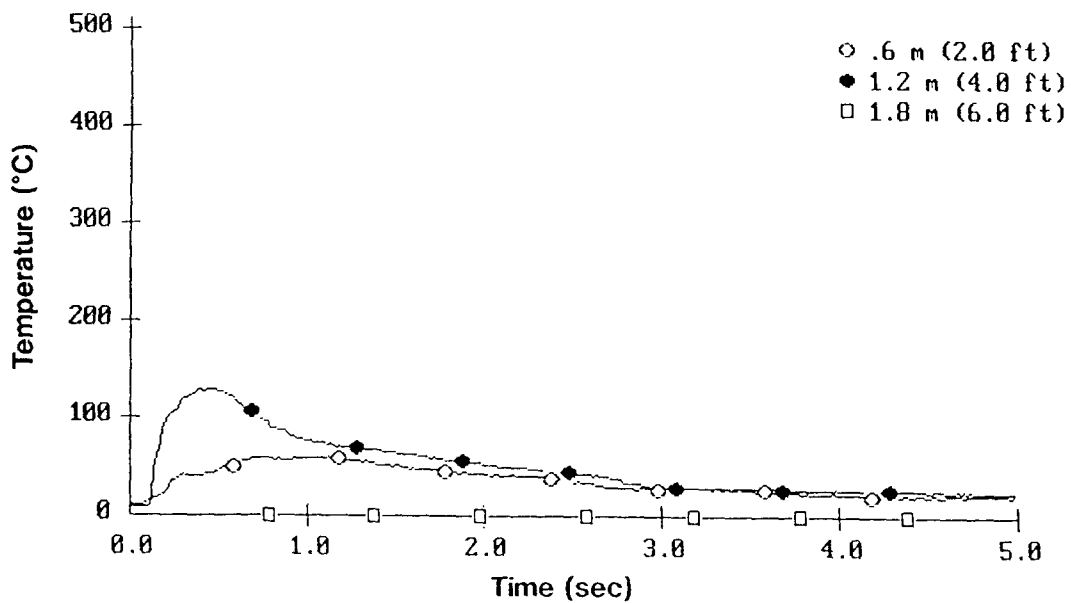
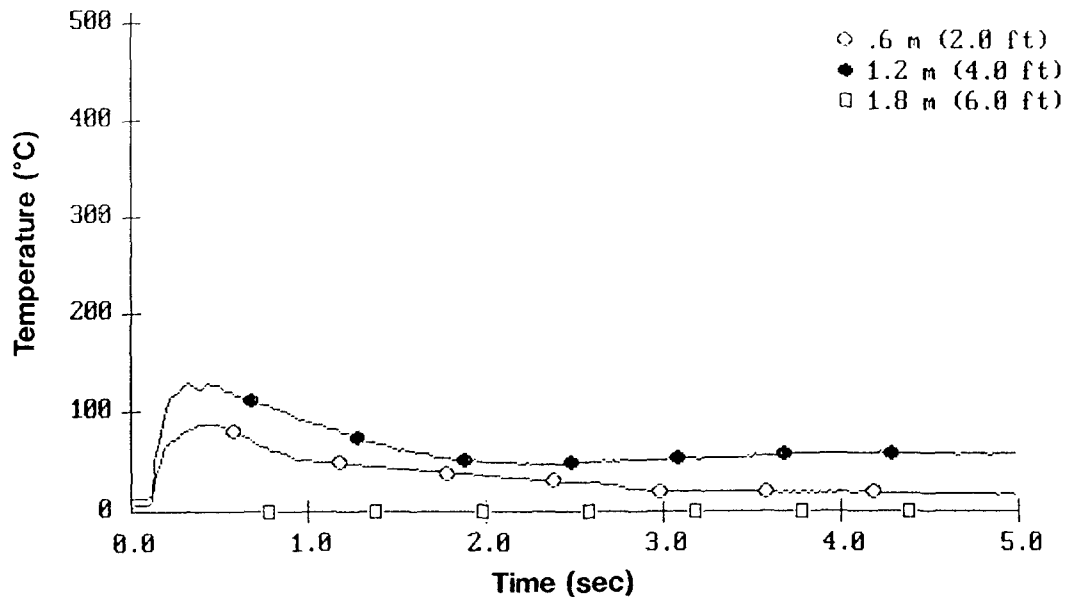
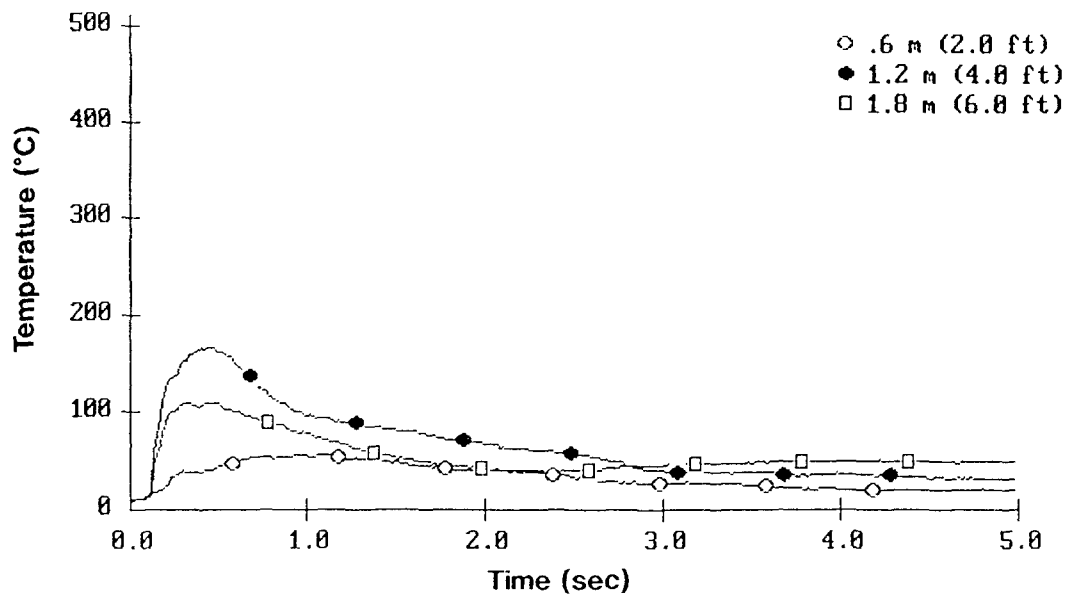
The temperature profiles obtained for the second test (Martest 204) are shown in Fig. 18a-d. The most severe thermal conditions occurred on the starboard side of the ship rather than on the port as in the previous test (compare Figs. 18a and 10a). This was attributed to the inefficient fuel/air explosion. The temperatures measured during this test reached 350°C on the starboard side decreasing across the compartment to 125°C on the port side. The duration of the pulse was also lengthened from less than a half-second to over a second by the combustion of the fuel as shown in Fig. 18a-d.

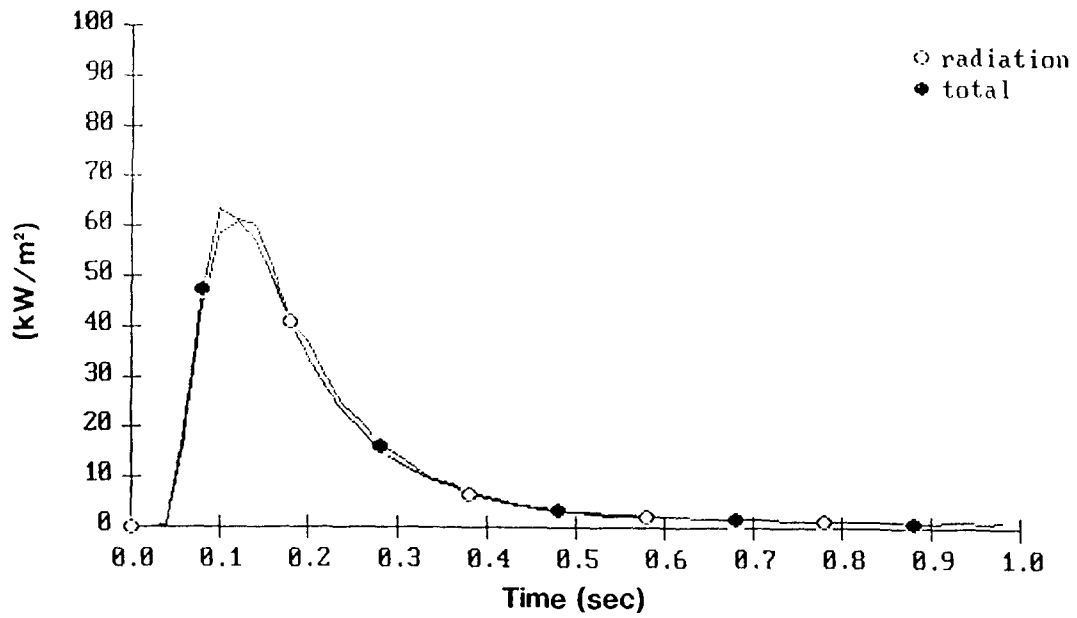
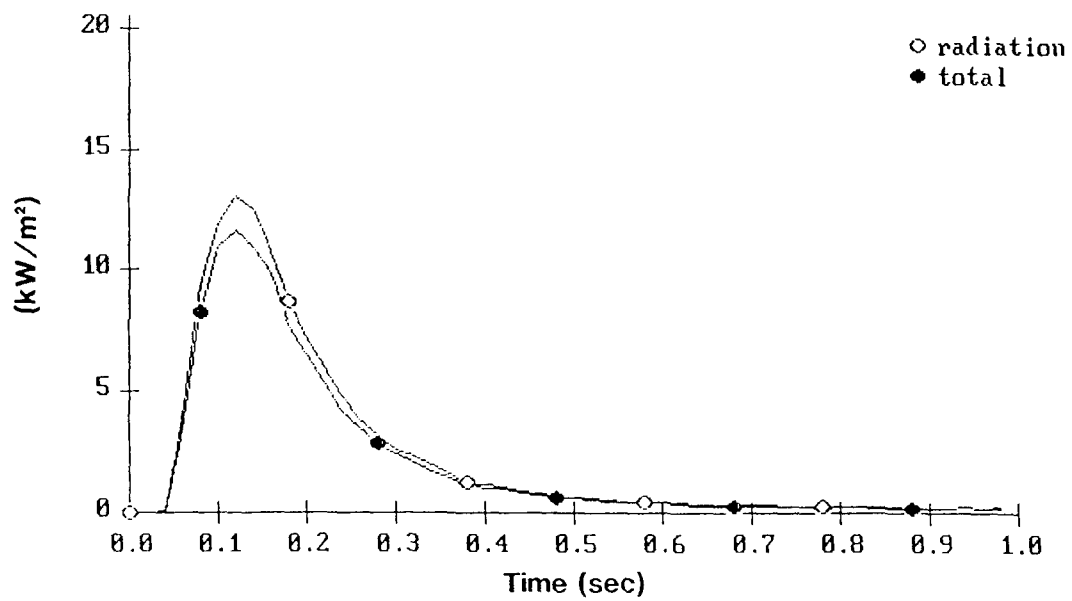
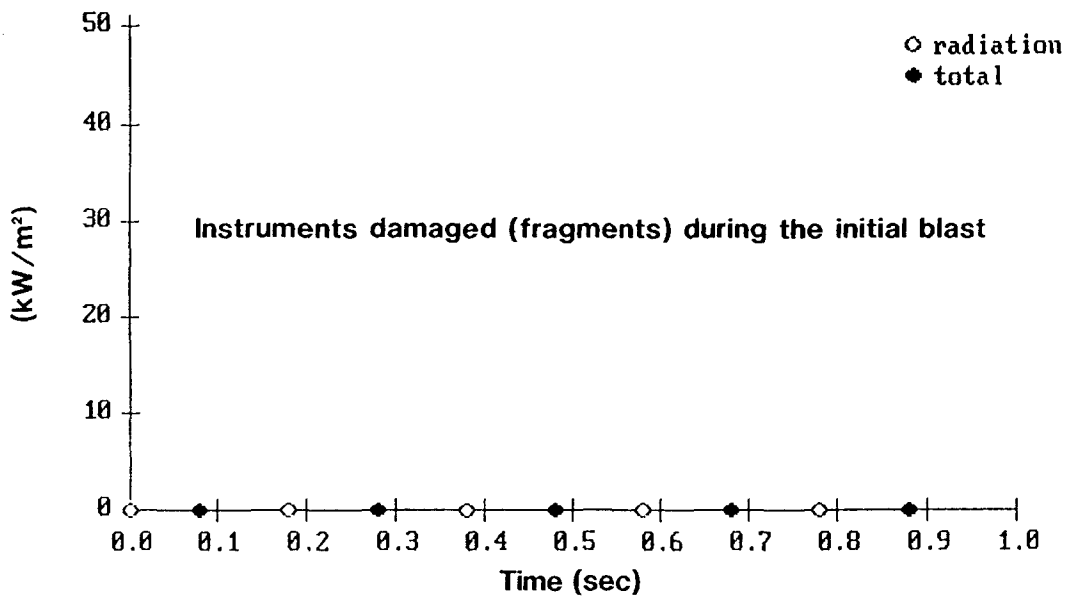
The radiant and total heat flux measurements were also dramatically higher for the second test (compare Figs. 11a-c and 19a-c). The maximum exposures were measured on the starboard side of the ship with both the radiation and total heat flux levels reaching values over 60 kW/m^2 (Fig. 19a). This increase was well over an order of magnitude greater than those measured during the first test. The exposures in the center of the compartment were also observed to increase a factor or two from the first test (averaged from 6.5 kW/m^2 to 12.5 kW/m^2) (see Fig. 19b). Although the heat fluxes recorded in Martest 204 were higher than in Martest 203 and of longer

duration, they were still below the threshold required for ignition of Class A materials. For example, the peak value of 60 kW/m² in Fig. 19 would have to be sustained for 2.5 seconds in order to cause ignition compared with only 0.05 seconds in Fig. 19a.

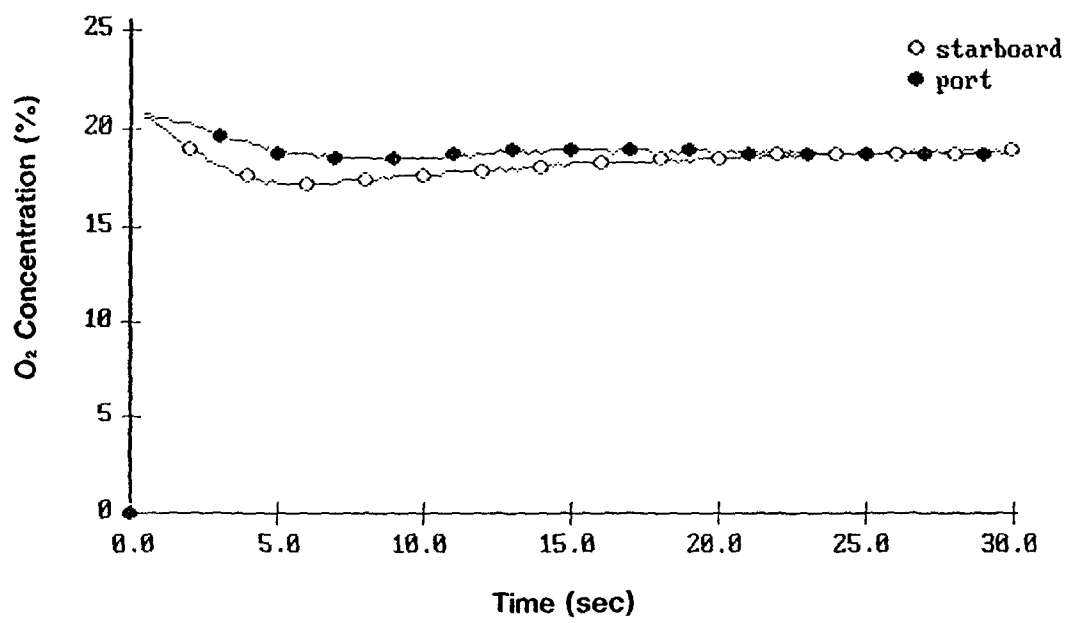
Fig. 20 - Fire compartment oxygen concentrations Test #2

The oxygen concentrations were measured to be lower on the starboard side of the compartment than on the port (Fig. 20). The starboard oxygen concentration was observed to drop to 17% as compared to 18.5% on the port side of the ship. The localized oxygen depletion was the result of liquid fuel burning inside the ship. Although these concentrations were lower than those of the previous test, there was still enough oxygen remaining in the compartment to support ignition and combustion of Class A materials.

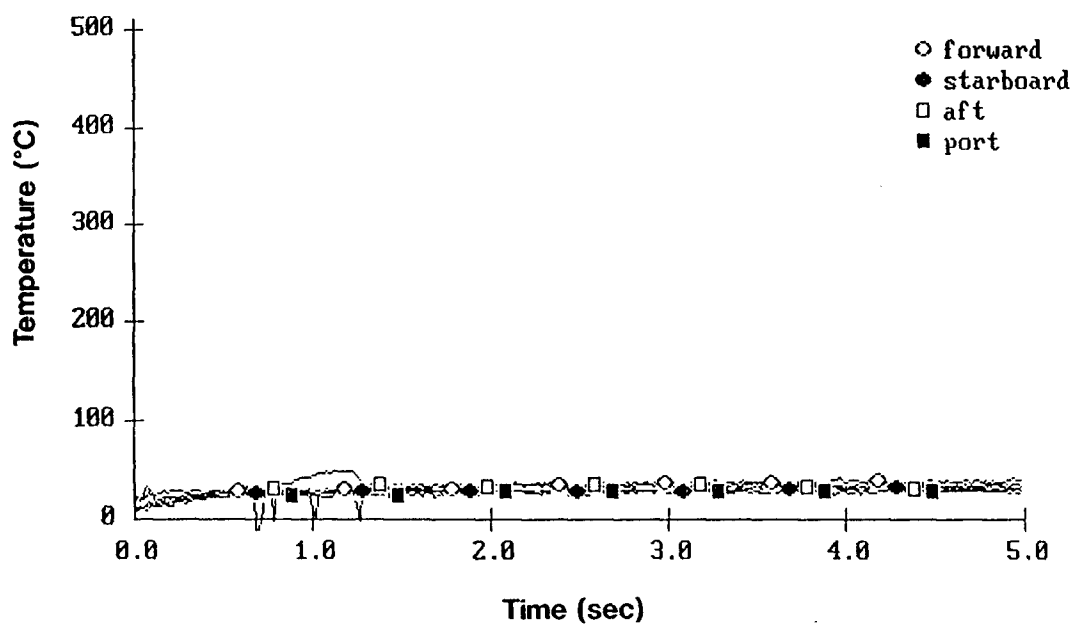
Fig. 21 - Ignition indicator temperatures (all) Test #2

Although the intensity of the thermal pulse recorded in the second test (Martest 204) was substantially greater than in the first (Martest 203), the ignition indicators still did not ignite (see Fig. 21). As in the first test, the thermal pulse was of too short a duration to cause ignition of the paper ignition indicators even though there was evidence of combustion of liquid fuel in the compartment.

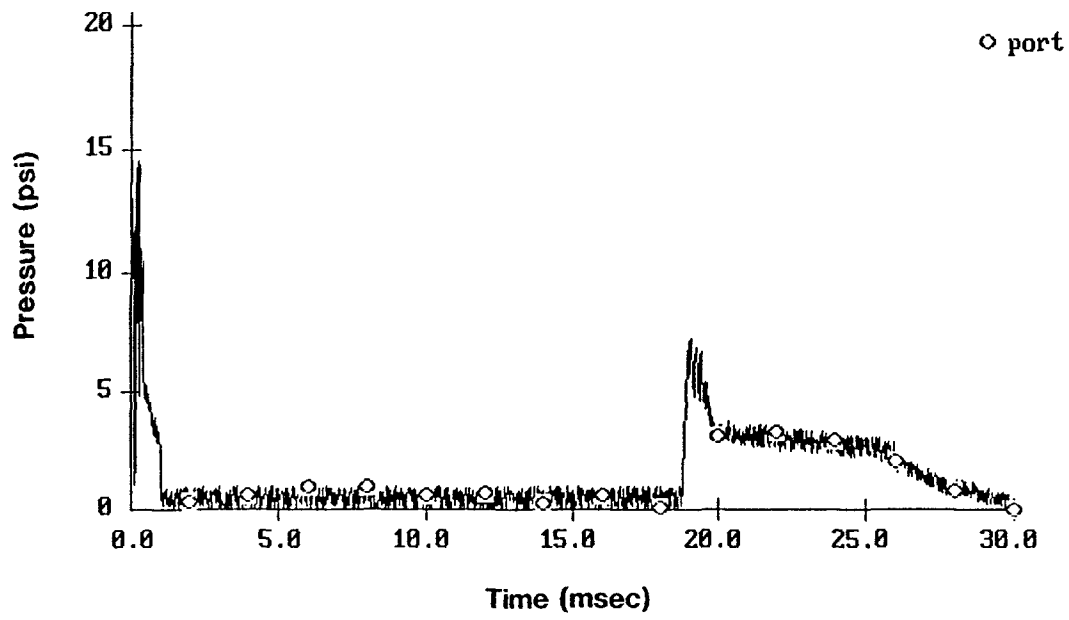
Fig. 22 - Fire compartment pressures in Martest 204

The combustion of the liquid fuel had very little effect on the shape of the pressure curve. A comparison of the pressure readings for Martests 203 and 204 (Figs. 14 and 22) shows that the peak pressures were approximately the same in both tests (8 psi in Martest 203 and 7 psi in Martest 204), but the pressure was drawn out for an additional 5 ms in Martest 204. The shape of the pressure pulse indicates an initial spike in pressure due to the hull penetration and then a sustained pressure as the fuel/air cloud ignited. The only explanation for the similarity in magnitude between the two tests was the presence of the opening produced during the first test which may have served to vent a portion of the pressure pulse in the second test.
