**Fatigue Damage Mechanisms of Advanced
Hybrid Titanium Composite Laminates**

In Partial Fulfillment
of the Requirements for the Degree
Master of Science in Mechanical Engineering

Georgia Institute of Technology
November 1999

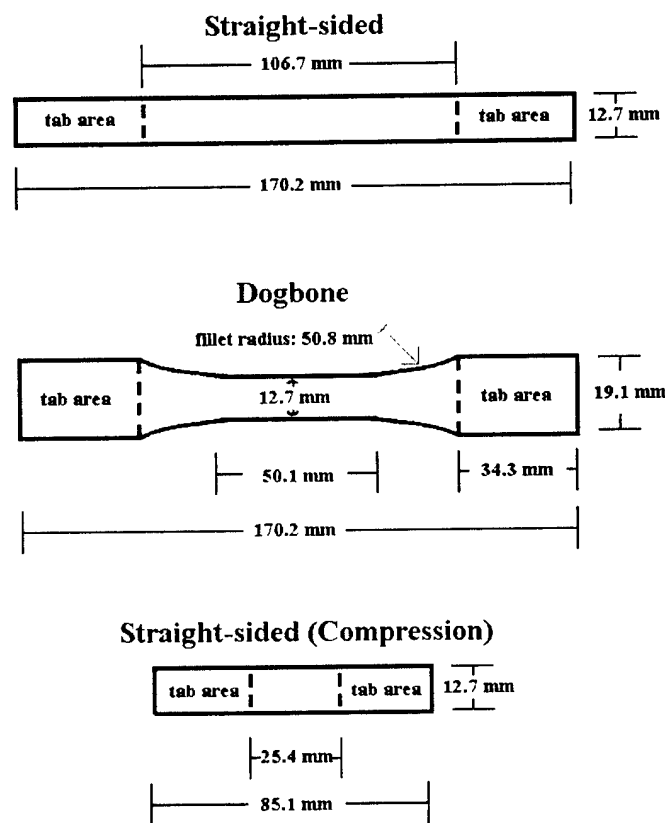
Figure 5.1 Specimen configurations for advanced HTCL mechanical testing

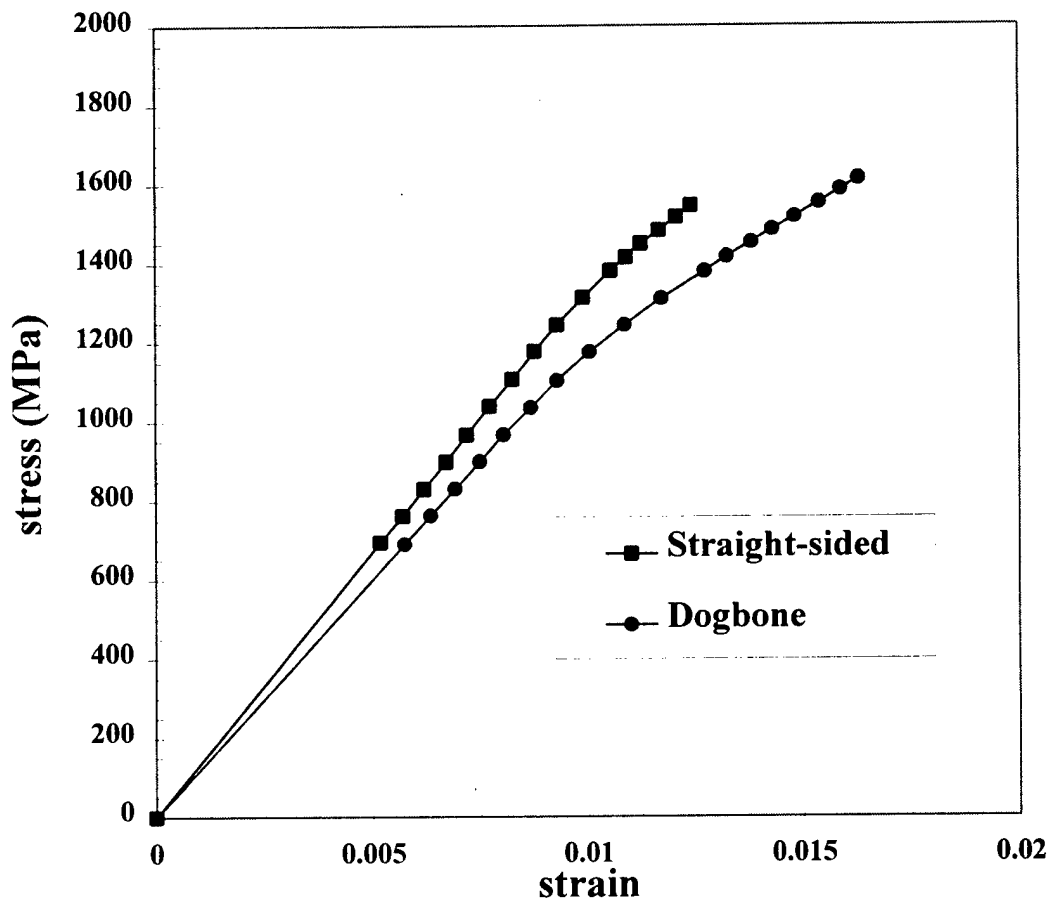
Figure 6.2 Average tensile results for advanced HTCL configuration testing

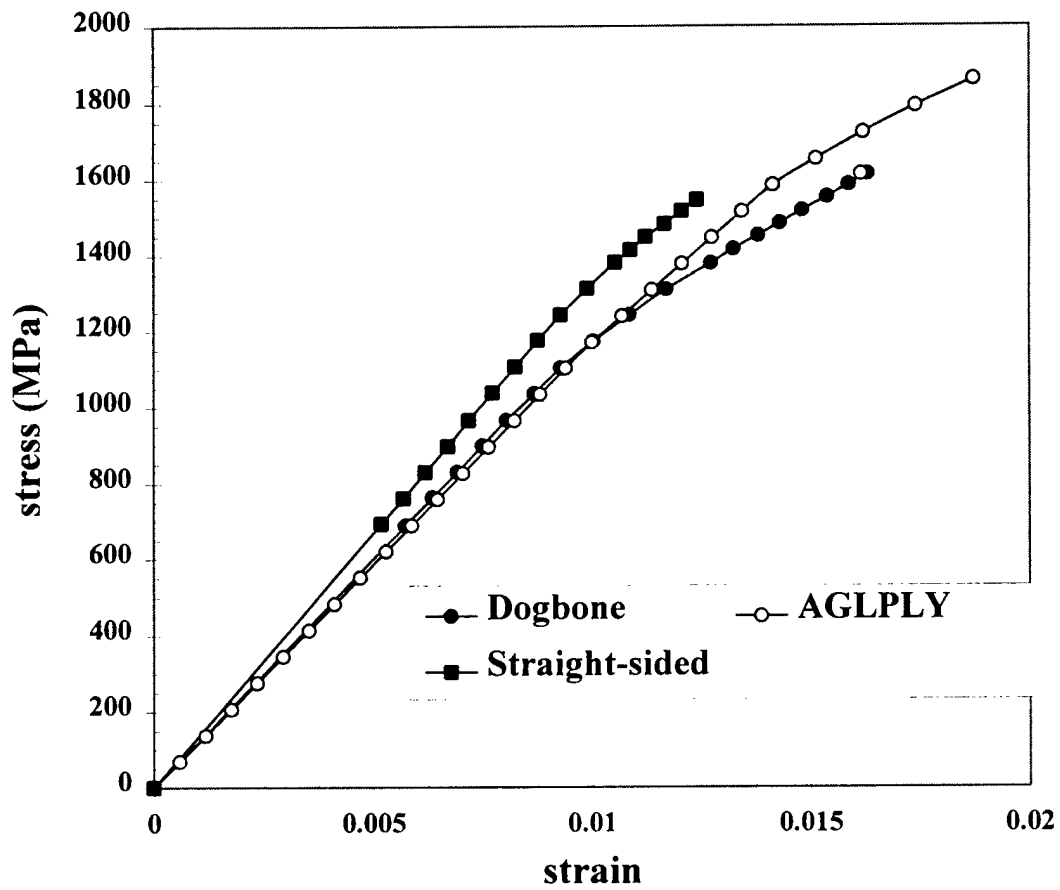
Figure 6.3 Correlation between AGLPLY prediction and both dogbone and straight-sided configuration tensile test results

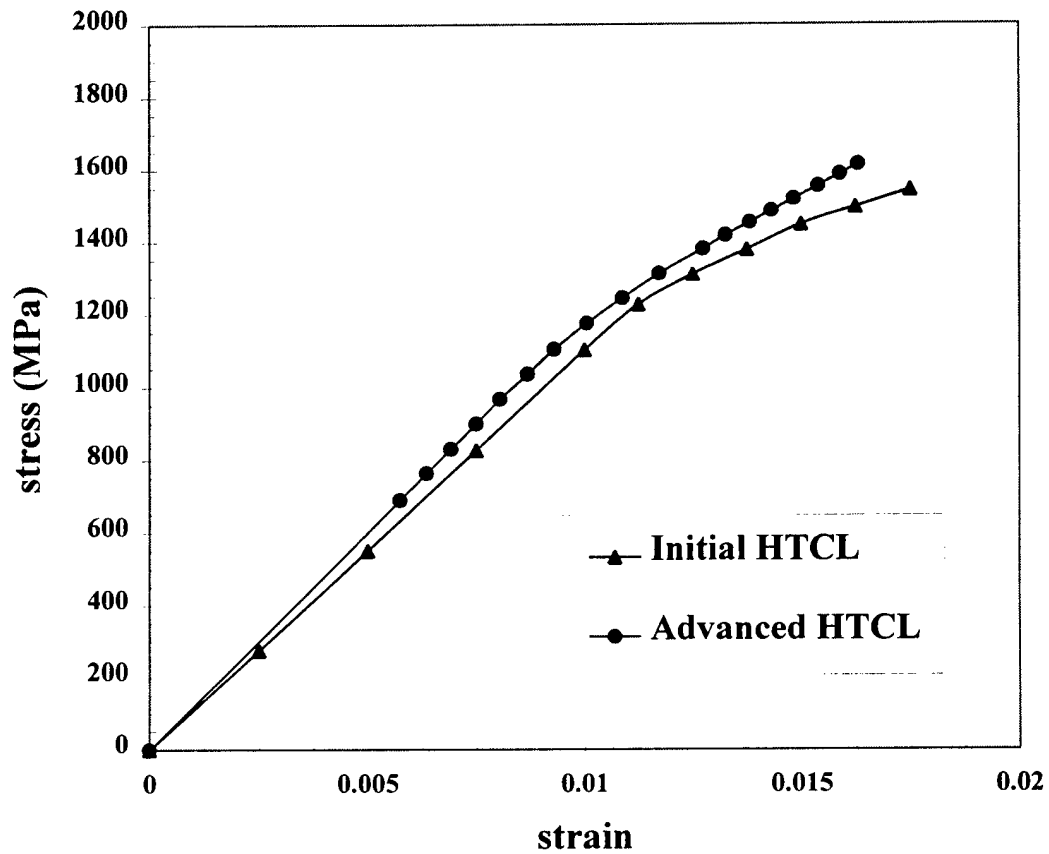
Figure 6.4 Experimental tensile test comparison of advanced HTCL and initial HTCL (Note: The initial HTCL was constructed with 11 mil (.279 mm) thick Ti-15-3 foil, resulting in a V_{PMC} of 0.25 and V_{Ti} of 0.75. The advanced HTCL possesses 10 mil (.254 mm) foil, resulting in a V_{PMC} of 0.28 and V_{Ti} of 0.72.)

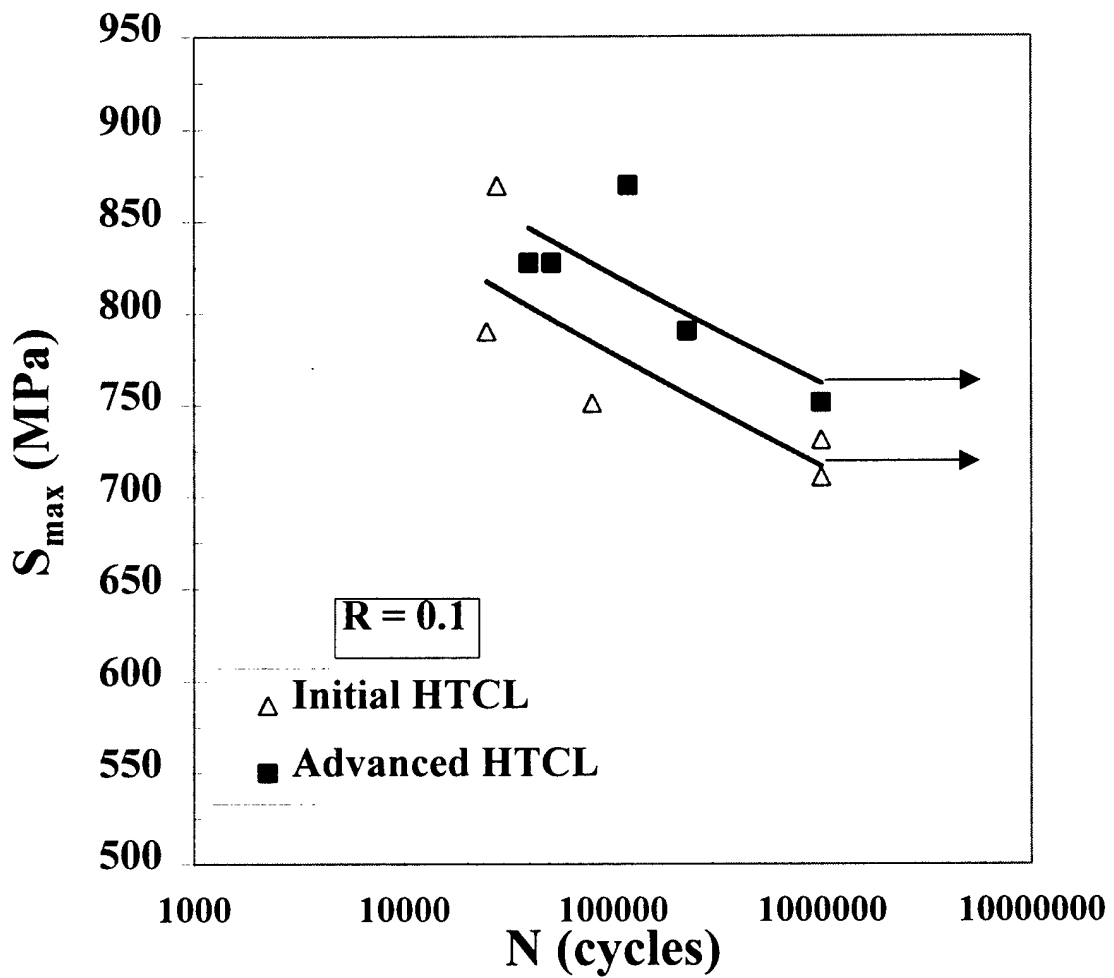
Figure 6.5 S-N curve comparison between fatigue of initial and advanced HTCL in tension-tension fatigue

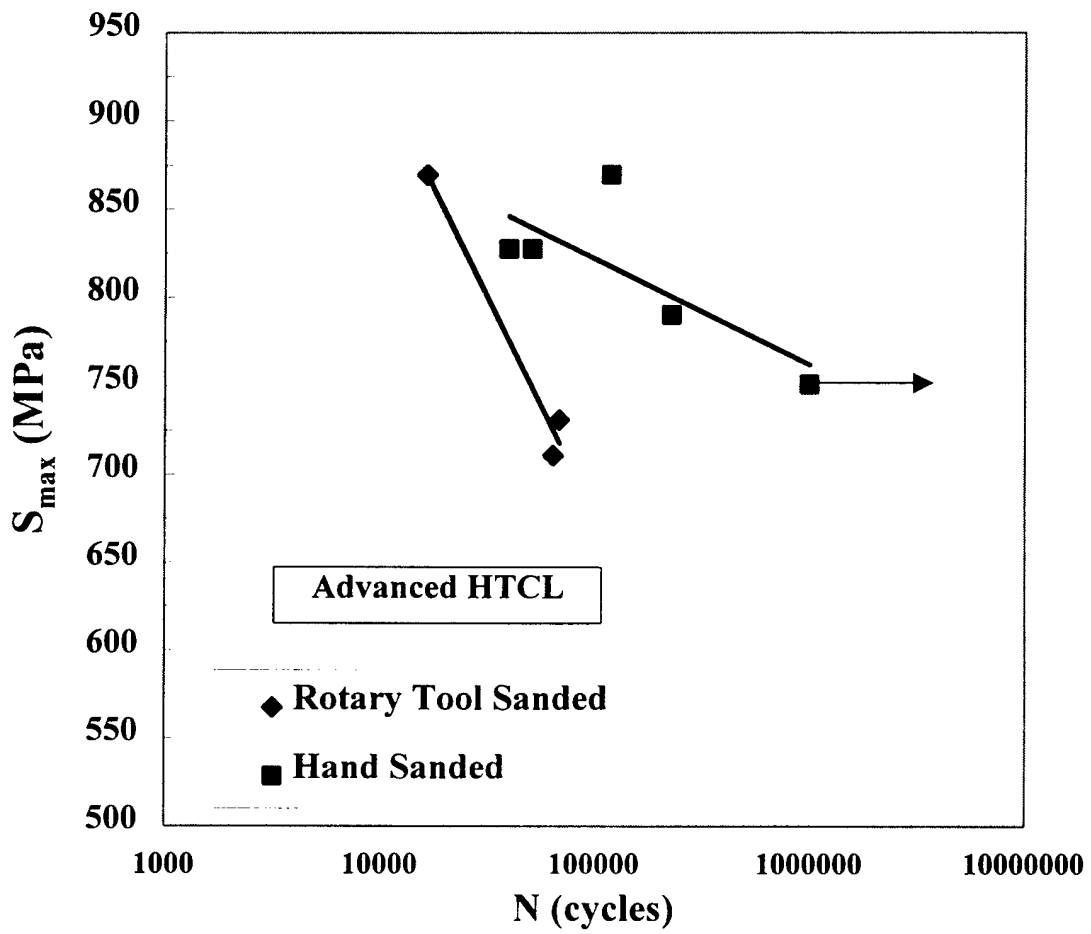
Figure 6.9 S-N curves for advanced HTCL showing effect of oxide removal sanding techniques

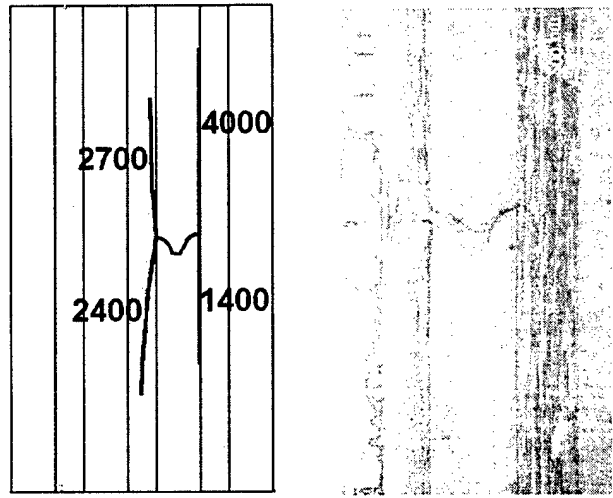
Figure 6.16 Replication and schematic of HTCL front edge showing fatigue crack and damage after 110,000 cycles. ($S_{max} = 869$ MPa, $R = 0.1$)

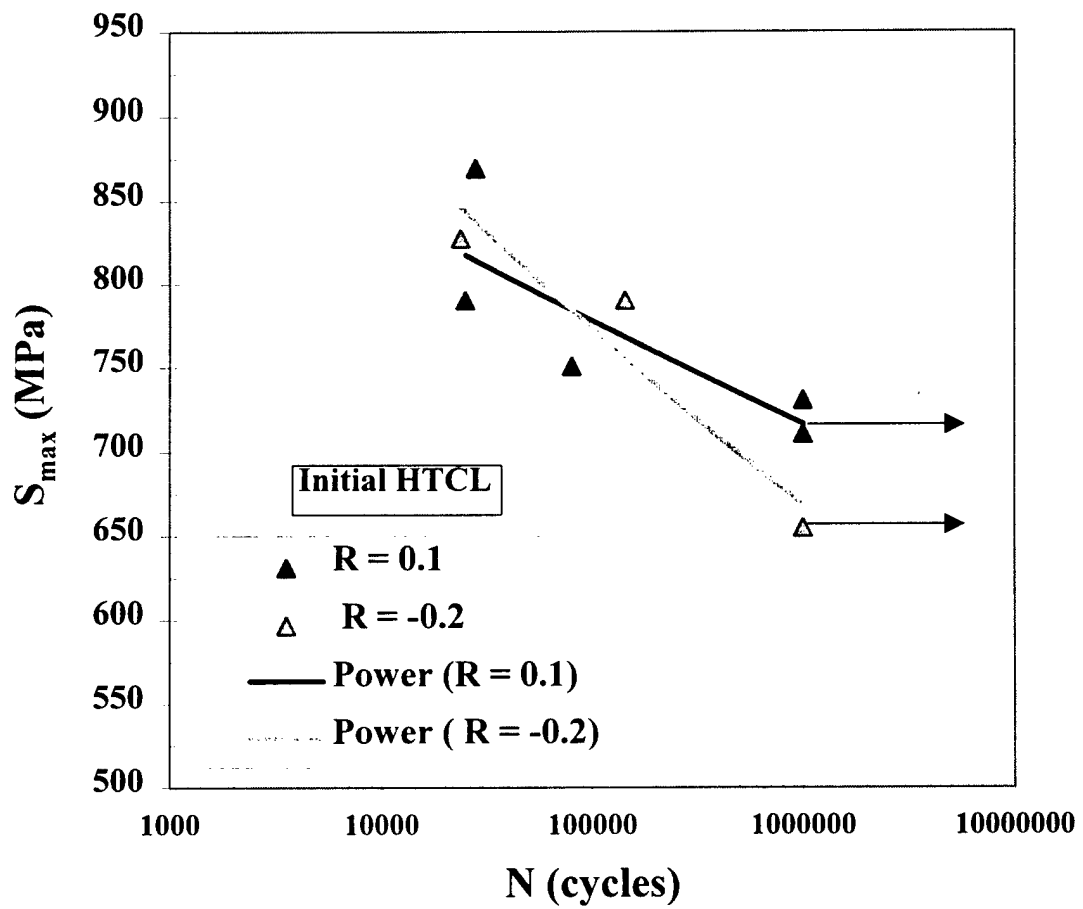
Figure 6.28 Experimental S-N data comparing initial HTCL fatigue at R = 0.1 to R = -0.2.

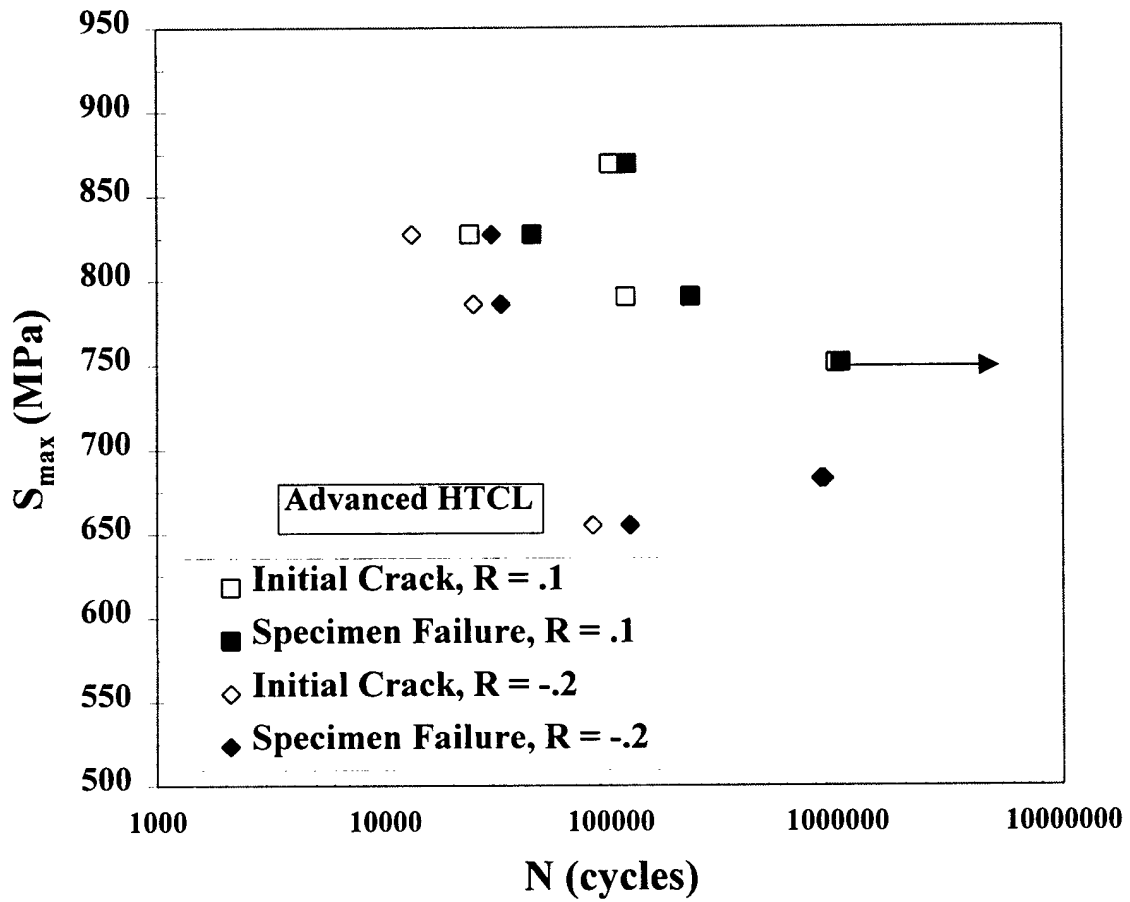
Figure 6.30 Comparison of initial titanium ply and specimen failure for advanced HTCL at R = 0.1 and R = -0.2.

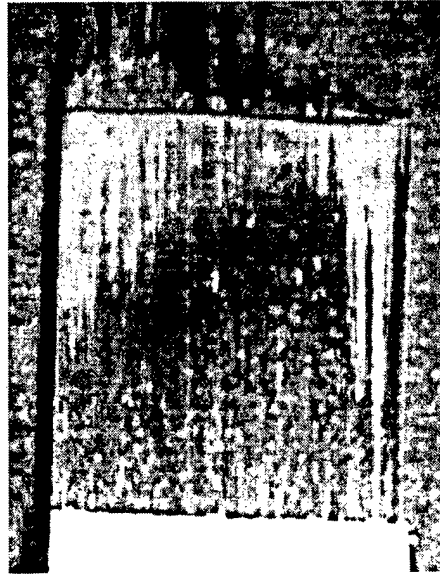
Figure 6.42 Advanced HTCL inner ply surface following tension-compression fatigue. Note fibers bonded to titanium ply.
