NAVAL FACILITIES ENGINEERING SERVICE CENTER
Port Hueneme, California 93043-4370

TECHNICAL MEMORANDUM TM-2328-SHR

INVESTIGATION INTO ACRYLIC PAINT CRACKING (APC) ON ASPHALTIC PAVEMENTS

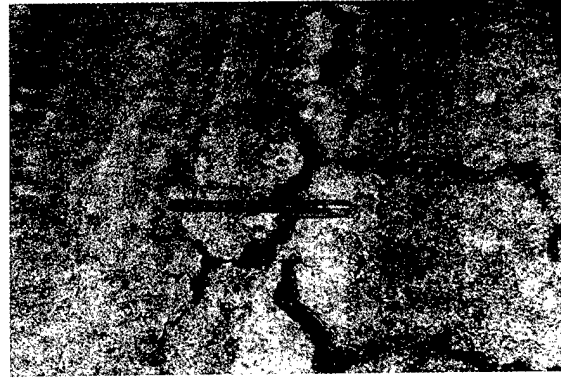
APC, NAS North Island.

Runway 29 – 11 contains a Slurry Seal (SS) applied to 4” of Asphaltic Concrete (AC) over 8” of Portland Cement Concrete (PCC)¹¹. In FY 97, the runway received 129,000 combined take-offs and landings¹². Extreme annual temperatures range from 30°F to 108°F with daily averages between 56°F to 71°F¹³. In 1987, the runway received a new SS and was subsequently coated¹⁴. Since 1987, the runway has received two or more overcoats for a total Dry Film Thickness (DFT) ranging from 55 mils to 120 mils (1 mils = 0.001”). White markings displayed 3” to 6” diameter sections of paint outlined by cracks whereas yellow taxi lines displayed smaller 2” to 3” diameter sections of paint

outlined by cracks. In general, APC penetrated the full 3/8" SS depth and, in some cases, cracking was observed to a depth greater than 1".

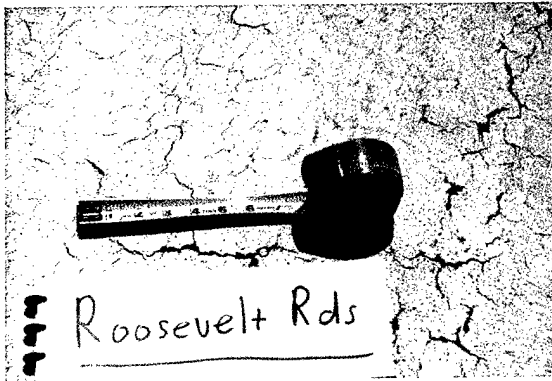
APC, NS Roosevelt Rds.

Forty-five percent of Runway 7 – 25 contains 3.5" of AC applied to a paving fabric over 11" of PCC²⁰. In FY 95, the runway received approximately 10,300 combined take-offs and landings²¹. Rainfall averages 58 inches per year and mean annual temperatures range from 74°F to 82°F with summer highs reaching the middle 90s²². In 1993, the runway received its' AC overlay and was subsequently coated²³. The overlaid AC contains two coats of marking paint²⁴. Overall, painted surfaces displayed moderate APC with paint crack depths ≤ 1/2" and paint crack widths ≤ 3/8". However, dime to quarter sized sections of paint have begun to spot fail and may contribute to an increase in FOD (Foreign Object Damage).

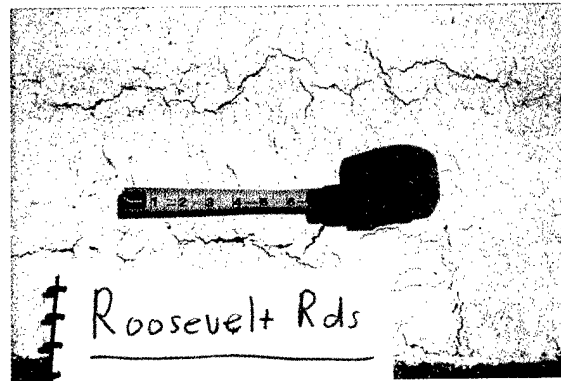
APC, NS Roosevelt Rds.

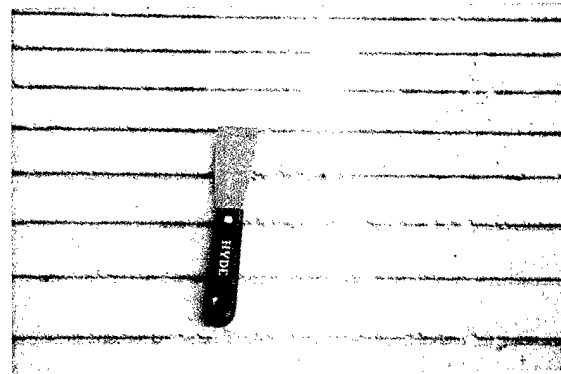
Threshold marking, Shreveport Regional.

Shreveport Regional's AC runway contains a grooved, friction course. Grooves are 1/4" wide by 3/8" deep and have been placed transverse at 1.75" intervals. Airfield markings contain a 3.5 year-old coating base and, built-up by overcoating, display an approximate thickness of 50 mils²⁵. The centerline marking was free of APC whereas threshold markings contained microchecked paint (small, hairline mudcracks). Although combinations of waterborne and water-based acrylics are used, APC, as identified on the above three runways, was absent. It appears that the grooved, friction course may have relieved the stresses which generally produce APC.

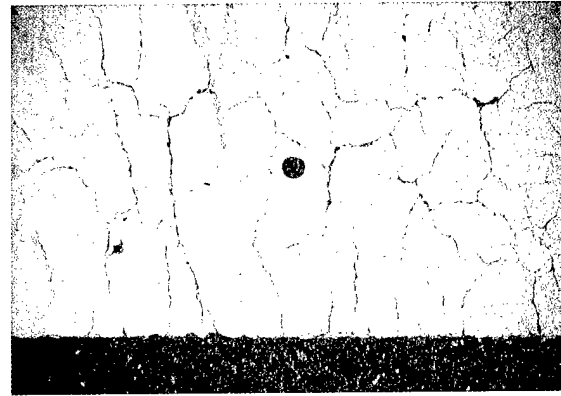
Early stage of APC.

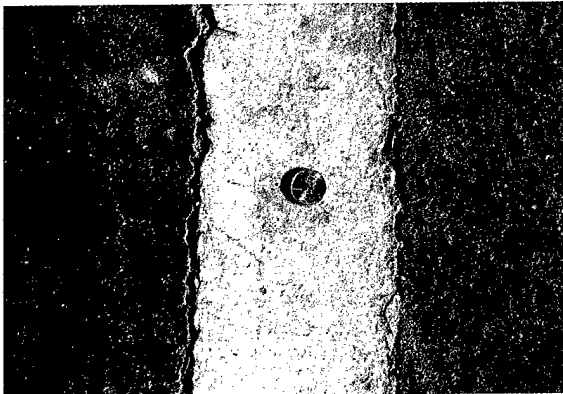
Advanced stage of edge cracking.

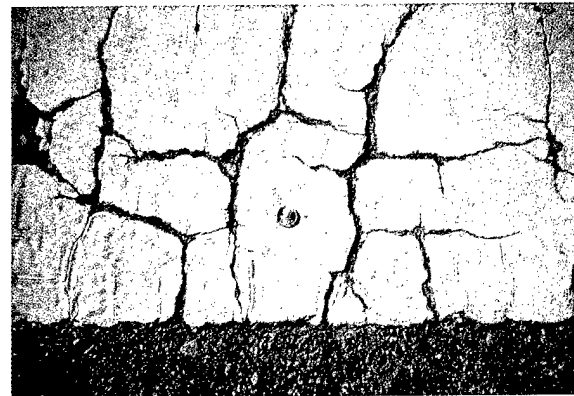
Advanced stage of APC.

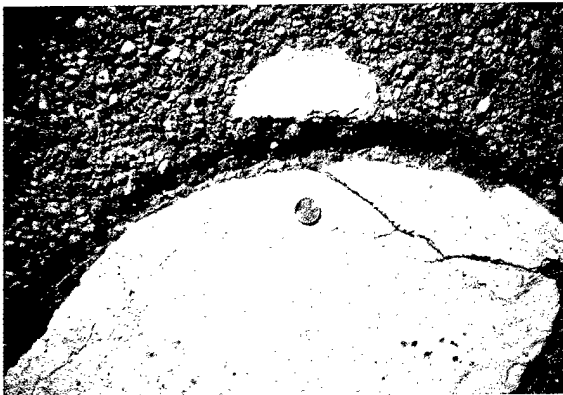
Severe edge cracking.

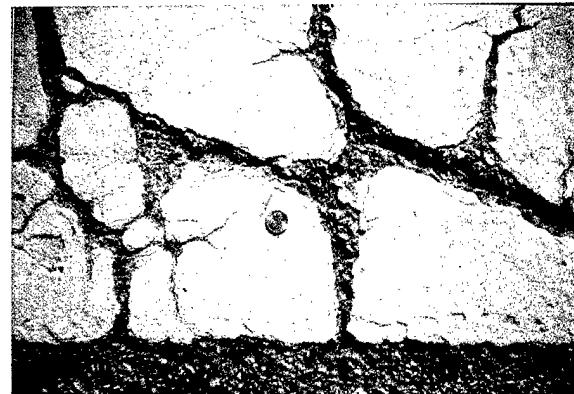
Severe APC.

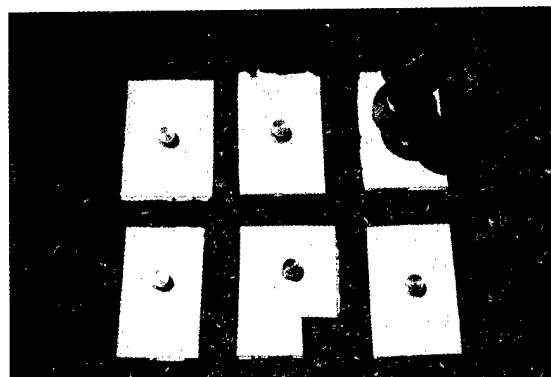
Elcometer adhesion tester and 3/4" pull-off pucks attached to paint samples.

An Elcometer adhesion tester with 3/4" diameter pull-off pucks was used to quantify the cohesive strength of paints. Paints were applied to either grit blasted aluminum or grit blasted steel. Table 2 lists the cohesive strength of paints at room temperature whereas Table 3 lists the cohesive strength of Paints I, II at elevated temperatures.

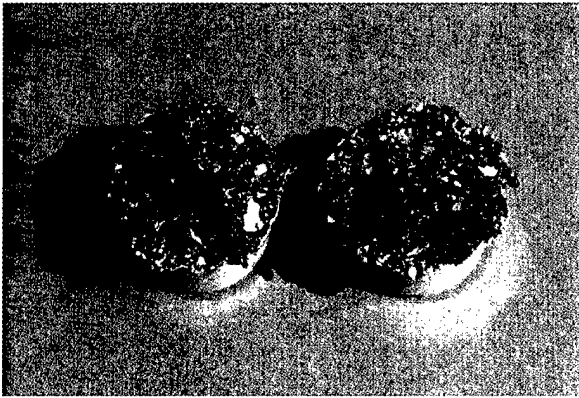
Paint with attached chunks of AC indicate paint adhesion > AC cohesive strength.

Paints were applied to clean AC in one coat at an approximate Dry Film Thickness (DFT) of 10 mils. Paint adhesion was quantified using a Proceq Dyna Tester and 2" diameter pull-off pucks. Table 4 lists adhesion values at a specific AC surface temperature and represents the average of two tests per paint. Each pull-off test produced an AC cohesive failure and results signify maximum paint adhesion to AC. Table 5 lists overcoat adhesion values of Paint I applied over each of the six paints. Results from overcoat adhesion suggest waterborne acrylics develop excellent bonds to previously applied acrylics.

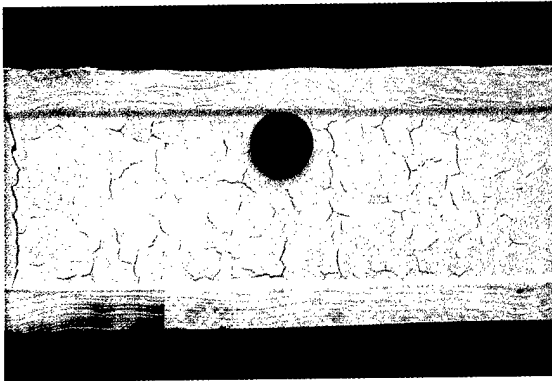
Paint I cracking at > 30 mils DFT.

Paints were applied in one coat at several DFTs to either a Teflon sheet or a metal substrate (aluminum, steel) and observed for the presence of cracks. Paint cracking occurs when the paint's internal stress exceeds the paint's cohesive strength. Table 12 identifies the presence of cracked paint at several DFTs.

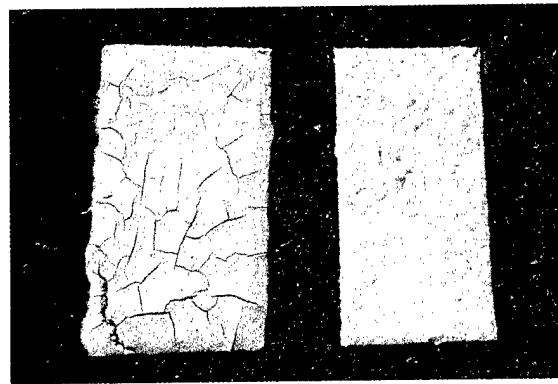
Paint I (left), Paint HB (right).

Paint I and batch two of Paint HB displayed slight cracking at DFTs as low as 22 mils whereas batch one of Paint HB and Paint EA were crack free at DFTs up to 50 mils. As anticipated, the elastomeric modified acrylics (EA/I, EA/II) displayed less cracking at higher DFTs when compared to the unmodified formulations. It was disappointing to observe the high degree of variation between the two commercial batches of Paint HB. The first batch of Paint HB displayed excellent crack resistance whereas the second batch displayed cracking at approximately 1/3 the DFT of batch one.

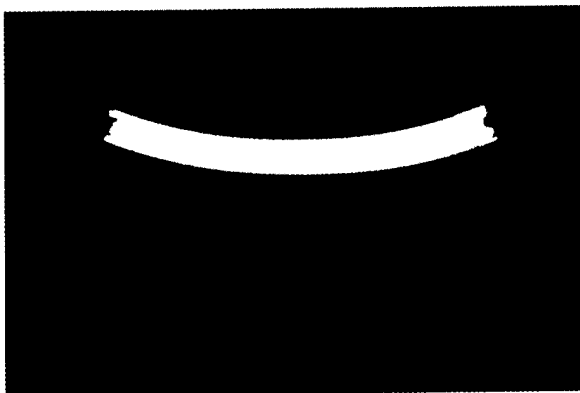
Shim bending technique.

Residual Cure Stress (RCS) was quantified using the freely supported beam method (shim bending technique)^{33,34,35,36}. Paints were applied to stainless steel shims (0.012" x 10" x 2": SS 302) at DFTs ≥ 38 mils. The initial shim deflection, prior to coating, was used as the zero point. Equations (1) and (2) are presented in Reference 35 and were used to calculate RCS. Table 13 lists RCS per mil of cured paint.

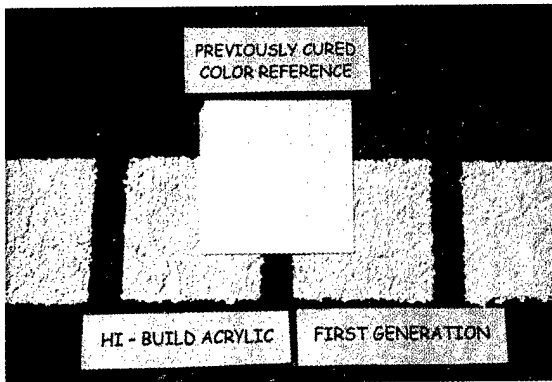
Paints HB, I displayed poor asphaltic bleed resistance.

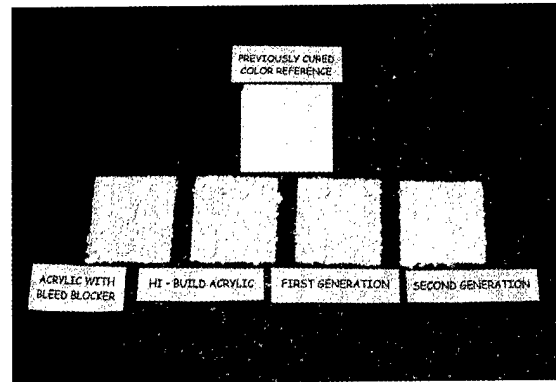
Testing for asphaltic bleed resistance.

Paints were applied to a clean, four-year old AC surface at approximately 10 mils DFT by brush. Table 15 lists qualitative visual results for asphaltic bleed resistance whereby paint EA, doped with an asphaltic bleed-blocking agent, outperformed the acrylic marking paints.

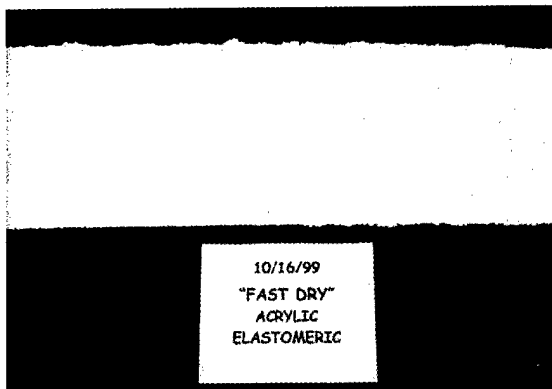
Patch applied to parking lot SS.

Two Paint EA patch tests were applied to the following areas located in Southern California at approximately 10 mils DFT: A) Stop sign stripe over AC, and B) One-year old parking lot SS. Patch A was used to evaluate abrasion resistance whereas Patch B was used to evaluate the effects of both RCS and short-term thermal cycling. Adjacent Patch B, the parking lot SS displayed a cohesive strength of 18.5 psi at 103°F and previously applied marking paints contained significant edge cracking. At two months service, patches were evaluated for performance. After approximately 20,000 car passes, Patch A displayed poor abrasion resistance whereby previously coated high spots had failed. Patch B, however, was not subjected to automotive traffic and remained crack free (0 % edge and internal cracking). Results validate the following Paint EA properties: 1) Poor abrasion resistance, 2) Low transfer of RCS to substrates, and 3) Flexibility sufficient to combat thermally induced SS movement.

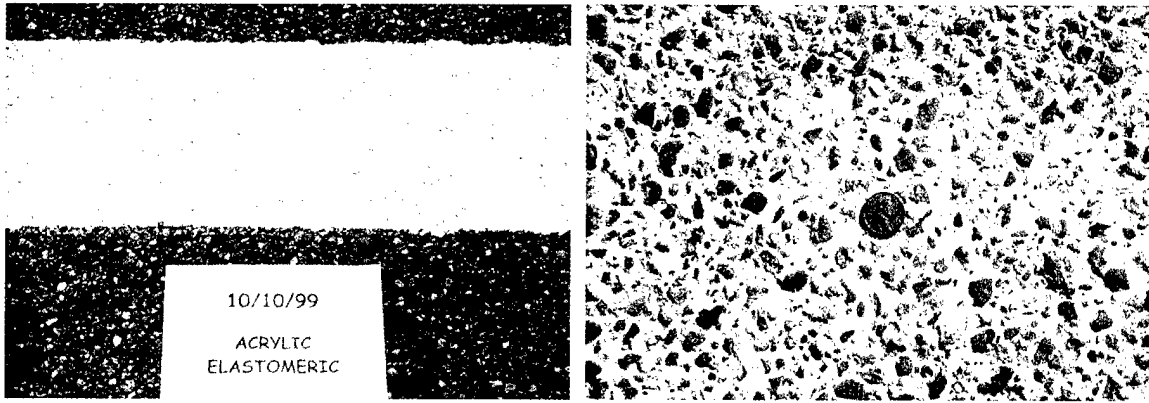
Patch applied as stripe for stop sign.

Poor abrasion resistance at 2 months service: Stop sign stripe.

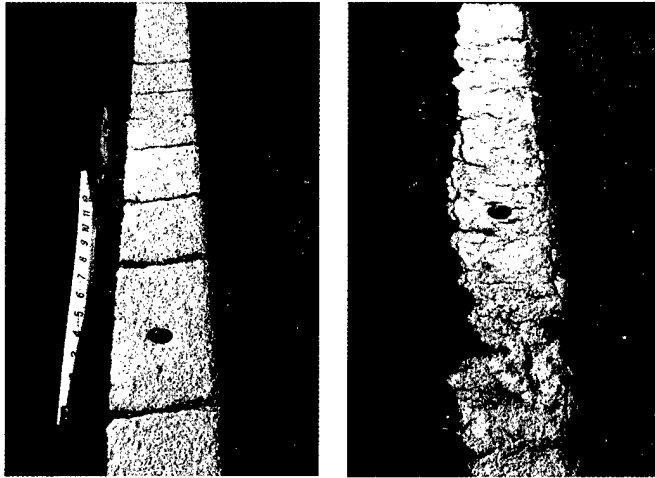
Stripes were applied at the same time: right stripe receives sprinkler runoff.

Moisture induced stress occurs when coatings absorb moisture from rainfall, high humidity, dew, and pavement moisture vapor emission. Cycling between water absorption (volume increase) and drying (volume contraction) increases cohesive and adhesive paint stress. As previously noted, the tested paints displayed water absorption weight increases ranging from 5.5 % to 12.6 %. In general, a 10 % increase in weight represents approximately a 13 % increase in volume⁵⁰. Paints I, II displayed approximately a 10 % weight increase from water absorption and, since they also displayed poor flexibility, should weather poorly when subjected to high levels of moisture. As evident in the above photographs, high levels of moisture accelerate acrylic marking paint failures.

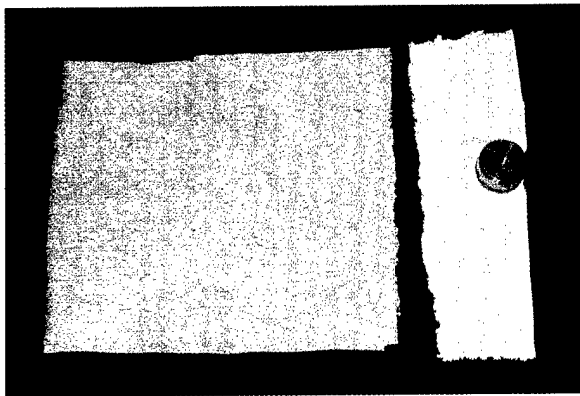
The above flexible acrylic was lifted in sheets, using hand pressure, from a concrete substrate.

Flexible acrylic marking paints designed for asphaltic pavements must contain the appropriate level of tensile strength, adhesive strength, and percent elongation. If coating/substrate adhesion is well below the coating's tensile strength and the paint contains a high percent elongation, the marking paint may fail in sheets when subjected to various stresses. The above photograph shows a flexible coating which developed an adhesive strength of 70 psi to concrete and, as a result of a high percent elongation ($\geq 300\%$) and a high tensile strength (≥ 300 psi), was pulled off the concrete in sheets. Ideal properties for semi-flexible marking paints are presented in Table 18 below.
