CERL Technical Report 99/100 December 1999

# ROOFER: Steep Roofing Inventory Procedures and Inspection and Distress Manual for Asphalt Shingle Roofs

This report gives instructions for using ROOFER procedures for establishing a steep roofing inventory and evaluating the condition of asphalt shingle roofs. ROOFER is an engineered management system designed to help facility managers more efficiently manage their roofing assets and make the best use of roof maintenance and repair dollars.

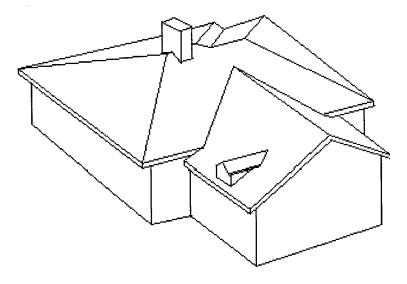
Figure 2. Example of a building roof comprising a roof section.

Building roofs are managed by units called "roof sections" for which all repair and replacement decisions can be made. To achieve this, each roof section is inspected and evaluated independently of other roof sections. As a rule, a building having a steep roofing system of approximately 10,000 SF or less should be managed as one section. Roofing on dormers and similar projections should be included with the main roof section. As an example, all exposed roof areas on the building shown in Figure 2 would comprise one roof section.

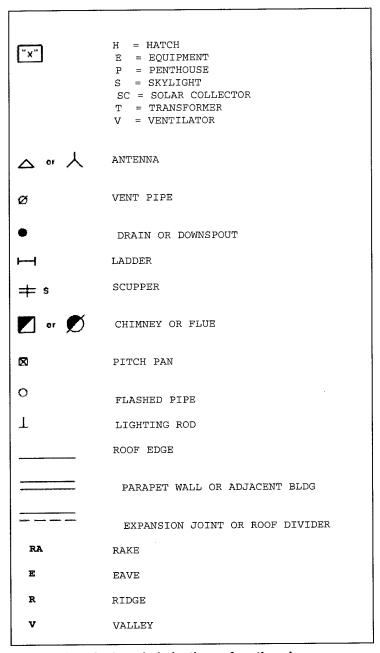
Figure 7. Standard symbols for the roof section plans.

Each roof section should have a roof plan drawn to a scale that fits on the Roof Inspection Worksheet (Figure 6). The plan should show all physical roof features, including perimeter conditions (e.g., roof edge, ridge, valley, parapet wall), rooftop equipment, and projections through the roof. The standard symbols shown in Figure 7 should be used to identify these items.

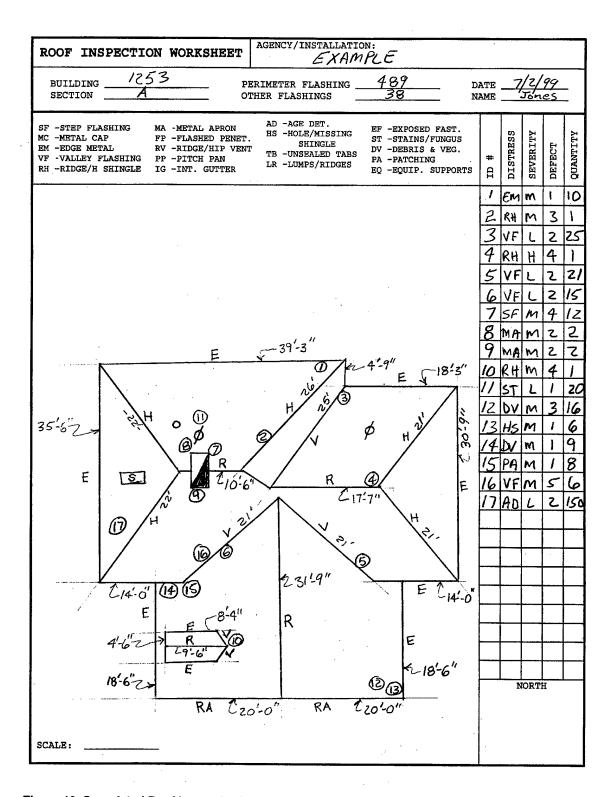
Figure 10. Completed Roof Inspection Worksheet.

When performing the inspection, identify each distress as it is encountered. Determine the severity level, the specific defect present, and measure the quantity using the criteria defined in Chapters 3 and 4. A description of the valley flashing distresses and specific defects is shown in Figure 9. Enter this information in the columns on the right side of the Roof Inspection Worksheet (Figure 10). Each distress encountered is assigned an identification number, starting with 1 and numbering consecutively. The identification number should be recorded in column 1 of the inspection worksheet. Record the location of each distress on the roof plan using the identification number as shown in Figure 10. If the Roof Inspection Worksheet becomes filled during the inspection, continue recording on a second worksheet An abbreviated copy of the distress/defect identifier list (Figure 11) can be attached to the bottom of a long (8 by 14 in.) clipboard so it is ex-

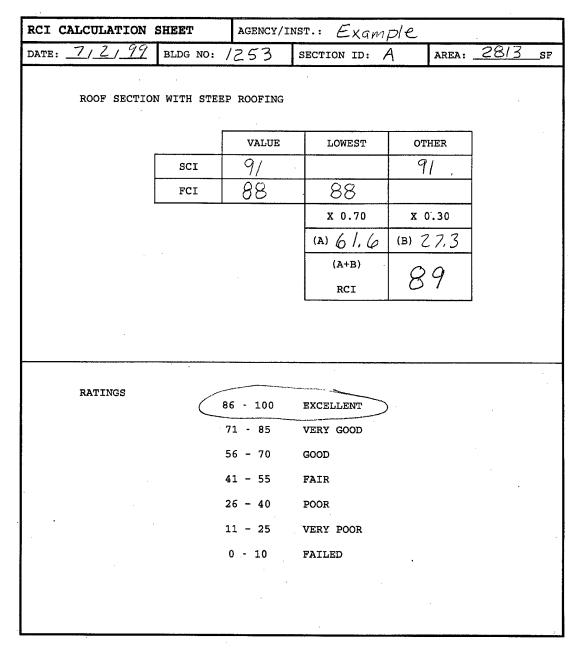
Figure 13. Completed RCI Calculation Sheet.

RCI = (0.7 x lowest condition index) + (0.3 x remaining condition index)

The above equation gives the greatest weight to the component with the lowest condition index and then modifies it by adding "value" from the remaining index.

A completed RCI Calculation Sheet is shown in Figure 13.

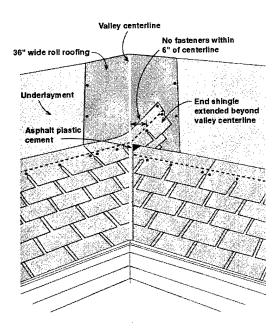
Valley Flashing - Closed

Roof valley flashings are formed when two sloping roof sections intersect to form a "V". Water from both sections of roof runs through the valley making it especially vulnerable to deterioration and leakage. Valley flashings for asphalt shingles may be of three types: (1) open valleys lined with sheet metal or mineral-surfaced asphalt roll (composition) material, (2) closed cut valleys having shingles on one side of the valley cut on an angle parallel with the valley, and (3) woven valleys lined with interwoven asphalt shingles from the adjoining roof sections. All three types of valley flashings should have underlying asphalt roll material.

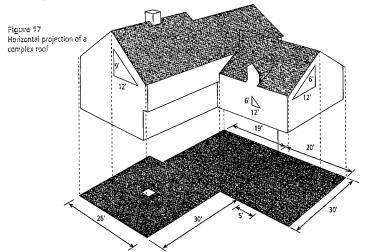
- ① Calculate the horizontal area under the 9" slope roof.
- ② From this gross figure, deductions must be made for the area of the chimney and for the triangular area of the ell roof that overlaps and is sloped differently from the main roof:
- 3 Calculate the net projected area of the main roof.
- (4) Calculate the horizontal area under the 6" slope roof:
- Calculation for Horizontal Area Under a 9" Slope Roo

$$(26 \times 30) = 780$$
+ (19 x 30) = 570
