**TECHNICAL REPORT M10**

**SEDIMENTATION AND NAVIGATION STUDY OF THE  
MISSOURI RIVER,  
COPELAND BEND  
MILES 569 TO 564.5**

**HYDRAULIC MICRO MODEL INVESTIGATION**

Final Report - September, 1999

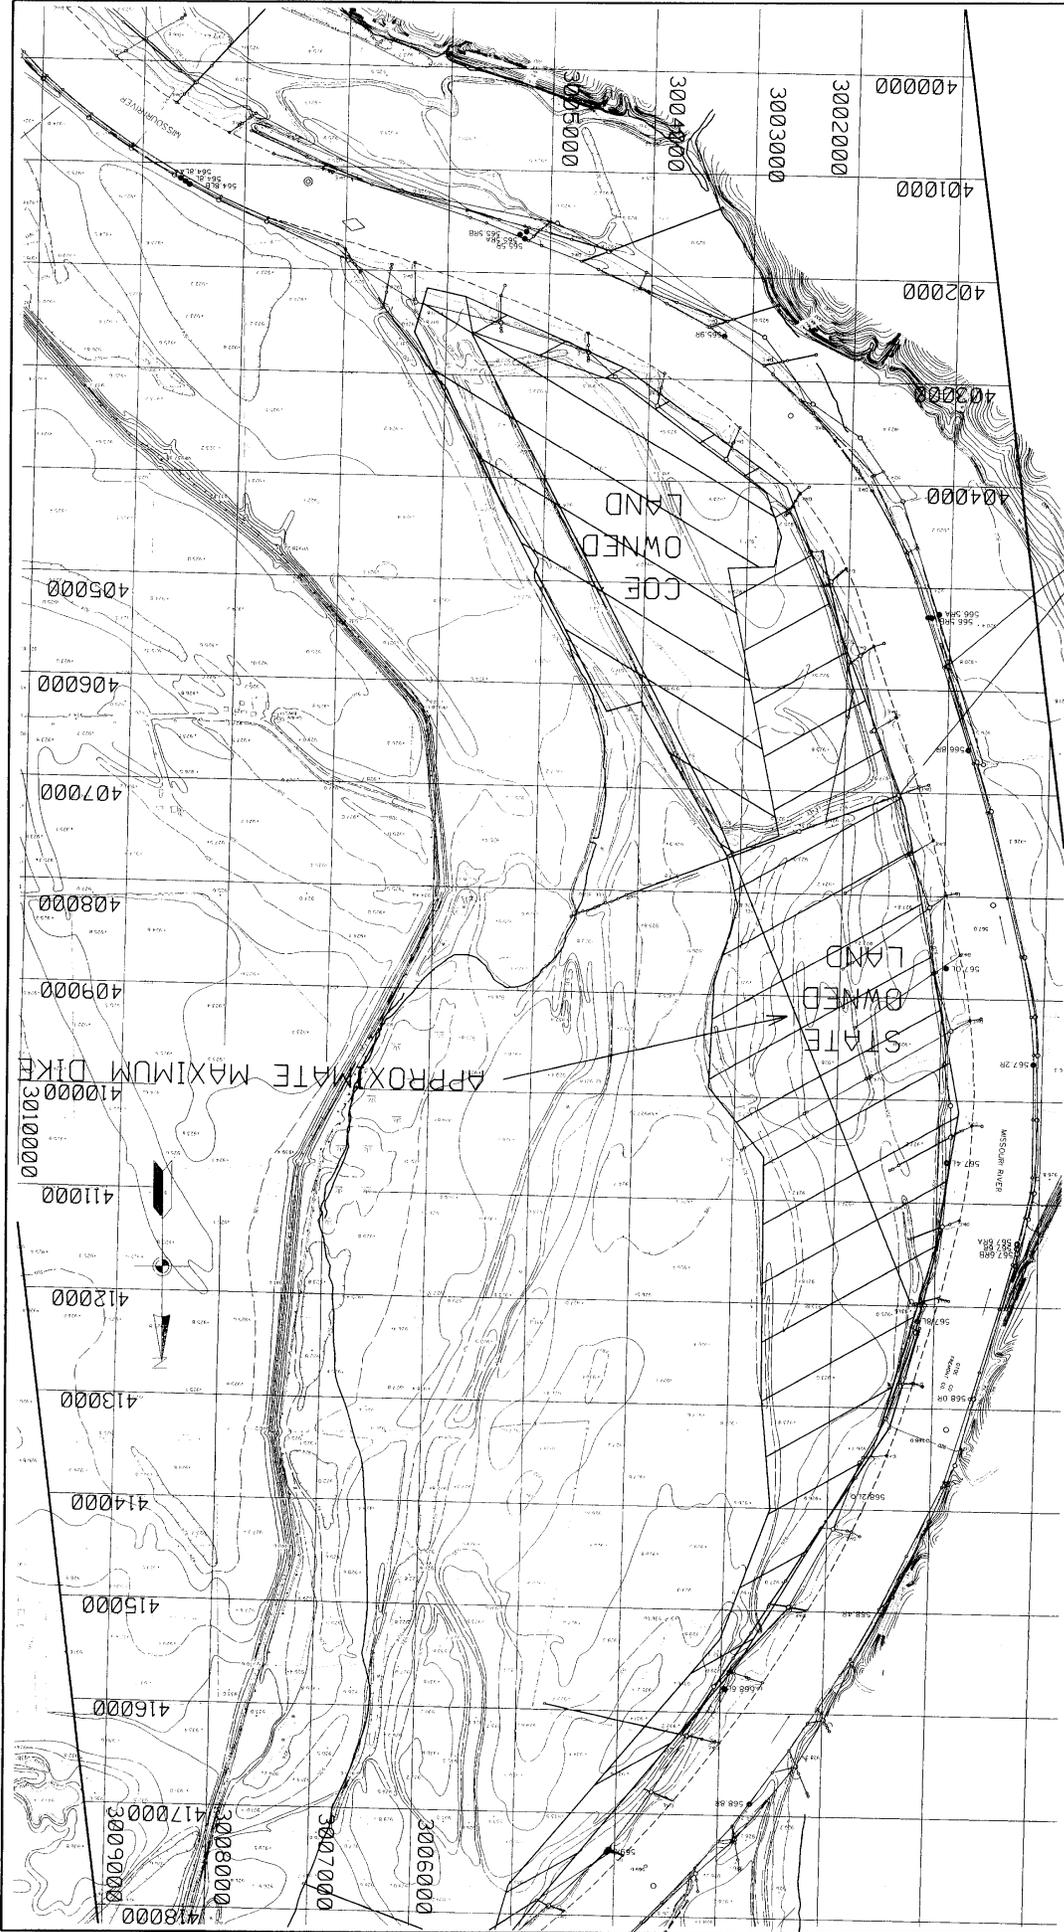
DESIGN FILE: CORP/HP/SD/100  
PLOT SCALE: 1000  
PLOT DATE: 6/27/99  
PLATE NO: 2

SEDIMENTATION STUDY - MICRO MODEL STUDY  
MILES 568 TO 580  
RIVER MILES 568 TO 580  
STUDY REACH MAP

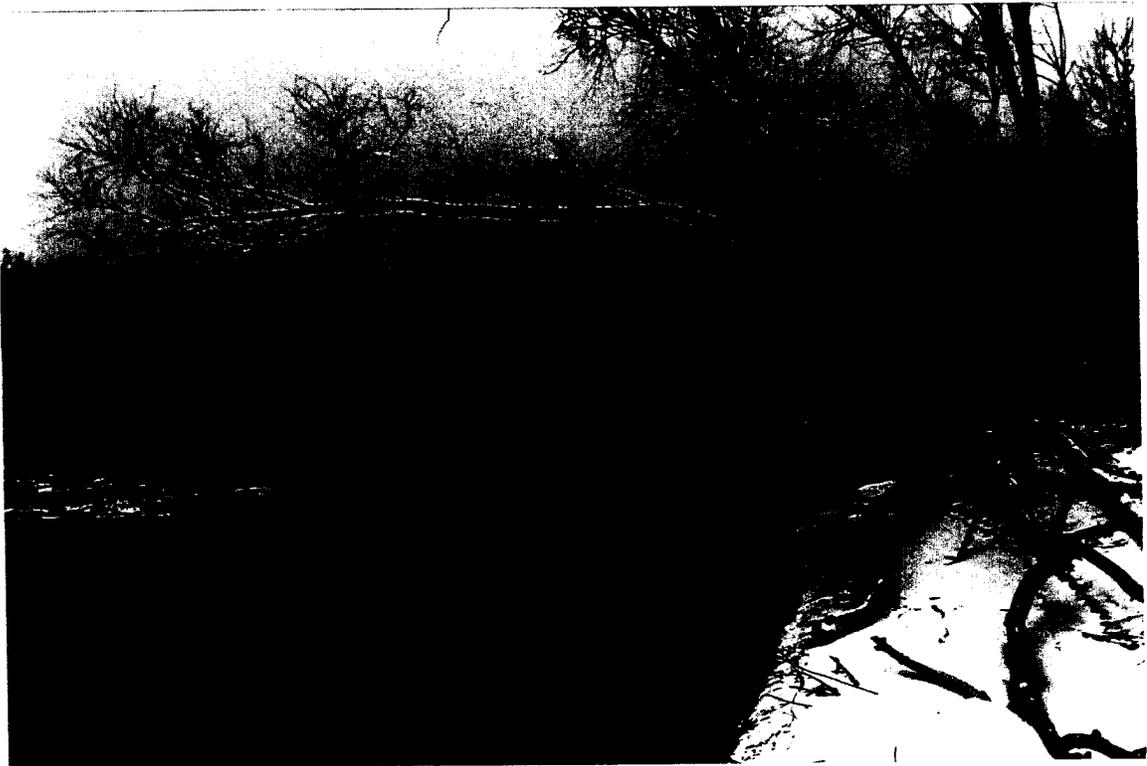
5

**Copeland Bend, Looking Upstream at Dike 612.5**

In December of 1998, river engineers from the St. Louis District made a field investigation of the study reach. Plates 4 through 10 are photographs taken during this inspection. The following observations were noted:

- All of the dikes were angled slightly downstream, which has caused small bankline roundouts to occur below each structure. The bankline roundouts appeared to be stable, however, and the integrity of the dikes was not in jeopardy.
- An unusual amount of mature trees were destroyed near and along the left descending bankline due to beaver impacts. This could cause future lateral erosion of the existing bankline.

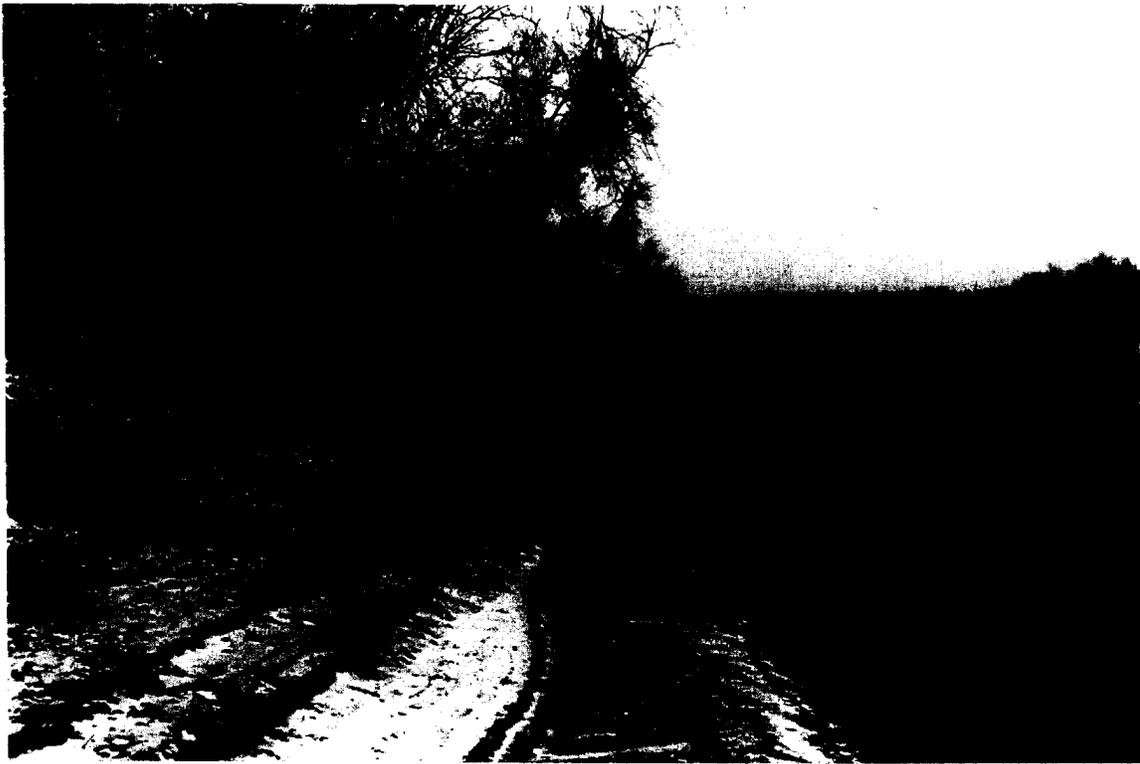
7

Copeland Bend, Looking Downstream From Dike 612.5

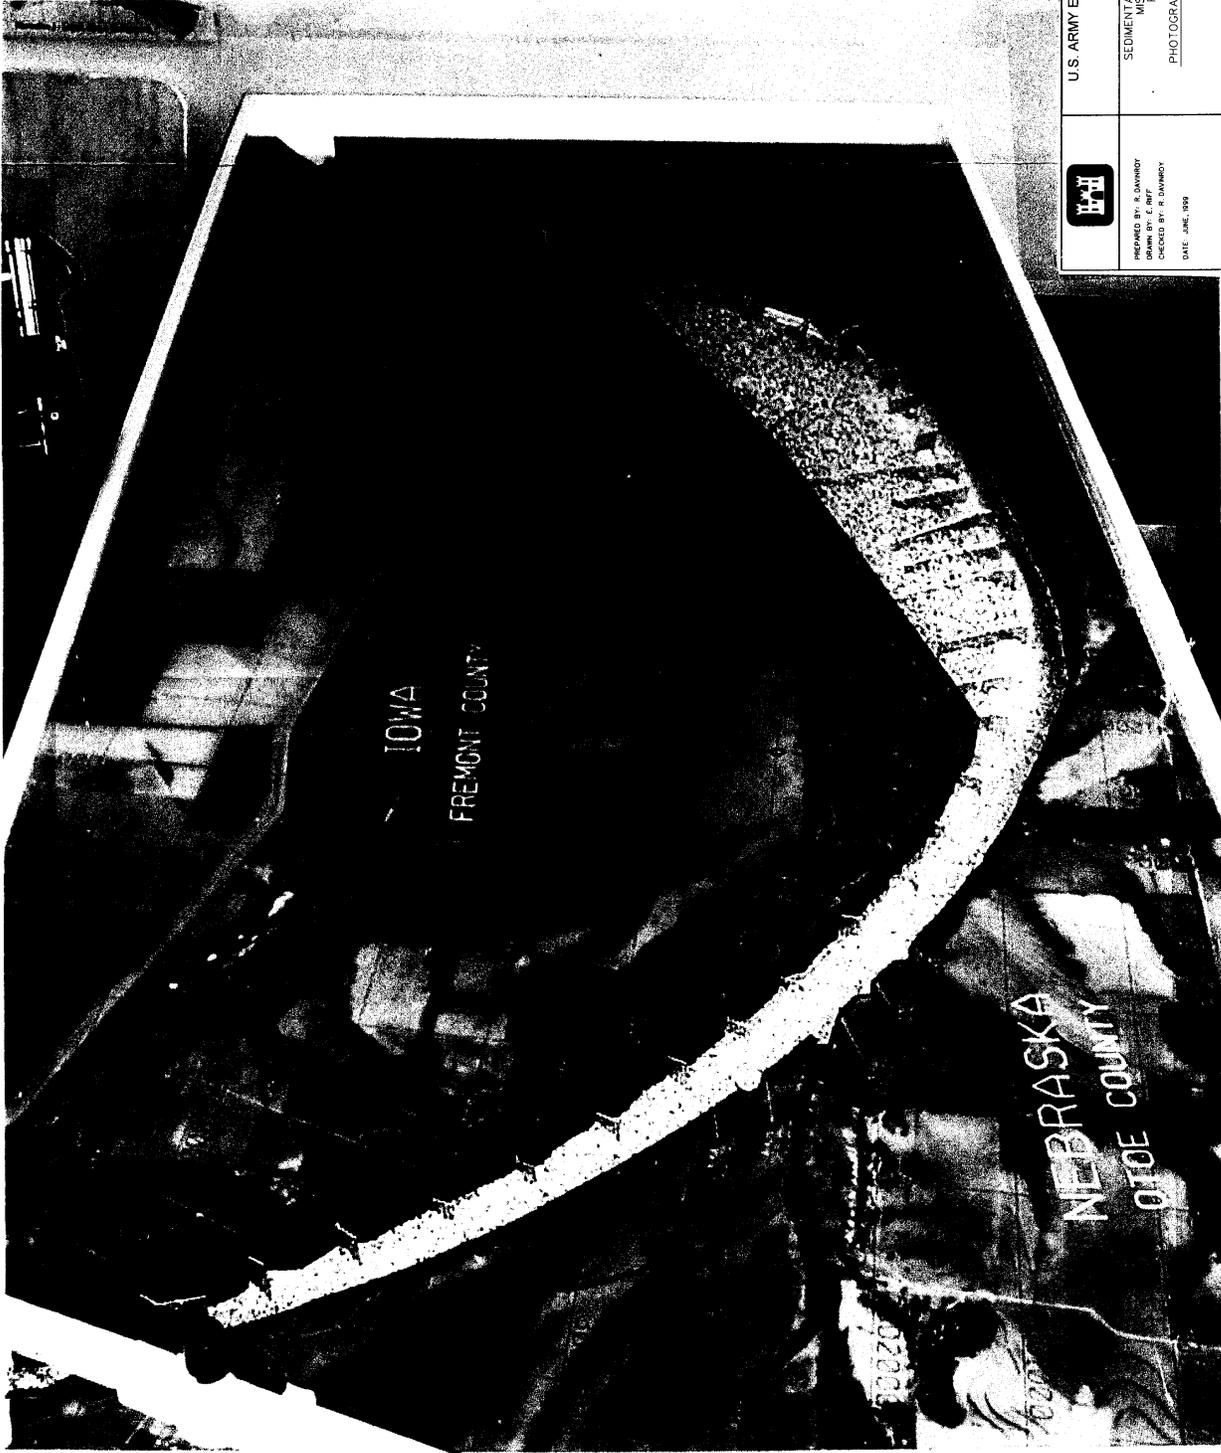
DESIGN FILE: CORPENG-102  
PLATE NO: 11

Plate 11 is a photograph of the Copeland Bend hydraulic micro model used in this study. The scales were 1 inch = 300 feet, or 1:3600 horizontal, 1 inch = 20 feet, or 1:240 vertical, for a 15 to 1 distortion ratio. This distortion supplied the necessary forces required for the simulation of sediment transport conditions similar to those of the prototype. Both the bed material and the erodible floodplain section were composed of granular plastic urea, Type II, with a specific gravity of 1.23.

SEDIMENTATION STUDY - MICRO MODEL STUDY  
MISSOURI RIVER, COPELAND BEND  
RIVER MILES 569 TO 564.5  
PHOTOGRAPH OF COPELAND BEND, MICRO MODEL

The model was constructed according to 1996 aerial photographs of the Missouri River. Flow was controlled via an electronic/computer program interfaced with a centrifugal pump and a mechanical process control valve. Stages and dike structures were recorded with a mechanical three-dimensional digitizer.

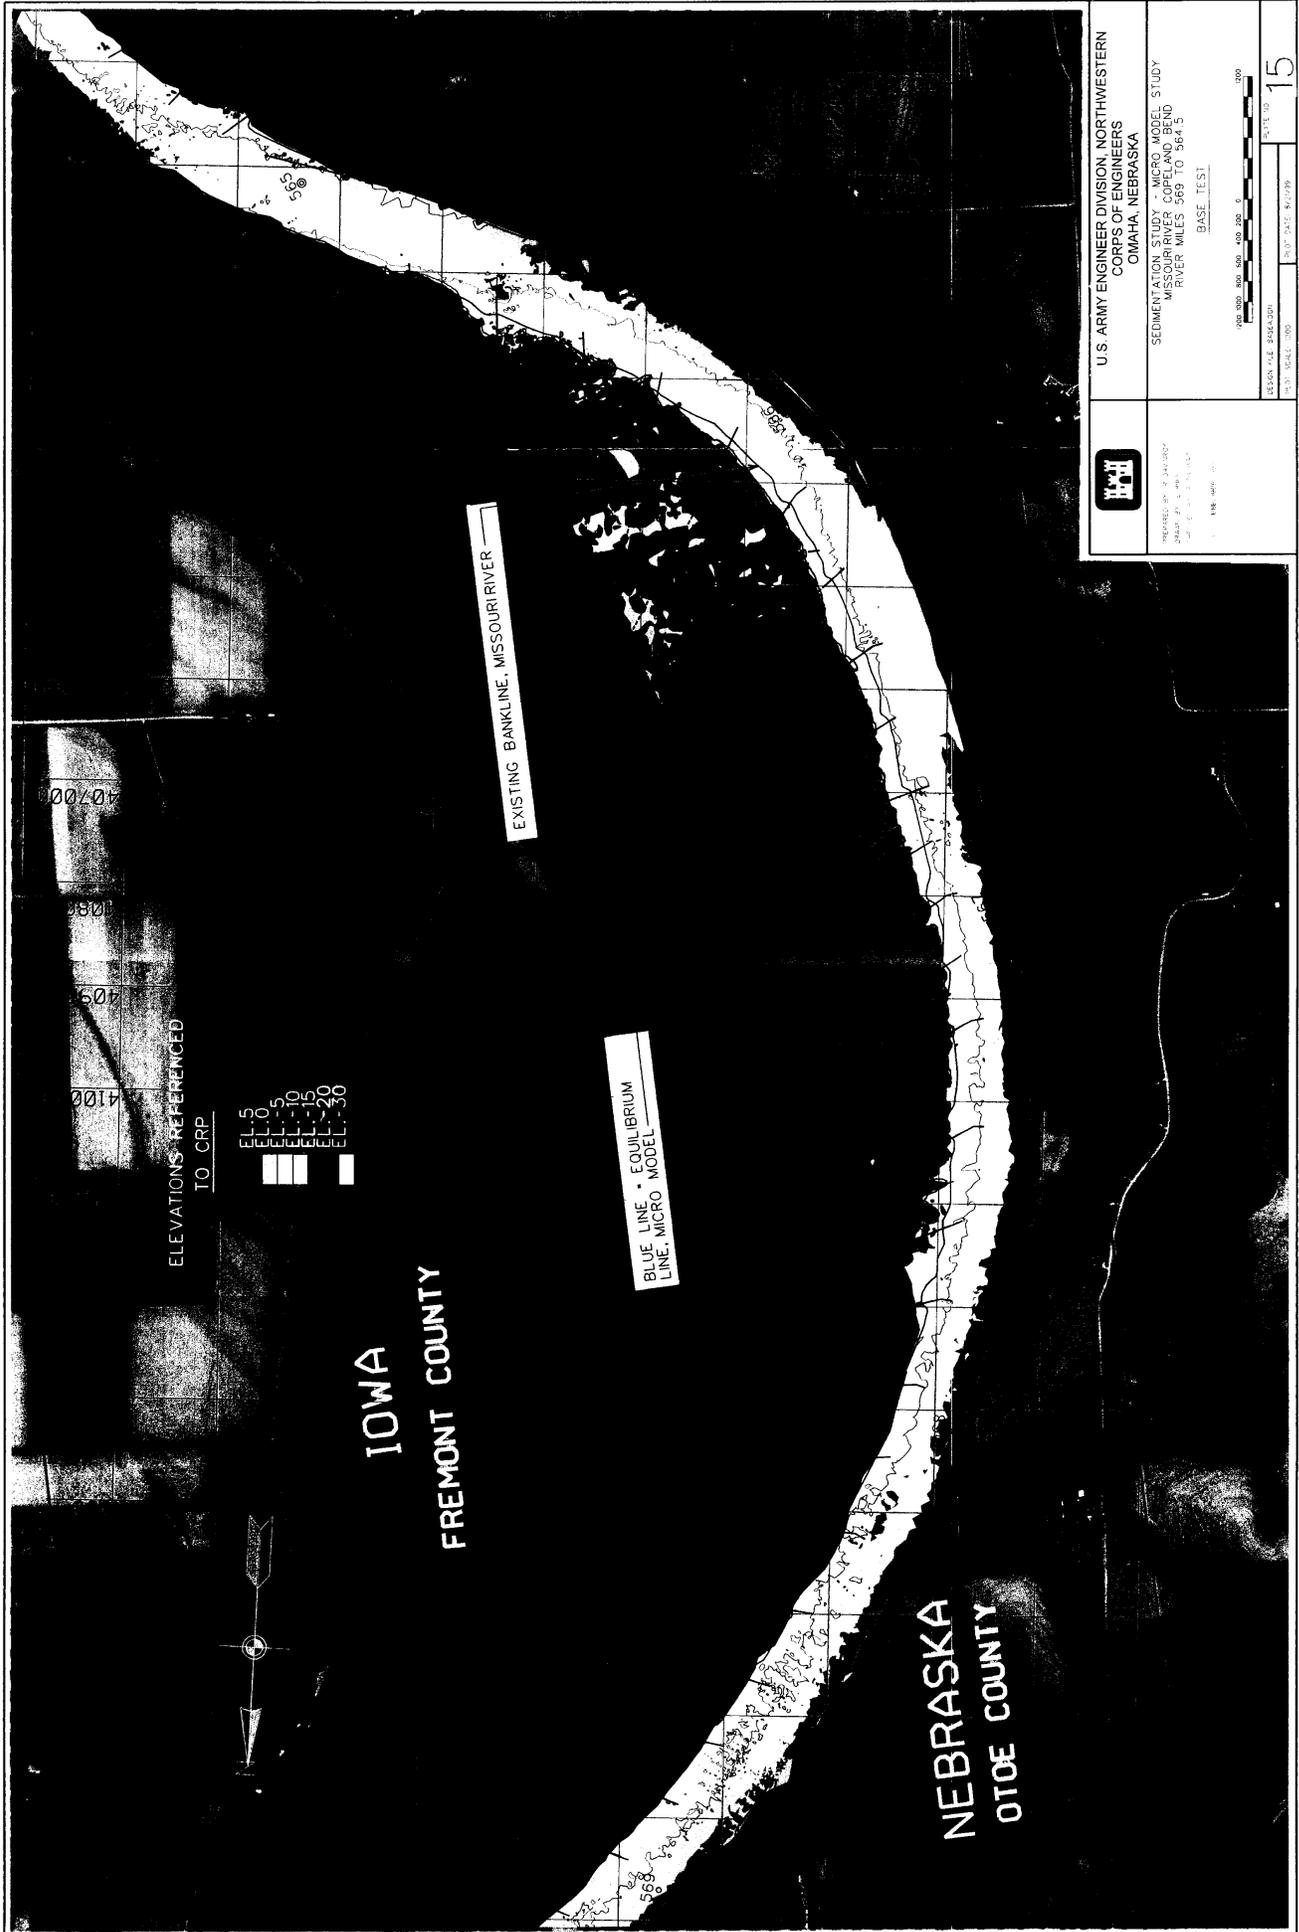
PL. NO.: 15

Plate 15 shows the resultant bed configuration of the micro model base test. The base test was developed from the simulation of successive design hydrographs until bed stability was reached and a similar bed response was achieved as compared with the prototype surveys. The observed trends of the model were as follows:

The general bathymetric trends of the base test were very similar to those of the two observed prototype surveys of 1991 and 1996. Generally, the thalweg was located in the same positions as in the prototype. The depositional patterns

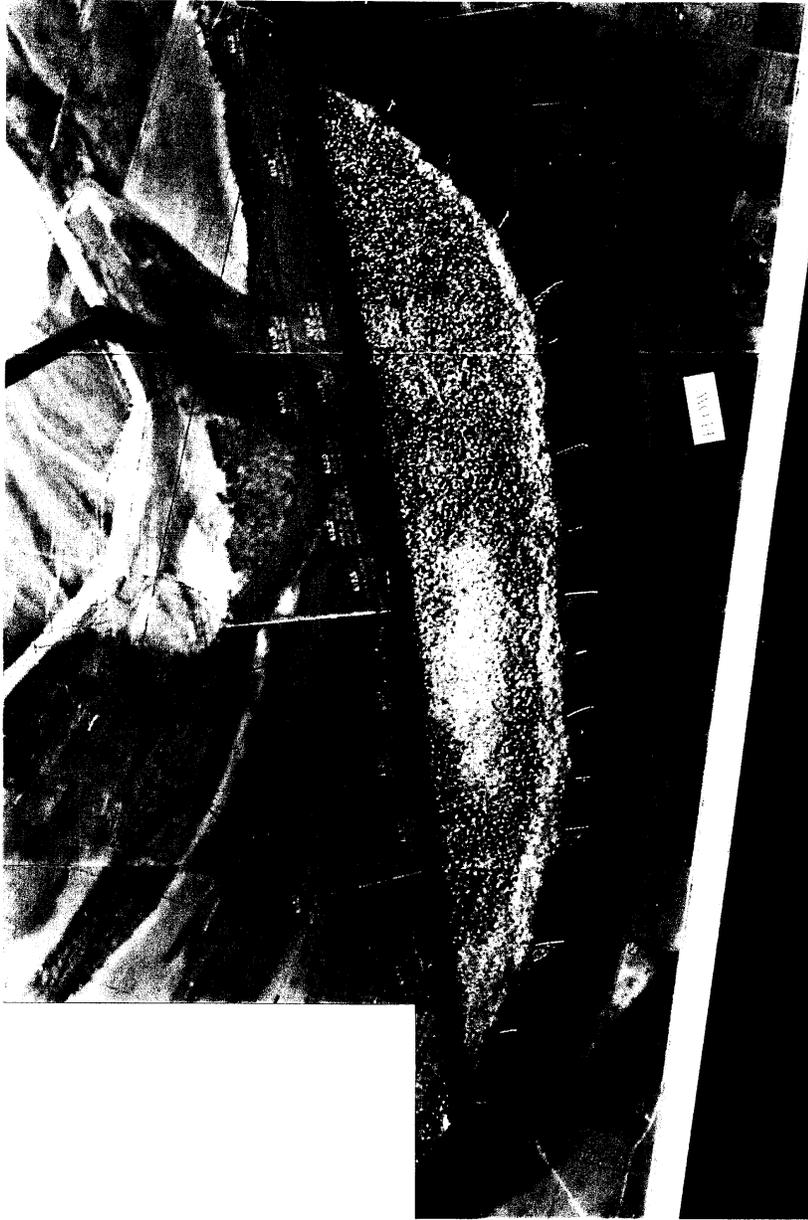
PLATE NO. 16

Plate 16 shows the flow visualization of the base test. All flow visualization photographs were captured throughout the model tests with the stage of the model at approximately + 2 CRP. Results indicated that the flow through the study reach was distributed fairly uniformly in the navigation channel, between the ends of the dikes and the right descending bankline, except at Mile 566.0, where flow was more concentrated at the apex of the bend adjacent to the point bar. The influence of the dikes in diverting flow away from the left descending bank and generating eddies was observed in the model. Flow visualization did not capture the eddies, however, the visualization did show the relative slower moving water within the dike field.

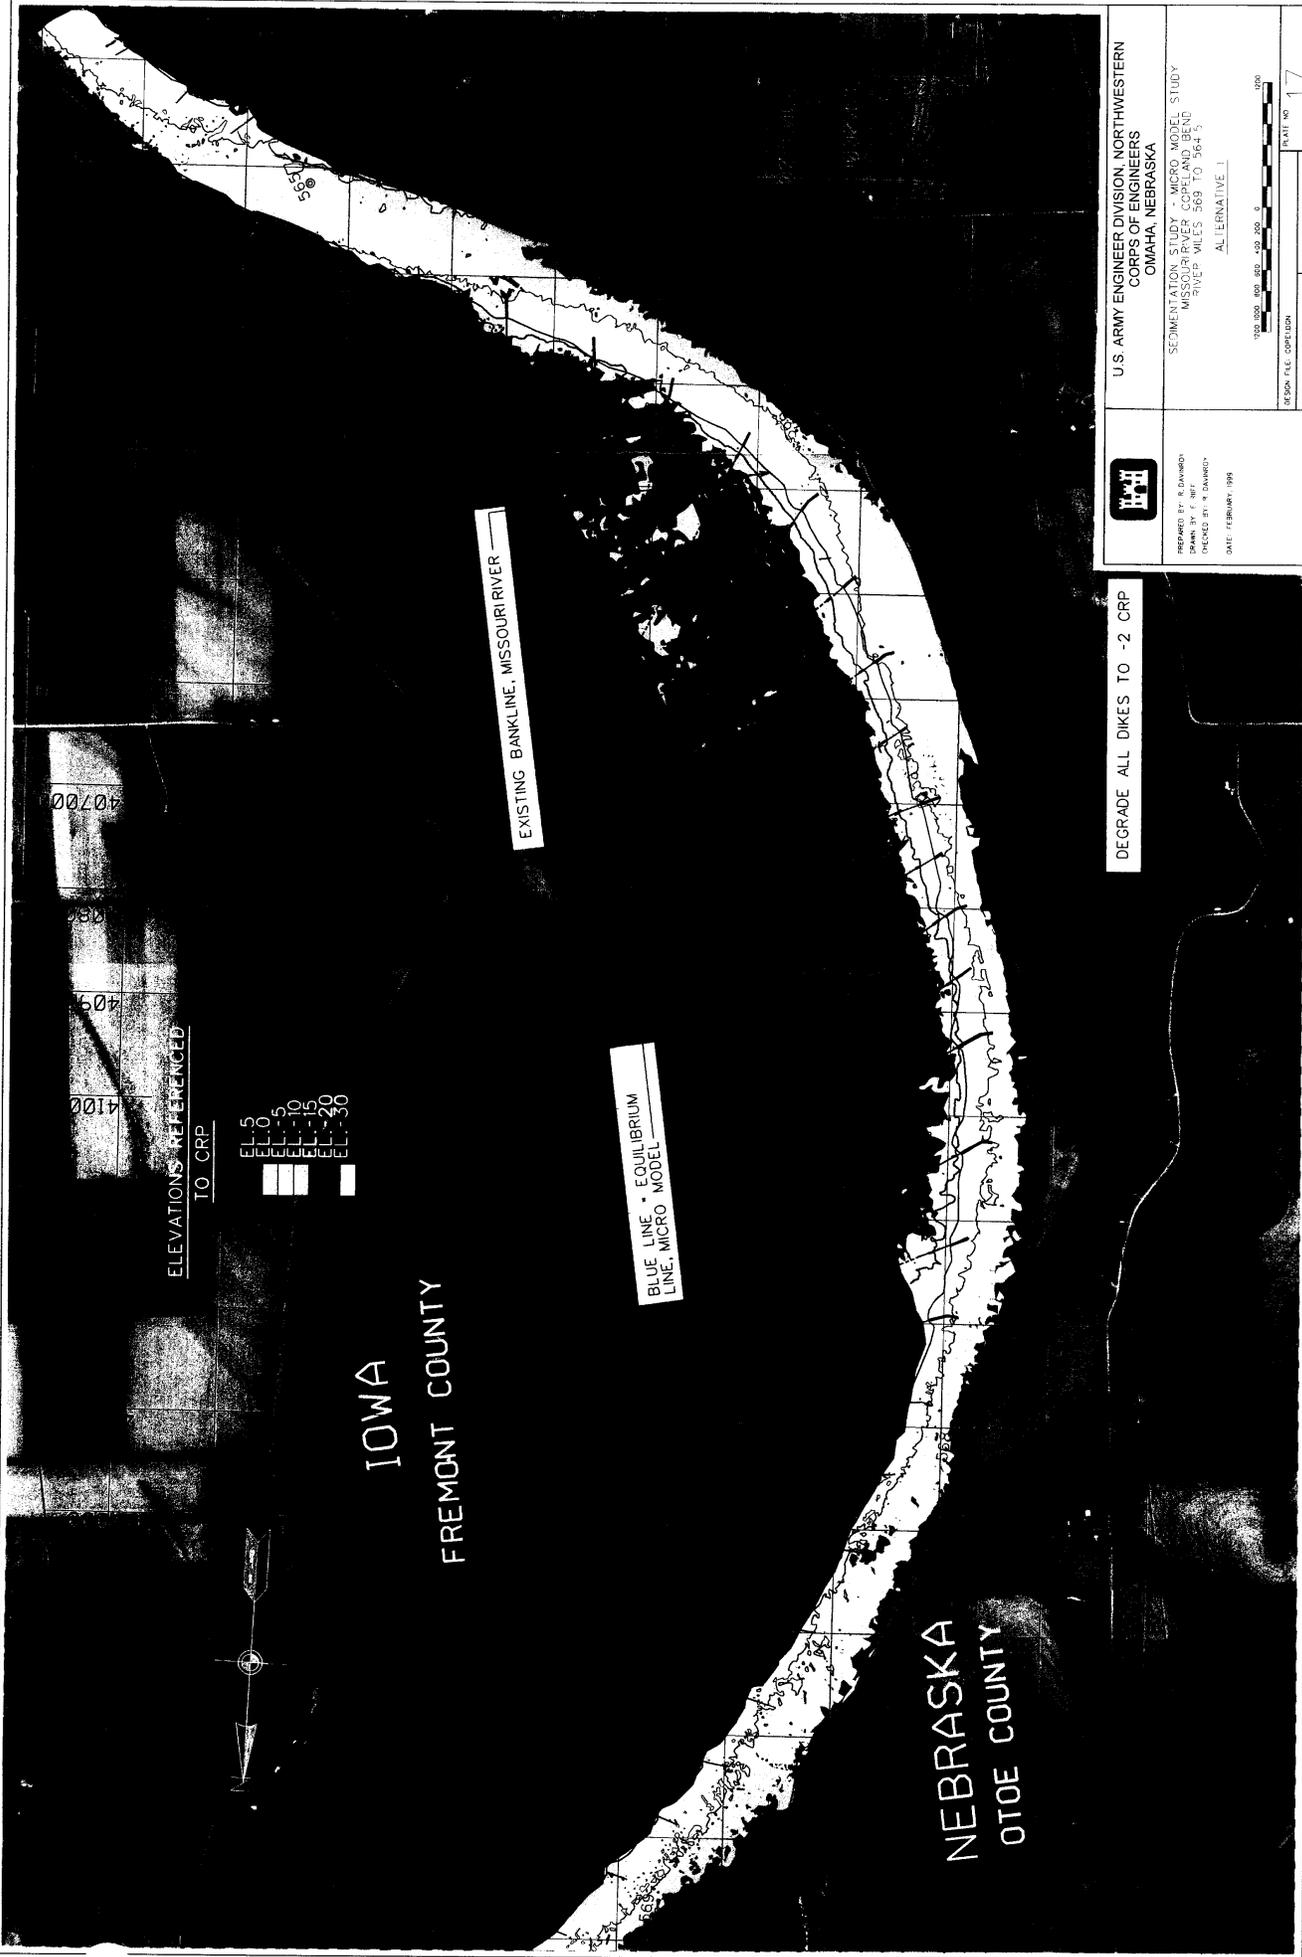
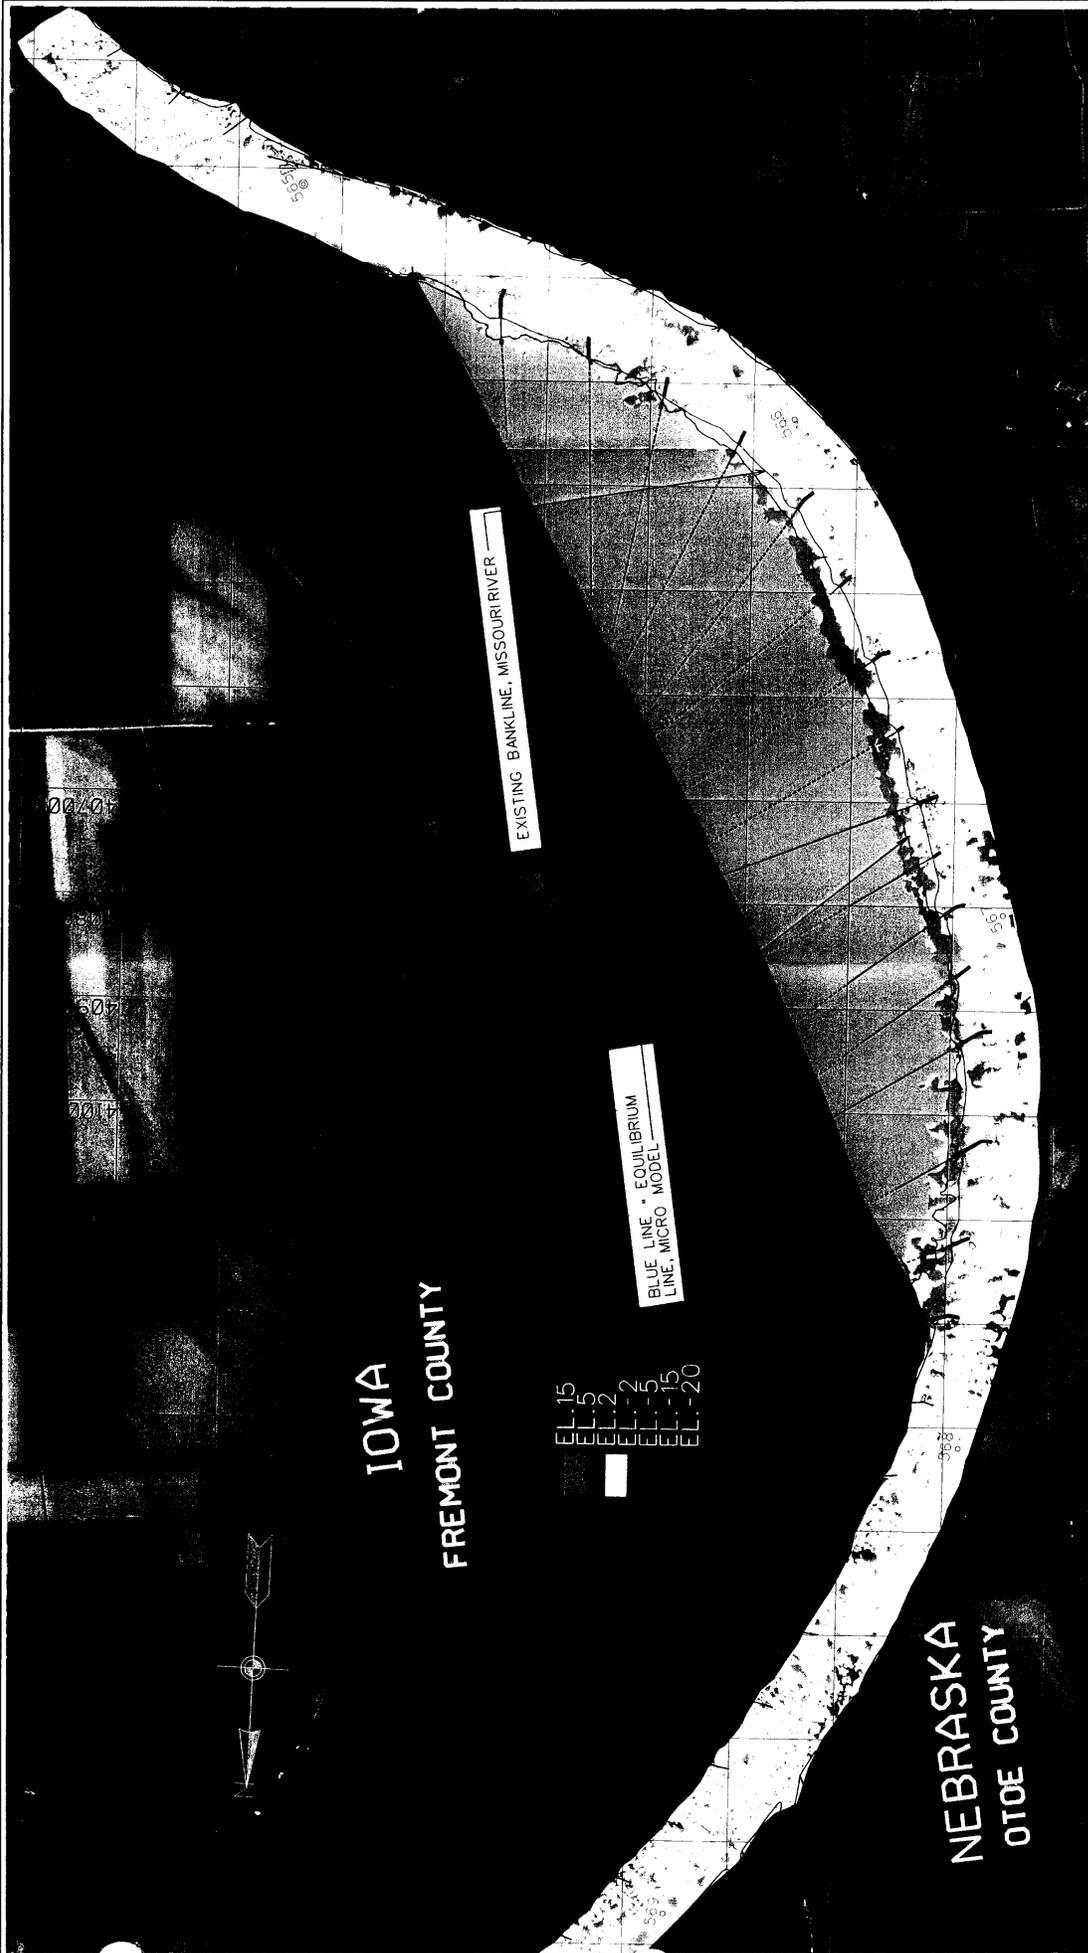
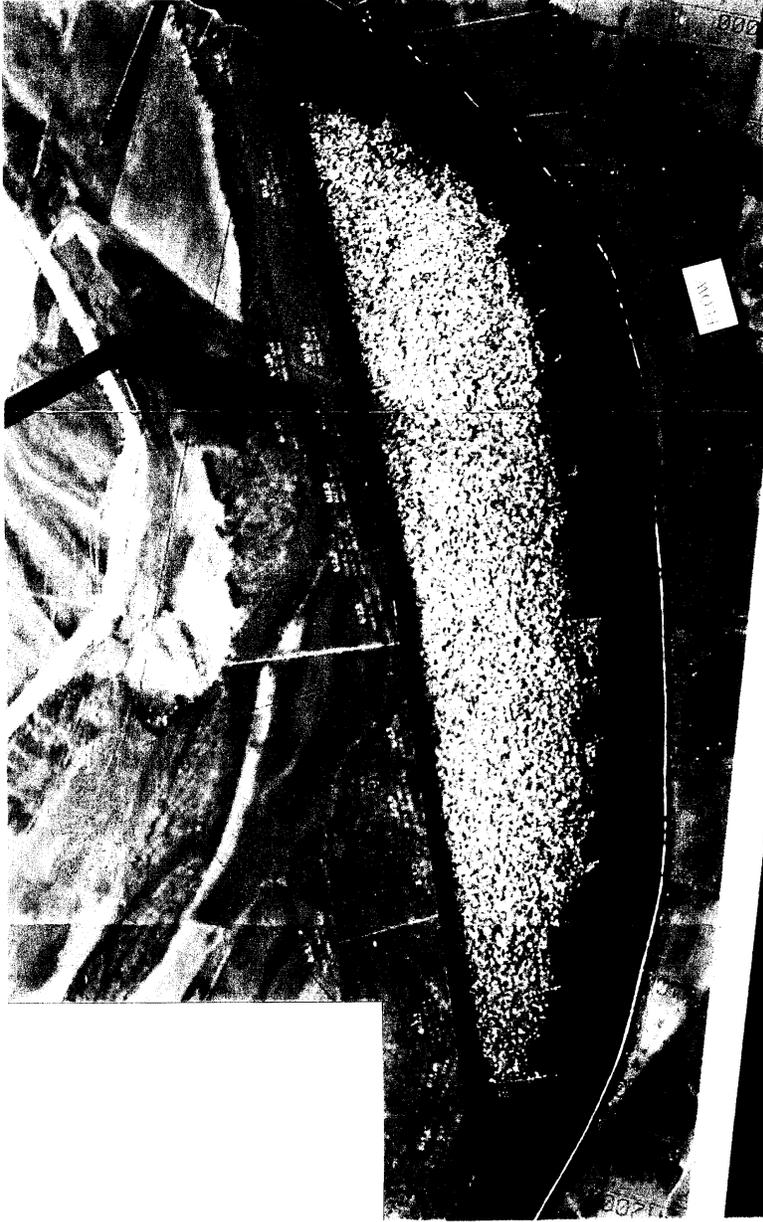
**Alternative 1. Degrade All Existing Dikes To -2 CRP.** Alternative 1 involved the degradation of all dikes to -2 CRP on the left descending bank, between Miles 567.8 and 565.3. Results (Plates 17, 18, 19) indicated the following trends:

Flow visualization showed that flow distribution through the main channel was similar to the base test. Flow still had a tendency to be concentrated at the apex of the bend at Mile 566.0. A greater amount of flow was observed within the dike fields as compared to the base test.

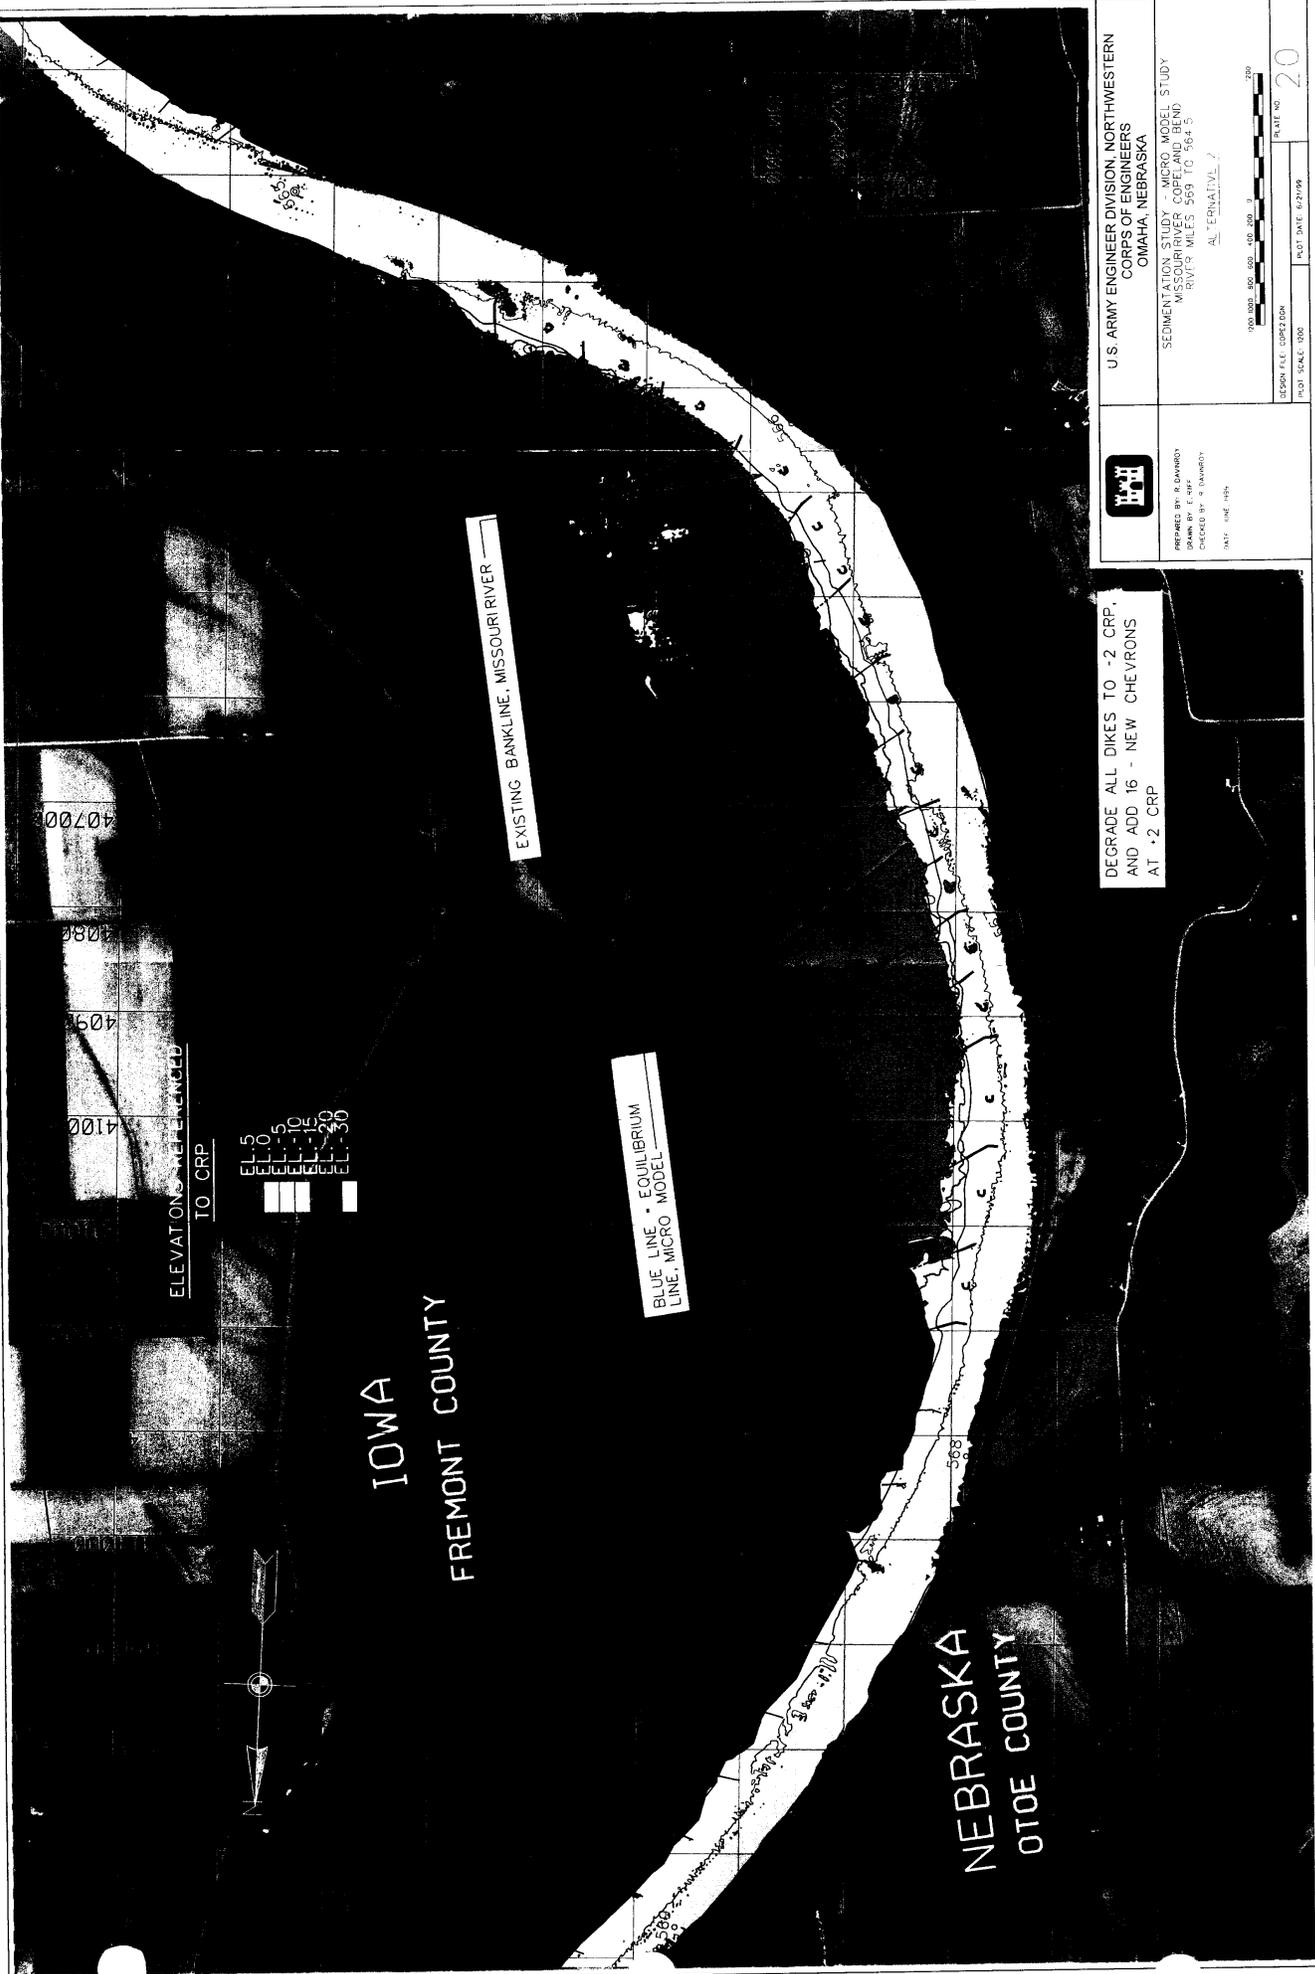
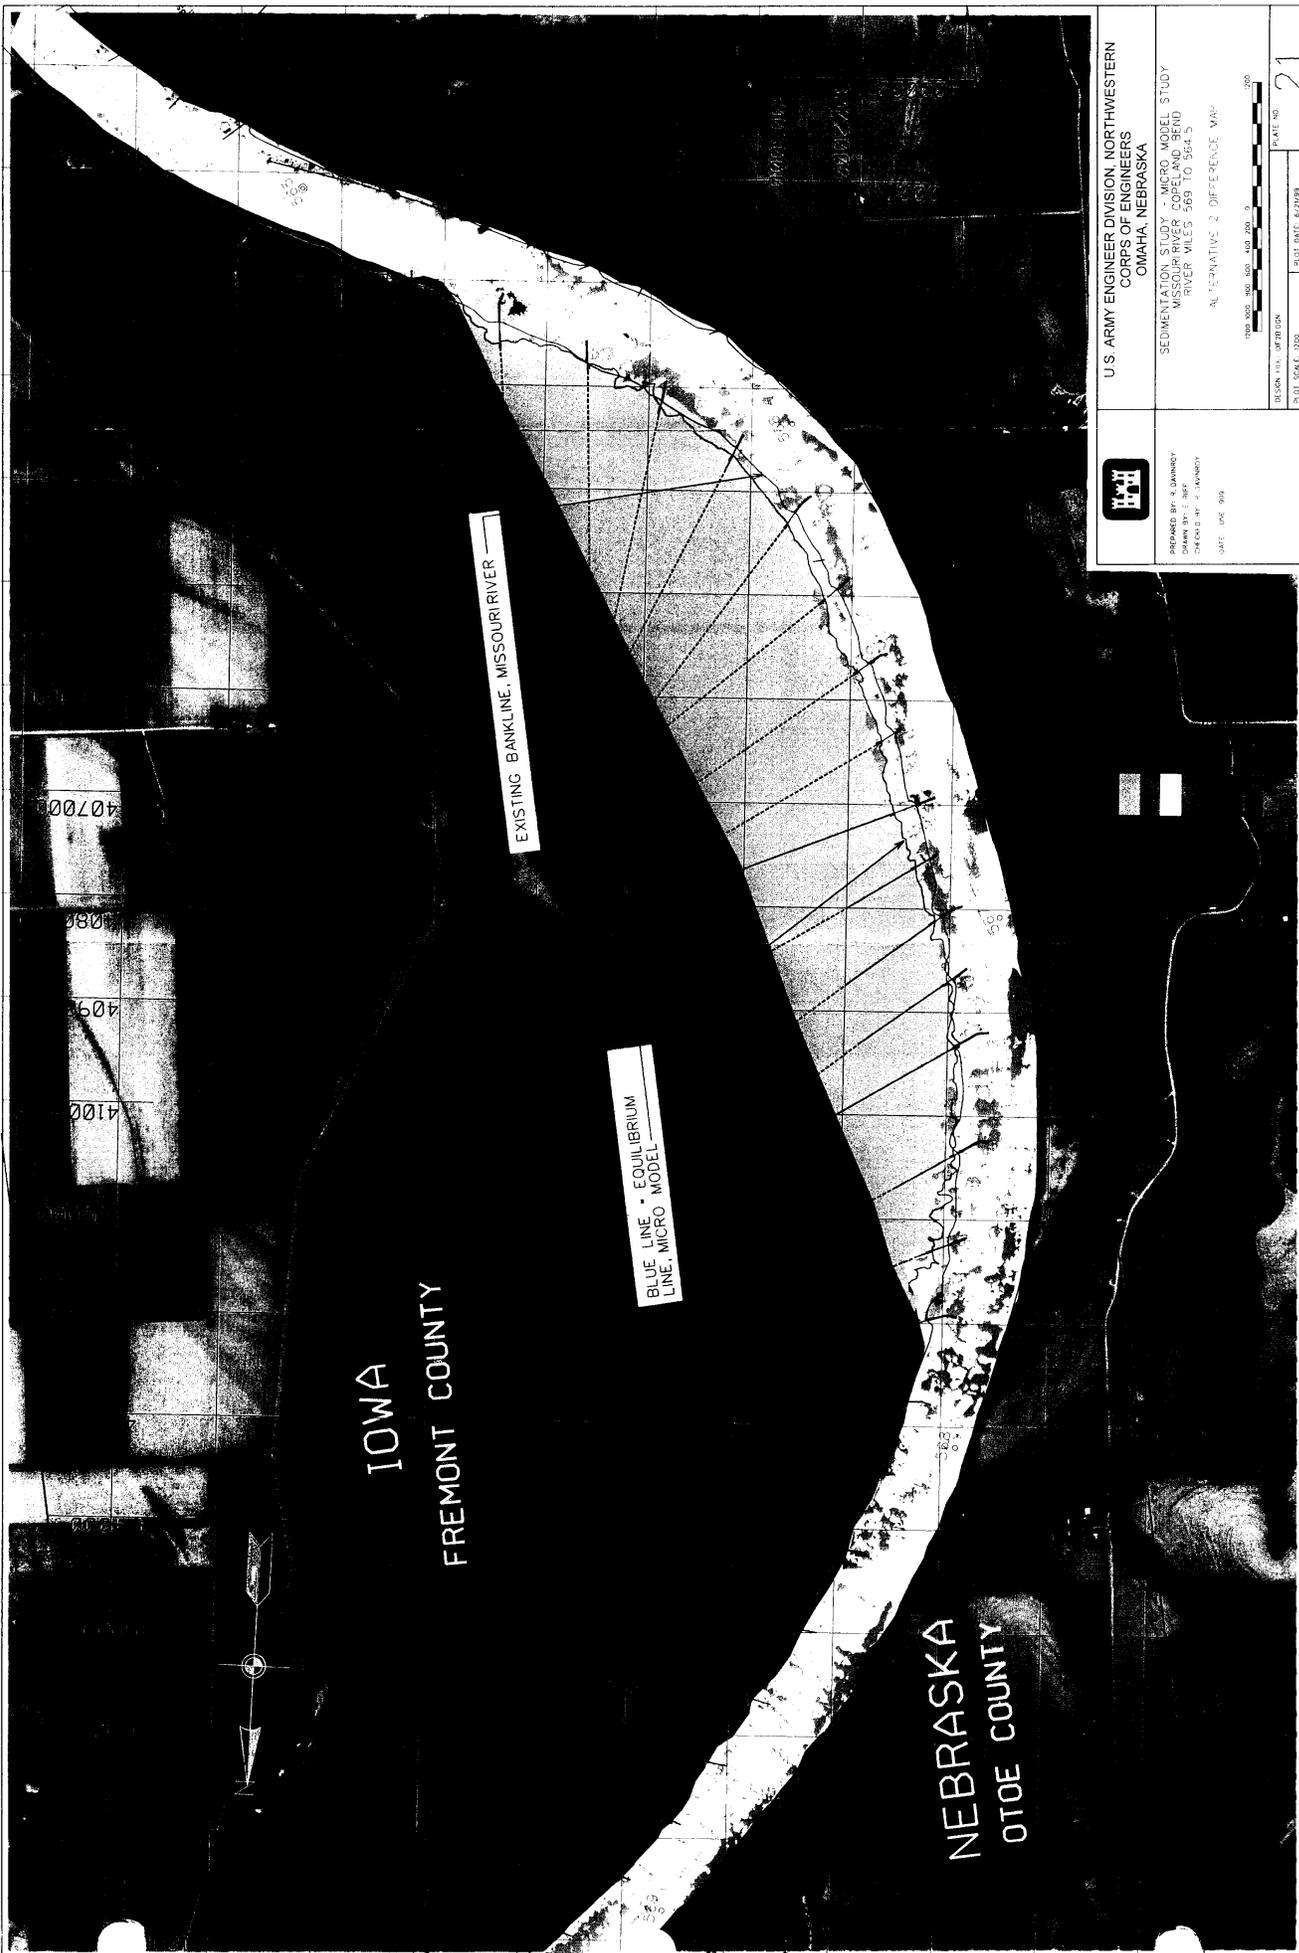
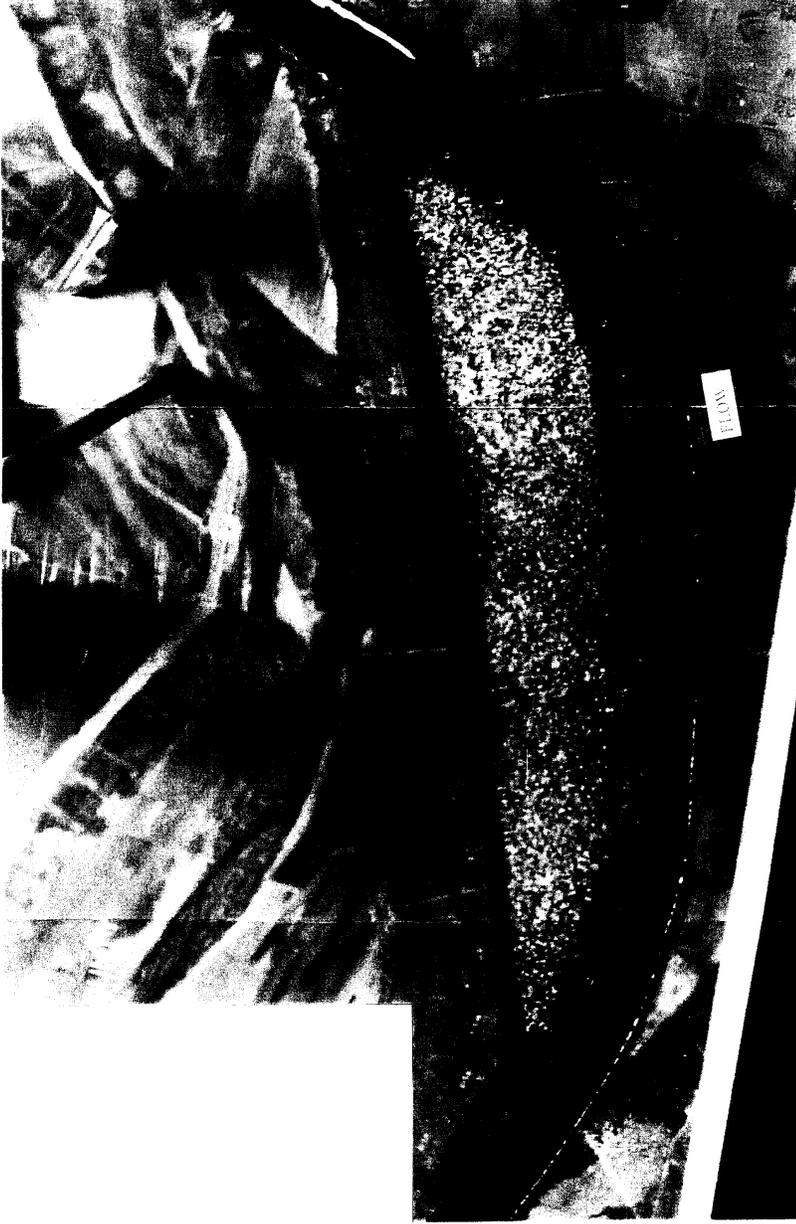
PLAT NO. 20

**Alternative 2. Degrade All Dikes To -2 CRP and Add 16 New Chevrons At +2 CRP.** Alternative 2 involved the degradation of all dikes to -2 CRP as in Alternative 1 and the addition of 16 new chevrons. The chevron crown elevations were placed in the model at +2 CRP. The chevrons were of the blunt-nosed type. Each deflection leg was 75 feet in length at a centerline deflection angle of 30 degrees. Radius of the blunt nose was approximately 25 feet. The chevrons were strategically placed in the middle of each dike spacing, except between dikes 612.0 and 611.85, where the structures were placed closer to the existing dikes. The chevrons were streamlined just within the dike endpoints for the purposes of generating maximum effects to the navigation channel. The goal was to place the structures as close to the main channel as possible but still
