**TECHNICAL REPORT M10**

**SEDIMENTATION AND NAVIGATION STUDY OF THE  
MISSOURI RIVER,  
COPELAND BEND  
MILES 569 TO 564.5**

**HYDRAULIC MICRO MODEL INVESTIGATION**

Final Report - September, 1999

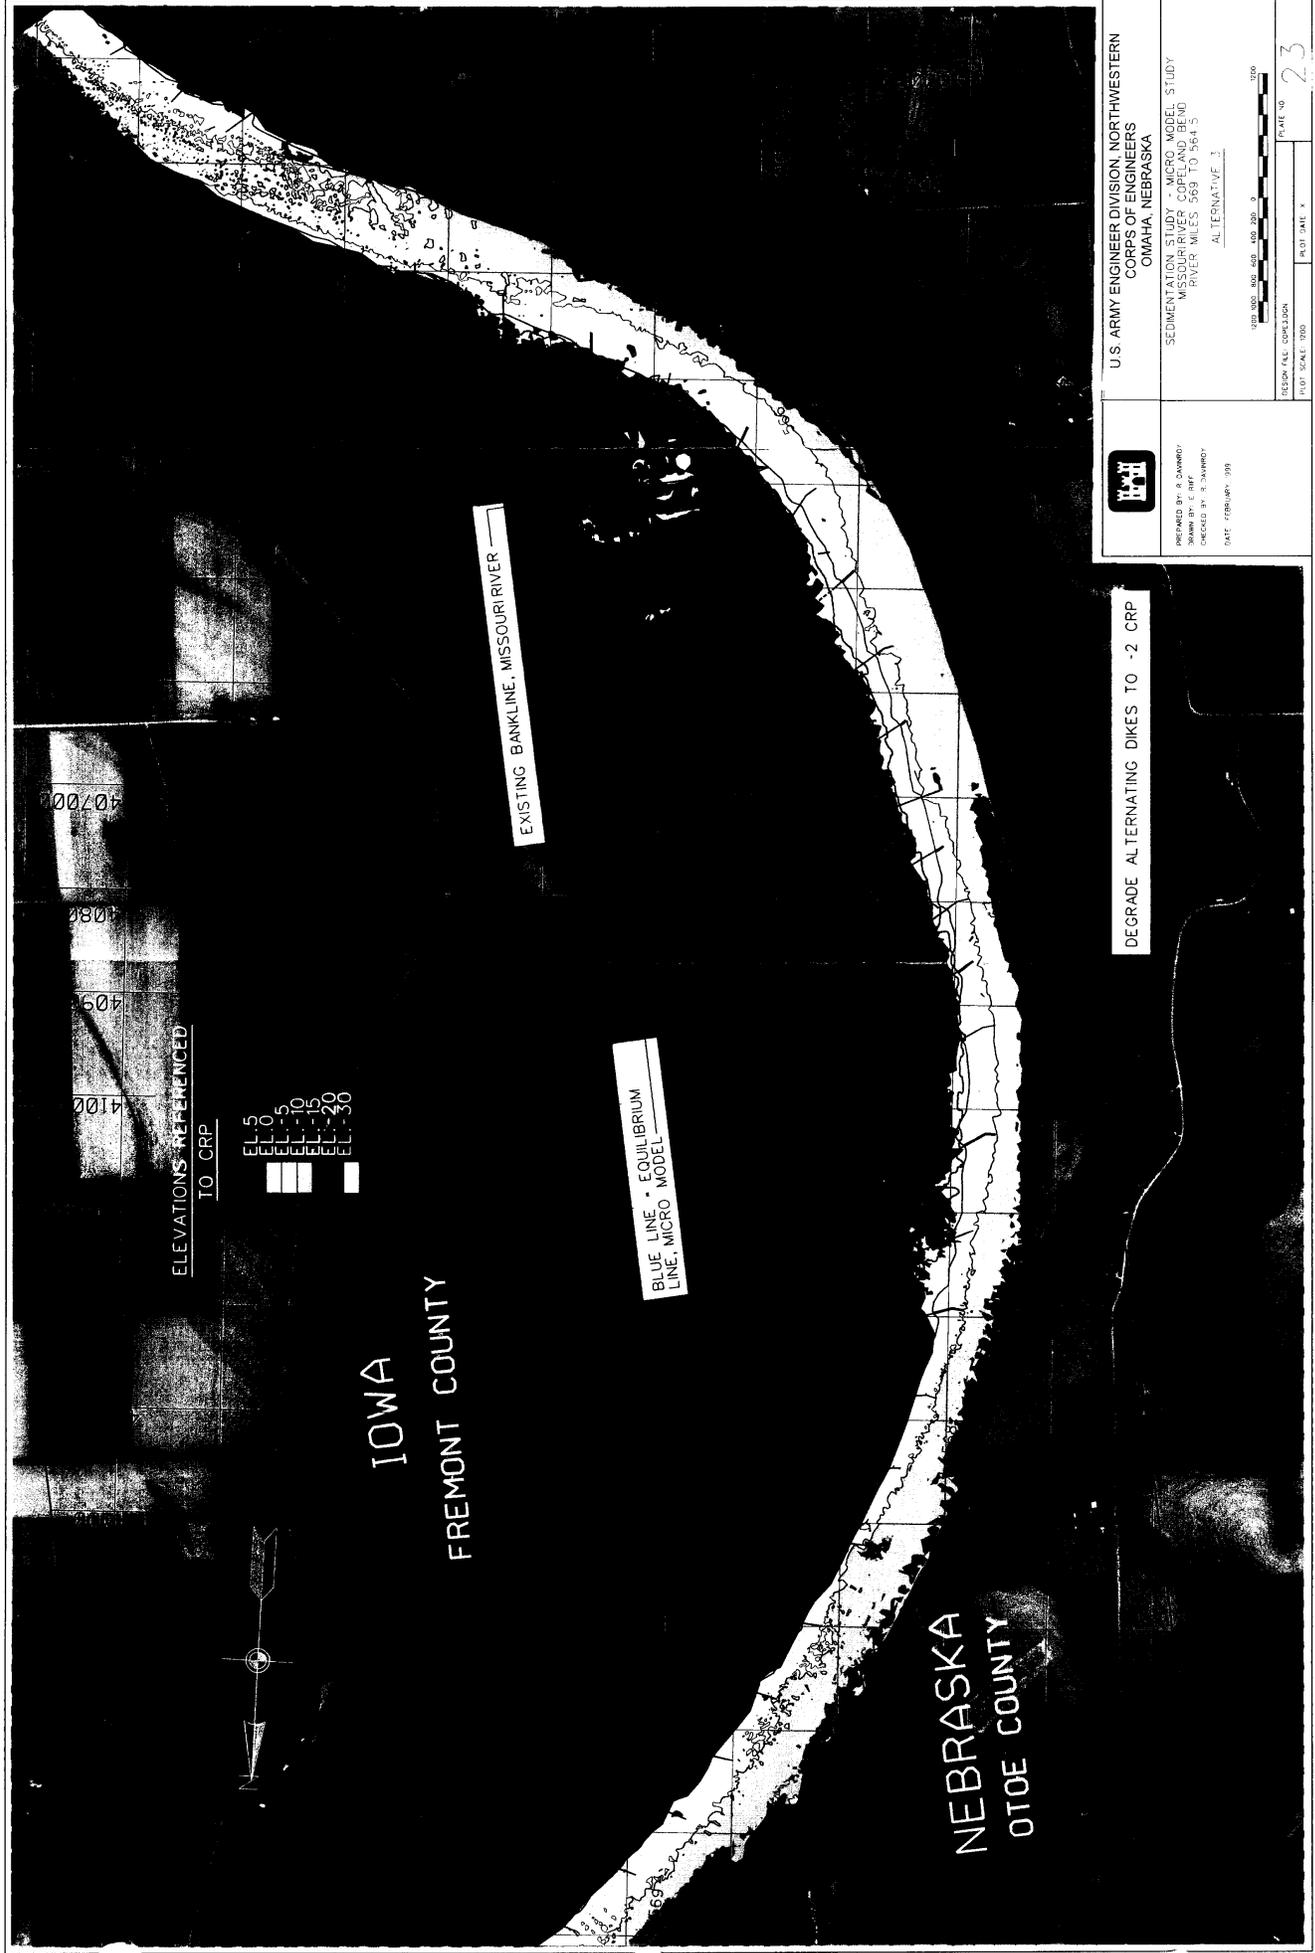
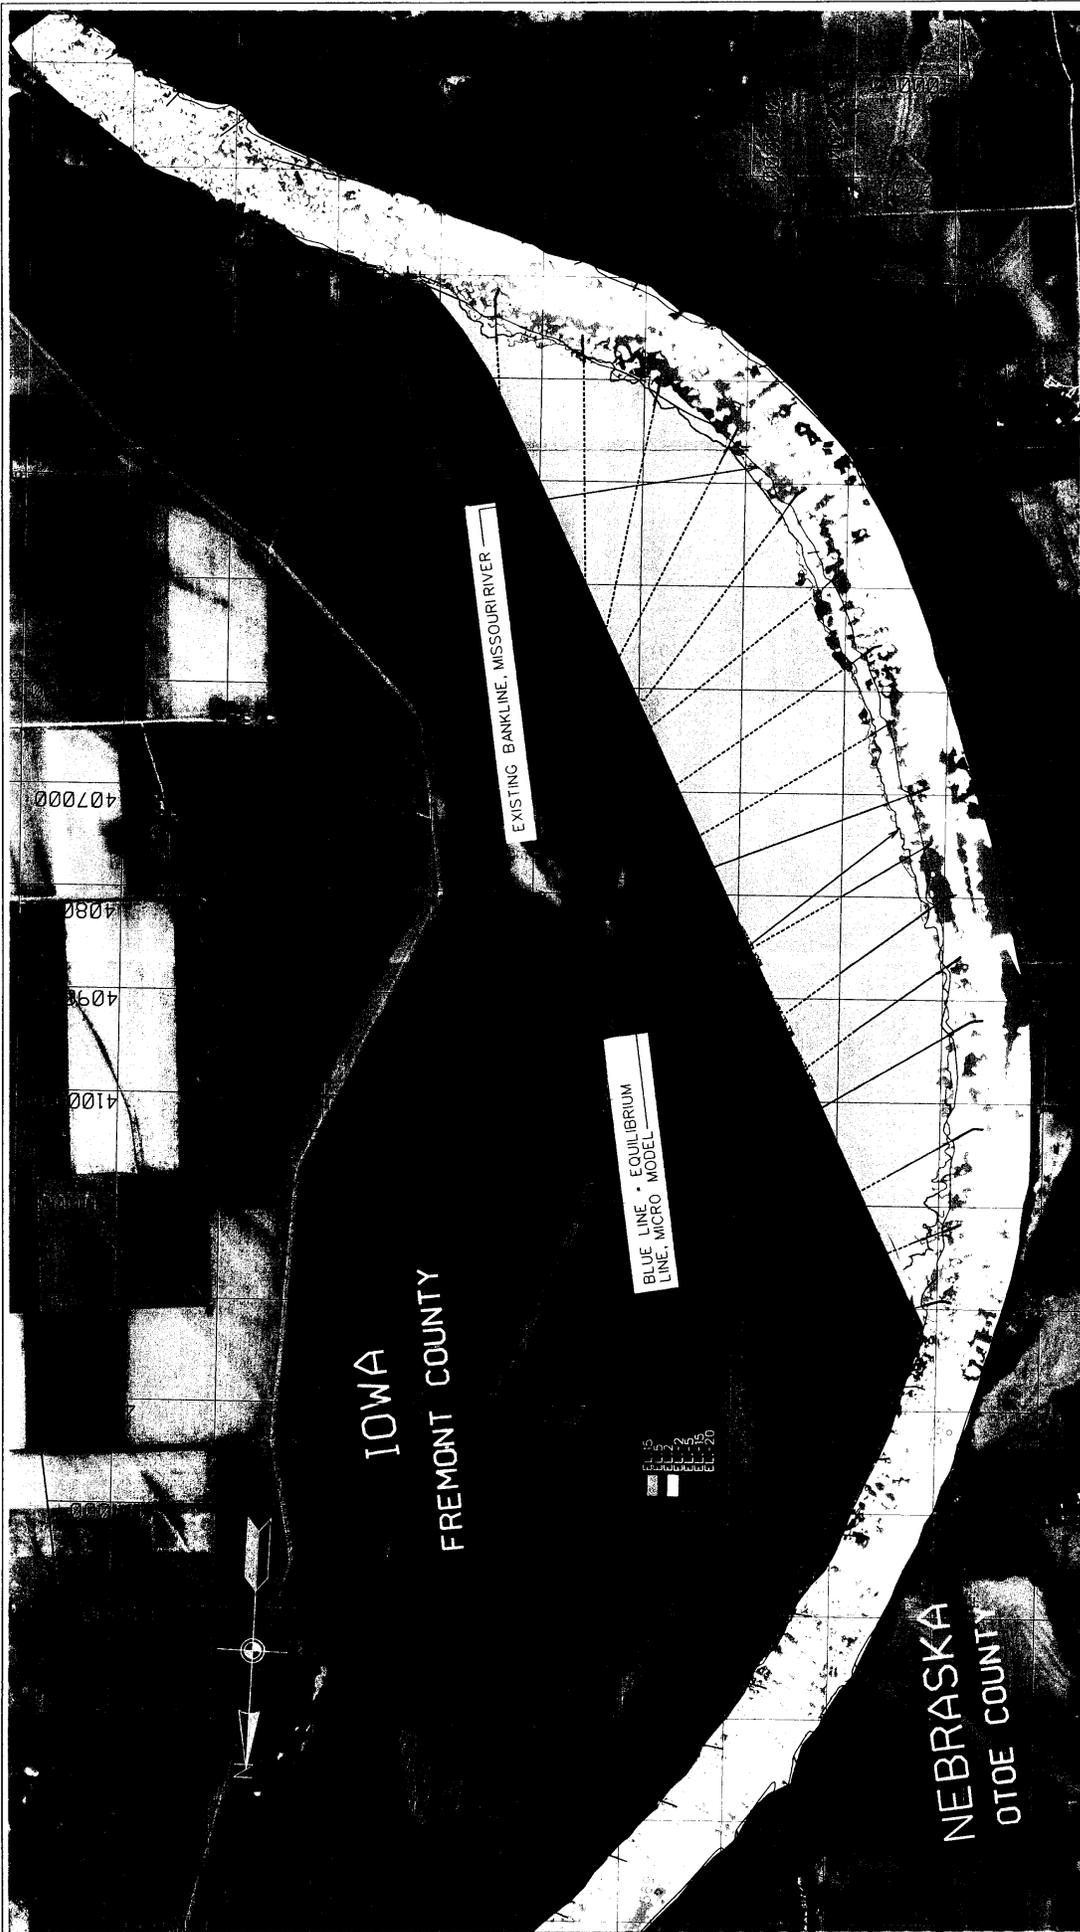
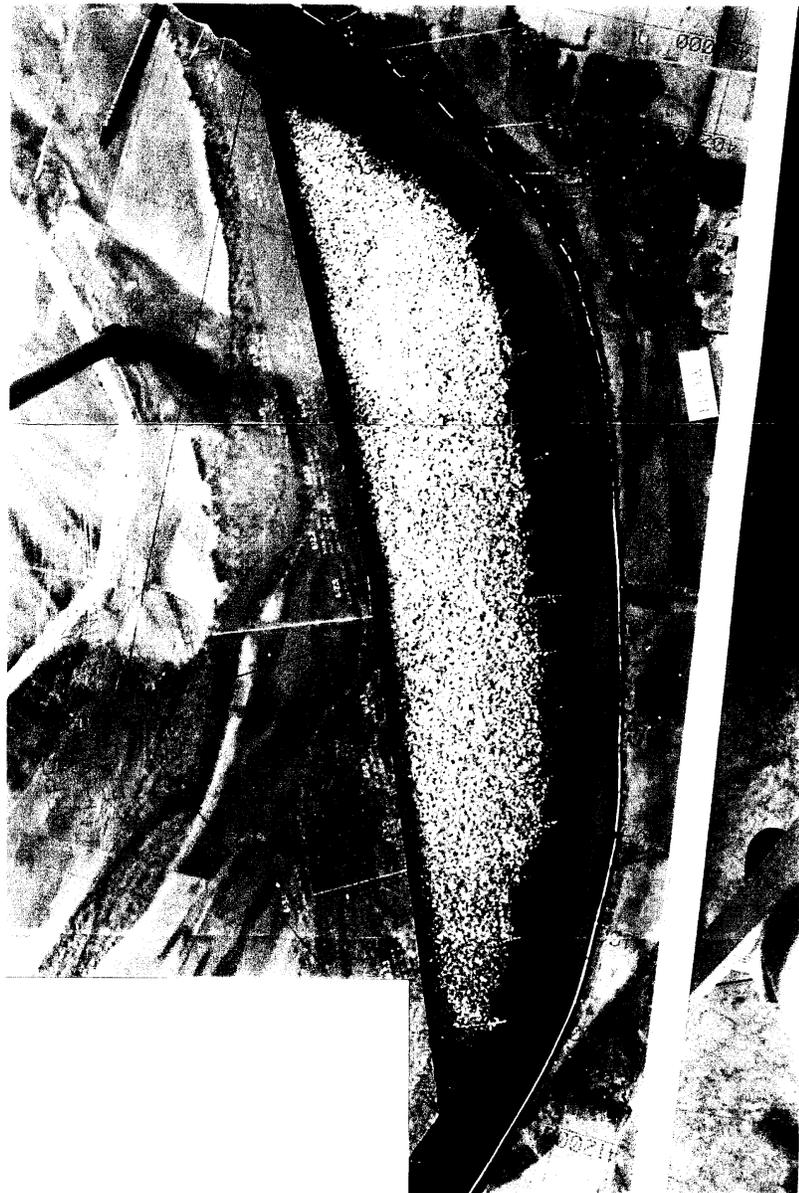
**Alternative 3. Degrade Alternating Dikes To -2 CRP.** Alternative 3 involved the degradation of alternating dikes along the left descending bank. Results (Plates 23, 24, 25) indicated the following trends:

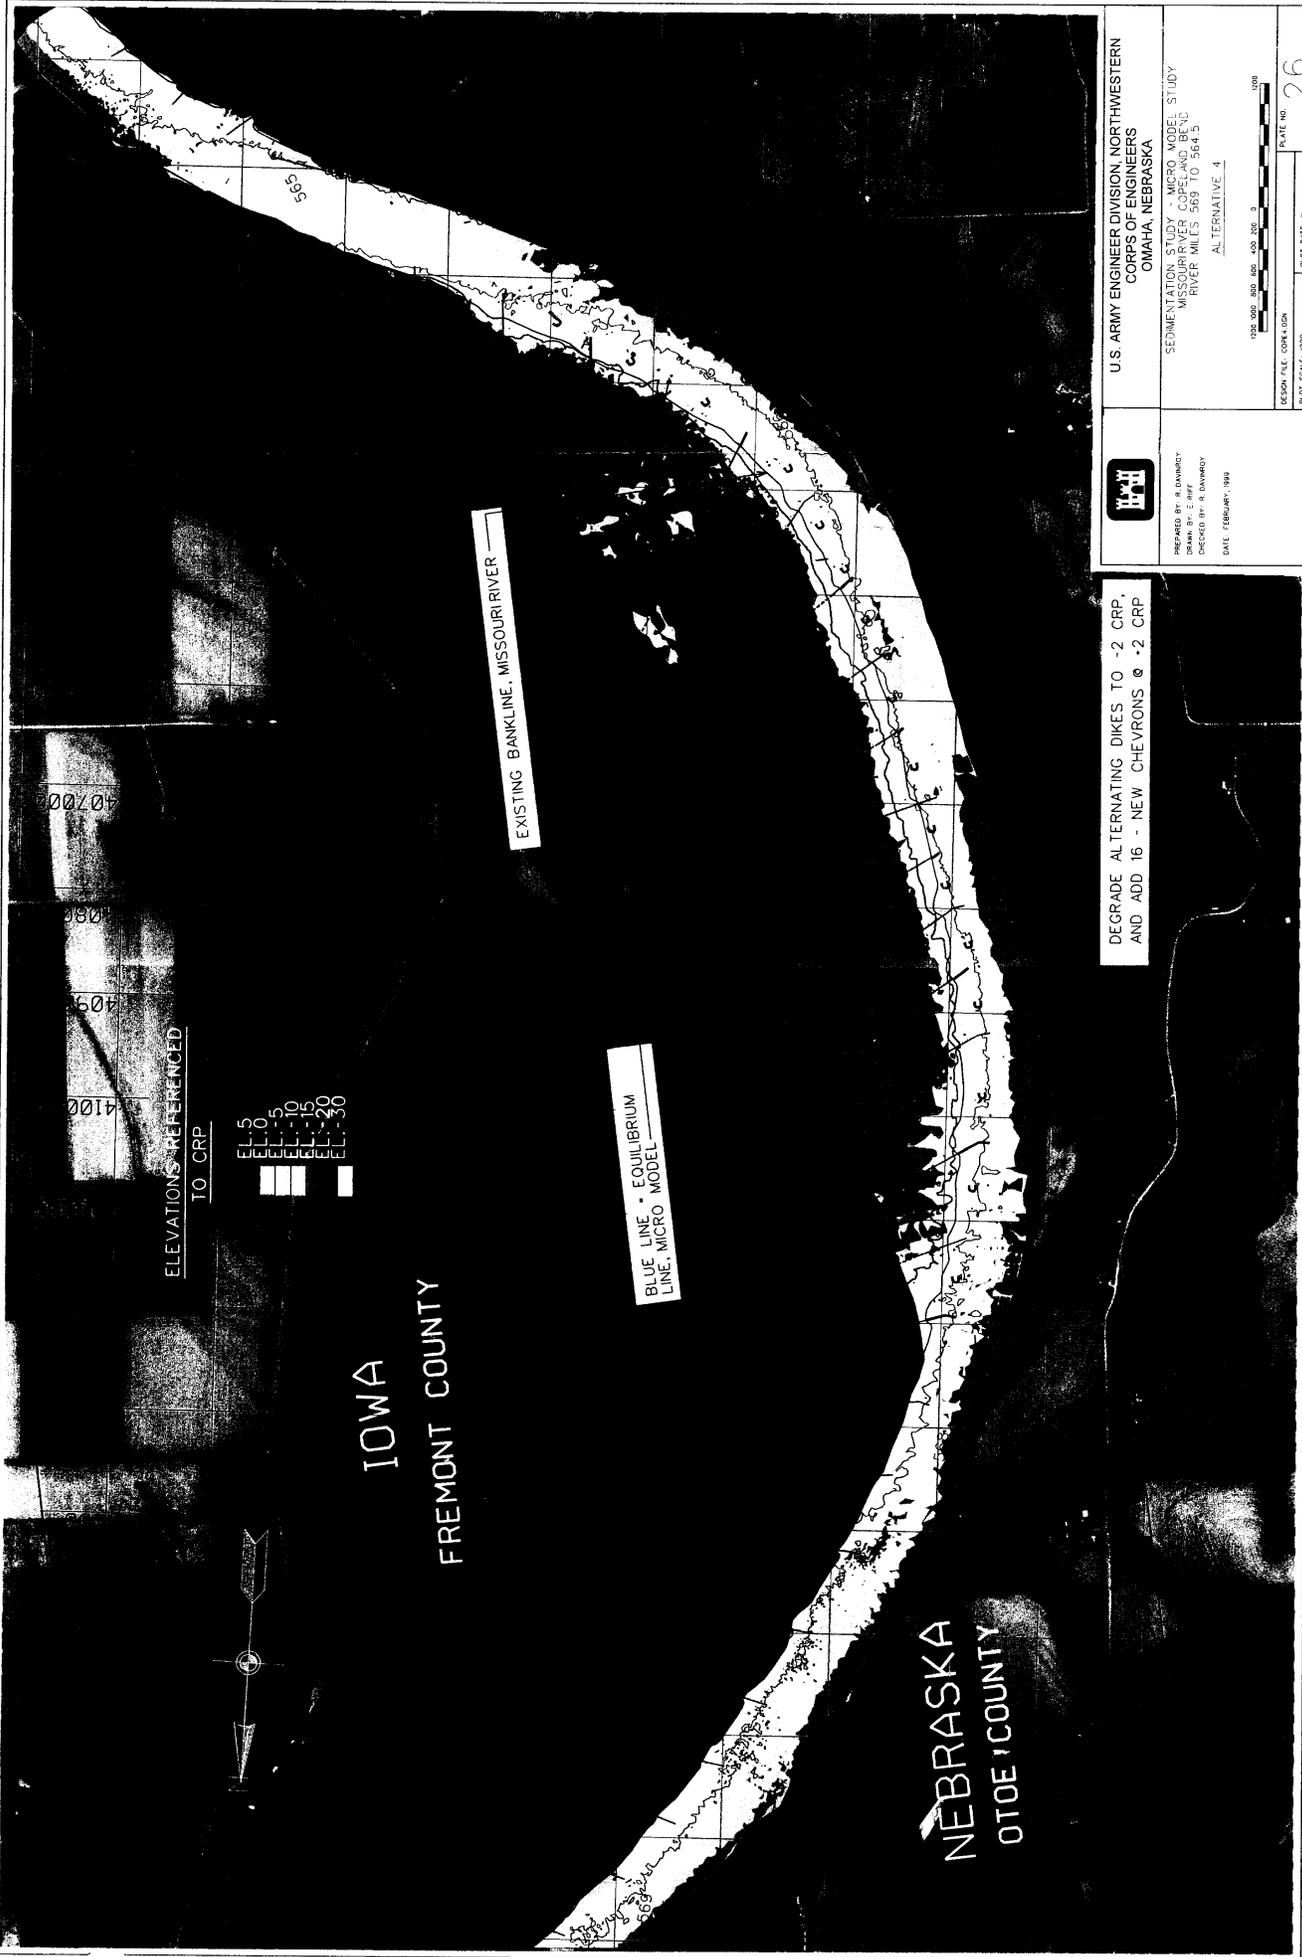
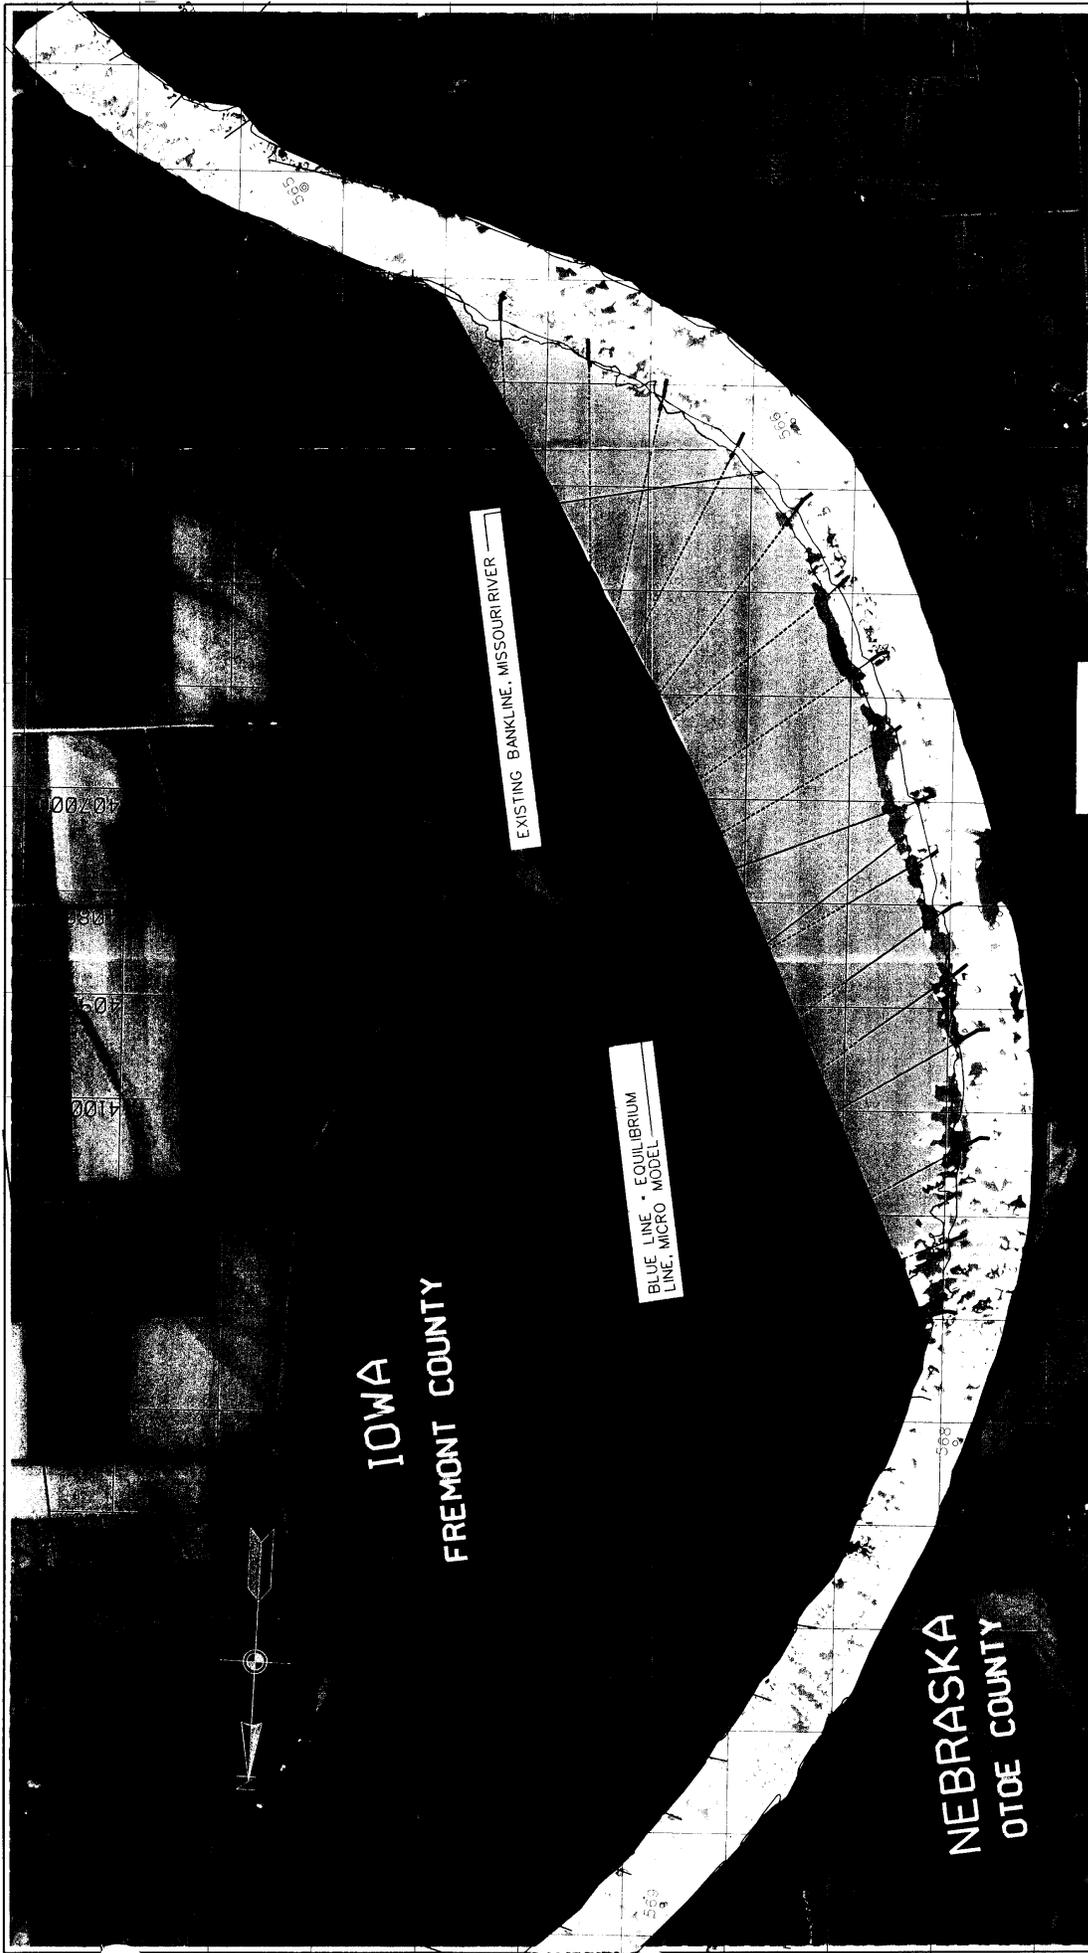
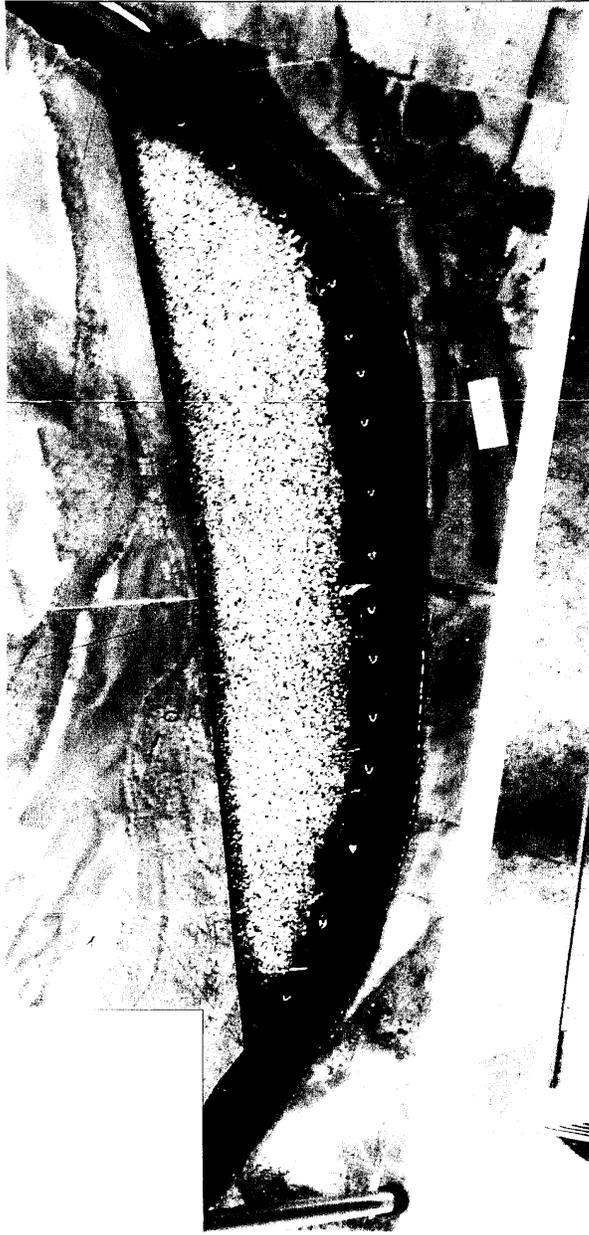
PLAT NO 26

**Chevrons At +2 CRP.** Alternative 4 involved the degradation of alternating dikes to -2 CRP along the left descending bank in addition to 16 New Chevrons placed in the same configuration as Alternative 2. Results (Plates 26, 27, and 28) indicated the following trends:

Flow visualization showed that flow distribution through the main channel was similar to the base test. Flow still had a tendency to be concentrated at the apex of the bend at Mile 566.0. Results also indicated that more flow was distributed over the dike fields as compared to the base test. In addition, some of the chevrons produced flow "shadows" directly downstream of each structure as a result of individual boundary effects, similar to what was observed in the previous Alternative 2.

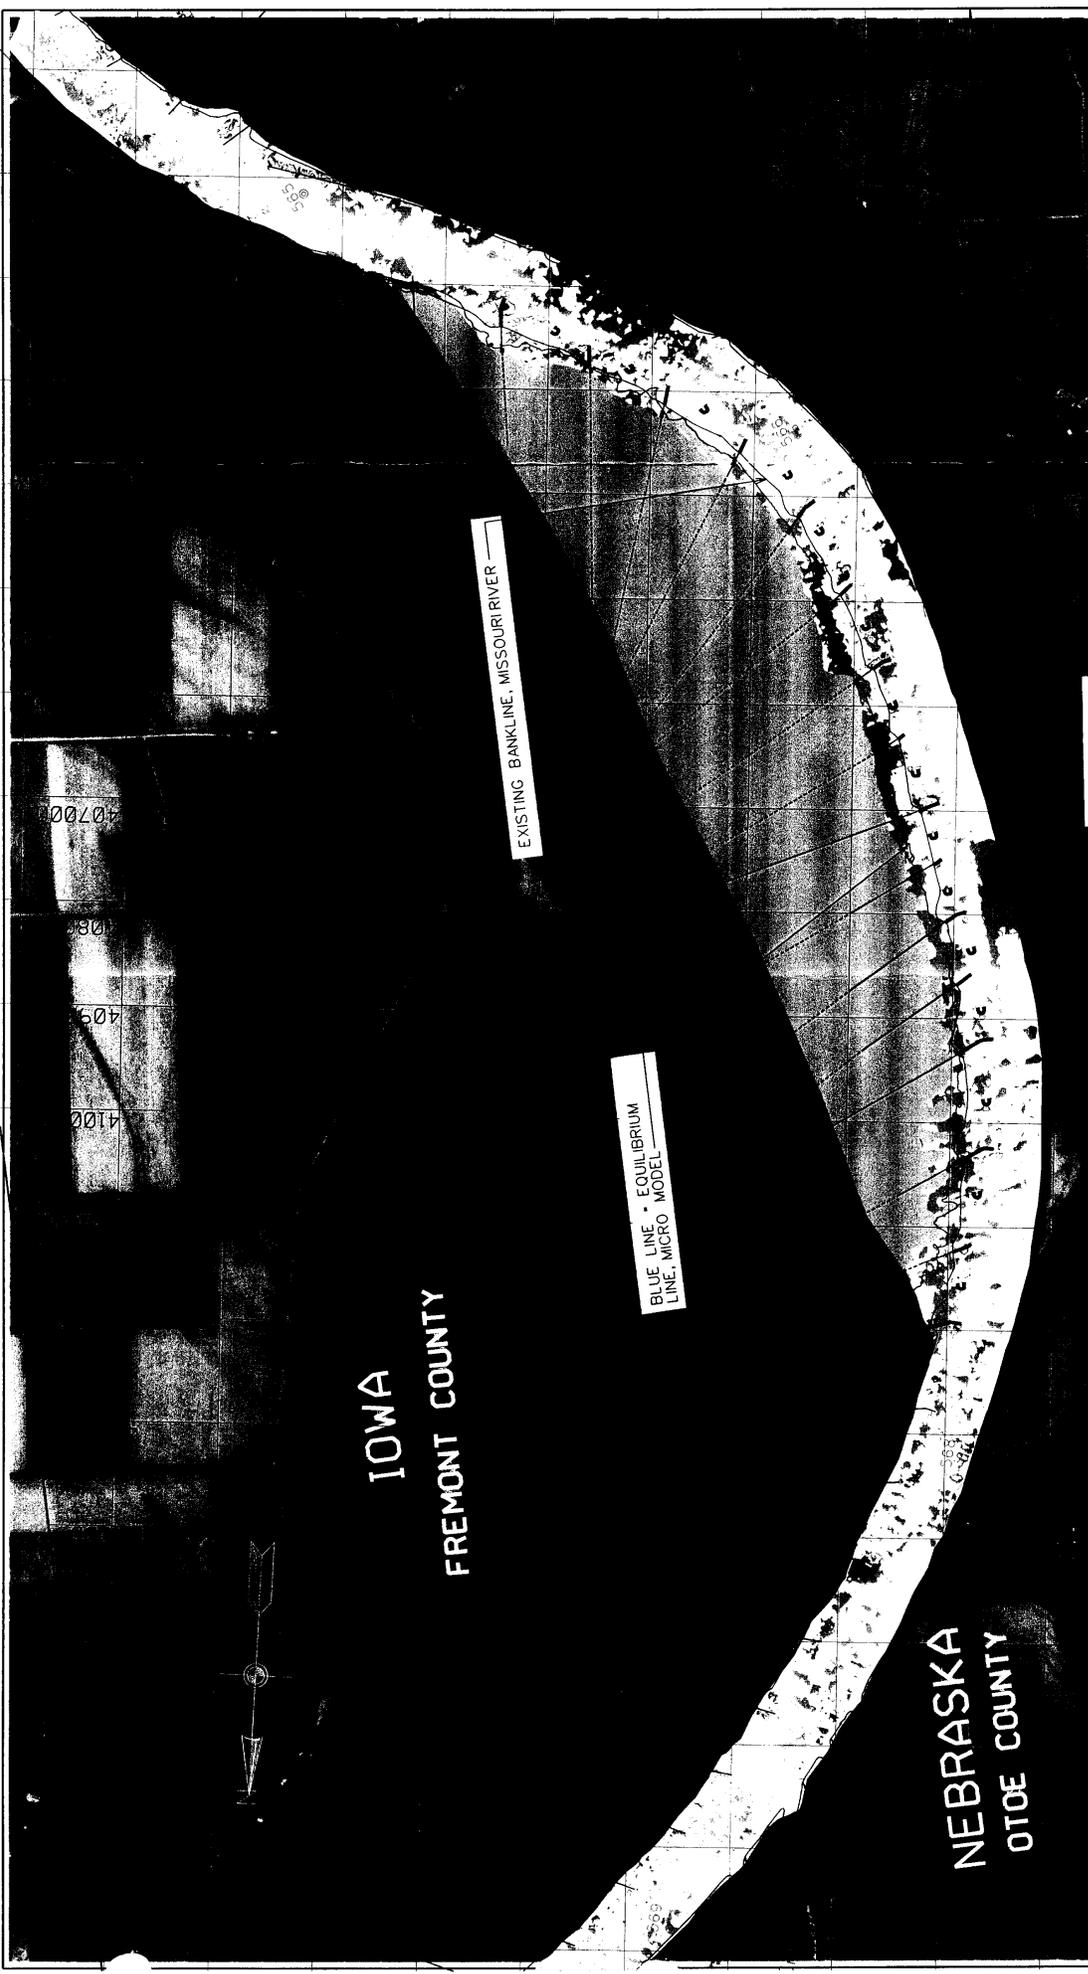
<p>U.S. ARMY ENGINEER DIVISION, NORTHWESTERN CORPS OF ENGINEERS OMAHA, NEBRASKA</p>	<p>SEDIMENTATION STUDY - MICRO MODEL STUDY MISSOURI RIVER, GORLAND BEND RIVER MILES 569 TO 584.5 ALTERNATIVE 6 DIFFERENCE MAP</p> <p>DESIGN FILE: 29A-604 N. 30 SCALE: 2000</p> <p>DATE: JUL 1979</p> <p>SCALE: 1" = 2000'</p> <p>PLAT NO. 33</p>
---	---

**Alternative 6. All Dikes Notched To -5 CRP and Add 16 New Chevrons At +2 CRP.** Alternative 6 involved excavating a 50-ft landward notch on all existing dikes between Miles 567.8 and 565.3 in addition to 16 new chevrons strategically placed between the dikes as in Alternative 2. Results (Plates 32, 33, 34) indicated the following trends:

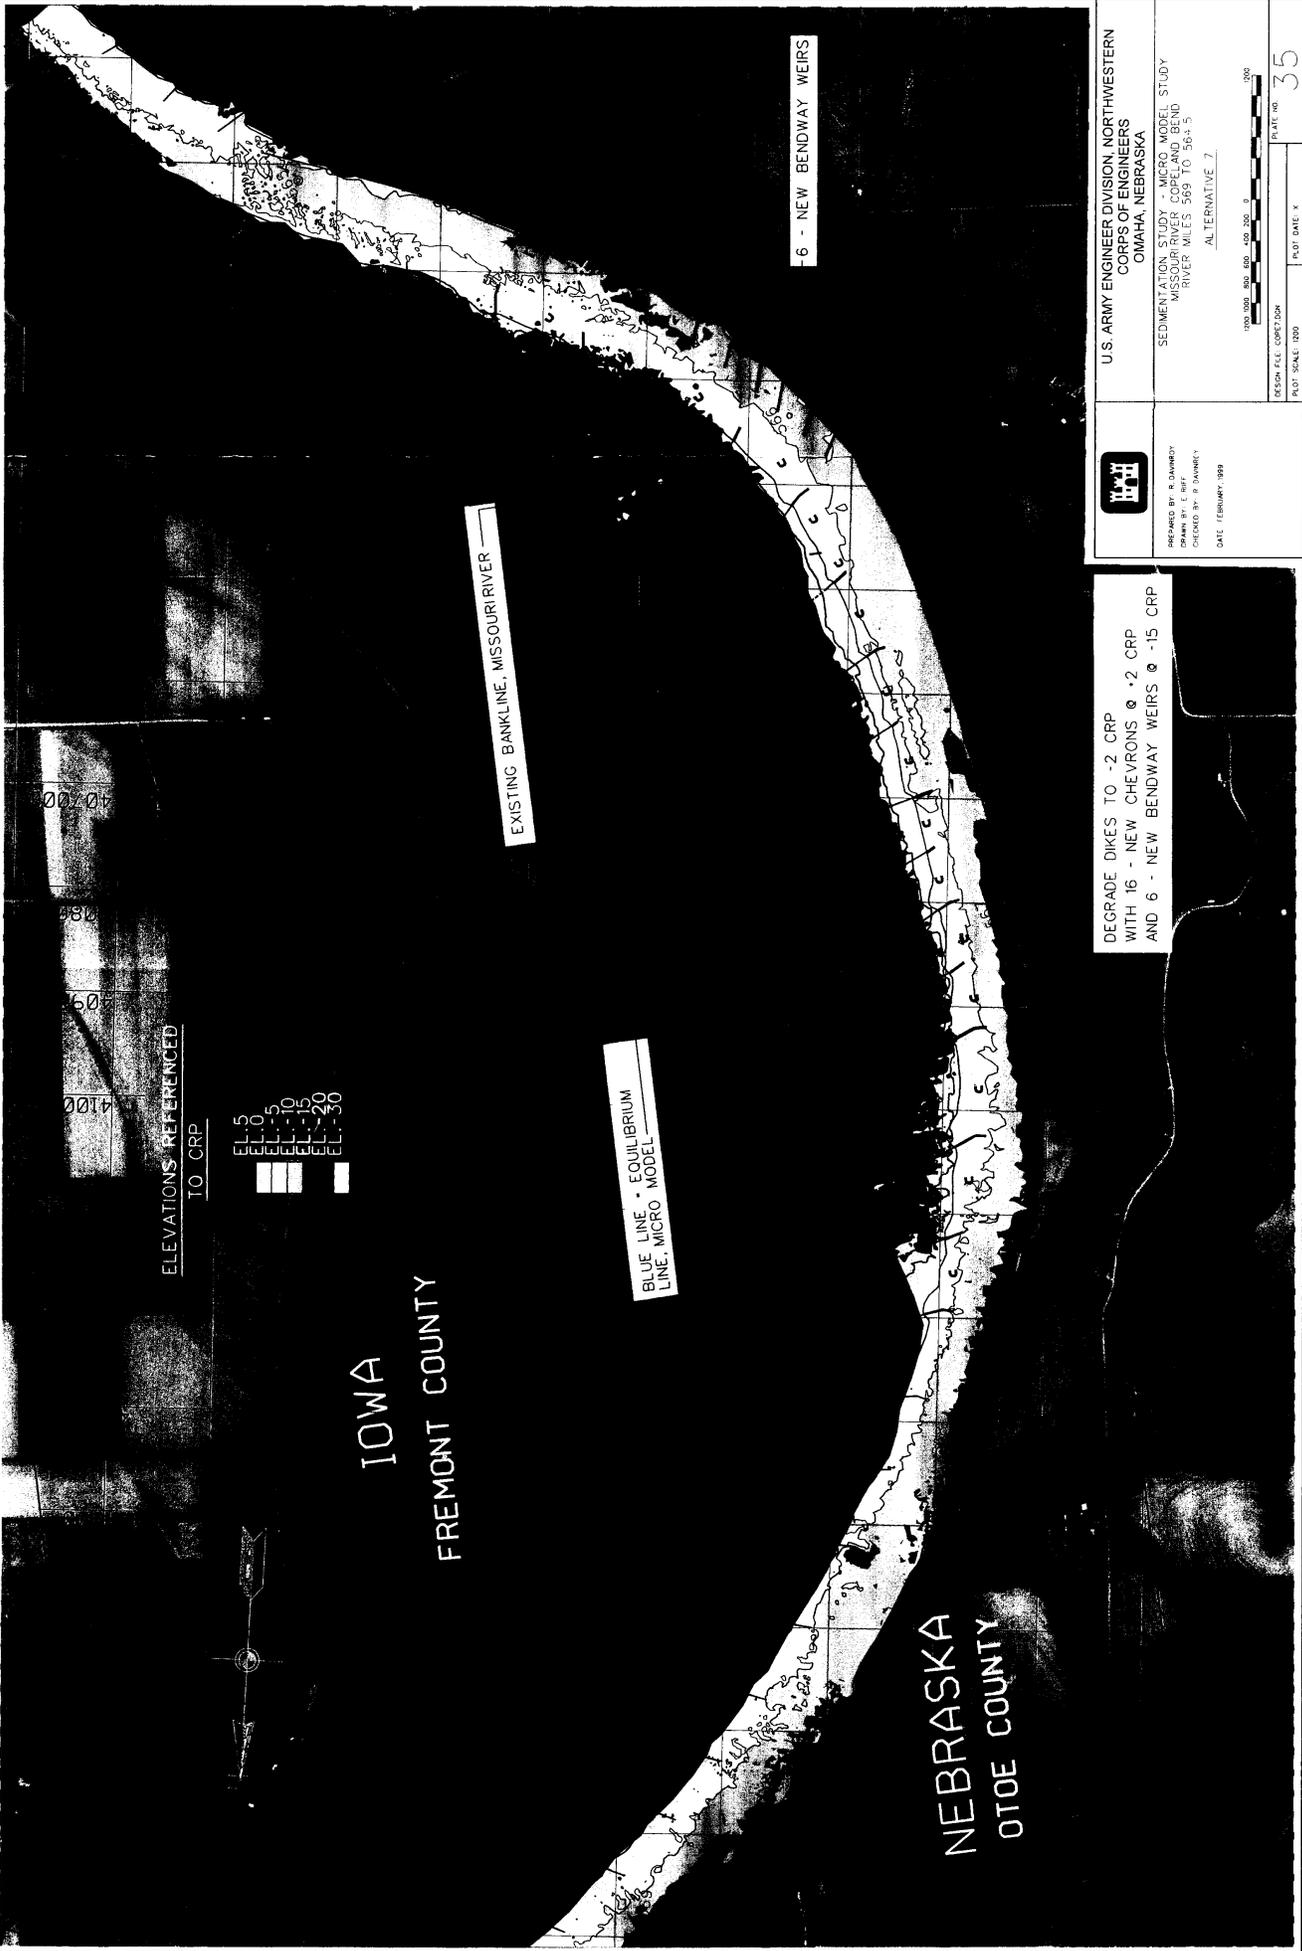
1" = 2000'  
0 500 1000 1500 2000  
DESIGN FILE: CORPZ 30K  
PLOT SCALE: 1000  
PLATE NO: 35  
PLOT DATE: X

DEGRADE DIKES TO -2 CRP  
WITH 16 - NEW CHEVRONS @ +2 CRP  
AND 6 - NEW BENDWAY WEIRS @ +15 CRP

SEDIMENTATION STUDY - MICRO MODEL STUDY  
MISSOURI RIVER BENDWAY WEIR AT BEND  
RIVER MILES 399 TO 394+5  
ALTERNATIVE 7

Alternative 7 was a repeat of Alternative 2 with the addition of 6 Bendway Weirs placed in the navigation channel between Miles 566.2 and 565.8. Results (Plates 35, 36, 37) indicated the following trends:

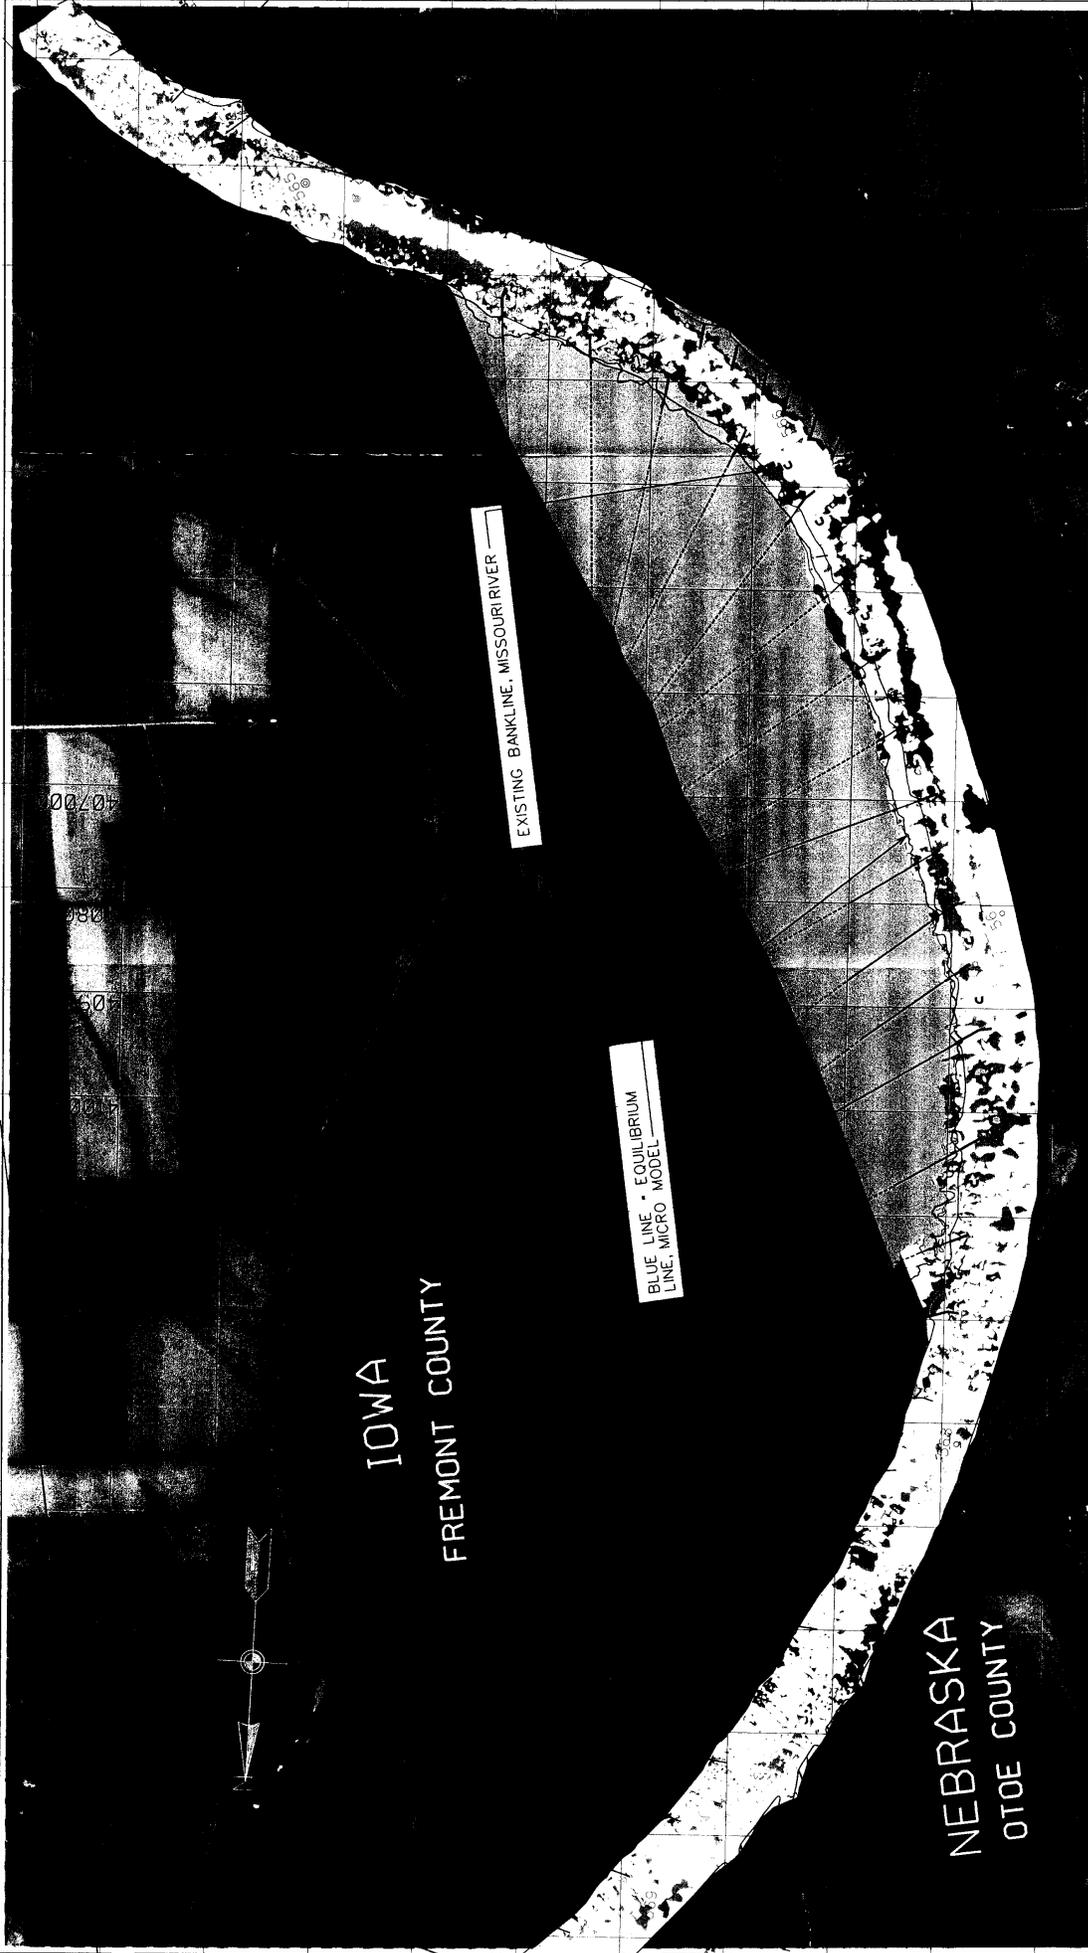
<p>U.S. ARMY ENGINEER DIVISION, NORTHWESTERN CORPS OF ENGINEERS OMAHA, NEBRASKA</p>
	<p>SEDIMENTATION STUDY - MICRO MODEL STUDY MISSOURI RIVER, COPELAND BEND RIVER MILES 569 TO 564.5 ALTERNATIVE 7 DIFFERENCE MAP</p>
<p>DESIGN FILE: DPT 730A PLOT SCALE: 1:500</p>	<p>PLOT DATE: 02/19/88 PLATE NO: 36</p>
