**TECHNICAL REPORT M10**

**SEDIMENTATION AND NAVIGATION STUDY OF THE  
MISSOURI RIVER,  
COPELAND BEND  
MILES 569 TO 564.5**

**HYDRAULIC MICRO MODEL INVESTIGATION**

Final Report - September, 1999

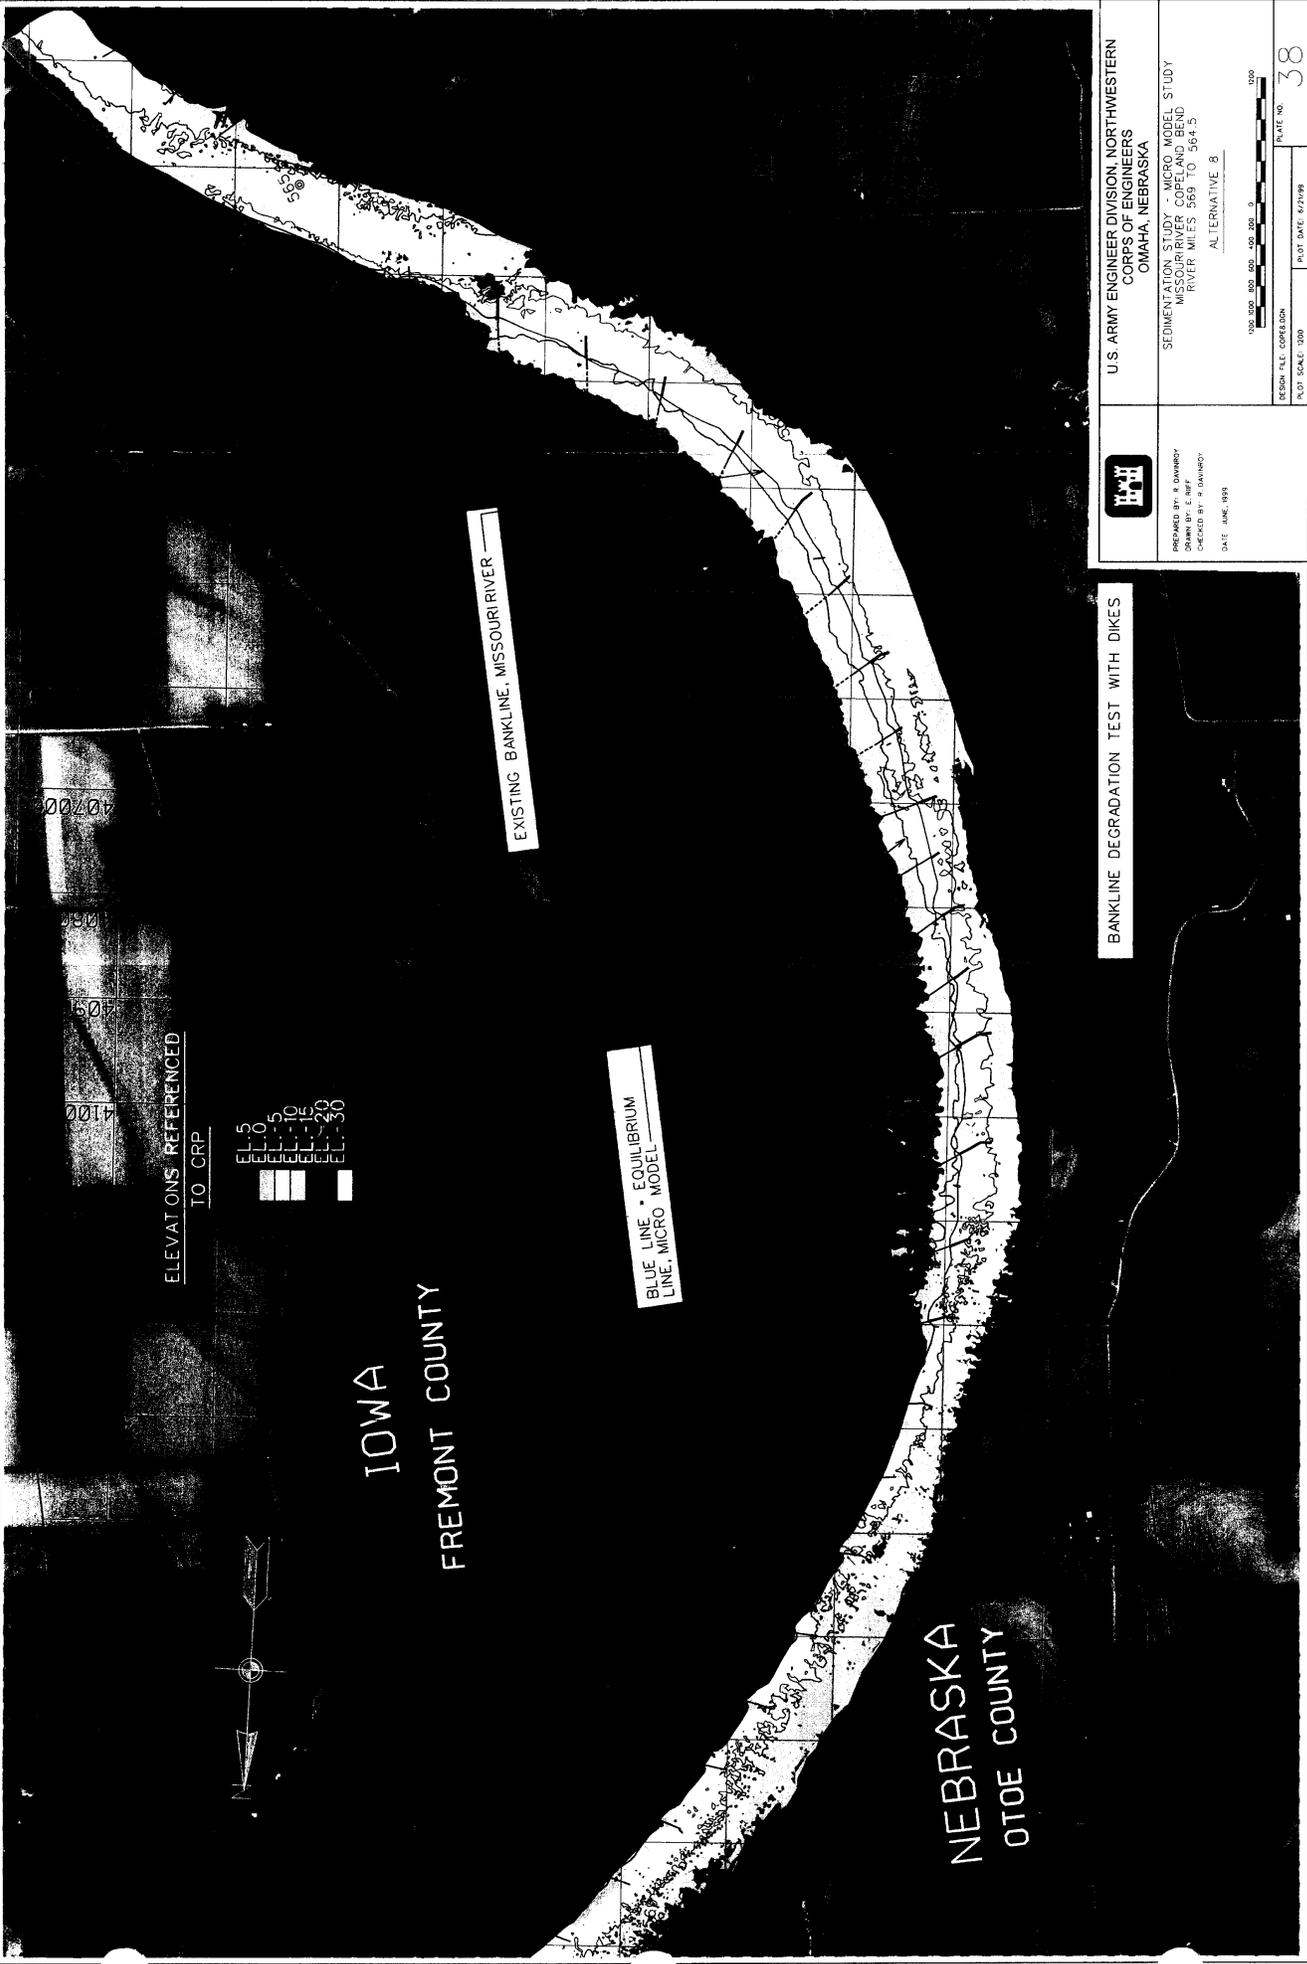
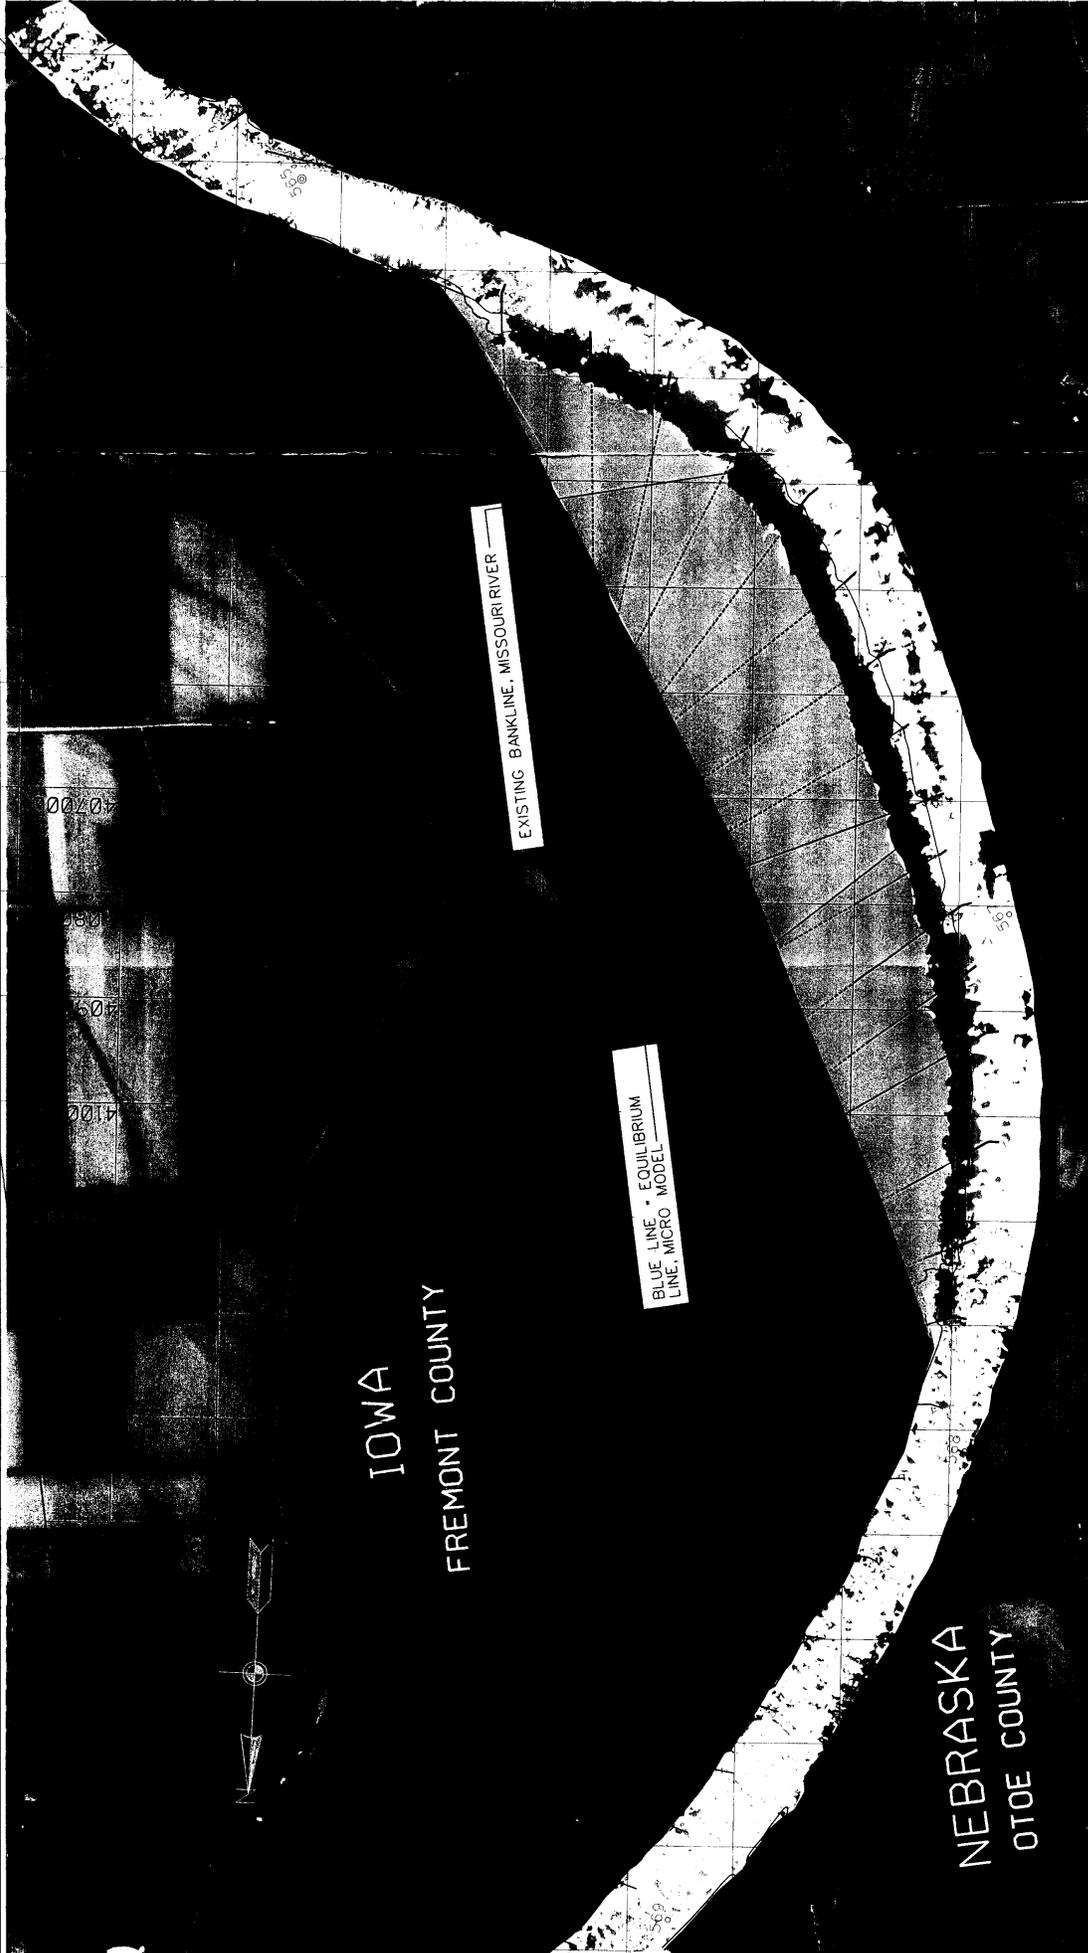
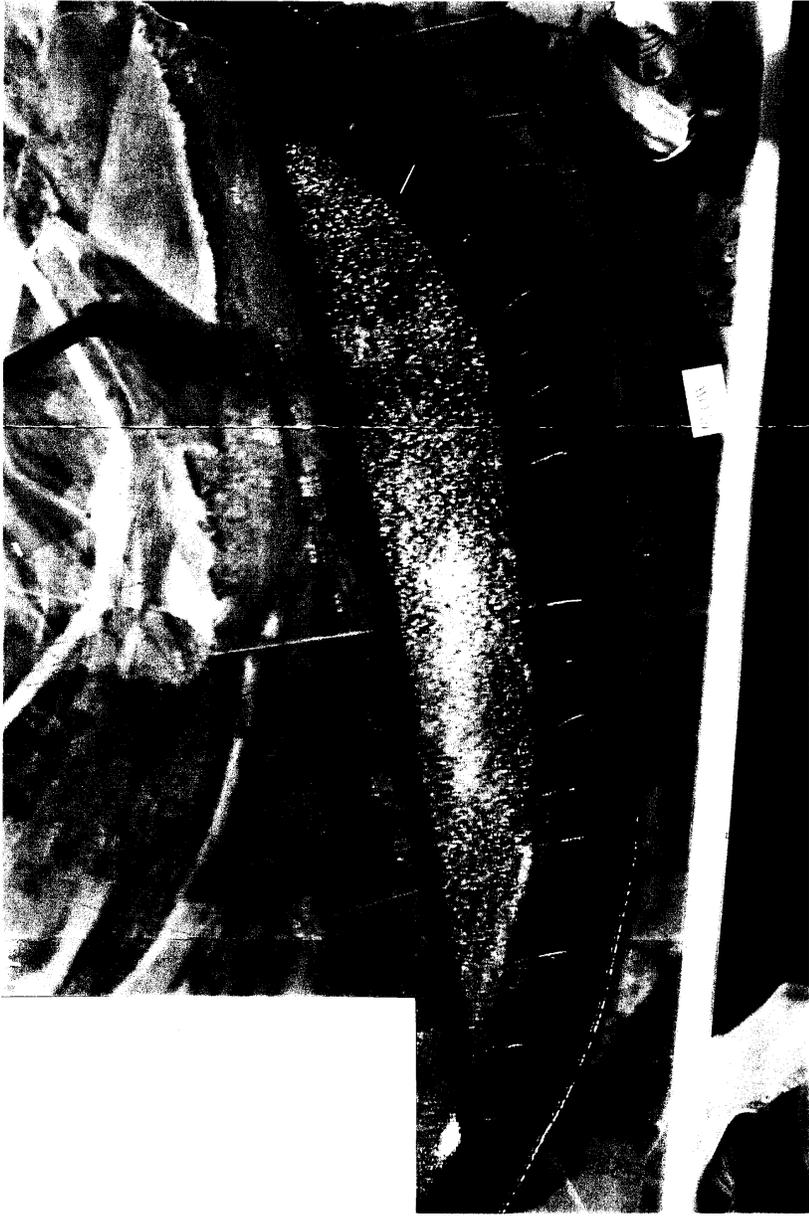
PLATE NO. 38

Alternative 8 involved degrading the left descending bankline between 0 and 400 feet, or approximately 300 feet on the average landward from the base test equilibrium line, to a depth of approximately -10 CRP. Results (Plates 38, 39, 40) indicated the following:

Depths and widths in the navigation channel remained similar to the base test. Some slight deposition was observed in the channel between 566.6 and 566.7. Since the bankline was artificially degraded, no additional lateral erosion was observed.

Flow visualization indicated a greater amount of flow distributed over the dike field as compared to the base test. A continuous path of flow was observed along the excavated portion of the left descending bank.

- Alternative 8 showed that a relatively large amount of bankline degradation and increased depth distribution could be permitted on the inside of Copeland Bend as long as the existing dikes were not removed. Alternative 9 showed that the removal of all dikes threatened the integrity of the navigation channel.
