TECHNICAL SUPPORT PACKAGE FOR TECH BRIEF 68-10534
IMPROVED THERMAL TREATMENT OF ALUMINUM
ALLOY 7075

National Aeronautics and Space Administration
Washington, D.C.

IMPROVED THERMAL TREATMENT OF
ALUMINUM ALLOY 7075

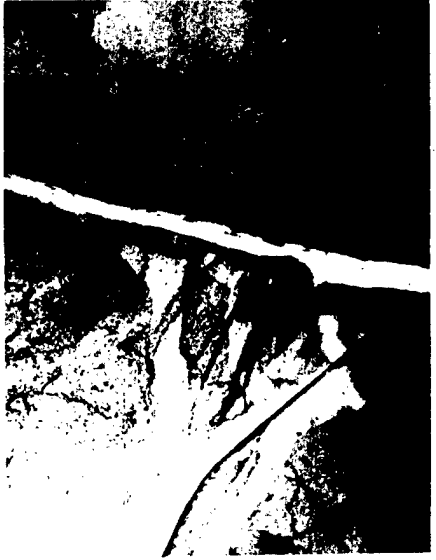
Fig. B. 4 Electron micrographs showing effect of pre-precipitates on oxide formation: (a) in matrix, 37,000X and (b) along grain boundary, 14,000X.

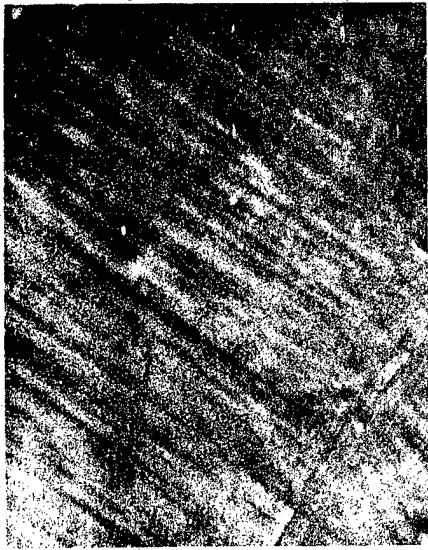
Fig. B.7 (Cont.)

Fig. B.7 Fracture surfaces of Al-7.5 Mg-2.4 Zn (a) aged 24 hours at 100°C (b) aged 72 hours at 100°C (c) aged 16 hours at 150°C. 1600 X.

A study using the scanning electron microscope was carried out on fracture surfaces of specimens of Al-7.5 Zn-2.4 Mg which were aged to bring them into the region of susceptibility by three varying degrees. These treatments were (1) heating for 24 hours at 100°C, (2) heating for 72 hours at 100°C, and (3) heating for 16 hours at 150°C.

In all cases the specimens were first put in the solutionized condition by heating at 480°C for 6 hours and were then water quenched. In this study photographs were obtained showing the change in marking

form and type which occurred on going from treatment (1) to (2) to (3), Figs. B.7 a, b, and c, respectively. In condition (2) in which the alloy is most susceptible, the striations were observed to be coarser than in either conditions (1) or (3). This finding is in agreement with the theories of Holl* and of Speidel** that maximum susceptibility should be associated with the appearance of planar arrays of dislocations.

These planar arrays would be expected to produce coarse striations on the fracture surface because they represent points of stress concentration when stress is applied to the sample and hence would perturb the advance of the crack front, i.e. at a dislocation pile-up. The crack would advance faster because of the higher stress concentration. Similarly, in between pile-ups, advance would be slower. These sudden changes in crack velocity would cause a concomitant change in plastic relaxation at the crack tip which would in turn lead to markings on the fracture surface.

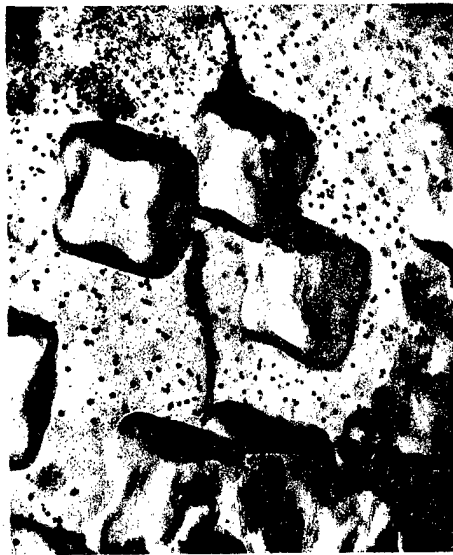
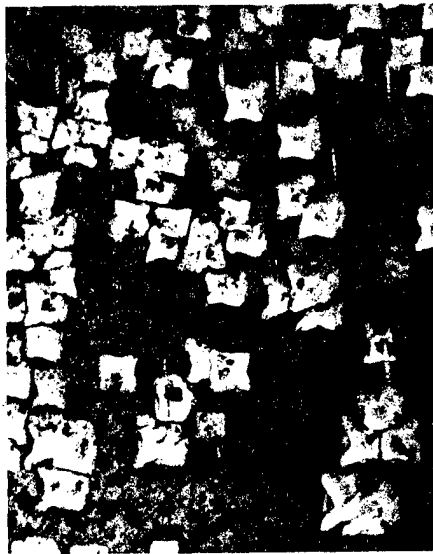
Fig. B. 9 (a) Corrosion patterns developed on Al-4Cu. 100,000 X.
(b) Further evidence for specific pattern attack. 37,000 X.
