PROTECTION BY CONCRETE AGAINST A-BOMB RADIATION
SICKNESS IN HIROSHIMA CITY

SELECTED ARTICLES FROM THE COLLECTION OF
INVESTIGATION REPORTS ON ATOMIC BOMB DISASTER,
VOLUME 1, 1953.

A-BOMB DISASTER INVESTIGATION

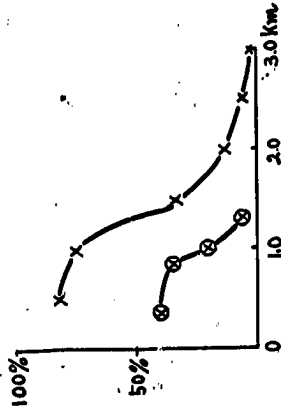
Fig. 1. Incidence of RS and distance from the bomb center in Hiroshima.

x -- Within the General area; ⊗ -- within concrete buildings.

It is well known that the incidence of radiation sickness (hereafter abbreviated RS) among people who were in solid buildings at the time of the atomic bomb explosion in Hiroshima was far below that of people in the same area who were not in these same buildings. The curve marked x in Fig. 1 gives the RS incidence in the general area while the ⊗ curve gives the

incidence among people who were in concrete buildings. It was observed that concrete afforded considerable protection against RS. These curves represent average values, and there were many instances in which some people within a given concrete structure were affected by RS while others in the same structure were unaffected. It is evident that concrete attenuated the radiation from the blast. Representatively concrete structures at various distances from the blast center were selected for more detailed study.

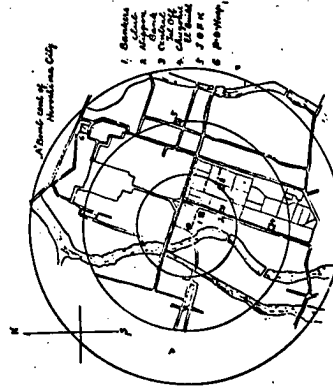
Fig. 2. Locations of buildings investigated.

(The center represents bomb center, the other circles are spaced 500 m apart.)

The sites selected for this study are the buildings shown in Fig. 2. They include 1. Bankers Club (280 m), 2. Hiroshima Branch, Bank of Japan (280 m), 3. Central Telephone Office (500 m), 4. Chugoku Power Building (800 m), 5. JOFK Studio (1000 m), and 6. Communications Office and Hospital (1350 m). (The figures in parenthesis give the horizontal distance to the blast center.)

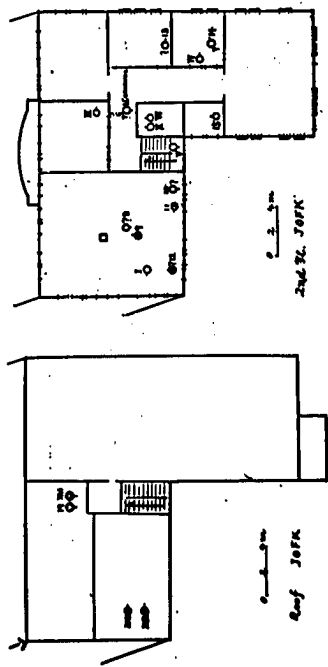
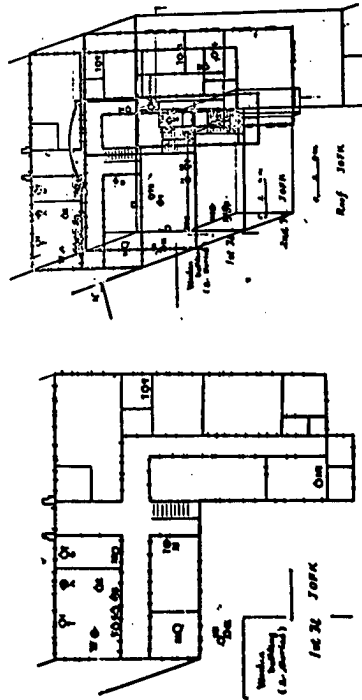
FIG. 3 (a)-(d). Injury sites at the JOFK Studio.
 (The arrows indicate the direction of the radiation)

FIG. 3 (a) Top Floor

FIG. 3 (b) Second Floor

FIG. 3 (c) First Floor

FIG. 3 (d) Transparent View.

building (Fig. 3 a), ⑩ and ⑪ were killed by exposure to the fireball. Both were stripped and had been wiping their bodies when they were exposed to the flash from the right. ⑫ XVII and ⑬ XIV were in the wooden addition with concrete walls that had been placed on the roof and were exposed to radiation through one concrete wall but not to the fireball. Both began to lose the hair on their heads from about the end of August. The effective shielding by the concrete for these two as determined by the method previously cited was 18 cm. (The outside of this addition had burned, and the thickness of the wood was subtracted from the thickness of the remaining concrete wall. The angle of incidence of the radiation upon this wall was taken into consideration for calculating the effective thickness): ⑭ X and ⑮ XV who were on the first floor (Fig. 3 c) developed RS, and XV died on September 13. As seen from the floor plan of Fig. 3 d, these two must have been standing by windows to be in the direct path of the radiation. The RS situation of people at other sites was not clear. It can be deduced that an effective concrete thickness of 30 cm would prevent RS at this distance from the blast. The results obtained in a similar manner for the Chugoku Electric Building are shown in Table 2. These results show that people shielded with more than 100 cm of concrete did not develop RS while 80-90 cm could not prevent RS. The safe effective thickness for each site determined in this manner is given in Table 3.

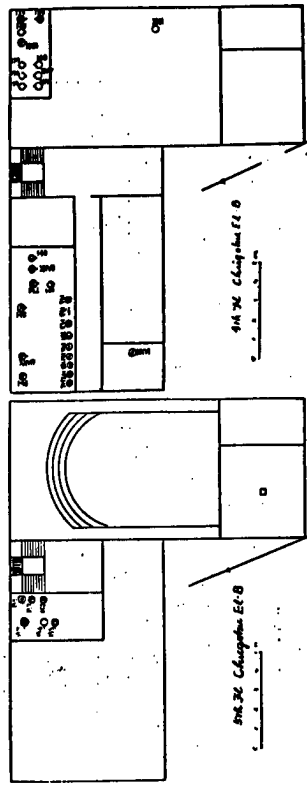
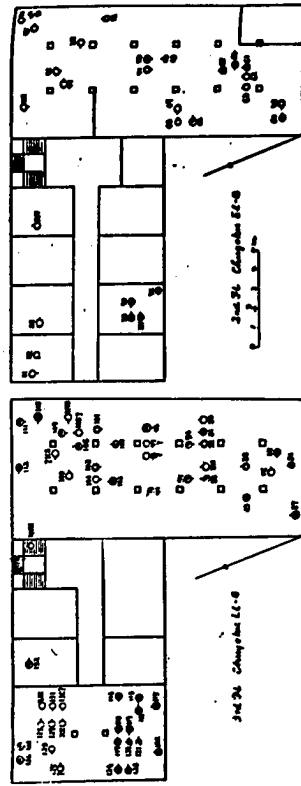
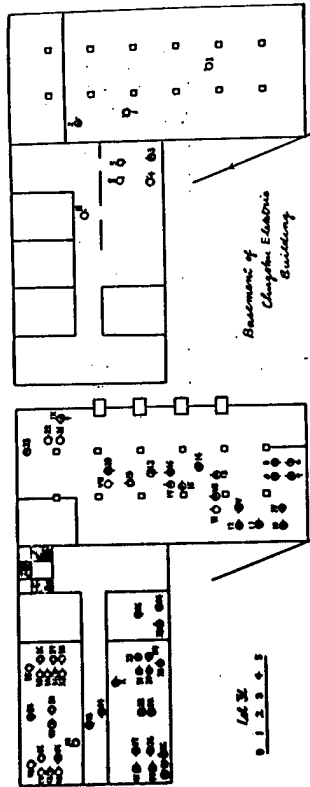
FIG. 4 (a)-(f). Injury sites at the Chugoku Electric Building.

(The arrows indicate the direction of the radiation)

FIG. 4 (a) Fifth Floor

FIG. 4 (b) Fourth Floor

FIG. 4 (c) Third Floor

FIG. 4 (d) Second Floor

FIG. 4 (e)

FIG. 4 (f)

Summary of Injuries at the Chugoku Electric Building (see Fig. 4)

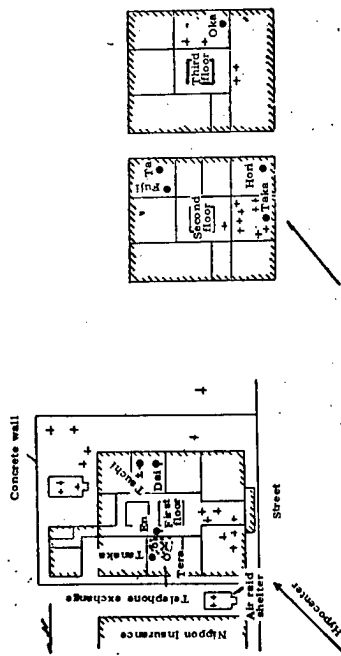
Fig. 1. First floor of the Hiroshima Bankers Club.

● -- Died later; ○ -- survivor; + -- instantaneous death.

4. (1) The positions of two survivors and nine who later died have been established as well as those of the 36 instantaneous deaths. (2) The records of the survivors and those who died later were plotted. (3) The effects of the radiation on the survivors were clearly manifested in the form of loss of hair, decrease in white blood cell count, temperature, vomiting, subcutaneous bleeding, or menstrual irregularity. (4) There were three people in the telephone exchange room on the first floor at the time of the explosion of which two died. One of the reasons this person survived is that he was protected by more walls from the radiation.

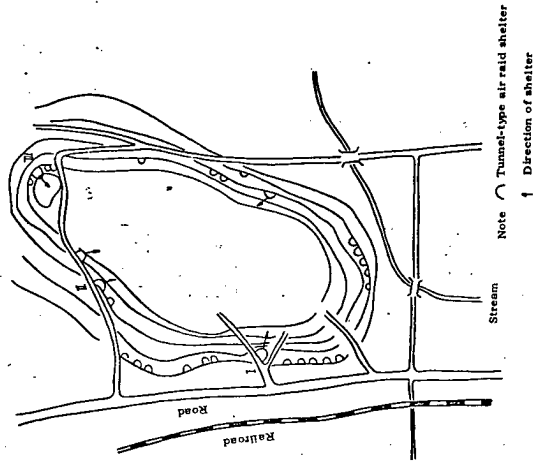
Fig. 1. Prison hill.

The Nagasaki Prison is located near the epicenter of the atomic bomb explosion. As a result, most of the people in this vicinity were killed instantaneously. The prison itself is located on a rise about 50 m above the surrounding plain. Several tunnel-type air raid shelters were dug into the side of this rise about the periphery. A few who were engaged in repair work and a few who by chance happened to be in the tunnel survived the blast. The air raid shelters dug into this hill were as shown in Fig. 1. Seven people in Shelter No. 1, one in Shelter No. 2, and two in Shelter No. 3 or a total of ten survivors were counted.

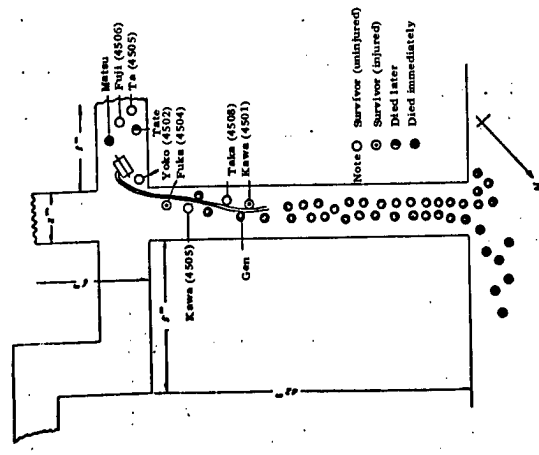
FIG. 2. No. 1 Air Raid Shelter.

This is the largest shelter located on the west slope at about the same altitude as the road. At the time of the blast, 52 men and women were engaged in removing water that had leaked into this shelter. Those deepest in the shelter were using hand pumps which sent the water out part way through a pipe from which point a bucket relay brought the water all the way out. The distances from the entrance are shown in Fig. 2.

All the people from the entrance to about halfway into the tunnel died, and the seven who were further in survived. The location of these survivors are shown on this chart. The types of injuries suffered by these survivors are listed in Table 1. The survivors related the morning after the explosion that there were about 40 dead bodies between the entrance and the halfway mark. Some had been burned, some had been bruised, others had internal organs exposed, and

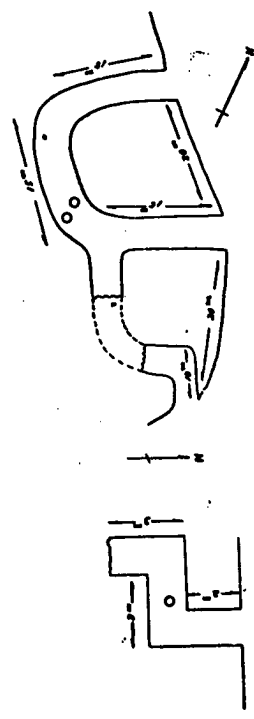
FIG. 3. No. 2 Air Raid Shelter.

This is a small shelter dug part way up the north slope (see Fig. 3). A girl had gone into this shelter to escape the heat temporarily and was in the spot shown in the figure. This girl received no wounds and was miraculously saved. She had fallen flat just about halfway into the shelter with her feet pointing toward the entrance, but all she received was the effect of a minor shock blast.
