TA98-030  
NEDU TR# 3-00  
29 Jun 00

NAVSEA 00C5 DESIGNED GROUND FAULT  
INTERRUPTER BREADBOARD AND PROTOTYPE  
TEST AND EVALUATION

Author: JERRY D. PELTON, NEDU 0352

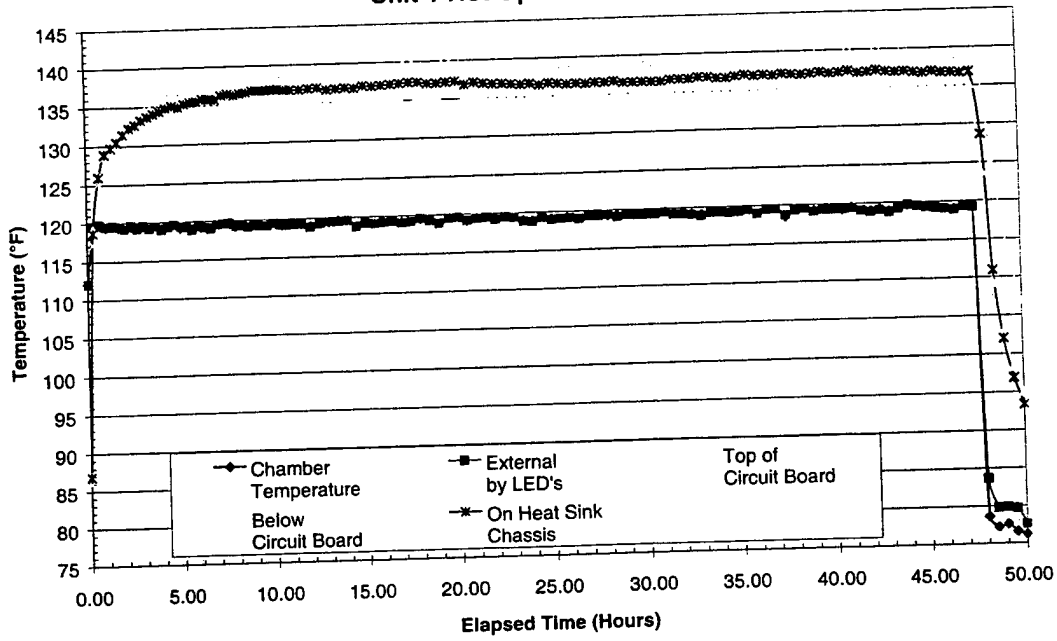
FIGURE 1: Temperature Profiles During Hot Operation Testing of the GFI Units  
(a) Unit 1 (b) Unit 2

The testing was resumed on November 9, 1999. Since the failure occurred so early in the test, it was decided that the test should be performed for the full 48 hours. However, the 2 hour soak was eliminated and the test was started as soon as the units were placed in the chamber. The testing was completed on November 11, 1999 with no anomalies observed. Figure 1 shows the temperature profile for each unit over the course of the test. This data indicates that Unit 2 had a slightly higher average internal temperature than Unit 1. The appropriate test data sheets and operational log is included in Appendix B. At the completion of the test, NEDU personnel performed the appropriate functional tests and found the units to be operating correctly.

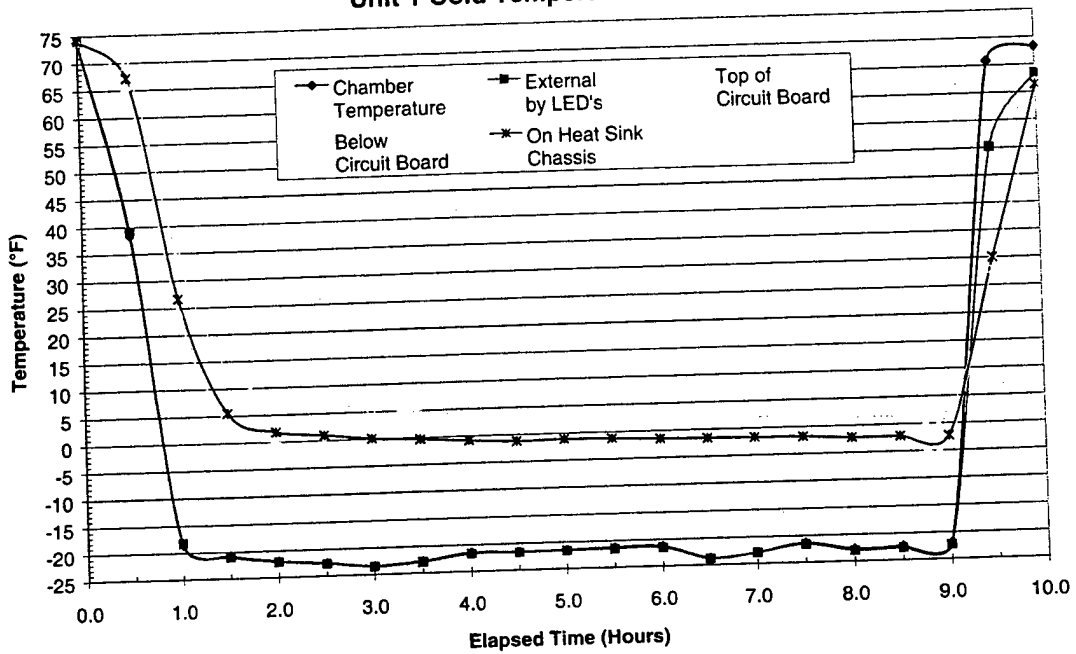
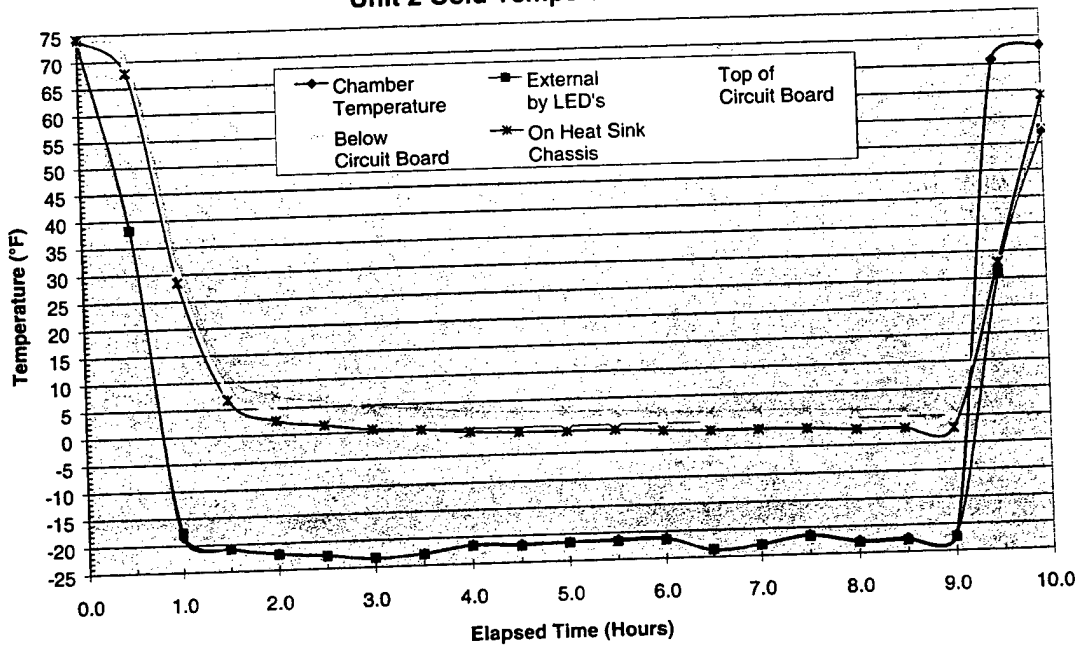
FIGURE 2: Temperature Profiles During Cold Operation Testing of the GFI Units  
(a) Unit 1 (b) Unit 2

The testing was completed with only one minor anomaly. The trip LOW switch for Unit 1 did not always function. Throughout the test it would require toggling the switch 3 or 4 times in order to activate the unit. Once activated, the unit would reset correctly and continued to operate normally. This anomaly was not observed in Unit 2. At the completion of the test the switch returned to normal operation. No other anomalies were observed. At the completion of the test, NEDU personnel performed the appropriate functional tests and found the units to be operating correctly.

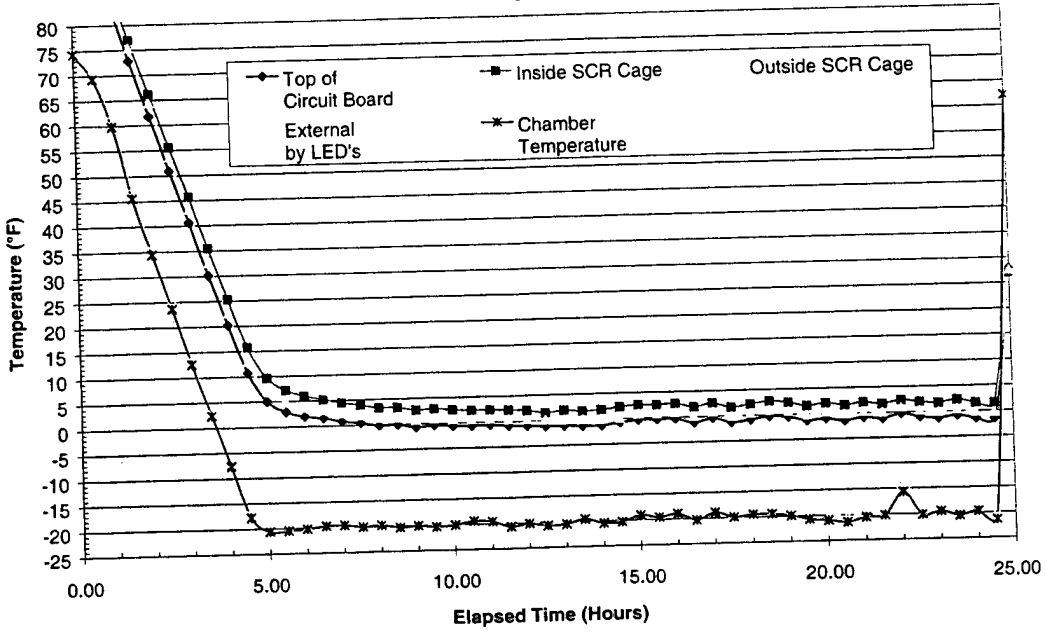
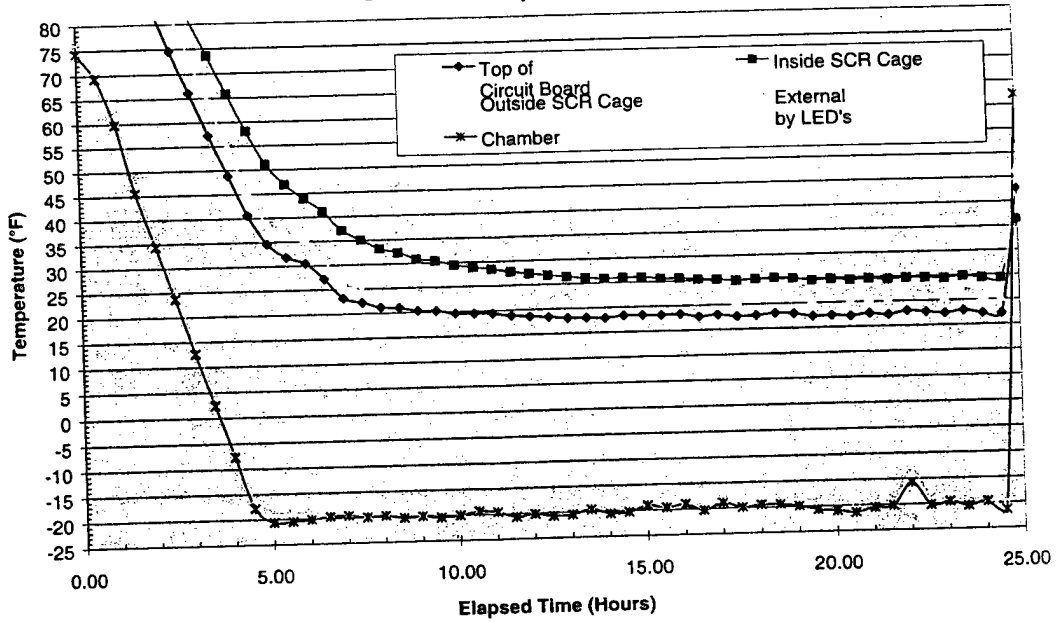
**FIGURE 7: Series 2 Temperature profiles for Cold Operation Testing  
(a) Unit 1 (b) Unit 2**

The testing was completed with only one minor anomaly. The trip LOW switch for Unit 1 did not always function. Throughout the test it would require depressing the switch 3 or 4 times in order to activate the unit. Once activated, the unit would reset correctly and continued to operate normally. This is the same problem that was observed during the first test series. As with the first test series, this anomaly was not observed in Unit 2. At the completion of the test the switch returned to normal operation. No other anomalies were observed. At the completion of the test, NEDU personnel performed the appropriate functional tests and found the units to be operating correctly.

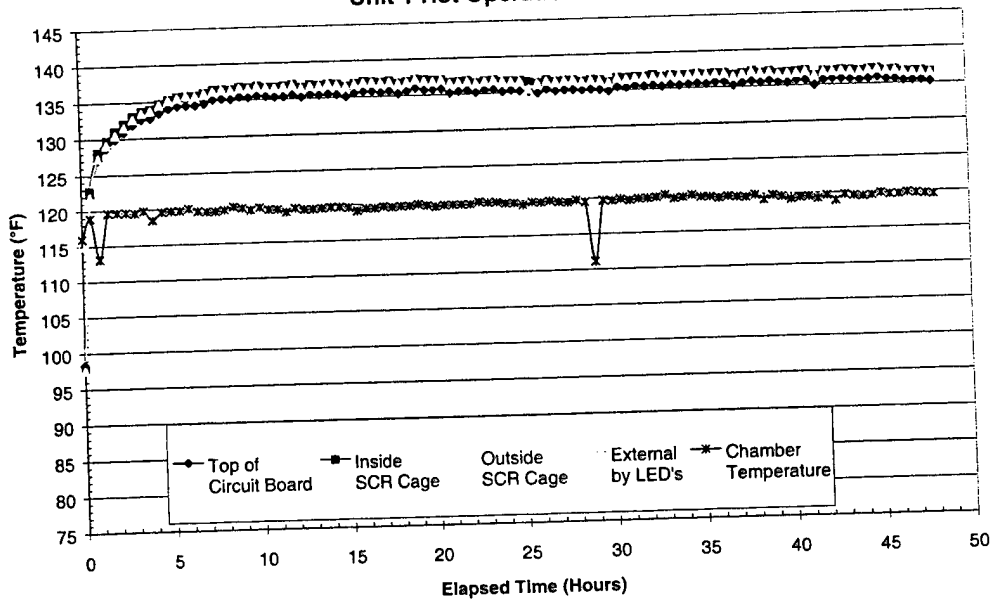
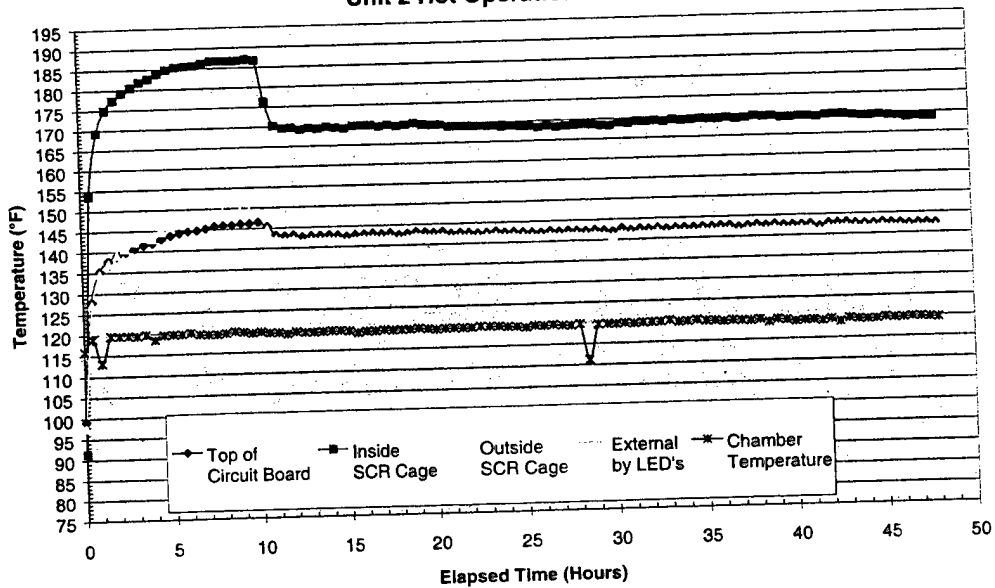
FIGURE 8: Series 2 Temperature profiles for Hot Operation Testing  
(a) Unit 1 (b) Unit 2

The testing was completed on March 24, 2000 with no anomalies observed. Figure 8 shows the temperature profile for each unit over the course of the test. This data indicates that Unit 2 had a slightly higher average internal temperature than Unit 1. The appropriate test data sheets and operational log is included in Appendix C. At the completion of the test, NEDU personnel performed the appropriate functional tests and found the units to be operating correctly.

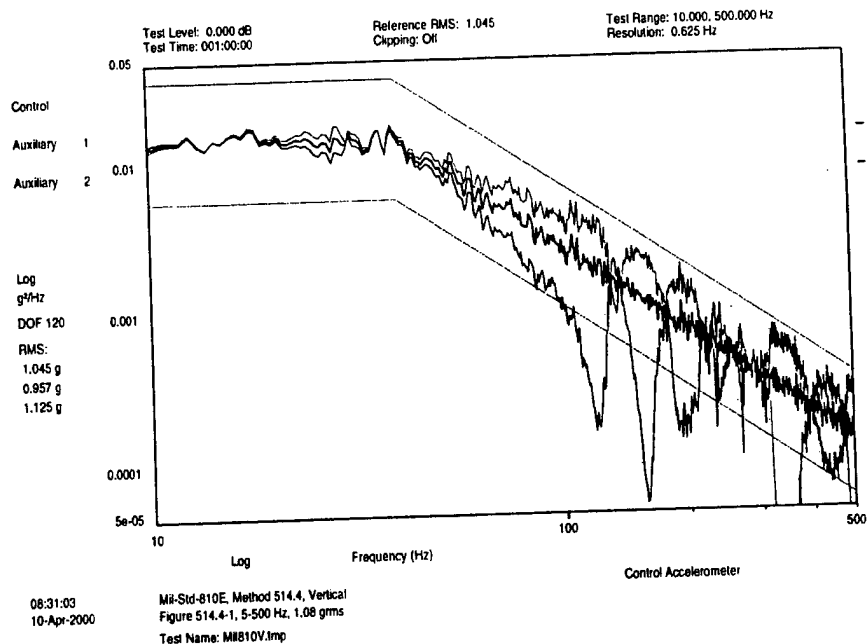
FIGURE 9-A: Typical Series 2 vibration test profiles showing difference between the two control accelerometers for the Vertical Direction

As with Series 1, two accelerometers were used for control of the test. One accelerometer was located on the vibration table and one accelerometer was located on top of one of the tie down bars. Figure 9 shows the typical responses observed for testing in all three directions. For all plots the center trace is the average of the two accelerometers. The blue (upper) trace is the accelerometer on the table and the green (lower) is on the top of the fixture.

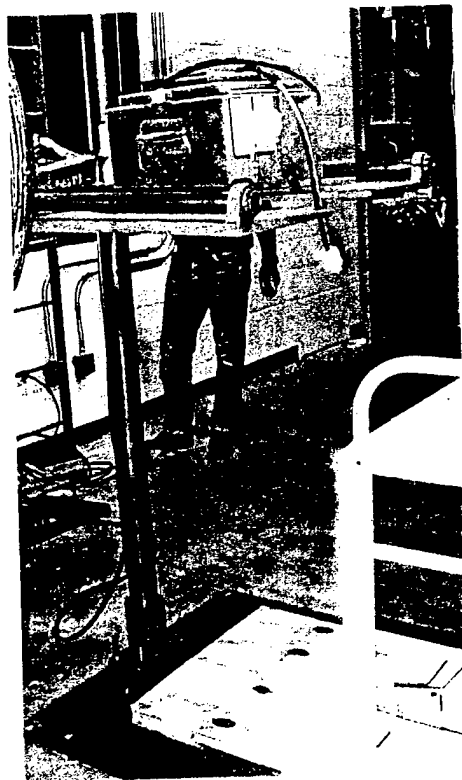
FIGURE 10: Unit 1 ready for drop test on the bottom surface

On April 12, 2000 the Drop tests were performed. The drop tests consisted of dropping the units from a height of 4 feet onto 2.25 inches of plywood. The plywood was placed on a  $\frac{1}{2}$  inch steel plate, which was bolted to a concrete surface. Unit 1 was dropped on all six flat surfaces. Figure 10 shows Unit 1 ready for the first drop.

Drop Orientation	Description of damage
Bottom	No visible external damage
Left Side	One of the plastic receptacle covers broke off
Right Side	Minor bending of side near metal receptacles
Top	Top Cover Bent
Front End	No visible external damage
Back End	Power cable penetration housing broke
