**INSIDE A SOVIET ICBM SILO COMPLEX: THE SS-18  
SILO DISMANTLEMENT PROGRAM AT DERZHAVINSK,  
KAZAKHSTAN**

John R. Matzko

*Technical Report*

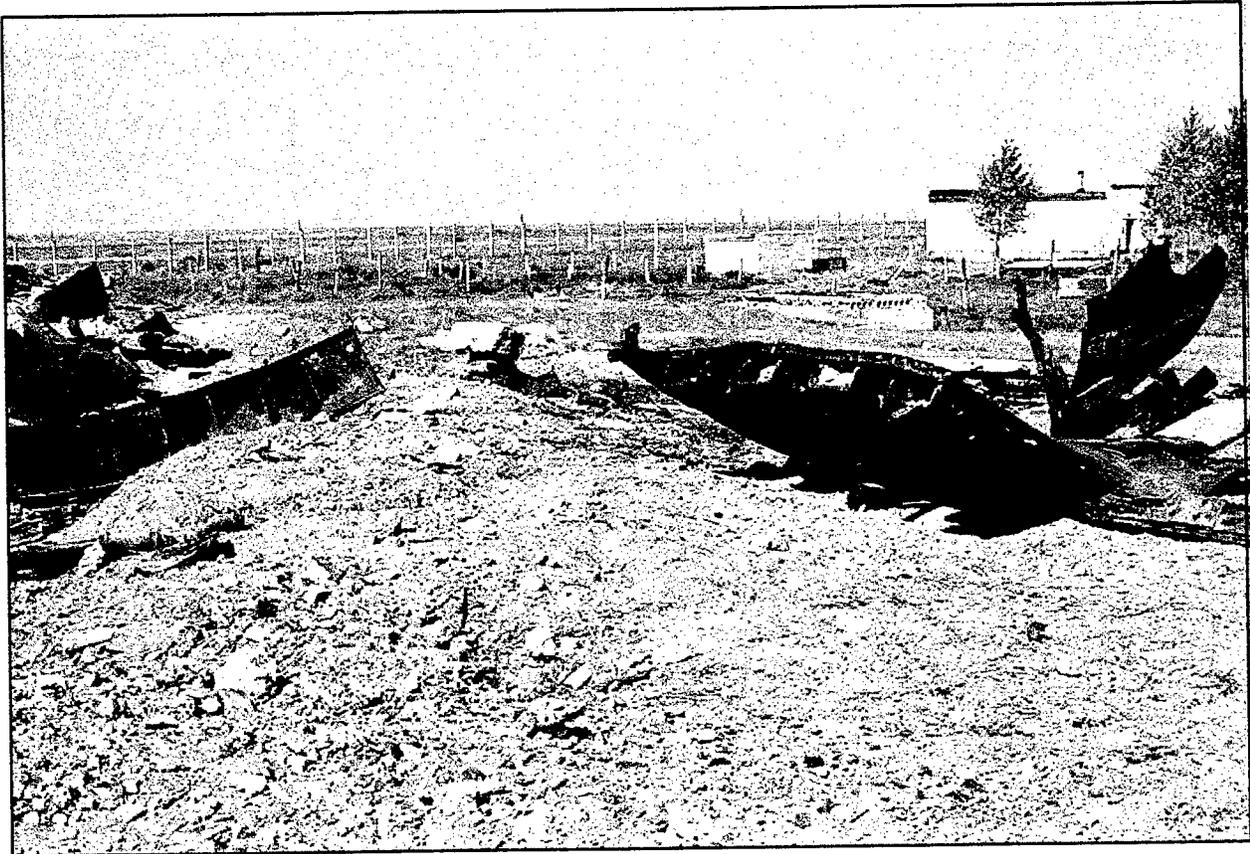
Figure 8. Metal and concrete debris on the crater rim. The ribbed metal plate on the right may be part of the headworks wall. The transformer substation is in the right background. Derzhavinsk, Regiment 2, Silos 5/7.

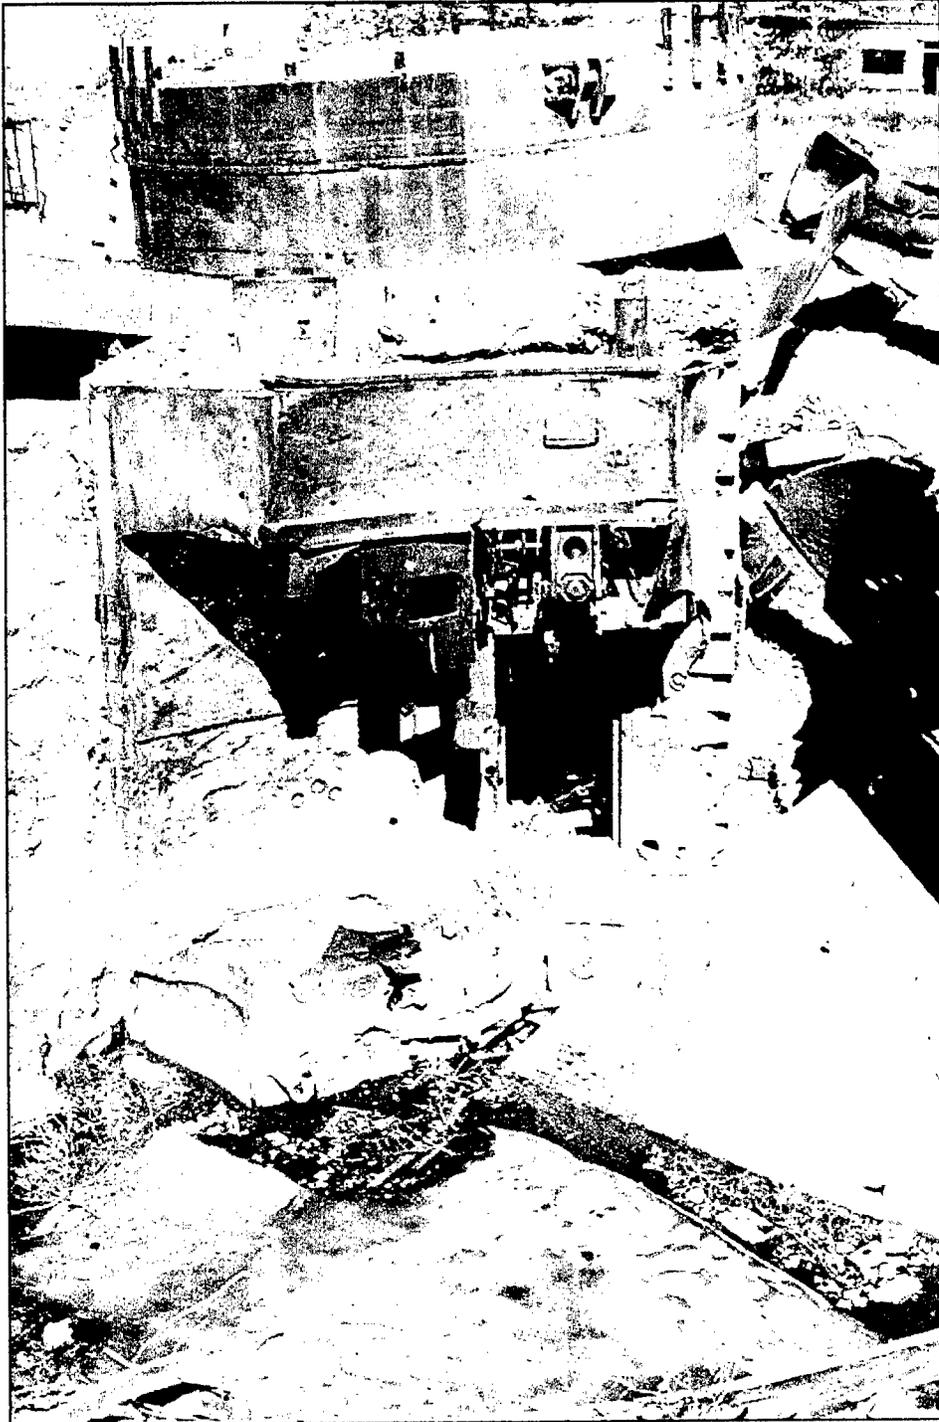
Figure 16. Underground tunnel entrance into the LCC silo headworks revealed in the crater. The round silo door rests on the crater rim. Derzhavinsk, Regiment 2, Silo 7.

Generally, the initial blasting by the Russians to destroy the silo left the silo door, silo door pocket, and headworks wall in large pieces. The heavy silo doors were only rarely broken up by the blasts (see Figures 13, 14, 16, 32, and the relatively intact door pocket/headworks wall in Figure 37). Because these pieces were commonly too large and heavy to handle with the available equipment, they were blasted again into smaller pieces by *Almatypromstroy*, a subcontractor to Brown & Root/ABB SUSA, using anti-tank mines. Some larger pieces were also cut up into fragments of about 1.5 x 2 meters (about 25 tons). The metal debris from the blasted headworks, antenna structures, and other metal from the site, was collected at a rail spur and shipped to a foundry for recycling.

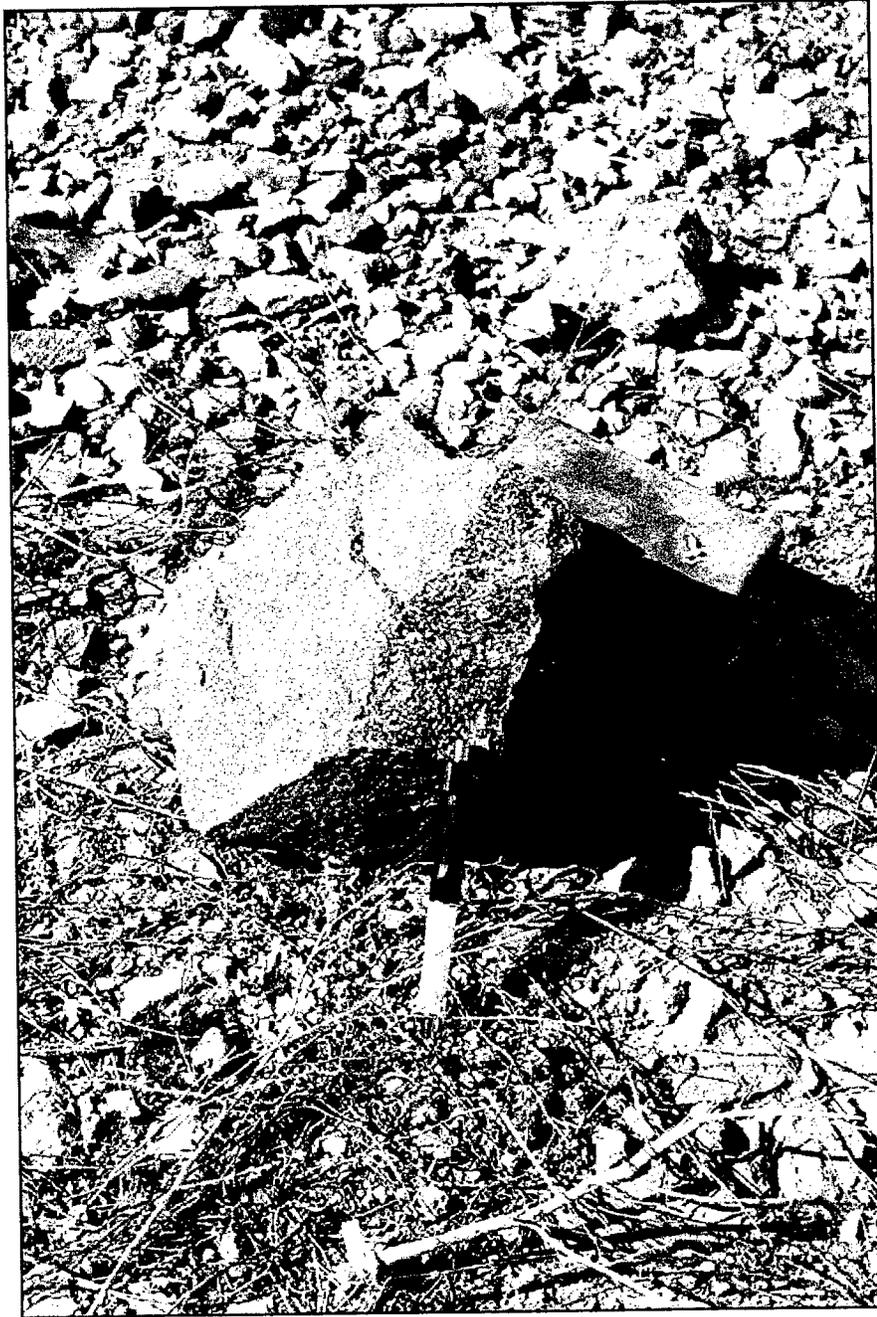
Figure 17. Fragment of a porphyritic igneous rock in the debris field around the crater. The rock has a dark matrix with white veins and crystals. The pen is six inches in length. Derzhavinsk, Regiment 2, Silos 5/7.

The debris that formed the crater rim around the headworks was composed mostly of silt, sand, clay and gravel. At co-located silos 5/7, Regiment 2, several large fragments of igneous and metamorphic rock were observed (Figures 17 and 18). The origin of these rocks is uncertain. The bedrock in the area of the Derzhavinsk base is composed of Paleozoic igneous rocks and Precambrian to Cambrian metamorphic rocks (see the section on Geology). It is possible that the fragments were excavated during the construction of the silo tube and added to the backfill, or the rocks may have been brought in from a quarry two or three kilometers east of the town of Derzhavinsk, and added to the backfill around the headworks. At least some silos appear to have been built up to about 1.5 m above the original ground surface and backfilled, possibly during modification of the original SS-9 silo to accommodate the larger SS-18 missile.

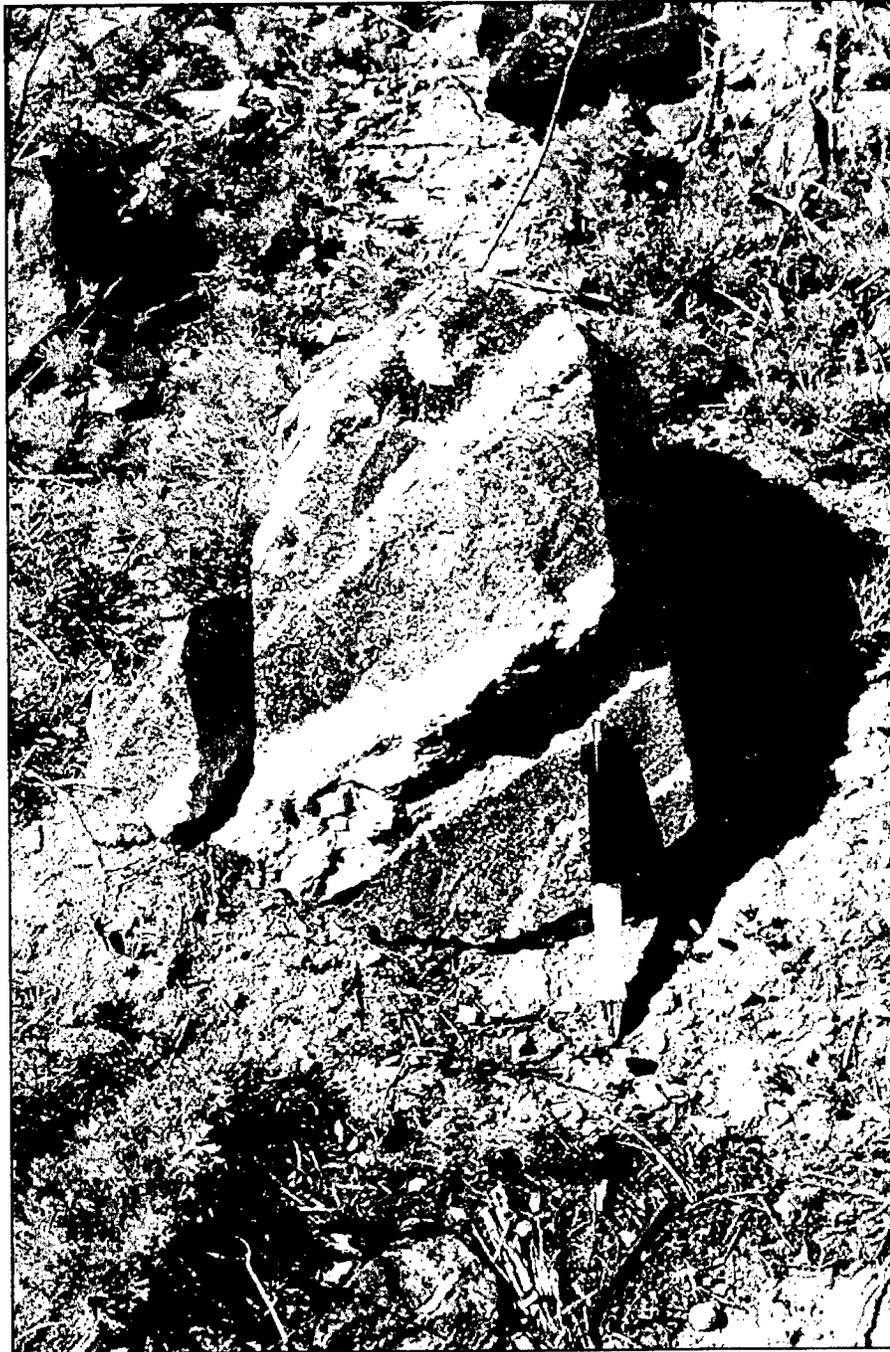
Figure 18. Fragment of banded igneous rock in the debris field around the crater rim. The pinkish bands intruding into the fine-grained matrix give a "gneissic" appearance to the rock. The pen is six inches in length. Derzhavinsk, Regiment 2, Silos 5/7.

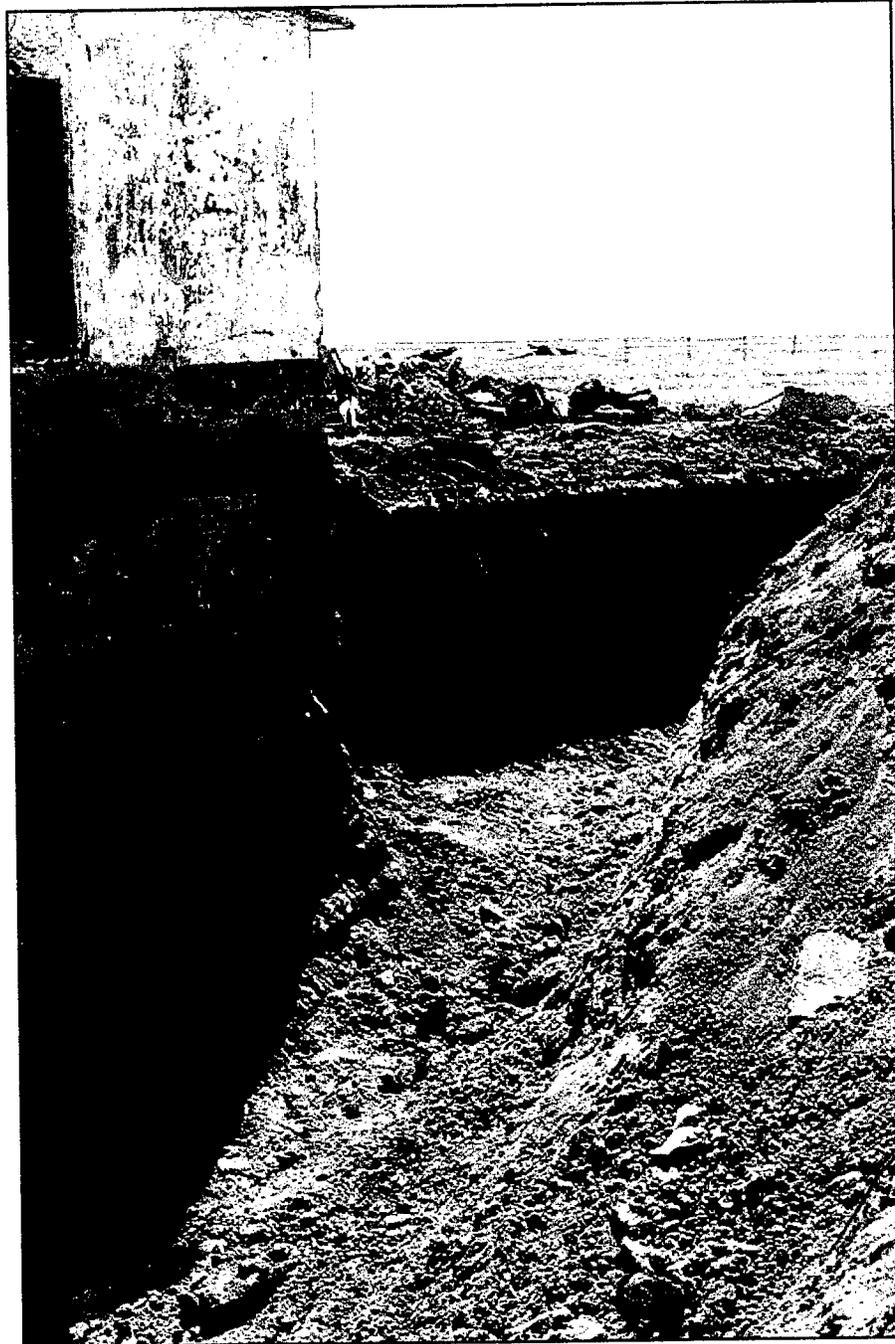
Figure 21. Trenching along side the "Force Protection" security building has exposed the subterranean level of the building and the associated shallow buried tunnel. The buried structures are lined with red clay brick. The excavation is about three meters deep in dry fine-grained silt and clay. Derzhavinsk, Regiment 2, Silo 2.

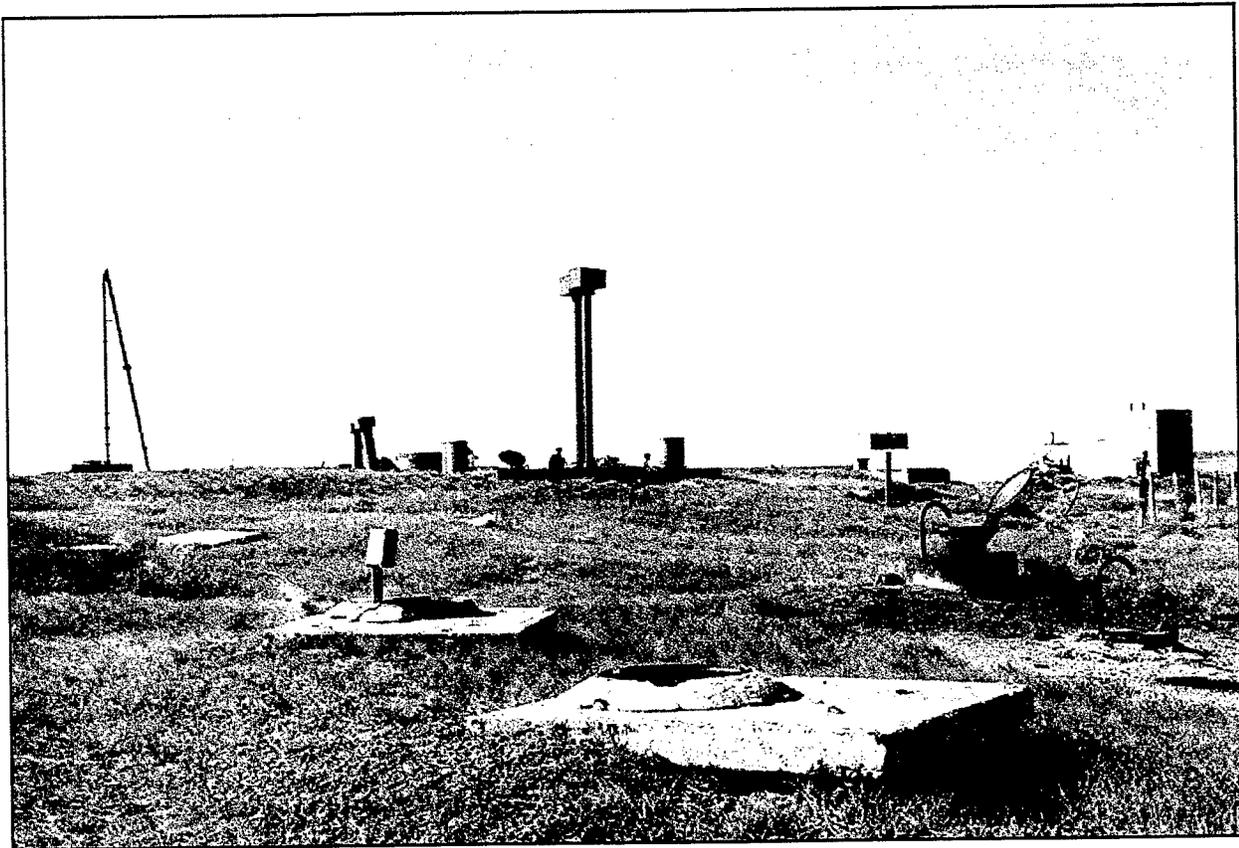
Figure 23. The "old" bermed control facility, marked by ventilation and exhaust shafts and hatches in the middle background of the photograph. The large building in the right background is the cooling system building; buried ventilated fuel tanks in the right foreground; hatches to storage tanks (?) in the middle foreground; broken lay-down mast antenna in the left background. Derzhavinsk, Regiment 2, Silos 5/7.

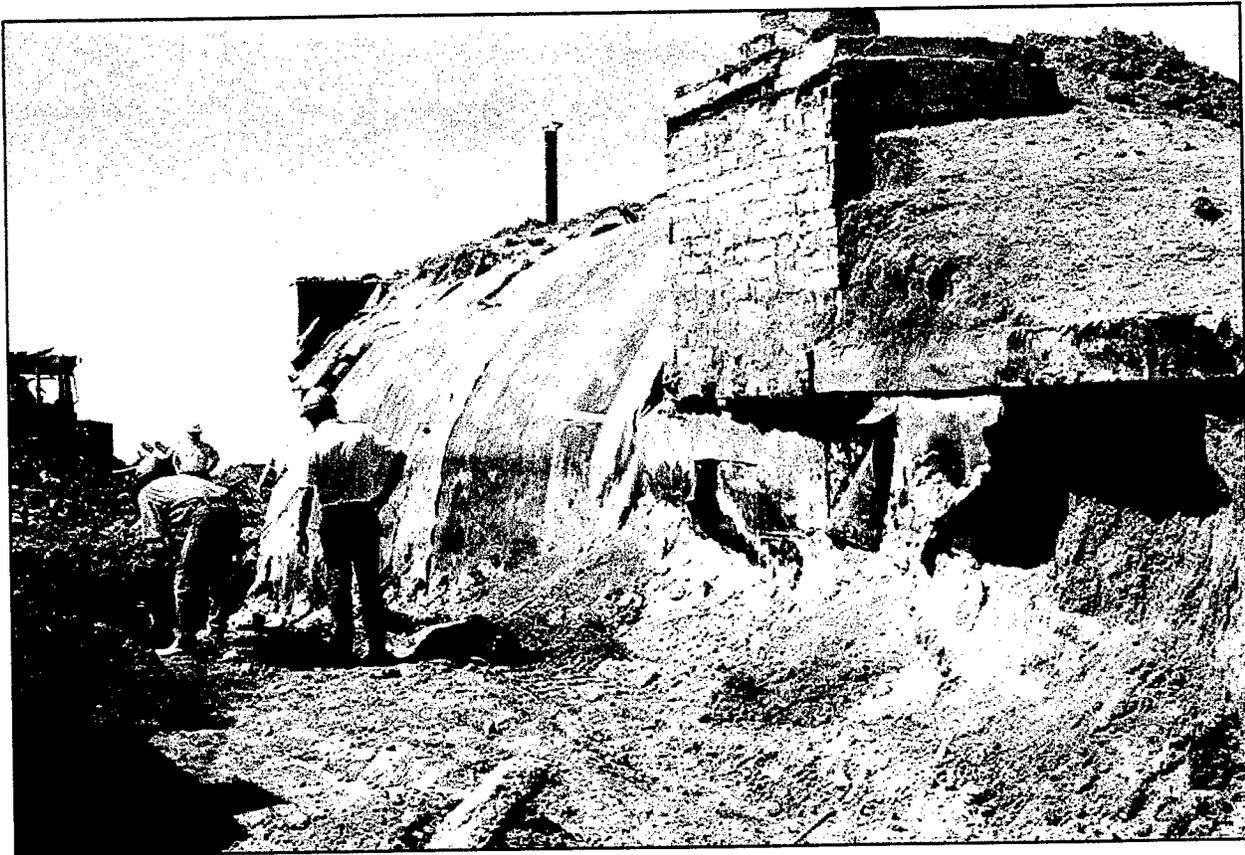
Figure 33. Bermed storage facility being exhumed for destruction and disposal. A black tar paper-like material covers the reinforced concrete. Derzhavinsk, Regiment 2, Silo 3.

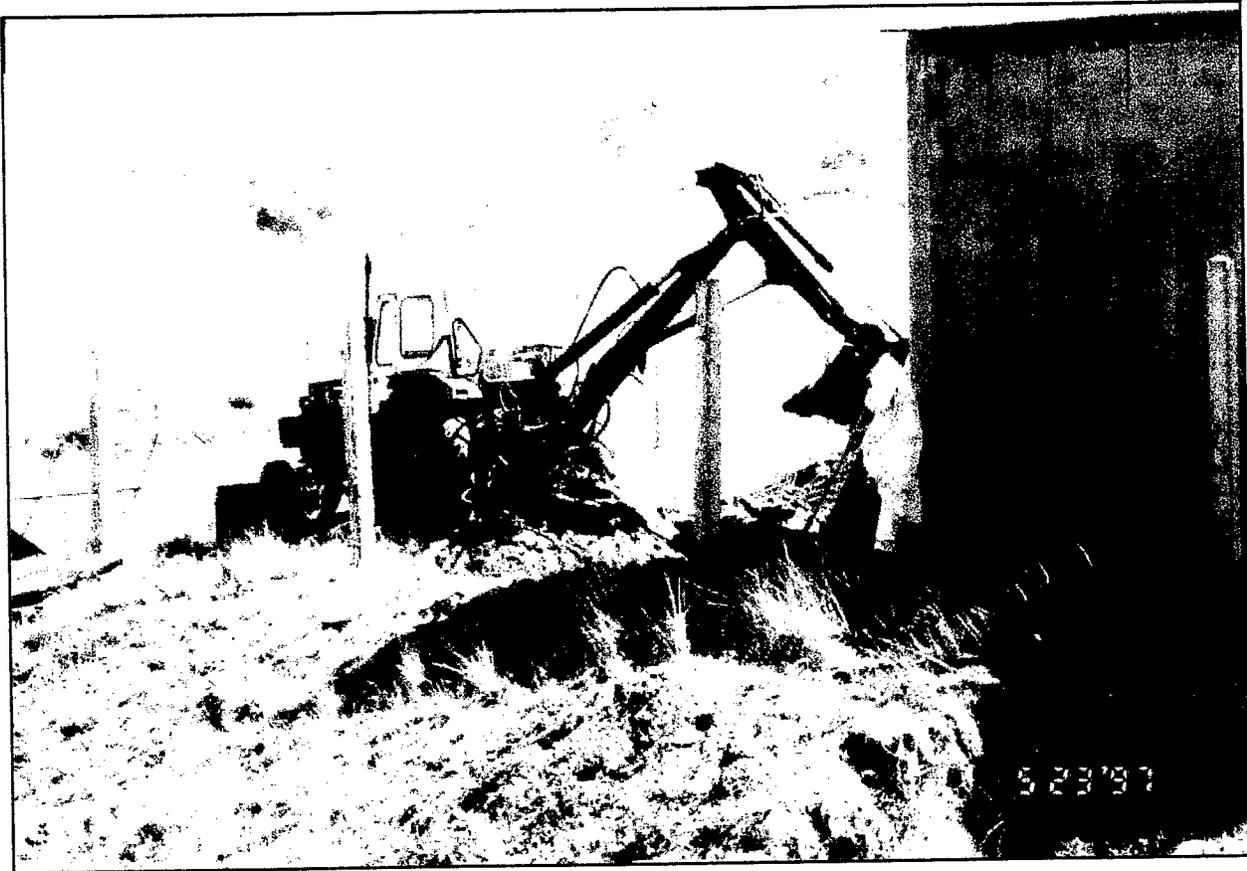
Figure 35. Abatement contractor crew removing PCB contaminated soil near a transformer building. Zhangiz Tobe. Photo courtesy of Brown & Root/ABB SUSA.

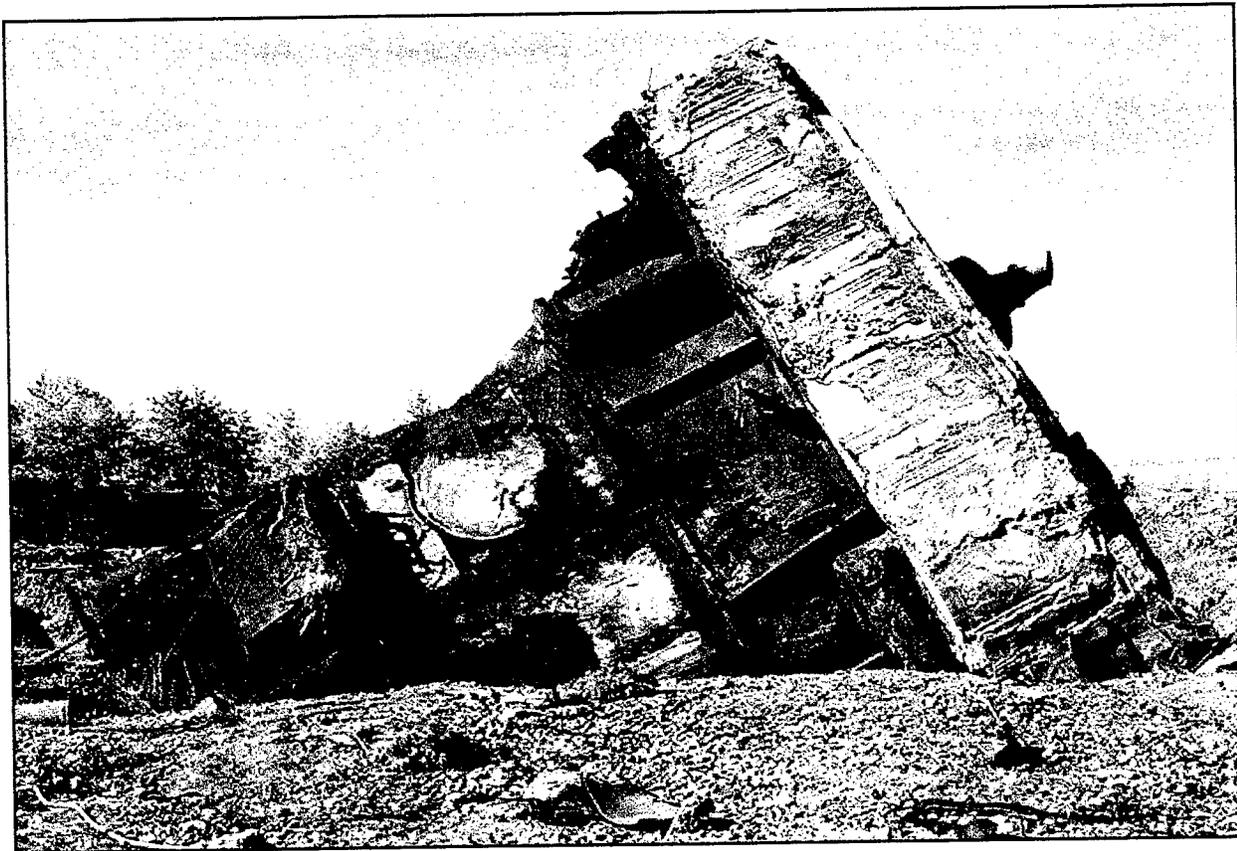
Figure 37. Relatively intact LCC silo door pocket still attached to part of the headworks wall.  
Derzhavinsk, Regiment 2, Silo 7.

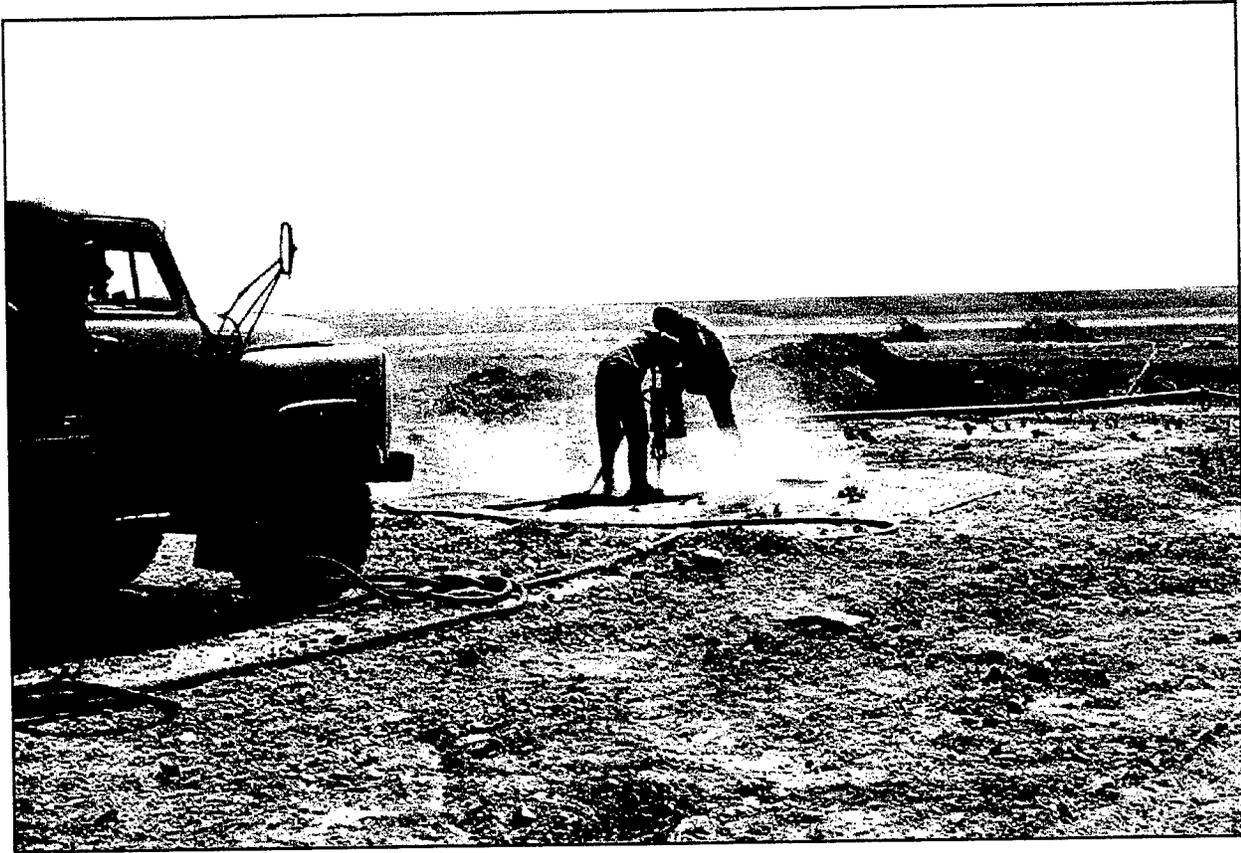
Figure 39. Drilling dynamite emplacement holes in the two-meter thick reinforced concrete support blocks of the transporter loading ramp. Derzhavinsk, Regiment 2, Silo 2.

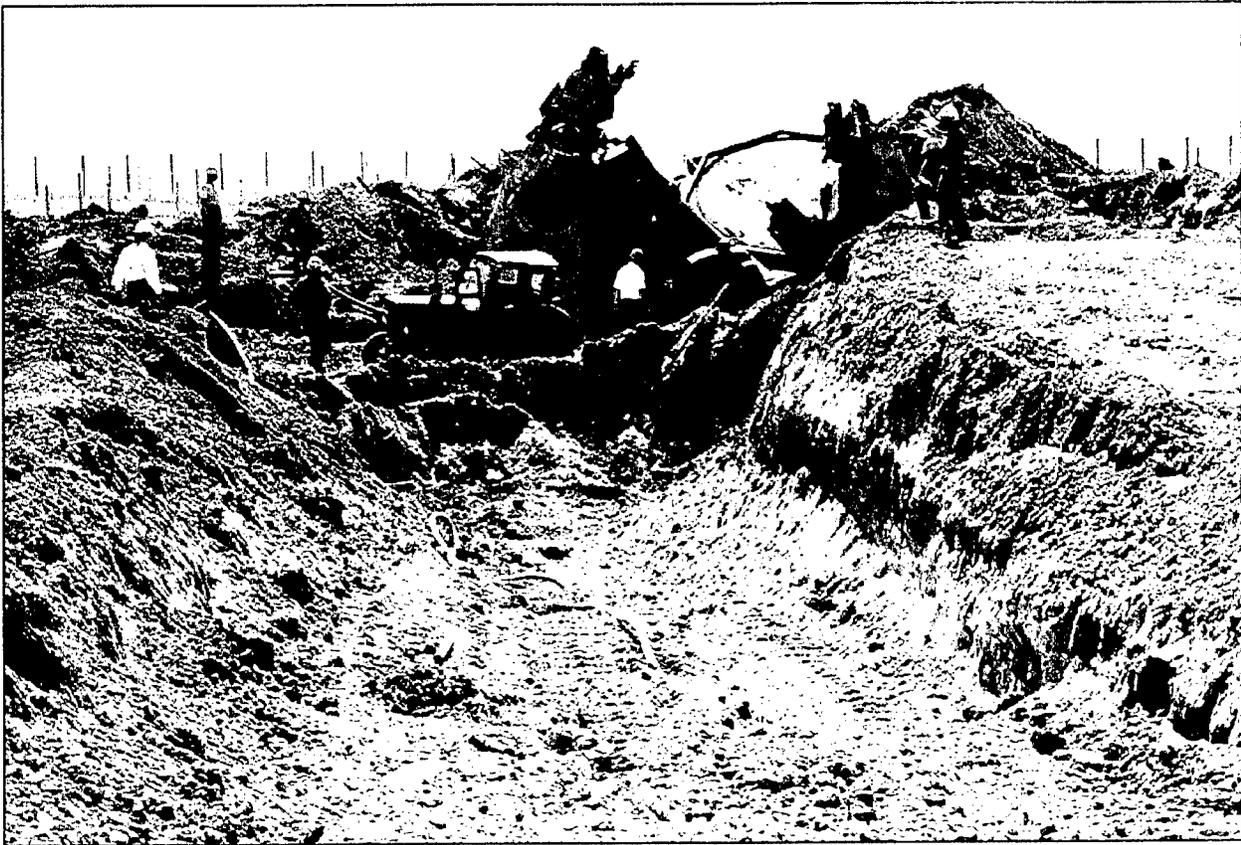
Figure 40. Ramp partially dug down to the silo crater for removal of metal and concrete, and backfilling of the silo tube with debris. The silo door pocket is on end. Derzhavinsk, Regiment 2, Silo 4.

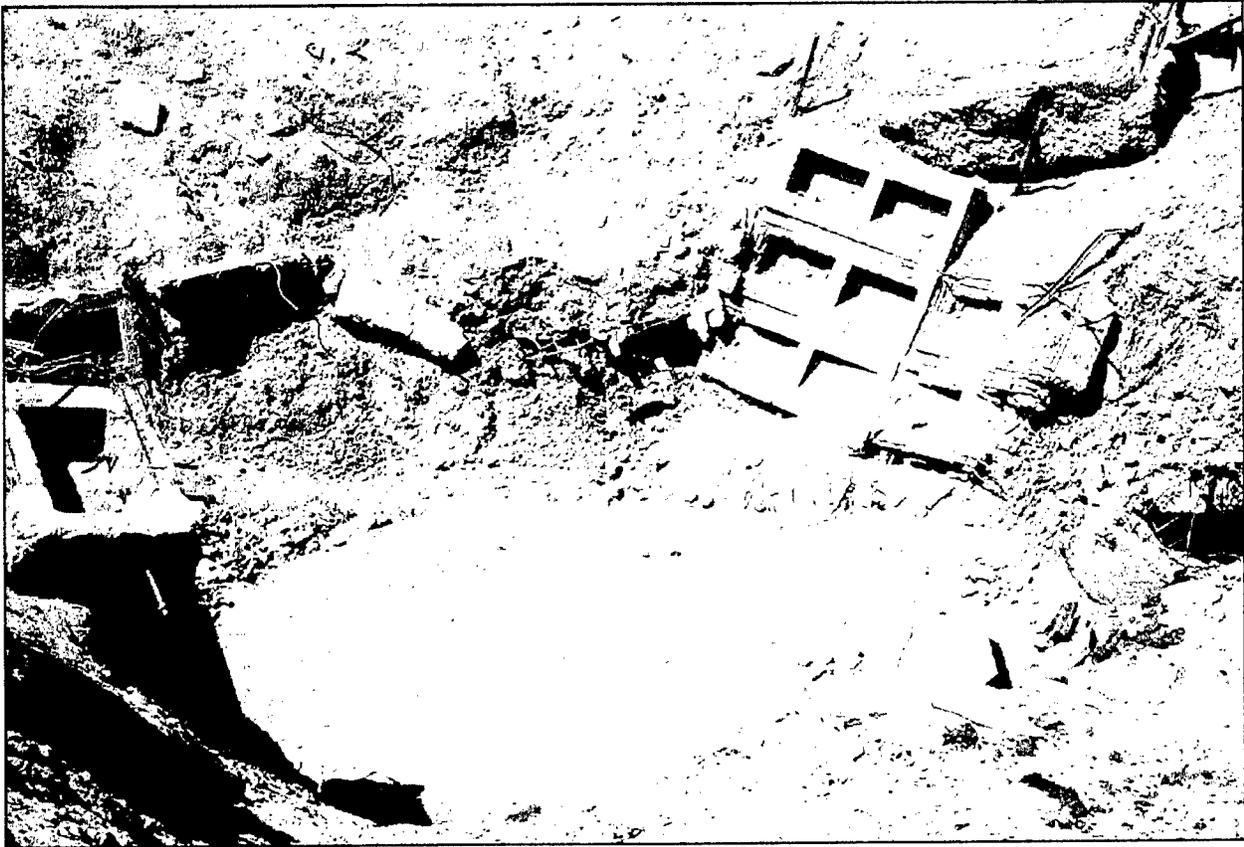
Figure 42. Poured reinforced concrete cap in place over the filled silo tube. Part of the "barbette" wall is exposed in the crater. Derzhavinsk, Regiment 3, Silos 5/7.

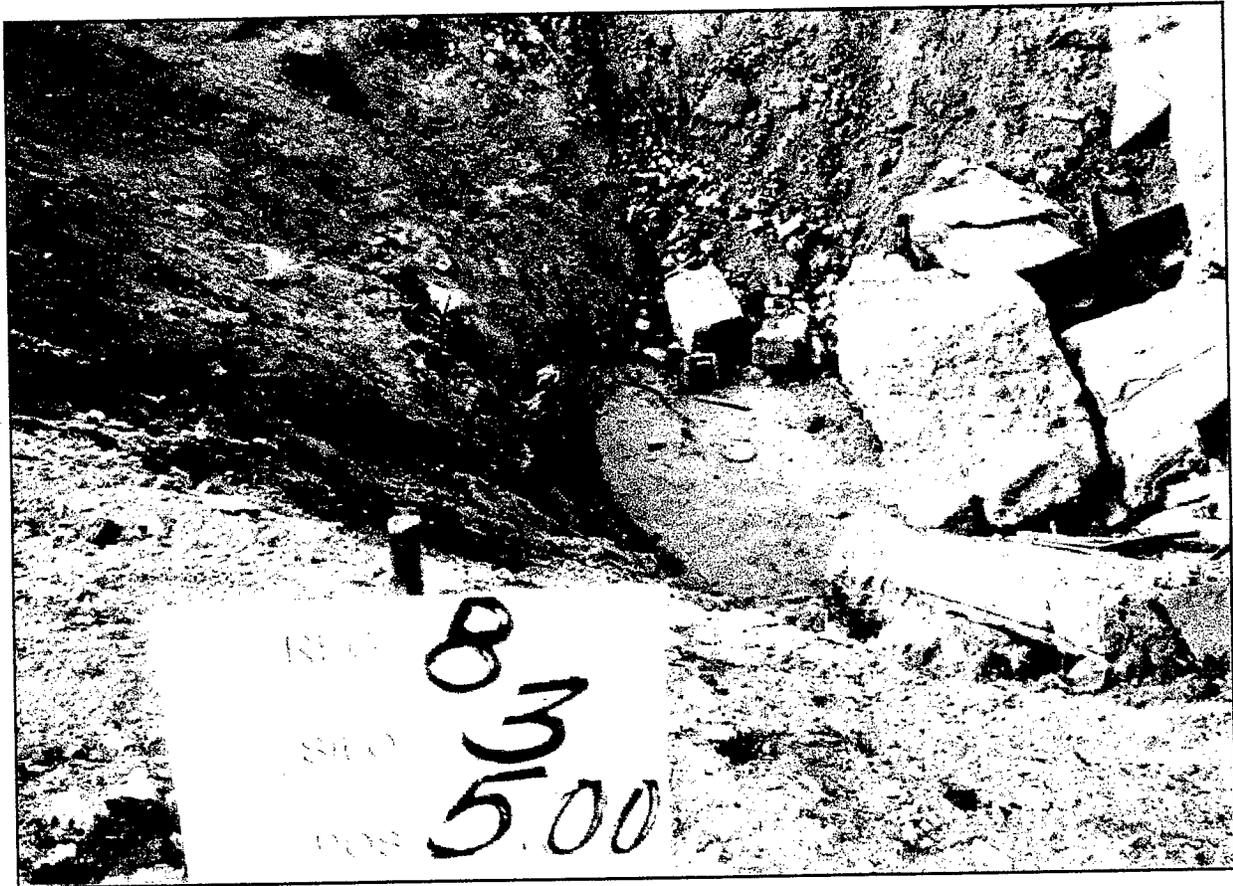
Figure 43. After the silo tube has been capped, additional rubble is pushed into the crater over the cap. Zhangiz Tobe, Regiment 8, Silo 3. Courtesy of Brown & Root/ABB SUSA.

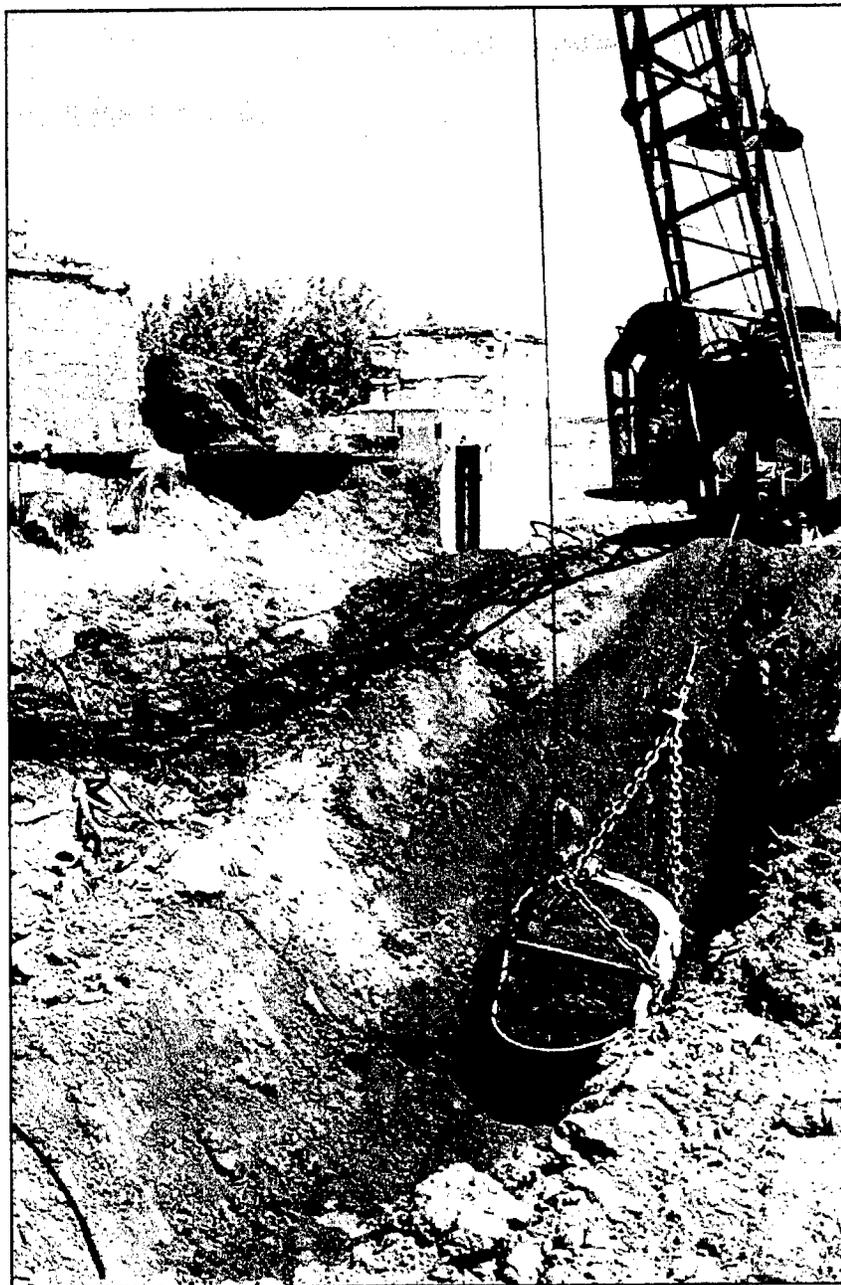
Figure 46. Excavating a pit along side a bermed storage bunker for the disposal of the bunker. The earth is brown, fine-grained silt and clay; the gray-white material is poorly sorted sand, possibly dumped in place during construction. Derzhavinsk, Regiment 2, Silo 3.

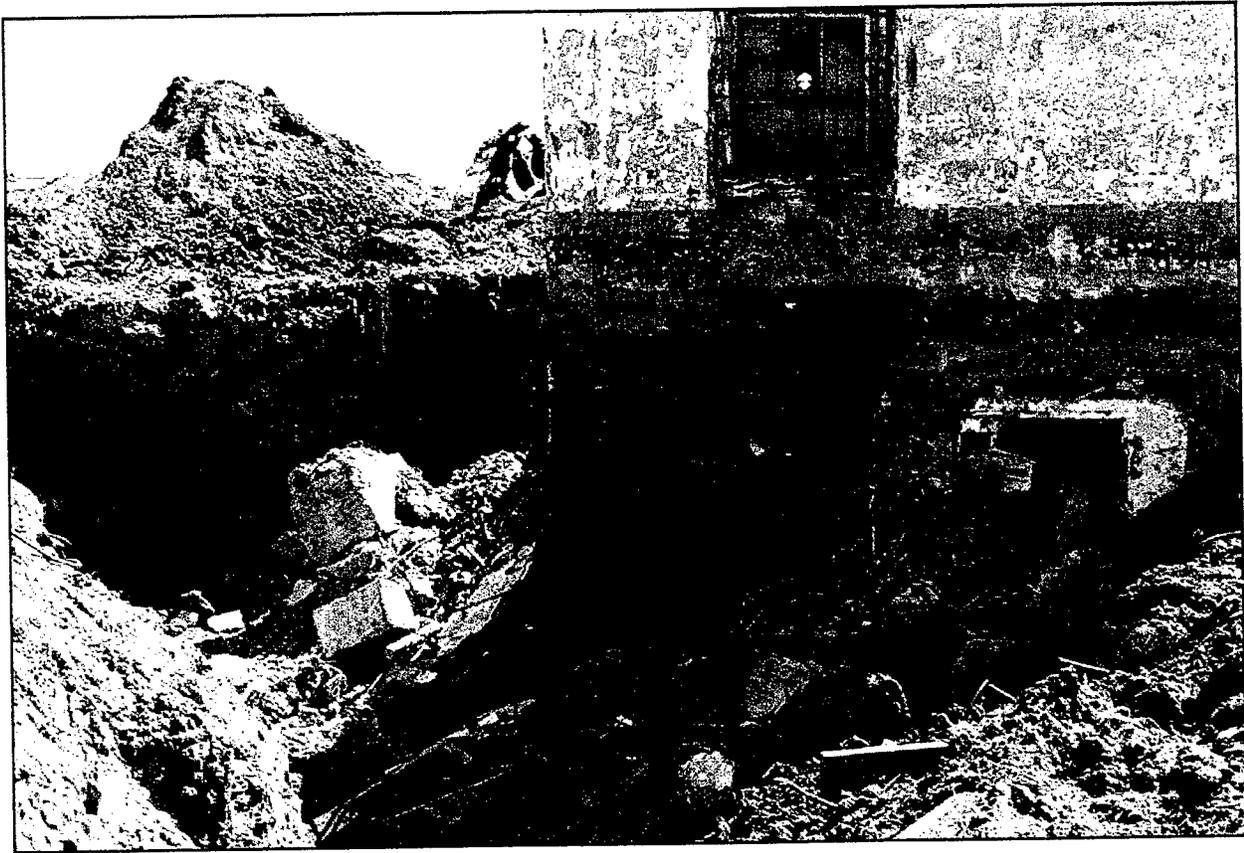
Figure 47. A pit has exposed the subterranean section of the "Force Protection" security building. The pit is partially filled with building rubble. Derzhavinsk, Regiment 2, Silo 2.

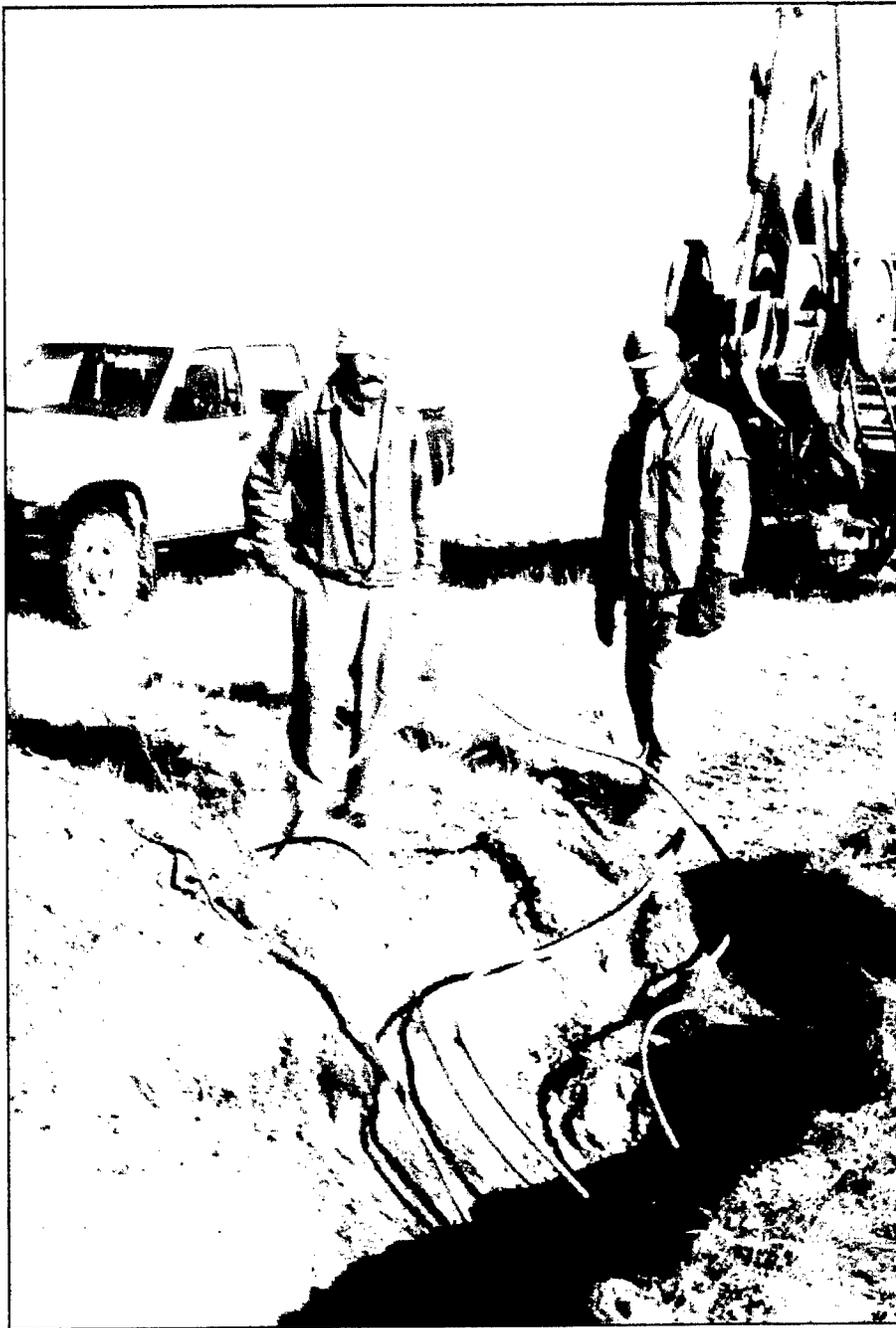
Figure 48. Cable salvaging operations. Four cables are being retrieved from one trench. Zhangiz Tobe. Courtesy of Brown & Root/ABB SUSA.
