Assessment of Potential Archaeological Collections Facility Sites at Edwards Air Force Base

Archaeological Curation-Needs Assessment
Architectural-Archaeological Report No. 1

U.S. Army Corps of Engineers
St. Louis District

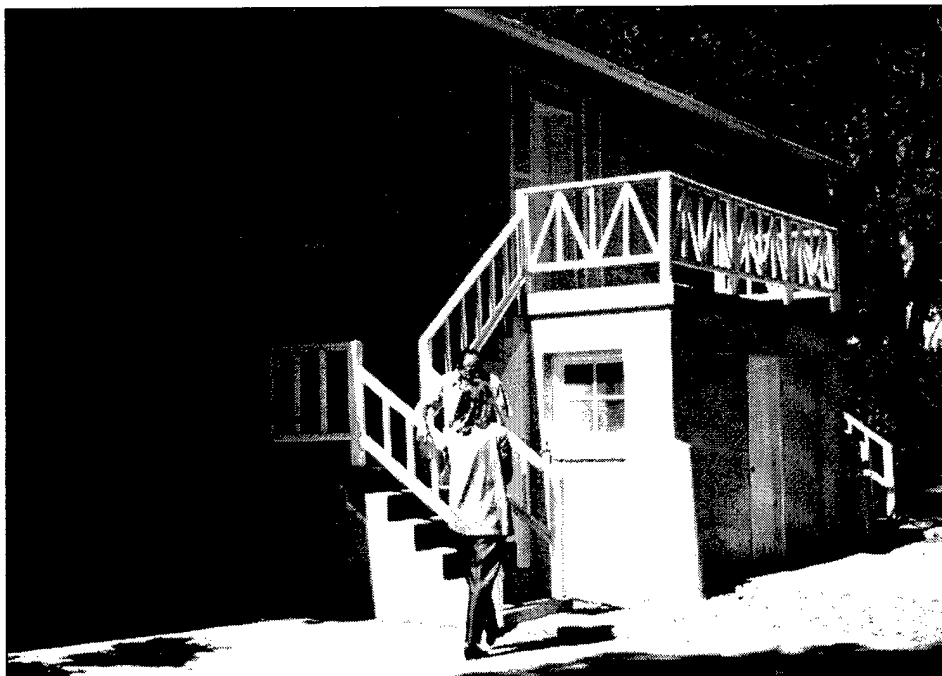
**Figure 3. View of the north side of Building 16.
Note the picture window and the ground-level entrance.**
