Archaeological Curation-Needs Assessment
Technical Report No. 8

An Archaeological Curation-Needs Assessment for the Legacy Resource Management Program

**U.S. Army Corps of Engineers
St. Louis District
Mandatory Center of Expertise for the
Curation and Management of Archaeological Collections
Archaeological Curation-Needs Assessments
Technical Report No. 8**

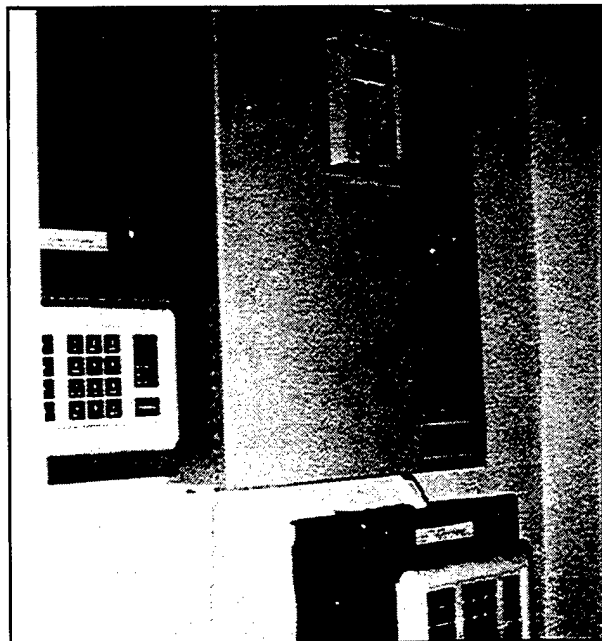
Security for the building and the collections storage area consists of an intrusion alarm (Figure 4) on exterior doors wired into the military police station, motion detectors, and controlled access. All doors have dead-bolt locks

Figure 4. Fort Lewis Military Museum security system.

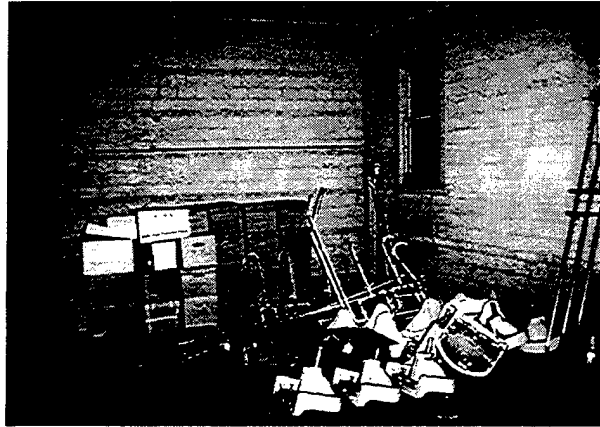
At the beginning of the visit, boxes with archaeological materials were stacked on the cement floor and/or on a piece of plywood on the floor (Figure 6).

Figure 6. Fort Lewis collections stored on floor in Building T4294.

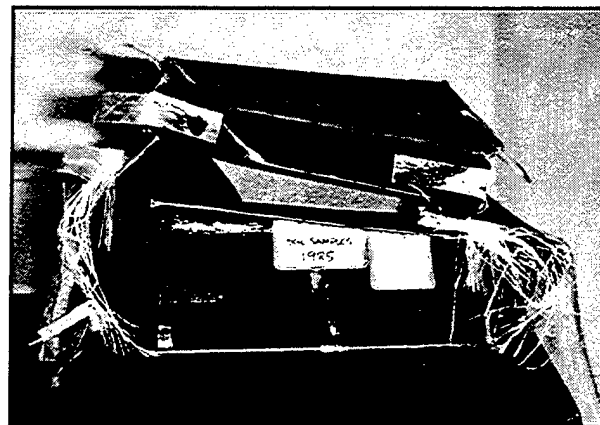
Primary containers consist of various-sized acidic cardboard boxes with telescoping or flap lids. Boxes are labeled, either directly or on an adhesive label, with marker. Labels contain the project name, site numbers, and/or provenience information. Several of the boxes are unlabeled. Most of the boxes are compressed, dirty, and/or torn (Figure 7). Insect remains were noted in several of the boxes.

Figure 7. Severely compressed secondary containers for Fort Lewis collections.

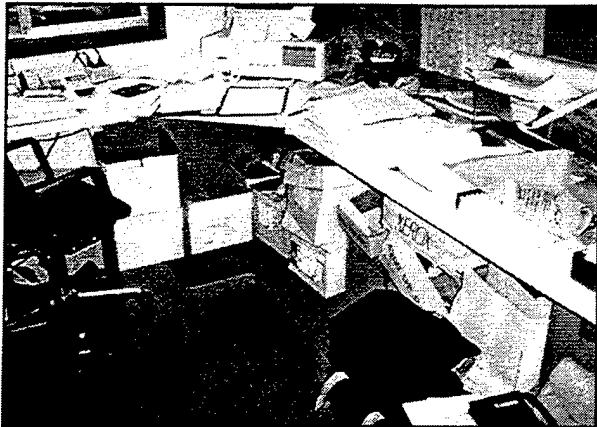
Figure 9. Paper records for Fort Lewis archaeological collections stored in Building 4301.

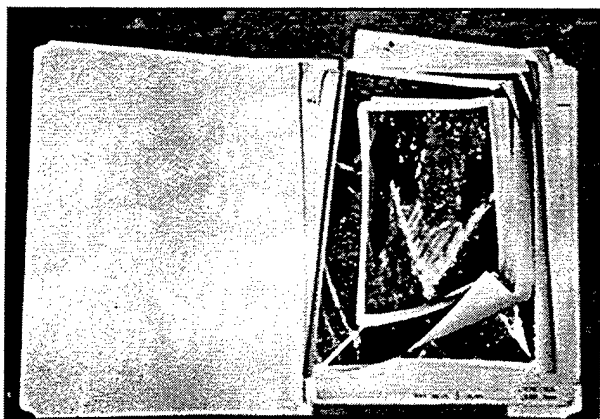
Figure 10. Condition of Fort Lewis photographic documents (note curling edges).

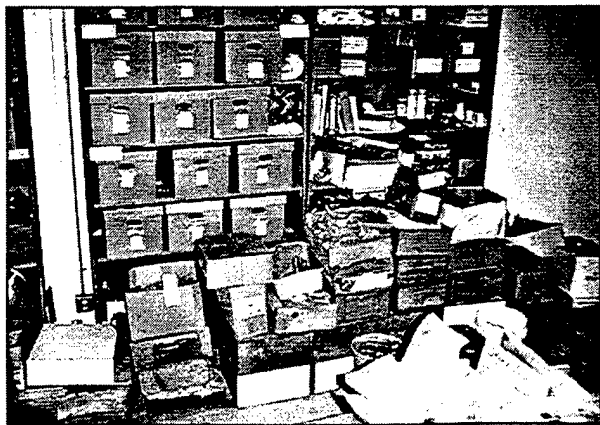
Several types of storage units are used to store the archaeological collections. Collections in boxes are stored on various-sized homemade wooden shelving units constructed of $\frac{3}{4}$ -inch plywood that line the north and south walls, a wooden table located against the east wall, and boxes stacked on the concrete floor (Figure 12). The shelving units are four different sizes (length x width x height): 4 x 1.3 x 4 feet; 3.3 x 1 x 4.1 feet; 4 x 2 x 3.5 feet; and 4 x 2 x 4.1 feet.

Figure 12. Storage units for collections in Building 127 at NSB San Diego.

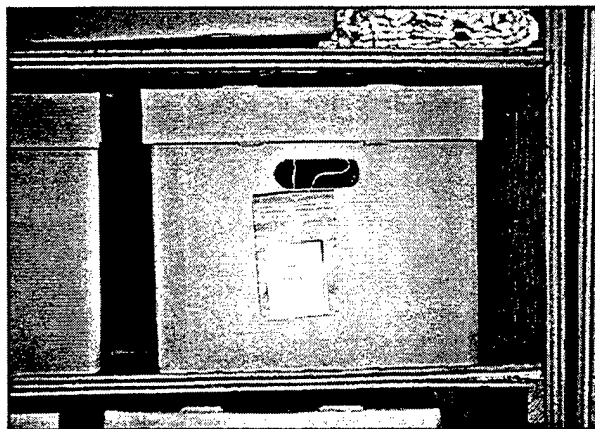
Box labels for material stored in the acidic cardboard boxes consist of acid-free tags inserted into polyethylene plastic zip-lock bags (Figure 13). The plastic label holders are affixed to the boxes by string looped through a hole in the lip of the bag and around the box handle. Label

Figure 13. Type of box label used for NSB San Diego collections.

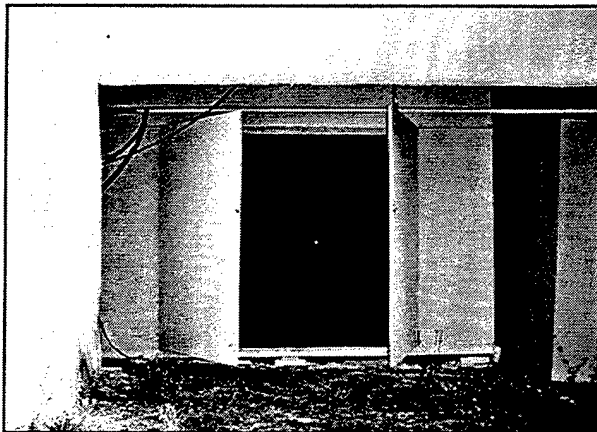
A 64 ft² storage locker is located under Building 5 (Figure 14).

Figure 14. View of storage locker under Building 5 at NSB San Diego.

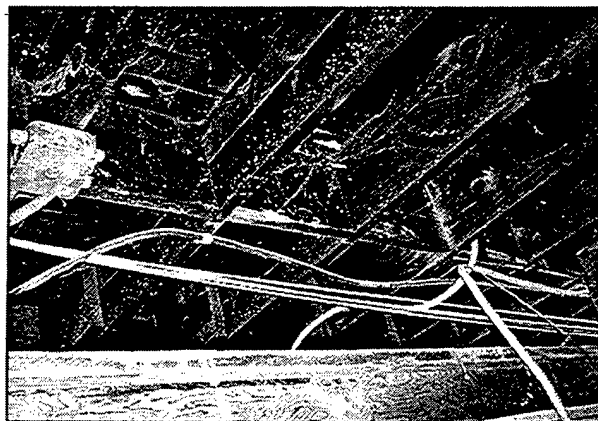
No integrated pest-management program is in place. Spider webs and dead insects were observed during the visit (Figure 15).

Figure 15. Evidence of lack of pest management in locker under Building 5.

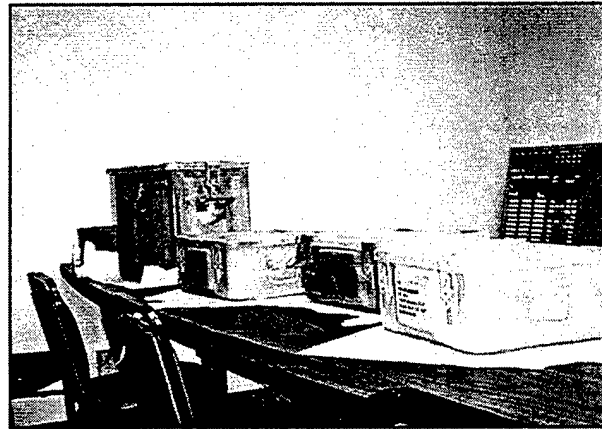
Figure 16. Type of primary containers used for collections in the storage locker.

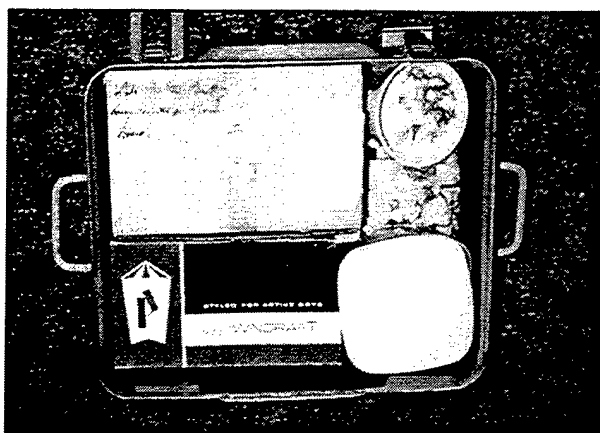
Five types of secondary containers (Figure 17) are present (Table 15). The majority (60%) of the containers include adhesive labels written in marker and/or pen stating content information. All are either directly labeled or contain adhesive labels. The plastic bags with twist ties are

Figure 17. Types of secondary containers for collections in the storage locker.

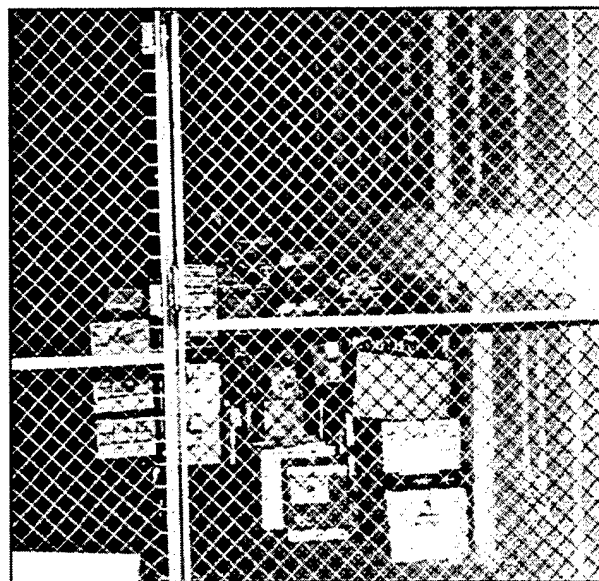
The library is protected by dead-bolt and key locks on all exterior doors and by campus police, who patrol the area several times per night. The collections storage area in the basement is protected by a dead-bolt lock on the mesh door as well as controlled access (Figure 20). Dr. Christenson stated that it takes three keys to

Figure 20. San Diego University library collections storage area.

access the collections storage area: one to access the elevator, one to access the floor, and one to open the mesh door. Several people have keys to access the basement area. These include Dr. Christenson, the library maintenance crew, and individuals in a separate department of the university that also have storage space in the basement. Access to the collections storage area is controlled by Dr. Christenson.

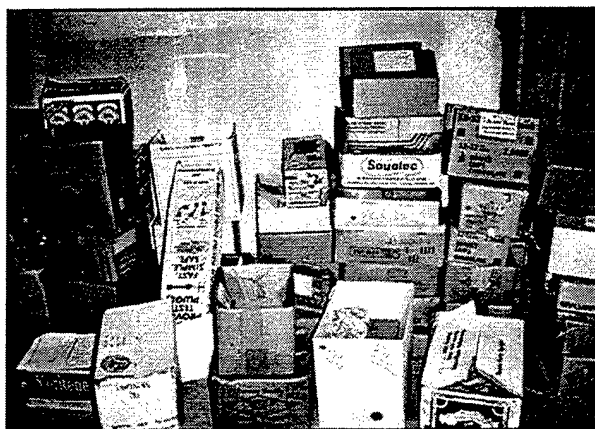
The concrete slab floor serves as the storage unit. The archaeological materials from Admiral Baker Field are stored in boxes stacked three to seven high on the floor along the south wall of the collections storage area (Figure 21).

Figure 21. Admiral Baker Field collections in the library repository.

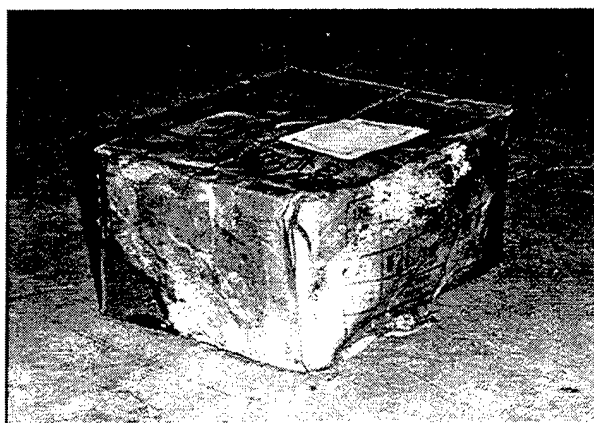
Figure 22. Example of water-damaged box in library collections area.

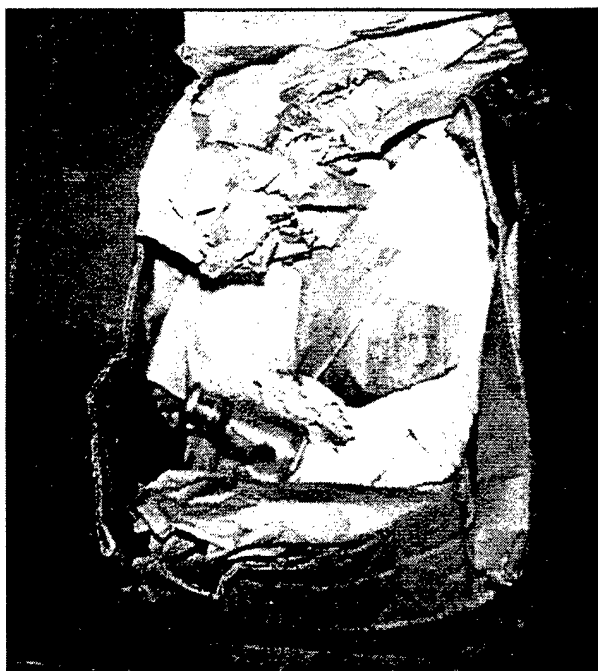
Figure 23. Example of water-damaged box in the shipping container.

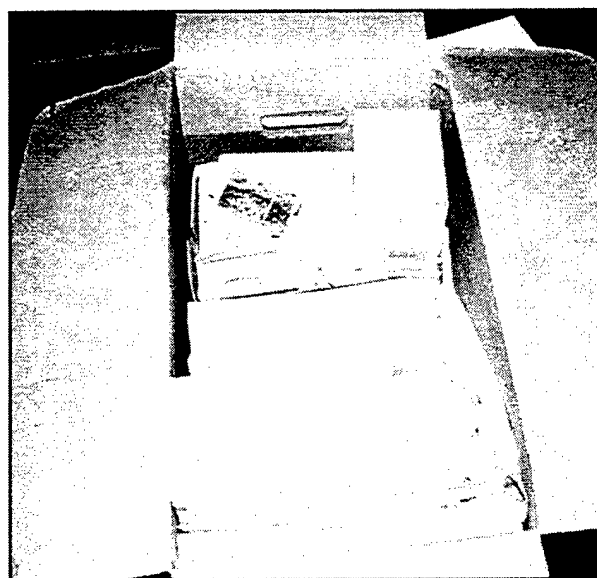
A variety of secondary containers (Figure 24) are used to store the archaeological materials from Admiral Baker Field (Table 18). The majority (78%) of the secondary containers are not labeled. However, 22% are directly labeled with marker with the site number, provenience, and date information.

Figure 24. Types of secondary containers used for collections.

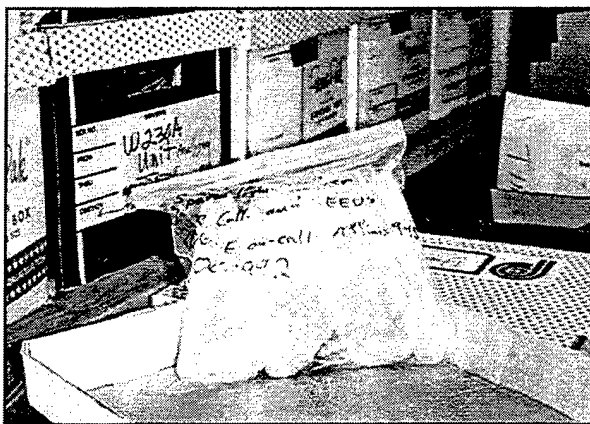
NAS Miramar artifacts are stored in a single 2-mil polyethylene zip-lock bag (Figure 26). The bag is labeled directly in black marker with the contents, date, and job number information.

Figure 26. View of the secondary container holding NAS Miramar artifacts.

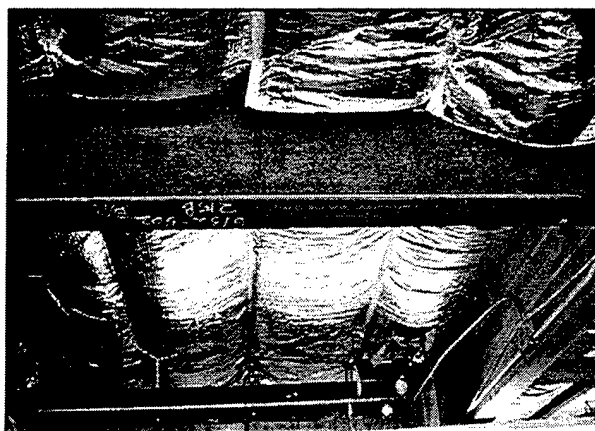
Figure 28. Ceiling beams and insulation in collections area.

The storage area is composed of two rooms separated by a single panel wood door on the second floor of Building 5550. Interior walls are covered with plasterboard but are unfinished. There are exposed steel and wood support beams in the ceiling overlaid with uncovered insulation (Figure 28). Tar, possibly from the roof, has permeated the ceiling around the joints in the support beams and hangs on the rafters. The floor is constructed of unsealed poured concrete, and there are several places where large cracks exist in the concrete floor. Plumbing and electrical systems are original to the building. Overhead pipes that are connected with an exterior storm sewer system are in close proximity to archaeological materials. Additionally, ductwork for the heating and cooling system is clearly visible (Figure 29). Numerous uncovered telephone panels and transformers are located on the south and east walls of the larger of the two rooms. Four doors are present in the two rooms: one in the "center" separates the two rooms, two west-facing single wood panel doors each leading to Analytical Technologies, Inc. offices (one from each archaeological material storage room), and one north-facing single wood panel door that leads to a hallway and to the outside. There are no windows in the archaeological material storage area, which is filled to capacity. The room has full

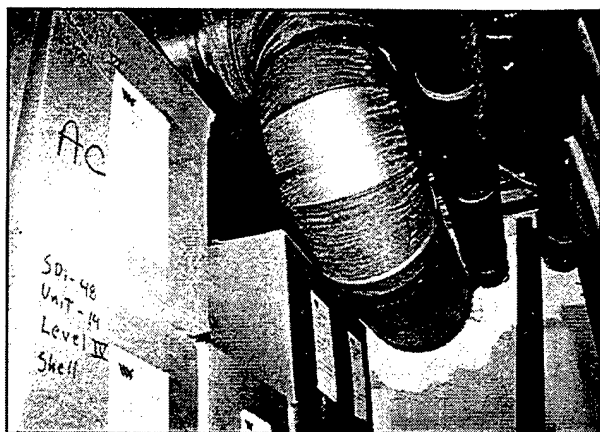
Figure 29. Ductwork touching primary containers in the OGDEN repository.

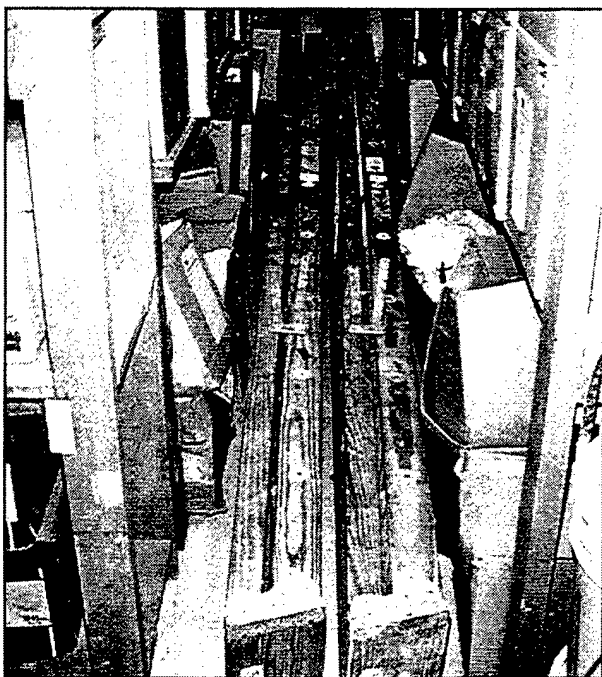
Figure 30. Clutter noted in OGDEN repository.

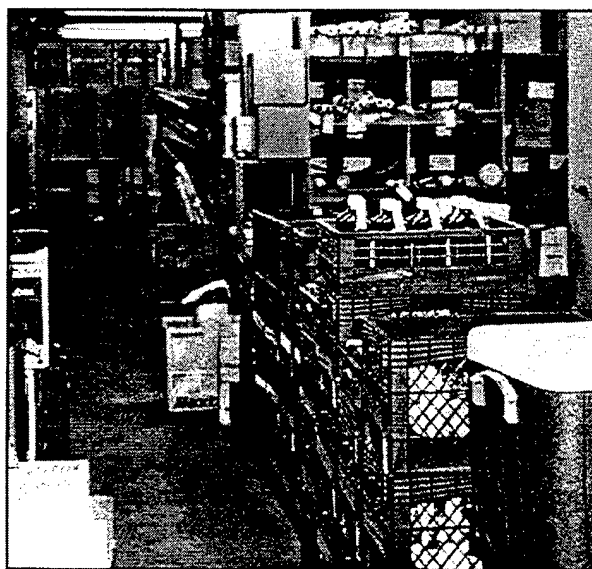
Temperature in the archaeological materials storage area is controlled by a central heating and air conditioning system. Humidity is not monitored or controlled. Staff indicated that dust filters exist for the heating/air conditioning system, but dust was abundant on all artifact boxes, especially those located directly under the air ducts. Light is provided by uncovered fluorescent tubes. The area is maintained on an as-needed basis by the curatorial staff. Adjacent to the north end of the storage area in the larger of the two rooms, and not separated by a wall, is a nonventilated area that Analytical Technologies uses to store hazardous chemicals. Multiple bottles stored in boxes are stacked on the floor (Figure 31).

Figure 31. Chemicals stored on floor in OGDEN repository.

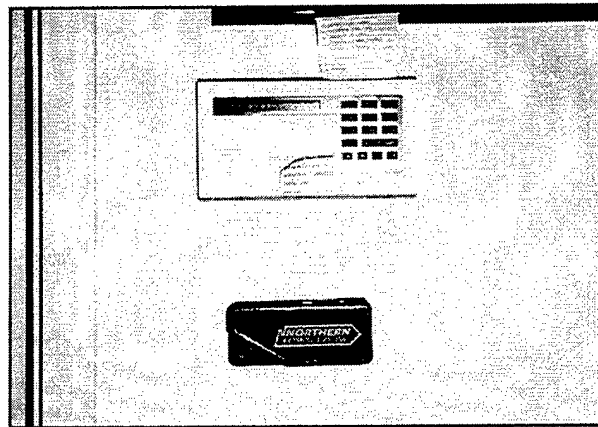
Security for the entire building is the same as that described for the archaeological material storage area. Additionally, the laboratory/records storage area is protected by a key lock on the door, motion detectors inside the room, and controlled access by use of an electronic key card system. The laboratory/records storage area was

Figure 32. Key card security system at OGDEN repository.

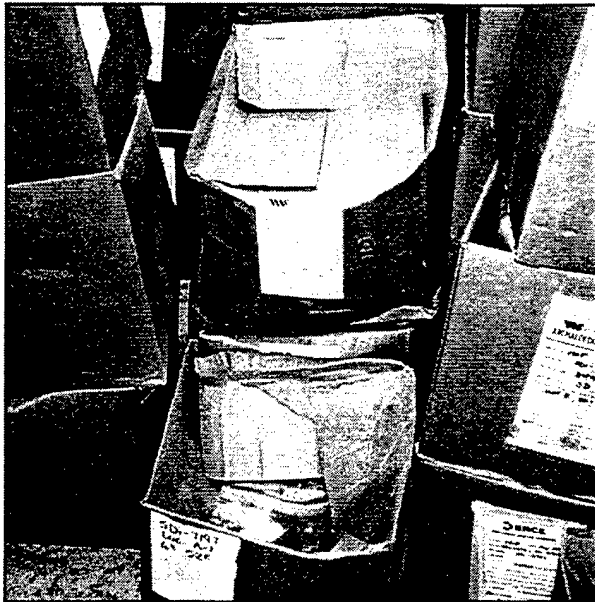
Two types of storage units are used to store archaeological materials. The majority (59%) of the storage units are boxes that are stacked four or five high on the concrete floor in the smaller of the two storage rooms (Figure 33). The remainder (41%) are stored on homemade wooden shelves in the larger storage area (Figure 34). The shelves

Figure 33. Storage containers for collections at OGDEN.

are constructed of unsealed 2-x-4-inch wood uprights and 1/2-inch plywood shelves. There are a total of eight rows of shelves, each measuring 12 x 2 x 6.5 (length, width, height). Each row contains three shelves, and boxes are stacked too high on the shelves. Many boxes in the smaller of the two collections storage areas are compressed from being stacked on the floor. All of the boxes are dirty and dusty.

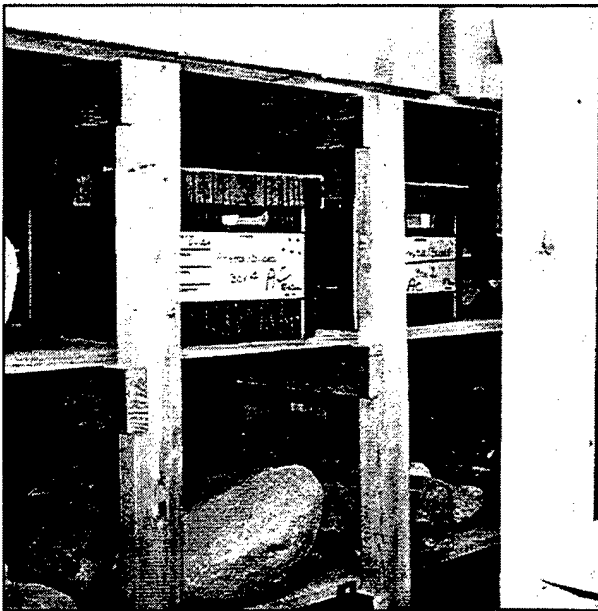
Figure 34. Other collections at OGDEN stored on wooden shelves.

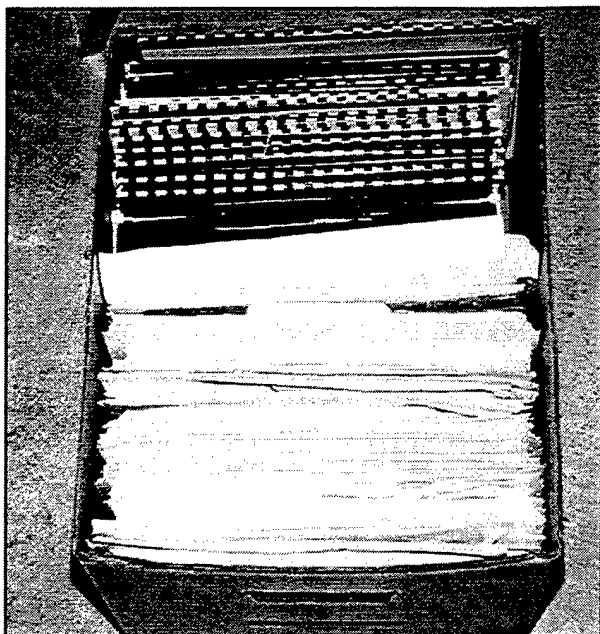
Paper records stored in the storage area are not archivally processed. The records are stored in various-sized acidic cardboard boxes with telescoping lids (Figure 35). When arranged, the records are sorted by project name and number. The majority of the boxes are directly labeled in marker with a mixture of box number, site number, site name, and contents. The remaining

Figure 35. Type of primary containers used for associated records stored at OGDEN.

box labels are preprinted adhesive and contain box number, date, site number, site name(s), and content information written in pen. Secondary containers consist of acidic manila folders. Folder labels are directly written in pen and/or typed. Label information consists of the project name. Types of paper records include administrative records, analysis records, and survey and excavation records. None of these records are duplicated on acid-free paper. However, the analysis and inventory data are stored on computer disks, and copies of these disks are stored in a locked cabinet in the laboratory as well as in the OGDEN offices in Building 5510. Original paper records are kept with the project files in the laboratory/records storage area of Building 5550.

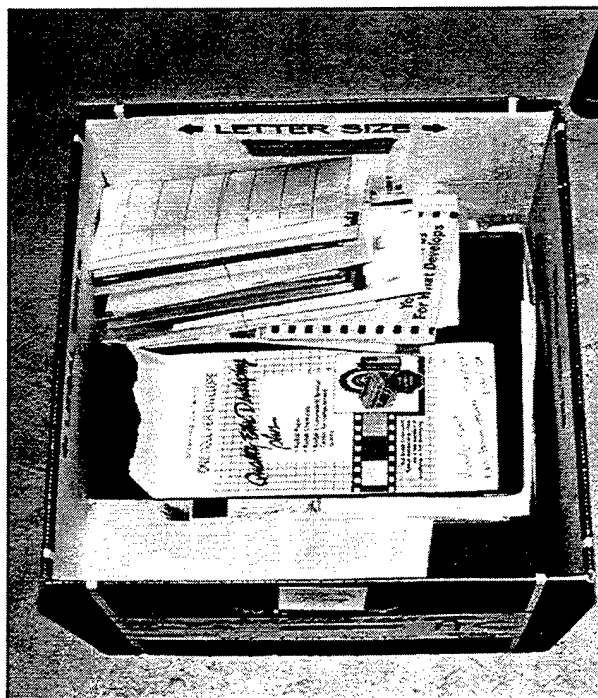
Figure 36. Storage of photographic documents at OGDEN.

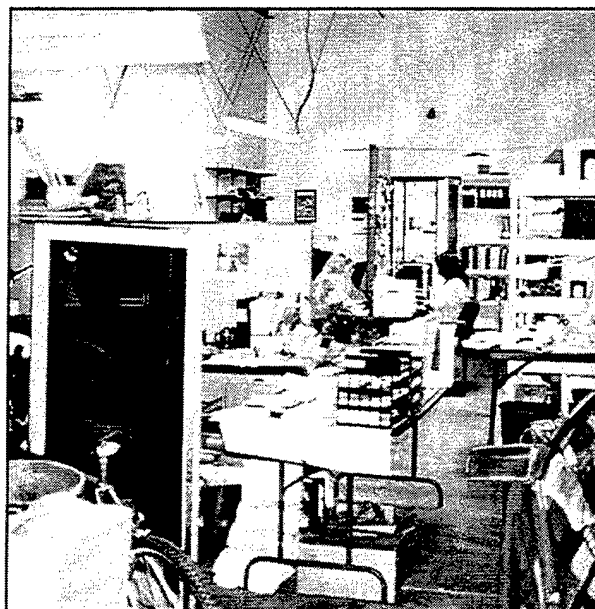
Figure 38. Interior view of the Gallegos and Associates collections area.

not monitored or controlled in the laboratory area. Air is circulated by a floor fan, but there is no dust filtration system. Light is provided by a central skylight, desk lamps, and uncovered fluorescent tubes. The laboratory area is maintained on an as-needed basis by the curatorial staff.

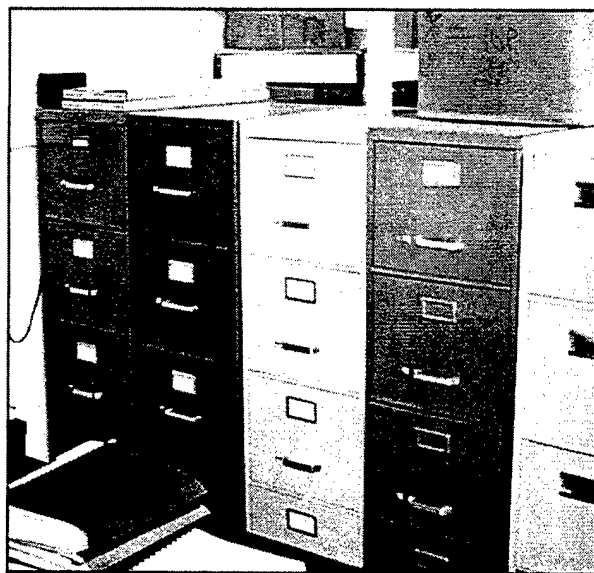
All original paper records are stored in four-drawer enameled metal file cabinets (Figure 39). These cabinets serve as the south wall of an office in the laboratory area. Records are arranged by project number and are stored in acidic manila folders, hanging file folders, and several three-ring binders within the file cabinets. File drawers contain acidic paper labels in metal tag holders. The drawer labels include project number information written in marker. Folder labels, both adhesive and direct, are written in marker and/or pen and contain project number information. A

Figure 39. Storage units for documents stored at Gallegos and Associates.

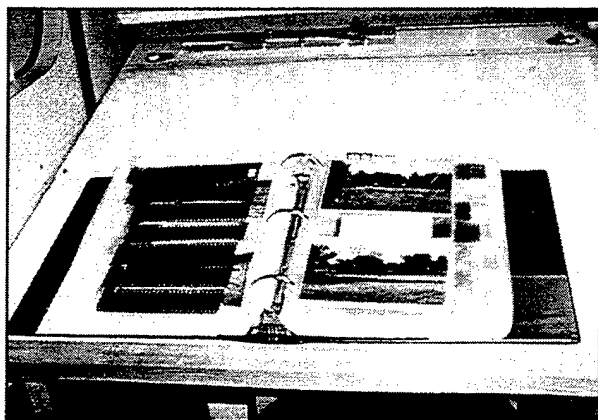
Photographic records are stored in plastic three-ring binders on a homemade, painted wooden shelving unit measuring 7 x 7 x 1.5 feet (length, height, depth). The shelving unit is located on the north wall of the laboratory area. Color prints, negatives, and slides are contained in archival-quality polyethylene sleeves within plastic three-ring binders. Plastic label holders with adhesive backs affixed to the spines of the binders contain typed labels, which include project number and project name information. Photographic documentation is arranged by project number. All prints, slides, and negatives from a specific project are stored together. The polyethylene sleeves with the color prints contain a paper tag with project number and name written in pen (Figure 40). Color prints are directly labeled on the back with marker and include project number, date, roll, and negative number information. Negative sleeves are directly labeled with marker and contain the date, project number, and project name. Slide sleeves have adhesive labels with the project name, project number, date, and photograph file number written in marker or pen. Individual slides are directly labeled in pen with project name, project number, and trinomial site

Figure 40. Photographic records at Gallegos and Associates and their secondary container systems.

number. The three-ring binders also contain photograph logs that are written in pencil.

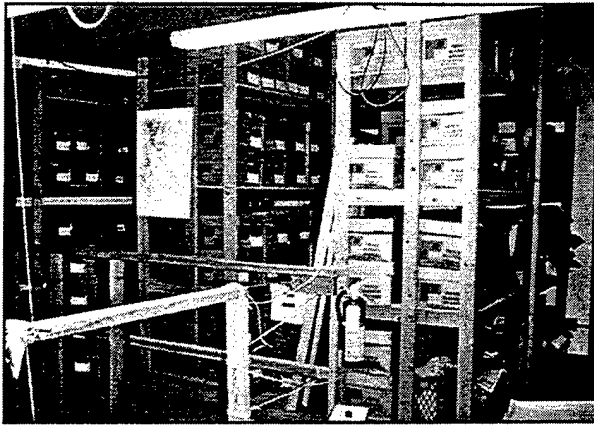
Figure 41. Collections area at Archaeological Resource Service.

ground floor and a mezzanine level built for additional storage space, totals approximately 2,000 ft². Offices and records storage occupy the first floor of the building while most artifact collections are stored in the mezzanine level (Figure 41). Additionally, an artifact holding, washing, and processing area, along with a receiving dock, a library, an equipment storage room, and a restroom, occupy areas within the ARS office.

The mezzanine level, which occupies the south and west half of the office, has a floor constructed of plywood supported by 2-x-6-inch joists surrounded by a railing made of 2-x-4-inch lumber. Approximately 700 ft² of additional storage space is provided by this mezzanine, and at the time of visit it was filled to 80 percent capacity. A leaking roof was evidenced by a homemade, plastic garbage bag “catcher” built on the mezzanine level (Figure 42).

1. Remove and curate these collections in a facility with proper fire suppression/detection, environmental control, security, and pest-management.
2. If collections cannot be removed at this time, the following measures are recommended: (a) implement an integrated pest-management system, including control and monitoring on a regular basis; (b) store archaeological collections under a proper security system, with limited access. This should include an intrusion alarm within the collections storage area; (c) install a proper fire detection and suppression system, including smoke detectors wired into the fire department and a sprinkler system; (d) install a humidity control device and monitor temperature and humidity.

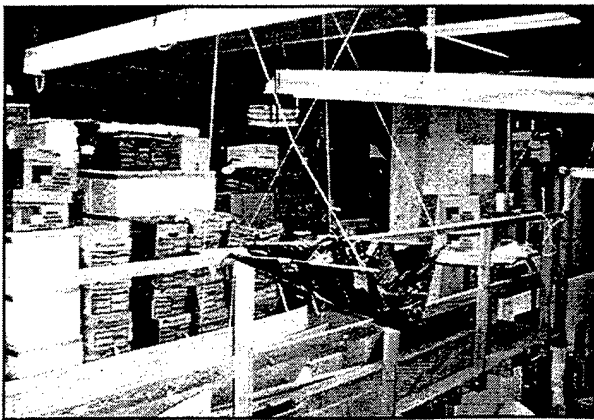
Figure 42. Handmade “rain catcher” is evidence of leaking roof at the Archaeological Resource Service repository.

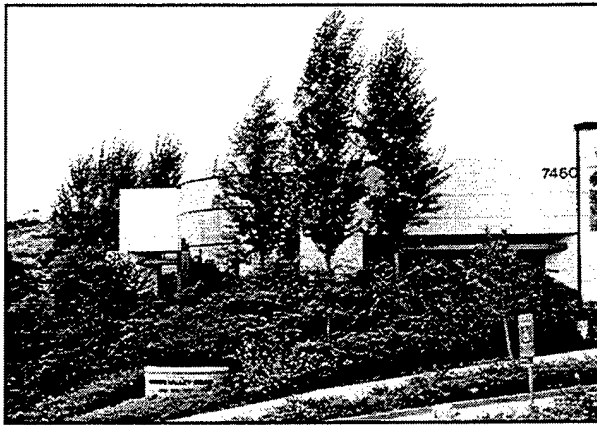
Figure 43. Exterior view of the RECON building.

The office building was constructed in 1991. The building is a single-story, steel, concrete, and glass structure with a concrete foundation and a built-up asphalt roof (Figure 43). The concrete

slab floor of the office/laboratory area is carpeted. Interior walls are covered with plasterboard, and the ceiling is composed of suspended acoustical tiles. There are three windows in this room, all with blinds, one facing east and two facing south. Windows measure 3 x 5 feet and have aluminum frames. Aside from various office doors, there are two interior doors and one exterior door. Interior doors are single wood panel, one on the northwest wall leading to the lobby and one northeast door leading to an interior hallway. There is a glass exterior door on the southwest wall of this room. Plumbing and electrical systems are original to the building.

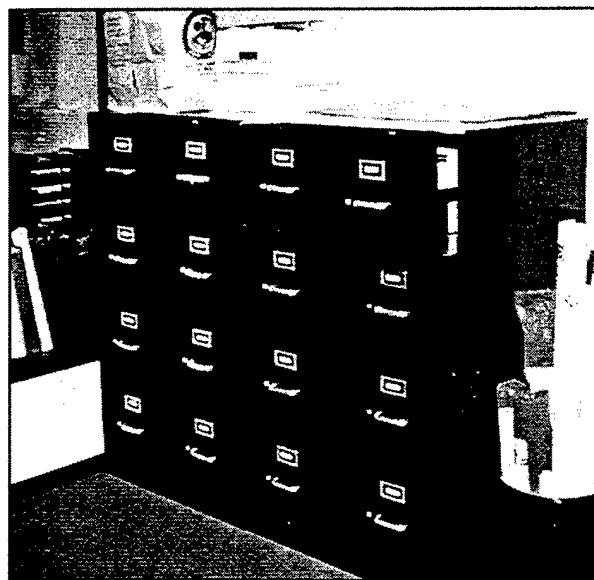
Figure 44. Storage units for project records at RECON.

Reports consisting of approximately 0.9 linear feet are from NAB Coronado and NRTF Chollas Heights. Reports are arranged by job number and are stored in a series of four four-drawer metal file cabinets (Figure 44). Adhesive labels on the file drawers list the range of job numbers inside each drawer. Secondary containers consist of acidic manila file folders labeled with job number.

marker and contain the job numbers included on each shelf of each row. Papers records are contained in acidic manila file folders stored in acidic expanding file folders. Expandable file folders include adhesive “punched” labels with the job number, as well as a typed tag inserted into a plastic tab that is attached to the side of the folder. Most of the acidic manila folders are directly labeled in marker and/or pen with job number and, occasionally, folder contents. Types of paper records include correspondence, analysis records, background records, and survey records. All are in good condition, although many contain contaminants such as paper clips, staples, and folding metal clips. None of the paper records are duplicated.

1. Store all paper records in acid-free folders. Store photographic records in archival-quality sleeves. Store maps and/or oversized documents flat in map flats. Duplicate all records on acid-free paper and store at a separate and secure location.
2. Upgrade the fire-detection and -suppression system in Archaeological Material Storage Area 1 to include a sprinkler system and smoke detectors.
3. Install humidity-monitoring devices. If an HVAC system cannot be installed, purchase commercial dehumidifiers and hygrothermographs to control and monitor humidity.

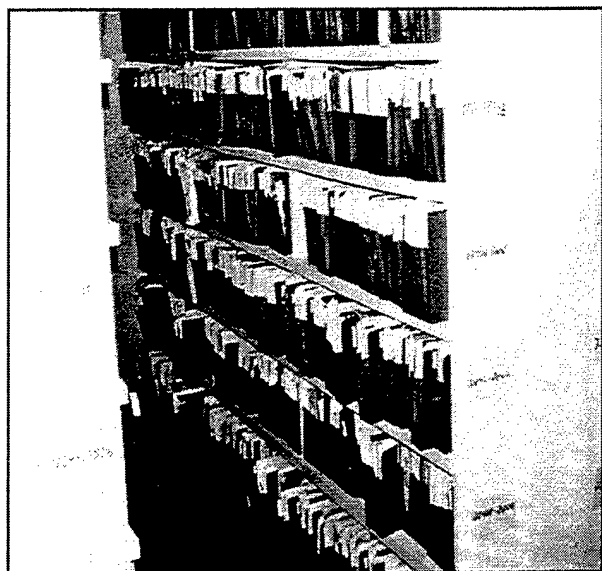
Figure 45. Archives room at RECON (note records stored on floor).

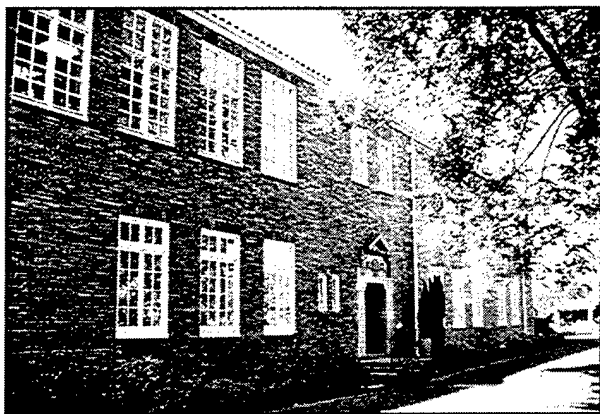
Figure 46. Exterior view of the Jones and Stokes repository.

The building was originally constructed as a school in 1929 and remodeled into an office building in the 1980s. It has a concrete slab foundation, brick exterior walls, and a clay tile roof (Figure 46). Interior walls are covered with plasterboard. The ceiling is composed of suspended acoustical tiles. The floor is carpeted. There are numerous windows throughout the building. Two windows are in the second-floor office with the records. The windows measure 3 x 10 feet (width, height), are located on the east wall, and have wooden frames that were replaced during the 1980s renovation. One interior single wood panel door is present in the west wall of the office with the records. The facility functions well as office space. However, if long-term storage of archaeological materials ever occurs, additional renovations are needed.

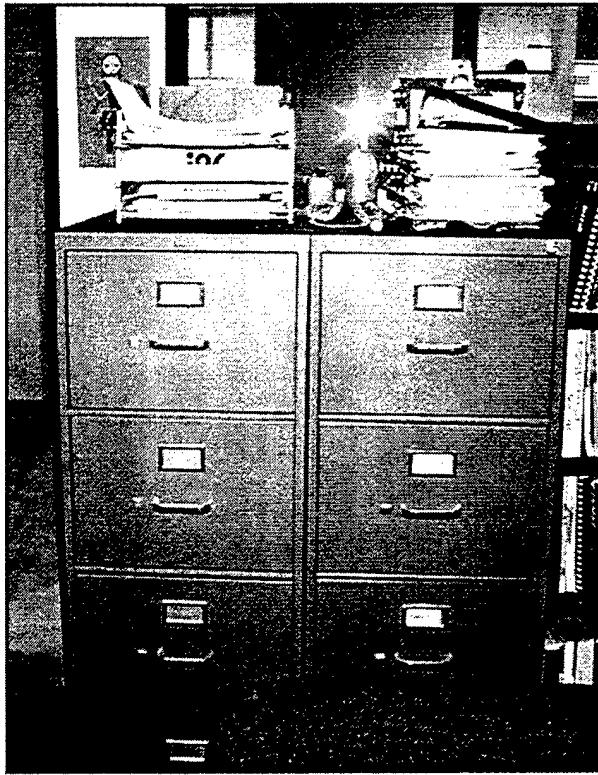
Figure 47. Documentation storage units at Jones and Stokes.

Approximately 0.4 linear feet of records associated with archaeological projects carried out at Camp Roberts (0.2) and Fort Hunter-Liggett (0.2) are stored at JSA. The majority of the records are stored in two four-drawer, enameled-metal file cabinets in the office of Ms. Dana McGowan (Figure 47). It should also be noted that a few records are located on the floor of Ms. Jane Russell's office.

Different kinds of records are combined in individual folders, making it difficult to calculate the linear feet of each type of record (e.g., paper records, photographic records) for an individual installation. Any permanent employee of JSA has access to the records. There is a basic check-out system that includes inserting a signed and dated

slip of paper into the file that contains the record. A duplicate copy of the records may exist, but the assessment team was unable to obtain information on where the copy is stored or the medium on which it was reproduced.
