## **ELECTROCHEMICAL IMPEDANCE SPECTROSCOPY EVALUATION OF PRIMED BMI-GRAPHITE/ALUMINUM GALVANIC SYSTEM**

Rimi O. Rivera and Narinder K. Mehta  
Naval Air Warfare Center, Aircraft Division, Patuxent River, MD

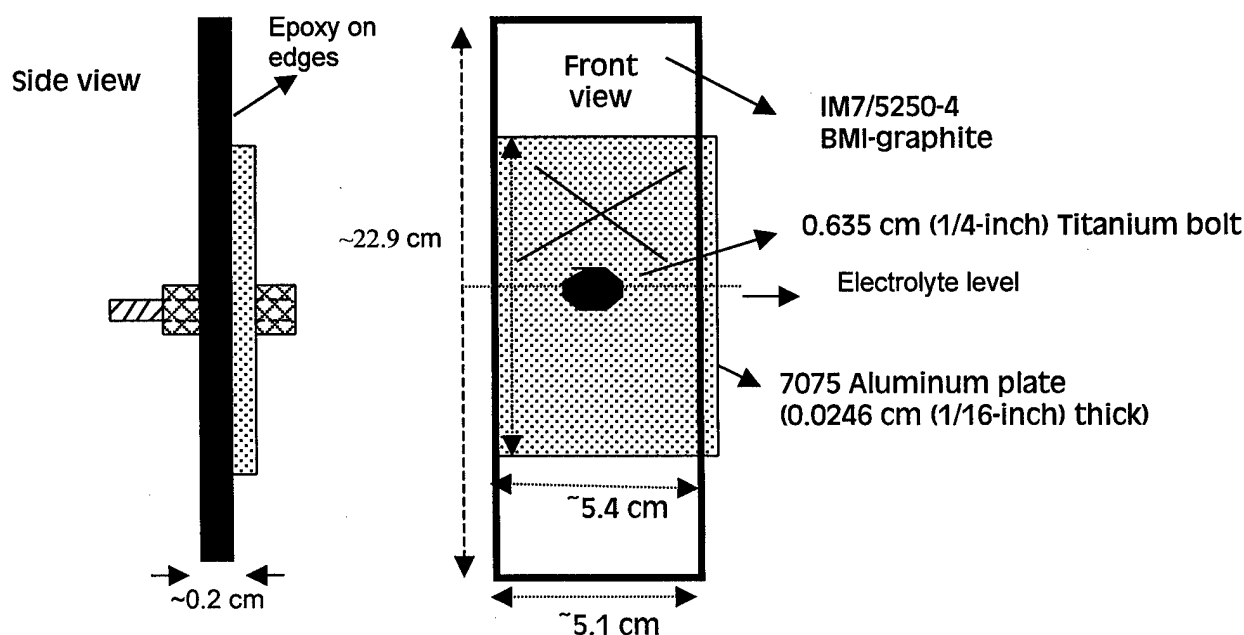
Figure 1. BMI-graphite/aluminum assembly configuration with "X" grooved on aluminum surface above titanium bolt.

The focus of the experiment was to simulate the galvanic couple created in BMI-graphite/aluminum joints under "real world" aircraft environmental exposure conditions. Specimens were prepared using Hexcel Corporation's 5250-4/IM7 BMI-graphite material attached to a 7075-T6 aluminum plate using a titanium (Ti) bolt. Sixteen plies, in a unidirectional configuration, were used to fabricate the BMI-graphite plate. Both sides of BMI-graphite composite (~22.9 cm x ~5.1 cm) and the aluminum (~10.2 cm x 5.4 cm) plates were primed with MIL-P-23377 epoxy primer and allowed to cure at room temperature for two weeks before assembly with a titanium bolt into the test configuration shown in Figure 1. In one of the test configurations, a 2-mil (0.002-inch) groove, shaped like an "X", was milled thru the primer to expose the bare metal on the upper half of the front face of the aluminum plate to accelerate the onset of galvanic couple. Un-primed bolted configurations were also prepared to obtain baseline EIS data at room temperature.

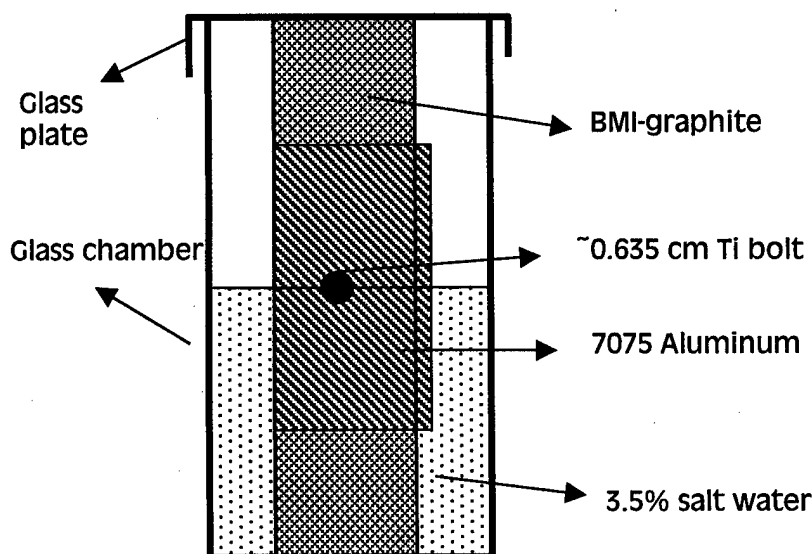
*Figure 2. Test set up for BMI-graphite/aluminum assembly*

Test specimens were immersed vertically in a rectangular 4-liter Pyrex<sup>TM</sup> glass chamber containing 3.5% salt-water solution. Testing was conducted in a laboratory oven maintained at 180°F. The top of the chamber had an airtight removable glass plate for the removal and insertion of test assemblies. The water level was maintained at the center of the Ti bolt. In other words, half of the specimen was submerged in the salt-water electrolytic solution while the

other half was exposed to the moisture-saturated air environment. Figure 2 shows a diagram of the exposure setup configuration.

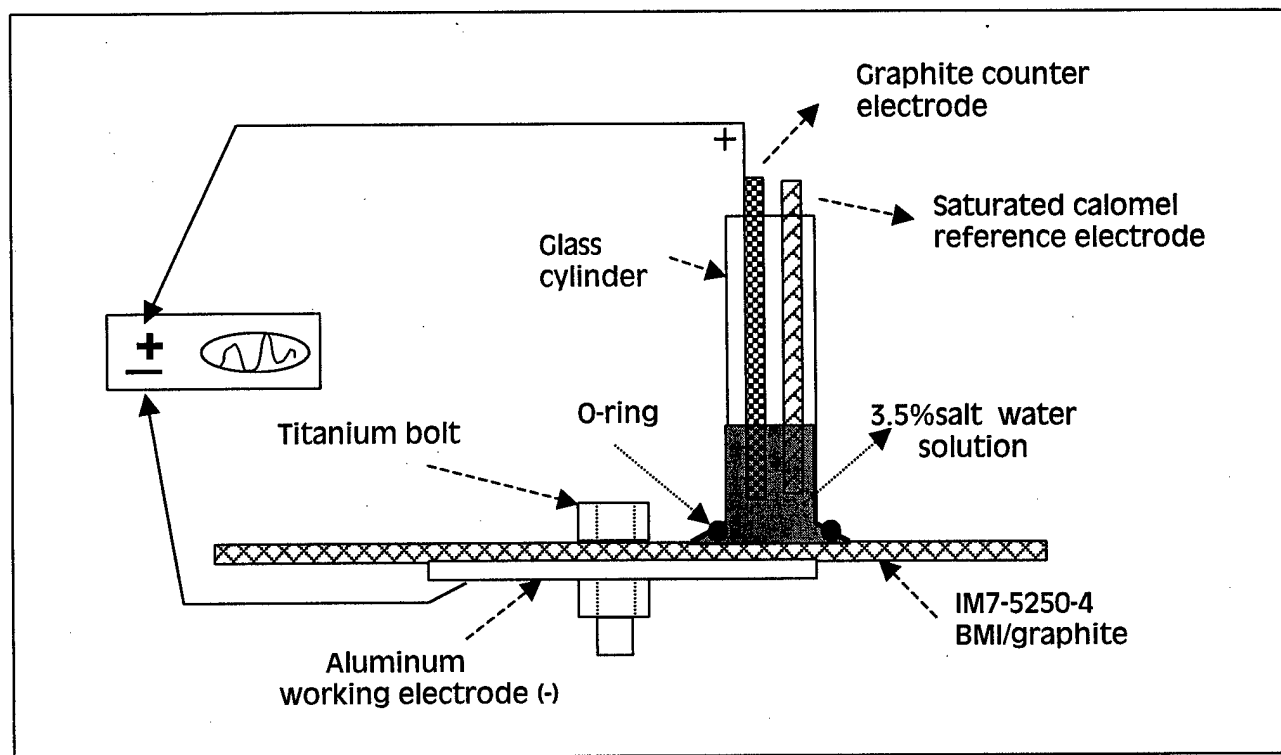
Figure 3. EIS test cell configuration

For an optimum EIS test run, specimens were taken out of the salt solution and wiped with paper tissue to remove excess electrolyte solution remaining on the surface. Specimens were maintained in a vertical position to avoid seeping of residual electrolyte embedded between the composite material and the aluminum plate on the section of the specimen immersed in the solution into the portion of the assembly that was not immersed. The EIS test cell consisted of a glass cylinder clamped with an O-ring seal on the composite surface, slightly tilted to avoid seeping of electrolyte. The cell was clamped approximately one centimeter away from the titanium bolt on the composite surface not immersed in the electrolytic solution. The cell area was 7.544 squared centimeters ( $\text{cm}^2$ ). Approximately 30-35 milliliters of 3.5% salt-water solution was added to the test cell for making the impedance measurements. The graphite rod counter electrode and the saturated calomel reference electrode were adjusted to reach about 1 millimeter above the BMI-graphite surface for all the EIS measurements. Figure 3 shows a schematic of the EIS test cell configuration.

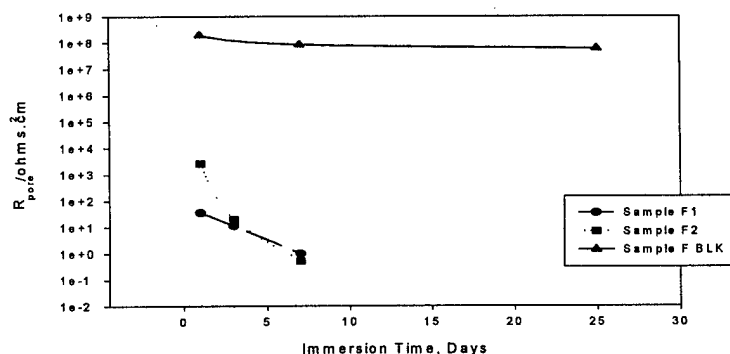
Figure 5. Pore Resistance for un-primed BMI-graphite composite/Al assemblies exposed to 3.5% salt solution at 180°F. No "X" grooved on any surface (undamaged)

The degradation trend of the exposed test assemblies F1 and F2 followed a similar pattern as reported in previous work<sup>3,8</sup> done with similar specimens at room and elevated temperatures.  $R_{ct}$  for F1 and F2 decreased drastically within 24 hours of exposure; it was in the range of  $10^5$  ohms-cm<sup>2</sup> as compared to  $10^{10}$  ohms-cm<sup>2</sup> for the control specimen in air at room temperature (data not shown). The samples degraded completely at a very fast rate within 7-days of exposure time. It was not possible to record EIS spectra for these samples after 7-days of exposure time due to the severity of degradation. Also,  $Q_{dl}$  increased drastically within 1-day of exposure reflecting extreme damage to the composite. The data reflected the occurrence of extensive surface adsorption of water/ion species by the polymeric BMI-graphite composite material within 7 days of exposure time. As shown in Figure 5,  $R_{pore}$  also decreased drastically within 1-day of exposure time. It reached  $\sim 1$  ohms-cm<sup>2</sup> for 7-day exposure time as compared to  $10^8$  ohms-cm<sup>2</sup> for the control sample for the same test period. A drastic decrease in  $R_{pore}$  reflects the

development of porosity and absorption of water and other chemical species diffusing along the fiber-matrix interface at a very fast rate to increase the electrochemical sites.

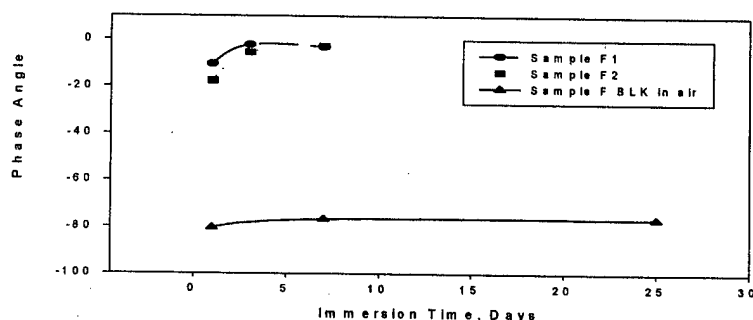
Figure 6. High frequency phase angle for un-primed BMI-graphite composite/A1 assemblies exposed to 3.5% salt solution at 180°F. No "X" grooved on any surface (undamaged)

As shown in Figure 6, the shift in Bode phase angle in the high frequency (i.e.,  $10^4$  Hz) range as a function of immersion time was also drastic for the duplicate test assemblies as compared to the control specimen. It reached a value of  $< -20^\circ$  within 1-day of exposure and reached almost zero degree within 7-day of exposure whereas the control sample demonstrated a highly capacitive behavior with  $\sim -80^\circ$  phase angle value in high frequency range. The impedance Bode plots for F1 and F2 assemblies demonstrated a drastic reduction in its slopes within 7-day of immersion time reflecting diffusion and onset of Warburg impedance. The plots also reflect fast kinetics resulting in rapid growth of pores and cavities due to diffusion of electrolyte and other chemical species into the BMI-graphite matrix, and are probably responsible for initiation of side reactions to accelerate the degradation of BMI resin in the composite material. The data has reflected that galvanic couple started developing within hours of exposure of test specimens to 3.5% NaCl at 180°F. As expected, at the end of the 7-day test period, aluminum plates in the test assemblies were found to be oxidized (or degraded) with white metal hydroxide and chloride gelatin precipitates all around the metal edges and in the solution.

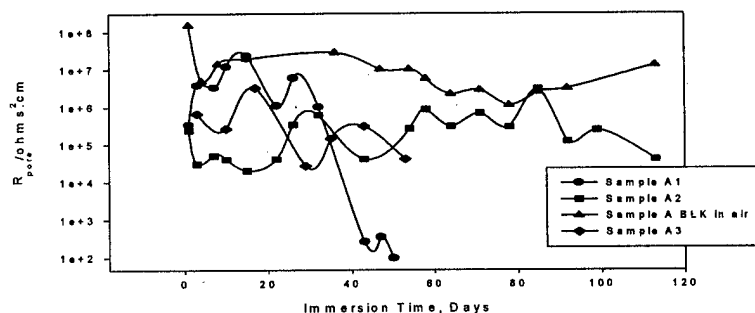
Figure 7. Pore Resistance for primed BMI-graphite composite/Al assemblies exposed to 3.5% salt solution. No "X" grooved on any surface (undamaged)

$R_{ct}$  for A1 specimen was in the range  $10^8$  -  $10^9$  ohms-cm<sup>2</sup> for up to 32 days of immersion time and decreased drastically to  $4 \times 10^3$  ohms-cm<sup>2</sup> between 32-43 days of exposure with a simultaneous increase in  $Q_{dl}$  from its approximate value of  $10^{-8}$  -  $10^{-9}$  Farad-cm<sup>-2</sup> for up to 32 days of immersion time to  $5 \times 10^{-4}$  Farad-cm<sup>-2</sup> between 32-43 days of exposure (data not shown). It reflected onset of corrosion between the metal and composite interface due to diffusion of electrolyte, water and other species. It also reflected that the primer resistance decreased due to diffusion of electrolyte into the interface between the primer and the composite. This diffusion is responsible for the initiation and development of conductive paths for early formation of cavities and delamination of the primer. As shown in Figure 7,  $R_{pore}$  for A1 assembly also decreased drastically for between 32-43 days of exposure time reflecting development of porosity and gradual absorption of water, electrolyte and other chemical species diffusing along the primer-fiber-matrix interface to increase the electrochemical areas. Once the integrity of the primer is compromised due to delamination or development of cracks/crevices in the primer film, it is probable that crevices/blisters on the BMI-graphite composite at microscopic level started growing due to highly electrochemical diffusion activity created by mass and charge transfer. Pore resistance is due to ion conducting paths (fissures) that develop or start growing. The fissures and crevices may act as anodic sites and may help in the degradation of BMI matrix by developing galvanic couple with graphite in the composite.

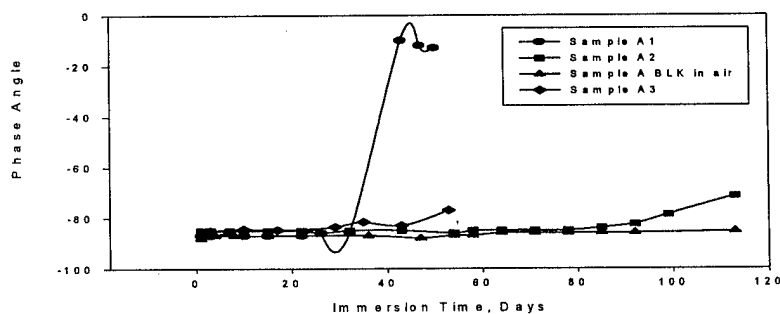
Figure 8. High frequency phase angle for primed BMI-graphite/Al assemblies exposed to 3.5% salt solution at  $180^\circ\text{F}$ . No "X" grooved on any surface (undamaged)

Bode phase angle (Figure 8) in the high frequency range ( $\sim 10^4$  Hz) demonstrated a drastic decrease in its value from  $-86^\circ$  to  $-10^\circ$  between 32-46 days of exposure time reflecting that pores and cavities started growing due to diffusion of electrochemical species and water into the primer-composite interface, and that it has initiated side reactions to accelerate the degradation of BMI resin in A1 assembly.

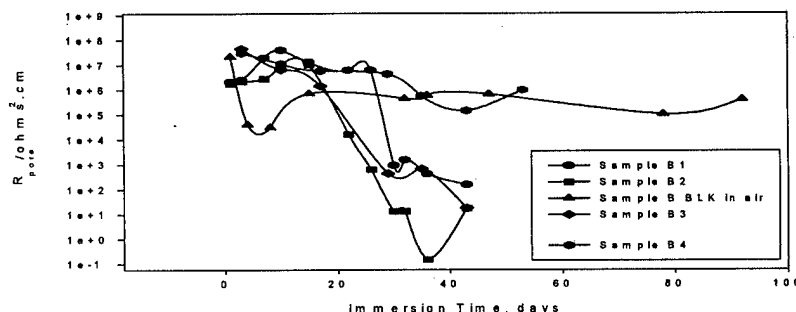
Figure 9. Pore resistance for primed BMI-graphite composite/Al assemblies exposed to 3.5% salt solution at 180°F. "X" grooved on Al surface above Ti Bolt.

The purpose of scratching/damaging the aluminum surface by marking a groove "X" was to accelerate the degradation of the primed composite-graphite matrix in a short time as in "real field" environmental conditions.  $R_{ct}$  for B1, B2 and B3 specimens were in the range  $10^8$ - $10^9$  ohms- $cm^2$  for ~15-32 days of immersion time (data not shown). It decreased after this period with a simultaneous increase in  $Q_{dl}$  value from its approximate initial value of  $10^{-9}$  Farad- $cm^{-2}$  to  $10^{-4}$  Farad- $cm^{-2}$  for the same immersion time. It reflected that the primer film degraded quickly and permitted the diffusion of electrolyte and other species to develop conductive paths for the formation of cavities and fissures on the BMI-graphite composite surface. As shown in Figure 9,  $R_{pore}$  followed a similar pattern as of  $R_{ct}$  reflecting gradual absorption of water along the primer-fiber-matrix interface to accelerate the development of electrochemical sites for the onset of galvanic couple.

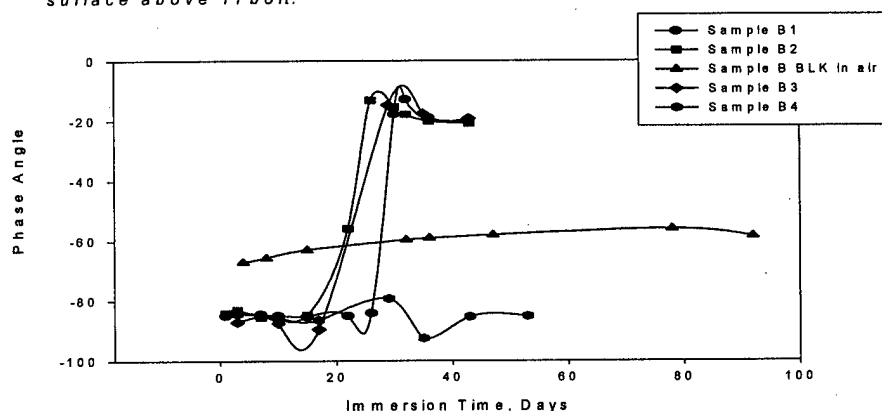
Figure 10. High frequency phase angle for primed BMI-graphite/Al assemblies exposed to 3.5% salt solution at 180°F. "X" grooved on Al surface above Ti bolt.

Figure 10 demonstrates the shift in the Bode phase angle in high frequency range for the specimens exposed to the salt solution at elevated temperature. As the surface porosity is increased due to the development of the electrochemical sites such as pores, crevices and fissures, the phase angle in the high frequency range starts decreasing due to gradual deterioration of primer and the composite matrix. Once, the pores and cavities starts growing, it augments the reduction of oxygen in the presence of exposed graphite fibers to produce hydroxyl ions, and thus initiates the BMI-matrix degradation kinetics. It is good to mention that for a pure capacitive impedance (primer/composite not damaged), the phase angle should be  $\sim 90^\circ$ . However, if diffusion of electrolyte, water and other ionic species is taking place the phase angle will decrease reflecting porous coating/material and poor adhesion (Warburg impedance). The fact that phase angle and its magnitude are decreasing gradually reflects moisture penetration down the fiber/matrix interface. A close visual look at the exposed B1, B2 and B3 assemblies reflected primer flakes delaminating from the composite surface and the degradation of the BMI resin was visible with the naked eye as shown in Photograph C. Assembly B4 did not demonstrate any onset of degradation for up to 53 days of exposure time. It reflects that the

primer is providing excellent inhibiting effect to electrical induction as well as to the development of microscopic cavities/pores on the primer-composite surface to enhance the onset of galvanic couple and also to the diffusion of electrolyte under the primer-composite-metal interphases.
