AD NO. _____
TECOM PROJECT NO. 8-EI-495-BPF-001
REPORT NO. ATC-8199 (VOLUME II)
USAISR INSTITUTE REPORT LEAP 99-2

VOLUME II
FINAL REPORT
OF THE

LOWER EXTREMITY ASSESSMENT PROGRAM (LEAP 99-2)

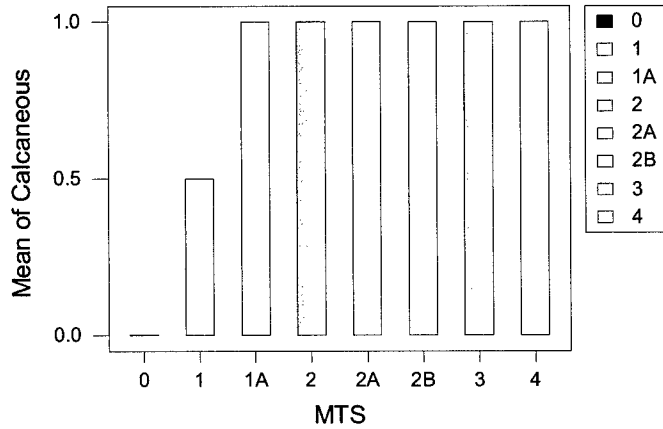
Figure 11 shows the average value of calcaneus fractures that occurred with MTS for all mines. It is interesting to observe that a fracturing of the calcaneus is characteristic of the mine injury.

Figure 11: Calcaneus fracture by MTS.

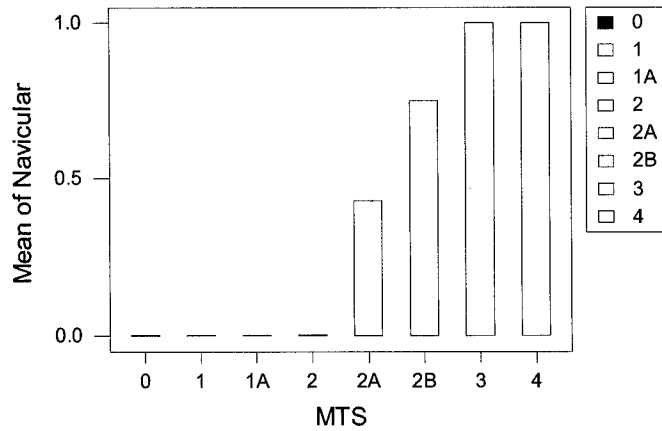
Figure 12 shows the probability of navicular fracture occurrence that compared to the MTS. Fractures of the navicular were not observed for MTS less than 2A, and that a fracture of the navicular is characteristic of MTS of 3 or greater.

Figure 12: Navicular fracture by MTS.

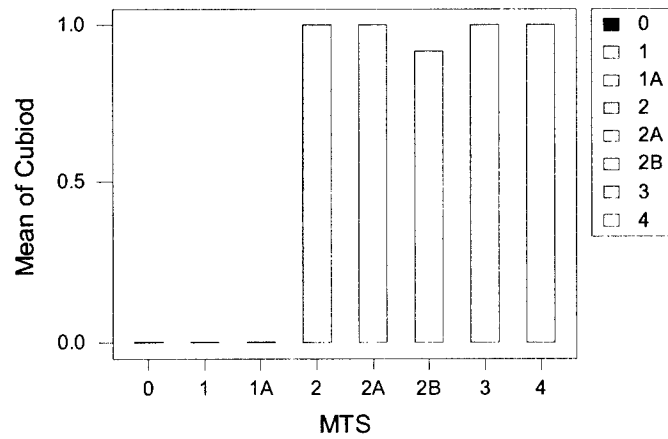
Figure 13 shows that a fracture of the cuboid is characteristic of the MTS of 2 or greater.

Figure 13: Cuboid fracture by MTS.

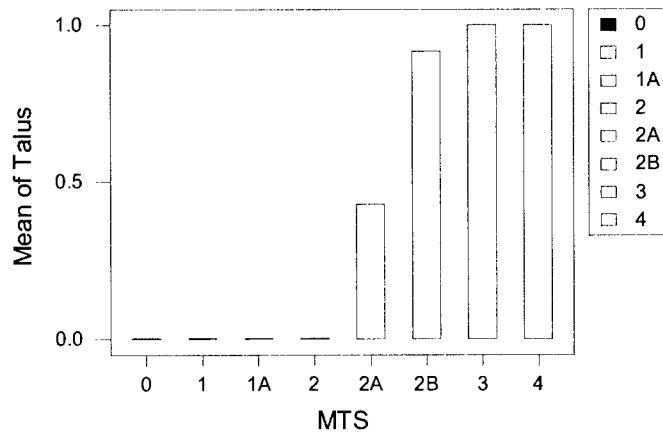
Figure 14 shows that fracture of the talus follows the same trend as the navicular, with a talar fracture not occurring with a MTS less than 2A.

Figure 14: Talus Fracture by MTS.

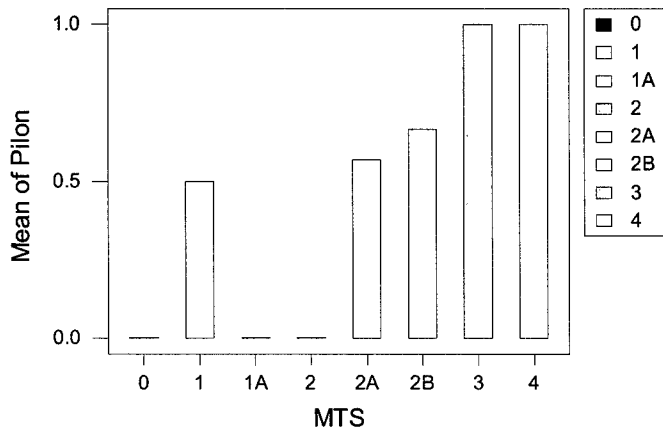
Fracture of the pilon area with respect to the MTS is shown in figure 15. Significant pilon fractures occur with higher MTS.

Figure 15: Pilon fracture by MTS.

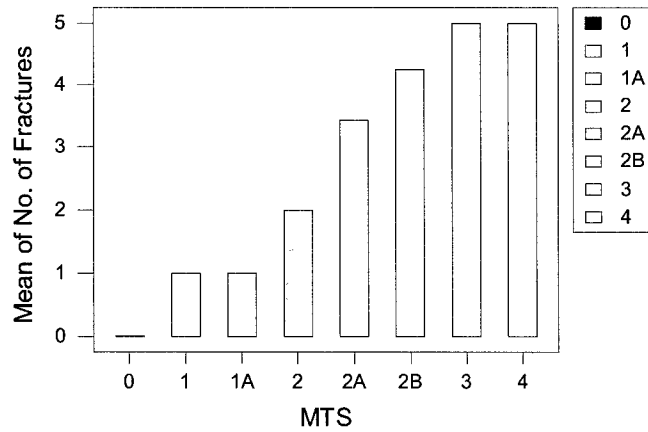
Figure 16 shows the number of fractures that generally are associated with a mine injury.

Figure 16: Number of fractures associated with MTS.

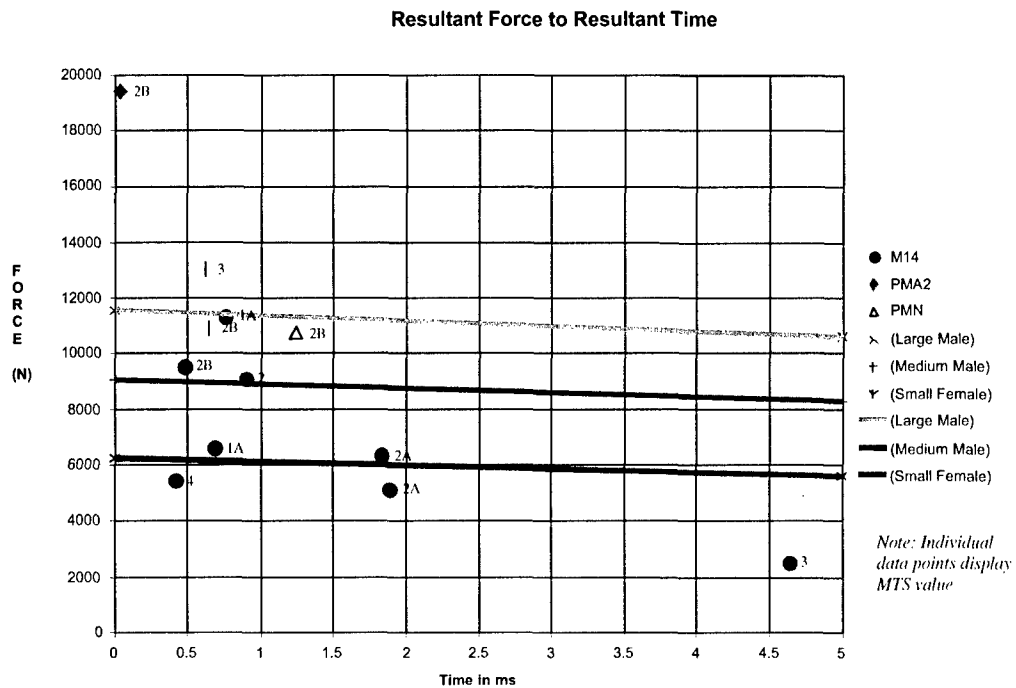
When resultant peak load data is plotted against time to peak load for the various MTS scores (*Figure: 17*) there does not appear to be a correlation. Superimposed on the same figure are injury predictive curves for long bone failure in axial loading of the lower limb derived from automotive crash testing (United States Army Aeromedical Research Laboratory, 1997). MTS values denoting severe injury fell below the low risk threshold curves invalidating the use of existing automotive crash test risk curves in predicting direct contact mine injury.

Figure 17: MTS to Femur Injury Threshold Curves (Hybrid III) (Mertz, 1993)

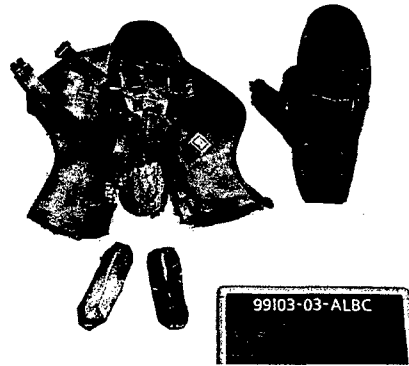
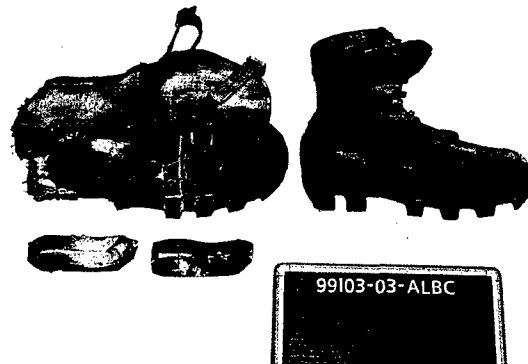
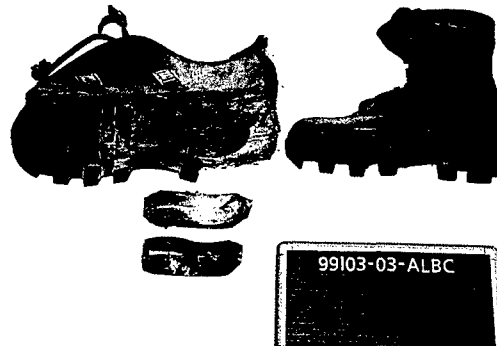
The overboot has had approximately 3 1/2 inches of the heel portion of its sole completely destroyed. The blast deflector, attenuator, and attenuator plate have been completely separated from the overboot. The rear two-thirds of the blast deflector has been flattened and bent upward approximately 1 inch. The rear two-thirds of the attenuator has been completely compressed and bent upward 1 inch. The Kevlar insole is intact, and apparently undamaged. The cloth covering over the Kevlar insole has two longitudinal tears, one approximately 1 inch, the other 3 inches, both in the heel area. The overboot's Kevlar upper has been completely split down the Achilles seam and is separated from the sole over the entire heel area, but otherwise appears to be intact with no damage to the Kevlar material itself.

The blast boot is intact with the only apparent damage being a slight concavity of the heel area of the sole, and a longitudinal 1 1/2-inch cut in the sole on the lateral one-half of the heel. It appears that there has been a significant internal compression/bending of the deflector/attenuator, but no other damage is noted.

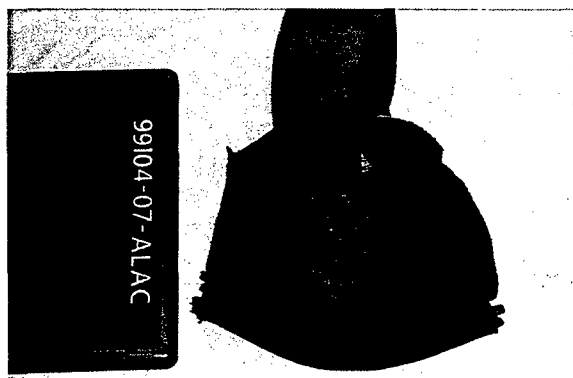
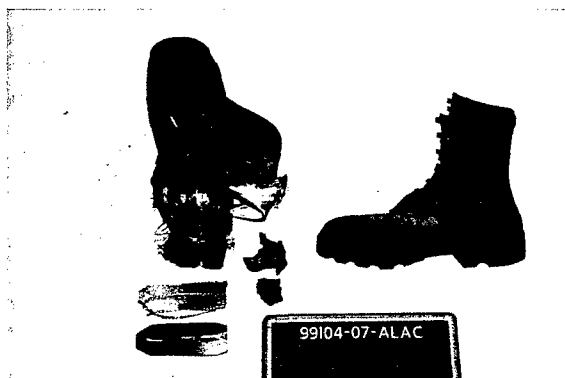
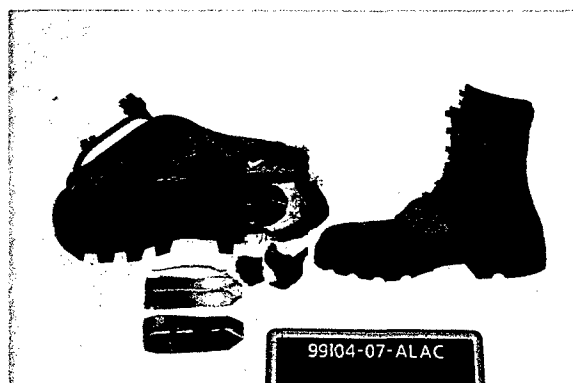
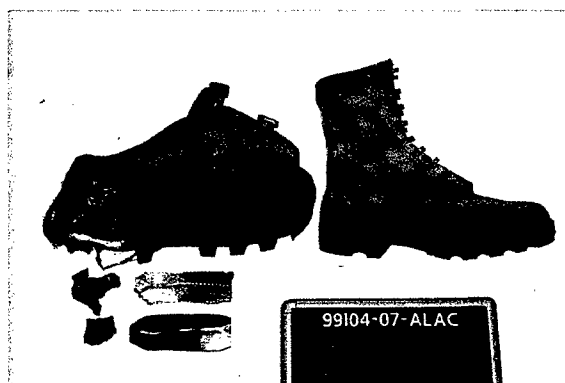
M14 Mine with combat boot/overboot combination.

The rear 3 inches of the overboot's sole has been removed by the blast. There is a 3-inch longitudinal tear down the midline of the sole from mid-heel to the front of the blast deflector. The blast deflector and attenuator have been completely separated from the overboot. The attenuator plate remains attached to the overboot. The rear one-half of the blast deflector has been flattened. There has been complete compression of the rear one-half of the attenuator, with the front half remaining uncompressed. There is a slight indentation in the attenuator plate at the center of the heel. The Kevlar insole and canvas covering remain attached to the overboot and appear to be undamaged. The Kevlar upper has been separated from the sole around the heel area on both sides and has been separated down the Achilles seam, but is otherwise undamaged. The sole and leather upper of the combat boot appeared to be undamaged. Removal of the boot's cushion insole reveals a 1½-inch lateral tear in the leather insole of the boot across the mid-point of the heel, and a 2-inch longitudinal tear at mid-heel.

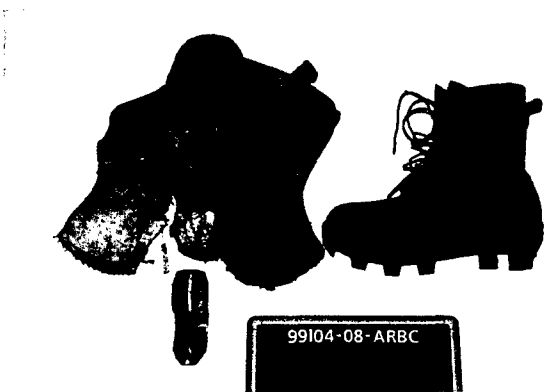
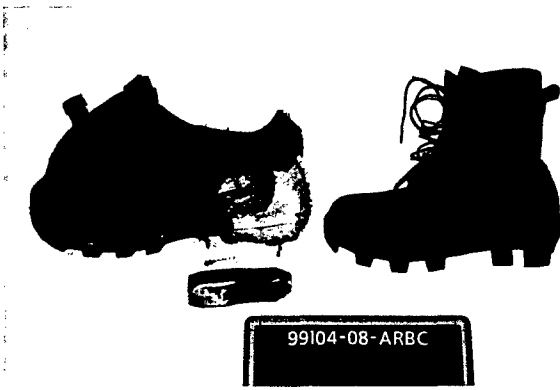
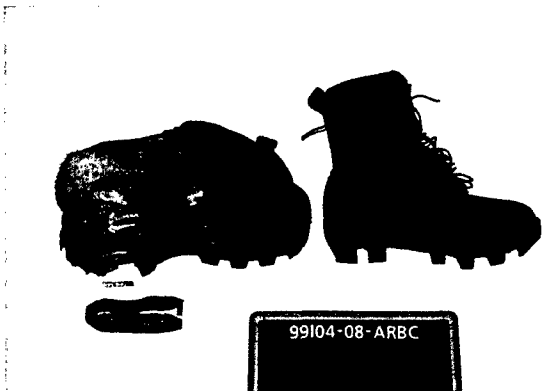
M14 Mine with blast boot/overboot combination.

The rear 3 1/2 inches of the overboot's sole have been blown off. The blast deflector has been completely separated from the overboot. The attenuator and attenuator plate remain attached to the overboot. The rear one-half of the blast deflector has been flattened and bent upward approximately 1/2 inch. The rear one-half of the attenuator has been completely flattened with the front half remaining relatively uncompressed. The attenuator plate has sustained no damage. The Kevlar insole and canvas covering are intact and appear to be undamaged. The Kevlar upper has been separated from the sole over the entire heel area. The lateral section of the Kevlar upper sustained a 1-inch vertical tear at mid-heel.

The sole and leather upper of the blast boot have sustained no obvious damage. There appears to be internal flattening/compression of the blast deflector/attenuator resulting in a slight concavity of the sole at mid-heel.

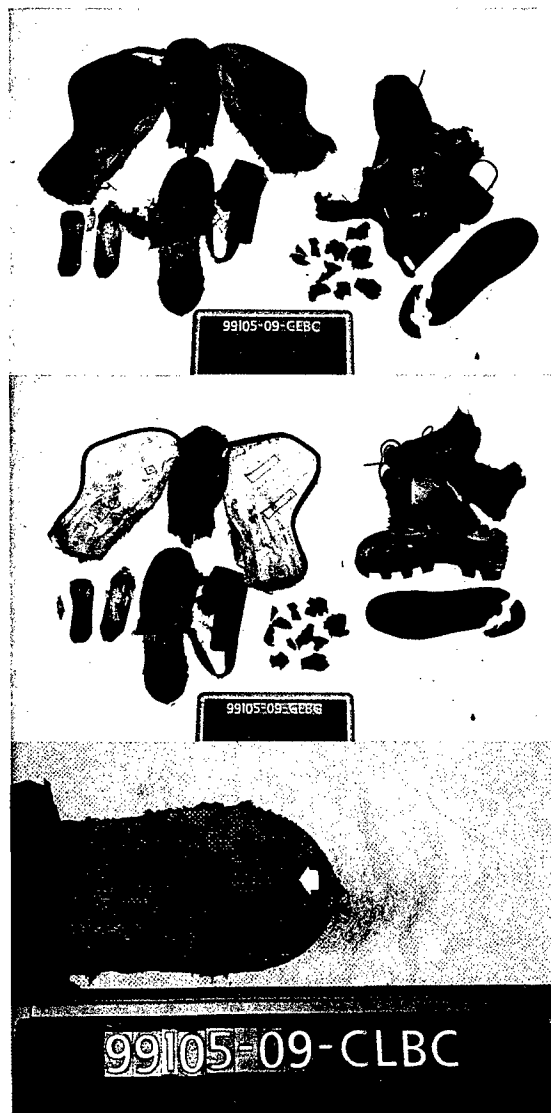
The sole of the blast boot has a 4-inch split down the mid-line of the heel exposing the blast deflector. The sole has been peeled up and over the insole on the lateral side. The rear one-half of the blast deflector has been flattened with subsequent compression of the attenuator. The Kevlar insole appears to be intact and undamaged. The leather upper has been completely separated from the rear one-half of the blast boot, and shredded by three vertical tears: one from the sole through the padded-collar of the upper, one 6-inch tear in the rear of the boot, and one 2-inch tear on the medial side of the heel.

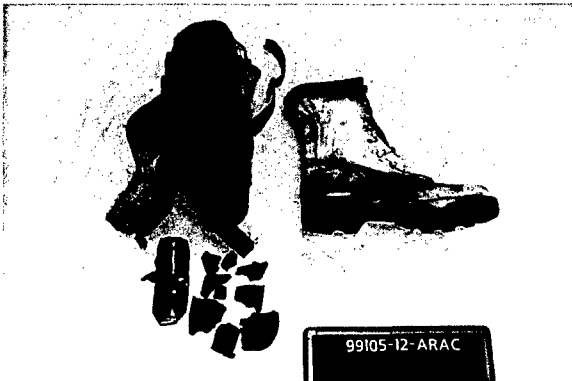
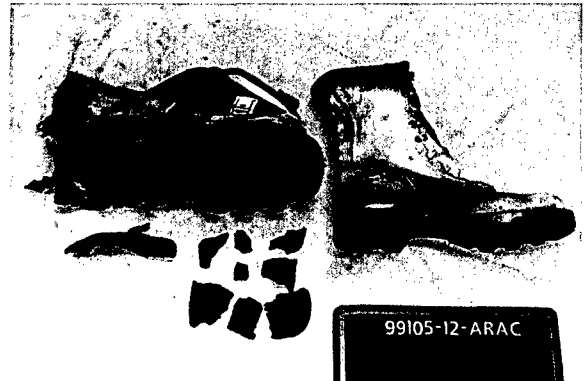
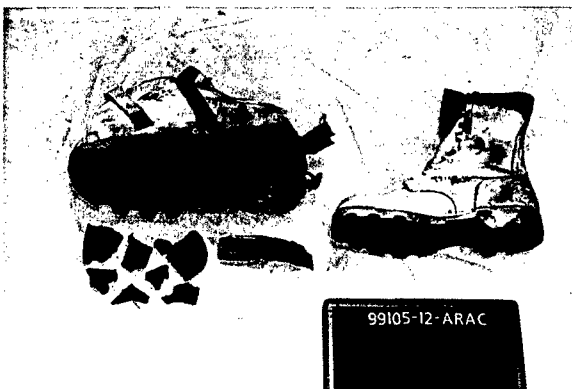
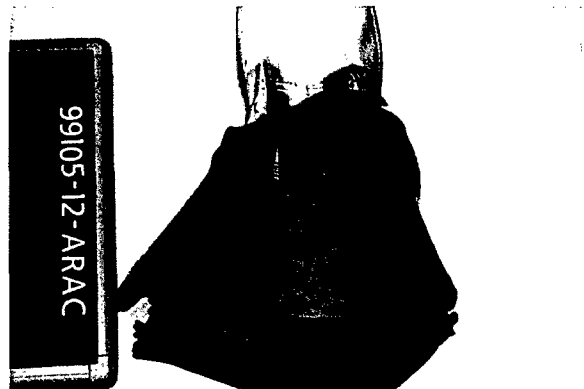
The sole and leather upper of the combat boot are intact and undamaged. Removal of the combat boot's cushion sole reveals a 3 1/2-inch longitudinal tear and a 1-inch lateral tear at mid-heel of the boot's leather insole. There are small, superficial tears in the underside of the cushion insole, which correspond to the tears in the leather insole.

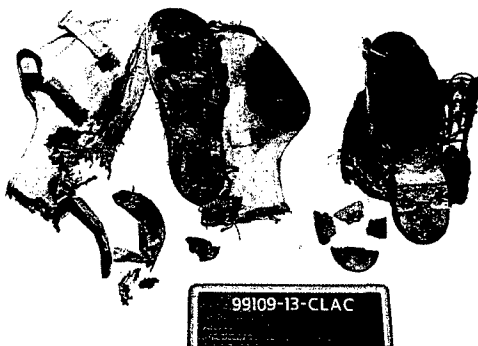
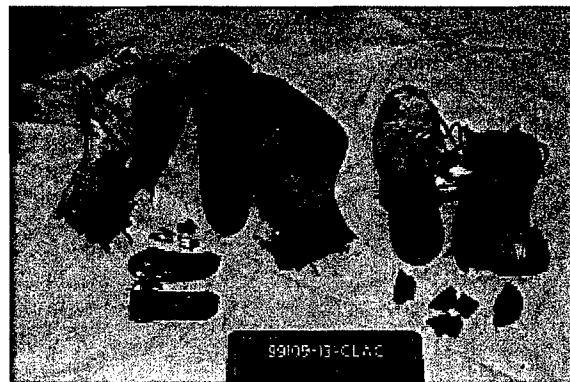
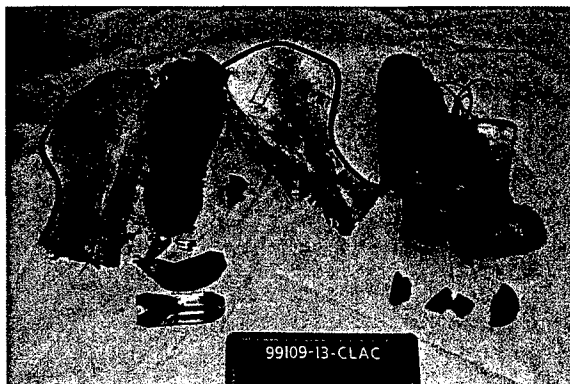
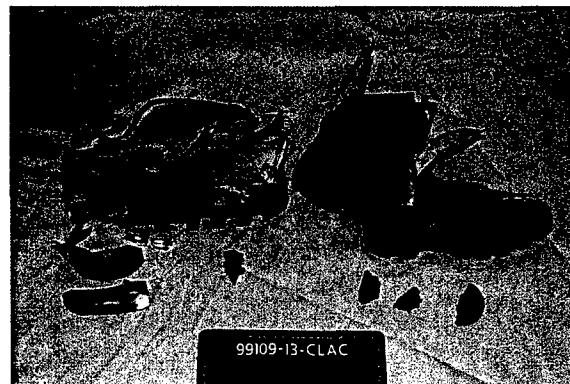
PMA-2 Mine with Combat boot/overboot combination.

The overboot has sustained extensive damage with approximately 5 inches of the heel portion of the sole destroyed and missing. The blast deflector, attenuator, and attenuator plate have been completely separated from the sole. The rear two-thirds of the blast deflector have been flattened and bent upward 1 inch. The attenuator has been completely compressed and shredded with only half remaining attached to the attenuator plate. The attenuator plate has been bent upward and twisted. The Kevlar insole has sustained some damage to the center of the heel area. There is separation of the Kevlar layers with a one-inch diagonal tear in the top layers, but the insole remains attached to the overboot. The canvas covering of the Kevlar insole has been shredded and separated from the insole approximately 4 inches from the heel toward mid-foot. The lateral portion of the Kevlar upper has been completely separated from the sole and has a 2-inch vertical tear in the Kevlar material approximately 3 inches forward of the Achilles seam. The medial portion of the Kevlar upper has been separated from the sole from heel to toe, and has been torn and shredded in an area approximately 3 inches x 3 inches on the medial portion of the heel. Both halves of the Kevlar upper have been completely separated at the Achilles seam.

The sole of the combat boot is intact with the only damage being a 3-inch lateral cut in the heel. The leather upper has been completely separated from the sole from heel to mid-foot. Four vertical tears have shredded the leather upper, each approximately 6 inches in length. The heel area of the leather insole has been removed by the blast and there are two 3-inch longitudinal tears in the leather insole at mid-foot.

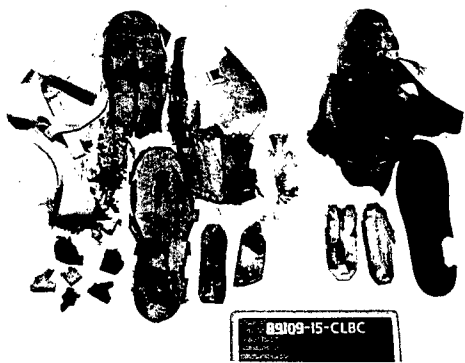
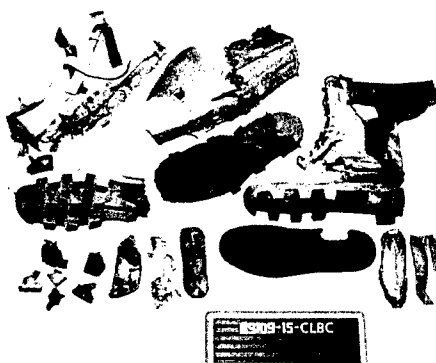
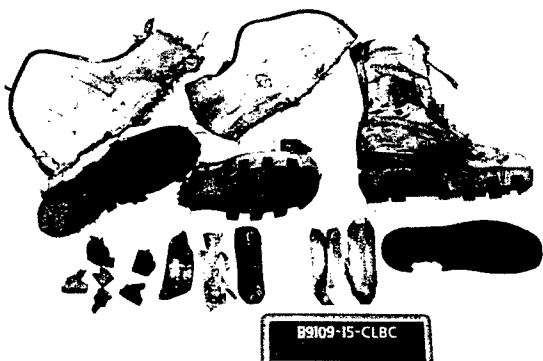
The sole of the blast boot has sustained a 3-inch curved tear from the rear of the heel to the medial side. The forward medial heel lug is missing. The leather upper has been completely separated from the sole from heel to the mid-foot. The blast deflector, attenuator, and attenuator plate have been completely separated from the blast boot. The forward two-thirds of the blast deflector has been flattened and bent upward approximately 1 inch. The attenuator has been completely flattened down the majority of its length and remains attached to the attenuator plate, which is slightly bent upward. The lateral side of the leather upper has been badly shredded by one long vertical tear from the heel through the top of the upper, and a 3-inch vertical tear from mid-foot to the third eyelet. There is also a diagonal tear in leather upper from the first eyelet to the fourth eyelet on the lateral side. The medial side of the leather upper has a 4-inch diagonal tear from the first eyelet to the arch. There is also a 4-inch vertical tear along the rear of the heel. The Kevlar insole remains attached to the blast boot, is intact, and has no apparent damage. The cushion insole has been torn and shredded across the mid-heel area.

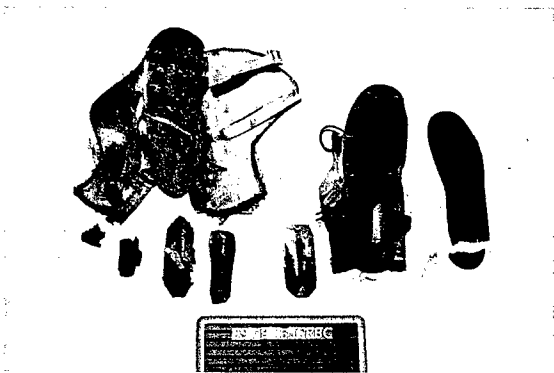
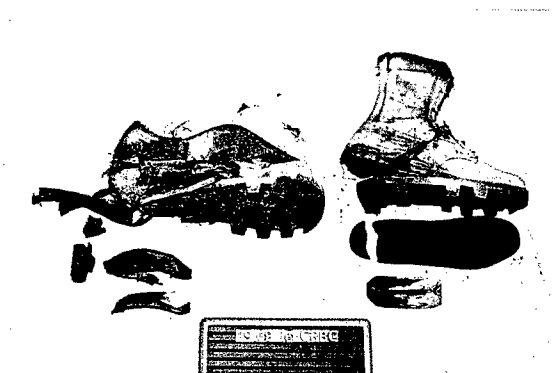
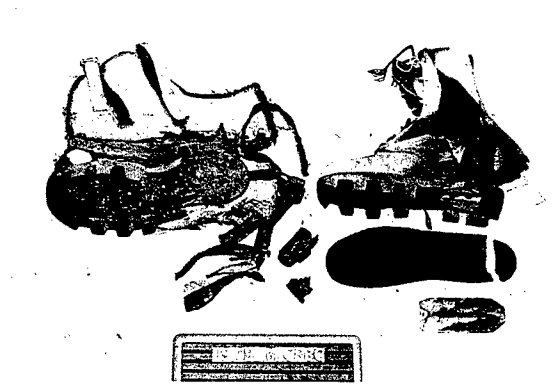
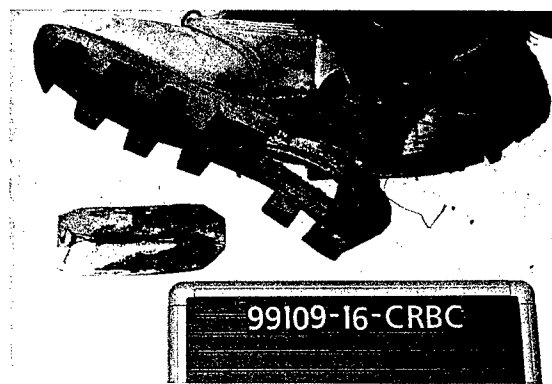
PMA-2 Mine with Blast boot/overboot combination.

The rear 4 inches of the overboot sole has been removed by the blast. There are two 2-inch longitudinal tears in the sole at mid-foot. The blast deflector, attenuator, and attenuator plate have been separated from the overboot. The rear one-quarter of the blast deflector has been badly flattened with a 2-inch longitudinal split in the metal down the mid-line at mid-heel. The rear one-half of the blast deflector has been bent upward approximately 1-½ inches. The rear one-half of the attenuator is missing with the remaining portion being completely compressed and remaining attached to the attenuator plate. The Kevlar insole remains attached to the overboot and appears to have a 1-inch lateral tear in the Kevlar material at mid-heel. The medial portion of the Kevlar upper has been completely separated from the overboot, but appears not to have incurred any damage to the Kevlar material itself. The lateral portion of the Kevlar upper remains attached to the overboot, and has been separated from the sole from heel to mid foot, and has a 1-inch vertical tear with shredding, at a point 4 inches forward of the Achilles seam where the upper attaches to the sole.

The sole of the blast boot is badly damaged with a 1-½ inch x 2-½ inch section of the medial portion of the heel missing. There are also two 1-inch diagonal tears at the rear of the heel. The blast deflector has been completely separated from the blast boot, and is almost completely flattened, and bent upward approximately ½ inch at mid-heel. The attenuator and attenuator plate remain attached to the blast boot with the attenuator completely compressed. The leather upper of the blast boot has been completely separated from the sole, from heel to mid-foot. It is also badly shredded on the medial side by a 9-inch vertical tear, from the sole to the padded collar of the upper, and a diagonal tear from the first eyelet to the fourth eyelet. A 5-inch vertical tear has shredded the lateral side of the leather upper, from mid-foot to the fifth eyelet, and a 2-inch horizontal tear over the ankle. The Kevlar insole remains attached to the blast boot, is intact and appears to be undamaged. The heel portion of the cushion insole has been shredded with the rear 1-½ inches missing.

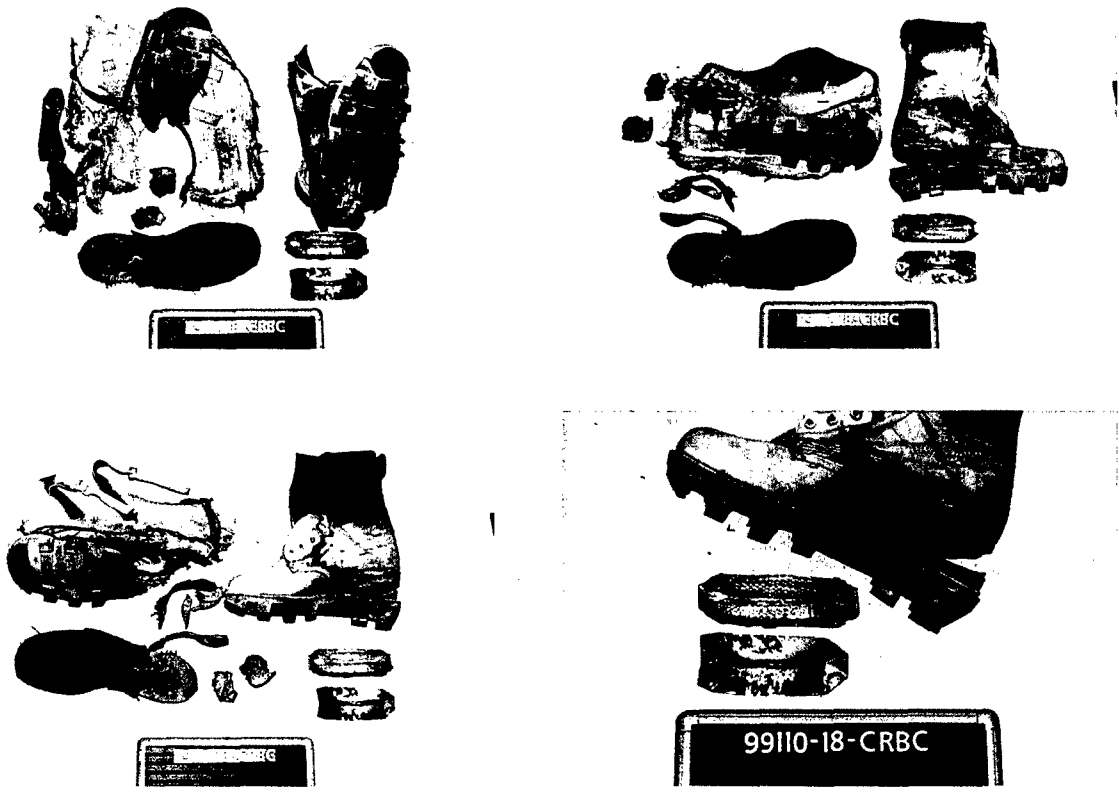
The sole of the blast boot has a 5-inch longitudinal tear down the midline of the heel from the rear of the heel to mid-foot. The blast deflector was completely separated from the blast boot. The blast deflector has been flattened and bent upward approximately 1/4-inch in its center. The attenuator and attenuator plate were completely separated from the blast boot and the attenuator completely compressed. The leather upper has been completely separated from the sole of the blast boot from heel to mid-foot. A 6-inch longitudinal tear along the sole in the heel area, and a 5-inch vertical tear from the arch to the fifth eyelet shred the medial side of the leather upper. The lateral side of the boot has a 3-inch diagonal tear from the first eyelet to the sole at mid-foot. The Kevlar insole remains attached to the blast boot and appears to have sustained no damage. The cushion insole has a 6-inch longitudinal tear from mid-heel to mid-foot, a 1-inch lateral tear at mid-heel, and a 1-inch lateral tear in the side of the heel.

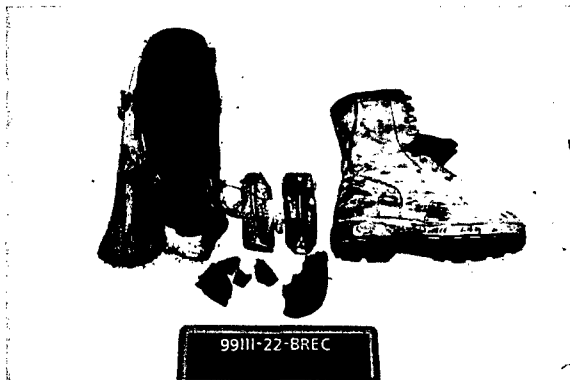
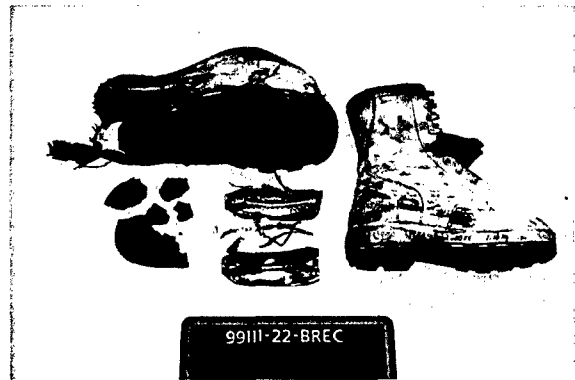
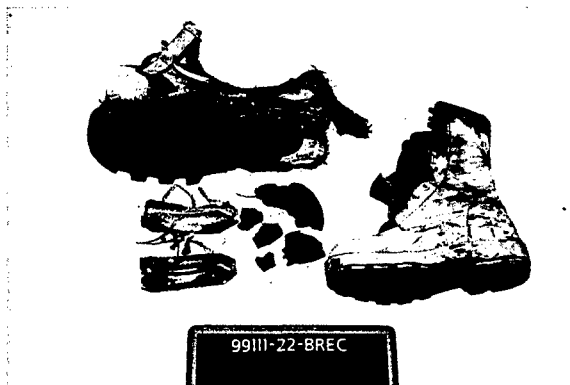
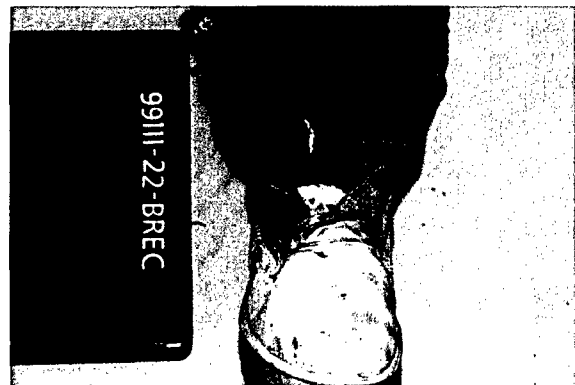
PMN Mine with Singapore manufactured boot/overboot combination.

The heel portion of the overboot sole has been completely destroyed by the blast, and recovered in several large pieces. The blast deflector, attenuator, and attenuator plate were completely separated from the overboot. The blast deflector has been partially flattened and bent upward approximately one-half inch at its center. The attenuator remains attached to the attenuator plate and has been completely compressed throughout its length with several long strips shredded from each side. The attenuator and attenuator plate have been bent upward approximately 1/2 inch in the center and slightly twisted. The Kevlar insole remains attached to the overboot and appears to be intact and undamaged. The medial portion of the Kevlar upper remains attached to the Kevlar insole and is apparently undamaged. Approximately 5 inches of the lateral portion of the Kevlar upper has been separated from the heel area of the Kevlar insole, but is otherwise undamaged. Both sections of the Kevlar upper have been completely separated at the Achilles seam.

The sole of the Singapore blast boot is apparently undamaged. There is a 1 1/2-inch vertical tear in the black cloth lining inside the boot 1 inch above the insole directly over the Achilles tendon. There are no tears or apparent damage to the leather upper of the boot, however the white paint applied to the boot pre-test has flaked off along wrinkle lines indicating there was some compression of the leather upper.

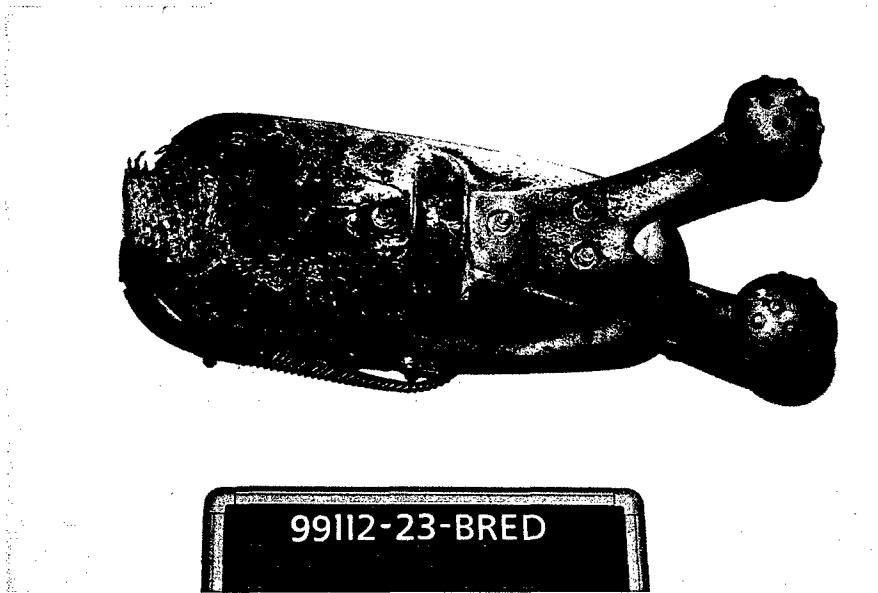
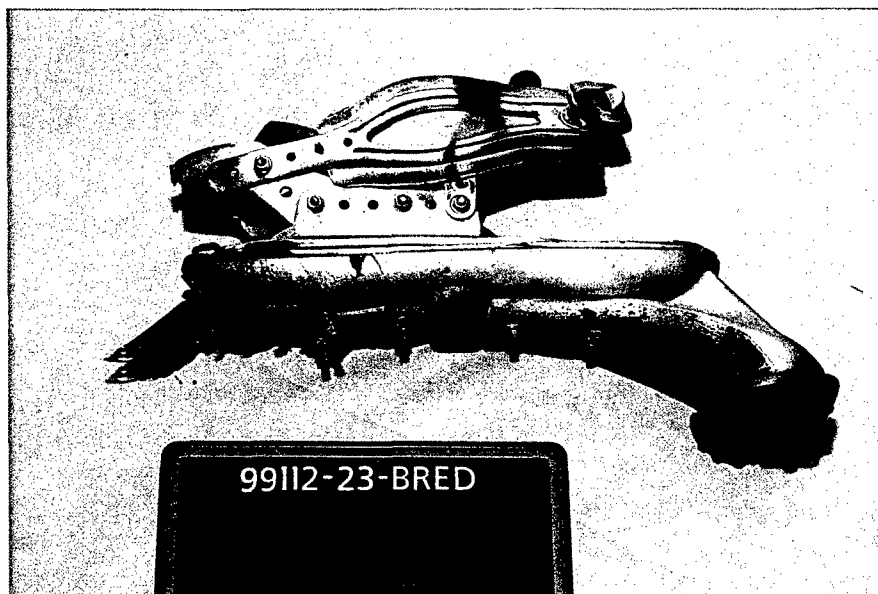
The rear two legs of the Canadian overboot were completely removed by the blast. Fragments of the legs were recovered along with one intact pod and one fragmented pod. A 1½ inch x 2 inch section at the extreme rear portion of the overboot has been destroyed. The screws attaching the rear set of legs to the overboot remain in place. The lateral edge of the insole plate of the overboot has sustained a 7-inch crack in the material from the heel to the mid-foot. There appears to be no damage to the bindings or binding attachment plate.

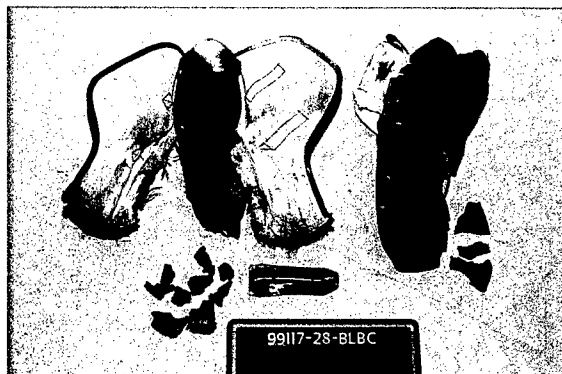
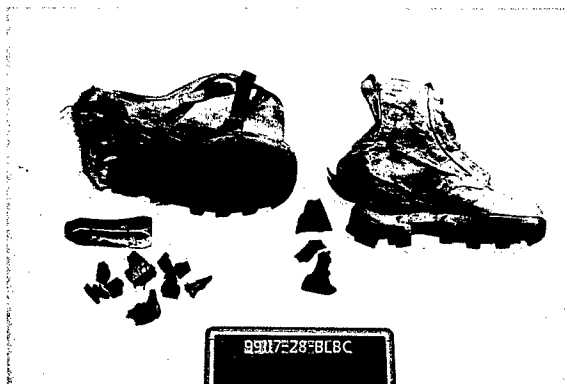
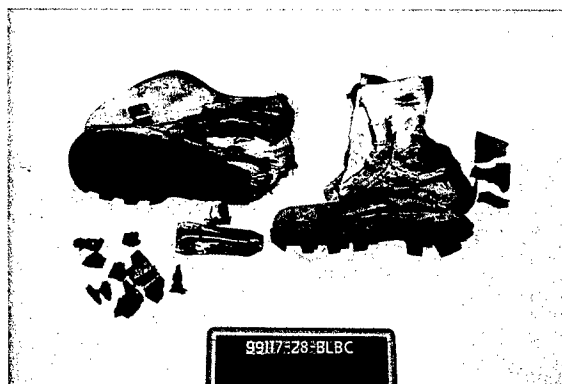
PMN Mine with blast boot/overboot combination

The outside 1-inch of the sole around the heel of the overboot has been removed by the blast, including the four heel lugs. Only a 2-1/2-inch x 3-inch portion of the sole is left over the mid-heel. There is a 2-1/2-inch longitudinal tear in the sole from heel to mid-foot. The blast deflector has been completely separated from the overboot and partially flattened down its entire length. The attenuator and attenuator plate remain attached to the overboot, with the attenuator being completely compressed and shredded down its medial side. The Kevlar insole remains attached to the overboot and appears to be undamaged with its canvas covering being separated and shredded over the heel area. The medial and lateral halves of the Kevlar upper have been completely separated down the Achilles seam and separated from the sole from heel to mid-foot. There appears to be no damage to the Kevlar material of either half of the upper.

The sole of the blast boot has a 3-inch diagonal tear across mid-heel. This tear is split open approximately 1-inch exposing the rear portion of the blast deflector. The blast deflector, attenuator, and attenuator plate remain attached to the blast boot. There appears to have been significant flattening/compression of the blast deflector/attenuator within the sole of the blast boot. The Kevlar insole remains attached to the blast boot with the only damage being a piece of bone which has penetrated the top layers on the medial side of the heel. The leather upper has been completely separated from the sole from the rear of the heel to the arch on the medial side. The upper has been shredded by a 6-inch vertical tear extending from the sole upward on the lateral side of the heel. The cushion insole has a 2-inch longitudinal tear at mid-heel and is missing a 2-inch x 1-inch section from the medial side of the heel.

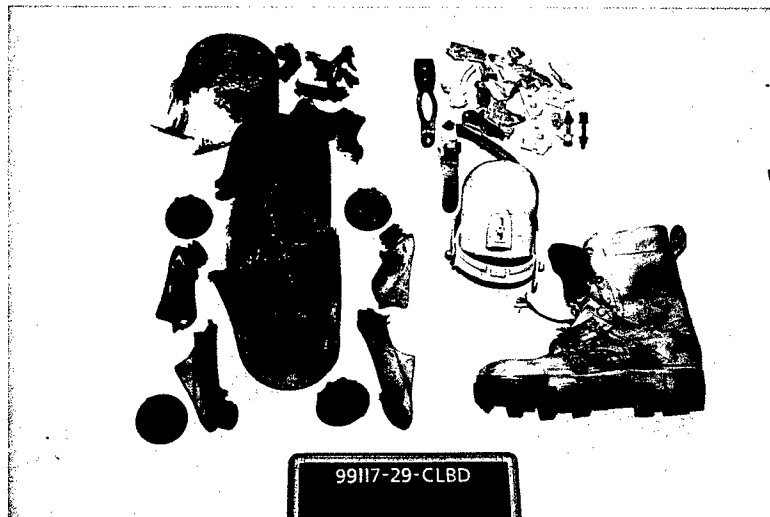
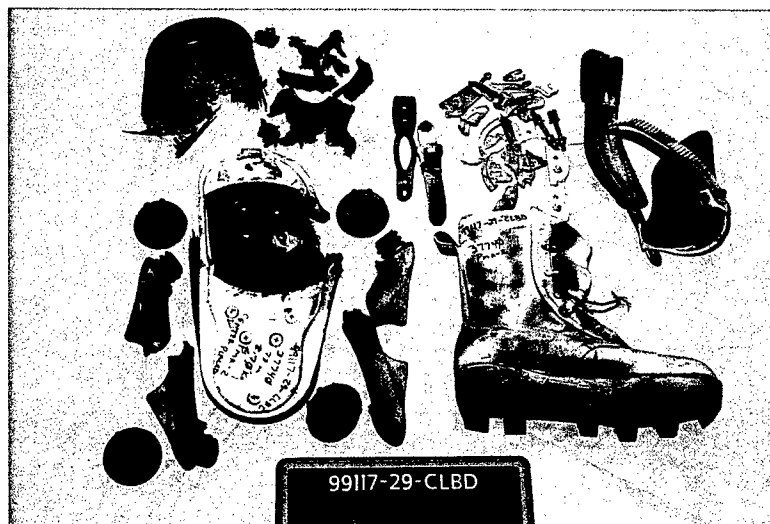
There is a 1/2-inch tear in the leather upper of the blast boot, below the third eyelet on the lateral side. There appears to be a slight concavity of the sole of the blast boot at mid-heel, indicating possible internal compression of the deflector/attenuator.

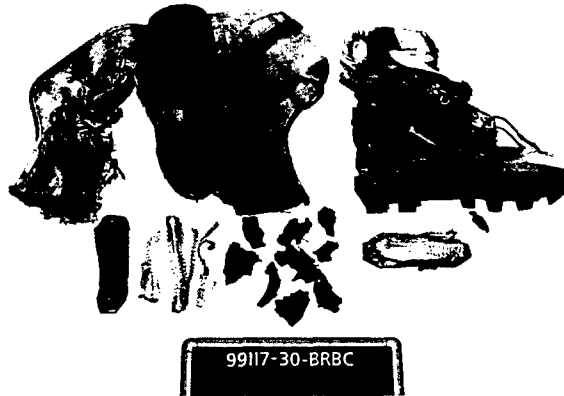
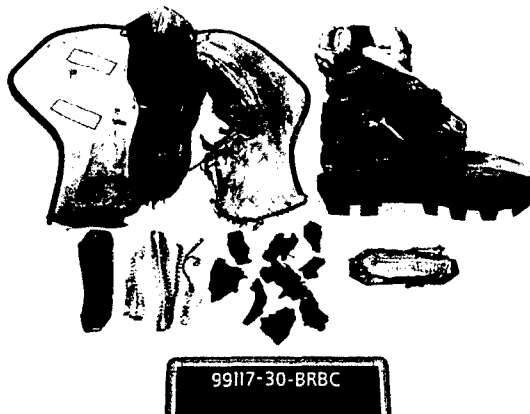
PMN Mine with blast boot / overboot combination.

The rear one-half of the overboot sole has been blown off. The blast deflector and attenuator have been separated from the overboot. The attenuator plate remains partially affixed to the underside of the Kevlar insole. The blast deflector has been flattened and bent upward in its center approximately one-quarter inch. The attenuator has been completely flattened and shredded and was recovered in 5 pieces. The Kevlar insole remains attached to the overboot and appears to be undamaged. The canvas covering over the Kevlar insole has been shredded in several places in the heel area. The lateral portion of the Kevlar upper has been torn from the sole to a point about two inches behind the toe, and has sustained a 4-inch vertical tear at about mid foot, with extensive shredding of the Kevlar material. The medial portion of the Kevlar upper has been separated from the sole to a point about mid-foot. Both halves of the Kevlar upper have been completely separated from each other at the Achilles seam.

The sole of the blast boot has been separated from the leather upper from heel to mid-foot, but is intact with the only apparent damage being small tears at the inside base of the heel lugs. The blast deflector remains attached to the sole with the rear one-half being flattened. The attenuator and attenuator plate are completely separated from the boot, with the attenuator being flattened completely and the attenuator plate dented and slightly bent in the middle. The Kevlar insole has been separated from the sole from heel to mid-foot, but otherwise remains attached to the boot and is intact and undamaged. The leather upper of the blast boot has been separated from the sole from heel to mid-foot and has been badly shredded by several tears. The leather upper has a 3½-inch diagonal tear over the lateral ankle, a 4-inch tear from the sole at mid-foot to the eighth eyelet, and a 7-inch vertical tear from the sole up the Achilles seam. There are also two long vertical tears on the lateral side of the boot, one 3-inch vertical tear over the medial ankle, and one diagonal tear from the first eyelet to the arch.
