AFRL-VA-WP-TR-2003-3003

**CORROSION-INDUCED FATIGUE
MEASUREMENTS ON 2024 AND 7075
ALUMINUM USING PHOTON-
INDUCED POSITRON
ANNIHILATION (PIPA)**

**Positron Systems, Inc.
6151 N. Discovery Way
Boise, ID 83713**

Final Report for 01 April 2002 – 01 November 2002

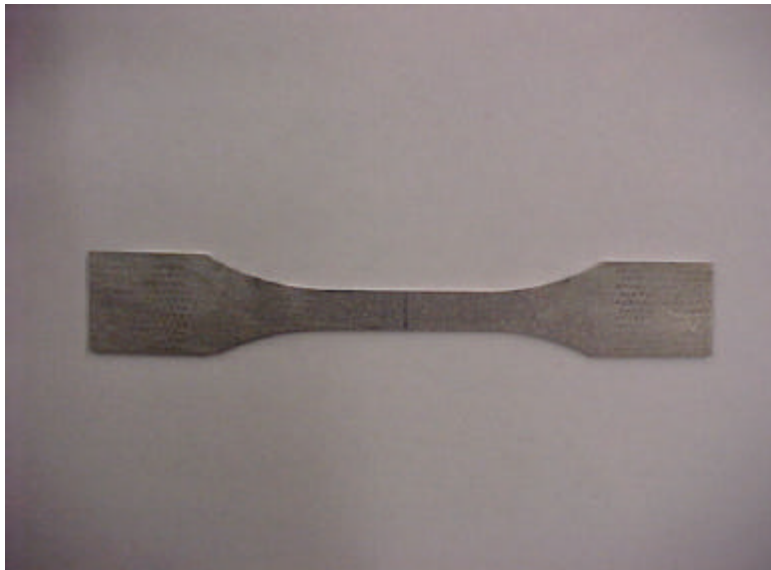
Figure 1. Representative Test Specimen

The basic sample specifications that were identified for this project are listed in Table 2. The specimens used were bare aluminum, which is more susceptible to corrosion than that with a surface treatment used for commercial applications. Figure 1 shows an example specimen.

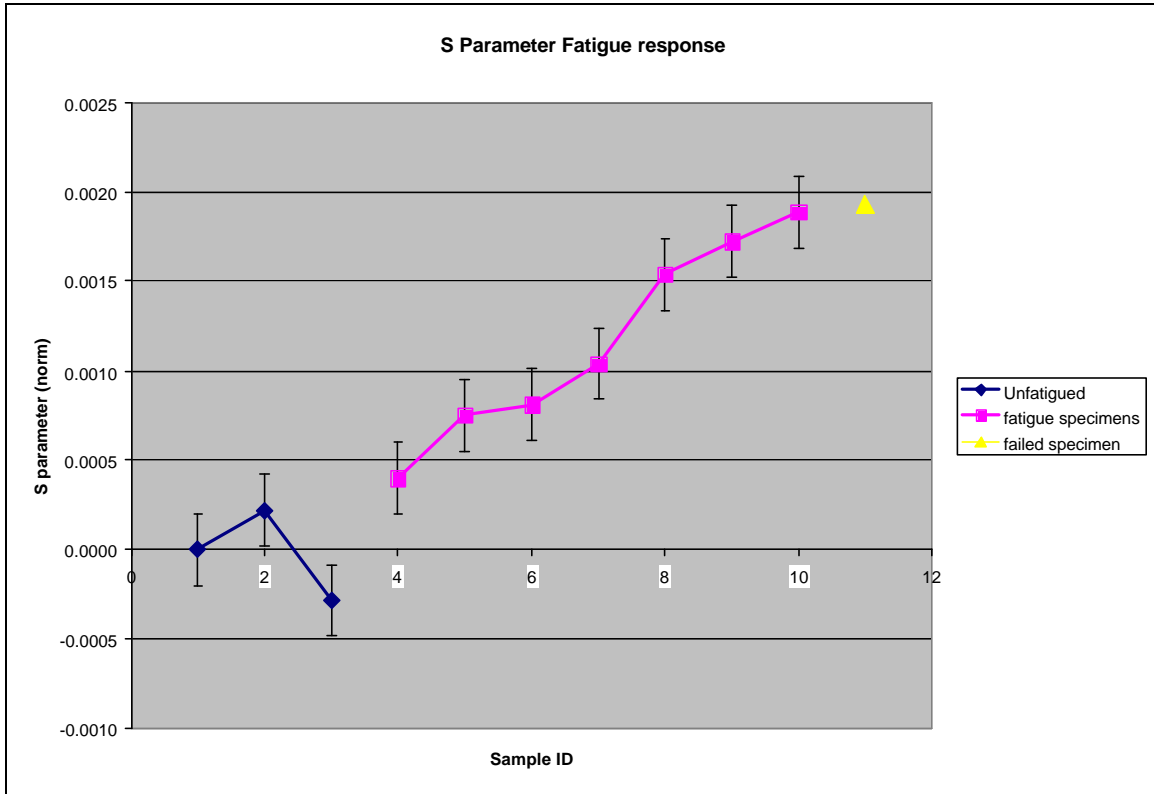
Figure 2. PIPA Fatigue Response

Several studies using the PIPA technique have been performed to assess fatigue damage in aluminum alloys. The results of one study where a lap splice joint was simulated with a hole in the center as a stress concentrator is shown. These data are being presented as they have some relevance to the detection of corrosion-induced fatigue damage in aircraft components. In this study, specimens of 7075 aluminum with a hole at the center of each specimen (to simulate a lap splice joint hole), and to act as a stress concentrator, were subjected to fatigue damage up to a failure point of about 345,000 cycles. Figure 2 shows the results of the study for a number of samples with different numbers of cycles associated with the fatigue damage.

Results of this study indicated a dynamic range of about 0.0020 with uncertainties of about 0.0003 as indicated by the range associated with the undamaged specimens which provide a measure of the uncertainties associated with the measurements. Consequently, the results indicated that it was relatively easy to detect damage accumulation essentially across the entire range from an unfatigued specimen through a failed specimen.

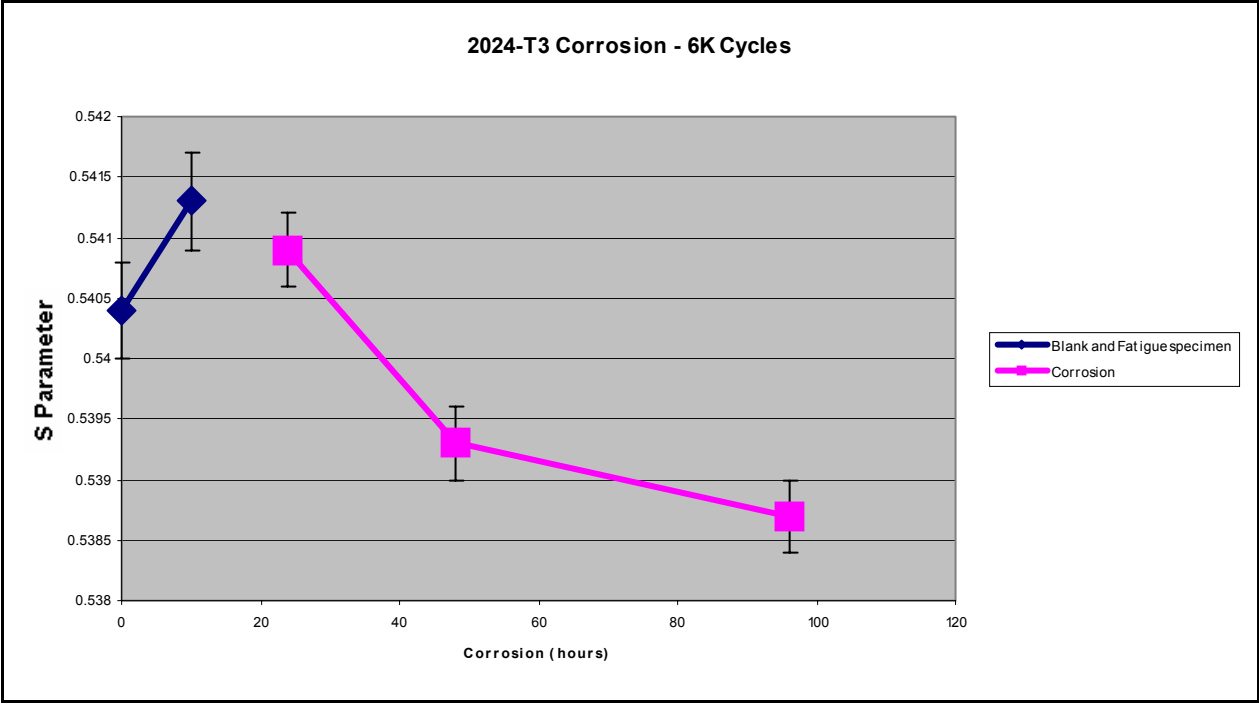
Figure 5. 2024 Fatigue Damage at 6000 Cycles

Tables 12 and 13 present the PIPA response at 6000 cycles for the 2024-T3 and 7075-T6 specimens, respectively. In the case of the 2024-T3 data as shown in Figure 5, the 24 hour corrosion response is similar to that of the fatigued specimens without corrosion, whereas the 48(24/24) and 96 hour specimens still show a pronounced reduction below the blank specimen that is consistent with the pure corrosion response in Table 10. However, the difference between the non-corroded and fatigued specimens has gotten much larger. The pure corrosion results were statistically the same whereas the difference between the fatigued specimen and corroded 48 and 96 hours specimens has increased to about 0.0026. Why the higher levels of corrosion damage should inhibit some of the PIPA response to fatigue damage is unclear; however, as will be discussed, the response for the high corrosion specimens increases more rapidly after the second fatigue series and becomes similar to the damage for the fatigued and 24 hour specimens. The uncertainties on this data for the corrosion specimens range from about 0.0002 to 0.0005, indicating good reproducibility.

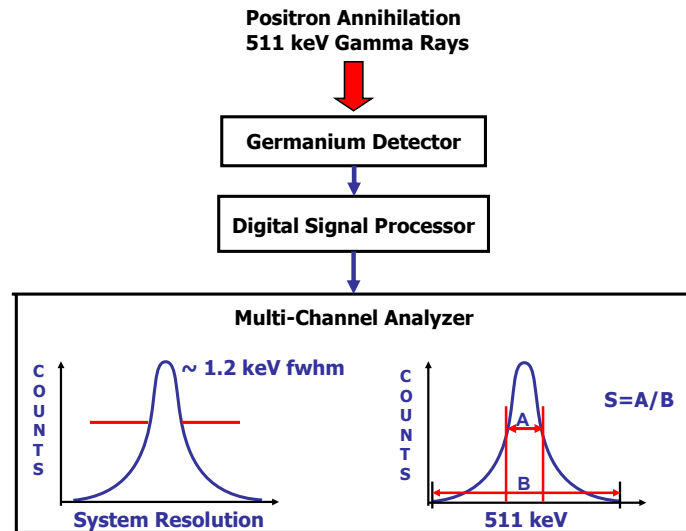
Figure A5. Doppler Broadening Analysis for the S parameter

Doppler broadening effectively compares the relationship of the positron annihilation gammas received in the narrow region surrounding the 511 keV energy level, primarily representing annihilations occurring in the defected areas, against all annihilation energy levels that occur. This “line shaping parameter” or “S” factor for the material is compared to known “S” factors for similar “as manufactured” and failed materials to quantitatively determine defect density and lifecycle percentage.
