DOT/FAA/AR-02/117

Crack Growth-Based Predictive Methodologies for the Maintenance of Structural Integrity of Repaired and Nonrepaired Aging Engine Stationary Components

January 2003

Final Report

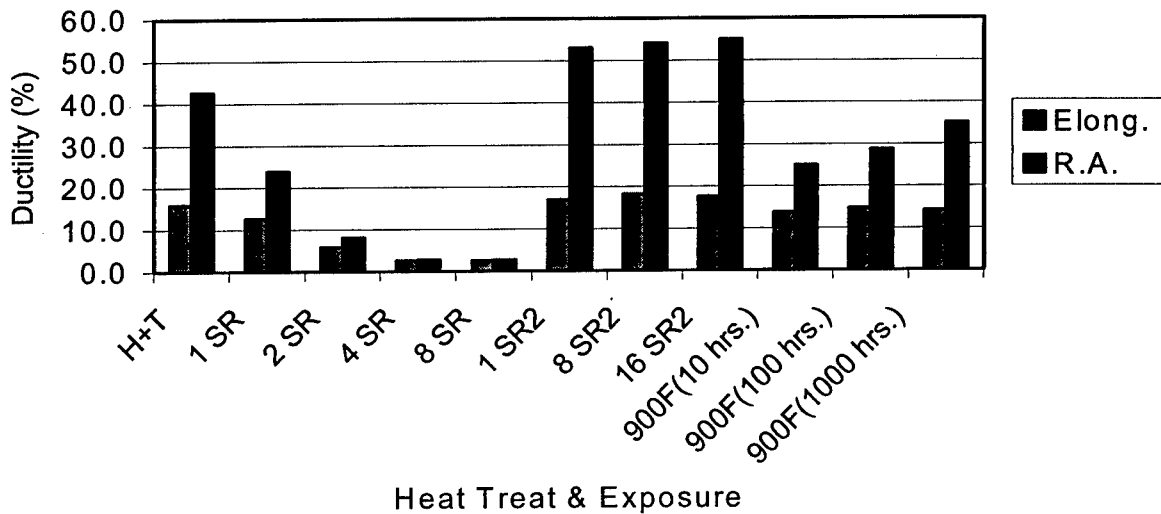
FIGURE 9. BAR CHART PLOTS OF AMS 5616 BASE METAL RT TENSILE STRENGTHS AS EFFECTED BY THE NUMBER OF STRESS RELIEF CYCLES AND HOURS OF EXPOSURE TO 900°F (SR2 refers to the main evaluation (Heat ZCESS), while the other data is from the preliminary evaluation (Heat PKRC).)

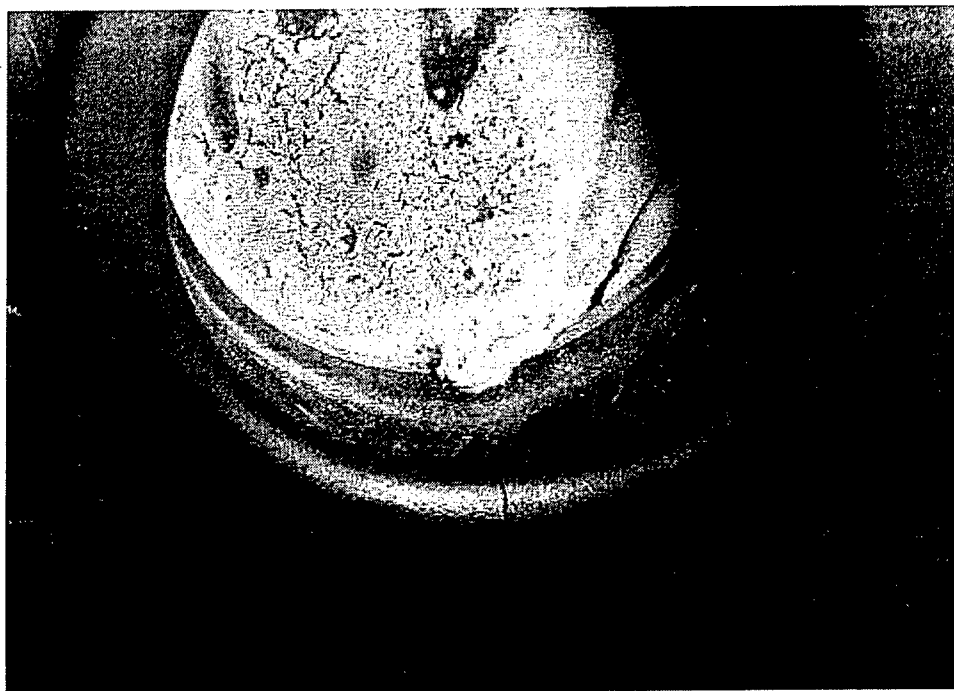
FIGURE 61. CRACK EXTENDING OUT OF AN EDM SLOT ON THE INNER SURFACE EMBOSSEMENT OF LARGE SERVICE BOSS 34 (LOCATION NO. 2.) (The crack has grown into the boss neck, parallel with the inner surface.)
