DOT/FAA/AR-02/121

Guidelines for Analysis, Testing, and Nondestructive Inspection of Impact- Damaged Composite Sandwich Structures

March 2003

Final Report

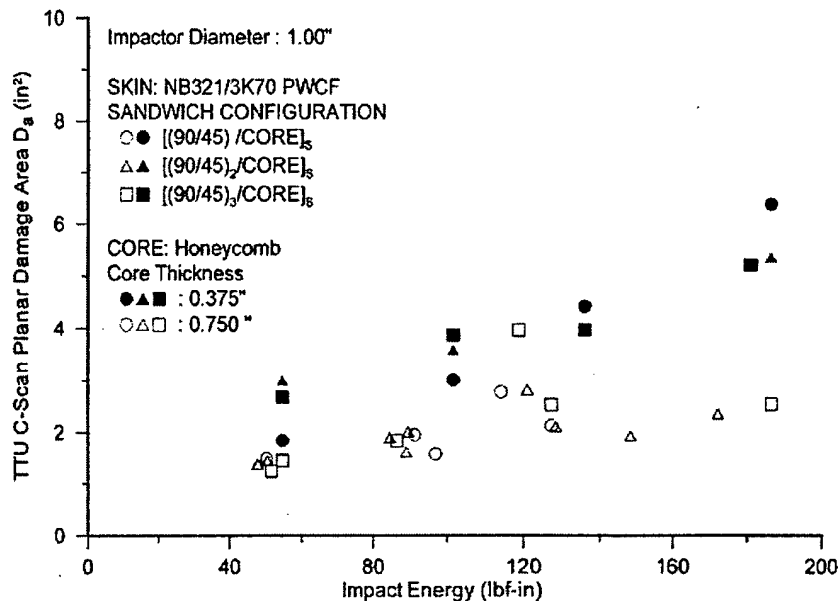
FIGURE 2-8. PLANAR DAMAGE RELATIONSHIP AS A FUNCTION OF IMPACT ENERGY FOR THE RELATIVELY SHARP (1") IMPACTOR

structure may experience during its service life. Figures 2-8 and 2-9 show the relationship between planar damage area and impact energy for a small (relatively sharp) (1") impactor and a blunt (3") impactor, respectively. As seen from these figures, the impact diameter plays a large role in the resulting planar damage area. It is also interesting to note the role that the core thickness plays with respect to planar damage area (particularly for high-energy impacts).

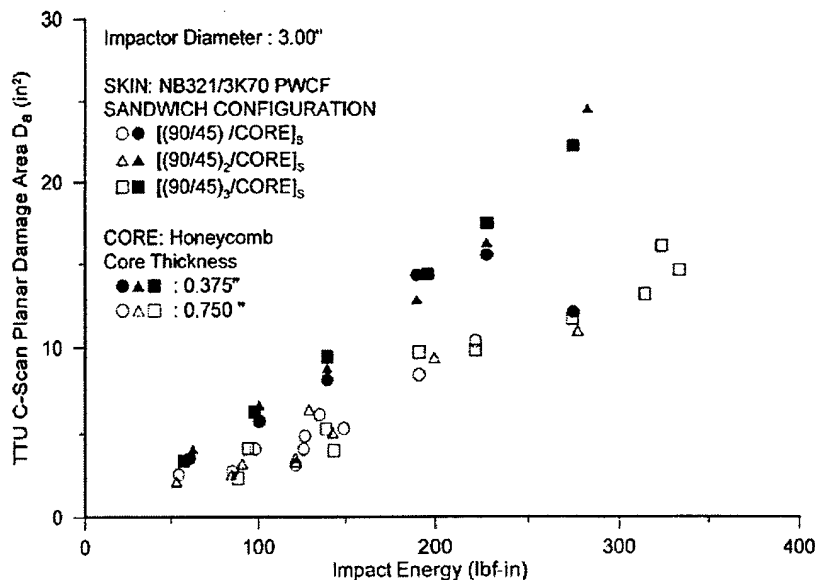
FIGURE 2-9. PLANAR DAMAGE RELATIONSHIP AS A FUNCTION OF IMPACT ENERGY FOR THE BLUNT (3") IMPACTOR

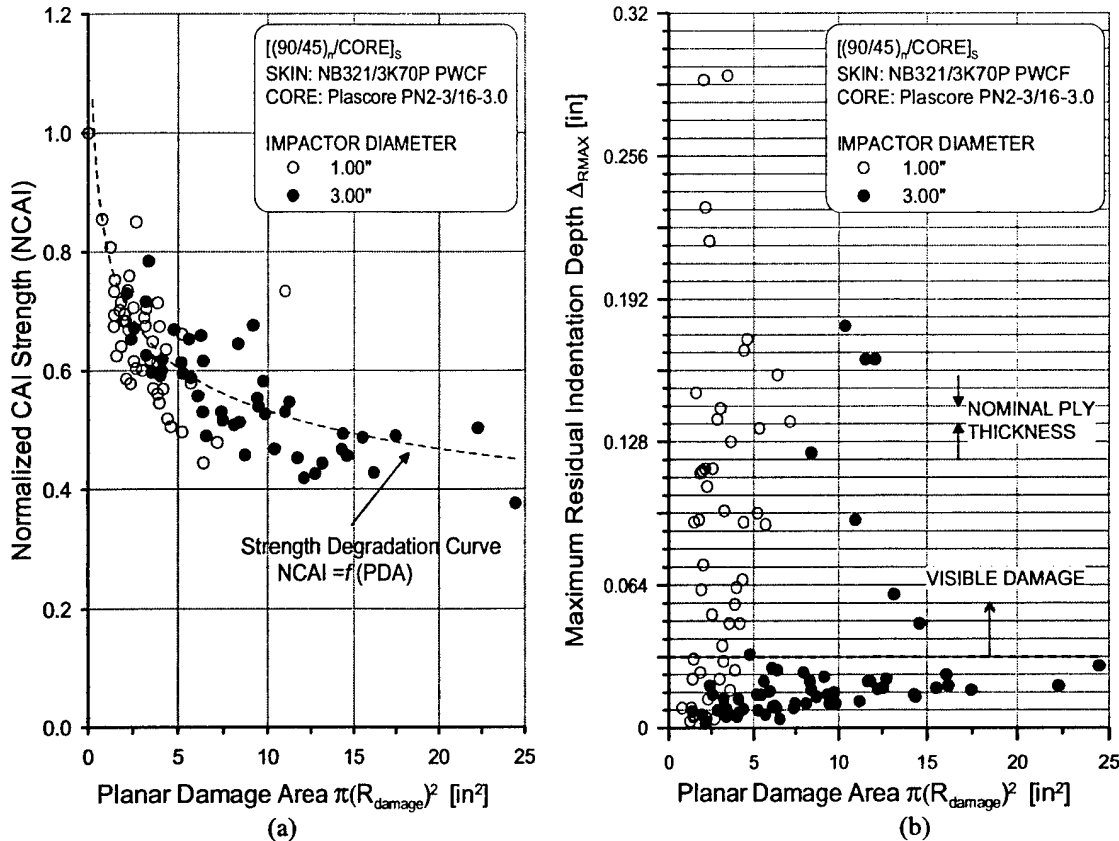
FIGURE 2-10. (a) NORMALIZED RESIDUAL STRENGTH FOR $[(90/45)_n/\text{CORE}]_s$ ($n=1,2,3$)* SANDWICH PANELS WITH HONEYCOMB CORE (3/8" AND 3/4" THICK) AND (b) VARIATION OF MAXIMUM RESIDUAL INDENTATION DEPTH WITH PLANAR DAMAGE AREA FOR THE SANDWICH PANELS

The normalized (to undamaged strength) residual strengths of sandwich panels impacted with 1" and 3" diameter impactors are plotted as a function of planar damage area in figure 2-10(a). It can be observed that the data is scattered around a hypothetical degradation curve irrespective of the impactor diameter. However, the data points corresponding to the smaller diameter impactor are spread over the initial portion of the curve, while those of the larger impactor fall over the asymptotic region of the curve. The impact damage states in practice will only undergo a posteriori analysis based on the damage metrics, without any knowledge of the associated impact energies. The maximum residual indentation has been typically used as a measure of the severity of impact damage. The threshold of detectability based on the residual indentation is known as Barely Visible Impact Damage. There is no consensus on a standard value for the BVID, even though it has been assumed that the strength degradation is proportional to the residual indentation depth. It has been shown in the previous study [3] that the maximum residual indentation depth does not necessarily correlate well with the CAI strength. It can be seen from figure 2-10(b) that large planar damage areas can exist while the maximum residual indentation is on the order of a few ply thicknesses (0.008" in this case). Thus, it was concluded that residual indentation depth is not a reliable indicator of impact damage; rather, the planar damage size better reflects the residual strength degradation in sandwich panels. To quantify the planar damage, damage state, or the structure's residual strength capability, it becomes necessary to identify damage detection techniques and their effectiveness in light of this observation.

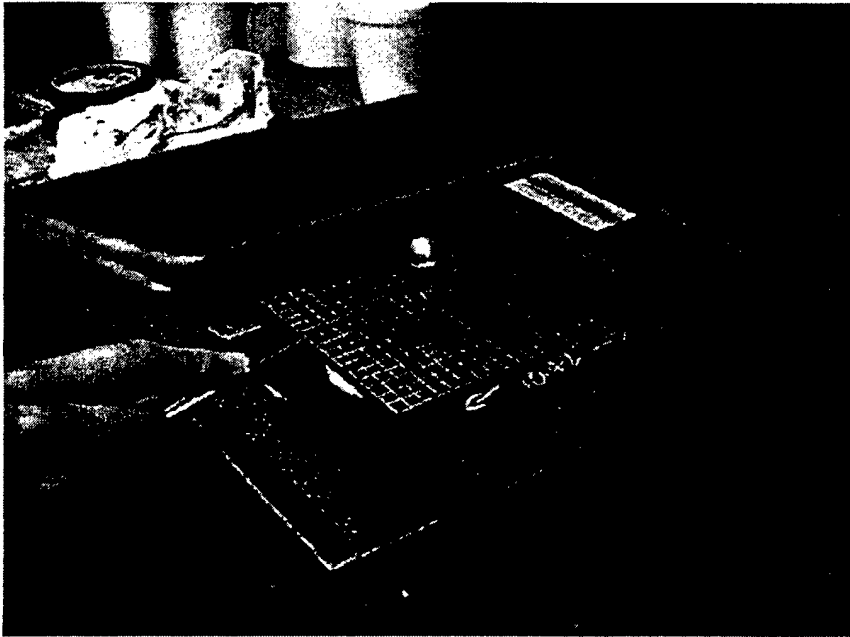
FIGURE 4-2. MANUAL IMPACT HAMMER (AIRBUS DESIGN)

In the acoustical tap testing, the characteristic resonant sound emanating from the tap test is analyzed by the human ear. The audible resonant sound will depend on the sandwich local impedance and tap mass/hammer characteristics. The damaged region is characterized by a dull (dead) sound, which can be attributed to the decreased participation of the higher frequency modes. The manual tap test hammer (Airbus design) is shown in figure 4-2.

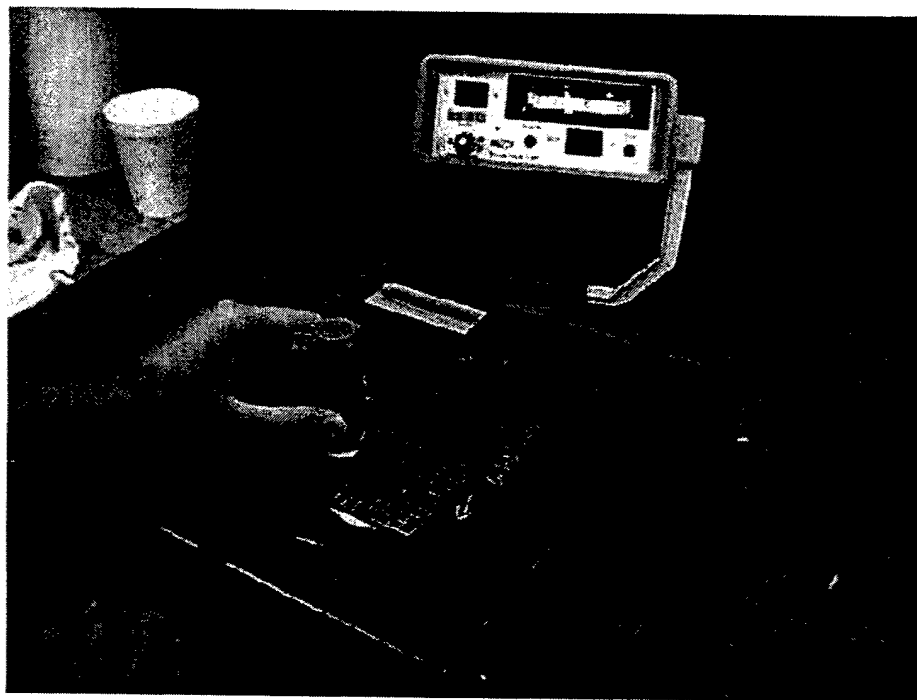
FIGURE 4-3. V-95 BOND TESTER USED FOR MECHANICAL IMPEDANCE ANALYSIS
