U.S.N.A. --- Trident Scholar project report; no. 304 (2003).

ENVIRONMENTALLY ASSISTED CRACKING PROPERTIES OF AA7249
EXTRUSIONS FOR AEROSPACE APPLICATIONS

Midshipman Kristen L. Deffenbaugh, Class of 2003
United States Naval Academy
Annapolis, Maryland

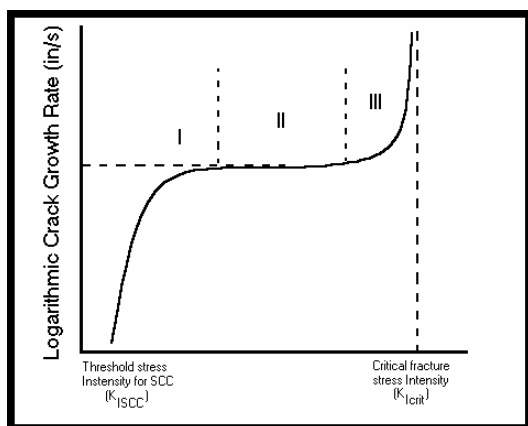
Figure 8: Schematic of the Stages of Stress Corrosion Cracking

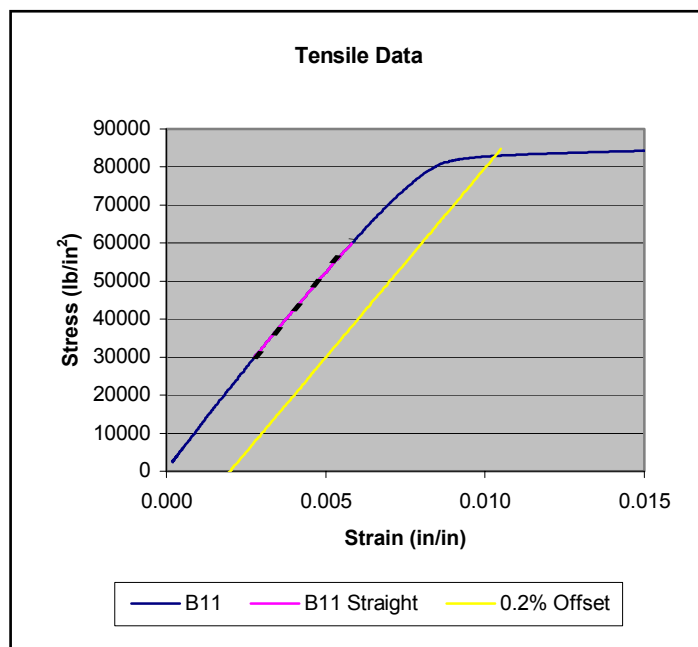
Figure 13: Sample tensile data

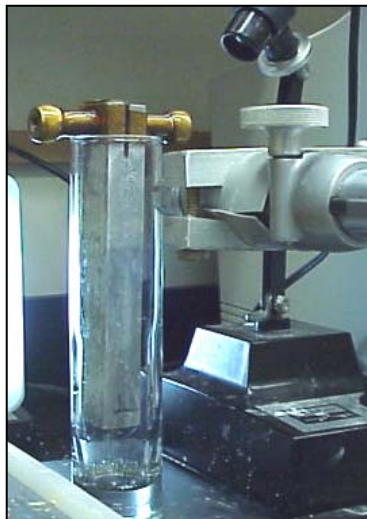
Figure 14: Double cantilever beam specimen

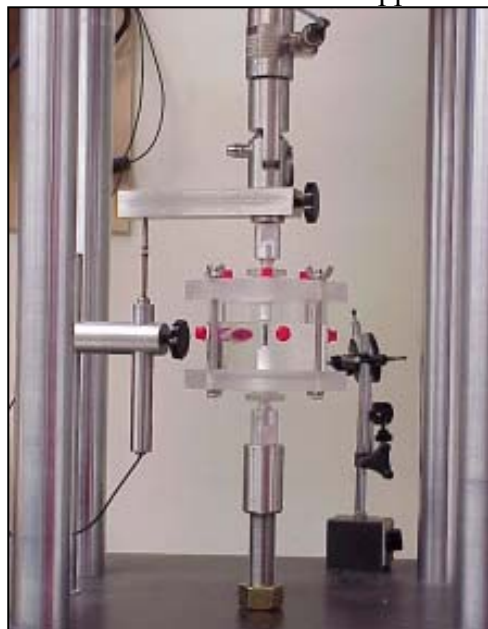
Slow strain rate testing (SSRT) was the other type of environmental testing employed in this study and was performed in accordance with ASTM standard G129-95.⁴⁰ This testing differs from double cantilever beam testing in that it provides a means to observe and measure crack initiation and propagation versus solely crack propagation. SSRT uses the same sub-sized specimen used in tensile testing. Instead of pulling quickly until fracture as in a tensile test, slow strain rate tests pull at a much slower rate (10^{-4} to 10^{-8} in/s), slow enough for the environment to interact with the sample. Typically, the results from the slow strain rate tests in a test environment are compared to a slow strain rate test in an ambient environment. The susceptibility to EAC is then determined by comparing the behavior in both environments.⁴¹ This allows investigation of EAC as a function of location within the extrusion. Figure 16 shows a slow strain rate test set up immersed in the salt-water environment. The procedure followed for the SSRT is detailed in Appendix E.

Figure 16: Slow strain rate test rig with specimen immersed in NaCl solution.

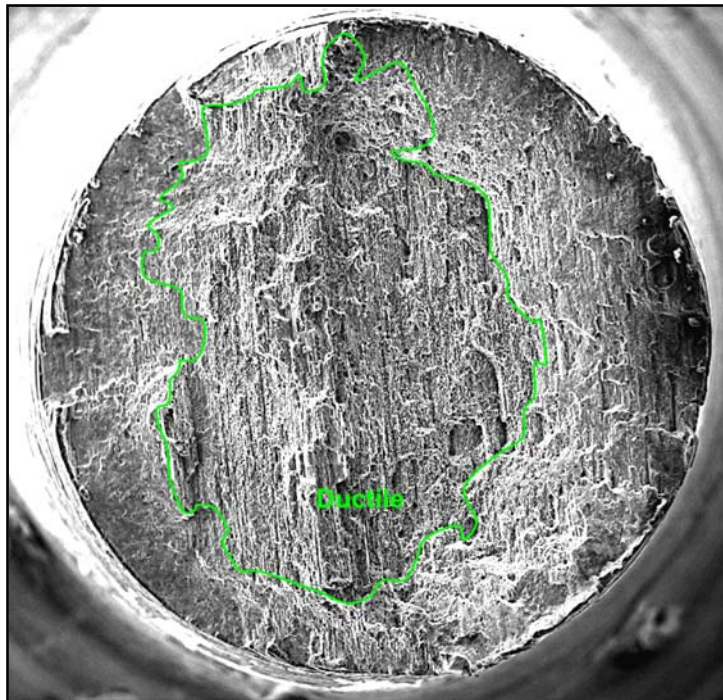
The specimens stressed perpendicular to the P plane were also observed using the SEM microscope. The fracture surfaces, seen in Figure 27, also highlight the brittle and ductile areas. Once again, the specimen run in laboratory air, as seen in the top figure, showed a large ductile area that constituted 59% of

Figure 27: Specimens from 2-inch extrusion stressed perpendicular to the P face in laboratory air (TMRA, above) and 1.0 M NaCl (TMRB, below) [77x].

the fracture area. Following the same trend as above, a specimen with the same orientation, but tested in 1.0 M NaCl solution showed a reduction of ductile fracture area; only 50% of the surface was ductile fracture.

It is also observed that the fracture surfaces of the specimens stressed perpendicular to the P plane are less textured in appearance than those stressed perpendicular to the O plane. This is due to the orientation of the microstructure relative to the stressing direction. Whereas the fracture surfaces represent a crack path along the ends of elongated grains for specimens stressed perpendicular to the O plane, the specimens stressed perpendicular to the P plane result in a fracture surface that travels along the elongated grain boundaries.

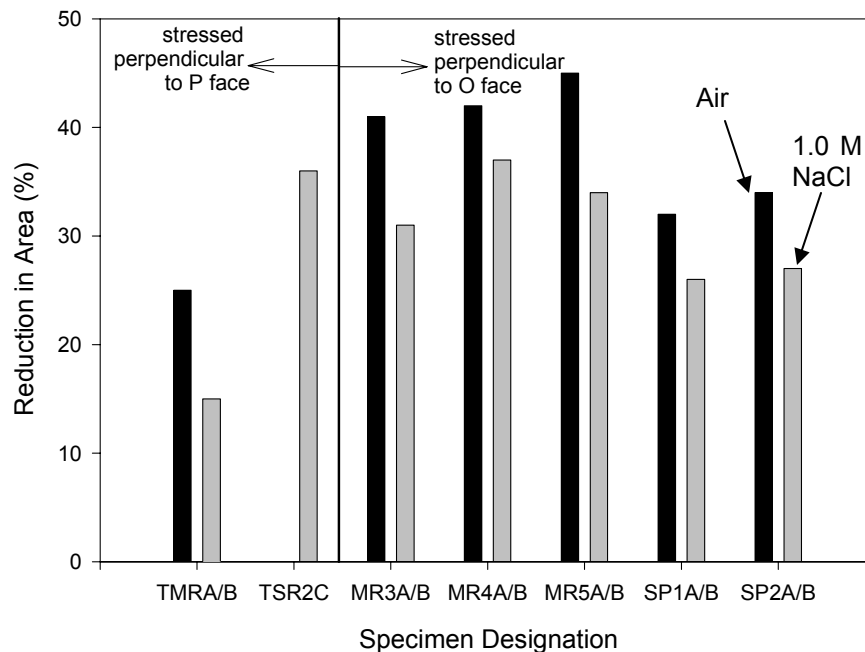
Figure 29 shows the location of the specimens drawn from the wide panel extrusion. Figure 30 shows the RA measurements for the WP slow strain rate tests. These results indicate that specimens stressed perpendicular to the O plane are more ductile if removed from the center of the riser (MR) as compared to in-between the risers (SP). It appears that the different microstructures that may be present on the P planes of these specimens (MR3, MR4, MR5) do not drastically affect ductility or EAC susceptibility. However, a decrease in RA for the salt-water tests indicates that these specimens are susceptible to EAC. Specimens stressed perpendicular to the P plane indicate a large variation in ductility. The specimens removed from the center of the riser (TMRA/B) indicate susceptibility to EAC, which may be expected based on the equiaxed grain structure.

Figure 30: Reduction in area results for slow strain rate tests in the wide panel extrusion.

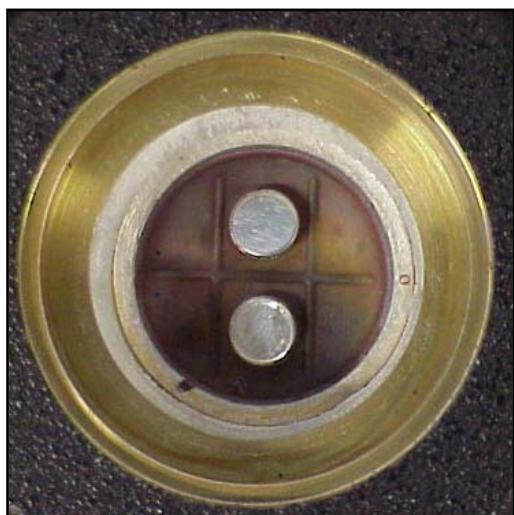
Figure 35: Sample and reference pan used in Differential Scanning Calorimetry (DSC)
