1. REPORT DATE (DD-MM-YYYY) 28-02-2003		2. REPORT TYPE A005 DATA ITEM		3. DATES COVERED (From - To) 01-04-1998 TO 28-02-2003	
4. TITLE AND SUBTITLE FINAL REPORT for Contract DAAE07-98-C-M012 (PART 3 OF 3) -Evaluation of Alternate Driveshaft Configurations for the FMTV Program				5a. CONTRACT NUMBER DAAE07-98-C-M012	
				5b. GRANT NUMBER	
				5c. PROGRAM ELEMENT NUMBER	
				5d. PROJECT NUMBER	
				5e. TASK NUMBER	
				5f. WORK UNIT NUMBER

14. ABSTRACT EVALUATIONS OF CANDIDATE DRIVESHAFTS FOR THE FMTV PROGRAM FROM DANA, ARVIN MERITOR (2 DESIGNS), AND GKN WERE CONDUCTED. THE EVALUATIONS INCLUDED INSTRUMENTED ROAD TESTING, A 1000-MILE DURABILITY TEST THAT INCLUDED HIGH SPEED DRIVING AND SUBMERSION, LABORATORY MEASUREMENTS, AND DADS MODELING. THE DRIVESHAFTS WERE (UN)BALANCED TO THEIR MANUFACTURERS PRODUCTION LIMITS PRIOR TO EVALUATION AND THEN TESTED ON THE VEHICLE USING A SPECIAL TRANSFER CASE TRANSDUCER CAPAPBLE OF MEASURING DRIVESHAFT DYNAMIC FORCES. A PRINCIPLE FOCUS OF THE PROGRAM INCLUDED SEVERAL METHODS OF MEASURING INSTALLED CRITICAL SPEED.

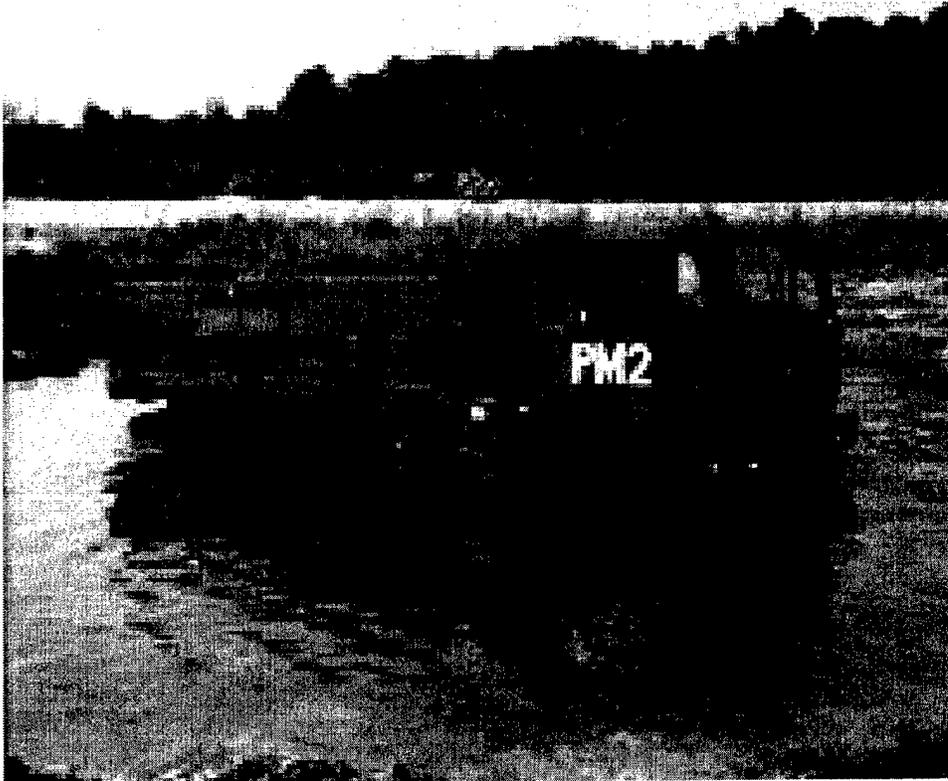
Figure 1
Submersion Test (MTV)
