Tri-Service Corrosion Conference

14-18 January 2002

Editors: Dr. Robert A. Mantz and Dr. Paul C. Trulove

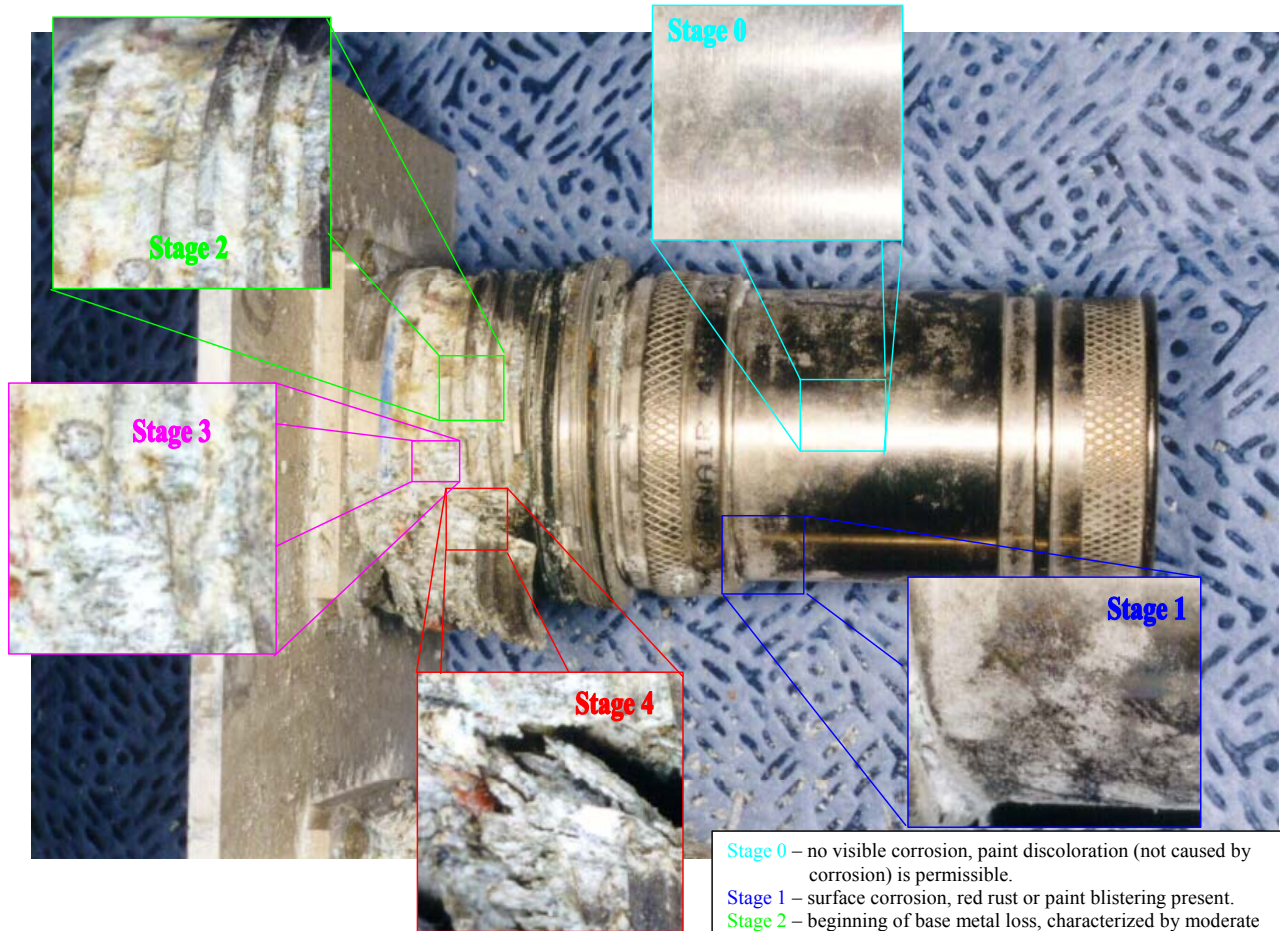
Stage 0 – no visible corrosion, paint discoloration (not caused by corrosion) is permissible.
Stage 1 – surface corrosion, red rust or paint blistering present.
Stage 2 – beginning of base metal loss, characterized by moderate corrosion products, blistering may be present.
Stage 3 – significant base metal loss, pin holes may be present.
Stage 4 – perforation of base metal, no metal remains at location of severest corrosion, loss of structural integrity.
