Outdoor Exposure Results for Pretreated and Topcoated Aluminum Armor Alloys 2519, 5083, and 7039

ARL-TR-3283

September 2004

**John V. Kelley and Brian E. Placzankis
Weapons and Materials Research Directorate, ARL**

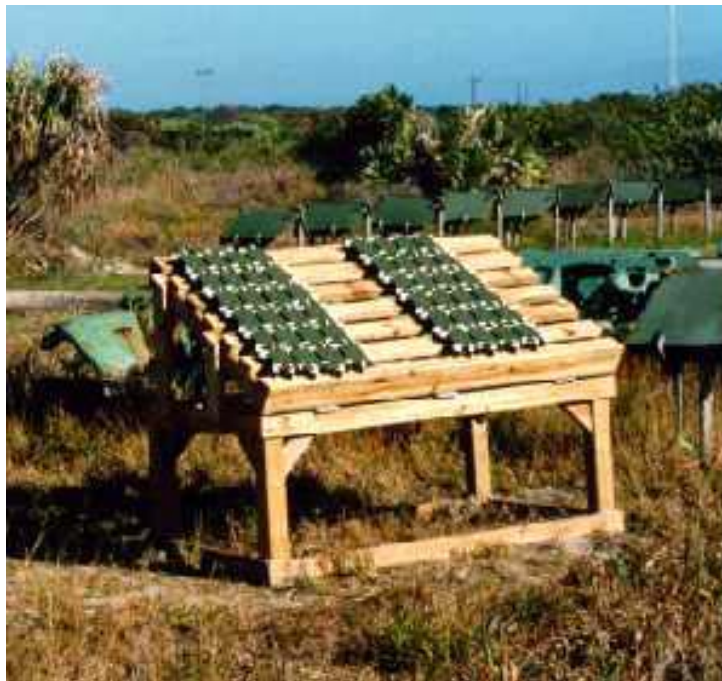
Figure 1. Exposure racks at Cape Canaveral.

From the five sets painted with the CARC system, two sets (a total of 48 panels) were selected for outdoor exposure and are the topic of this study. All specimens and their designations are tabulated in Appendix A. Each of these panels was “X” scored using a hardened steel scribe with a static load of 5 kg and placed on a rack on the beach at Cape Canaveral Air Force Base, FL (figure 1). A hole was drilled in each panel near the edge and was used to attach the “working electrode” lead with a screw for impedance measurements. The panels were propped up at about 30° horizontally, with screw holes on top so water would drain away from hole. The racks were positioned approximately 100 yards away from and facing the ocean. Each panel was held in place 1.25 in above the surface of the rack using Teflon* brackets. Teflon was used because of its inert qualities, durability, and electrical insulating properties (figure 2). The other seven sets of panels were tested in an earlier study using accelerated test methods and EIS (5).

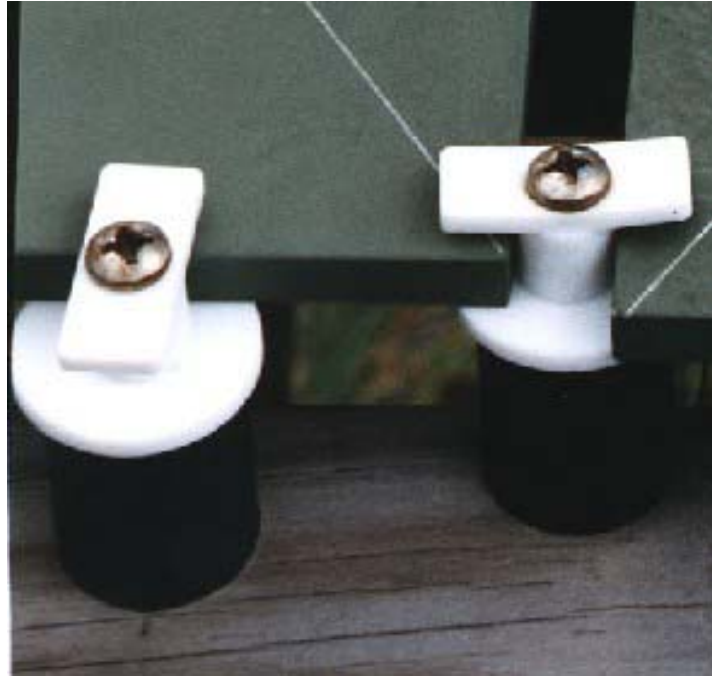
Figure 2. Teflon hold-down brackets.

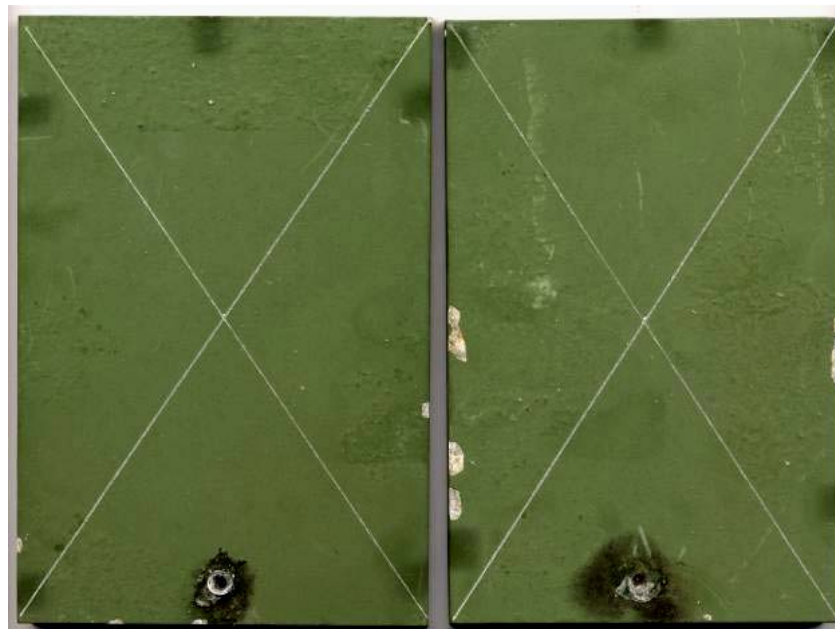
Figure 7. Alloy 7039 pretreated with Patchlin 2.

At each of the inspection intervals, every panel was visually examined, and any defects were noted. Some key photos are presented in figures 6–9. Note: regardless of the orientation of the photos, the bottom edge of the panel refers to the edge opposite the screw hole. One of the first observations made of all panels was of the noticeable fading of the paint at the 9-month inspection. At that time, it was also apparent that corrosion had begun on the edges of panels B, J, O, and P in set A, and panels A, I, L, O, Q, and R in set B (see appendix A). At 37 months, two of the sample sets were removed from the test because of excessive corrosion damage. They were P (7039/Patclin 2) and L (2519/Turcoat). All other samples completed the 48 months of exposure. When the test was terminated after 48 months, all samples were given a final thorough visual inspection. First, a general overall condition of the panels was estimated, and the average of each alloy-pretreatment combination was taken. These results are illustrated in figure 10.

Alloy 7039 displayed the greatest resistance to creepage from the scribes but still had significant attack away from the scribe for some pretreatments (figures 11 and 12). The Patclin 2 and grit-blasted panels had ratings of 2 and 4, respectively, for unscribed regions. Again, results from

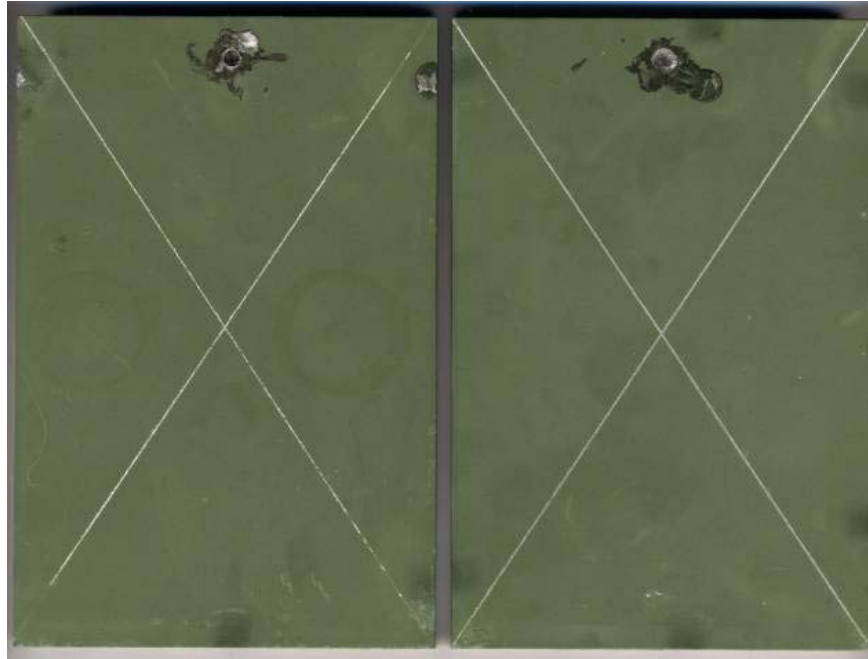
Figure 8. Grit-blasted 2519 after 48 months of exposure.

Accelerated corrosion testing proved to be disastrous for nonchromate conversion coatings on 2519. Total failure was seen on 2519 with all but three surface treatments—grit blasted, chromate, and Chemcote, with chromate performing best. However, as mentioned earlier, the 2519 samples performed much more admirably in outdoor exposure, with the biggest apparent surprise being the grit-blasted 2519 samples with no pretreatment. Although unexpected, the impressive performance of the grit-blasted 2519 panels was not in conflict with the accelerated

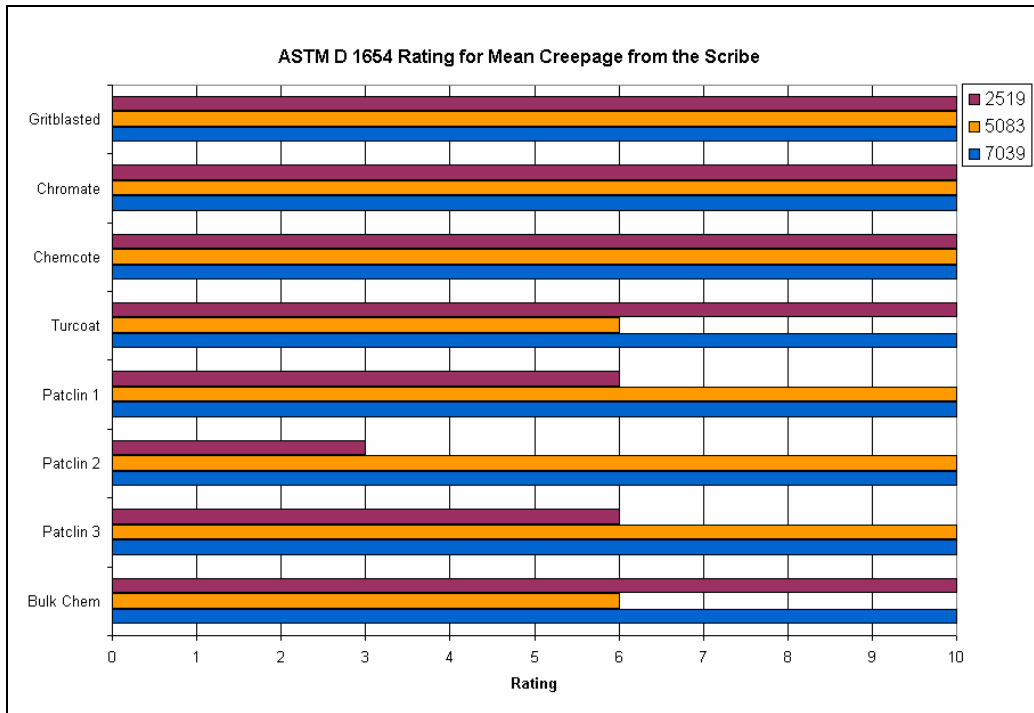
Figure 11. ASTM D 1654-79A procedure A ratings for panels in outdoor exposure.

Measurements of corrosion creepage outward from the scribes and the condition of the unscribed areas of the panels were done according to ASTM D 1654-79A procedures A and B, respectively. These results are shown in figures 11 and 12. For the evaluations of areas away from the scribe, an effort was made to discount any corrosion within 0.5 in from the edges and any corrosion initiating from the scribes. Despite these efforts, in several cases, the corrosion undercutting from the edges went beyond the 0.5-in boundary and therefore was included.

Despite the general corrosion resistance of alloy 5083, some of the pretreatments performed poorly on this alloy. As shown in figure 11, most of the alloy/coating combinations showed no appreciable creepage from the scribes. However, creepback was observed for both the Turcoat and Bulk Chemical pretreatments on alloy 5083. ASTM ratings of the unscribed areas are given in figure 12, and, again, two pretreatments (Patclin 3 and grit blasting) showed significant performance drops on this alloy. The impedance plots for the coatings on 5083 are shown in figure 14, while the postexposure adhesion results are shown in figure 18. Neither the total impedance measurements nor the postexposure adhesion results provided a simple explanation for this behavior. Overall, several of the nonchromate conversion coatings performed well on this alloy, as did the Alodine 1200 control.

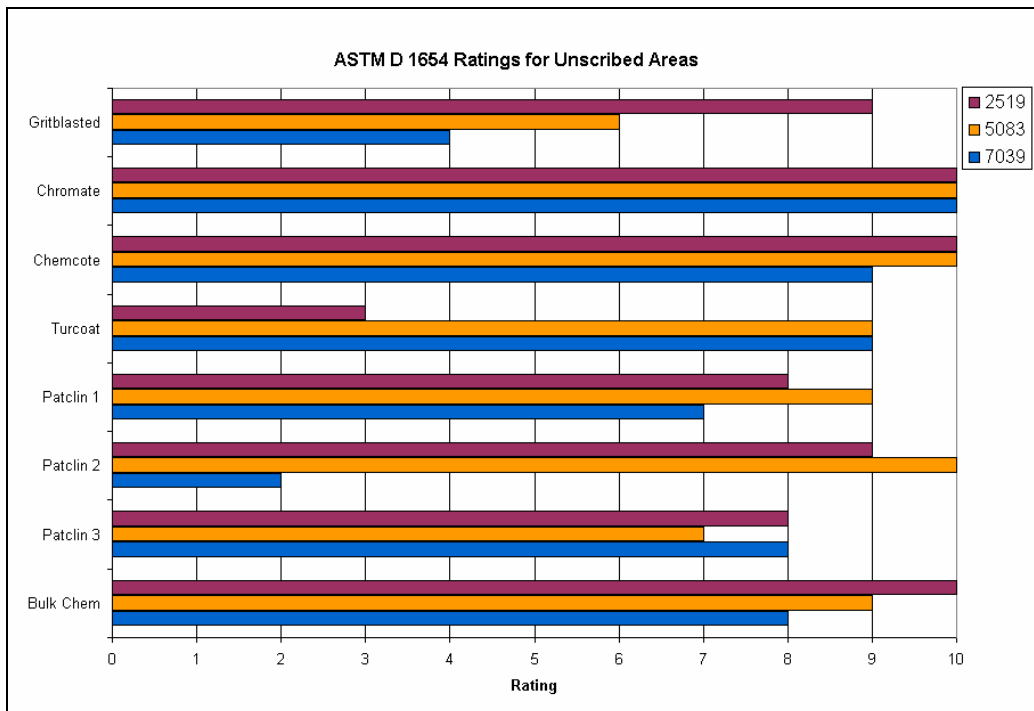
Figure 12. ASTM D 1654-79A procedure B ratings for panels in outdoor exposure.

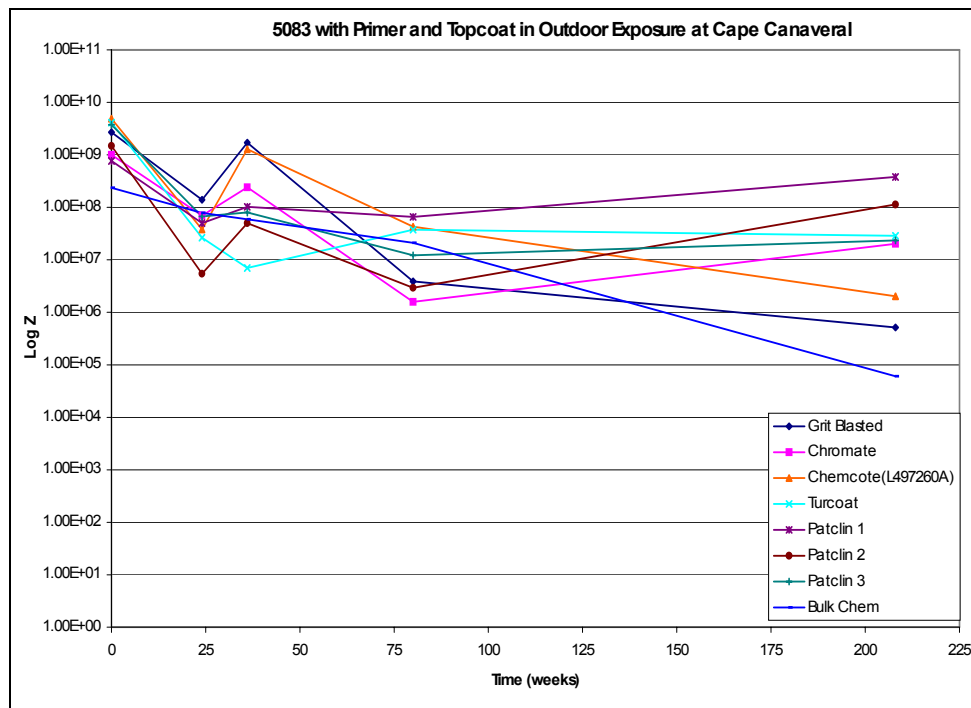
Figure 14. Al alloy 5083 in outdoor exposure.

The total impedance of a representative set of samples tested in outdoor exposure are given in figures 13–15. There was no real correlation between total impedance and corrosion performance of the pretreatment. Several samples had good corrosion performance and low impedance, while others had high impedance values with poor corrosion performance. That said, samples with high impedance and blistering may indicate that the pretreatment relies on barrier properties for protection and offers little resistance to undercutting. If the opposite is true, as in the case of chromate, the pretreatment may have inhibiting “self healing” qualities and provides better resistance to undercutting, but offers less barrier protection.

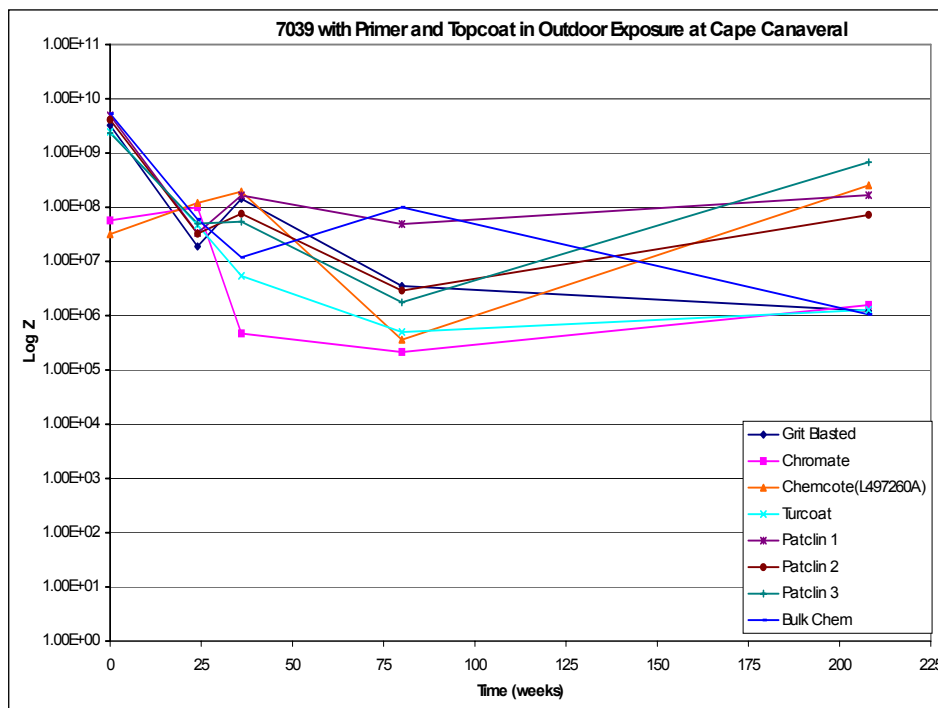
Figure 15. Al alloy 7039 in outdoor exposure.

impedance as a function of exposure (figure 15) and postexposure adhesion (figure 18) did not provide much insight to this behavior. The impedance values of both these pretreatments were within the scatter band. The postexposure adhesion strength of the grit-blasted panels was somewhat lower (1515 psi) than the average value of 2367 psi attained by all the alloy 7039 specimens, but the Patclin 2 adhesion was 2505 psi, which was the third highest. Again, as with 5083, several of the nonchromate pretreatments performed well, as did the chromate control samples.

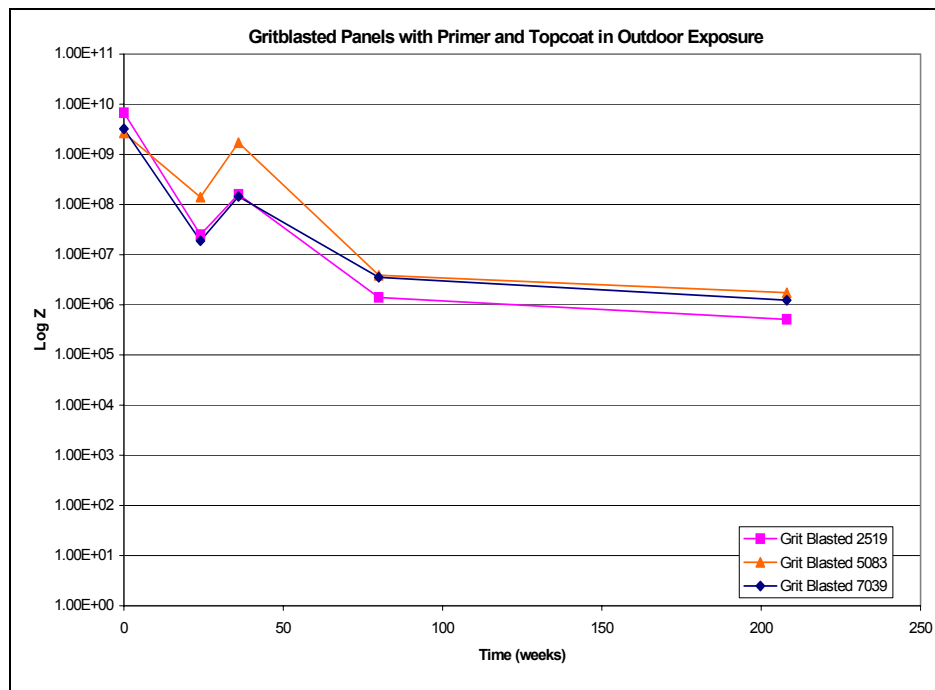
Figure 16. Grit-blasted panels in (a) lab immersion and (b) outdoor exposure.

Figures 16 and 17 offer a comparison of the impedance values of the two controls in outdoor exposure with the laboratory impedance measurements of similarly prepared control samples in laboratory immersion. There appeared to be a similar trend with both sets of data, especially with the grit-blasted samples, which eventually leveled off at about 10^5 ohms. There was clearly more noise in the chromate data for both outdoor exposure and laboratory, perhaps as a product of the inhibiting qualities of chromate. Nevertheless, this comparison is offered as a verification of the degradation trends of the like-prepared control samples in outdoor exposure.

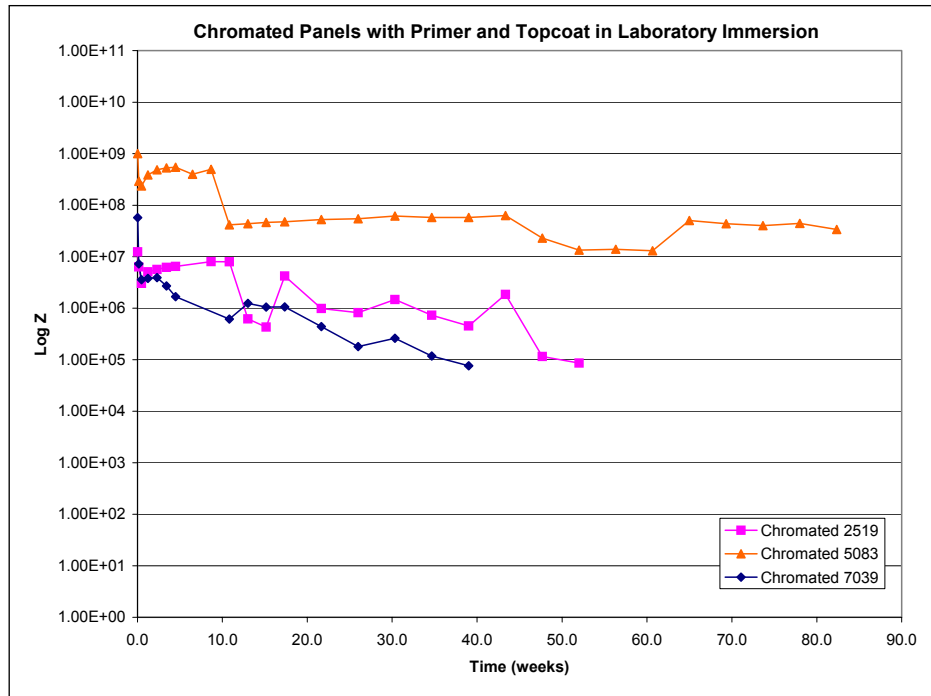
Figure 17. Chromated panels in (a) lab immersion and (b) outdoor exposure.

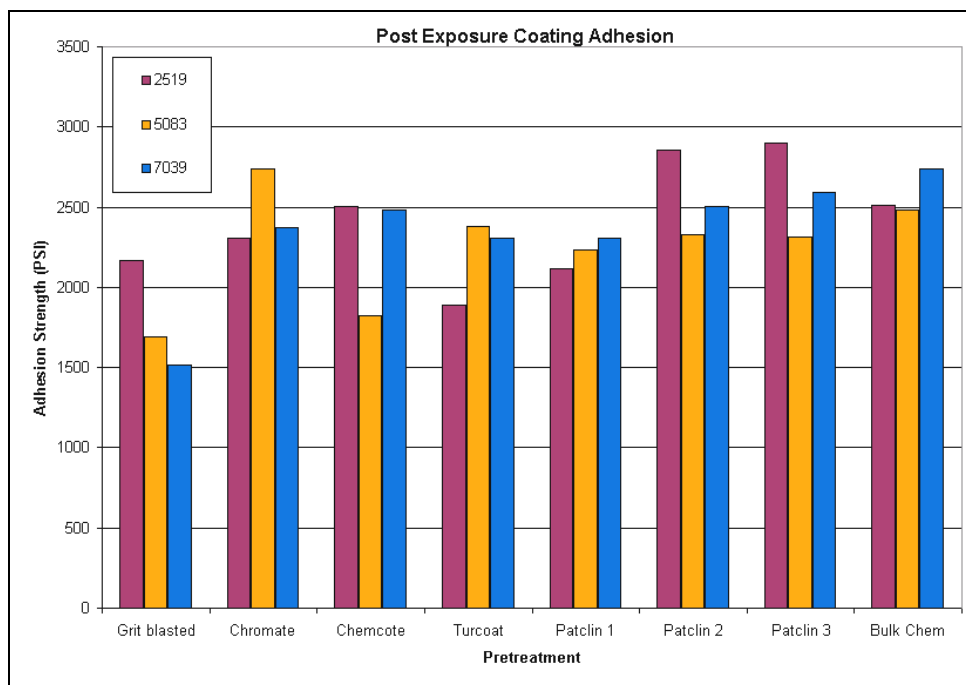
Figure 18. Averaged postexposure pull-off coating adhesion strength data.

Postexposure coating adhesion tests were performed on all samples exposed. Two “pull-off” tests per panel were done, and the results for each alloy/pretreatment combination were averaged and illustrated in figure 18. All of the pull-off results, along with the statistics, are tabulated in appendix B. The mode of failure for each pulloff was noted and is given in appendix C.
