ERDC/CHL TR-04-8

Coastal and Hydraulics
Laboratory

Toussaint River, Ohio, Ordnance Migration Study

Final report

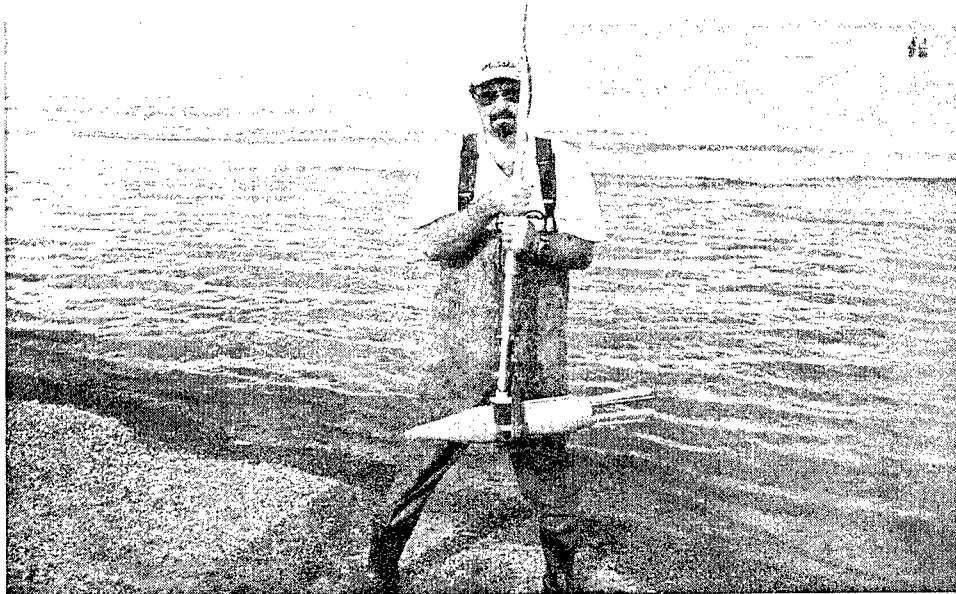
Figure 18. SO deployment device. Note the gentle bathymetry slope of study site illustrated by depth of water that the two people in upper right-hand corner are standing in and the waves shoaling on the first sand bar offshore

SO was placed on the lake bed using an SO deployment device (Figure 18). The device was needed to assure that the desired deployment orientation of the SO could be achieved, and to establish a deployment location when visibility was

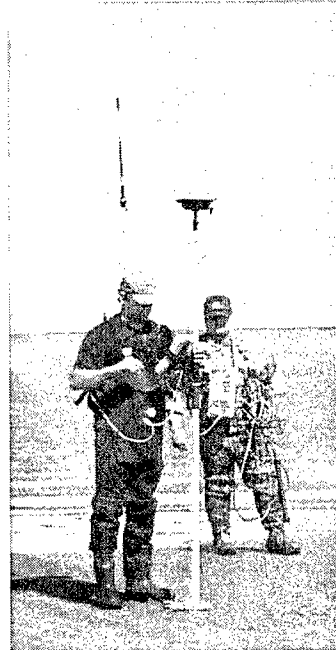
Figure 19. The Trimble Model 4700 RTK Rover positioning 60-mm SO
