**Effect of Sonic Thermographic
Inspection on Fatigue Crack
Growth in an Al Alloy**

DSTO-TN-0584

Air Vehicles Division
Platforms Sciences Laboratory

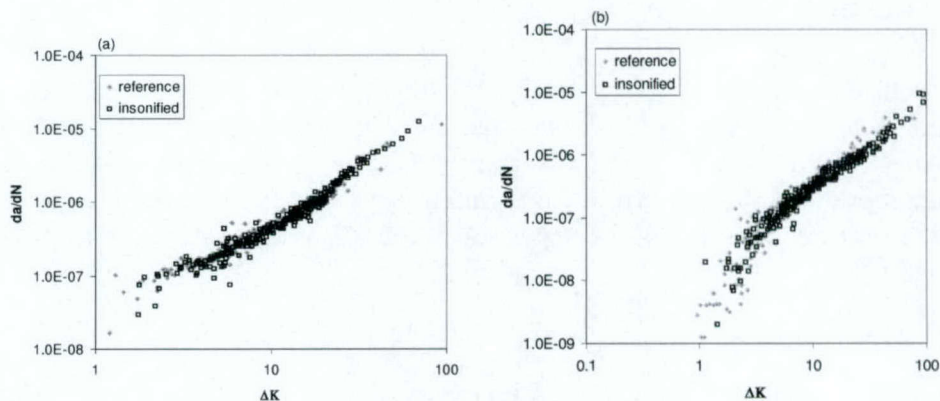
Figure 3: Crack growth rate curve for 1.6 mm and 3.2 mm thick specimens, respectively, showing reference and insonification at 5, 15 and 25 mm crack lengths, for 10 s.

Figure 3 shows the crack growth rate for reference and insonified specimens of 1.6 and 3.2 mm thickness, respectively. The overall crack growth characteristics for both types of specimens is similar with little evident variation between the reference and the insonified groups. To facilitate a crude quantitative measure of variation, both sets of data were fitted to a Paris-Erdogan type expression relating stress intensity factor to the crack growth rate. It takes the form

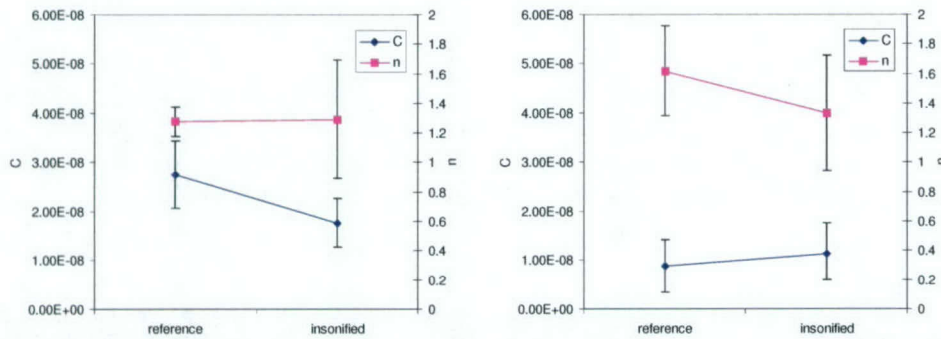
where C and n are material constants, $\frac{da}{dN}$ is the crack growth rate and ΔK is the stress intensity factor range. The material constants, C and n , were determined from the crack growth data using a least squares approach. Figure 4 shows the average of these values for the reference and insonified coupons. The error shown corresponds to one standard deviation. At this level of variation there is little statistical difference between the reference and insonified sets.

Figure 4: The average values of the material constants n and C for reference and insonified coupons for the 1.6 mm and 3.2 mm thick specimens, respectively.
