ERDC/CERL MP-04-1

Fury: Robotic In-Situ Inspection/ Condition Assessment System for Underground Storage Tanks

March 2004

Final Report

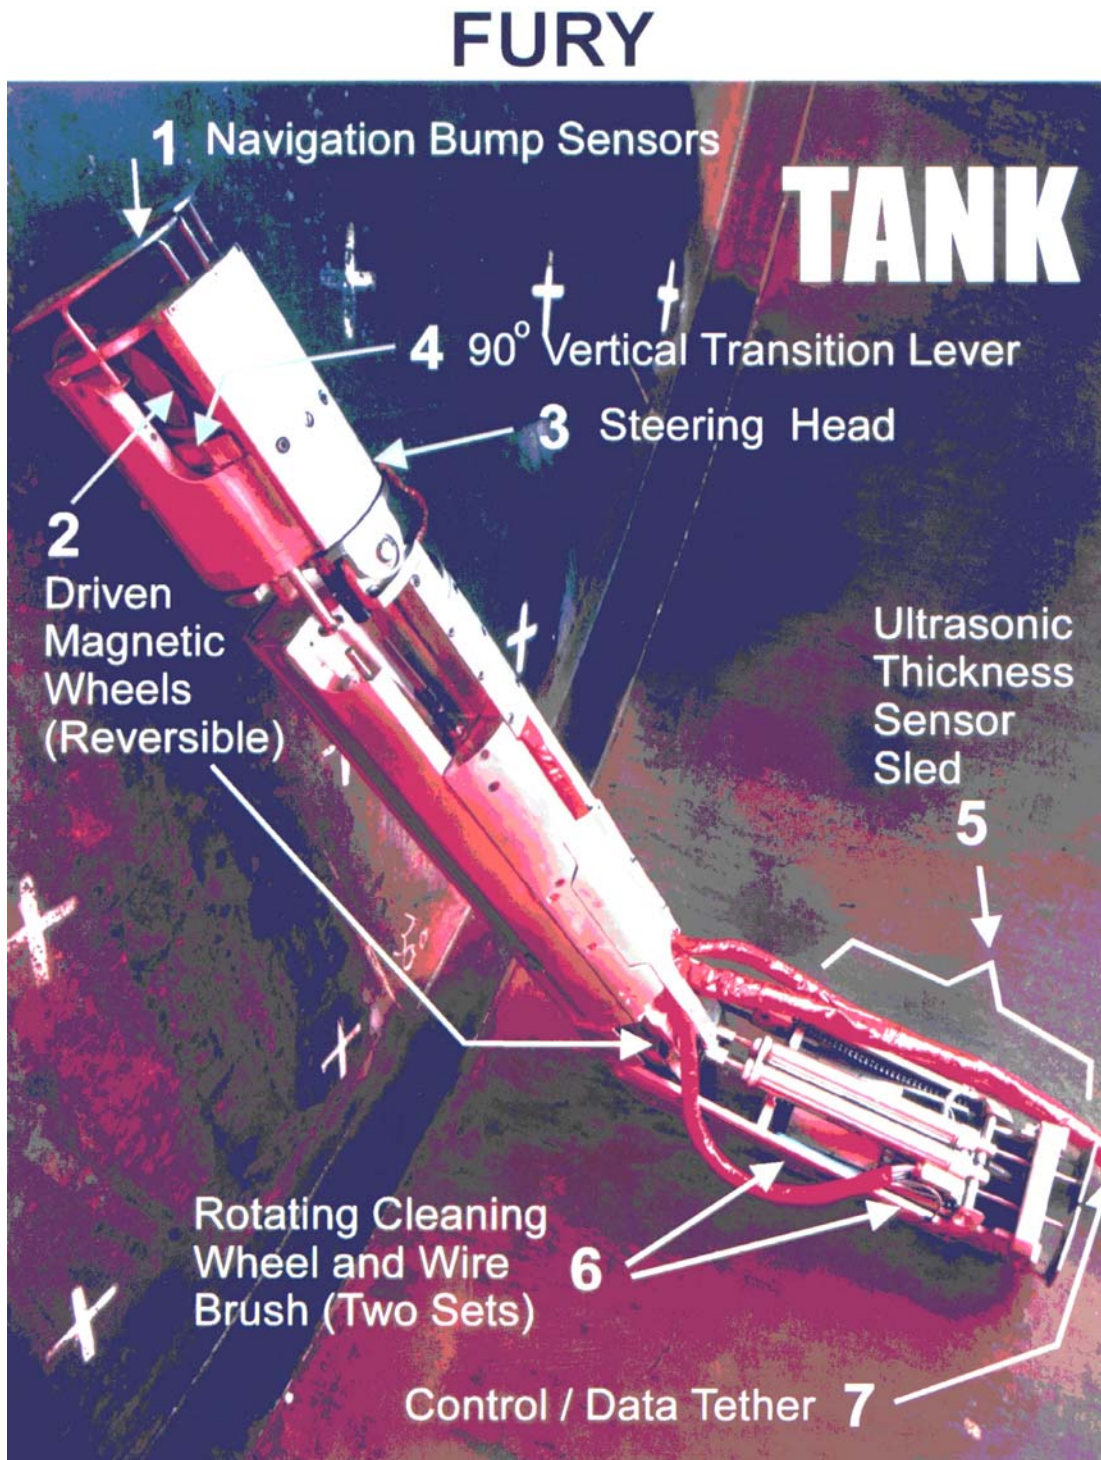
Figure 1. Photograph of *Fury* robotic system.

The *Fury* robotic tank inspection system (shown in Figure 1) consists of four assemblies: the robot assembly, the inspection assembly, the tether management assembly and the operator console. The robot is designed to fit through an existing riser (4-inch diameter minimum), which mitigates invasive tank entry during assessment and allows for non-destructive evaluation.

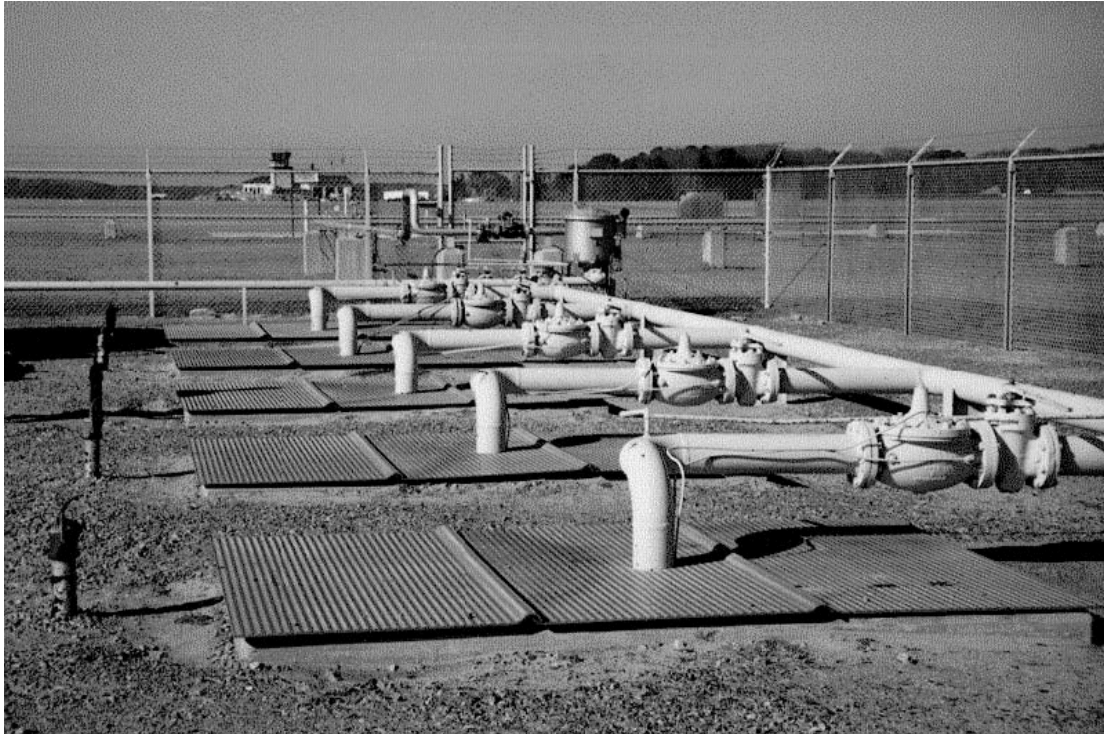
Figure 2. Photograph of Hunter Army Airfield USTs.

The second demonstration was conducted at the Hunter Army Air Field (a sub-installation of Fort Stewart, GA) from 18 February 18 to March 7, 1997. *Fury* performed the remote, in-situ assessment of the condition of three 50,000-gallon USTs (from a total of thirty-one 50,000-gal USTs at the site) according to ASTM ES40-94 [5]. These tanks were thought to be in good condition based on the condition of some previously removed tanks. Each of the tanks was selected from three separate pump stations, each consisting of a bank of ten tanks. Emphasis was on measurements on the bottom one-third of the tank (the most susceptible to pitting) in order to provide a conservative assessment.

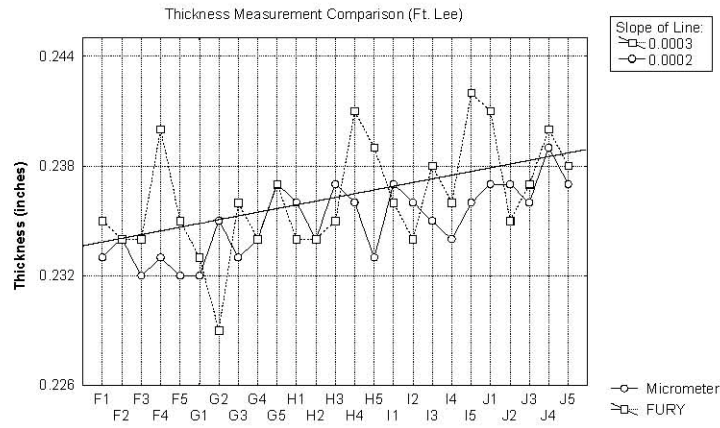
Figure 3. Mechanical vs. Fury Thickness Measurement (Bottom, Middle)

The in-situ *Fury* and ex-situ micrometer measurements are shown in Figures 3 through 5. Laboratory analyses of the three 5x5 grid pattern readings were performed in accordance with ASTM G46 [8]. In addition, MRI performed independent ultrasonic measurements on a different grid system in accordance with an EPA procedure for the field evaluation of USTs. The comparison of the measurements is given in Table 1. The external hand-held ultrasonic measurements taken by MRI [9], which were almost identical to those called for by NLPA 631[4], were, when considered alone, inadequate to determine the tank's condition. In fact, no measurement indicating a remaining wall thickness less than 50% of the original value (nominal 0.375 in.) was found. *Fury*, however, found several locations with wall thicknesses below 0.15 in. (see Figure 6).

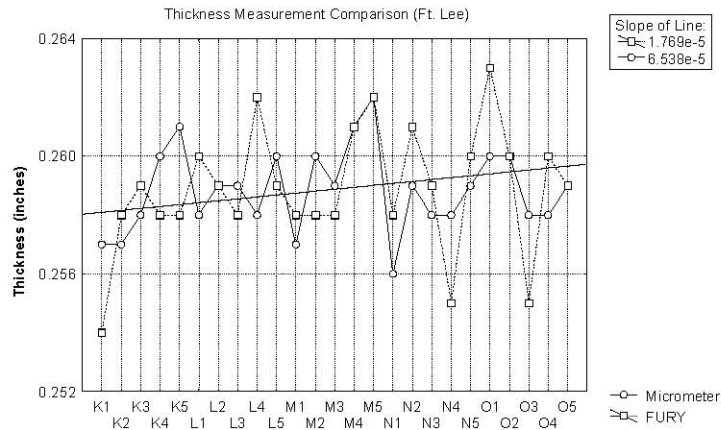
Figure 4. Mechanical vs. Fury Thickness Measurement (Bottom, Quarter)

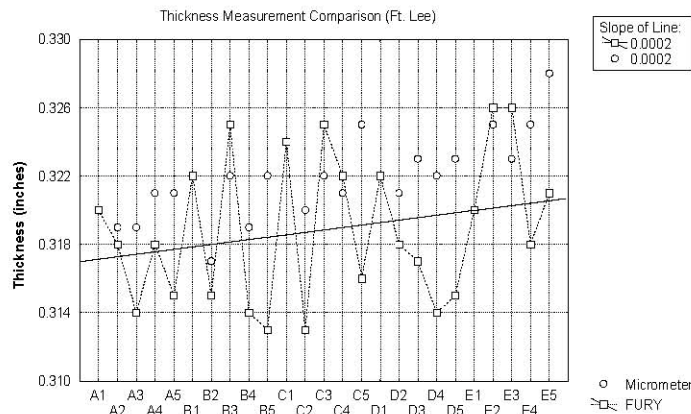
Figure 5. Mechanical vs. Fury Thickness Measurement (End Cap)

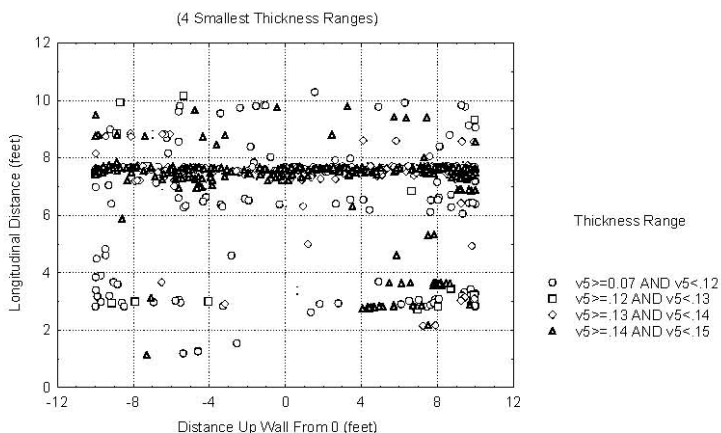
Figure 6. Location Distribution of 1,000 Thinnest Wall Thickness Measurements

One of the main advantages of the *Fury* robotic system is its ability to rapidly collect data while the unit is in motion. Virtually all of the data from Fort Lee were taken during the last day of a week-long effort after a number of other validation tasks had been completed. Table 2 shows the results of a statistical analysis for the full data set as separated into tank wall and end caps (which typically have a larger initial wall thickness). The *Fury* data can be displayed in a number of ways. With position coordinates associated with each measurement, the positions of the thinnest measurements can be displayed. Figure 6 shows the four thinnest ranges of measurement for the curved tank wall (displayed as if viewed from above and opened to each side from a longitudinal top seam). A feature along a lower circumference approximately 8 feet from the southern end cap is evident.

This feature was visually confirmed after the tank was removed. One possible explanation is that, during installation, a lifting strap caused some initial damage, which over time led to differential corrosive attack.

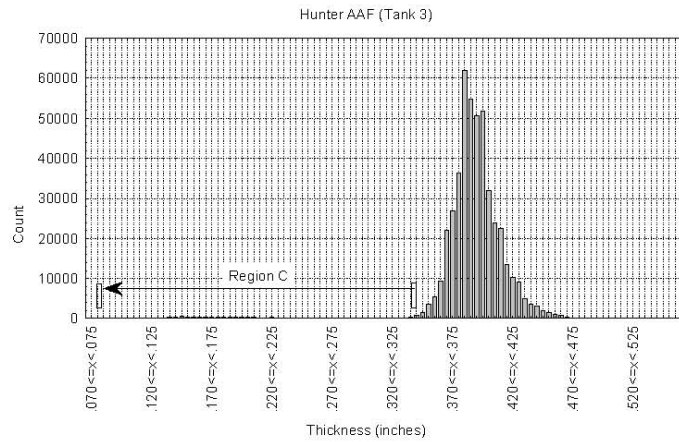
Figure 7. Tank 3 Thickness Distribution

Descriptive and inferential statistics were considered for the large data sets obtained by *Fury* for each tank at Hunter AAF. Extreme value statistics were utilized on the maximum pit depths obtained from the data to determine probability of failure. Two approaches were employed assuming that maximum pit depths followed a Gumbel Type I distribution. The probability of rejecting this null hypothesis was determined. The scale and shape parameters of the distribution were estimated in an iterative manner.

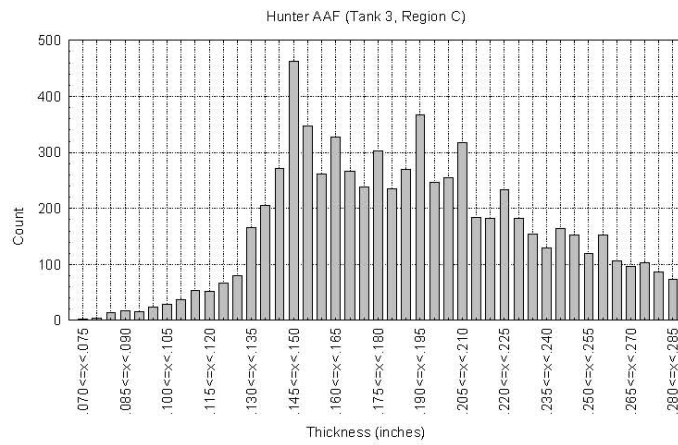
Figure 8. Thickness Distribution of Region C in Tank 3

The *Fury* inspection showed that tanks 3 and 4 were in good shape while tank 5 clearly showed a large number of observations at the lower thickness ranges. These observations combined with the findings from the external corrosion evaluation procedures, as required by ASTM ES40-94 [5], indicated that tanks 3 and 4 were considered suitable for upgrade while tank 5 was not. From a corrosion engineering viewpoint, the character of the wall thickness histograms is intriguing. It may be that, as a tank undergoes the accumulated damage of corrosive degradation, the condition represented by Figures 8 and 10 evolves more toward a condition represented by Figure 12.

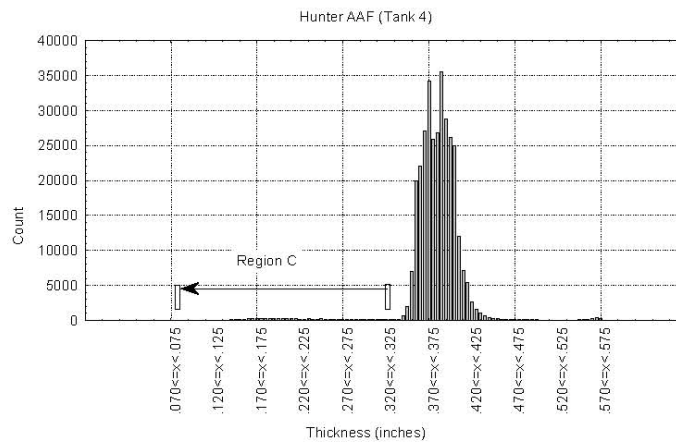
Figure 9. Tank 4 Thickness Distribution

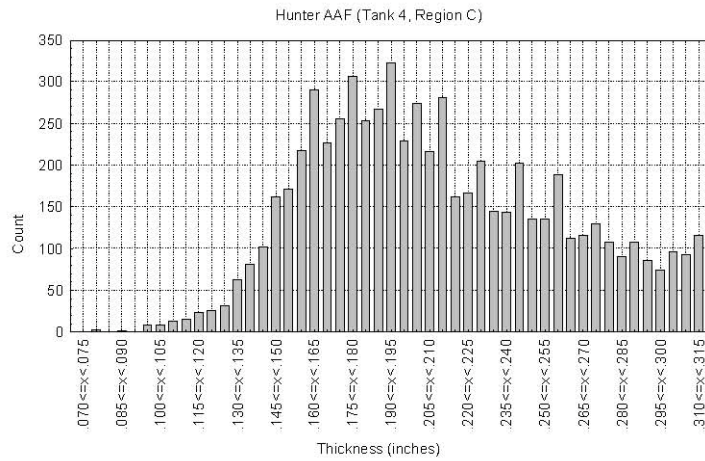
Figure 10. Thickness Distribution of Region C in Tank 4

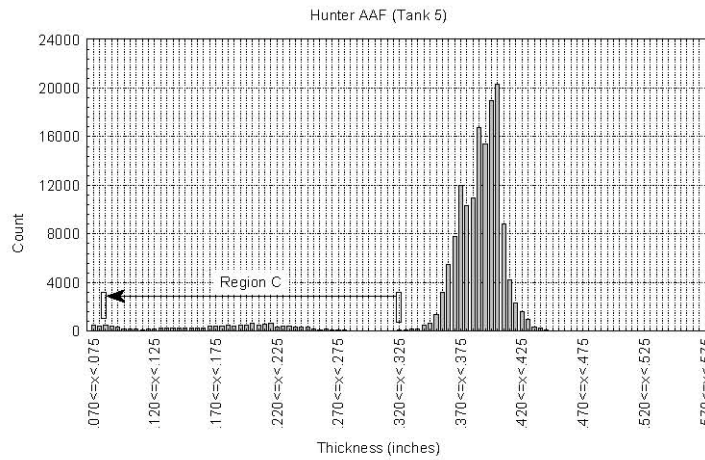
Figure 11. Tank 5 Thickness Distribution

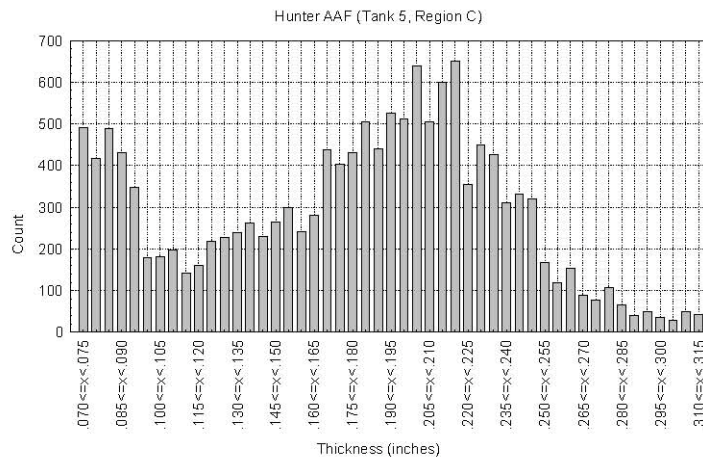
Figure 12. Thickness Distribution of Region C in Tank
