**An Evaluation of the Severity of
the January 1998 Ice Storm in
Northern New England
Report for FEMA Region 1**

Kathleen F. Jones
Nathan D. Mulherin

Prepared for:
Federal Emergency Management Agency
DR-1198-ME
DR-1199-NH
DR-1201-VT

April 1998

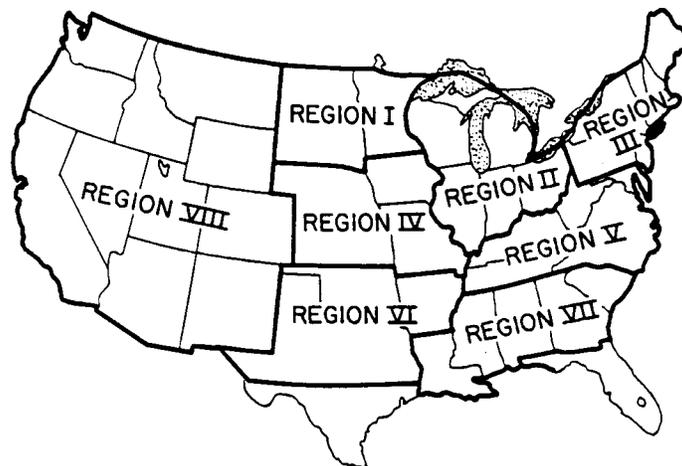
Region	Return Period (Years)											
	2		5		10		25		50		100	
	AVG	MAX	AVG	MAX	AVG	MAX	AVG	MAX	AVG	MAX	AVG	MAX
I	0.4	1.4	1.4	2.1	1.6	2.4	1.8	5.0	1.9	7.1	2.1	>7.5
II	0.7	1.0	1.4	2.1	1.7	3.3	2.0	5.0	2.2	6.0	2.4	7.0
III	1.2	1.6	1.6	2.4	1.8	3.8	2.0	5.8	2.1	7.2	2.3	>7.5
IV	0.5	1.4	1.4	2.1	1.6	2.4	1.8	5.0	1.9	7.2	2.1	>7.5
V	0.2	1.2	1.2	1.8	1.5	2.2	1.7	2.5	1.8	5.0	2.0	7.0
VI	0	1.0	1.2	1.9	1.5	2.4	1.7	3.8	1.9	5.0	2.1	6.0
VII	0	0.4	0.6	1.8	1.0	2.2	1.3	3.4	1.5	5.0	1.7	6.3

Figure 6. Maximum ice thicknesses (cm) for return periods from 2 to 100 years at representative points (AVG) and at the most severe location (MAX) in each of seven regions of the United States. (From Tattelman and Gringorten 1973.)

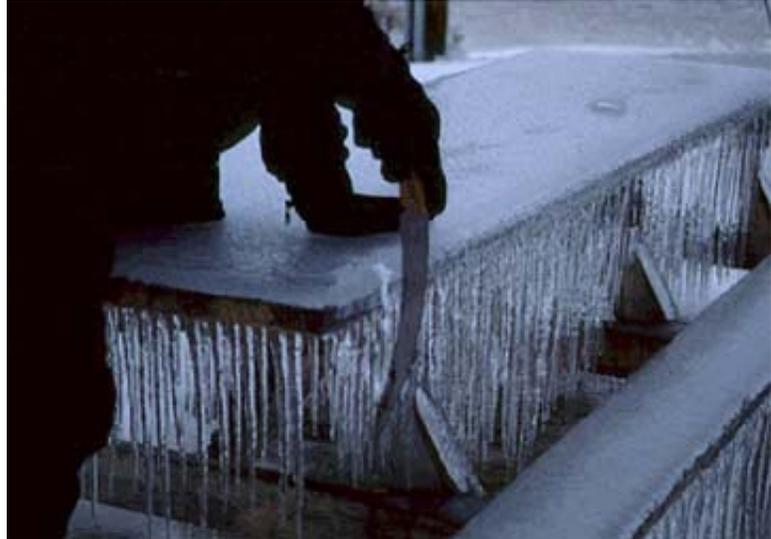
Figure 7. Ice on picnic table off Route 11, in northeastern New York, January 8, 1998 (photo Mulherin).

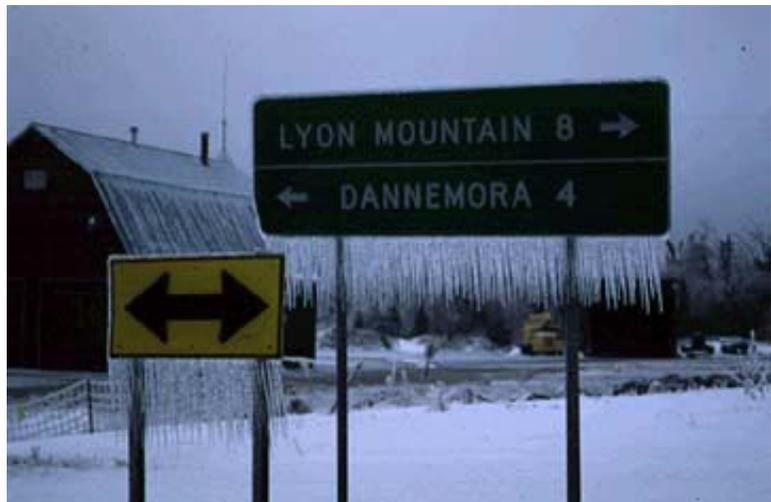
Figure 8. Ice on a sign near Dannemora, New York, January 8, 1998 (photo Mulherin).

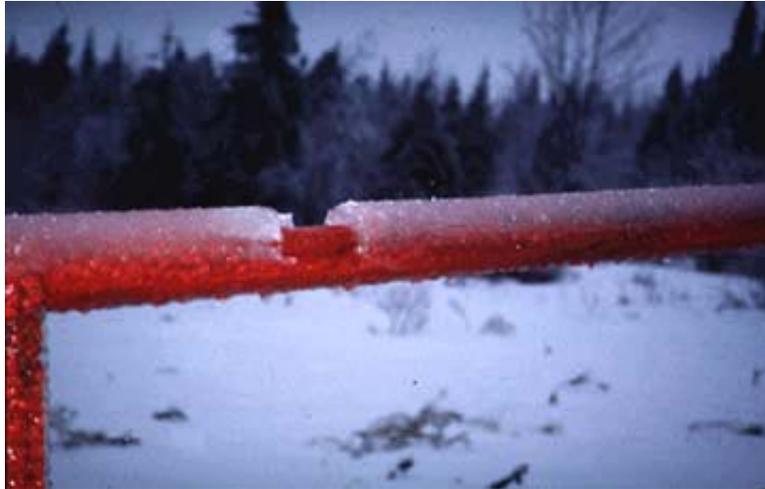
a. Crescent on one side (photo Jones).

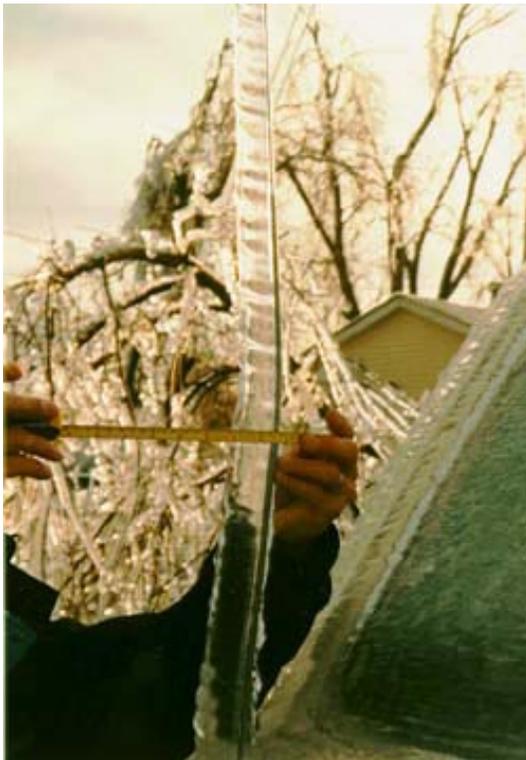
b. Large accretion on windward side of car antenna (photo Jones).

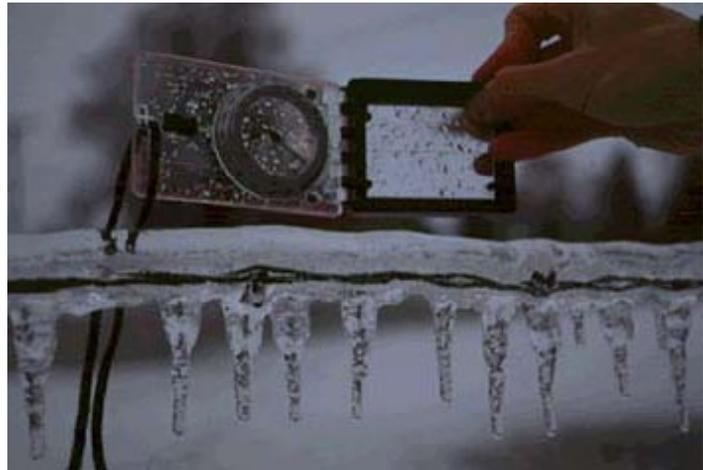
c. Icicles on wire fence (photo Mulherin).

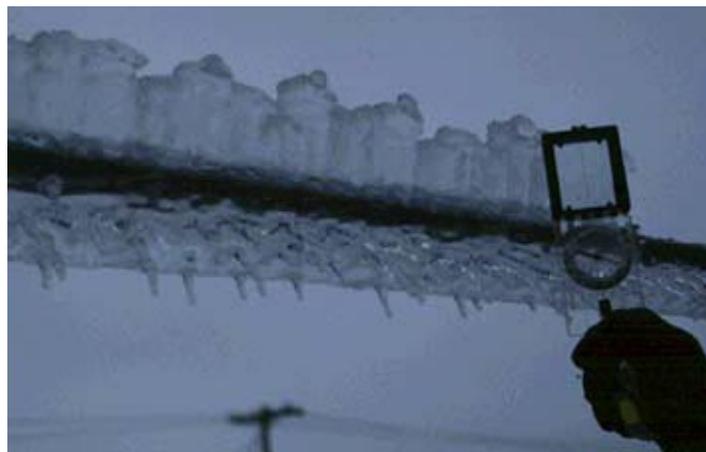
d. Knobby accretion on Triplex (photo Mulherin).

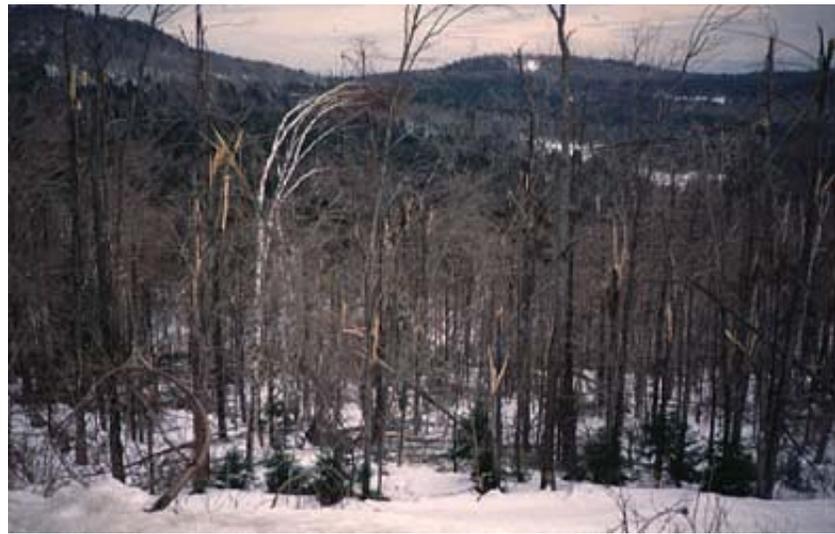
a. Along the road between Randolph and Bethel at 1830 ft (photo Jones).

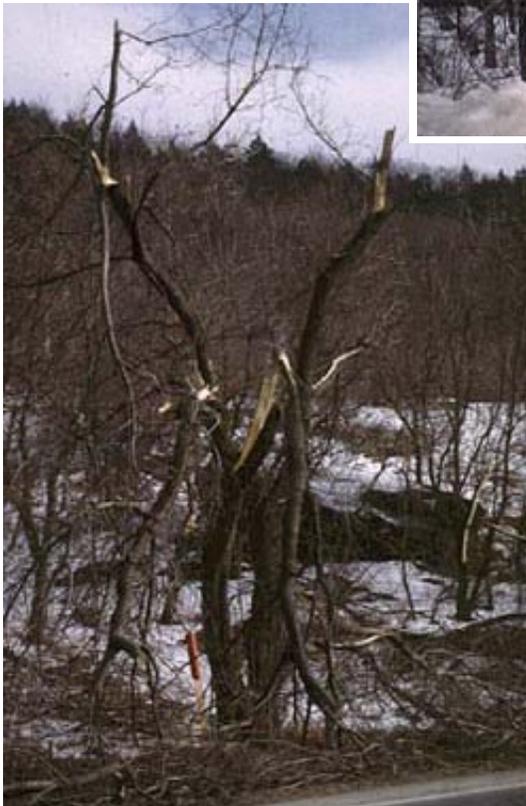
b. Near Starksboro (photo Jones).

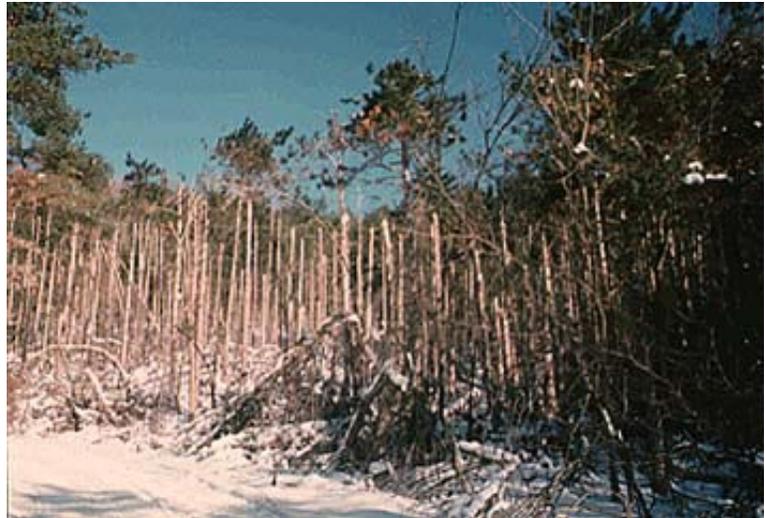
c. Mount Philo at 400 ft (photo Gary Salmon, VDFPR).

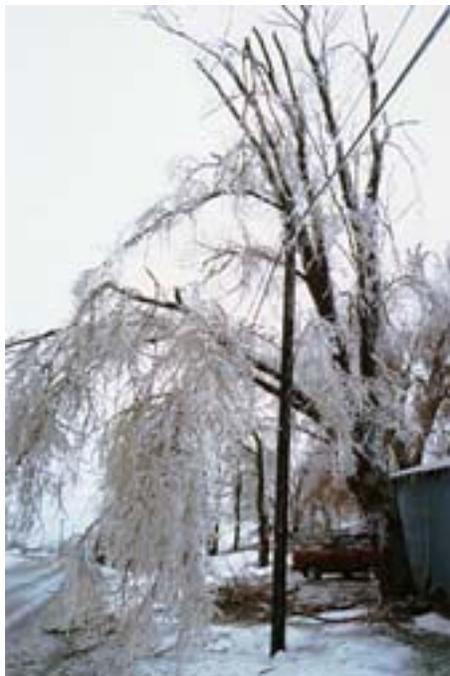
d. Near Swanton at 100 ft (photo Jones).

and extensive tree damage at and near lake level. Outside that area the boundary separating light and heavy damage trended toward higher elevations farther north in the state. Icing apparently did not extend above about the 3000-ft level. **Fig. 12a** shows the tree damage at 1830 ft between Randolph and Bethel. Farther east along this road, at elevations below about 1660 ft, trees were not damaged. Damaged trees near Starksboro (750 ft) in western Vermont are shown in **Fig. 12b**. On Mount Philo, south of Burlington in the Champlain Valley, even conifers were severely damaged. Mount Philo rises about 500 ft above the surrounding terrain, to an elevation of 800 ft, with a steep west-facing slope. Damage to red pines at the base of this slope is shown in **Fig. 12c**. Oaks and scotch pines growing on the northeast-facing terrace on the top of Mount Philo were also severely damaged. Tree damage farther north near Lake Champlain is shown in **Fig. 12d and e**. The photo in Fig. 12d was taken on January 8 at 8:50 a.m. near Swanton, Vermont at an eleva-

tion of 100 ft. That damage occurred with an ice load of 0.2 in. (Throughout this report we report ice loads in terms of the equivalent uniform ice thickness, as described in Sections 3 and 4.) The damaged trees in Fig. 12d were photographed at 11:15 a.m. on January 8 at the Beekmantown rest area on I-87 in New York, just north of Plattsburgh, two miles west of Lake Champlain at an elevation of 200 ft. The damage was caused by an ice load of 0.5 in.

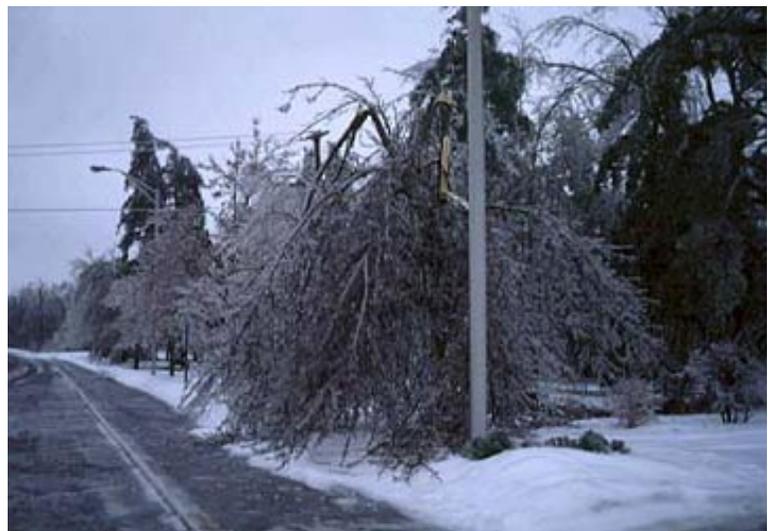
e. Two miles west of Lake Champlain near Beekmantown, New York, at 200 ft (photo Mulherin).

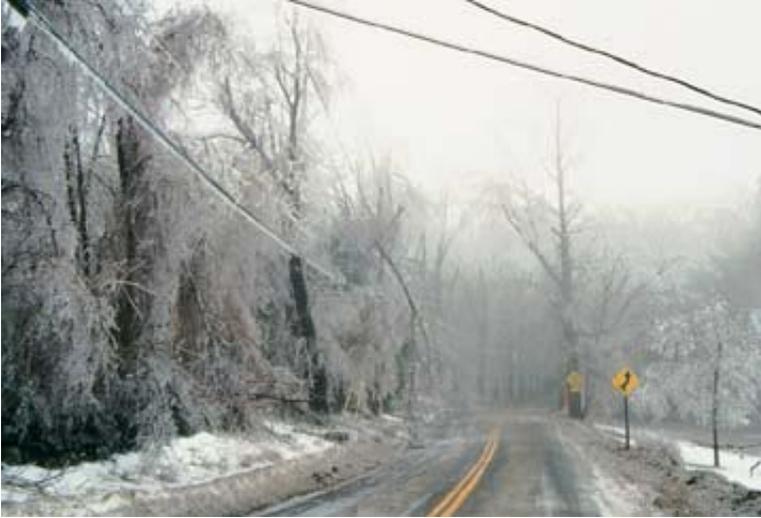
a. Between Harrisville and Dublin at about 1500 ft (photo Nick Collins).

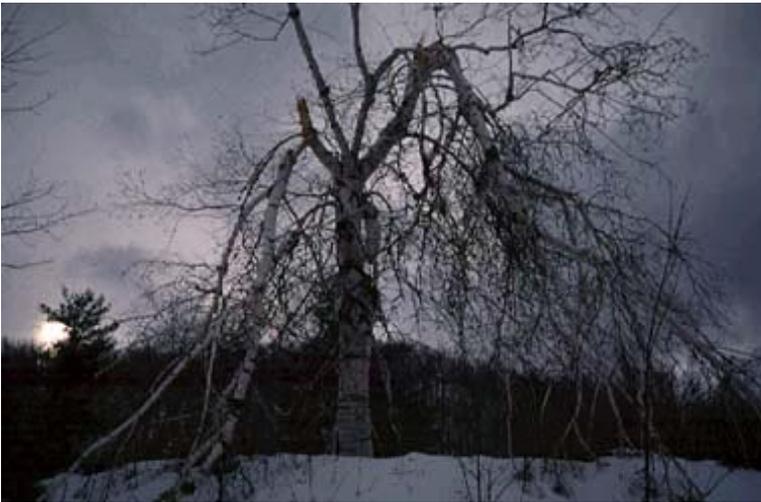
b. Bradford at 1250 ft (photo Jones).

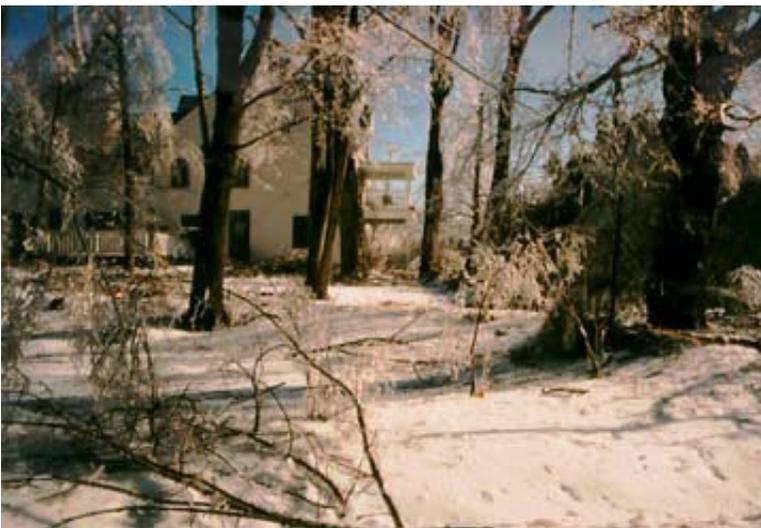
c. New London at 1300 ft (photo Kathy Lowe-Bloch).

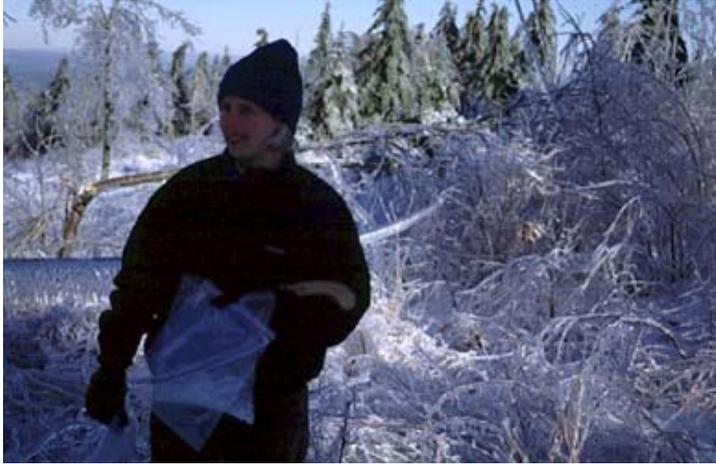
d. Enfield at 1660 ft (photo Mulherin).

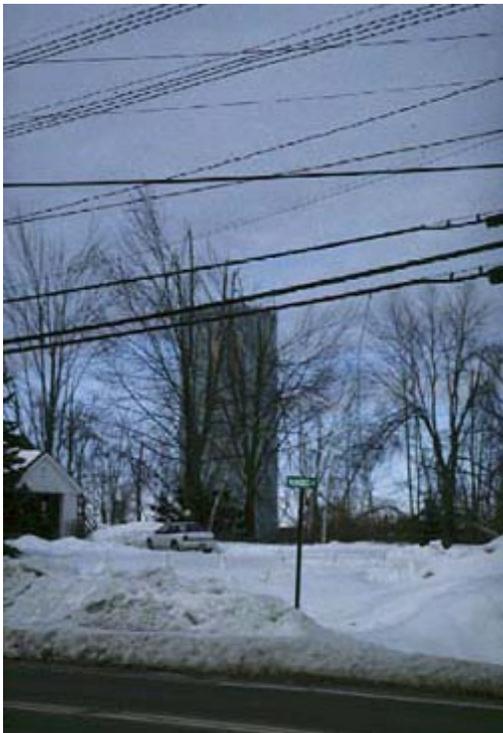
e. Wolfeboro at 540 ft (photo Jones).

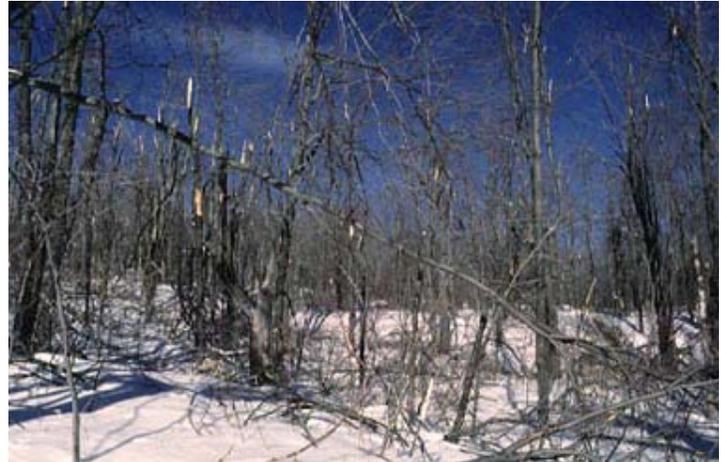
f. Berlin at 1640 ft (photo Mulherin).

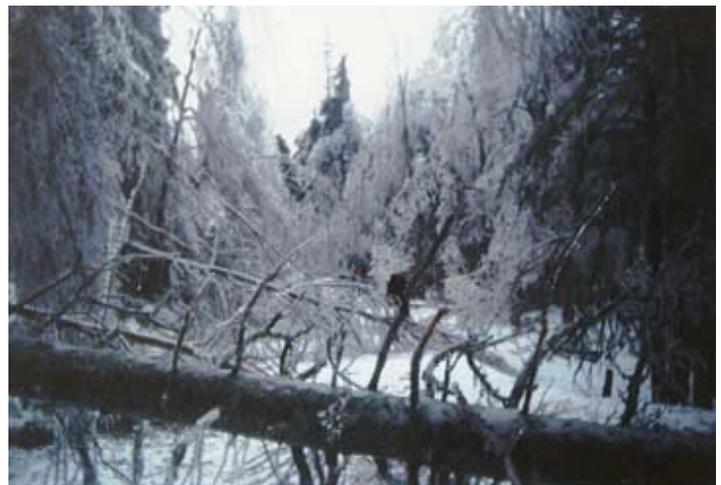
g. Mount Washington (photo Eric Meyerson, UNH).

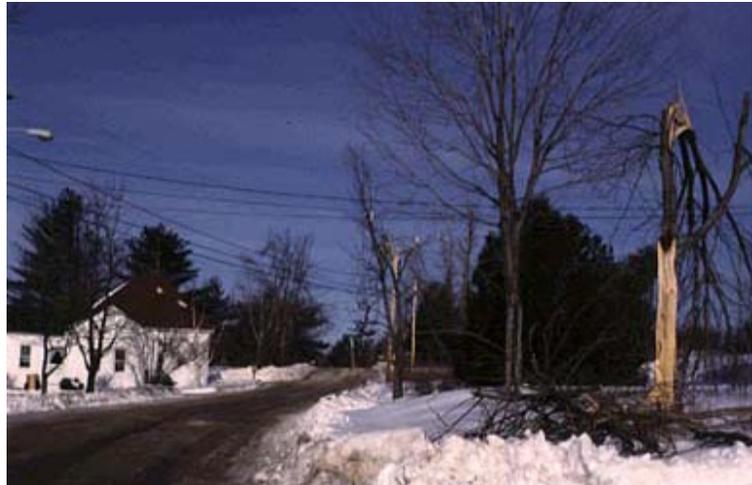
a. Minot at 330 ft (photo Mulherin).

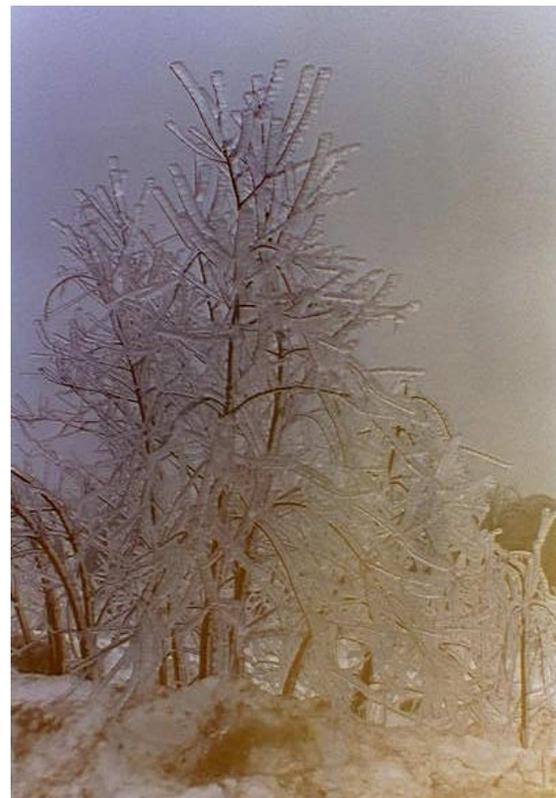
b. Gray at 400 ft (photo John Jensenius, NWS).

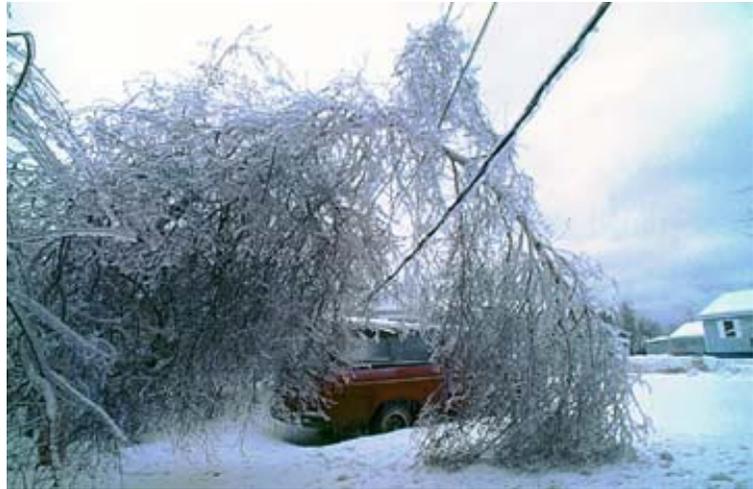
c. Near Augusta (photo Central Maine Power).

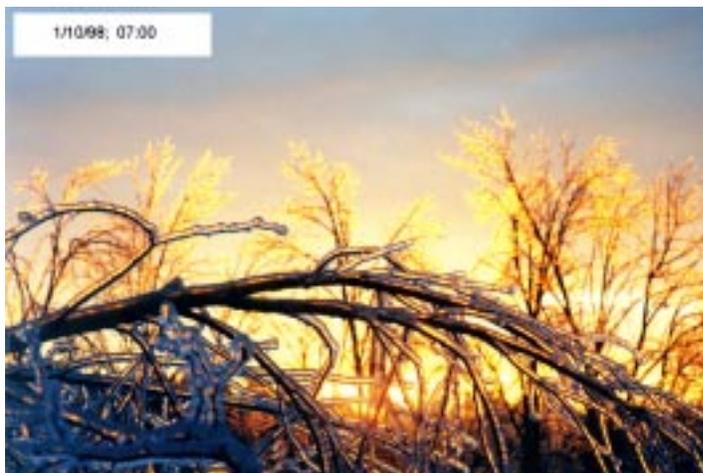
d. Between Mount Vernon and Vienna at 500 ft (photo Bill Duffy, Geomatics).

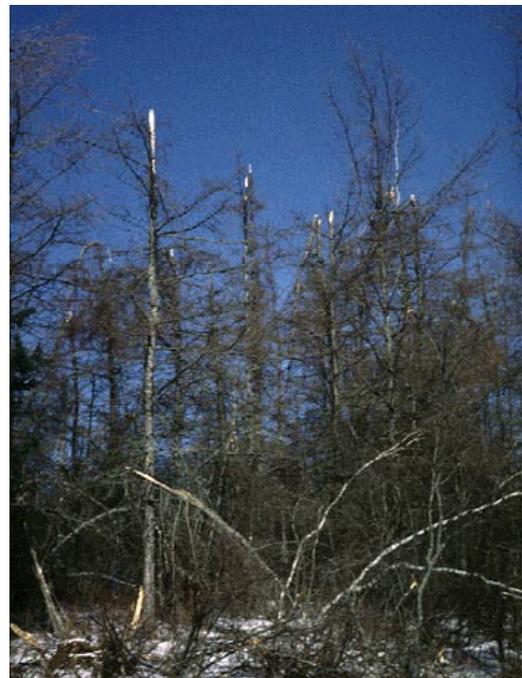
e. Near Deblois (photo Jones).

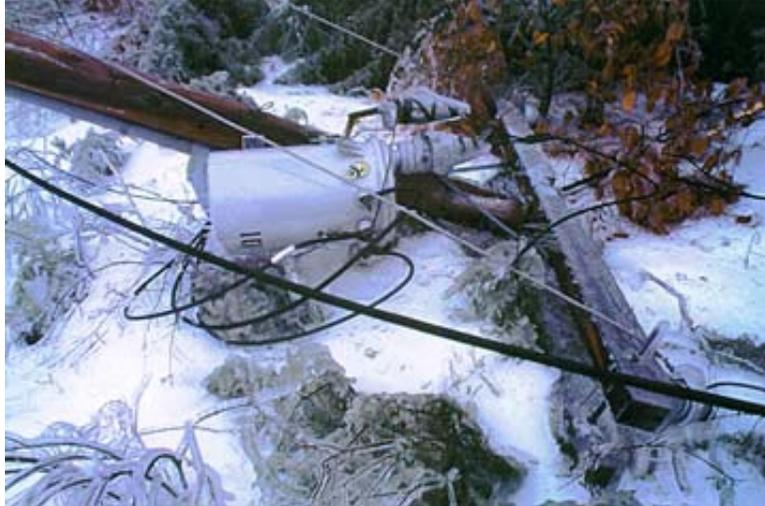
a. Near Augusta, Maine (photo Central Maine Power).

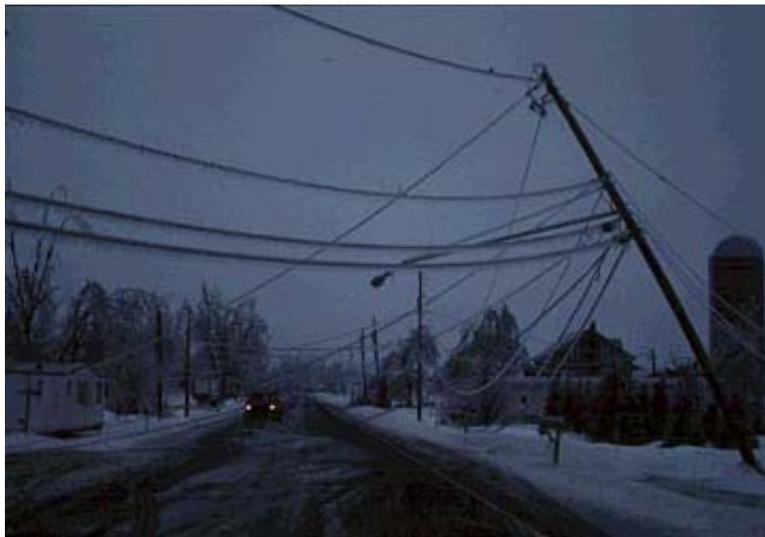
b. Champlain, New York (photo Mulherin).

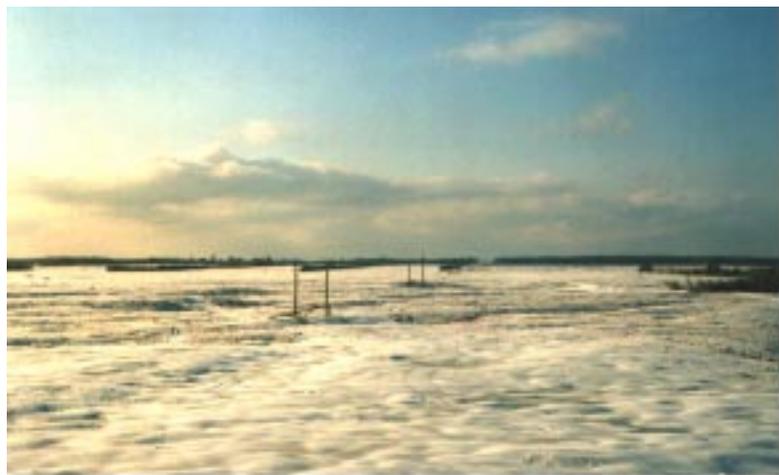
Figure 17. Six miles of Bangor Hydro's 115-kV H-frame transmission line in the blueberry barrens east of Deblois failed under the ice load (photo Larry Billings, Bangor Hydro).

In Maine, Bangor Hydro's 115-kV line east of Deblois failed (Ken Miller, Larry Billings, Jeff Fenn, George Baker, Bangor Hydro, personal communication). That radial line, built in 1955, is the only line serving the Calais region in eastern Maine. The cascade failure of six miles of H-frame structures (Fig. 17) was initiated by a single conductor breaking from the heavy (~1 in.) ice load. The cascade was stopped at one end by a corner tower, and at the other by a long span that absorbed the load. Power was restored to the region, while a new line was under construction, by routing electricity along existing 33-kV lines, and using local generation (diesel and wood). There were a number of problems in CMP's power transmission system, primarily in its 34-kV system, with only a few problems in the 115-kV system (Tom Bragg, CMP, personal communication). The 34-kV lines are particularly vulnerable to tree damage, because the wires are on relatively short poles (35 to 40 feet tall), and the lines are in narrow right-of-ways or near the edge of wider right-of-ways for 115-kV lines. As redundancy is incorporated in the system, many of the problems caused no outages. Other outages, generally limited to four hours, occurred during switching or sectionalizing of a line. There were, however, a

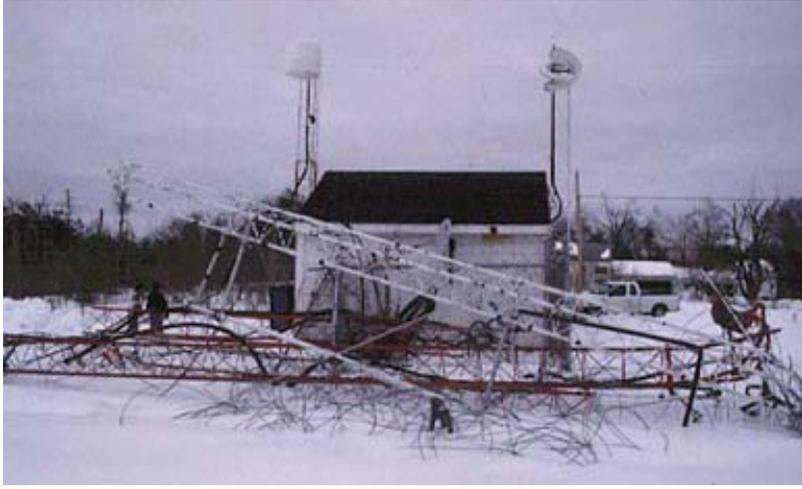
a. WLNH tower in Laconia, New Hampshire (photo Mulherin).

Figure 18. Communication tower damage.

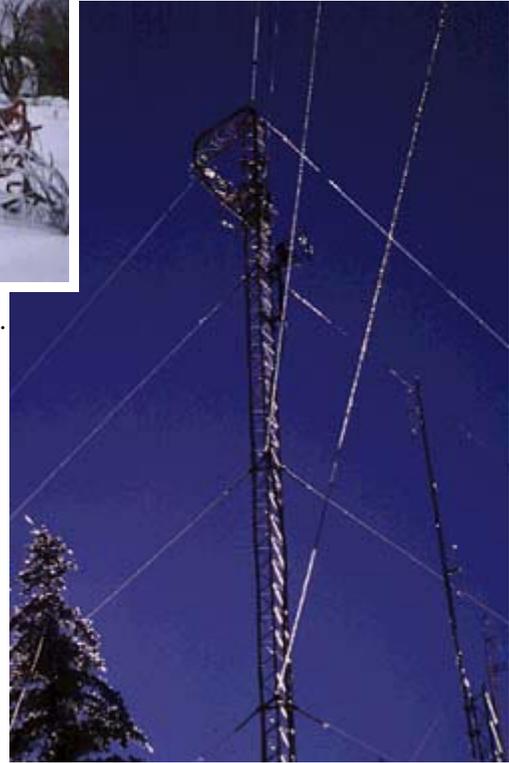
b. WEZQ tower in East Eddington, Maine (photo Mulherin).

WEZQ-FM	E. Eddington, ME N44-45-30 W68-34-00	140	1000	Guys failed, top half of tower fell
WKZS-FM WHTH-FM backup New Gloucester Fire Dept	New Gloucester, ME N43-57-10 W70-17-40	500	500	Top half of tower fell; ice on guys estimated 4 to 5 in. thick
WLNH-FM	Laconia, NH N43-35-50 W71-29-50	245	850	
WCIZ-FM	Watertown, NY N43-57-20 W75-50-25		1000	
WTNY-AM	Watertown, NY N43-56-40 W75-56-50		445	
WUZZ-AM	Watertown, NY			
Four 2-way towers	Watertown, NY N43-58 W75-55			
UNCONFIRMED TOWER FAILURES				
Cellular tower	Watertown, NY

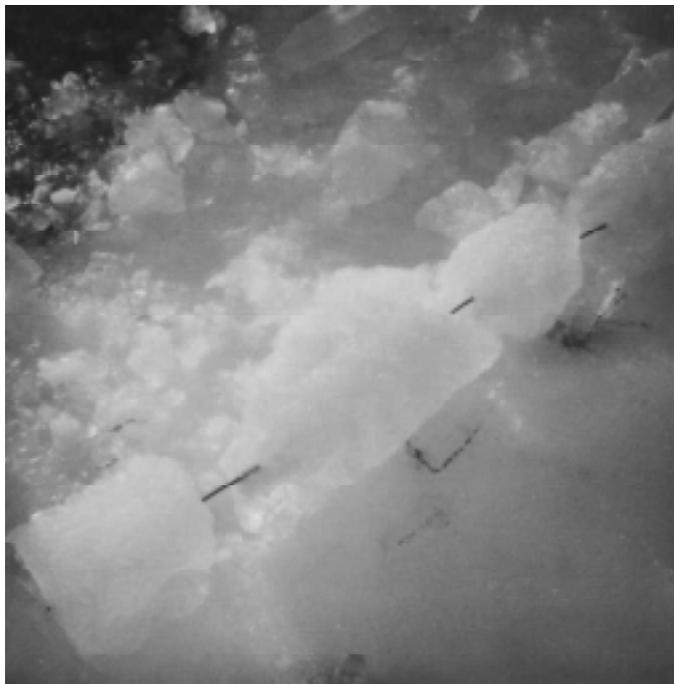
a. ~5 in. on a 0.25-in. guy on the summit of Cadillac Mountain (photo Robert Parker, U.S. Coast Guard).

between 4 and 5 in. This estimate is conservative. If the ice is not glaze ice, or if the accretion cross section is oval, then the equivalent uniform thickness is actually less. It is likely that ice that accreted on structures and trees on some mountaintops was from both freezing rain falling from clouds that were in the warm air layer, and in-cloud icing, from windblown supercooled droplets in low clouds in the cold air layer. The relative contributions to the ice load from the low-level clouds and from the rain can only be estimated because cloud liquid water contents are not measured except at a few sites (at Mount Washington Observatory in supercooled clouds, for example) and by research aircraft. From a database of measurements from research aircraft we have determined the average liquid water content of supercooled stratus-type clouds to be about 0.15 g/m^3

(Jones and Ryerson, unpublished). With an average freezing-rain rate of 1 mm/hr in this storm, and an assumed wind speed of 8 m/s at the summit of Cadillac Mountain (about 50% higher than was measured at weather stations, to take topographic effects into account), we estimated a flux of water from the supercooled cloud droplets that is about twice the flux of water from the freezing rain. The mass of ice that accretes on an object from cloud droplets depends not only on the flux of water, but also on the diameter of the droplets and the size of the object. Those factors, along with the wind speed, determine the collision efficiency of the droplets with the structure (Finstad et al. 1988). The accreted ice mass also depends on the density at which the ice accretes, because that determines the size of the accretion, which feeds back into the collision efficiency. The ice density is determined by the cloud liquid water content and air temperature as well as the previously mentioned factors (Jones 1990). The additional flux of water from clouds in the cold-air layer in this storm is likely to have been the major contributor to the accreted ice load on mountaintops that were high enough to be in the low-level clouds throughout the storm and low enough to be below the warm air layer. The contribution to the ice load on trees and structures on the sides of mountains at these elevations would be less pronounced because of the decreased topographic effect on wind speed.

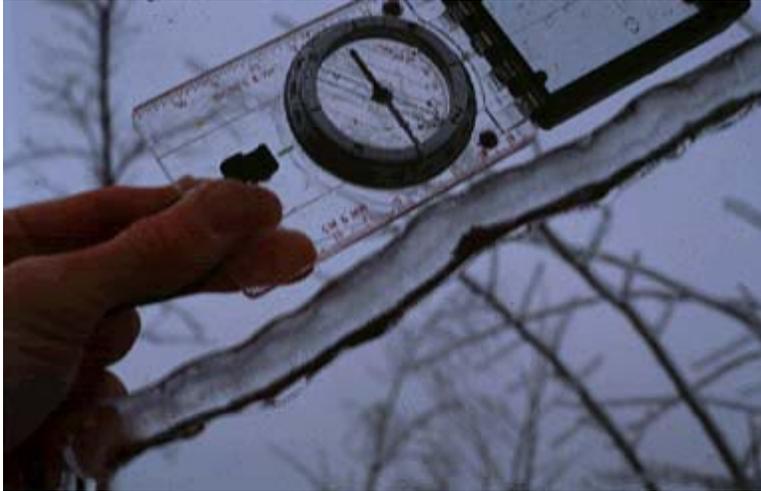
b. 0.2 in. at 100 ft in Swanton, Vermont, at 8:50 a.m. on January 8 (photo Mulherin).

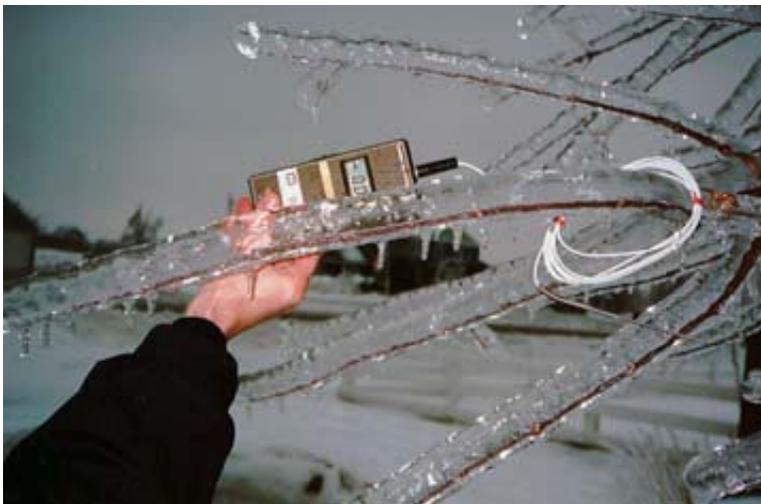
c. 0.7 in. at 110 ft near Rouses Point at 9:20 a.m. on January 8 (photo Jones).

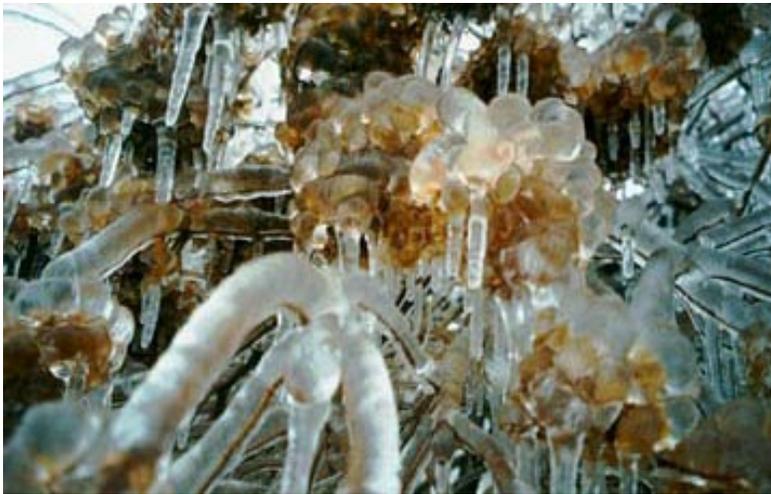
e. ~0.6 in. at 1300 ft in New London during the storm (photo Kathy Lowe-Bloch).

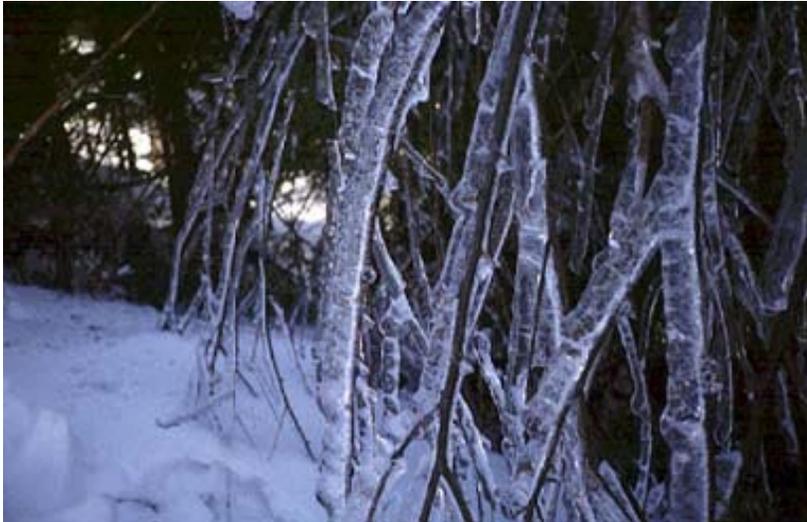
f. 0.5 in. remaining at 900 ft in Ossipee three weeks after the storm (photo Jones).

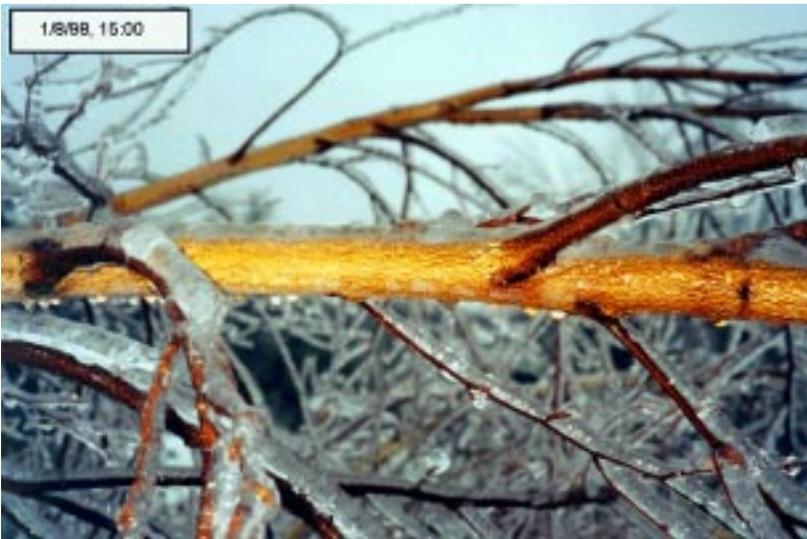
g. ~0.2 in. at 500 ft between Vienna and Mount Vernon, Maine, on January 8 (photo Bill Duffy, Geomantics).

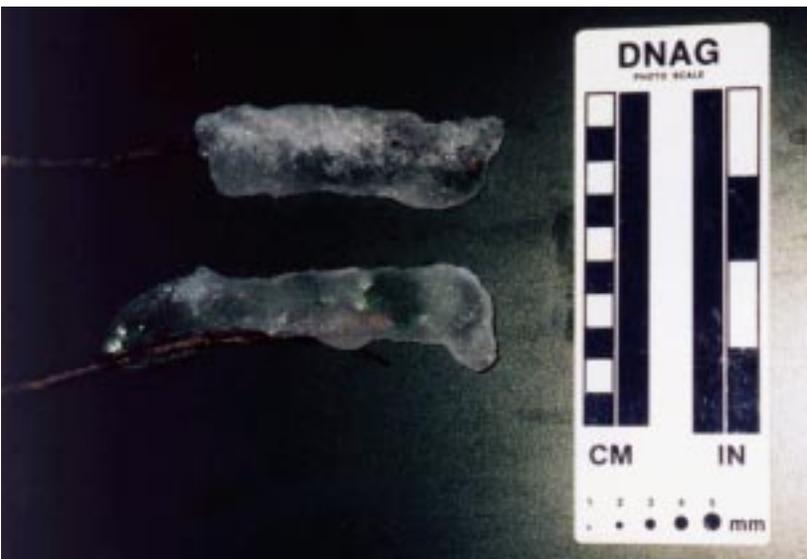
h. ~0.3 or 0.4 in. at the same location, preserved by being buried in the snow after the storm (photo Bill Duffy).

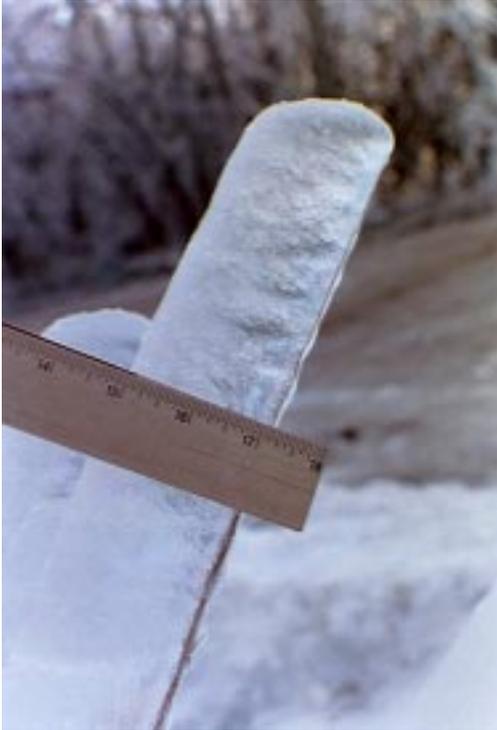
i. ~0.7 in. at 400 ft in Gray, Maine (photo John Jensenius, NWS).

tion) results in ice loads of 0.7 and 1 in., respectively. Royce Benedict and John Farr at the Berlin Fish Hatchery (1640 ft) in New Hampshire estimated the diameter of the round ice accretion on the fishing lines over the ponds in [Fig. 22k](#) to be 3/4 in. Including the icicles in the load and ignoring the small diameter of the fishing line, results in an ice load estimate of about 0.4 in. The photo in [Fig. 22l](#) of the ice that accreted on the conductor of the Bangor Hydro transmission line

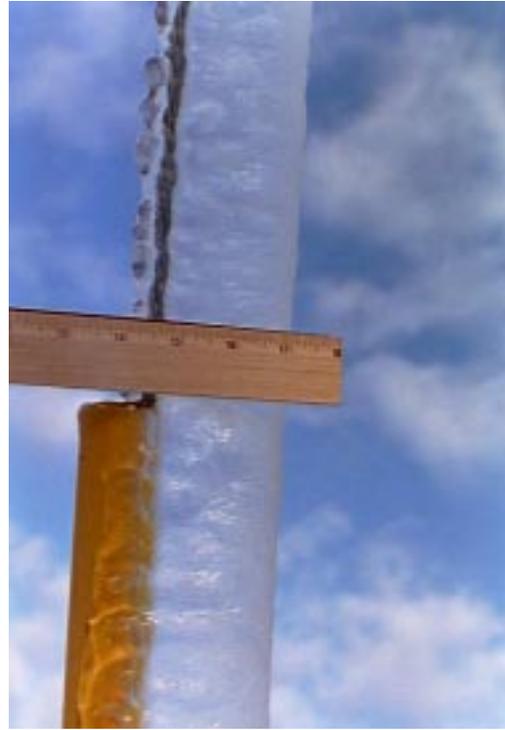
j. ~1 in. at the same location (photo John Jensenius, NWS).

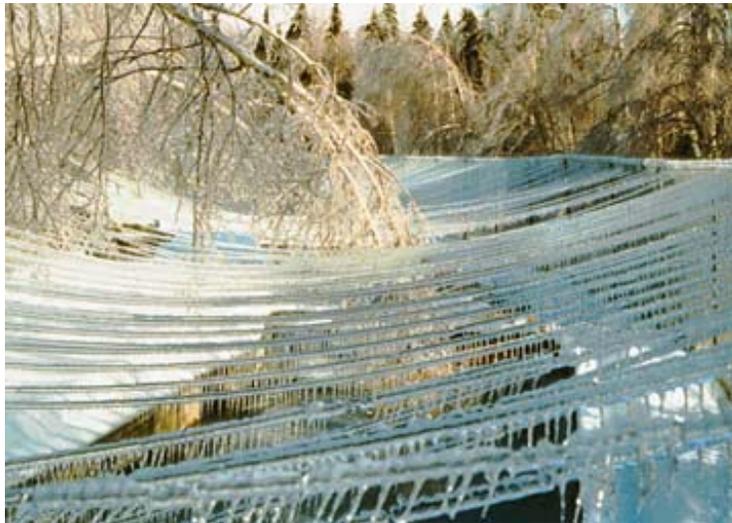
k. ~0.4 in. at 1640 ft near Berlin (photo Wayne Paschal, Berlin Fish Hatchery).

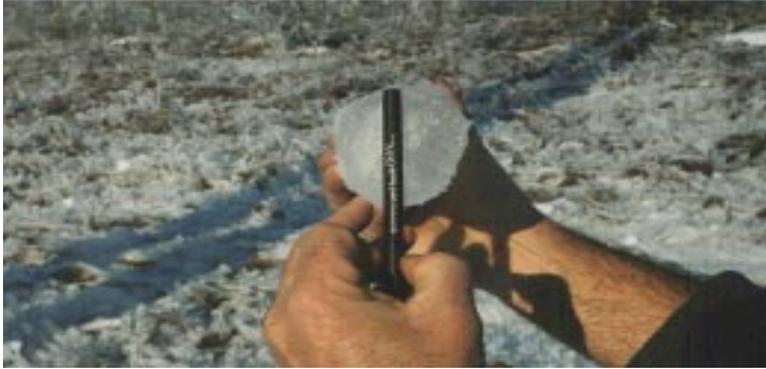
l. ~0.9 in. accreted on a conductor at about 200 ft east of Deblois, Maine (photo Larry Billings, Bangor Hydro).

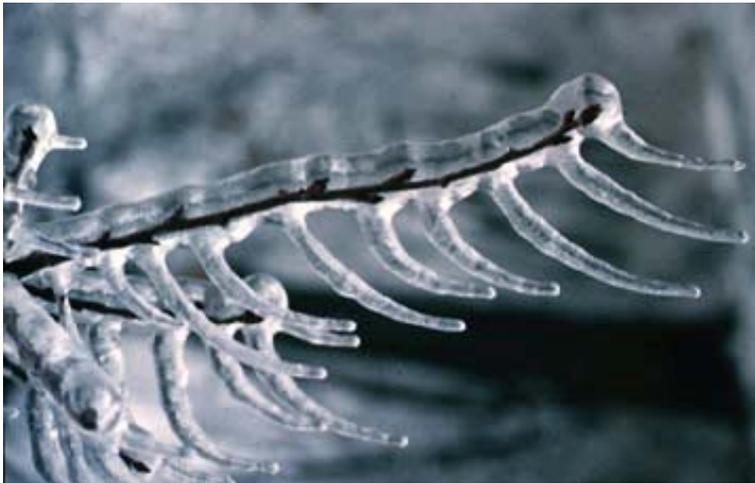
m. ~0.7 in. on a twig in Burlington, Vermont (photo Gary Salmon, VD-FPR).
