ERDC/CRREL TR-05-9

Placing Antifreeze Concrete at Grand Forks Air Force Base

Charles Korhonen and Peter Semen

April 2005

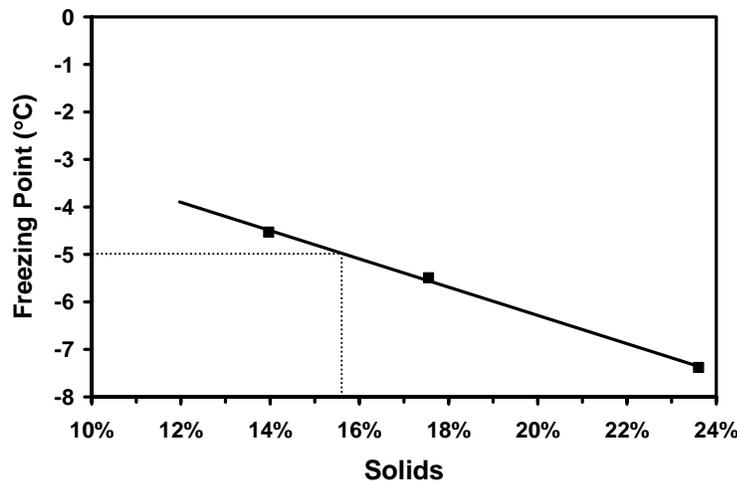
Figure 1. Relationship between the concentration of solids contributed by the admixtures to the water in the concrete and the freezing point of freshly mixed concrete made with admixture combination MB IV. (From Korhonen et al. 2004.)

(Note that less than the suggested amount of corrosion inhibitor was used. Without this adjustment, the solids content of the mixing water would have been higher than the 15.7% needed to create a –5°C freezing point, as shown later in

Figure 1.) Immediately following this, the accelerator was similarly pumped into the truck and mixed. At that point the concrete, having an apparent w/c ratio of 0.38 (based on water metered into the mixture, water in the admixtures, and expected water in the aggregates divided by the weight of cement in the mixture) and a fair amount of plasticizer on board, should have had some slump. It had no slump. In fact, steam was noticed wafting out of the drum, which signaled that the cement might be suddenly hydrating. We quickly dumped numerous pre-weighed pails of cold water into the drum to re-establish some slump and to cool down the mix. At that point the apparent w/c ratio had increased to 0.497, which was quite a bit higher than the target 0.409 and certainly higher than the 0.45 permitted in airfield pavements, so no more water was added and the concrete was tested. The resulting slump, air content and freezing point—6.5 mm, 3%, and -4.3°C , respectively—were unsatisfactory, and the concrete batch was discarded.

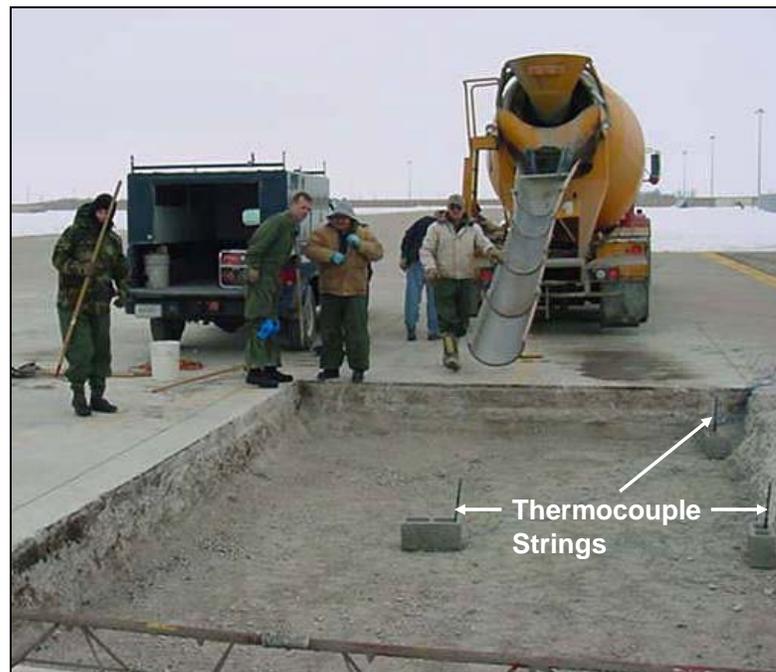
Figure 2. Repair section instrumented with thermocouples.

Figure 2 shows the repair section prepared to receive the antifreeze concrete. It was an unreinforced concrete pavement located in a non-trafficked area of a parking apron off the southwest end of the runway. It measured approximately 4.25 m wide by 7 m long by 0.6 m deep. Three locations were instrumented with thermocouples at three depths: 25 mm below the finished surface, at the center of depth, and directly on the base course. As shown, the three thermocouple strings were located at the edge, corner, and center of the slab. The edge and corner strings measured temperatures about 25 mm inboard of the existing concrete. All thermocouples were attached to a datalogger set to record at half-hour intervals.

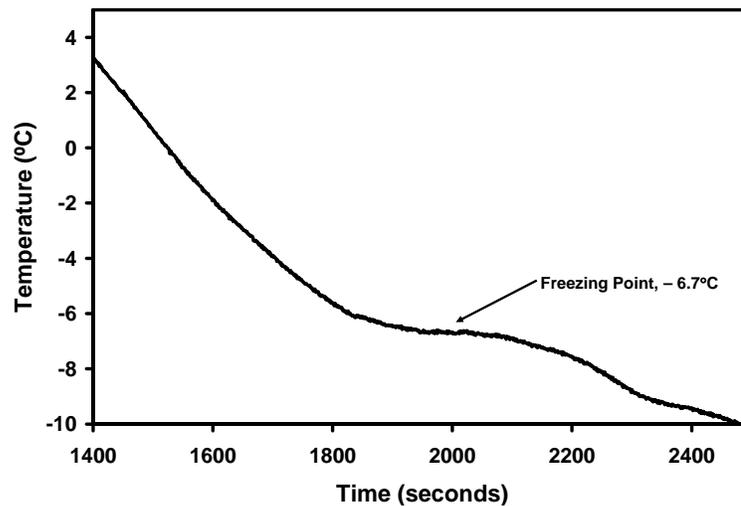
Figure 3. Freezing points determined by placing 50.8- by 101.6-mm cylinders of concrete into a picnic cooler containing dry ice. The freezing is identified as the temperature where the slope of the cooling curves flattens out. This is from one cylinder from Truck 1.

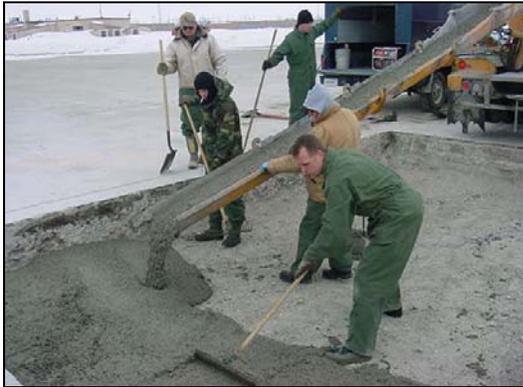
Figure 4. Placing and raking intermediate layers of concrete.

The concrete was layered truckload by truckload into the repair section. Thus, the work of finishing the concrete consisted of placing each layer with the truck's chute, raking it into final position (Fig. 4), and consolidating it with an internal vibrator. The top layer was leveled and compacted with a vibratory screed (Fig. 5). Because the concrete was rapidly setting, the surface was immediately finished with a magnesium bull float (Fig. 6) to embed aggregate and to further smooth it. Following the floating process, the surface was broomed (Fig. 7), and then the slab was edged (Fig. 8) and covered with 25-mm-thick insulation blankets (Fig. 9), not so much for thermal protection but to minimize evaporation, as the day was windy. The slab was sprayed with a curing compound the following morning when the blankets were removed.

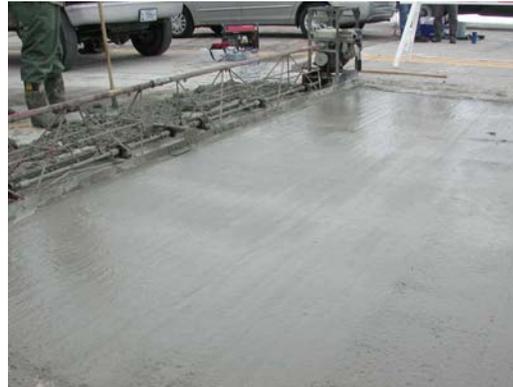
Figure 5. Screeding the top layer of concrete.

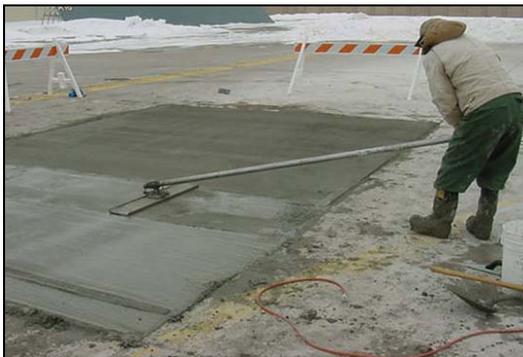
Figure 6. Floating.

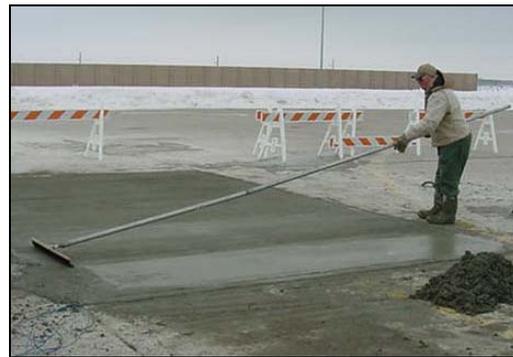
Figure 7. Brooming.

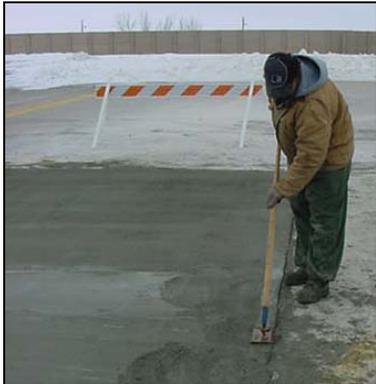
Figure 8. Edging.

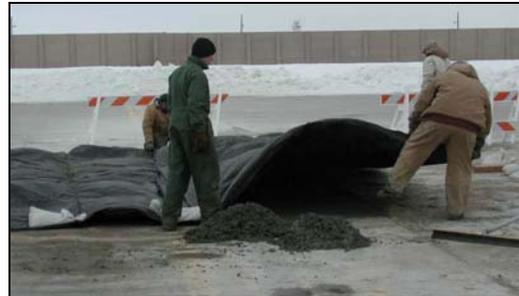
Figure 9. Laying insulation blankets in the wind and holding them down with sand bags.

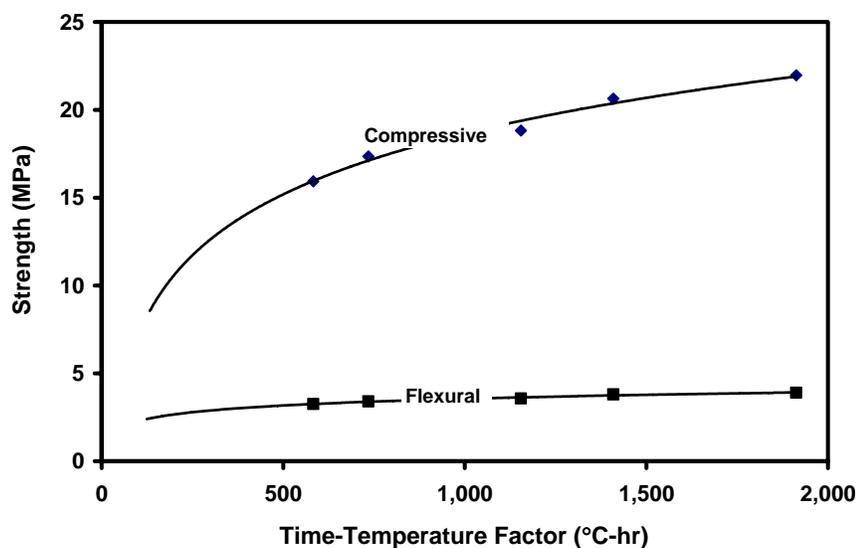
Figure 10. Maturity curve based on compressive strengths and time-temperature history from the cylinders cast during placement of the slab. The flexural strength is estimated.

To estimate the compressive strength developed in the slab over time, we compared strength data from test samples made from the third truckload of concrete to maturity data recorded by the datalogger. The compressive data were obtained from fifteen cylinders (150 by 304 mm) that were cast and stored in insulated plywood boxes placed near the repaired section. Two of these cylinders were instrumented with thermocouples embedded at their centers. All cylinders were transported to a commercial laboratory 24 hours later, stripped from their molds, and, except for three cylinders that were immediately tested for strength, placed in water baths maintained at about 20°C. Table 4 shows the resulting strength and maturity data obtained from the thermocouples embedded in the cylinders, along with corresponding estimated flexural strengths. The strength developed by the cylinders does not directly represent the strength developed by the slab because strength gain is a function of both the curing time and the curing temperature of the slab, and the temperature of the cylinders was always different from that of the slab. Thus, the Figure 10 maturity curve was developed from the compressive strength data and time–temperature history obtained from the instrumented cylinders. The slab’s strength was then estimated by plotting the time–temperature history recorded from the slab for each day onto the maturity curve.

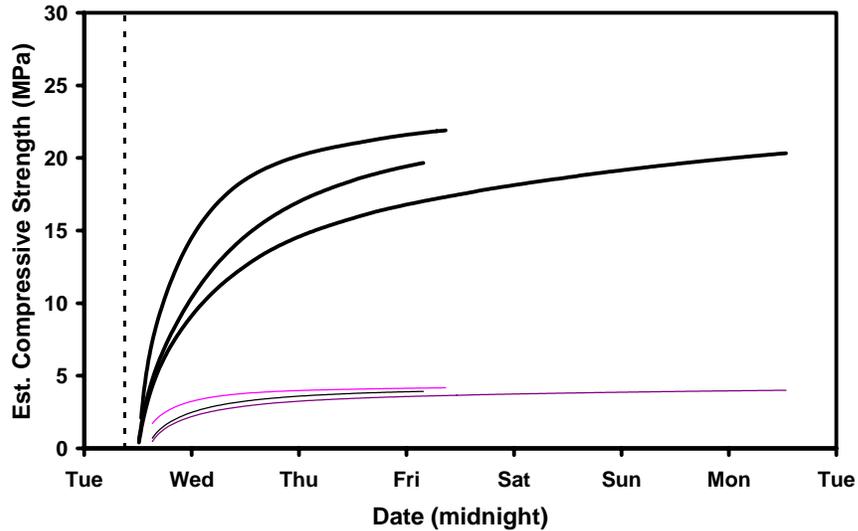
Figure 11. Predicted strength using the maturity curve from the cylinders and the time–temperature history from the top, bottom, and corner thermocouple locations. The top three lines show compressive strength; the bottom three lines show flexural strength.

The resulting strength development curves for three of the nine thermocouple locations in the slab are shown in Figure 11. As can be seen, strength developed rapidly over the first nineteen hours before the insulation blanket was removed at approximately 6:00 a.m. on Wednesday morning. At that time the warmest part of the concrete, the top 25 mm at the center of the slab, had developed a compressive strength of 17 MPa, whereas the bottom of the concrete, that in contact

with the substrate, had developed 13 and 11 MPa at the center and corner, respectively. Meanwhile, the flexural strength at the bottom of the slab was between 2.6 to 3.6 MPa, depending on location.

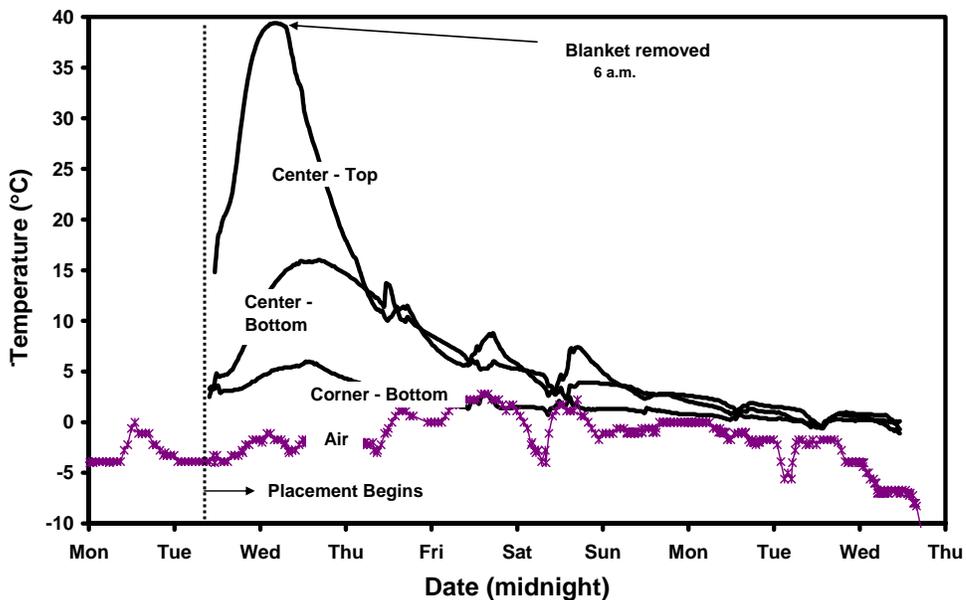
Figure 12. Temperatures from three locations in the slab and the ambient air from February 23 through March 3.

Figure 12 shows the temperatures of the three slab locations shown in Figure 11 plus that of the ambient outdoor air. In general, the entire cross section of concrete, from the top to the bottom, continually warmed up from when it was placed until the insulation blanket was removed, when it began to cool down. The top 25 mm of concrete increased from its initial 15°C placement temperature at noon on February 24 to nearly 40°C by 6:00 a.m. on February 25. Almost immediately thereafter, this near-surface layer of concrete cooled abruptly when exposed to the windy –2°C air, when the insulation was removed. The bottom locations also warmed up, but not as dramatically because they were in contact with frozen ground, estimated at –4°C.* (Typically, concrete is never placed on

frozen ground, but with antifreeze concrete that is now possible.) At the slab's center, the concrete quickly cooled off from its 17°C placement temperature to about 3°C when it came in contact with the ground, but, almost as quickly, it began to heat up again. It reached approximately 16°C before it began to feel the effects of the insulation being removed at 6:45 p.m. on Wednesday, February 25. The corner section, influenced by both the cold ground and two sides of the existing concrete, warmed from 3°C to only 6°C by 4:15 p.m., Wednesday, before it began to cool. The entire slab continued to cool, becoming essentially isothermal at 1.3°C at 2:15 p.m. on Tuesday, March 2, before ending up at -0.5°C at 10:45 a.m. on Wednesday, March 3, when the datalogger was disconnected.

Part of the reason that the concrete remained warm so long was that it was covered with insulation during the first nineteen hours. During that time the top surface of the slab had warmed up to nearly 40°C before it was suddenly exposed to freezing air. ACI (2004) warns against removing thermal protection too soon to avoid crack-inducing thermal strains between the inside and outside surfaces of the slab. To avoid such cracks, ACI recommends that the surface temperature of a slab 300–900 mm thick not be allowed to drop more than 22°C during any 24-hour period. As Figure 12 shows, the top surface of this slab, which was 610

mm thick, dropped approximately 26°C in the 24 hours after the insulation was removed. As would probably occur for any concrete structure, the slab cracked (Fig. 13). In fact, we believe that it cracked during our inspection between 8:00 and 9:00 a.m. the morning following concrete placement, about 3 hours after the insulation was removed. The crack could probably have been avoided if the insulation had been left in place another day.

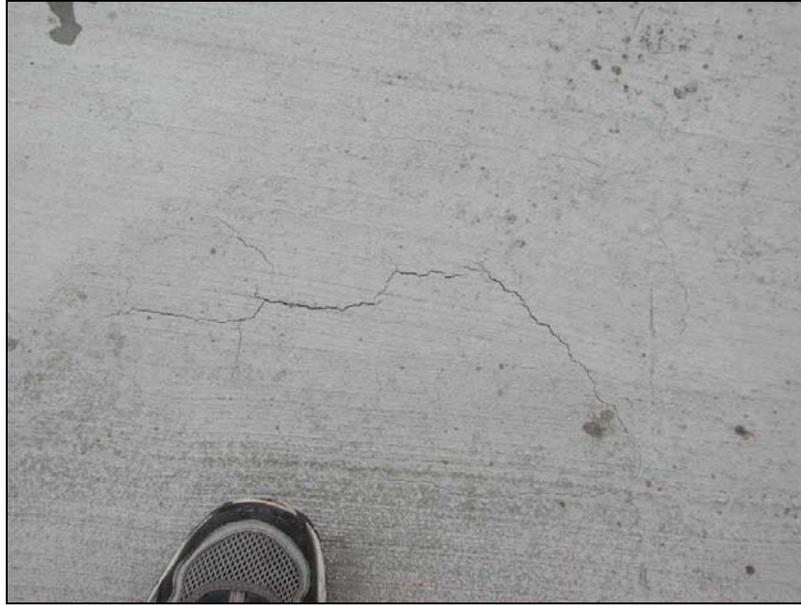
Figure 13. Crack that developed in the concrete approximately 3 hours after the insulation blanket was removed.
