ERDC/CHL TR-05-11

*National Shoreline Erosion Control Development and Demonstration Program
(Section 227)*

Geology and Historical Evolution of Sheldon Marsh Nature Preserve, Lake Erie, Ohio

Final report

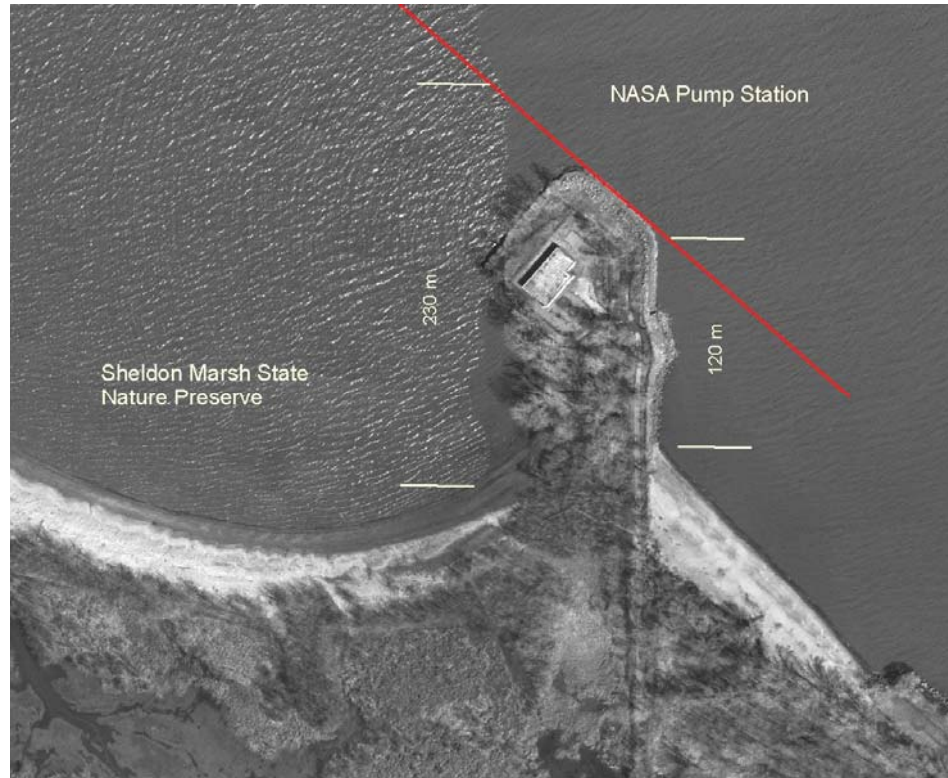
Figure 3. NASA pump station and beach at Sheldon Marsh, 12 April 2003 (north is to the top). The fact that beach has retreated on both east (updrift) and west (downdrift) sides indicate how little sediment is available in this system. Red line marks 1937 shoreline position (photograph courtesy of Erie County Auditor's Office)

Up to the late 1930s, the sand barrier at Sheldon Marsh extended east to Sawmill Creek. As long as most of the shore remained unarmored, it eroded relatively uniformly, and the shoreline was straight. Bray (1988) documented that once the pump was armored, the shoreline west of the pump began to retreat. To the west, most of the Cedar Point spit was privately or commercially owned. In 1937, its shore was still natural, but by 1956, most of it was fronted by rock shore protection structure, which anchored the position of the shoreline. However, at Sheldon Marsh, the beach remained unprotected, and over time, the overall feature became narrower as sand was lost from the system (discussed later). In November 1972, a rise in lake level coupled with a major northeast storm caused several 15-m- (50-ft-) wide breaches in the northwest end of the barrier. This separated the remaining (eastern) portion of the barrier from the Cedar Point spit (Figure 4). Thereafter, the entire beach retreated rapidly. By 2003, the beach had retreated 230 m (750 ft) immediately west of the pump (Figure 3).

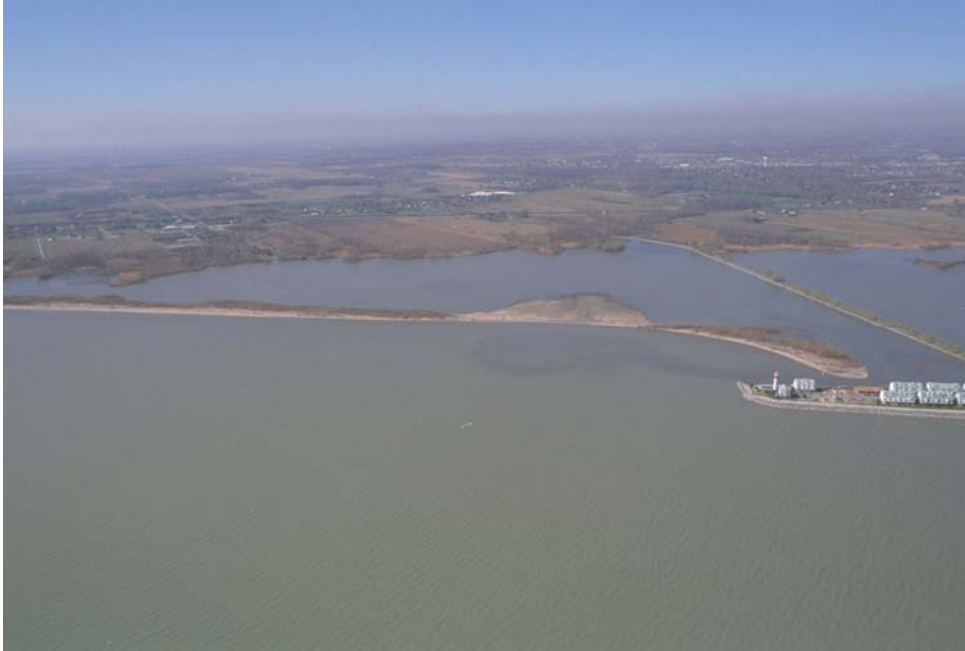
Figure 4. View looking south of west half of Sheldon Marsh, 13 April 1999. Armored spit on right is now easternmost end of Cedar Point Peninsula, but at one time, beach was continuous (photograph courtesy of U.S. Army Engineer District, Buffalo)

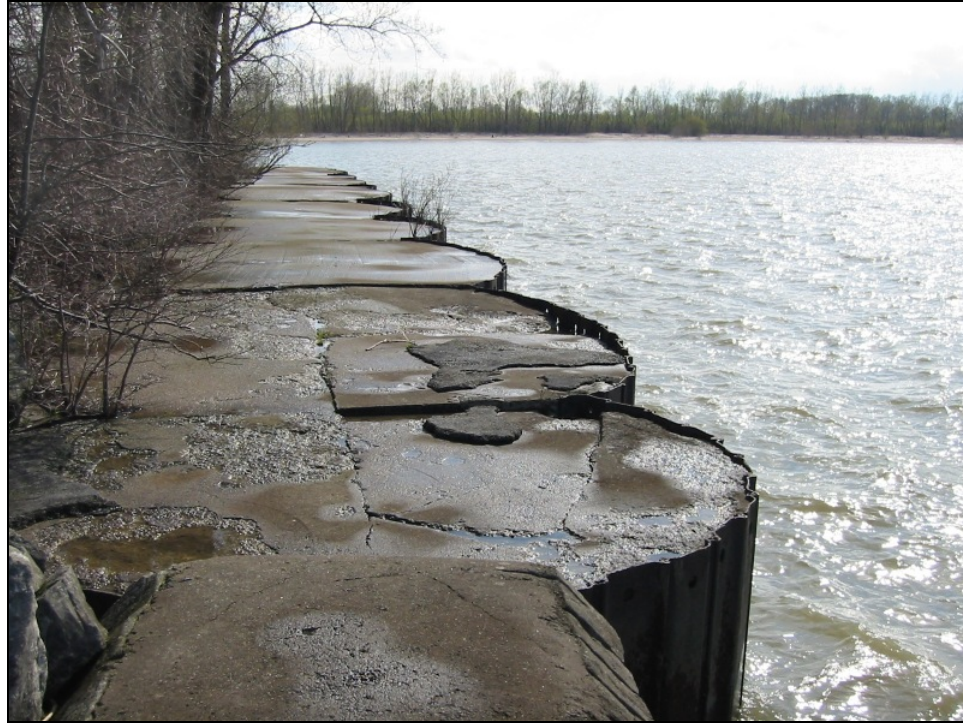
Figure 5. West side of NASA pump facility, 27 April 2005. Barrier beach at nature preserve is in background

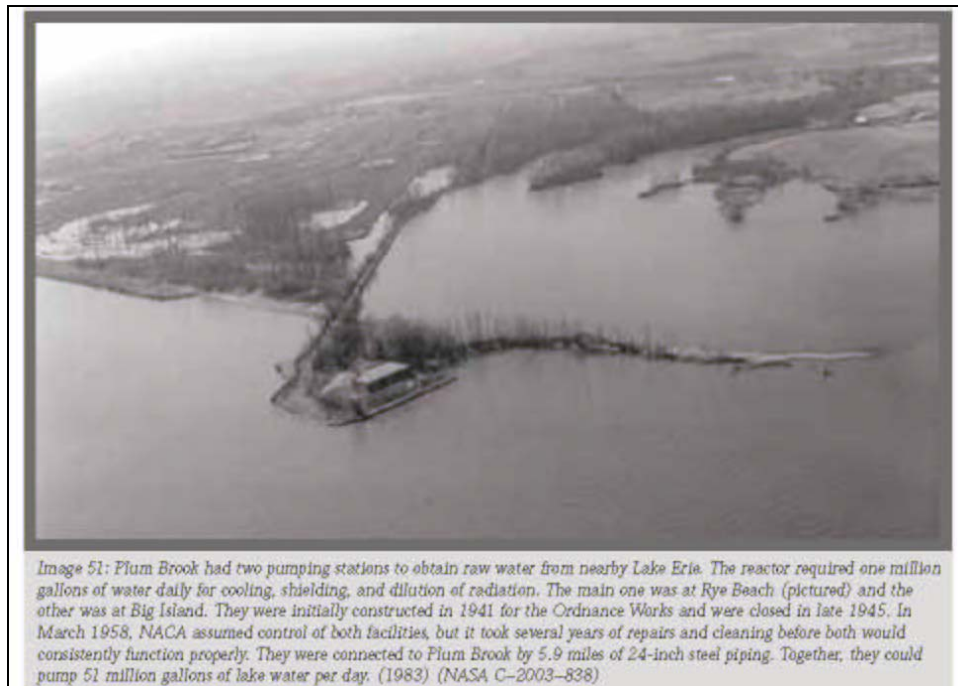
Figure 6. Pump station located at Sheldon Marsh. NASA photograph dated 1983 (from Bowles and Arrighi (2004), Image 51)

Image 51: Plum Brook had two pumping stations to obtain raw water from nearby Lake Erie. The reactor required one million gallons of water daily for cooling, shielding, and dilution of radiation. The main one was at Rye Beach (pictured) and the other was at Big Island. They were initially constructed in 1941 for the Ordnance Works and were closed in late 1945. In March 1958, NACA² assumed control of both facilities, but it took several years of repairs and cleaning before both would consistently function properly. They were connected to Plum Brook by 9.5 km (5.9 miles) of 61-cm (24-in.) steel piping. Together, they could pump 51 million gallons of lake water per day. (1983) (NASA C-2003-838).

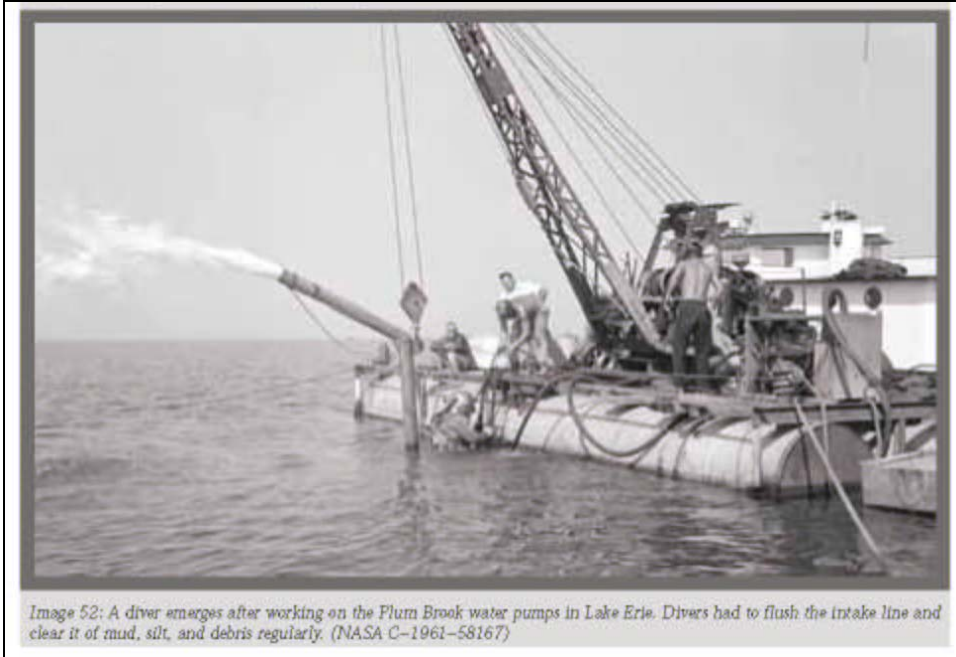
Figure 7. Maintenance work to clear silt and debris from water intake. NASA photograph dated 1961 (from Bowles and Arrighi (2004), Image 52)

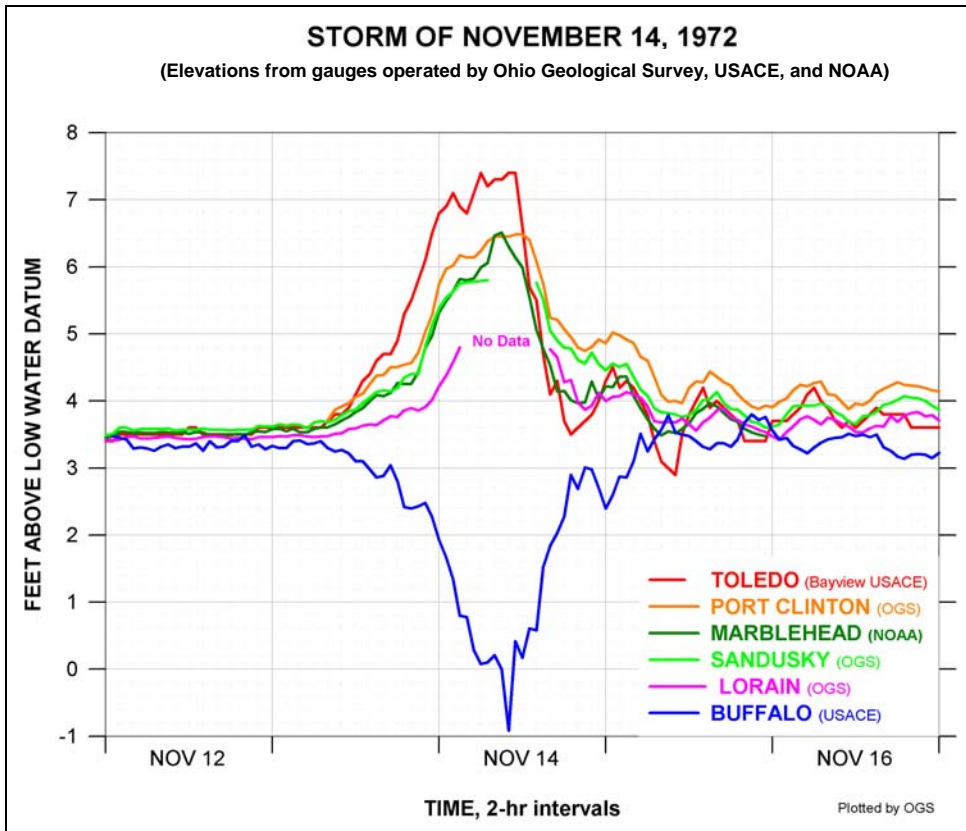
Figure 10. Water levels for 14 November 1972 storm (plot courtesy of Ohio Geological Survey)

The Lake Erie area was hit by a severe storm on the 13th and 14th of November, 1972. A north-northeast wind, which reached a speed of 60 knots, blew for 2 days directly down the long axis of the lake. This wind generated high (12-ft) waves and at the west end of the lake piled up water more than 6 ft above the lake’s average November level (or about 4 ft above the record high lake level set in November 1972). The waves and high water caused damage estimated at \$22 million to the Ohio shore. Northern Ohio was declared a major disaster area by the President, and the U.S. Small Business Administration declared Lucas, Ottawa, Sandusky, Erie, Lorain, Cuyahoga, and Lake Counties disaster areas.

This is the storm that caused several breaches in the barrier at Sheldon Marsh, after which the west end of the beach retreated rapidly.

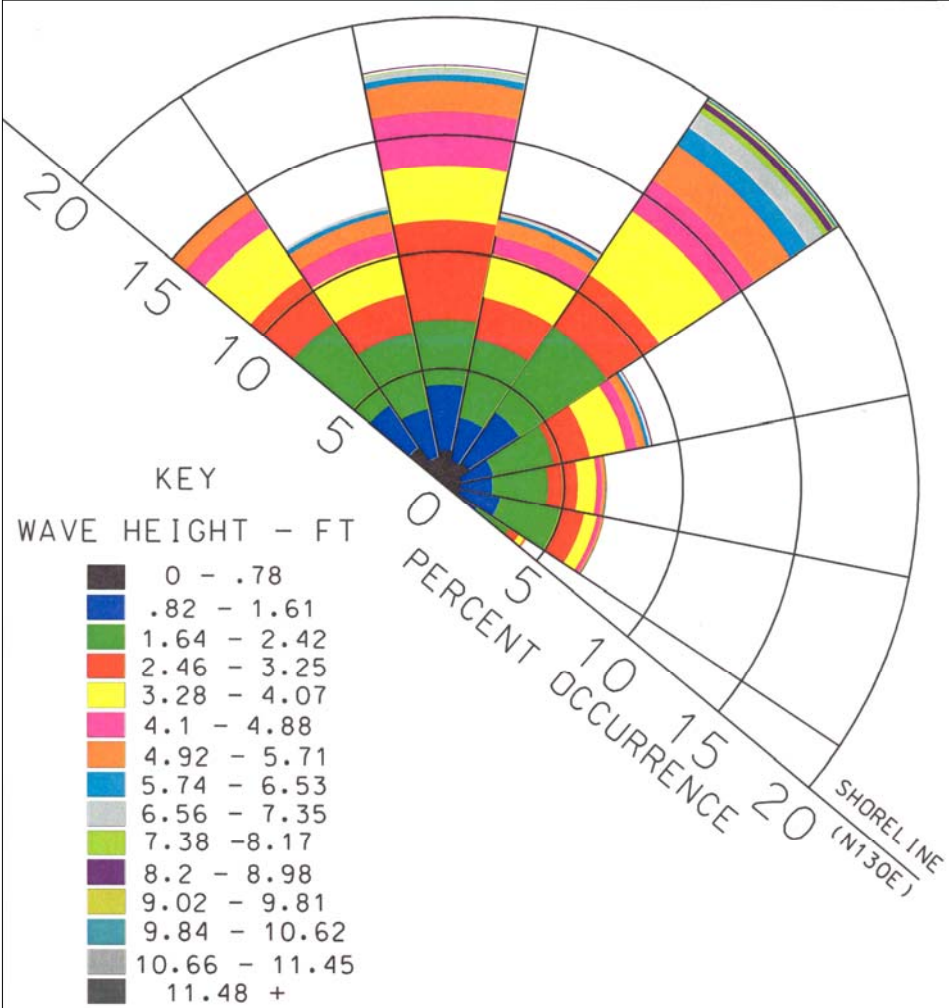
Figure 12. Deepwater wave rose based on WIS sta 6

Driver et al. (1991) presented tables of wave heights, periods, and number of waves within 22.5-deg angle bands. A deepwater wave rose for only waves approaching the shore was developed based on a shore orientation of 130-deg azimuth (Figure 12). More detailed information on wave statistics and modeling to project the waves into shallow water are presented in the reconnaissance report (U.S. Army Engineer District, Buffalo, 2005).

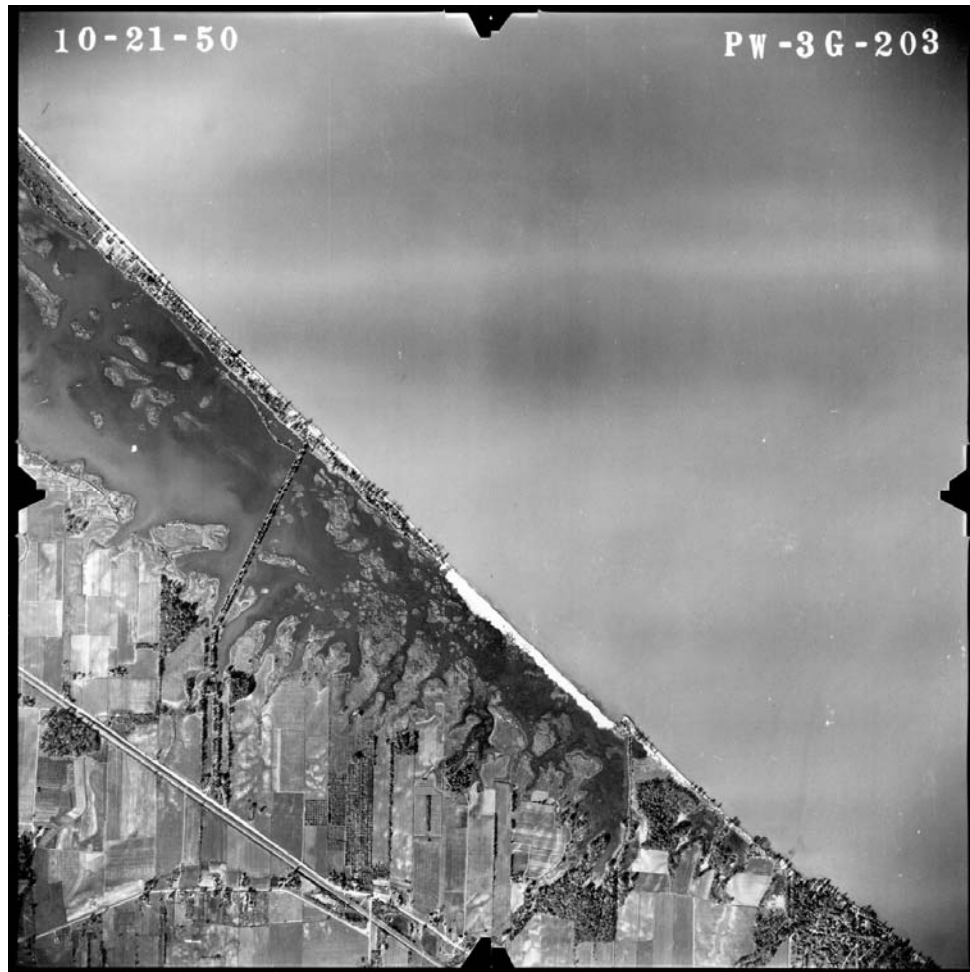
Figure 15. Sheldon Marsh, 21 October 1950. Ten years after pump's construction, beach had already retreated and lost most of its tree cover, to be replaced by washover fans (photograph courtesy of U.S. Army Corps of Engineers' Beach Erosion Board archives)

By 21 October 1950, the beach at Sheldon Marsh was already suffering the erosion that would continue for another five decades (Figure 15). The pump station was built in 1941 at the end of the former Chaussee Road and had been armored. As a result, immediately west of the pump, the downdrift shore had already retreated over 20 m (65 ft). About half of the beach had lost its tree cover, to be replaced by a broad washover apron. To the east (right) of the pump station, the sandy and partly vegetated shore was still almost flush with the station. However, further east it had retreated from a projecting area (armored or naturally more resistant to erosion). This suggests that there was little sediment available in the littoral system, and some of that was diverted by washover into the marsh. In addition, the period from 1940 to 1950 was one of rapidly rising lake level (see Figure 8), which would have made the beach more vulnerable to storm waves.

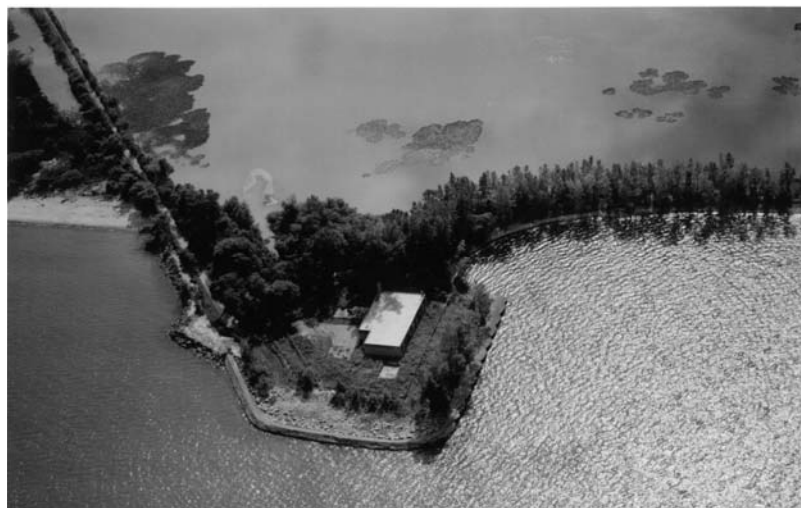
Figure 19. Sheldon Marsh, 1984. Oblique aerial photograph looking approximately south. (NASA photograph 5382, courtesy of NASA Plum Brook Station)

By 1984, the barrier west of the pump station was a narrow ribbon of sand with tree cover (Figure 19). Trees and brush had grown on the overwash fan next to the pump station (visible in the 1972 photograph). The east and west shorelines had retreated a similar degree.

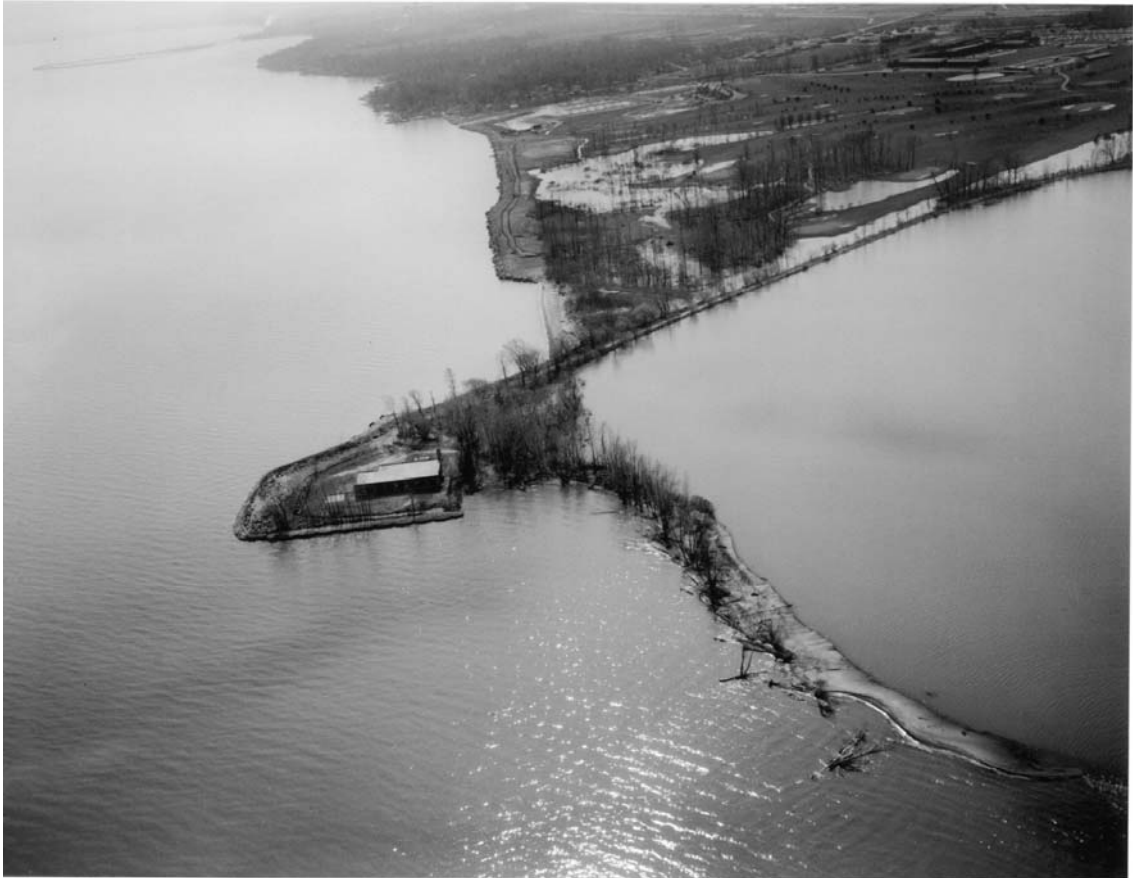
Figure 20. Sheldon Marsh, 1985. Oblique aerial photograph looking east. Trees in water attest to recent shore retreat and damage from storms (NASA photograph 2866, courtesy of NASA Plum Brook Station)

One year later, the beach had fewer trees and had been overwashed in some areas (Figure 20).

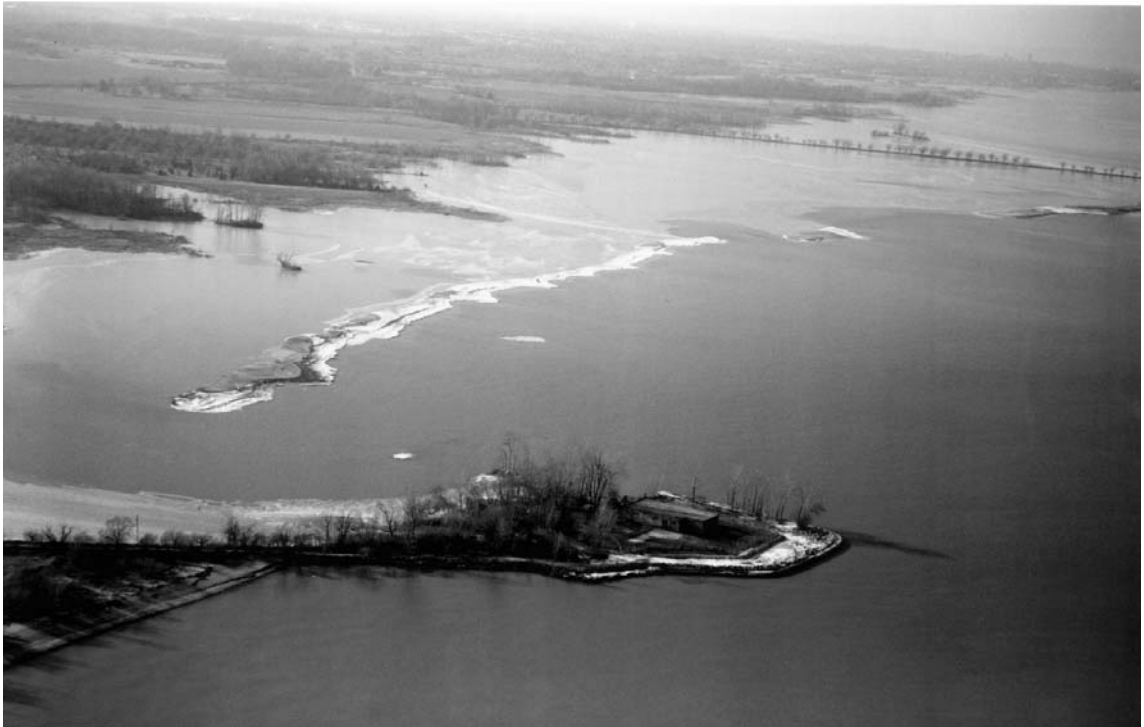
Figure 21. Sheldon Marsh, 1987, view looking southwest (NASA photograph 401, courtesy of NASA Plum Brook Station)

High water and storms had wrought major damage to the barrier by 1987. The beach had been severed from the peninsula where the NASA pump was located, and major areas of overwash had occurred on the western part of the barrier (Figure 21). There were no trees at all on the low remnants of the beach.

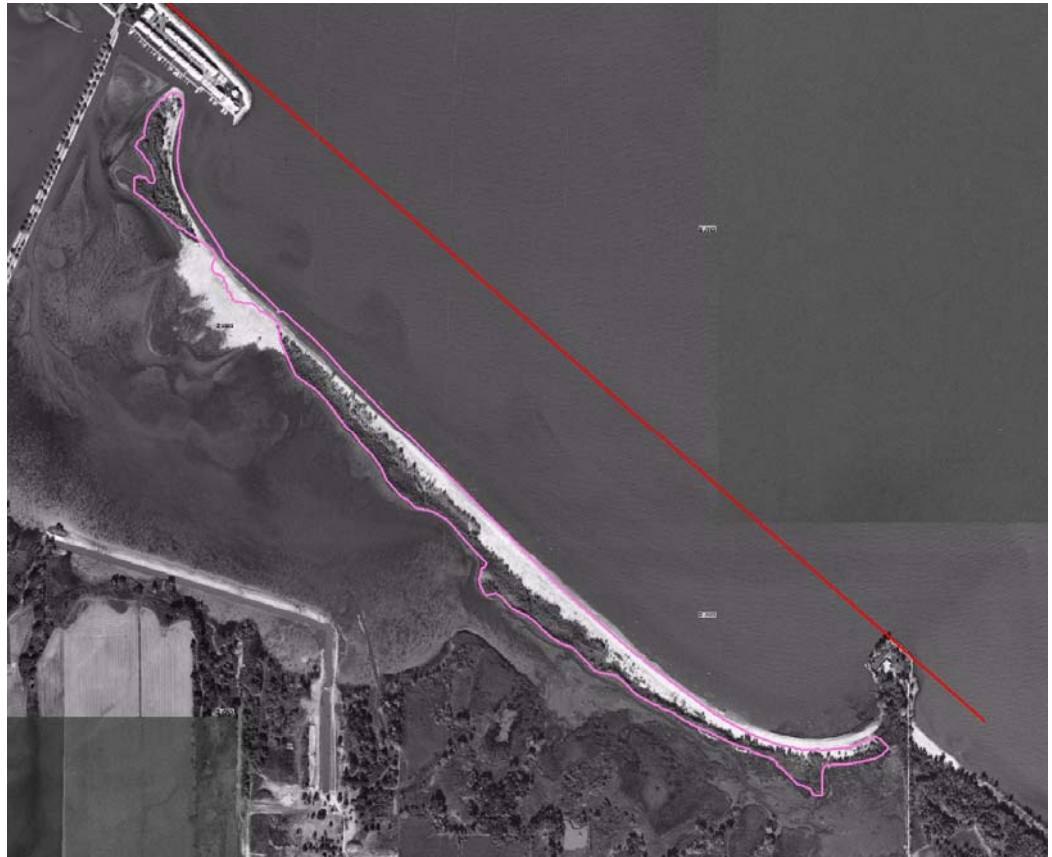
Figure 23. Sheldon Marsh, 10 Oct 2000. Overall position of beach is little changed compared to 1997 (purple outline). Washover occurred between two narrow portions of 1997 beach (north is top). (Digital photographs from U.S. Geological Survey, downloaded from TerraServer USA Web site (<http://terraserver-usa.com/default.aspx>), projected in ArcGIS software)

The beach on 10 October 2000 was in approximately the same position as in 1997, with some advance on the southeast end and retreat on the northwest (Figure 23). The relative stability may have been partly due to lower lake levels following the peaks of the late 1990s. The narrow area at the northwest end of the beach, as noted in the 1997 photograph, was overwashed (Figure 24).

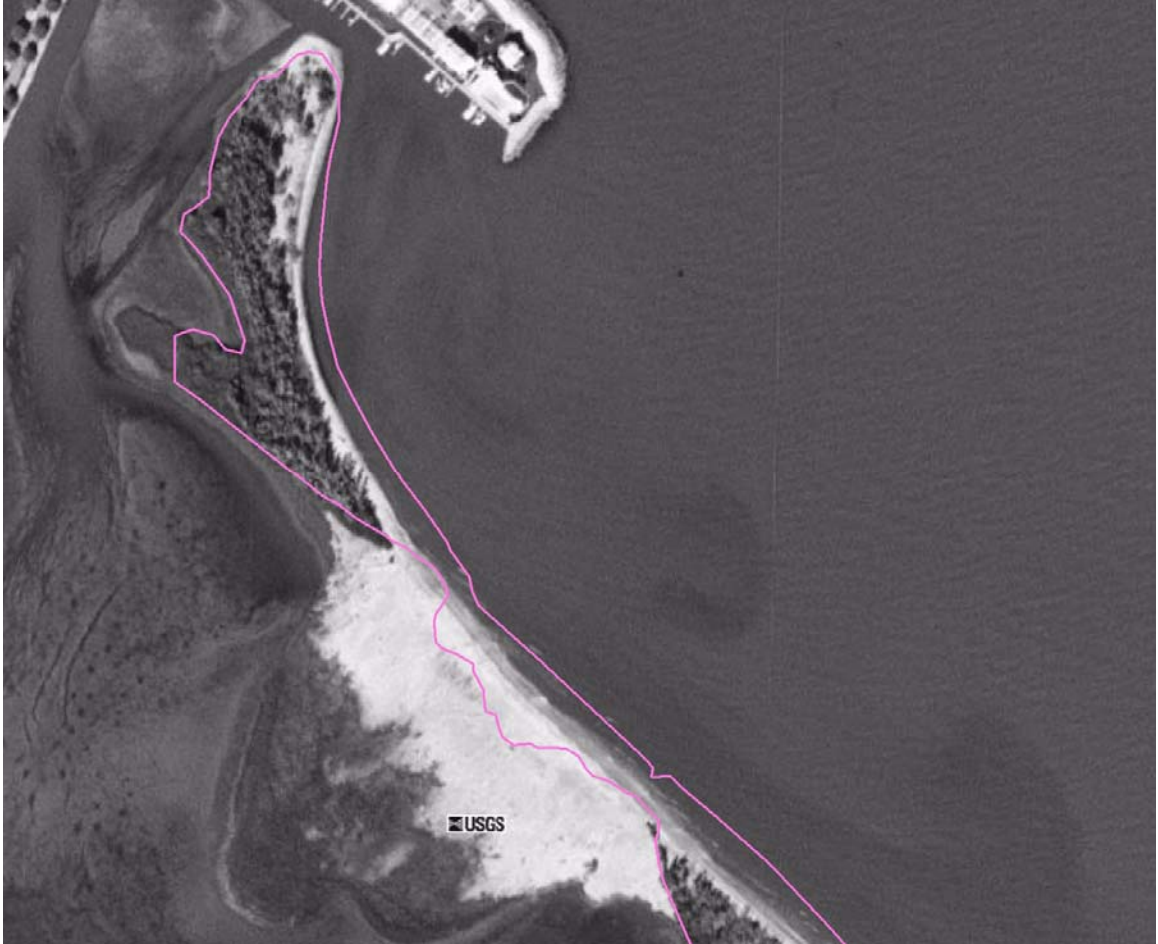
Figure 24. Sheldon Marsh, 10 October 2000. Washover near northwest end of barrier. Purple lines show outline of 1997 beach

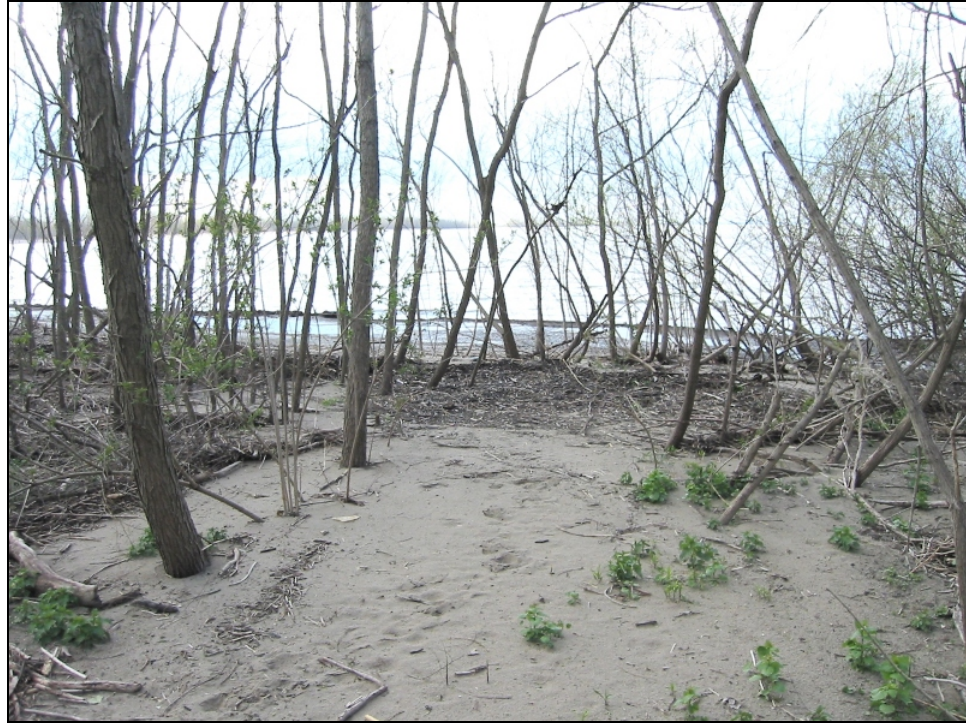
Figure 26. Overwash fans in woods on southeast end of barrier (27 April 2005)

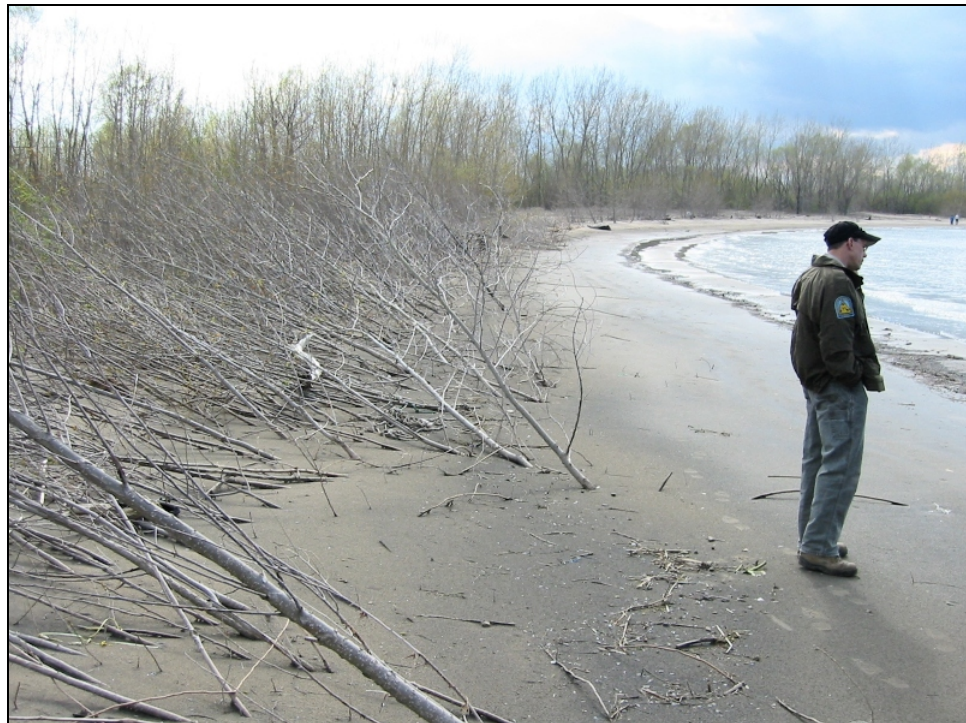
Figure 27. Trees damaged by storm waves (27 April 2005)

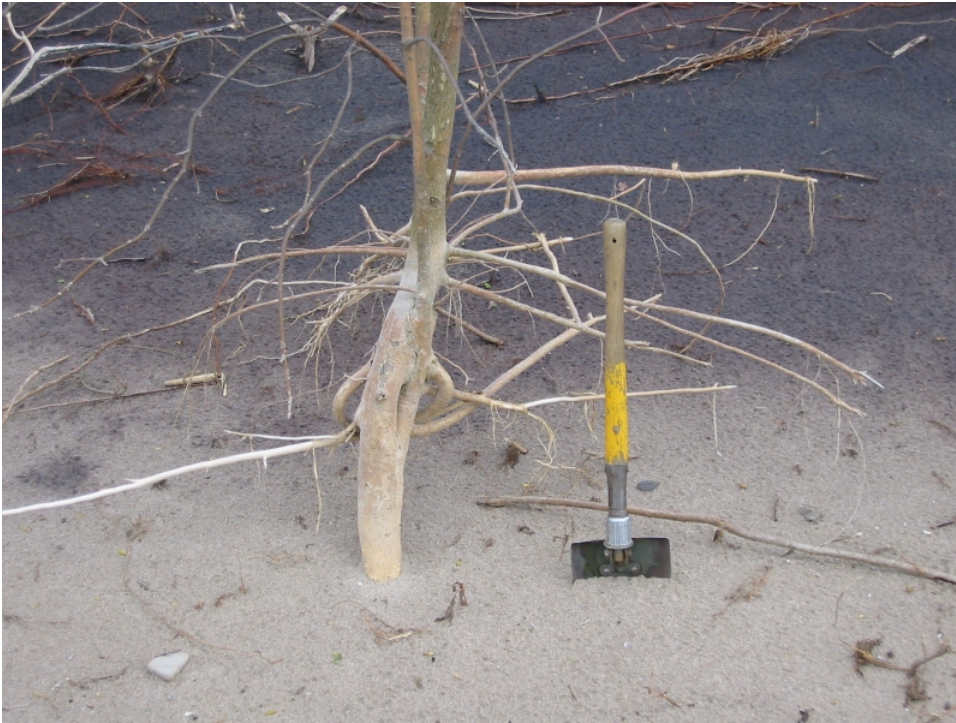
Figure 28. Horizontal roots that were formerly buried (27 April 2005)
